REPORT NUMBER: FHWA/AZ AZ88/227

# **POROUS PAVEMENT FOR CONTROL OF HIGHWAY RUNOFF**

## **First Annual Monitoring Report**

**July 1988**

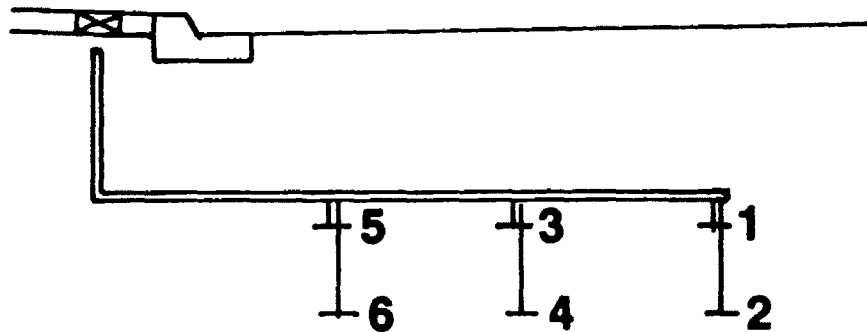
FIGURE 1. TYPICAL MOISTURE MONITOR POSITIONS

Moisture monitor gages located at Station 143+25 Lt indicate a fairly insignificant change in subgrade moisture except for gage 5. This gage is the upper gage nearest the curb and gutter (see Figure 1). Gage 5 indicated a moisture increase of 9.2% in the subgrade. This increase in moisture content is either a malfunction of the gage or is the result of some external source of water. A summary of the results of the moisture analysis is given in Table 3.

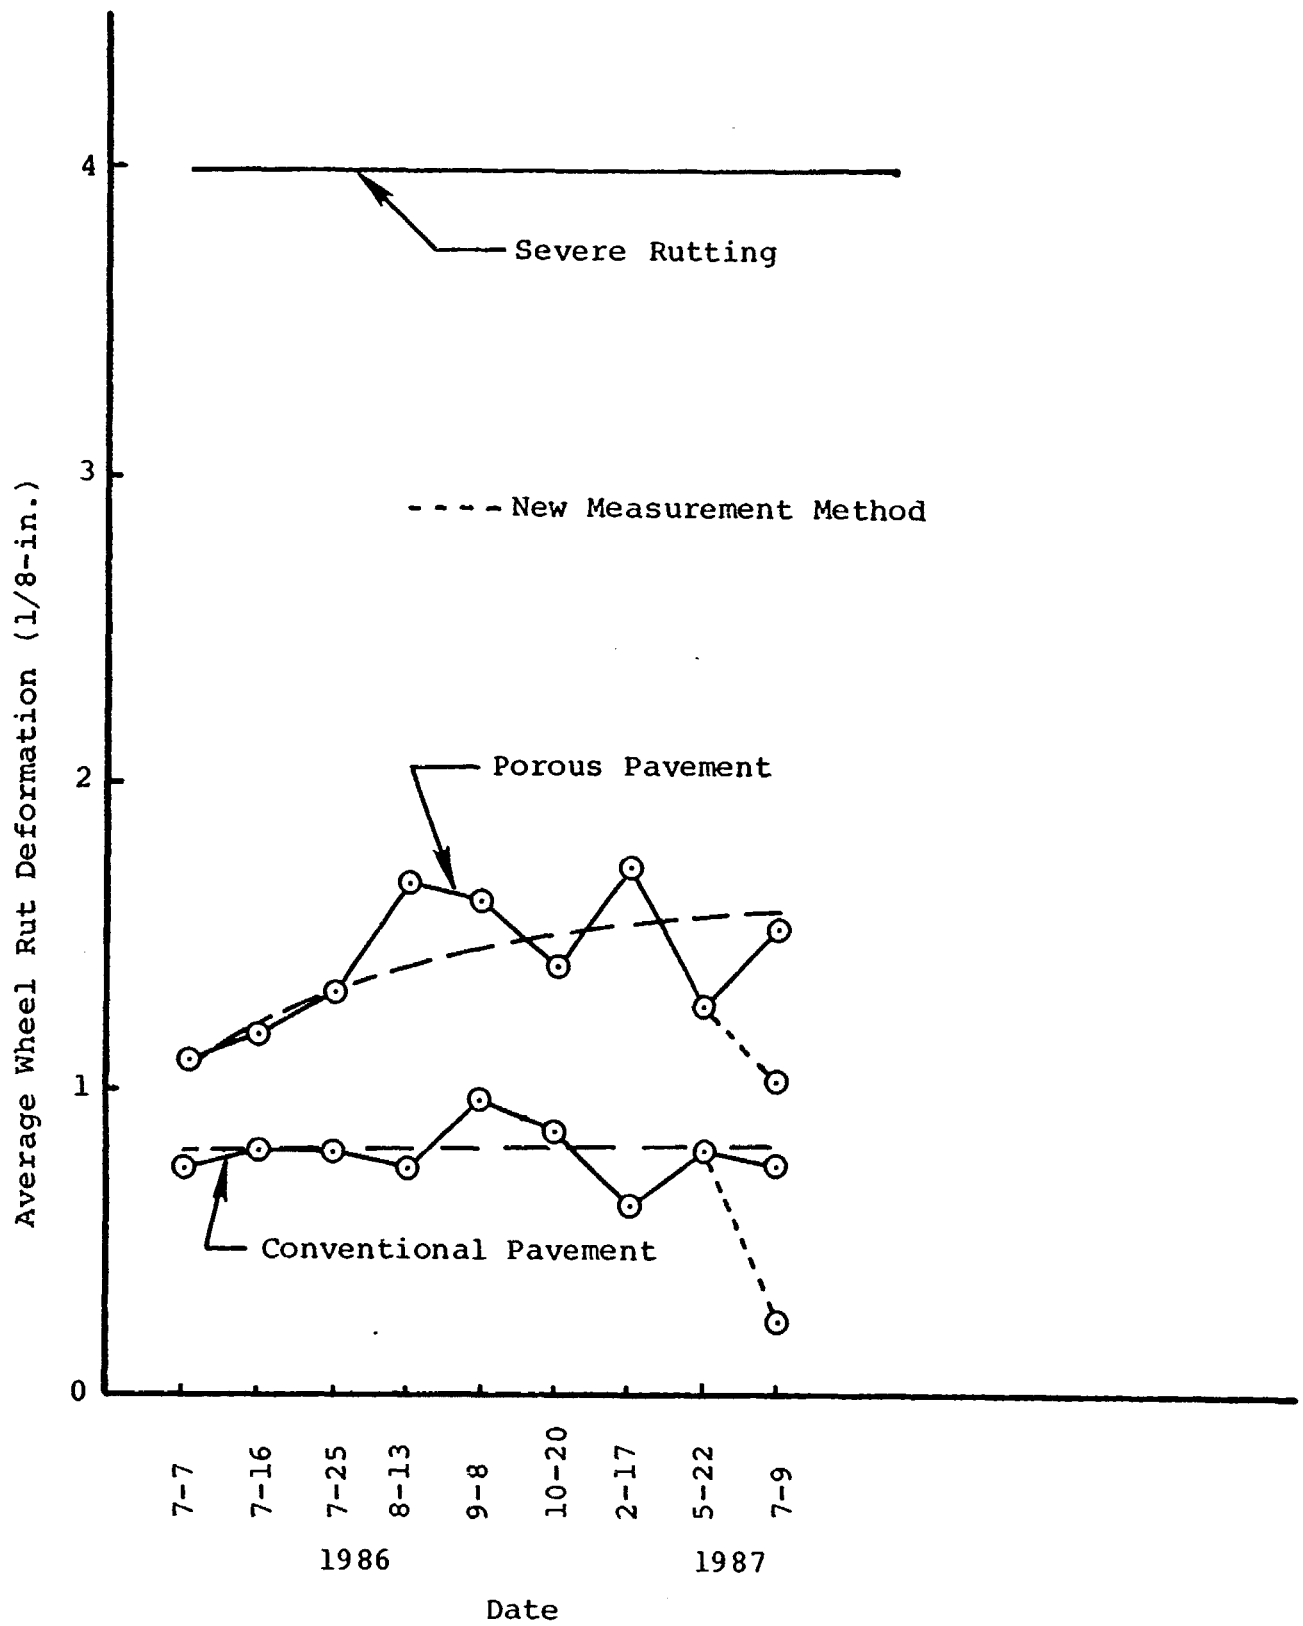
FIGURE 2. AVERAGE WHEEL RUT DEFORMATION

This change in reading method can be seen in the results given in Figure 2. Wheel rut deformation measurement data are given in Appendix B. Table 4 summarizes this data and Figure 2 graphically presents this information.

It was determined that the pavement at Station 138 had the largest amount of wheel rut deformation. The porous pavement exhibited average wheel rut deformations slightly over  $3/16$  in., while the conventional pavement measured slightly under  $1/8$  in. Table 5 summarizes the wheel rut deformation measurements. The largest measured wheel rut deformation using the stepped gage block or scale was one-half inch. This measurement was observed at Station 108 lane 2, Station 113 lane 3, Station 118 lane 3 and Station 138 lane 3. Figure 3, 4 and 5 illustrate the porous pavement deformations by lane and wheel path. The porous pavement section continued to increase in wheel rut deformations for a short period of time after opening to traffic and then stabilized with little further increase. This early increase in the wheel rut deformations in the porous pavement section is suspected to be caused by the additional recompaction of the untreated subbase by traffic. The conventional pavement underwent some deformation early after completion with little or no subsequent change. Wheel track rutting is not severe in either pavement type. Figures 6, 7 and 8 illustrate the conventional pavement deformations by lane and wheel path. Appendix C and D also summarizes this data.

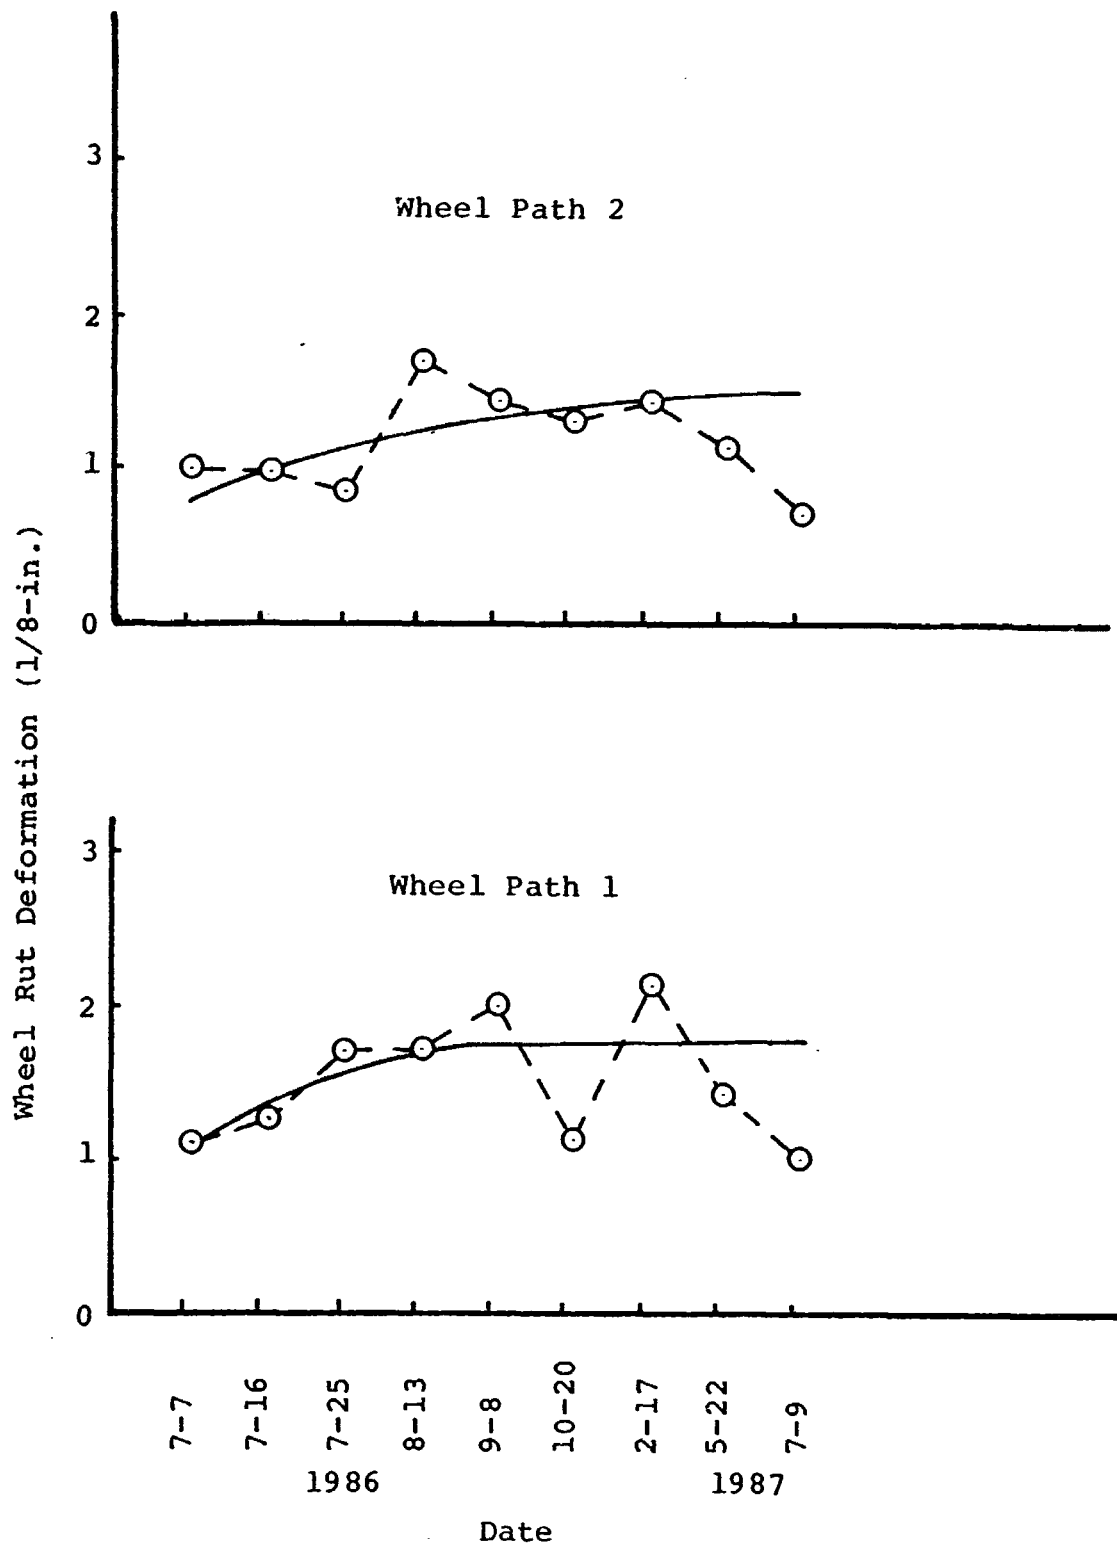
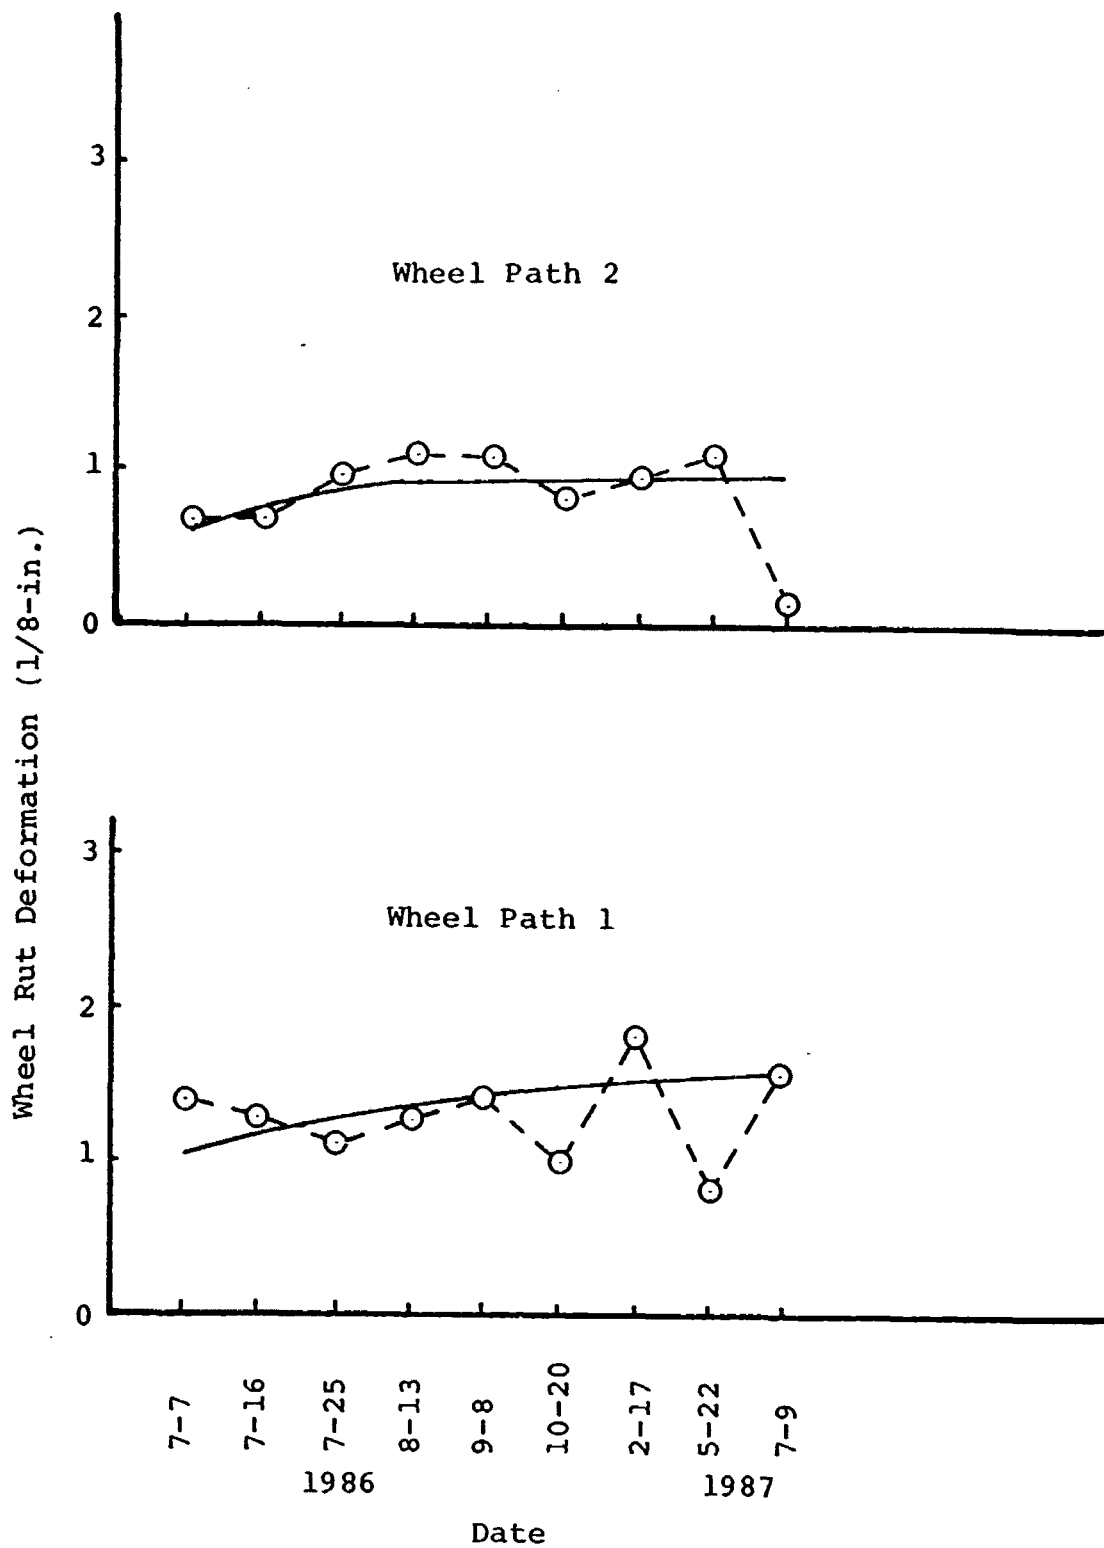
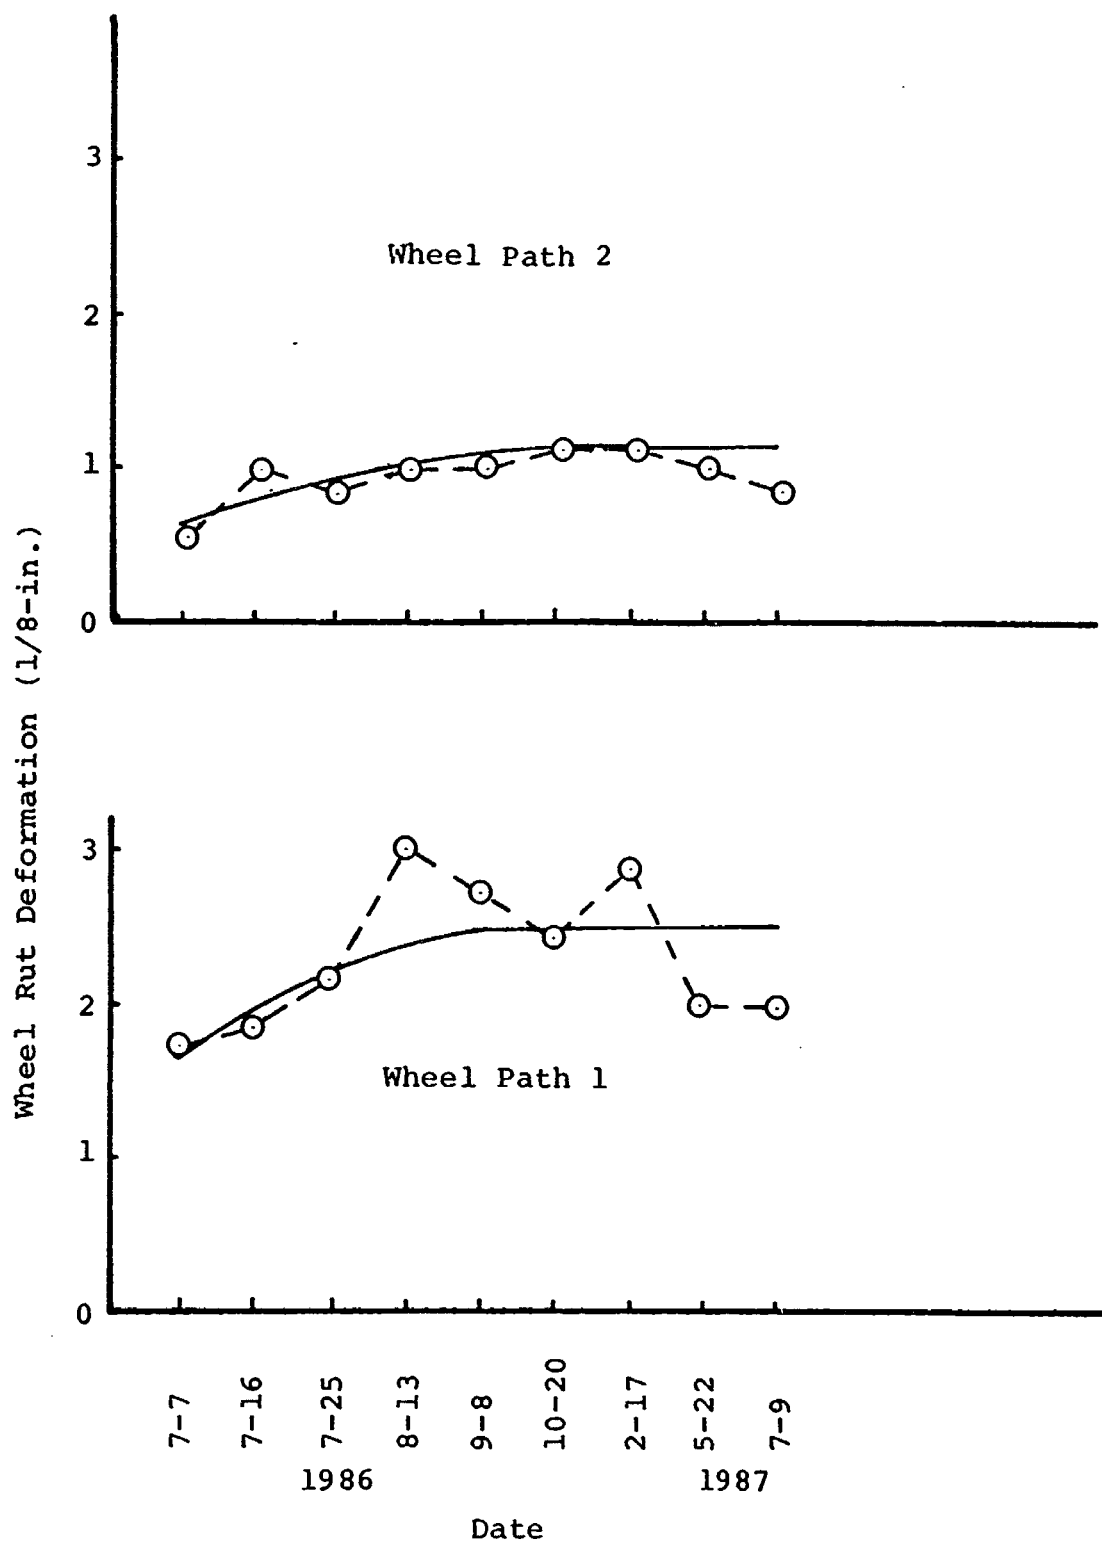
Wheel rut deformation measurements were evaluated by traffic lane and wheel path. It was found that lane 3 (next to median) in the porous pavement section had the greatest amount of deformation. Lane 2 had the greatest deformation in the conventional pavement section. The east wheel path in lane 3 of the porous pavement had the most deformation when compared to all other wheel paths. Table 5 summarizes the above information. The deformation location in lane 3 may be the result of the construction sequence for the porous pavement section.

Lanes 1 and 2 were first constructed and opened to traffic for approximately three weeks before lane 3 was placed. Therefore, the open-graded aggregate subbase was most likely recompactd by traffic in these lanes while lane 3 did not benefit from this construction sequence with the recompacting occurring following opening to traffic.

Appendix C and Figures 3, 4 and 5 outline information on each lane and wheel path in the porous pavement section. The average wheel path deformation for the porous pavement is slightly over  $3/16$  in. Appendix D and Figures 6, 7 and 8 outline information on each lane and wheel path in the conventional pavement section. The average wheel path deformation for the conventional pavement is slightly under  $1/8$  in.

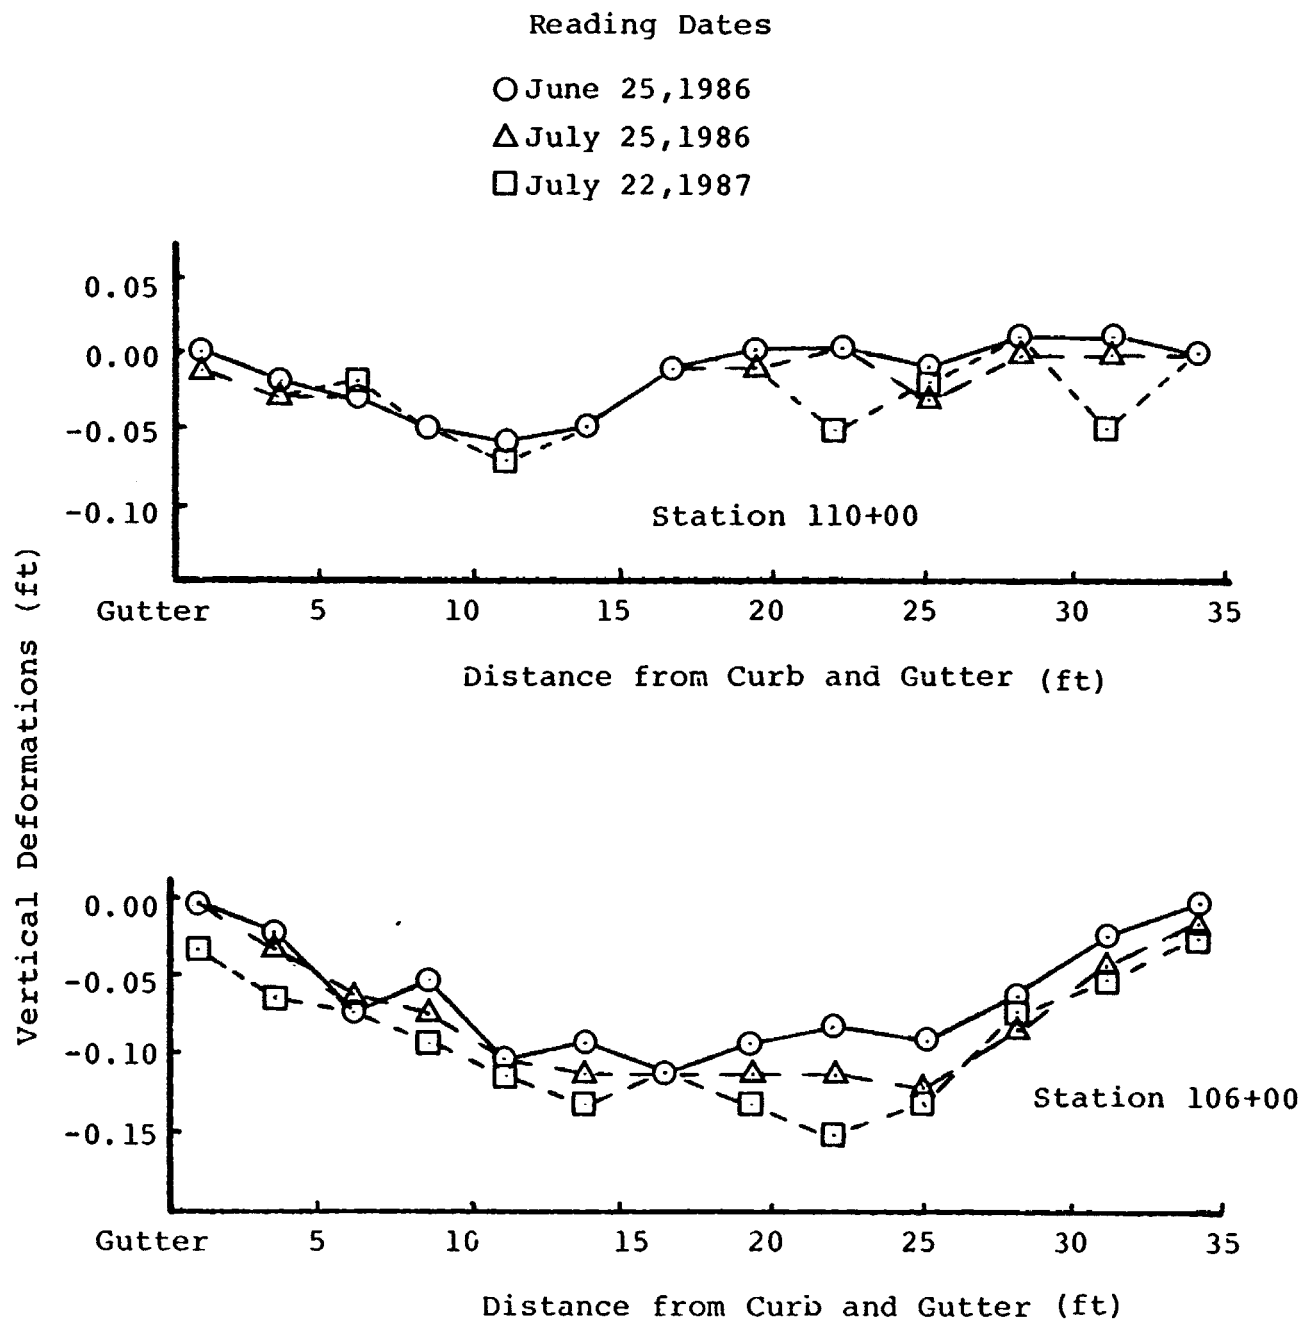
FIGURE 9. VERTICAL DEFORMATIONS  
STA 106 AND 110

Station 110, lane 3 (31 ft from curb and gutter), exhibited a 0.06 ft or 0.72 in. change in vertical deformation which was the largest at the site. Most vertical deformation graphs exhibited three distinct slopes which would relate to the three passes made by the paving machine. Since the median was constructed after construction of lanes 1 and 2 but before lane 3, a break in the cross slope often exists at lane 3. Deformation readings taken at Station 135, lane 3, were not used because the P.K. nails were paved over to correct for a cross slope problem. An increase in pavement deformation can be seen at Station 106, while other stations show relatively no change in the pavement cross section.

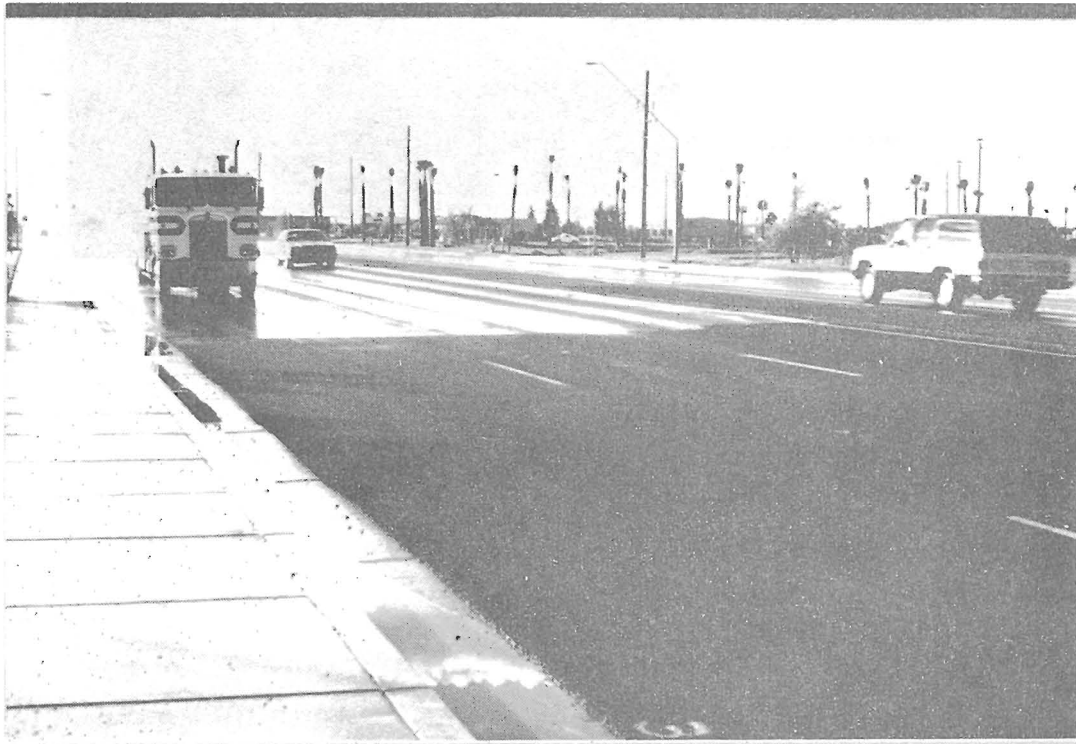
FIGURE 13. CONVENTIONAL AND POROUS PAVEMENT  
SHORTLY AFTER RAINSTORM

The surface of both pavements has been observed during rainstorms on October 9, 10, and 11, 1986. It was visually observed that the surface of the porous pavement, although wet, did not have any standing or excess water on its surface. The surface of the conventional pavement section was also wet, but sheets of water could be seen on the surface along with water flowing in the

curbs. Slides and video tapes of those conditions were made during a rainstorm on February 24, 1987, by Western Technologies Inc. showing that the porous pavement section was functioning properly. A typical condition of the two pavement surfaces after a rainstorm is presented in Figure 13.
