Arizona Department of Transportation Research Center

# **Performance Evaluation of Arizona's LTPP SPS-3 Project: Strategic Study of Maintenance Procedure Effectiveness for Flexible Pavements**

**SPR-396-3**

**August 2017**

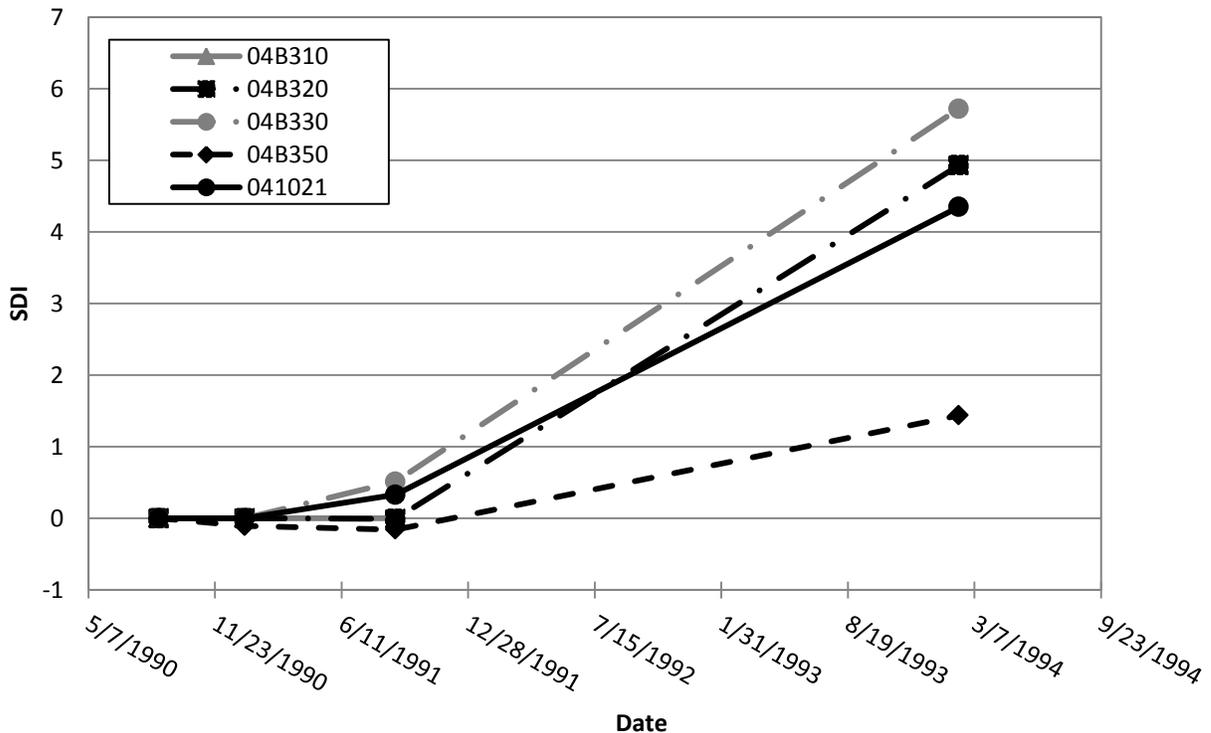
Figure 5. Structural Damage Index Trends for 04B300 Sections

It can be seen from Figure 5 that the thin overlay section did not exhibit any structural damage, but there were no distress measurements after 1991. Performance comparisons between this section and the other four are therefore based on the early measurements. The control section received pothole patching in 1991 and 1994, while the slurry seal and chip seal sections both received pothole patching in 1993. It is therefore important to note that the crack seal section, the worst performing of the five, was the only section to not receive pothole patching. From the three figures, it can be seen that environmental distress decreased over time for most sections, whereas structural distress and rutting both increased. At the B site, some environmental damage (i.e., longitudinal non-wheelpath cracking) was subsequently labeled as fatigue cracking as time and the distress progressed.

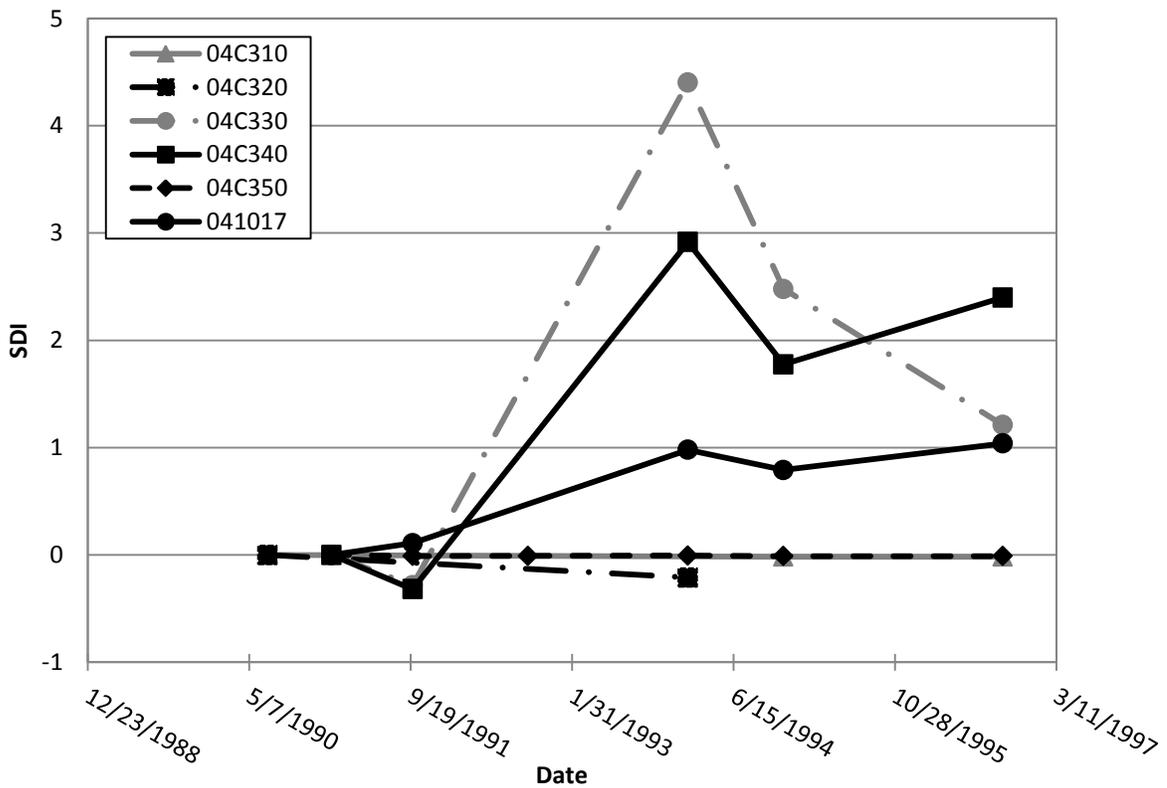
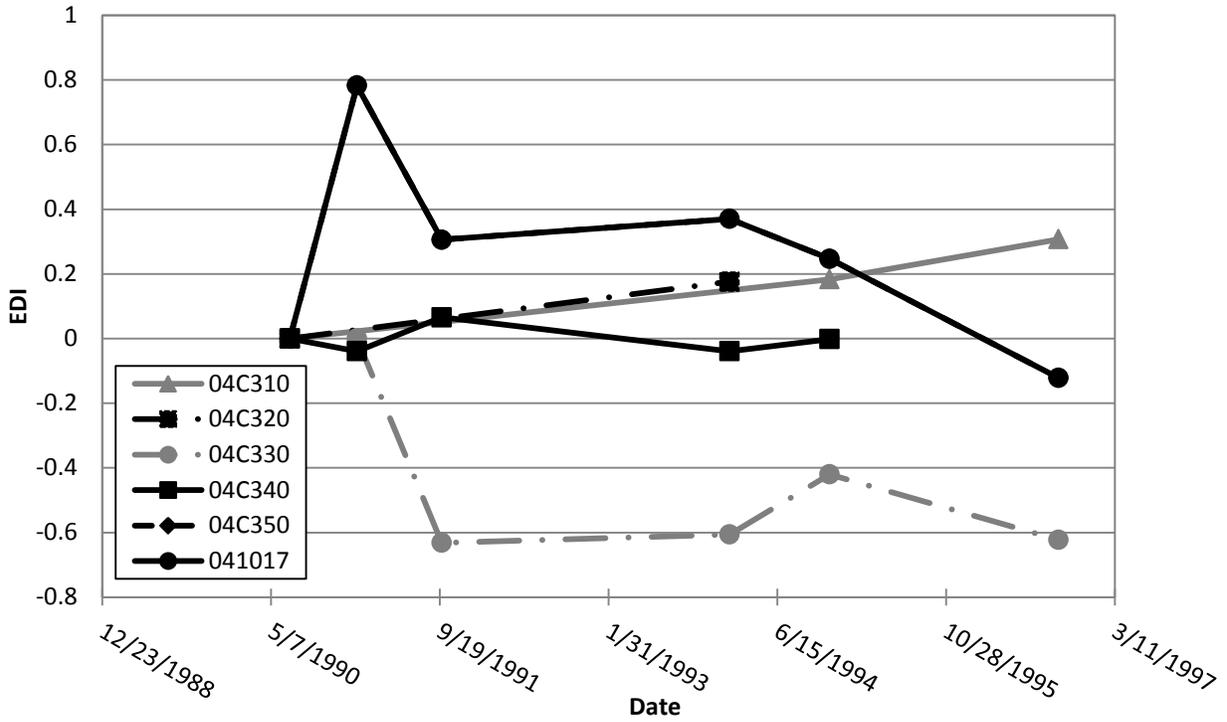
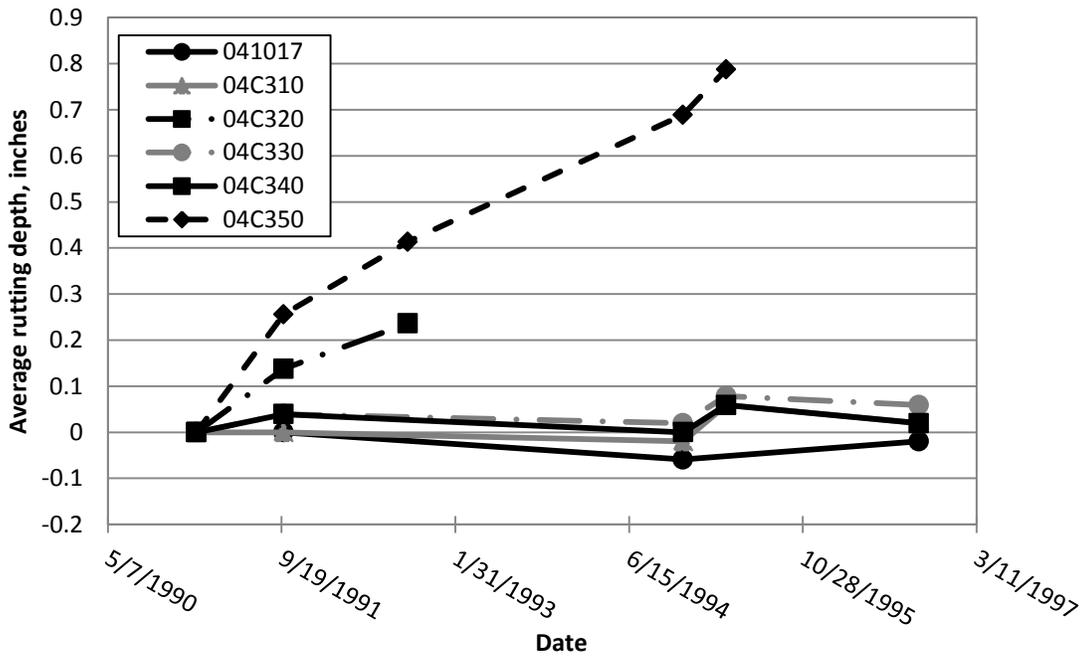
The most unusual trend seen in Figures 8 to 10 is the improving performance of the crack seal treatment between 1994 and 1996. It was documented that the crack seal section received pothole patching in 1993; however, some preventive maintenance treatment also appears to have been applied at this time, since all the distress data (SDI, EDI, and rutting) for the crack seal section decrease from 1994 to 1996.

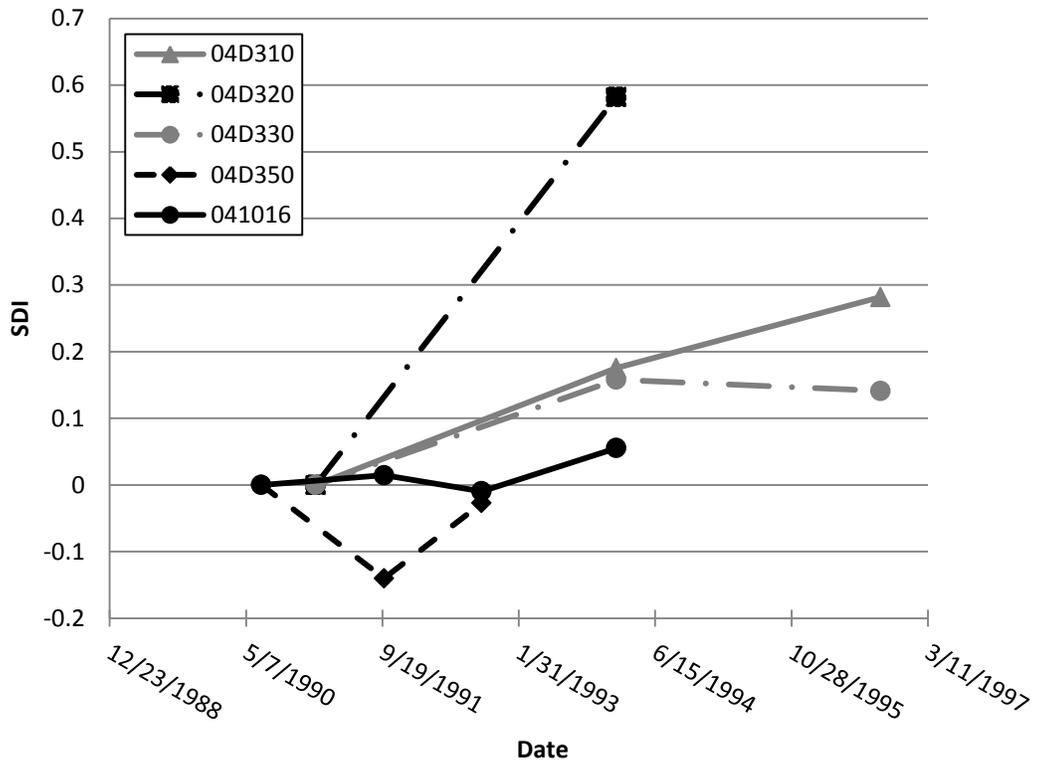
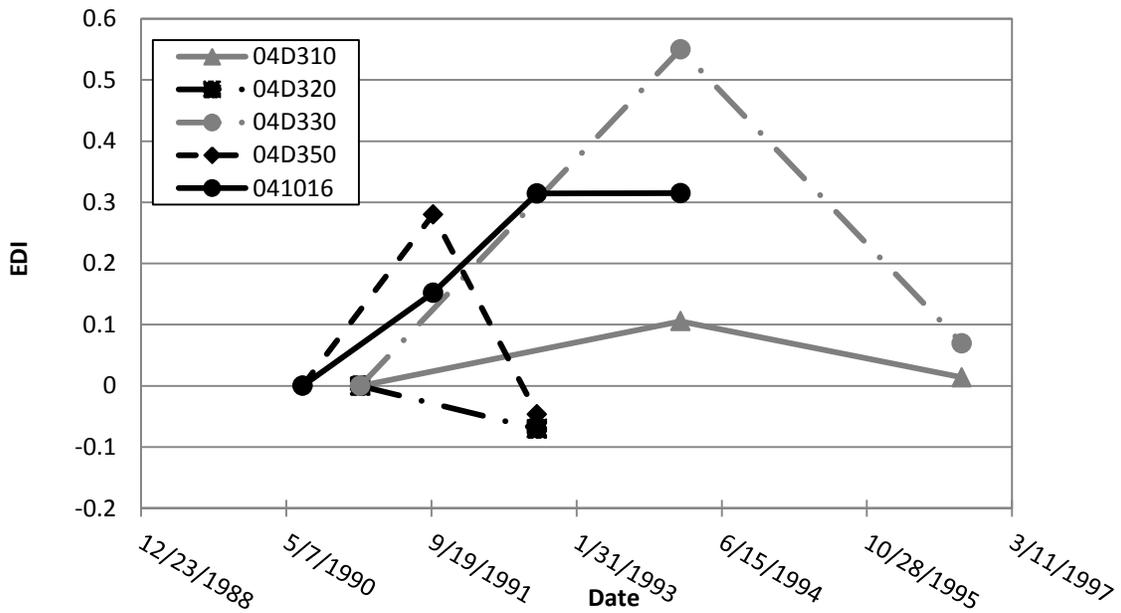
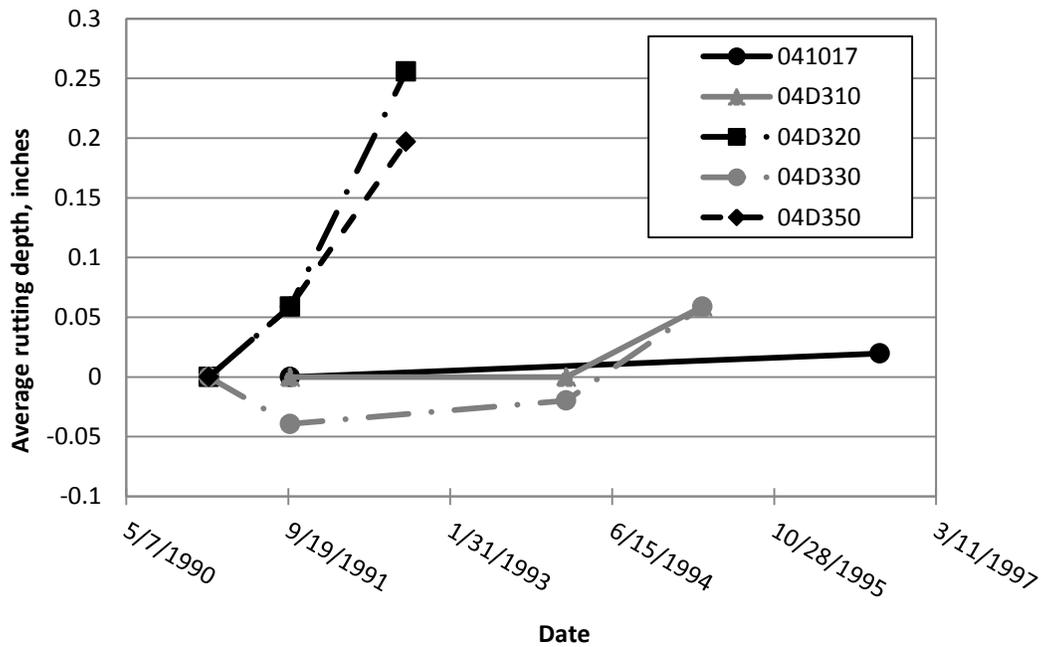
The 04D300 sections furnished less time series data than the other three projects because fewer manual distress surveys were completed for them, and the data were extremely limited for the slurry seal and chip seal sections. However, several trends still emerged that are summarized in Table 11. It should be noted that the slurry seal section received pothole patching in 1993, while the crack seal section received additional crack sealing in 1995. While performance trends revealed by the three types of distress data are inconsistent, the slurry seal section appears to have been the worst performer of all the sections.

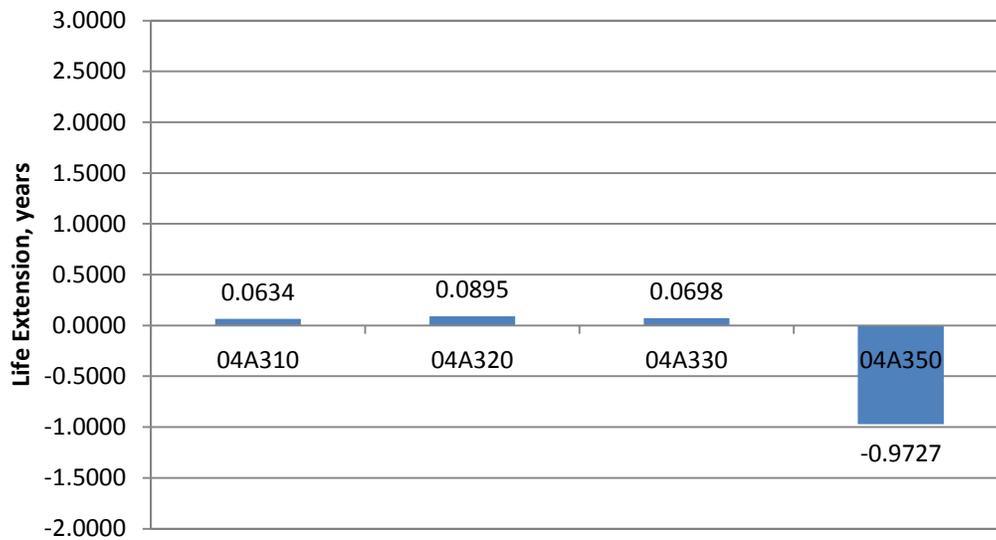
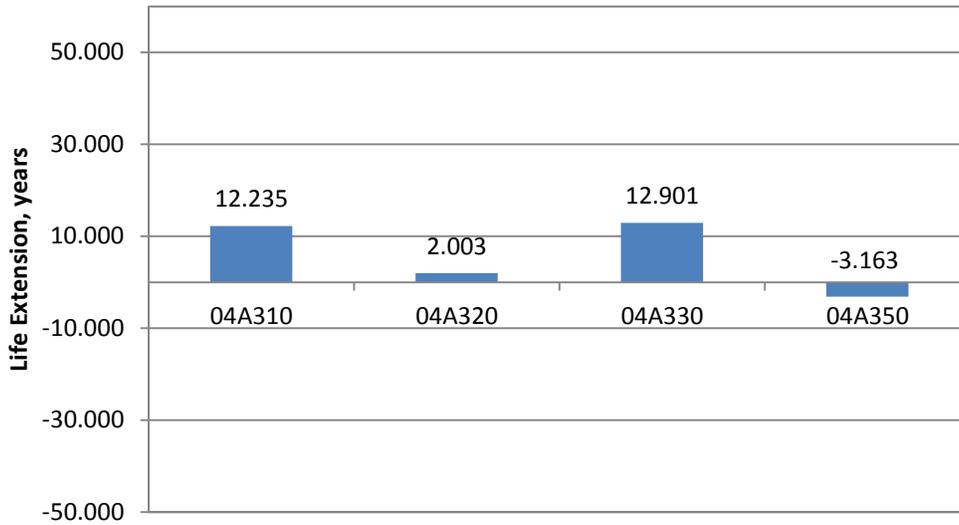
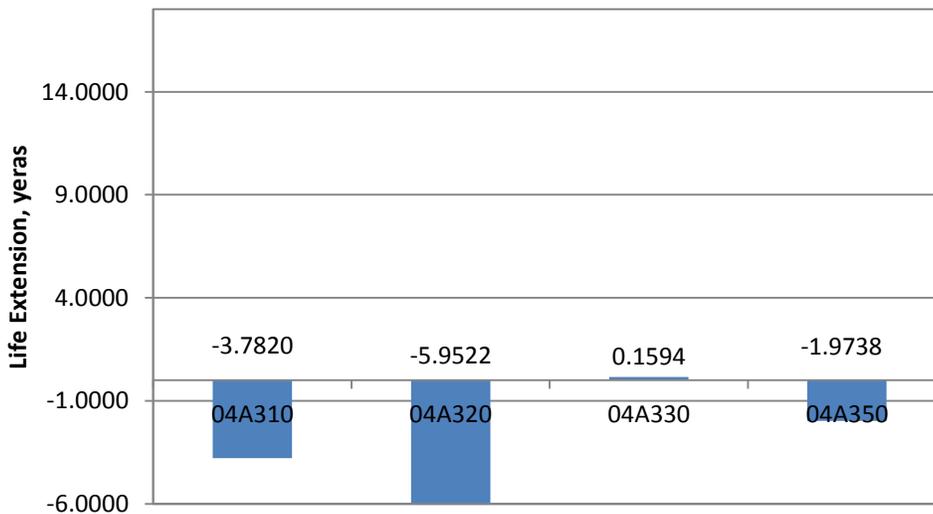
Table 17 summarizes the performance rankings from the figures above. The results appear to be quite inconsistent. The crack seal produced the longest life extension of the preventive maintenance treatments, and the chip seal performed the worst. This is logical because most of the chip seal wore away soon after it was placed.

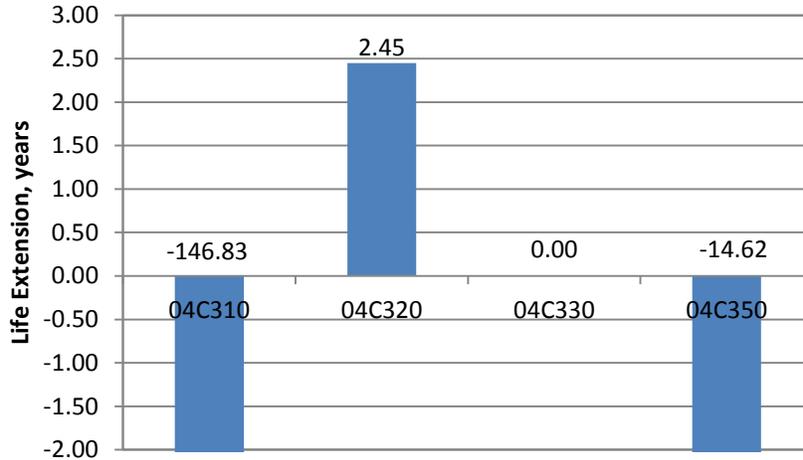
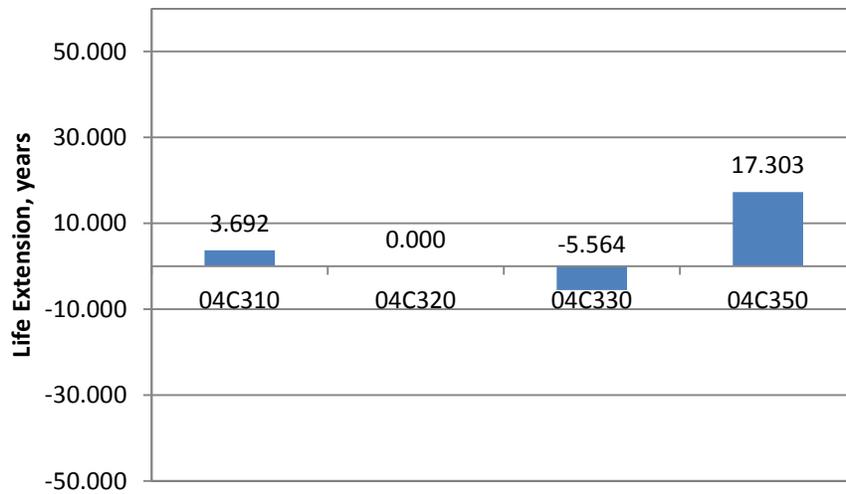
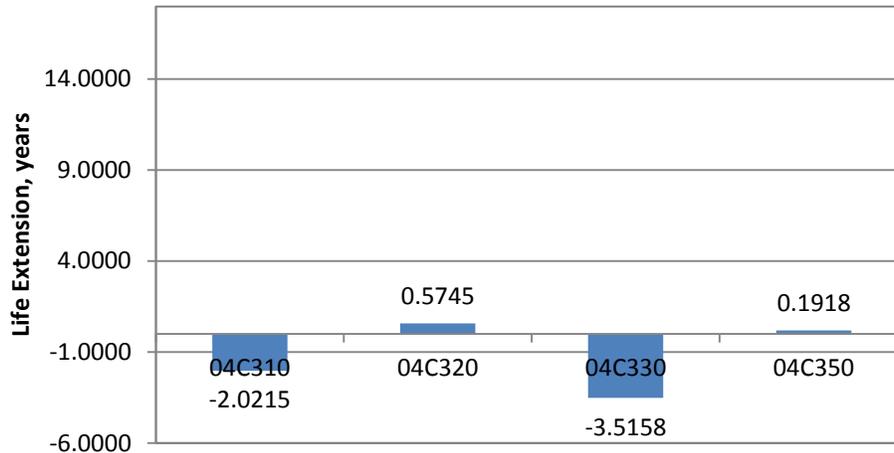
Table 19 summarizes the performance of the 04C300 sections. It can be seen that drawing conclusions between the three measurement methods is difficult; however, the crack seal generally exhibited the worst performance.

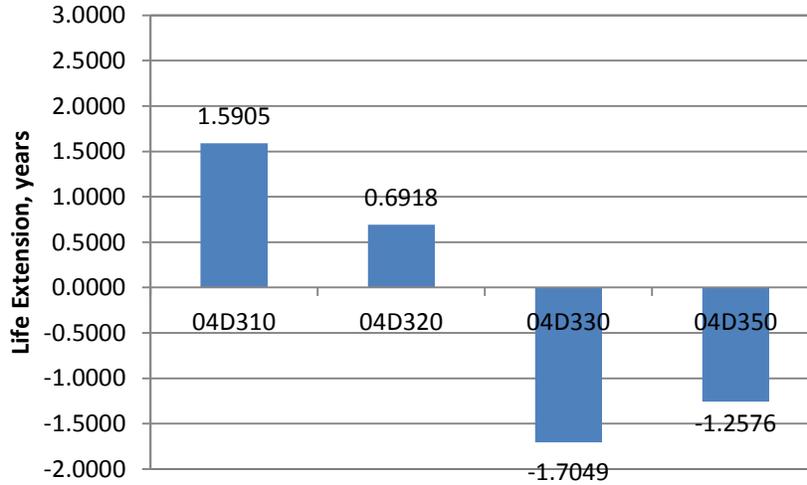
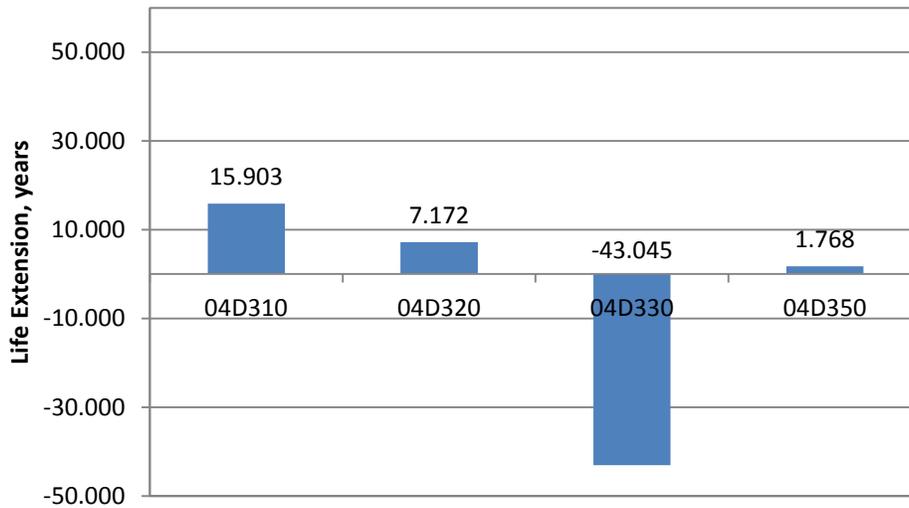
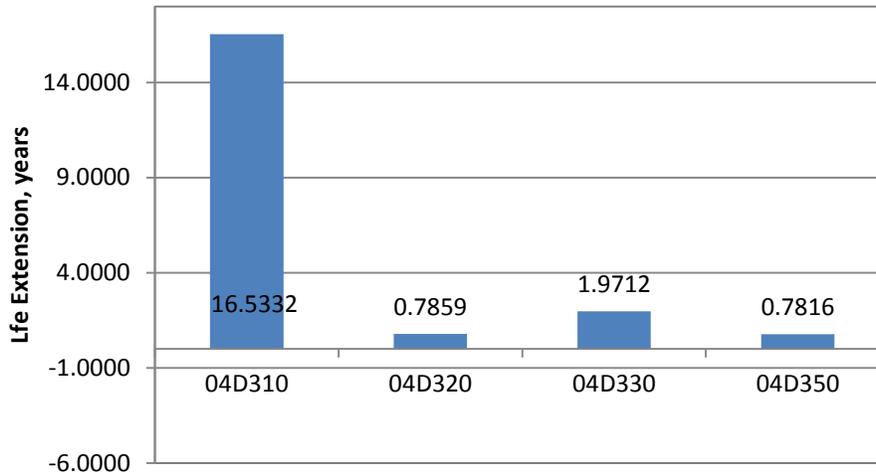
The plots from the 04D300 sections are summarized in Table 20. It can be seen that the trends are very consistent. Across all three measures, the thin overlay provided the longest life extension. Generally, the slurry seal contributed the second-longest life extension, followed by the chip seal. Finally, the crack seal section exhibited the shortest life extension of the 04D300 test sections.
