Salt River Pima-Maricopa Indian Community

Transportation Asset and Pavement
Assessment Study

Technical Memorandum

October 11, 2018

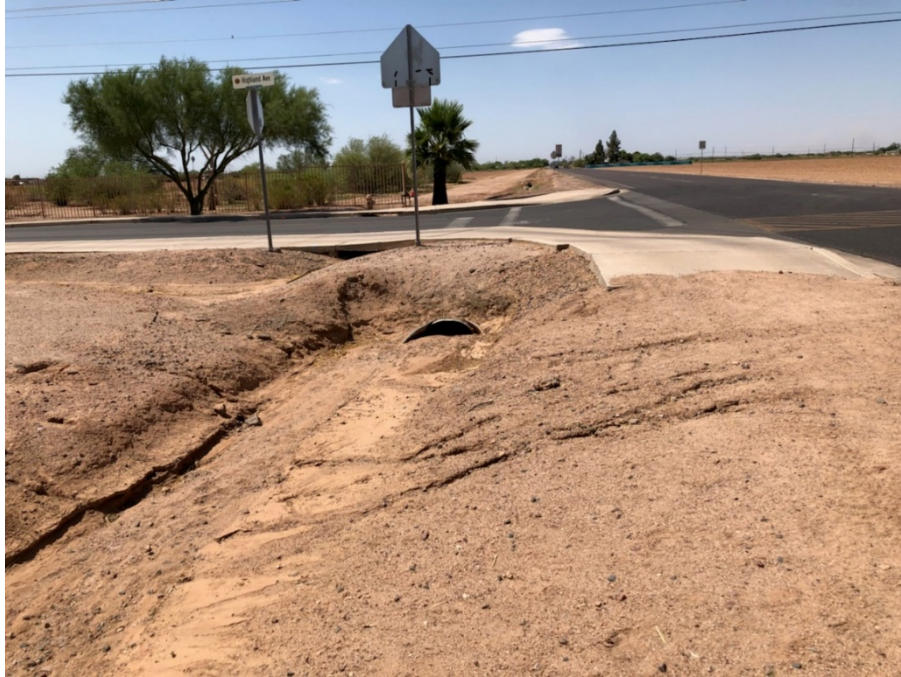
The vast majority of existing land use within the project limits is defined as agricultural. Cross culverts convey irrigation water, received from the Arizona Canal, beneath roadway intersections to the local agricultural fields. Field survey indicates the majority of these cross culverts are 2-ft diameter Corrugated Metal Pipe (CMP). Most of these cross culverts are in fair condition with only a handful being in poor condition. Poor condition structures consist of deformed or sediment laden culverts in which the conveyance capacity is severely limited. An example of a poor condition cross culvert include the cross culvert located at the intersection of Country Club Dr. and Highland Ave (on the northeast corner of the entrance to the Salt River High School and Salt River Elementary School), reference Figure 1. Sediment has nearly buried the inlet side of the pipe which

is severely limiting its drainage capacity. As a result of the damage, the culvert's ability to convey storm water flows is severely limited.

Figure 1. Cross culvert in poor condition due to sediment loading.

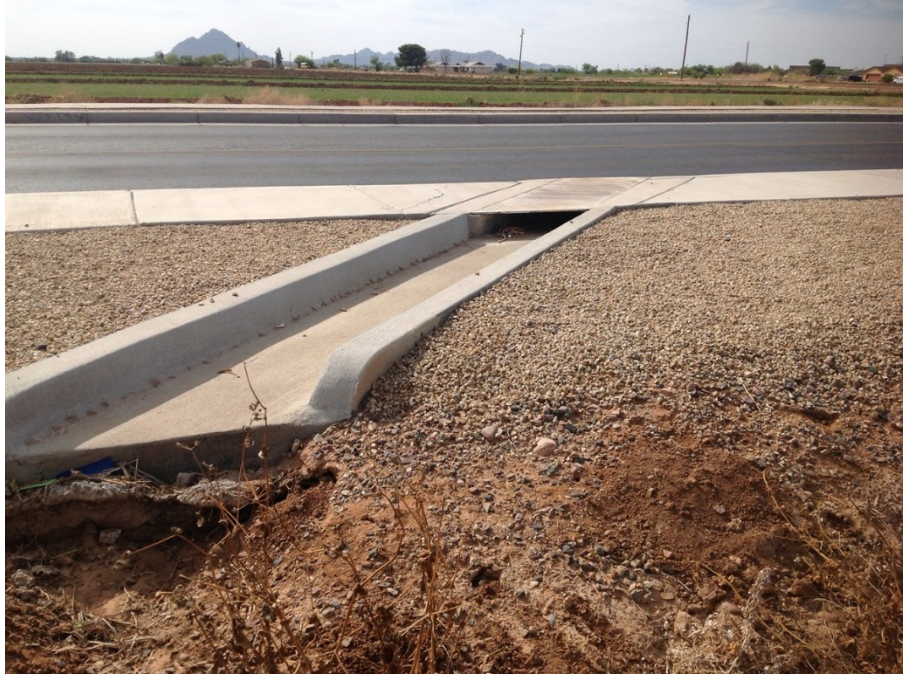
Figure 2. Curb inlet and concrete scupper along Center Street.

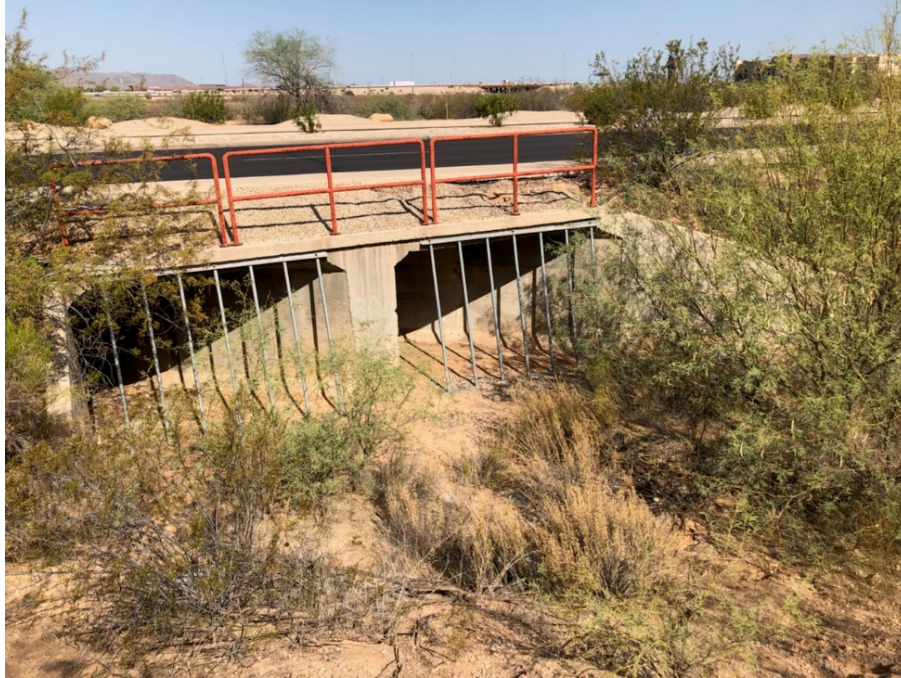
In addition to curb inlets, there are several large box culverts along Dobson Rd between Via de Ventura and Indian Bend Rd (see Figure 3) which convey offsite runoff from undeveloped land and drain to a 9-ft diameter RCP which runs north to south underneath Dobson Rd. The ultimate outfall of the large diameter RCP was undetermined through the field visit and desktop review.

Figure 3. Dual cell RCBCs (7-ft x 8-ft) along Dobson Rd.

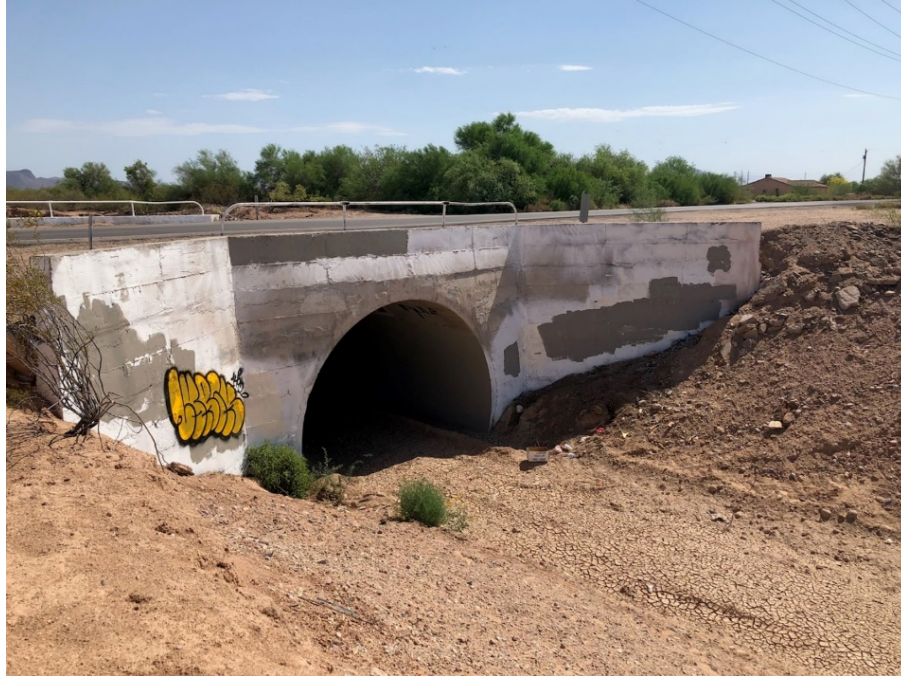
A 21-ft diameter culvert beneath Indian School Rd between Mesa Drive and 126th Street, conveys both local drainages as well overflows from the Arizona Canal located to the north. See Figure 4 and Figure 5.

Figure 4. Single cell 21-ft at Indian School Rd.

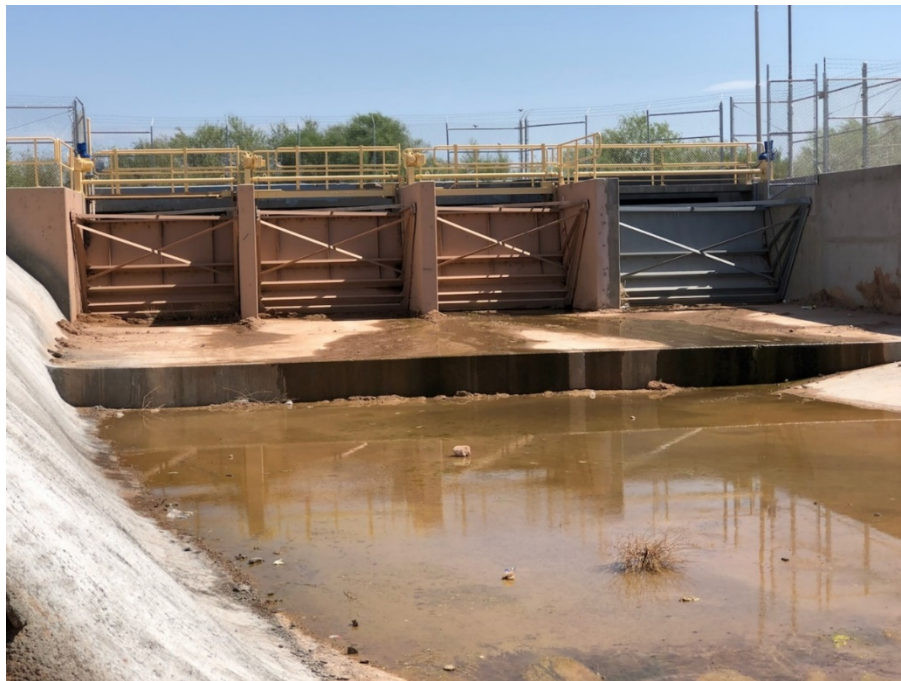
Figure 5. Arizona Canal overflow gates

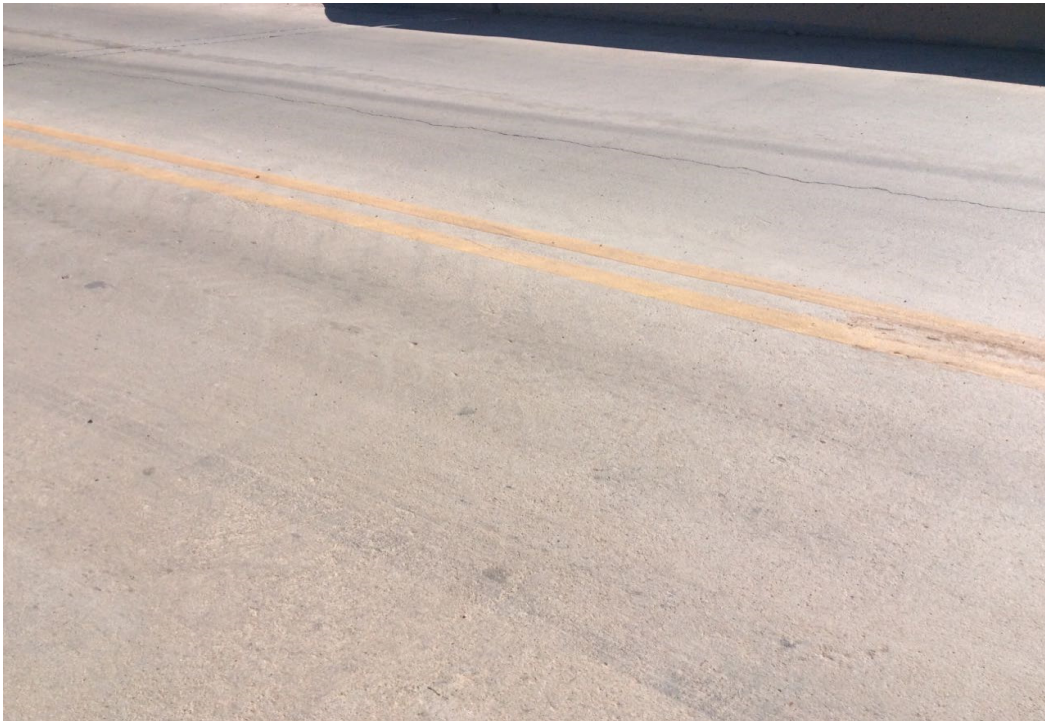
Photo 5

Typical Top of Deck

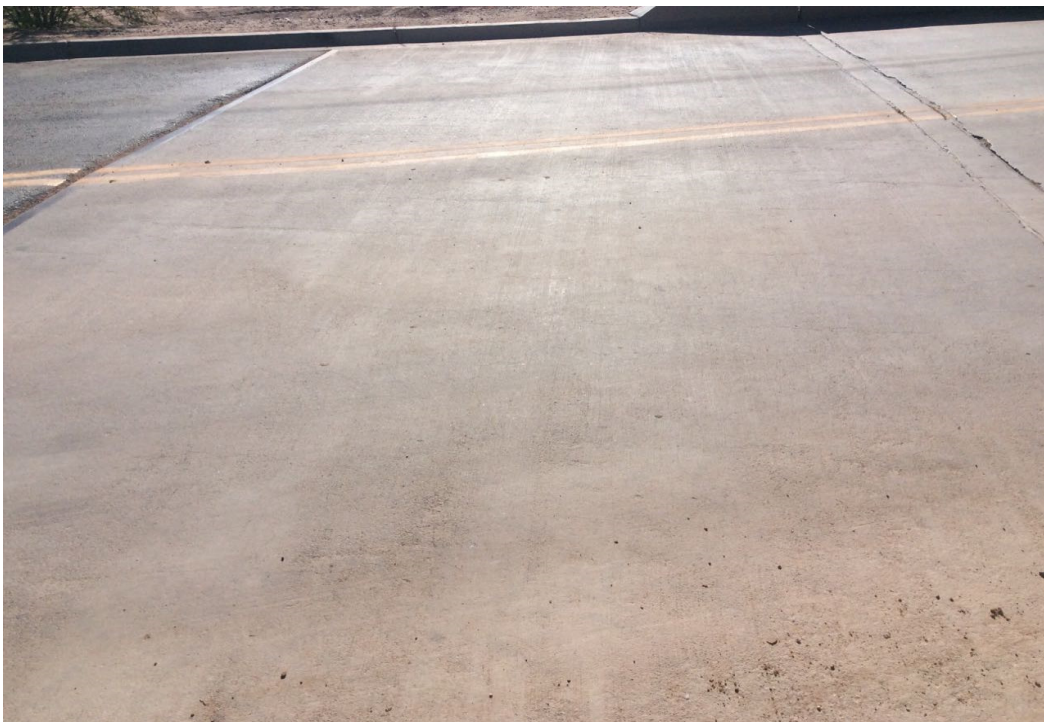
Photo 8

1. Approach slabs have random cracks that are up to 0.035 inches wide.
- 2.
- 3.
- 4.
- 5.

Typical Approach Slab (North slab shown)

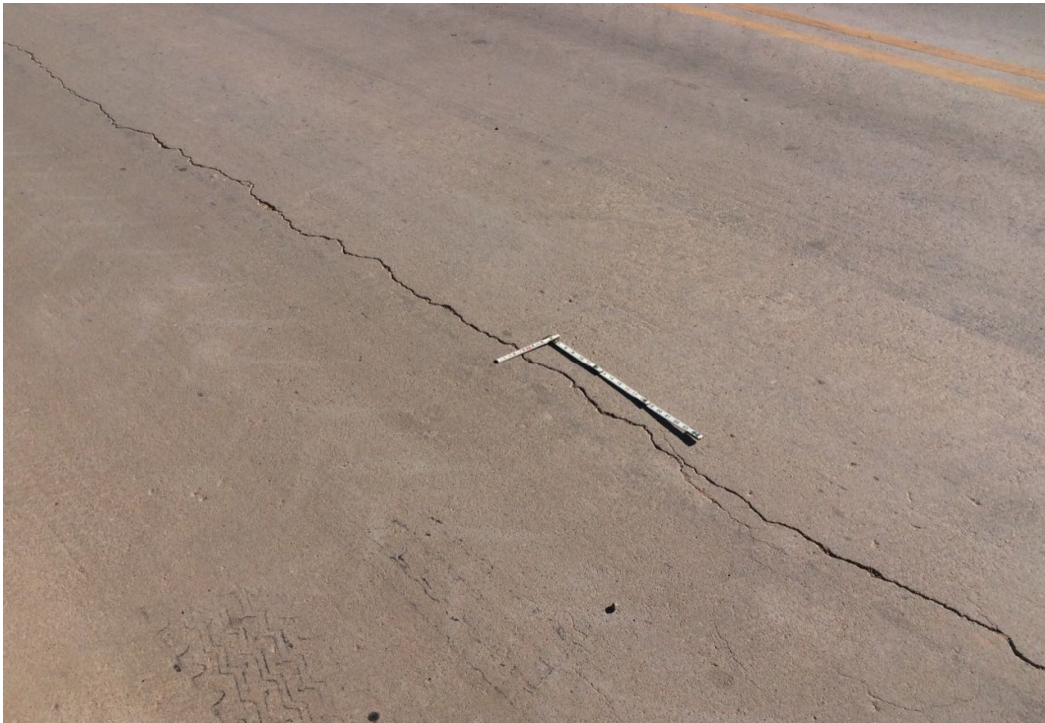
Photo 9

1. Bridge deck has 3 full length longitudinal cracks that are up to 0.06 inches wide. Cracks have the same spacing as the girders.
2. Bridge deck has random cracking that measure up to 0.01 inches wide.
- 3.
- 4.
- 5.

Full length longitudinal cracks in bridge deck

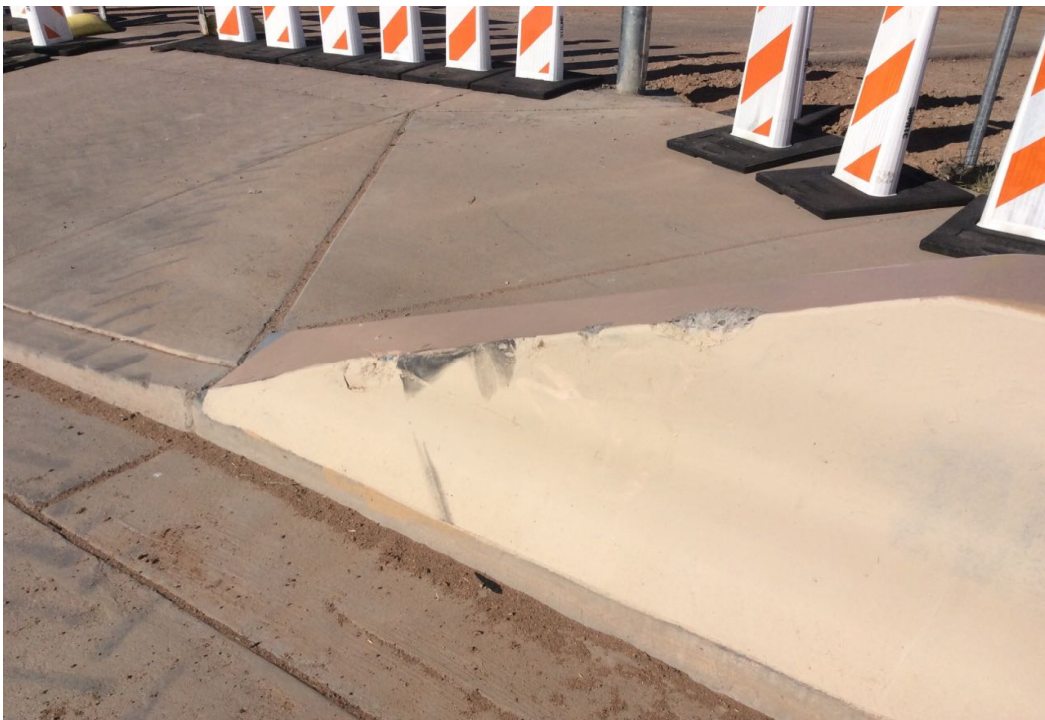
Photo 10

South West corner, impact damage to concrete barrier

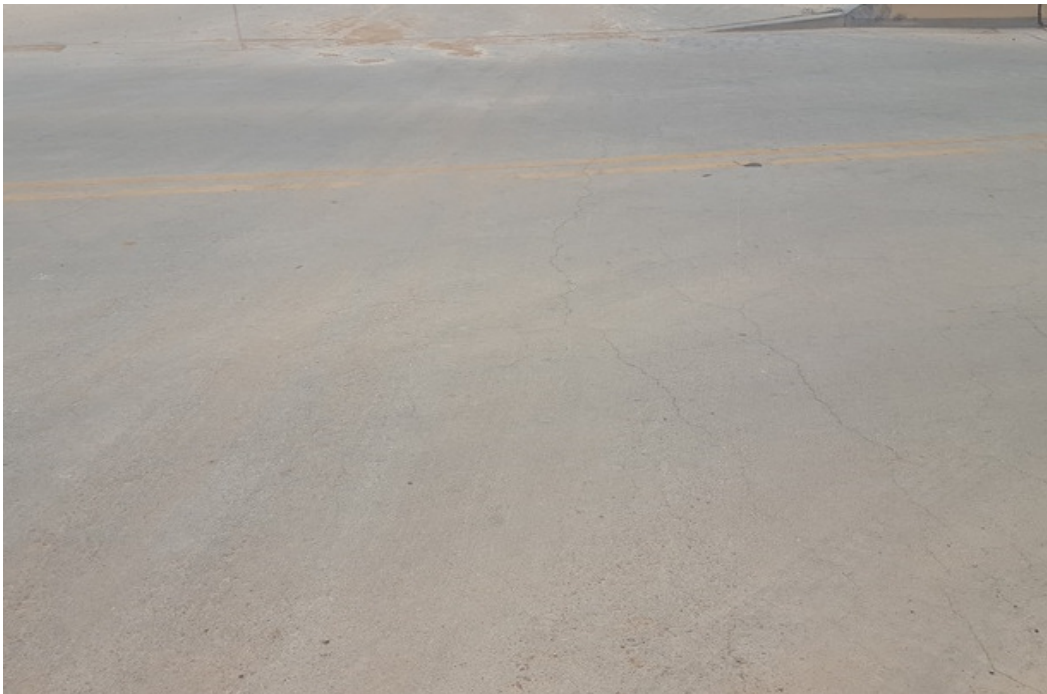
Photo 8

1. Approach slabs have random cracks that are up to 0.035 inches wide.
- 2.
- 3.
- 4.
- 5.

Typical Approach Slab (North slab shown)

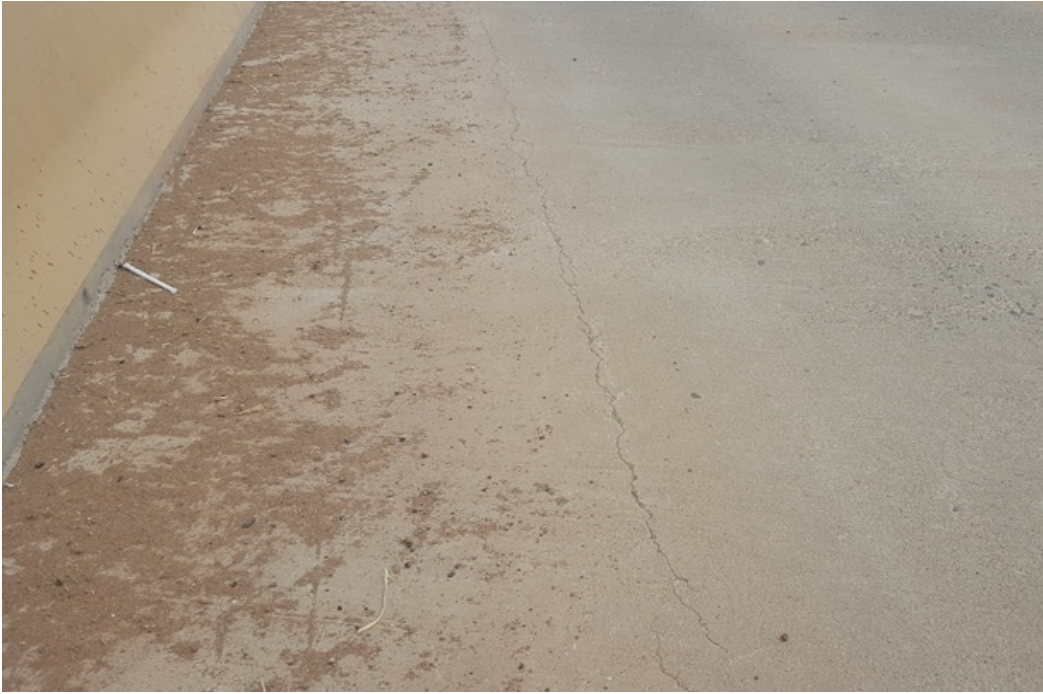
Photo 9

1. Bridge deck has random cracking.
2. Bridge deck has one full length longitudinal crack that is up to 0.06 inches wide, see photo 9.
There are also two other similar longitudinal cracks that are 2/3 of the bridge length and are up to 0.05 inches wide.
- 3.
- 4.
- 5.

Full length longitudinal cracks in bridge deck

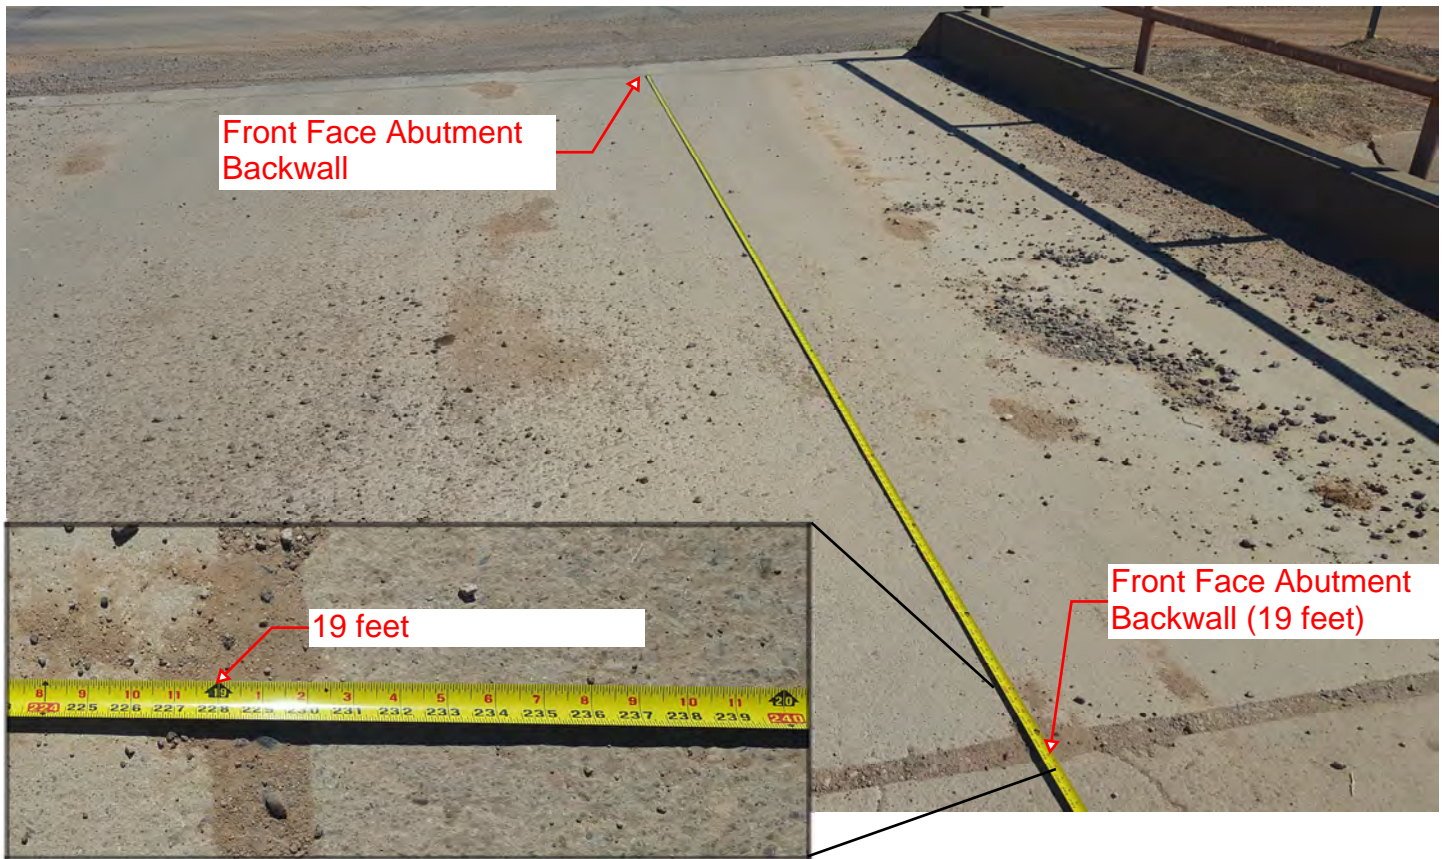
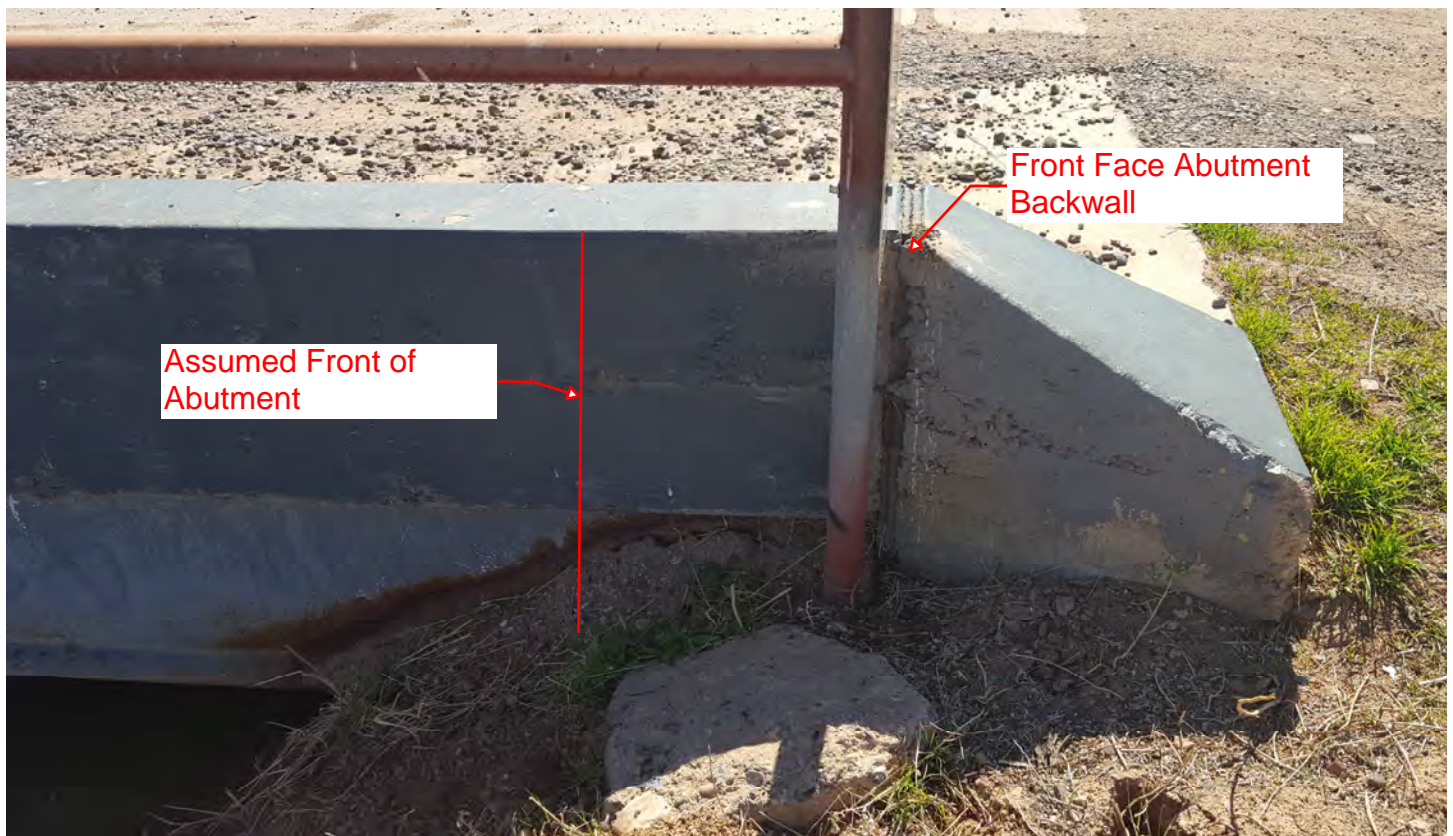
H127 Montebello Ave and Dobson

Measurement from Front Face Abutment Backwall (FFAB) to Front Face Abutment Backwall is 19 feet. There is a bearing seat that the steel beams were set on, and is now covered with dirt and debris. T Since the measured distance from FFAB to FFAB is 19 feet then the opening (undercropping of abutment) would be less that 19 feet and this structure does not meet the NBIS Bridge Length definition.

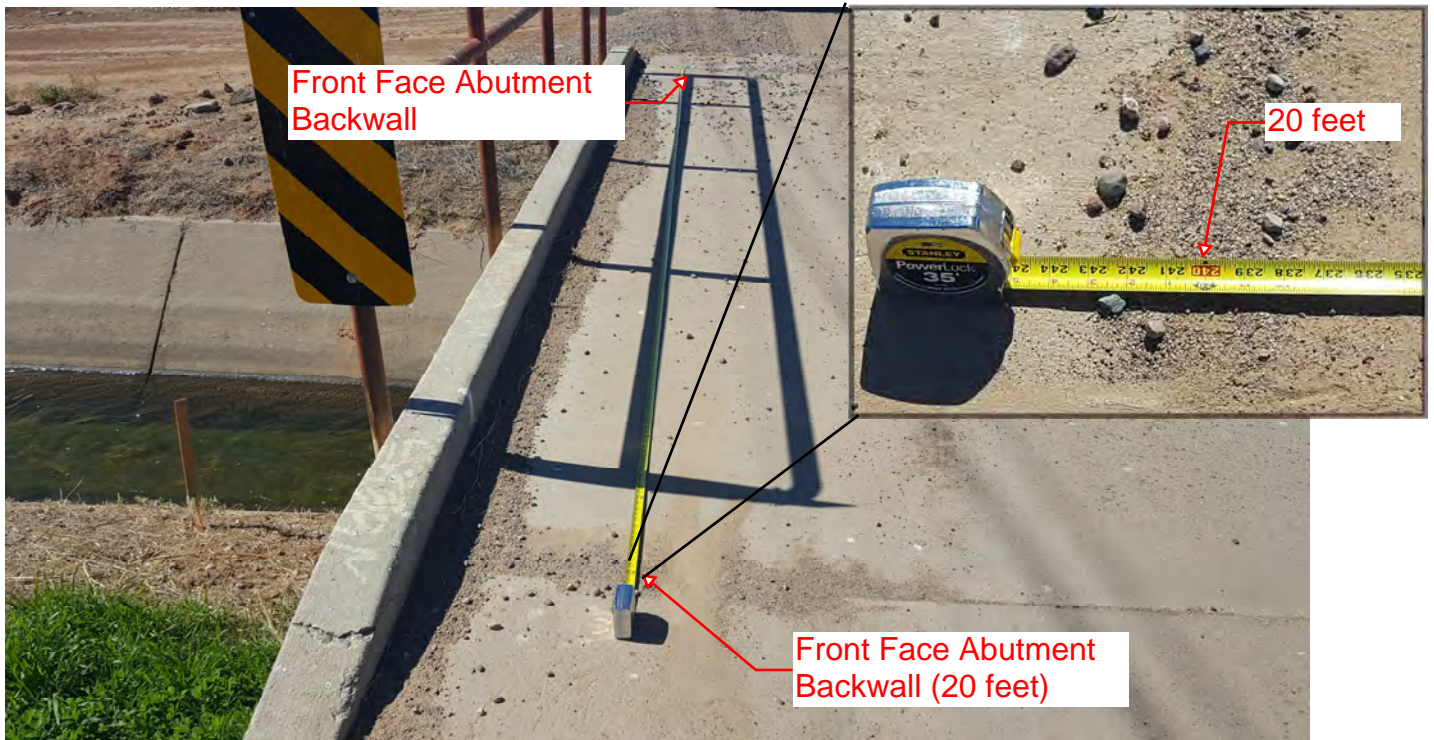
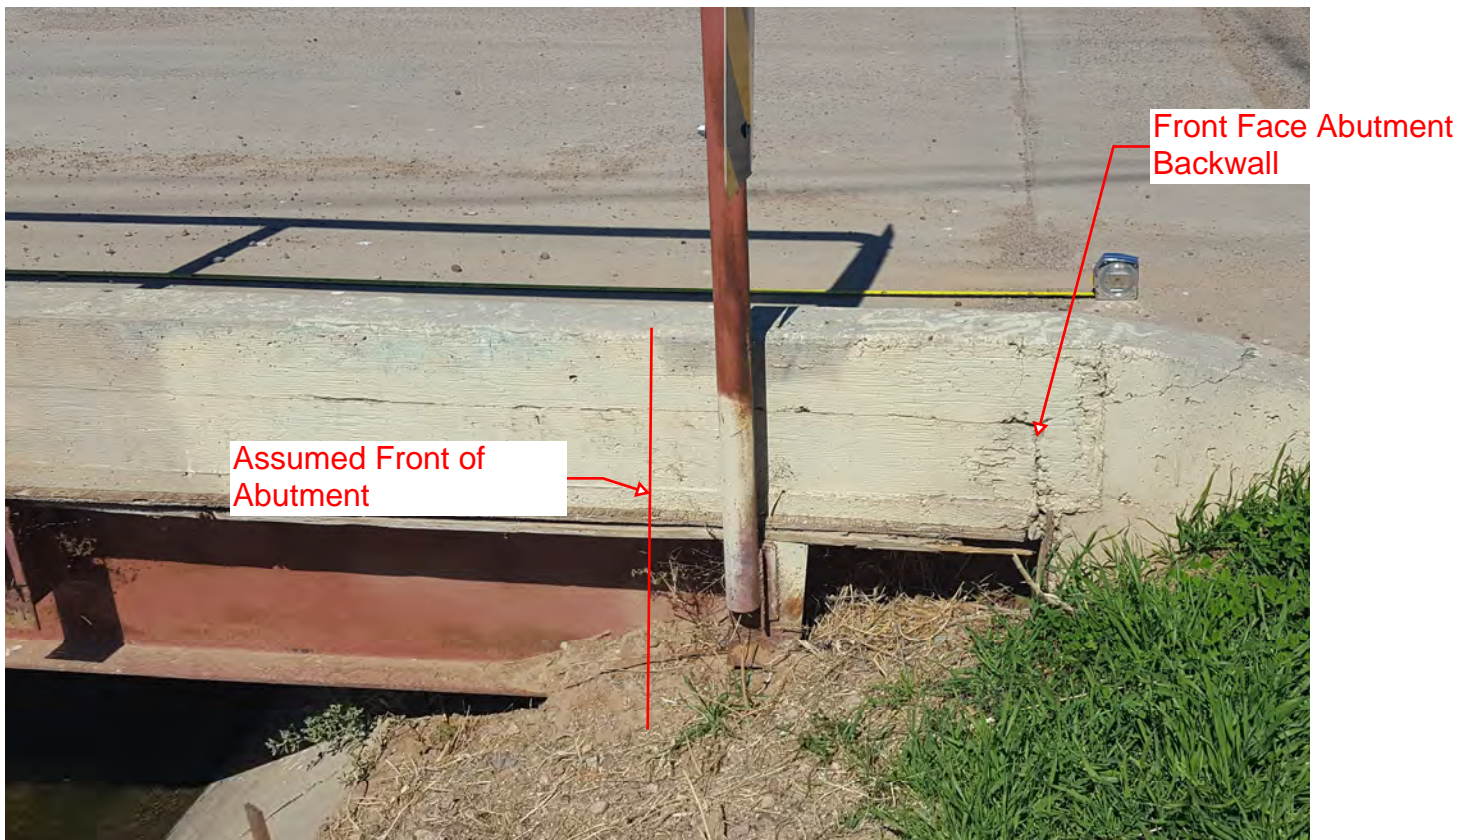
H128 McDonald Drive and Dobson

Measurement from Front Face Abutment Backwall (FFAB) to Front Face Abutment Backwall is 20 feet. There is a bearing seat that the steel beams were set on, and is now covered with dirt and debris. Since the measured distance from FFAB to FFAB is 20 feet then the opening (undercropping of abutment) would be less that 20 feet and this structure does not meet the NBIS Bridge Length definition.
