EXECUTIVE SUMMARY JANUARY 2017 This report was funded in part through grants from the Federal Highway Administration, U.S. Department of Transportation. The contents of this report reflect the views of the authors, who are responsible for the facts and the accuracy of the data, and for the use or adaptation of previously published material, presented herein. The contents do not necessarily reflect the official views or policies of the Arizona Department of Transportation or the Federal Highway Administration, U.S. Department of Transportation. This report does not constitute a standard, specification, or regulation. Trade or manufacturers' names that may appear herein are cited only because they are considered essential to the objectives of the report. The U.S. government and the State of Arizona do not endorse products or manufacturers.

The Town of Superior's Council approved and adopted the study on January 12<sup>th</sup>, 2017.

# **STUDY OVERVIEW**

The *Superior Pavement Assessment Study* is a joint effort by the Town of Superior (Town) and the Arizona Department of Transportation (ADOT) to evaluate the Town's existing pavement conditions in an effort to develop a pavement m

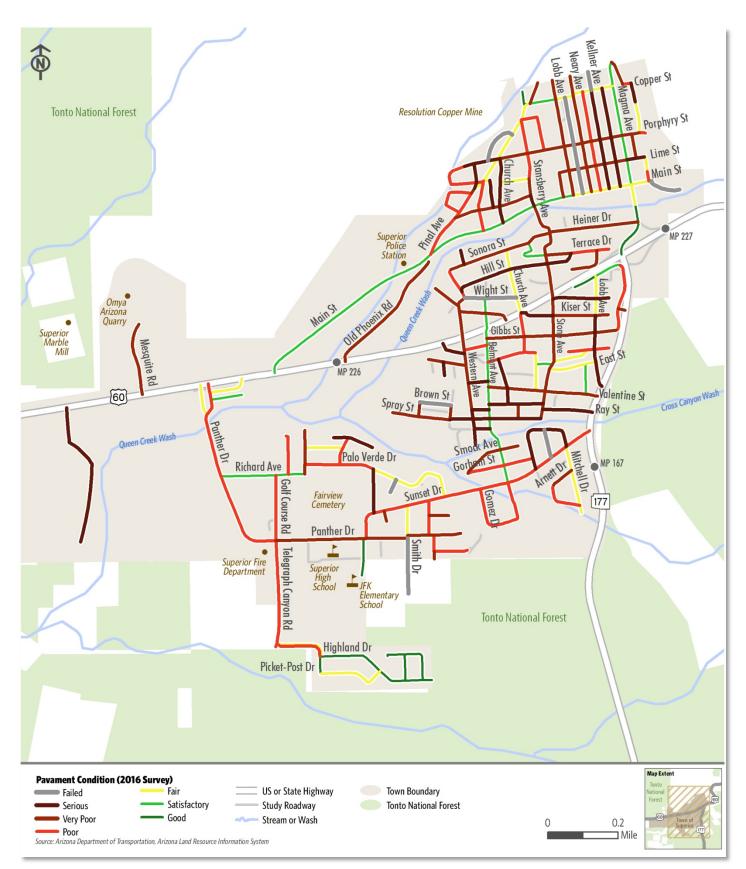
Based on pavement conditions identified during the field inspection and windshield survey, pavement condition ratings were calculated for each section of paved roadway. In total, 72% of roadways surveyed were identified to be in Poor to Failed condition. Figure 2 summarizes the pavement condition results of the study roadways. Figure 3 provides a graphical illustration of survey results. *Working Paper 1: Current Conditions* provides a detailed assessment of each study roadway's condition.

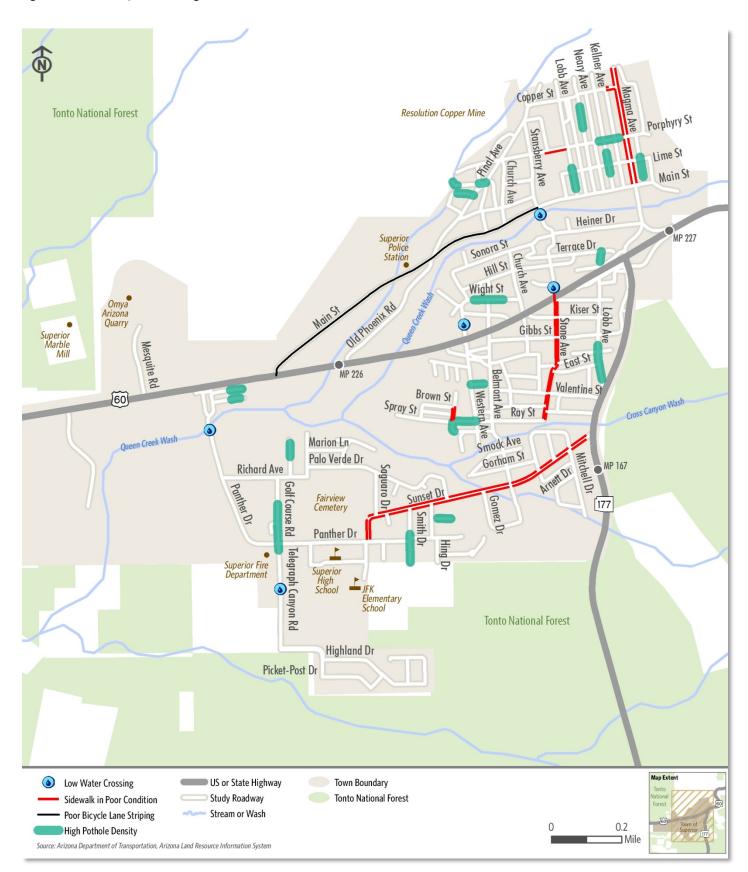
### Figure 4: Summary of Existing Issues

Low water crossings are areas where free flowing water crosses over the roadway, which may hinder vehicle traffic and cause impacts to a road's pavement condition. As shown in Figure 4, low water crossings were identified at five locations during the field review. Roads with low water crossings include:

- Panther Drive (Queen Creek Wash)
- Telegraph Canyon Road (south of Panther Drive)
- Western Avenue (north of US60)
- Stone Avenue (north of US60)
- Stone Avenue (Queen Creek Wash)

Adequate facilities for pedestrians and bicyclists are paramount to the safety and mobility of Superior residents. Sidewalks were examined with a windshield survey to determine the condition of the sidewalk and the facility's conformation to Americans with Disabilities Act (ADA) standards. Figure 4 illustrates the location of sidewalks in poor condition. The only roadway striped for a bike lane is on Main Street, from US 60 to Stansberry Avenue; however, the striping is faded.

In addition to the pavement condition ratings, areas with minor and major potholes were identified to determine "hotspots" for safety issues and poor pavement conditions. Areas prone to potholes are typically where drainage is poor, where vehicular traffic is the greatest, and where maintenance allows small fissures to develop in the pavement. Roadways with the highest density of potholes are shown in Figure 4.
