TOWN OF SUPERIOR
**PAVEMENT
ASSESSMENT**
STUDY

FINAL REPORT
JANUARY 2017

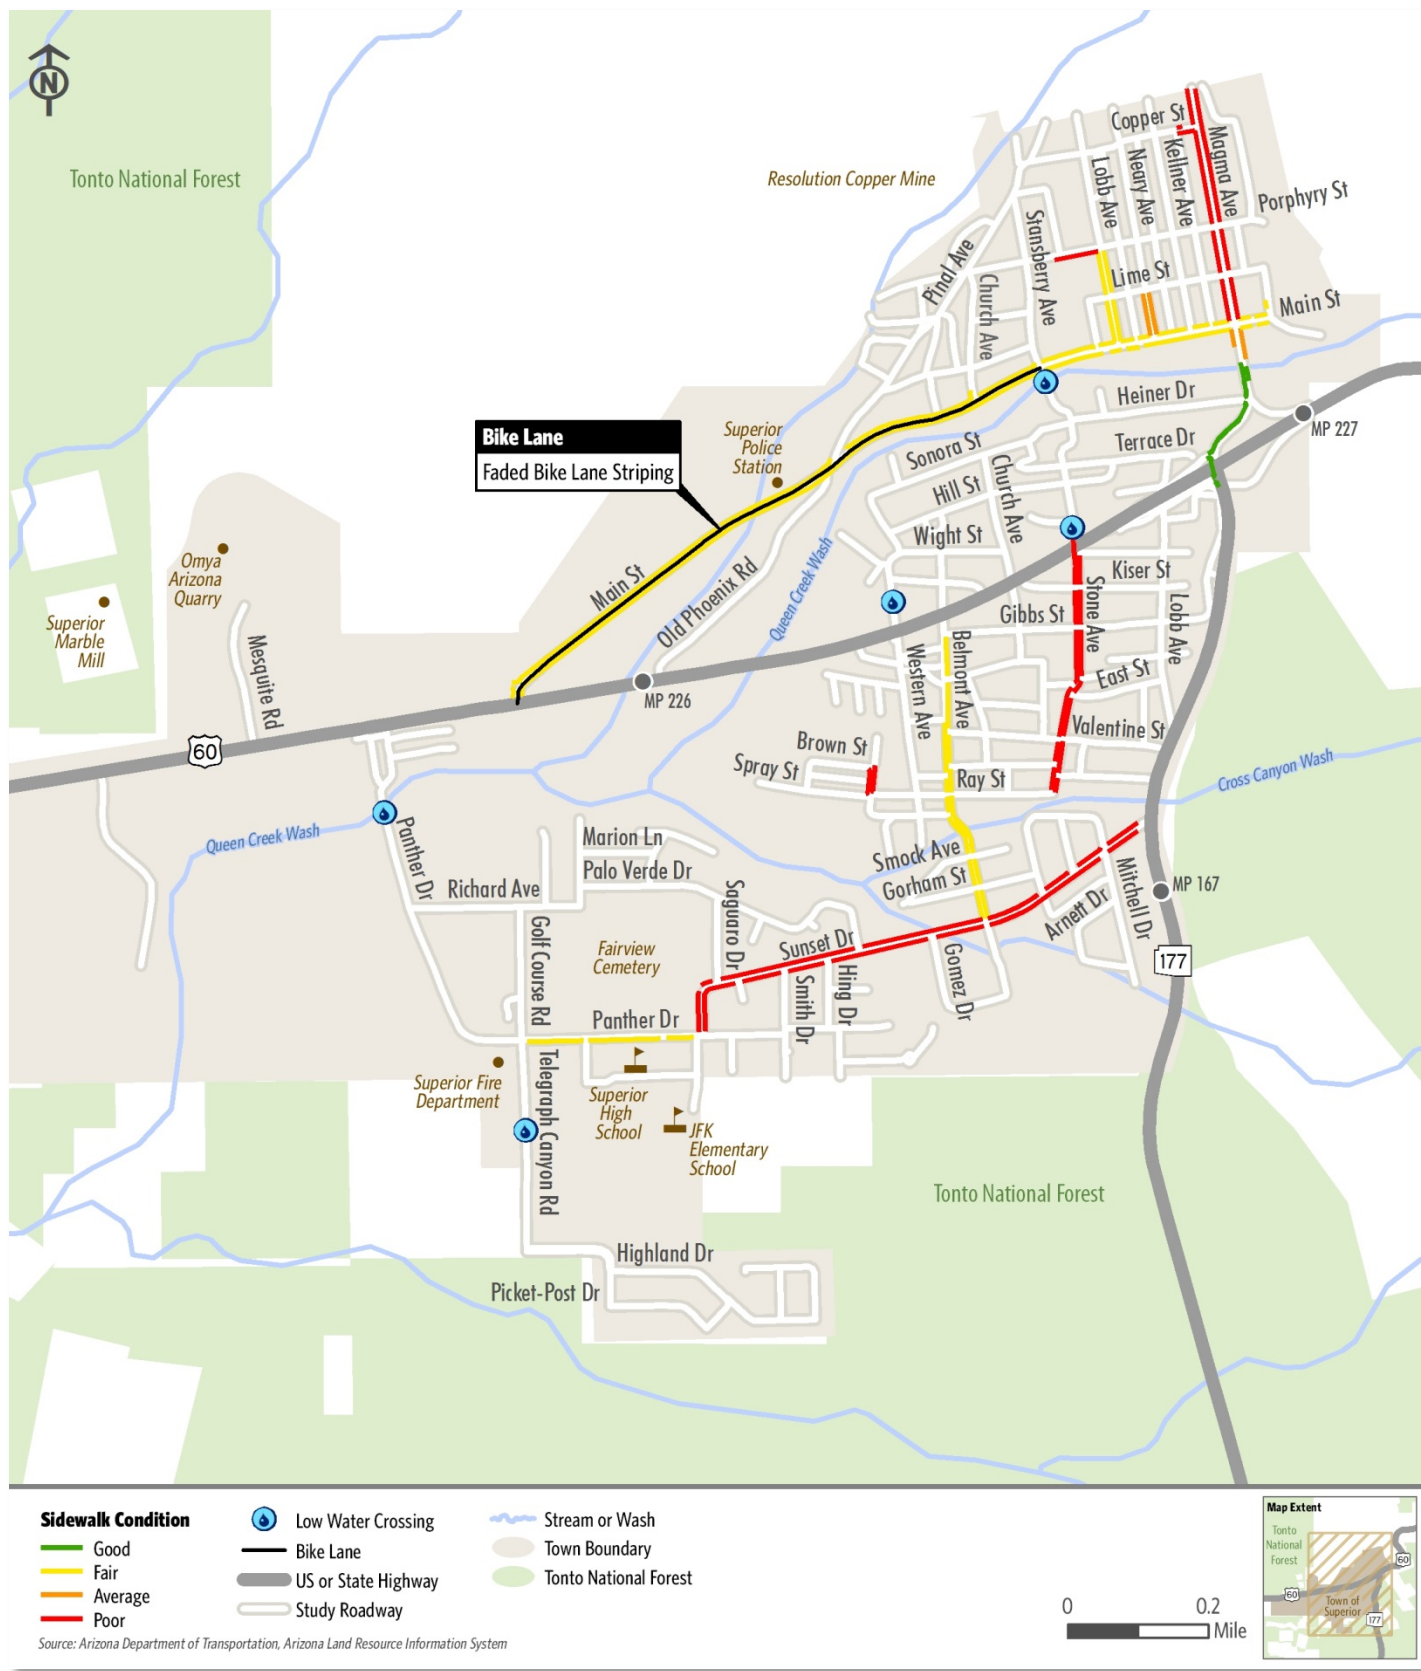
Figure 3.8: Pedestrian and Bicycle Facility Conditions

Figure 3.8 shows the existing conditions of sidewalks within the town limits. The information is summarized in Table 3.3. Overall approximately 4 miles of sidewalks were recorded, of which about 40% are in poor condition.

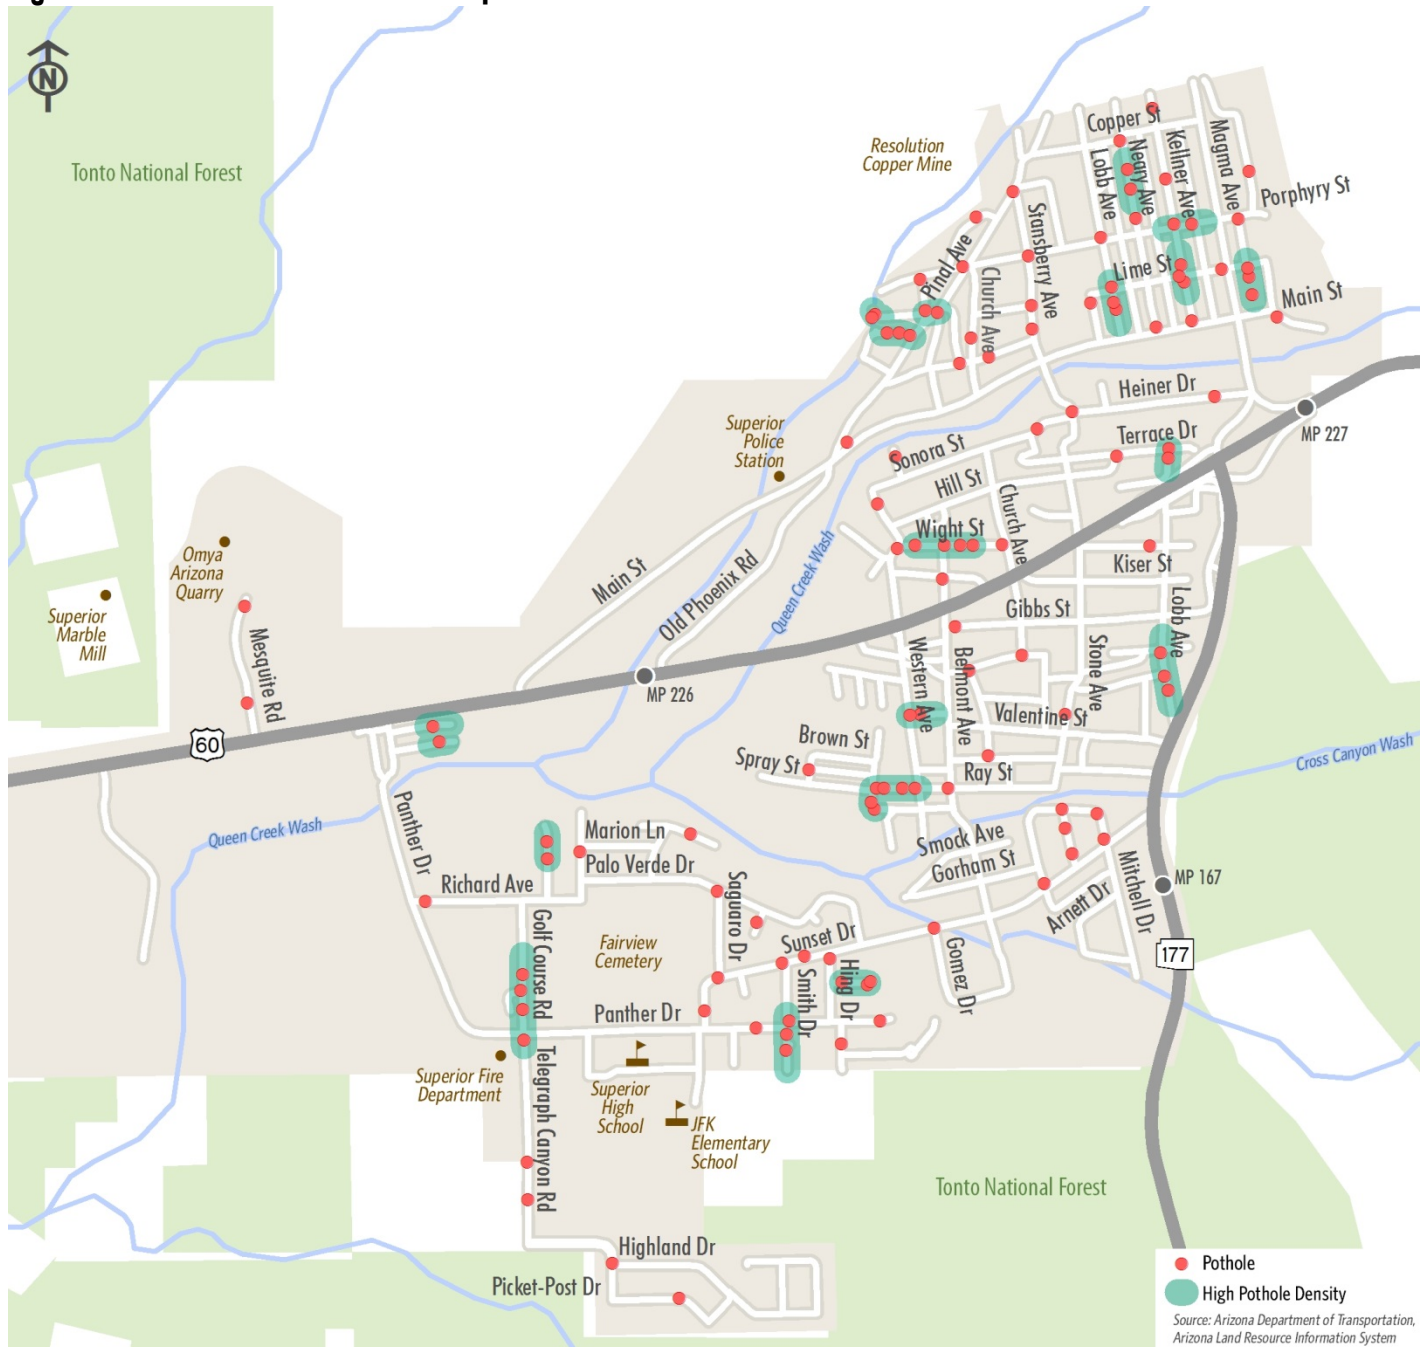
Figure 5.8: Pothole Locations and Hotspots

In addition to the pavement condition ratings, areas with minor and major potholes were identified to determine “hotspots” for safety issues and poor pavement conditions. Areas with high densities of potholes are typically where drainage is poor and vehicular traffic is the greatest. Figure 5.8 illustrates the location of potholes identified during the field assessment and high density pothole hotspots. As illustrated in the Figure, hotspot locations include:

- ▶ Wright Street
- ▶ Kellner Drive (particularly near Lime Street)
- ▶ Ray Street
- ▶ Sunset Drive
- ▶ Neary Avenue (North of Porphyry Street)
- ▶ Golf Course Drive

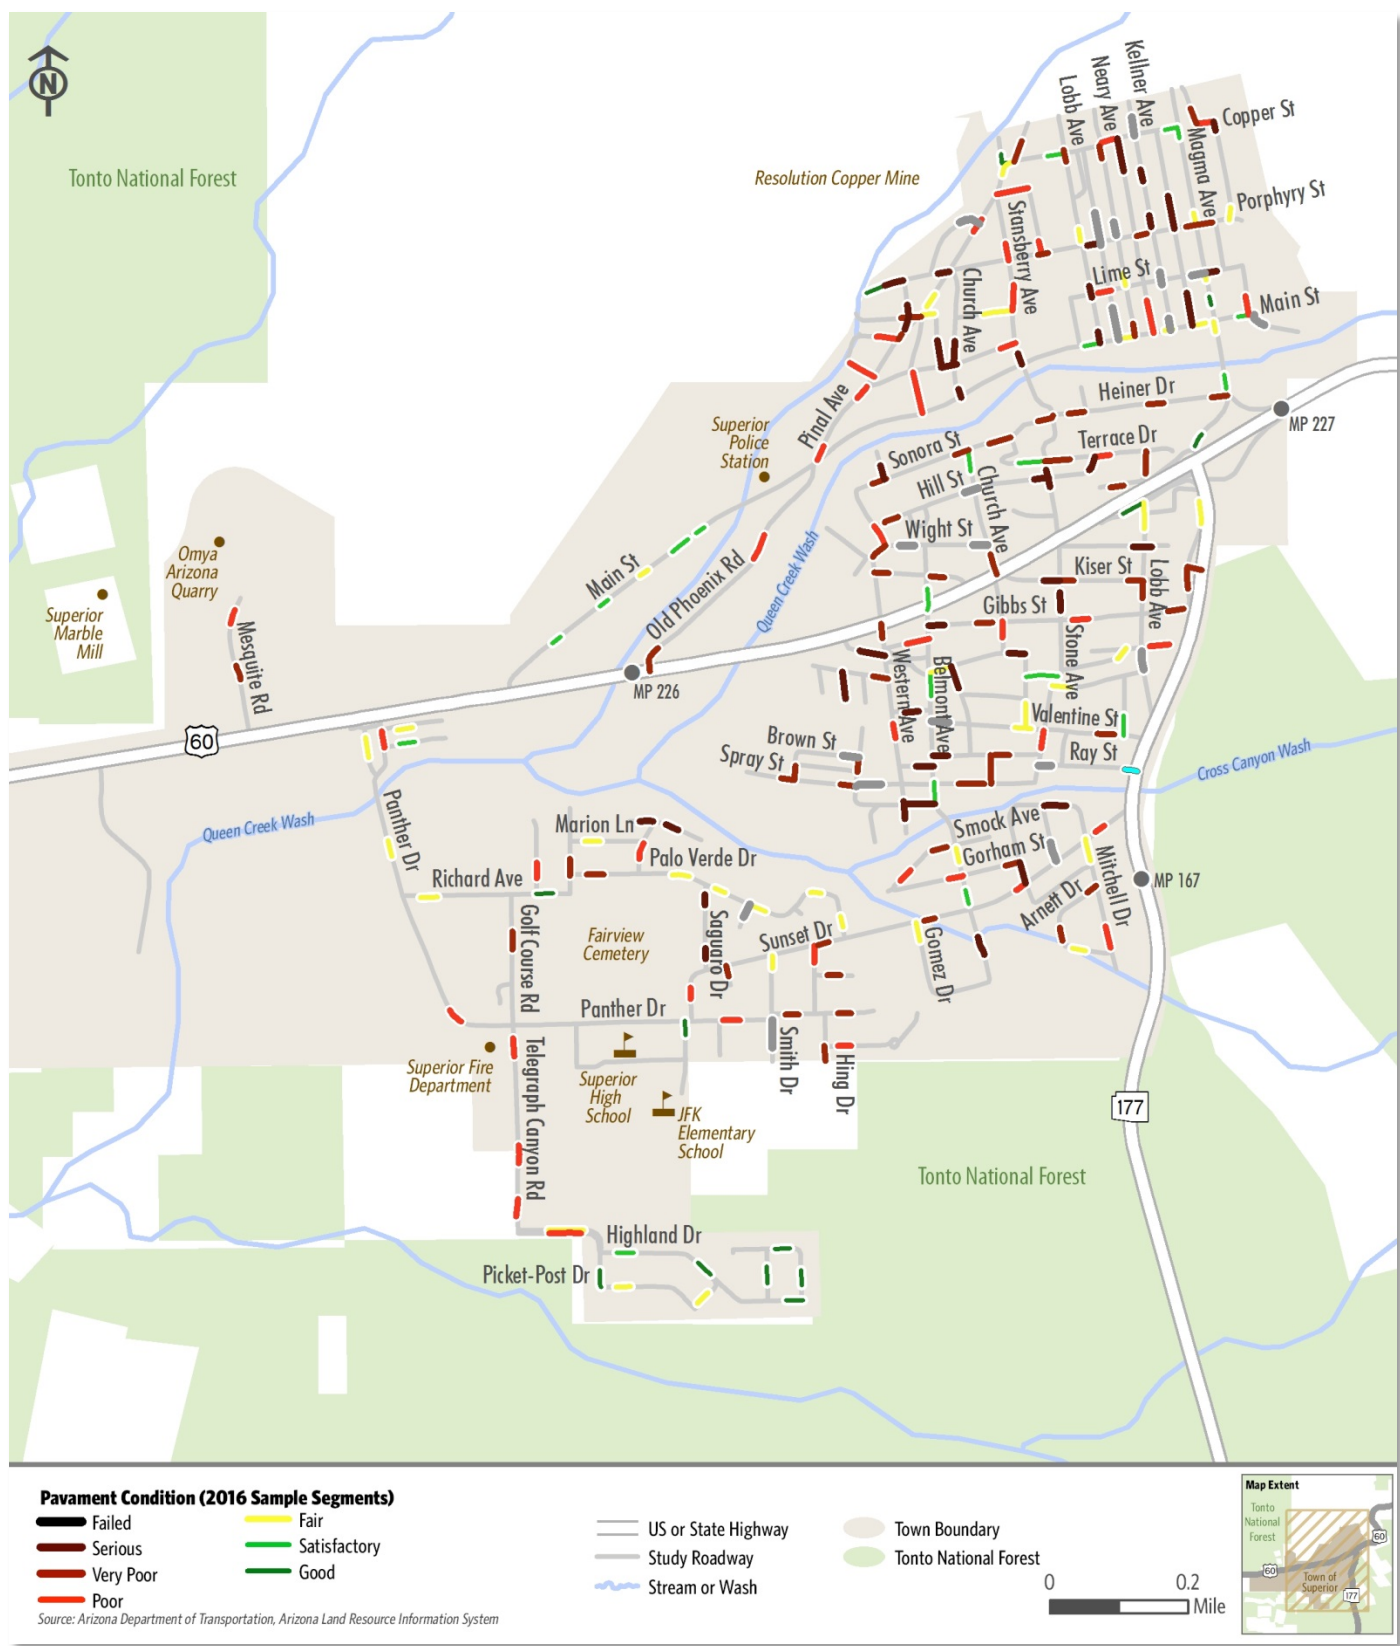
Figure A-1: Sample Unit Pavement Conditions

Sample Unit ID	Street Name	Description	PCI
R10-S1-SS1	Richard Avenue	North of Palo Verde Drive	30
R100-S1-SS1	Contreras Street	North of Valentine Street	84
R101-S1-SS1	Ray Street	West of SR-177	40
R101-S1-SS2	Ray Street	East of Stone Avenue	8
R102-S1-SS1	Lobb Avenue	South of South Street	70
R102-S2-SS1	Lobb Avenue	South of Kiser Street	26
R102-S2-SS2	Lobb Avenue	North of East Street	4
R103-S1-SS1	Ray Rd	South of South Street	60
R103-S1-SS2	Gibbs Street	South of Ray Rd	30
R104-S1-SS1	Ray Rd	West of SR-177	30
R107-S1-SS1	Magma Avenue	North of Porphyry Street	60
R107-S1-SS2	Magma Avenue	South of Lime Street	60
R107-S1-SS3	Magma Avenue	South of Copper Street	76
R107-S1-SS4	Magma Avenue	North of Main Street	87
R107-S2-SS1	Magma Avenue	South of Main Street	70
R107-S3-SS1	Magma Avenue	North of US-60	100
R107-S3-SS2	Magma Avenue	North of Heiner Drive	80
R109-S1-SS2	Main Street	0.1 miles North of US-60	76
R109-S1-SS3	Main Street	0.2 miles North of US-60	76
