PERFORMANCE TESTING OF HPC ON SUNSHINE BRIDGE

Final Report 658

Prepared by:
Tarif M. Jaber
Jaber Engineering Consulting, Inc.
10827 E. Butherus Drive
Scottsdale, Arizona 85255

September 2009

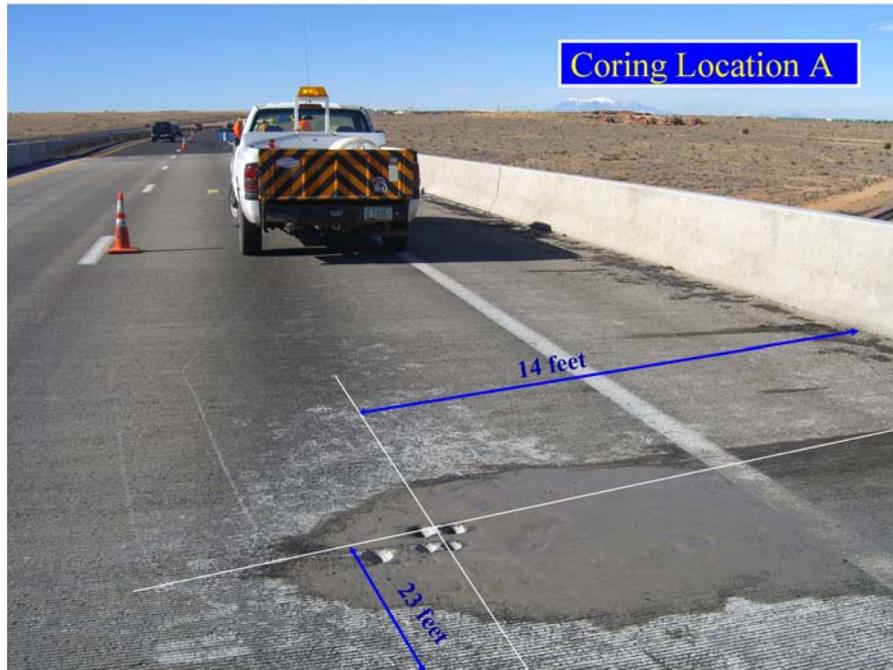
Photo 1- Coring location A

CORE INFORMATION			
AREA	CORE LOCATION	# CORES	DESIGNATION
A	14' S. of the north barrier and 23' W. of the E. end of the deck	5	A1, A2, A3, A4, A5 ¹
B	12' S. of the north barrier and 94.5' E. of the W. end of the deck	4	B1, B2, B3, B4
C	12' S. of the north barrier and 23' E. of the W. end of the deck	4	C1, C2, C3, C4

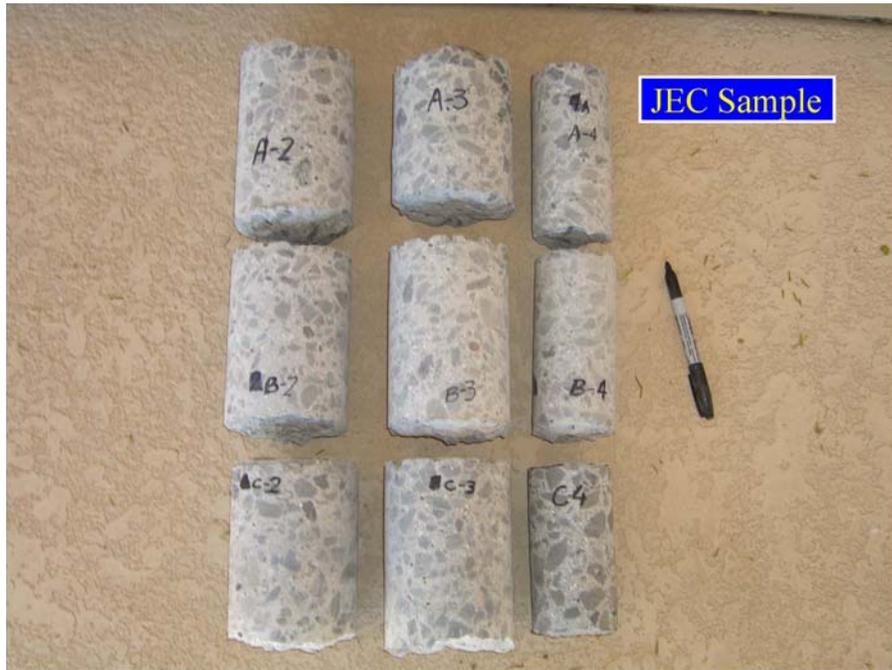
Photo 5- Concrete cores

On December 18, 2007, concrete from the bridge deck was sampled at three locations and at least four cores were taken at each location. A schedule of the concrete core samples is presented in Table 1 and coring is shown in photos 1 through 5 in the Appendix. All concrete samples were less than 6 inches long to avoid penetration of the full depth of the deck. A non-shrink grout was used to patch all cored areas.
