## ARIZONA DEPARTMENT OF TRANSPORTATION

REPORT NUMBER: FHWA-AZ89-260

# SIZING RIPRAP FOR THE PROTECTION OF APPROACH EMBANKMENTS & SPUR DIKES AND LIMITING THE DEPTH OF SCOUR AT BRIDGE PIERS & ABUTMENTS

**Volume I: Literature Review & Arizona Case Histories**

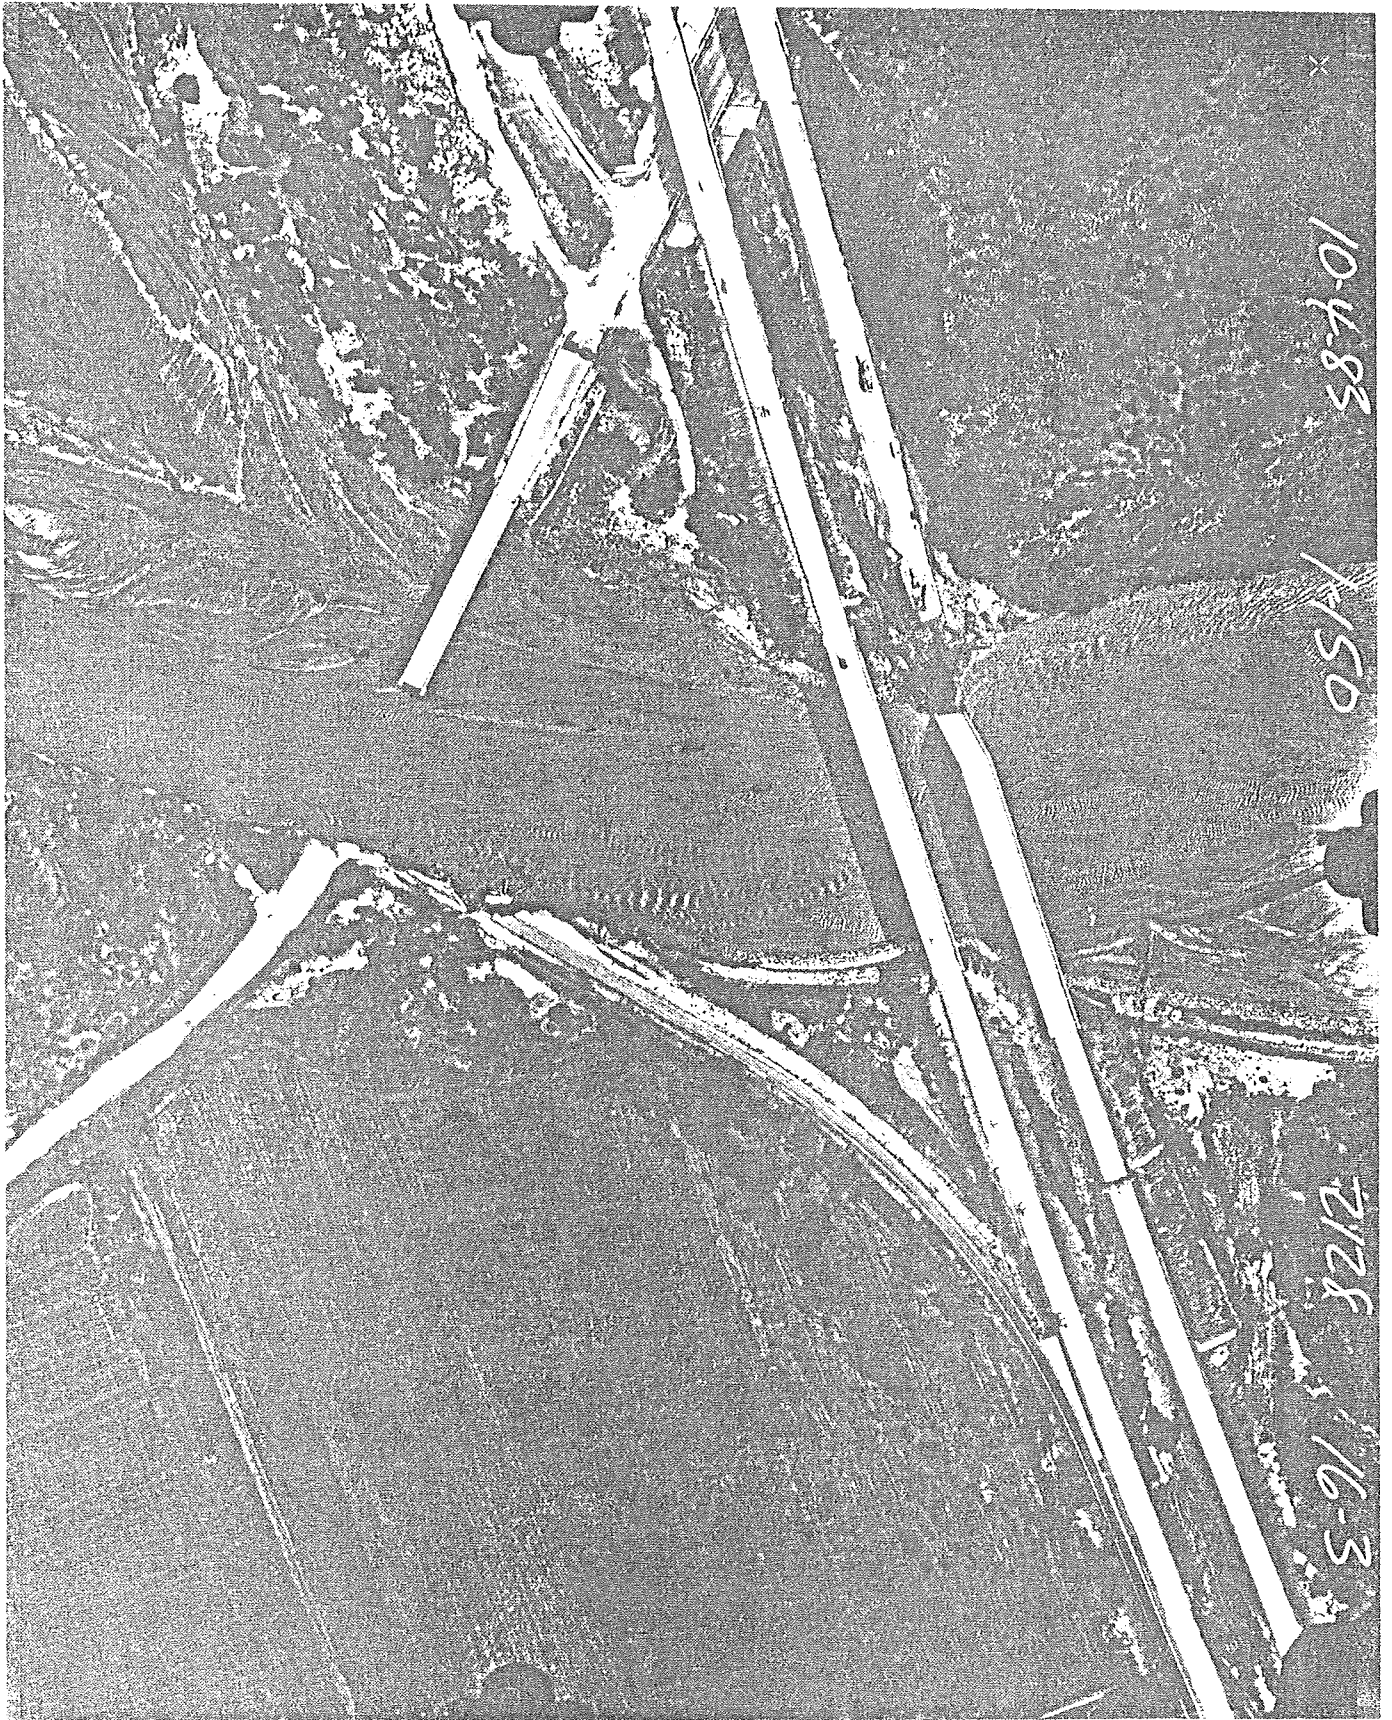
Figure 7. Aerial photograph of Santa Cruz River at I-19 bridge after October 1983 flood. (ADOT Photogrammetry Section)

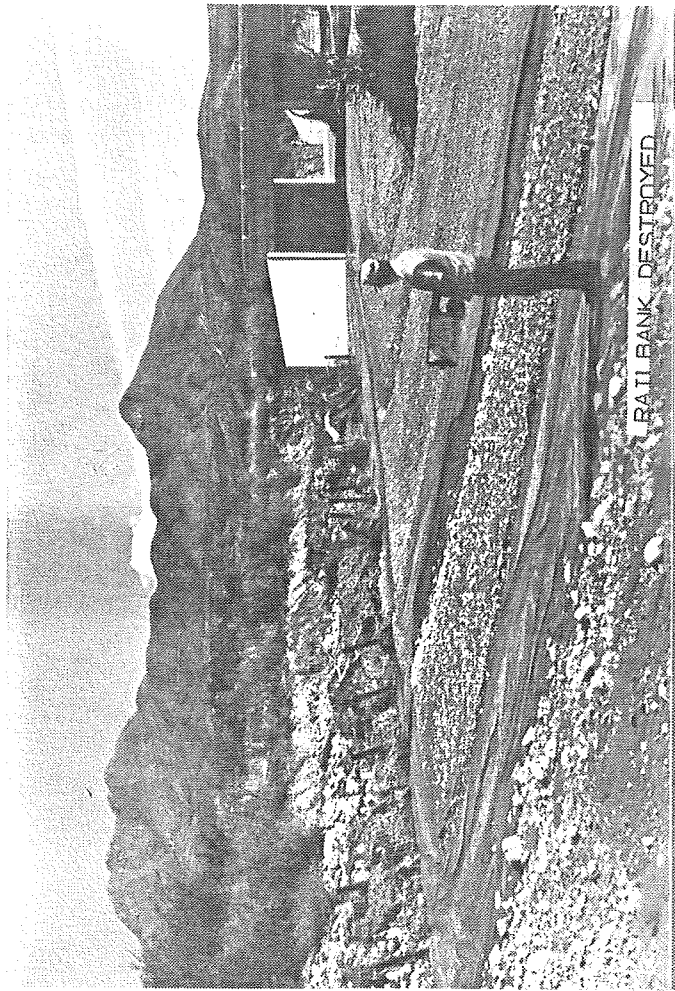
RAIL BANK DESTROYED  
(ADOT Bridge Inspection Files)

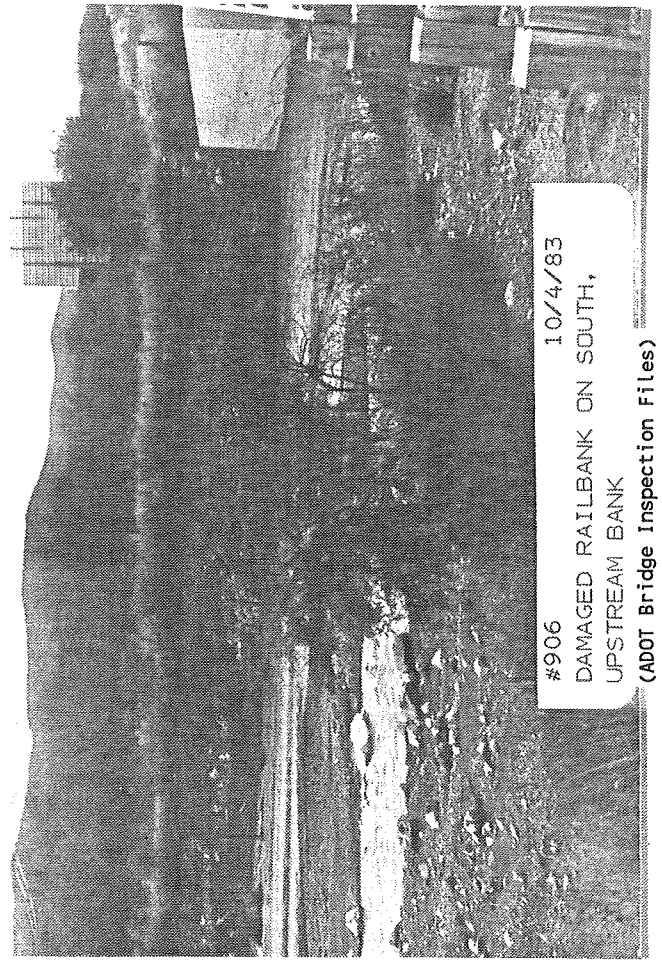
#906 10/4/83  
DAMAGED RAILBANK ON SOUTH,  
UPSTREAM BANK  
(ADOT Bridge Inspection Files)

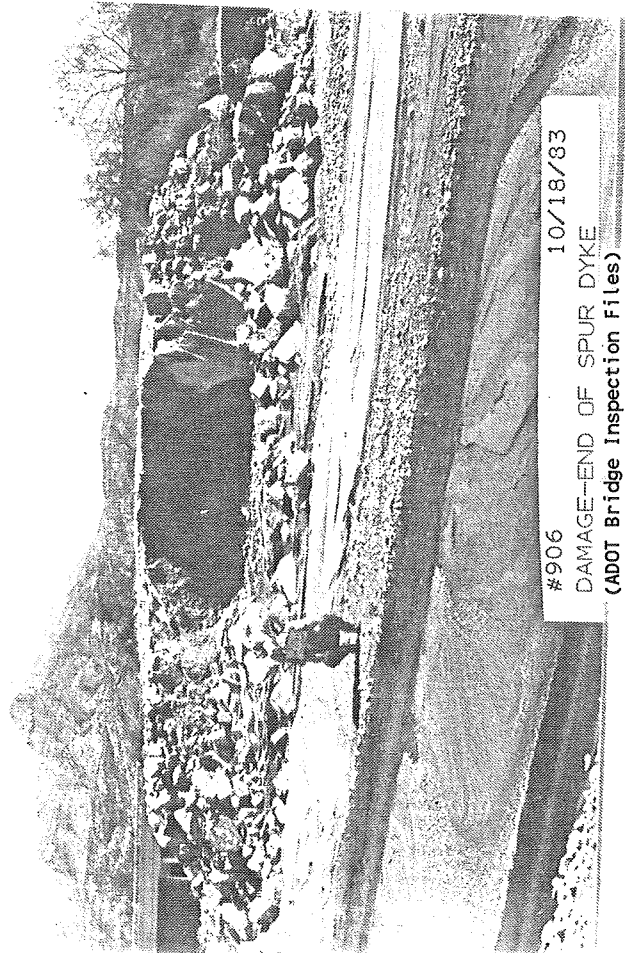
#906 10/18/83  
DAMAGE-END OF SPUR DYKE  
(ADOT Bridge Inspection Files)

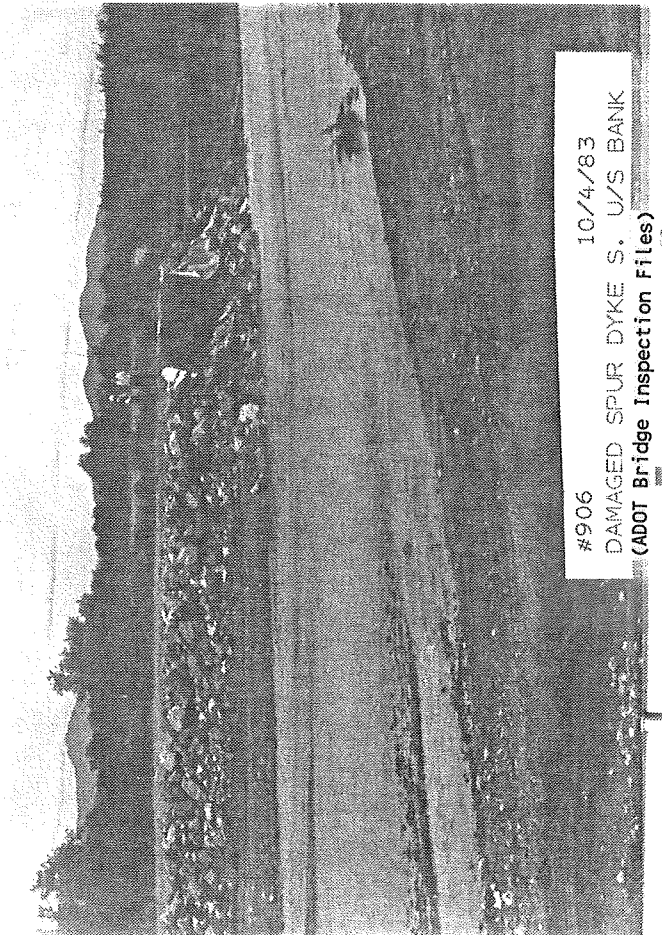
#906 10/4/83  
DAMAGED SPUR DYKE S. U/S BANK  
(ADOT Bridge Inspection Files)

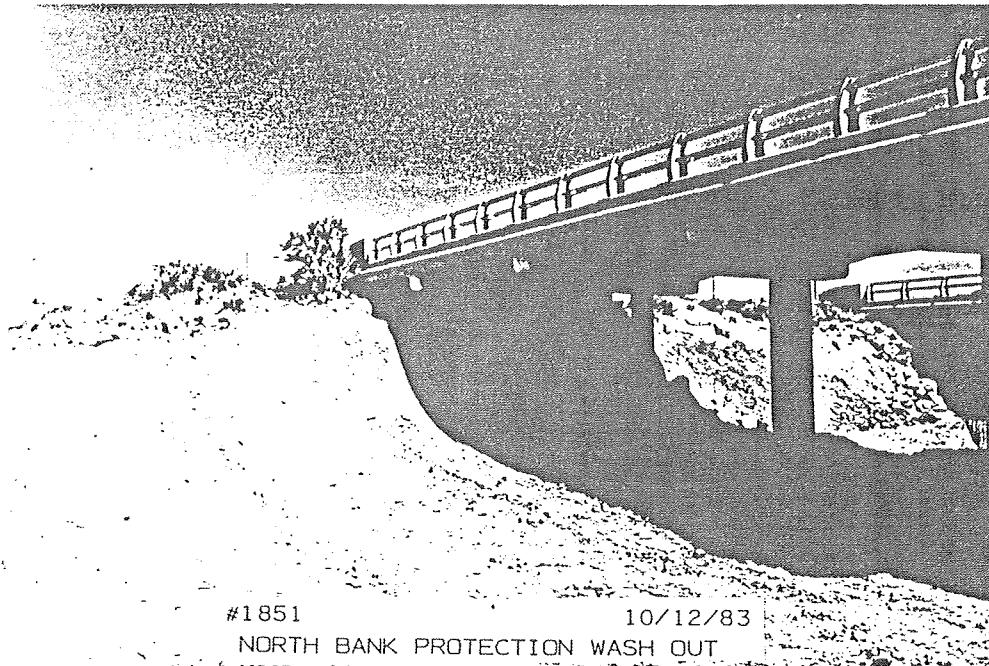
#1851 10/12/83  
NORTH BANK PROTECTION WASH OUT  
(ADOT Bridge Inspection Files)

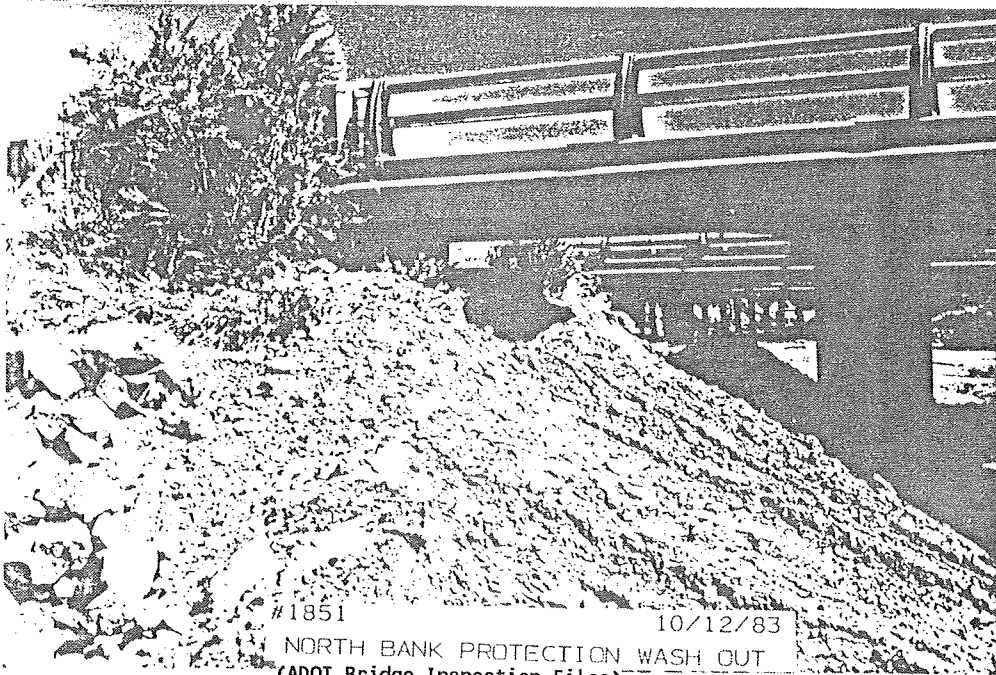
#1851 10/12/83  
NORTH BANK PROTECTION WASH OUT  
(ADOT Bridge Inspection Files)

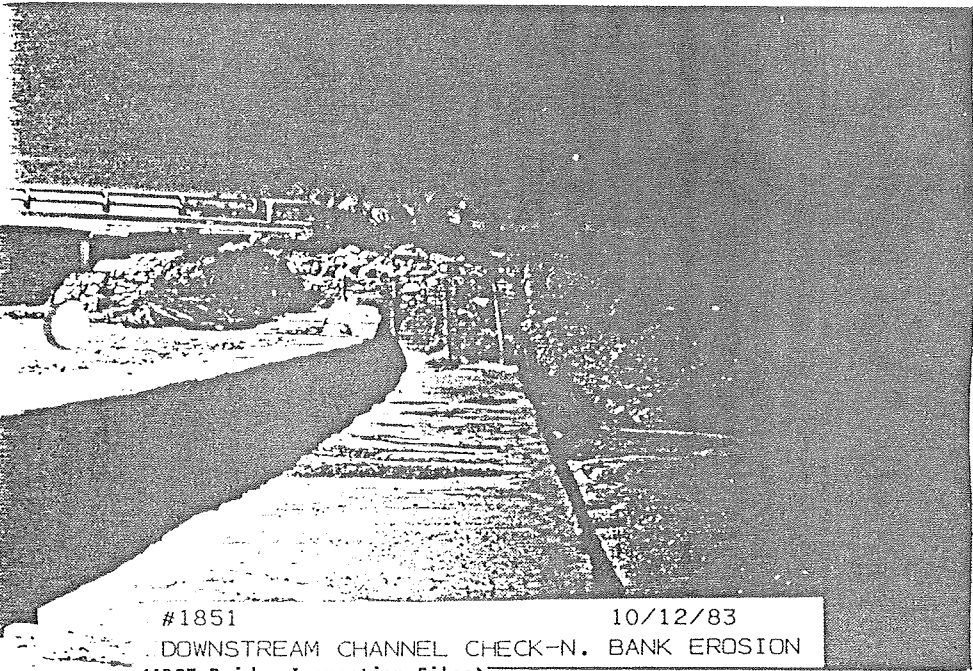
#1851 10/12/83  
DOWNSTREAM CHANNEL CHECK-N. BANK EROSION  
(ADOT Bridge Inspection Files)

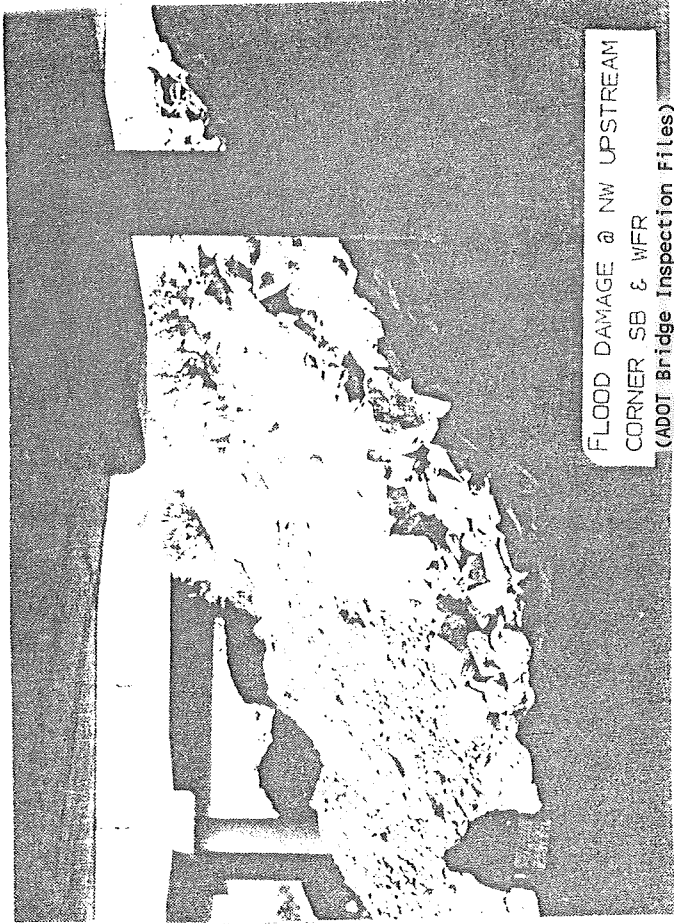
FLOOD DAMAGE @ NW UPSTREAM  
CORNER SB & WFR  
(ADOT Bridge Inspection Files)

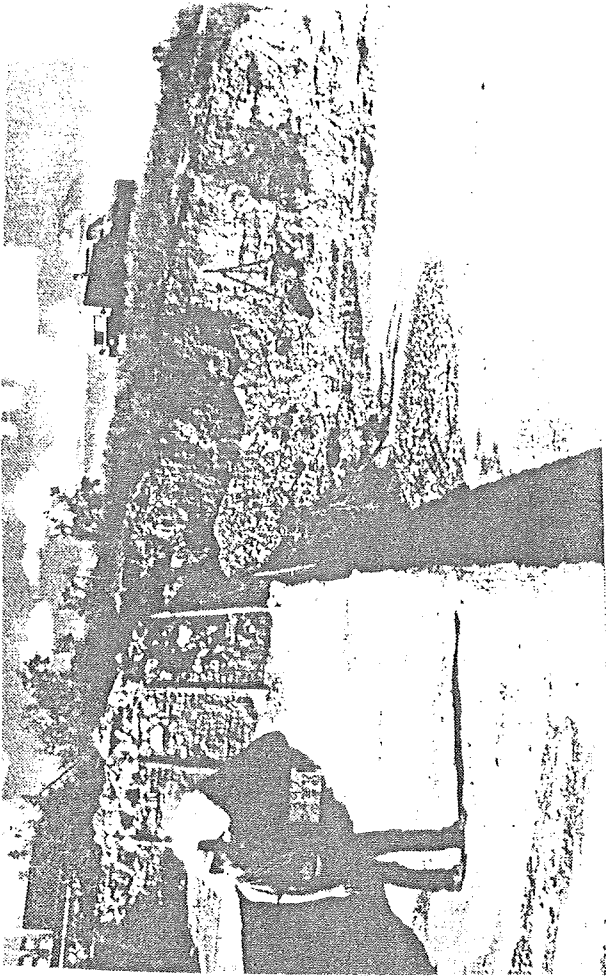
DAMAGE @ NORTH END OF CHECK WALL  
(ADOT Bridge Inspection Files)

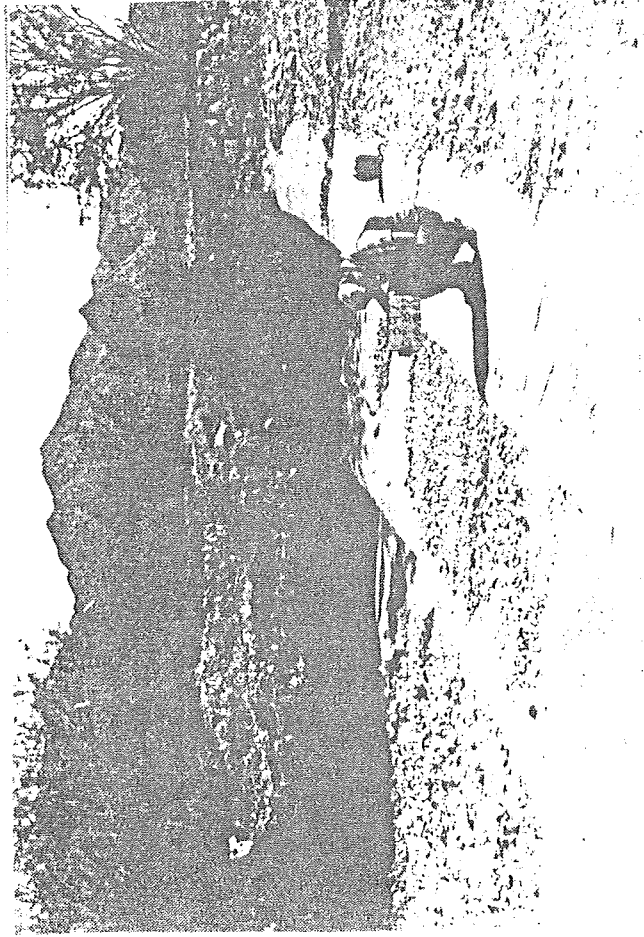
DAMAGE @ SOUTH END OF CHECK WALL  
(ADOT Bridge Inspection Files)
