PERFORMANCE EVALUATION OF COLD IN-PLACE RECYCLING PROJECTS IN ARIZONA

Final Report 460

March 2006

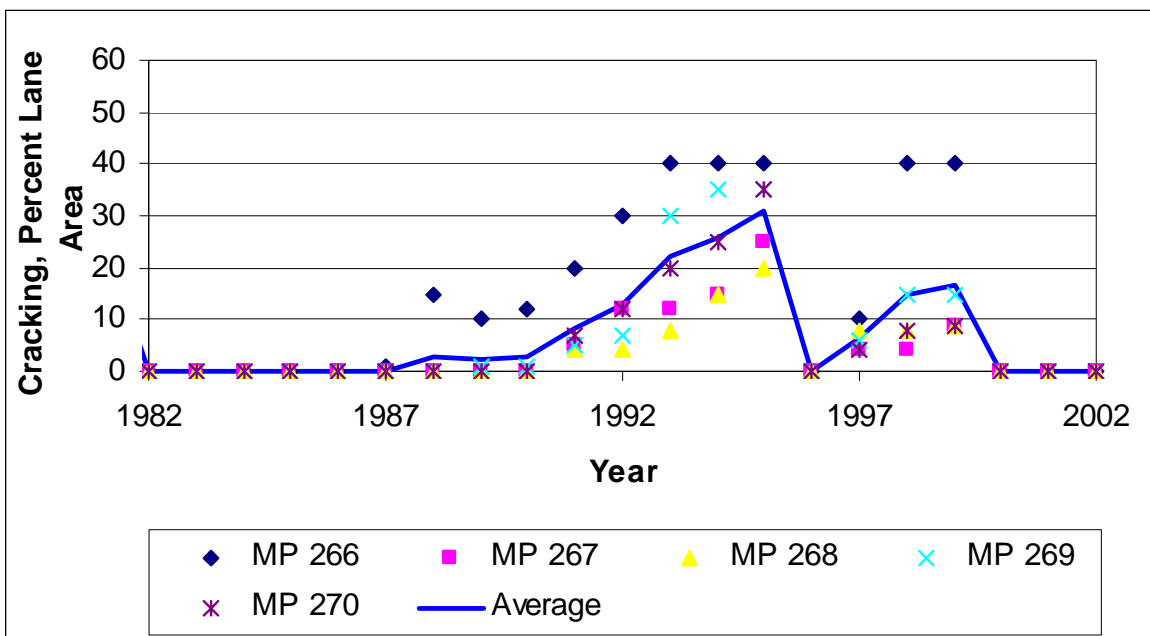
Figure 3. Cracking data for CIR Project 1—US 70 EB (ADOT Project No. F-22-4-517).

- It is clear from figure 3 that the cracking quantities are negligible until about 1989 and thereafter increase sharply. The values drop significantly in 1996, perhaps due to routine maintenance. The cracking quantities increase thereafter, only to drop again in 2000, suggesting another maintenance or rehabilitation action.

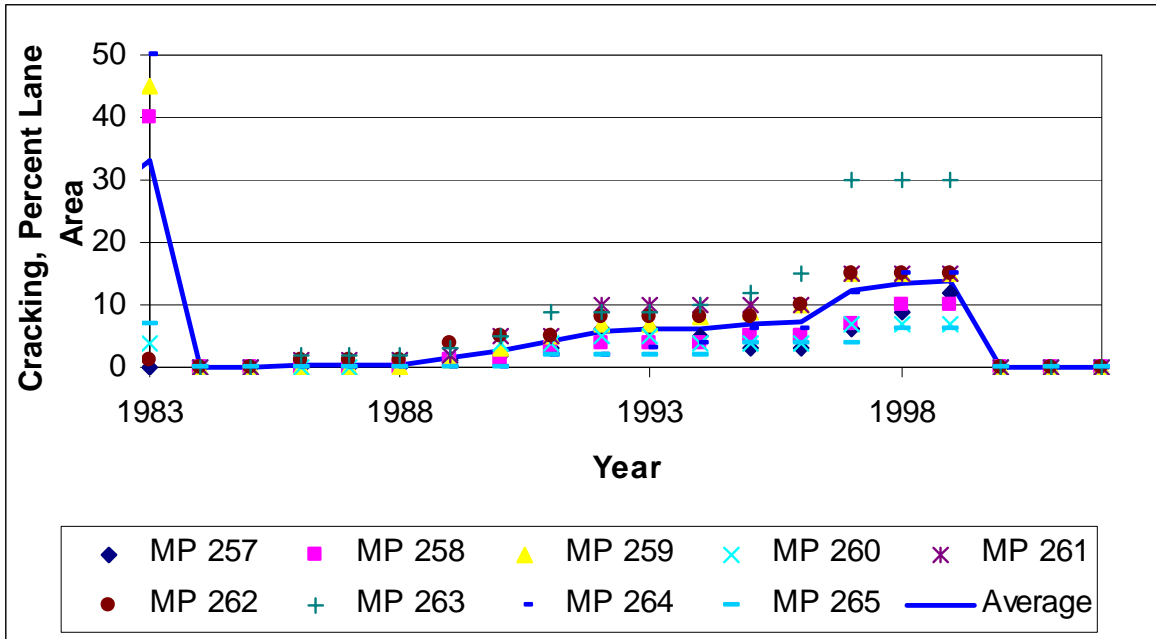
Figure 11. Cracking data for CIR Project 2—US 70 EB (ADOT Project No. BP-22-4-519).

- It is clear from figure 11 that the cracking quantities are negligible until about 1990 and sharply increase thereafter. The values drop significantly in 2000, suggesting that either a maintenance or rehabilitation action may have been taken at this time.

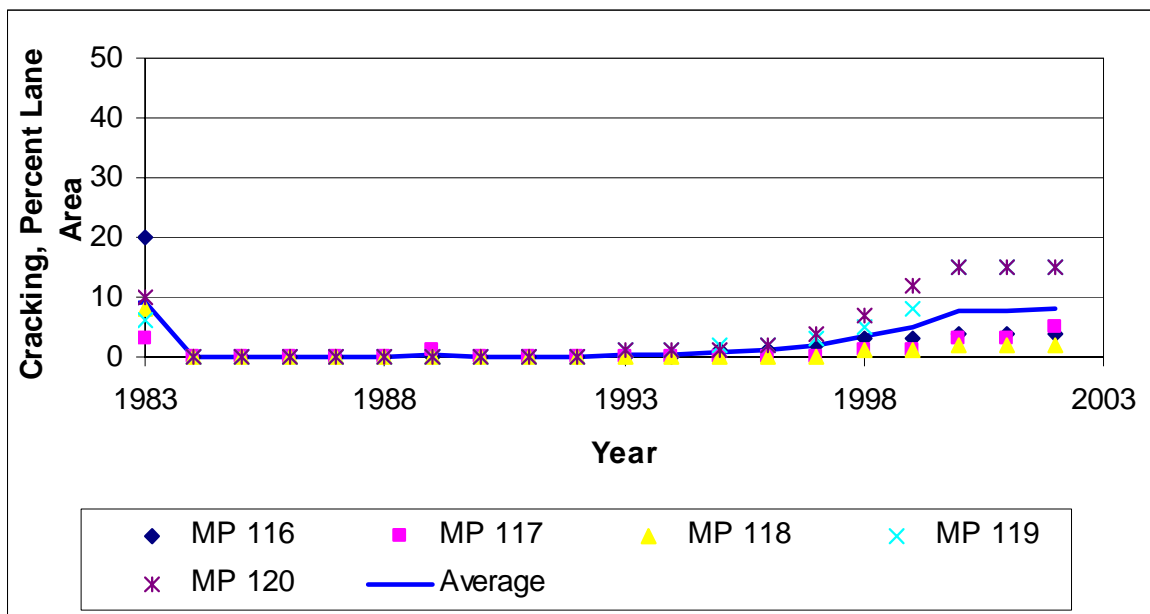
Figure 19. Cracking data for CIR Project 3— SR 87 NB (ADOT Project No. FR-55-1(4)).

- Figure 19 clearly shows that that the cracking quantities are negligible, even during the 2002 field inspection.
- Similar observations can be made regarding rutting from figure 20.
