Performance Evaluation of Arizona's LTPP SPS-1 Project: Strategic Study of Flexible Pavement Structural Factors

Final Report 396-1 February 2012

Arizona Department of Transportation Research Center

Nichols Consulting Engineers 1885 South Arlington Avenue Suite 111 Reno, Nevada 89509

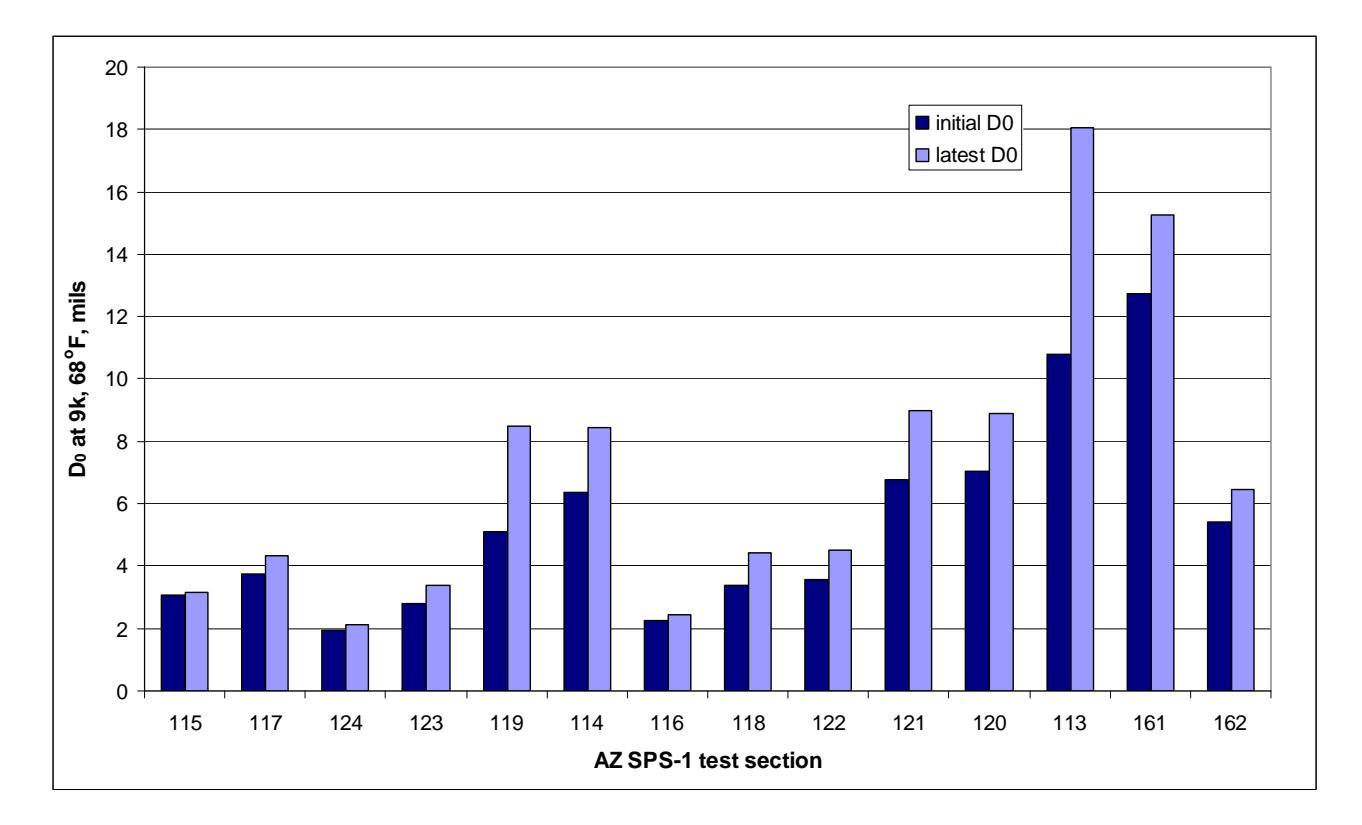
Figure 3. 1994 and 2004 average normalized maximum deflections by test section.

The normalized average maximum deflection is an indicator of the total stiffness of the pavement structure (surface and base) and the underlying subgrade. The increases in normalized average maximum deflection observed over time may thus be due to weakening of the pavement structure and/or weakening of the subgrade.

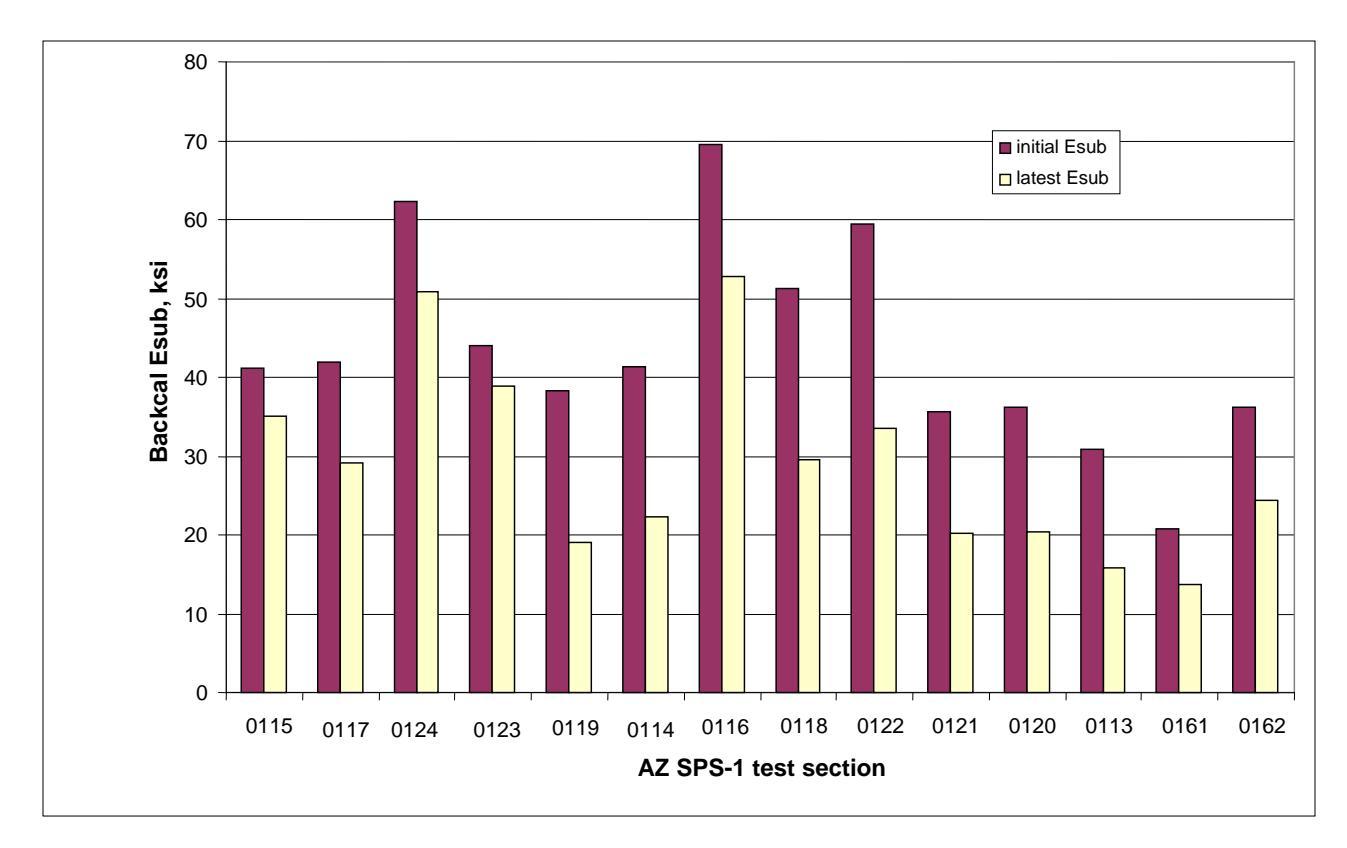
Figure 4. 1994 and 2004 backcalculated subgrade modulus by test section.

The overall average initial subgrade modulus for the site, backcalculated from the first round of deflection data in 1994, was about 43.5 ksi. The average subgrade modulus of each of the test sections declined between the first round of deflection testing in 1994 and the most recent round of deflection testing in 2004, as shown in Figure 4 and Table 5. The overall average subgrade modulus for the site, backcalculated from the last round of deflection data in 2004, was about 29 ksi.

This decrease in subgrade modulus over time is presumed to be due to a gradual increase and leveling off of the subgrade moisture content after construction. The fairly steady trend in decreasing subgrade moduli over time is illustrated by the values backcalculated for SMP test section 0113, shown in Figure 5 and Table 6.

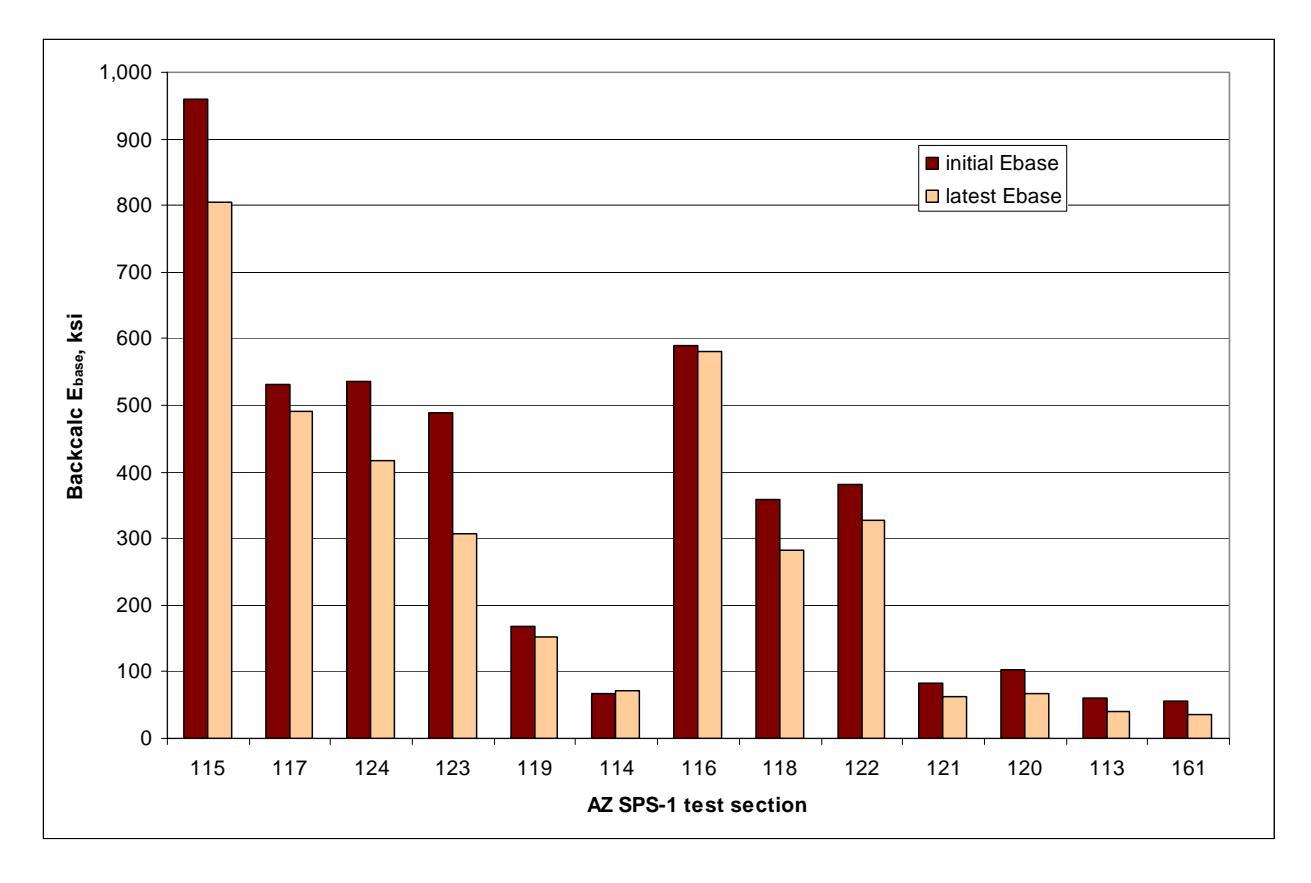
Figure 7. 1994 and 2004 backcalculated base modulus by test section.

The initial and latest average backcalculated base modulus values are shown by test section in Figure 7 and Table 8. All but one of the test sections showed a decrease in base modulus between 1994 and 2004. This effect may be coupled with the commensurate decrease in subgrade modulus. Whether an increase in moisture content in any unbound aggregate layers also played a role is difficult to say. For example, AC-over-aggregate test sections 0113 and 0161 experienced fairly large decreases in backcalculated base modulus, but AC-over-aggregate test section 0114 did not.

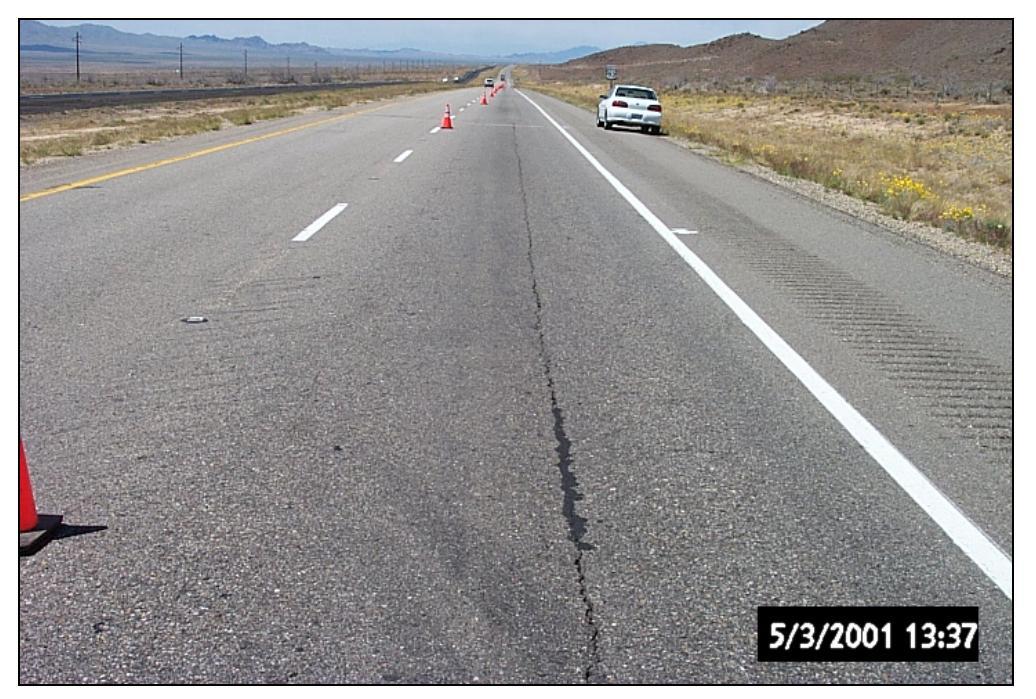
Figure 10. Photograph of paving seam.

As mentioned previously, the paving seam present throughout the SPS-1 project has contributed to the damage accumulated; however, the extent of the seam's influence on performance cannot be completely determined and isolated from deterioration that would have occurred naturally due to environment and traffic. To provide a complete picture of the deterioration, Figure 18 provides structural damage index values for each wheel path. Figure 18 does not isolate construction issues from natural deterioration, but it is expected that the paving seam will have a greater influence on the deterioration of the outer wheel path as compared to the inner wheel path, due to the proximity of the outer wheel path and the paving seam.

From Figure 18, it is apparent that the outer wheel path—largely governed by the paving seam—has driven the overall structural damage. The outer wheel path of every section contains significantly more deterioration as compared to the inner wheel path.

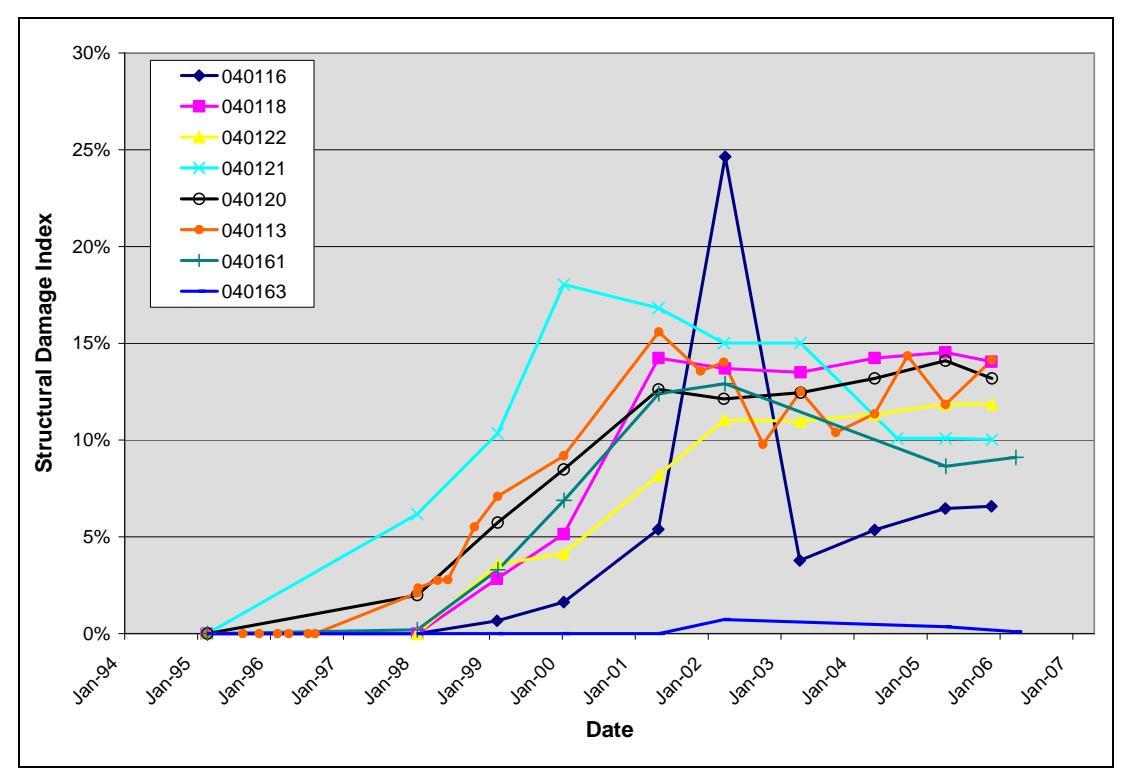
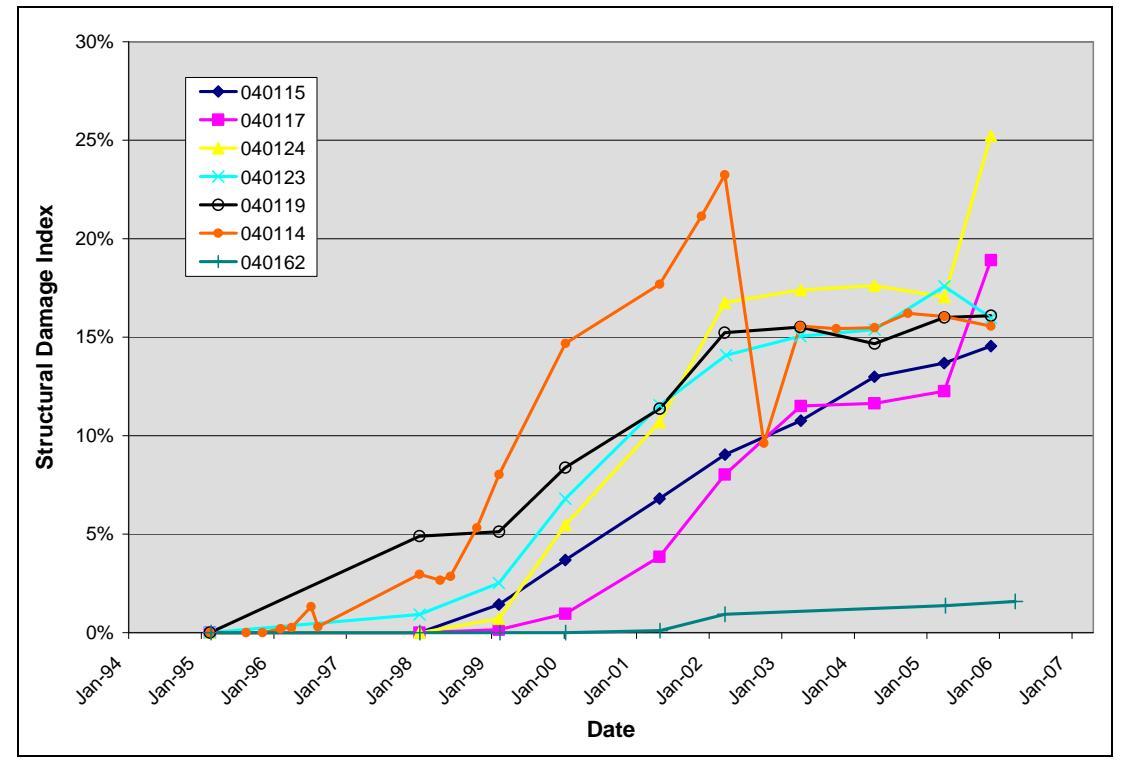
The overall structural damage trends for each section can be found in Figures 11 and 12. The performance trends are relatively consistent and within the expected range of variation. The drop in damage after May 2002 is indicative of the slurry seal masking the underlying deterioration.

In comparison with the rest of the SPS-1 project, sections 0162 and 0163 exhibit significantly smaller amounts of structural damage accumulation. The pavement structure for section 0162 is composed of 200 mm asphalt concrete placed directly on the subgrade. Section 0163 has a pavement structure consisting of an asphalt concrete friction course over roller compacted concrete.

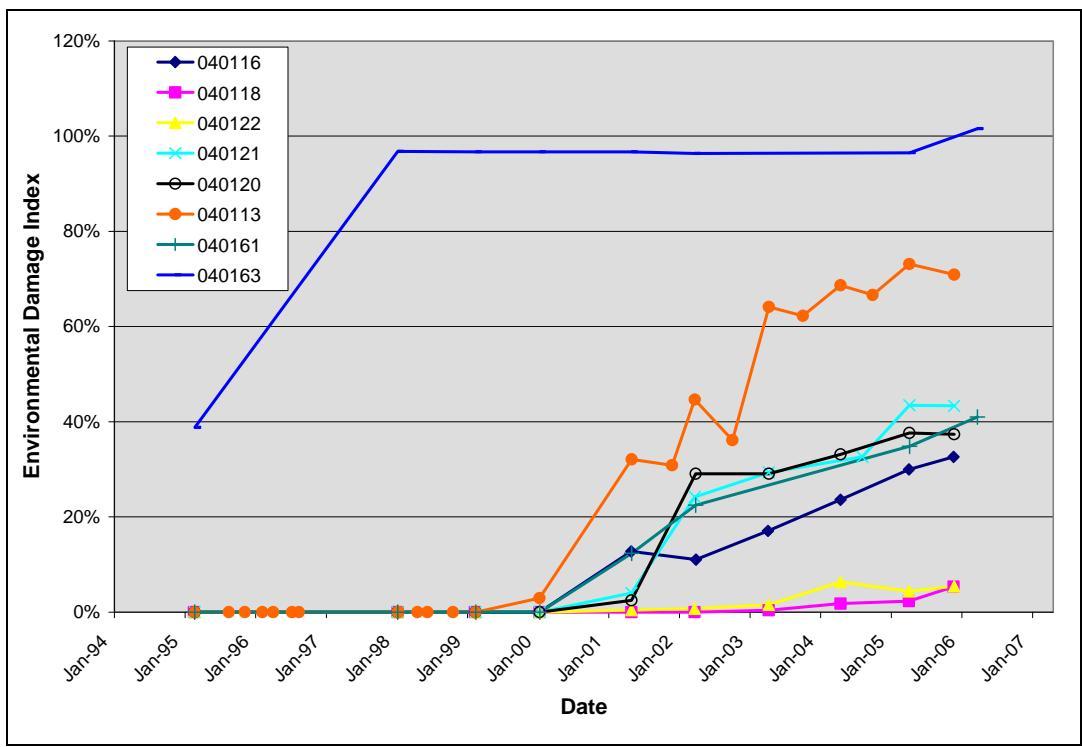
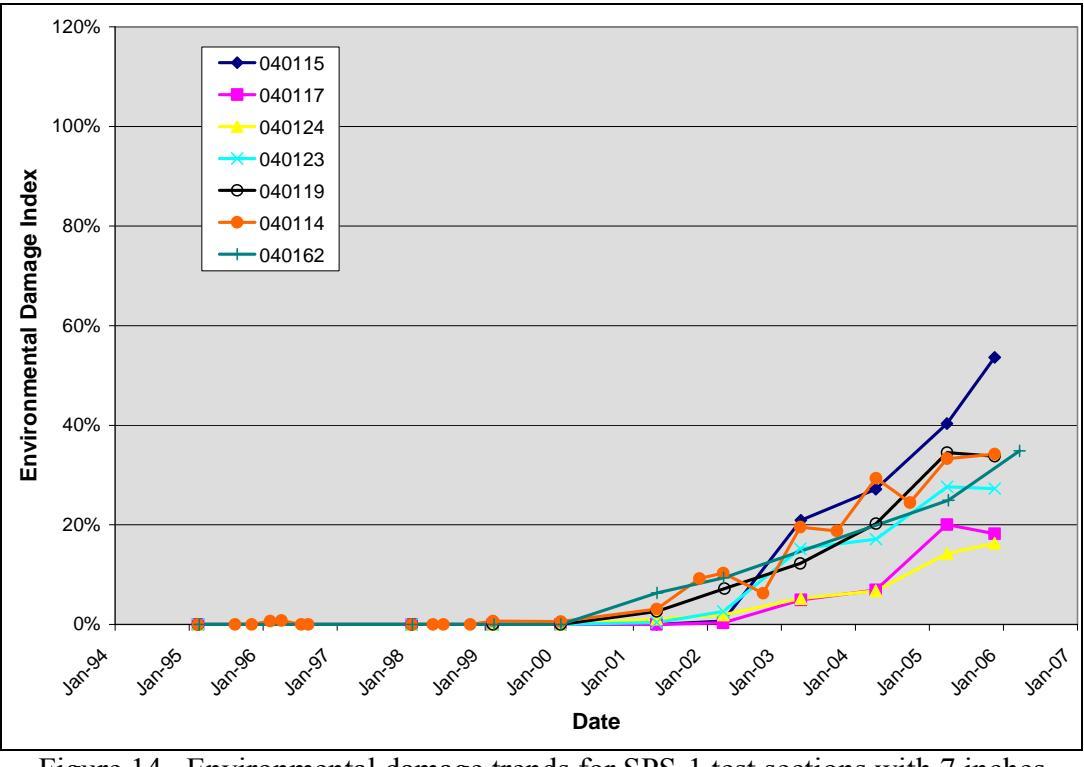
The overall environmental damage trends for each section can be found in Figures 13 and 14. The performance trends are relatively consistent and within the expected range of variation. Although slight decreases were somewhat discernible for surveys within a year of the slurry seal, environmental distresses clearly increased in magnitude approximately 10 years after construction, and there is not a clear indication that the slurry seal provided any abatement to environmental distress. In fact, environmental damage was observed reflecting through the slurry seal on some sections approximately seven months after placement.

Timing of surface applications is critical to the effectiveness of the treatments. Figures 4 through 7 indicate that the majority of sections had very little cracking in 1998 and the cracking that was present was likely to be of low severity. Applying the slurry seal in 1998 may have resulted in slower deterioration and improved effectiveness of the treatment.

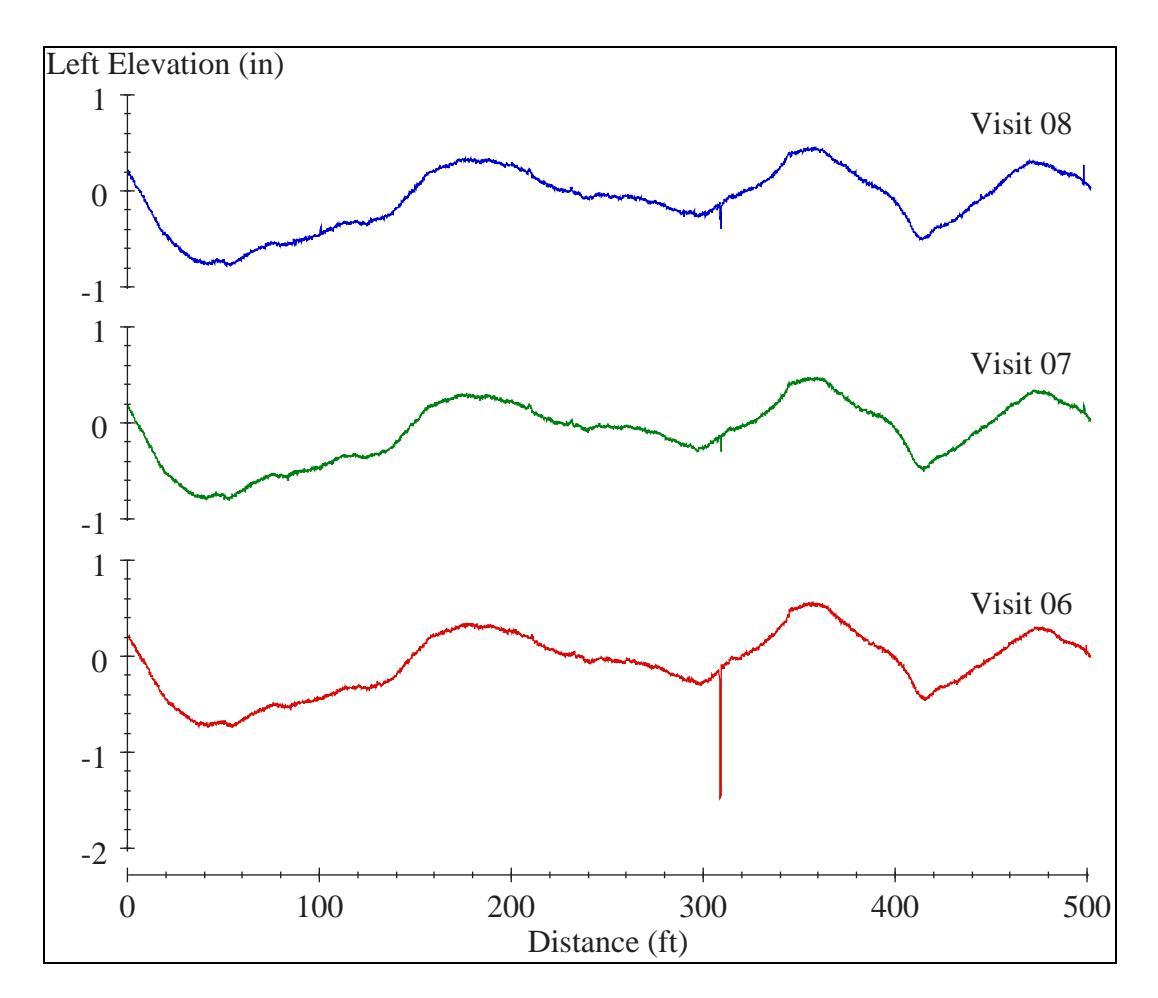
Figure 38. Raw profiles of section 0122.

A simple way to learn about the type of roughness that exists within a profile is to view the trace. However, certain key details of the profile are often not as obvious in a raw profile trace as they may be after the profile is filtered. For example, Figure 38 shows the left raw profile trace for three visits of section 0122. The plot shows that the long wavelength content, or the trend, in each plot is quite consistent with time. However, a narrow dip appears about 309 ft from the start of the section which is much more severe in visit 06 because the profile tracked directly over it.

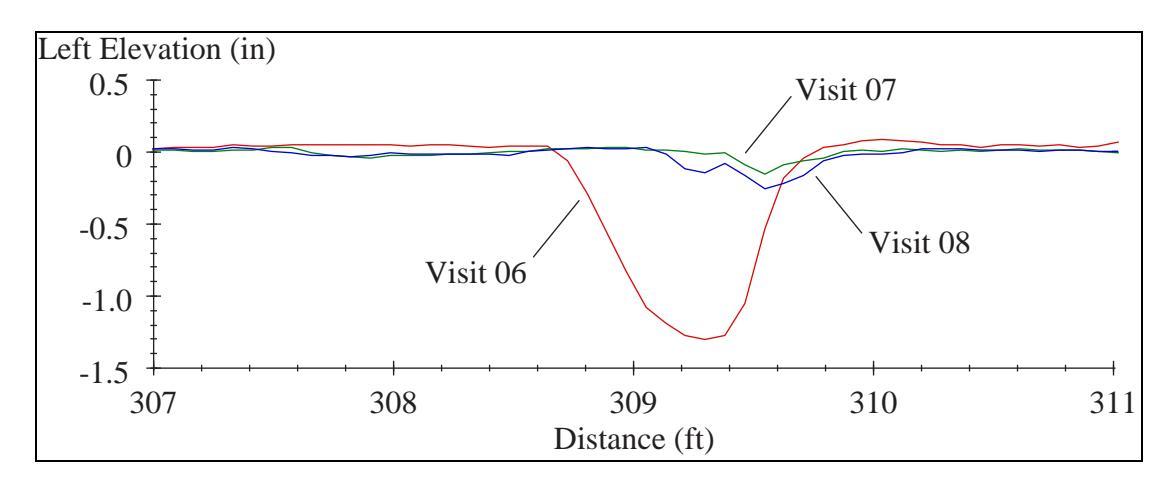
Figure 39. Filtered profile of section 0122.

Although the raw profile plots in Figure 20 provide very useful information about the nature of the roughness on section 0122, a filtered plot may provide a more detailed look at short-duration features of interest, such as the dip at 309 ft. Figure 39 shows a small segment of the profile after it has been high-pass filtered. In this case, a moving average (smoothing) filter with a base length of 20 ft was applied to the profile, and the result was

subtracted from the raw profile. Without the filter, the large changes in elevation along the profile may have masked the dip in visits 07 and 08, such that they may have been ignored. When the profile is filtered, the dip and its shape are much easier to evaluate.

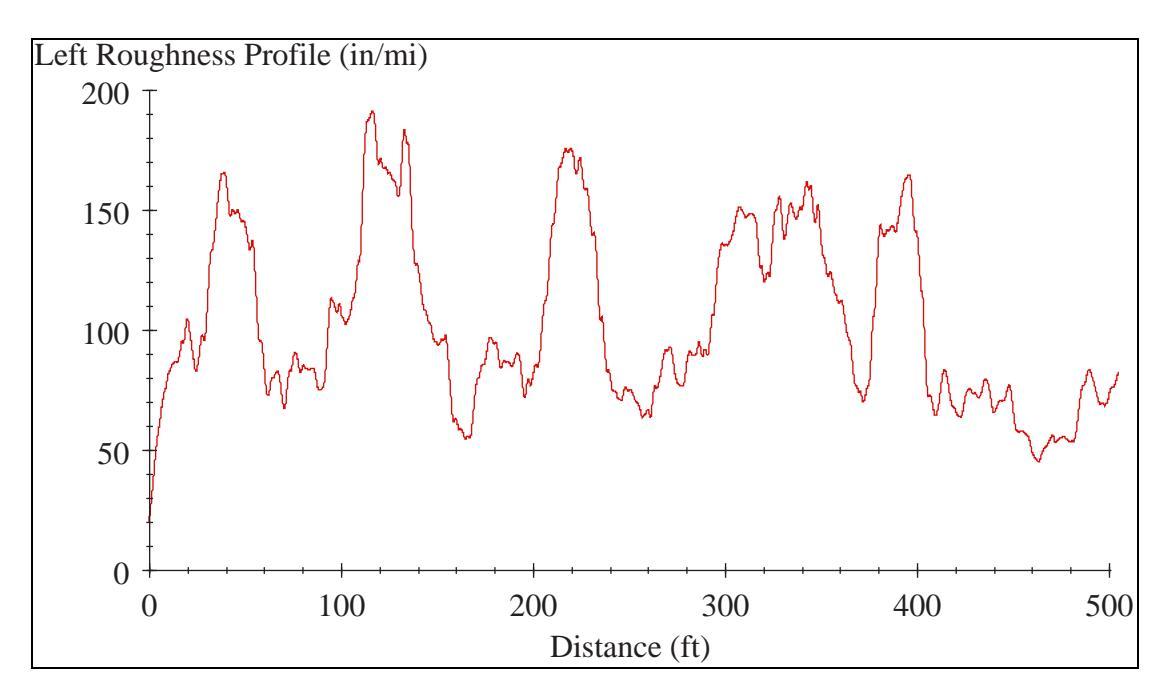
Figure 41. Roughness profile of section 0160, 25-ft base length.

Figure 41 shows an example of a roughness profile for visit 08 of section 0160. The roughness profile was generated using a base length of 25 ft. That means that every point in the plot shows the IRI of a 25-ft long segment of road, starting 12.5 ft upstream and ending 12.5 ft downstream. The plot shows several areas of elevated roughness over the first 400 ft. The smoothest 100 ft segment appears from 400 ft to 500 ft from the start of the section, but it is no smoother than the areas between isolated rough spots over the first 400 ft. Note that isolated roughness is absent over the last 100 ft of the section because it was diamond-ground to smooth the section for an approach to a weigh-in-motion scale just downstream of the section.

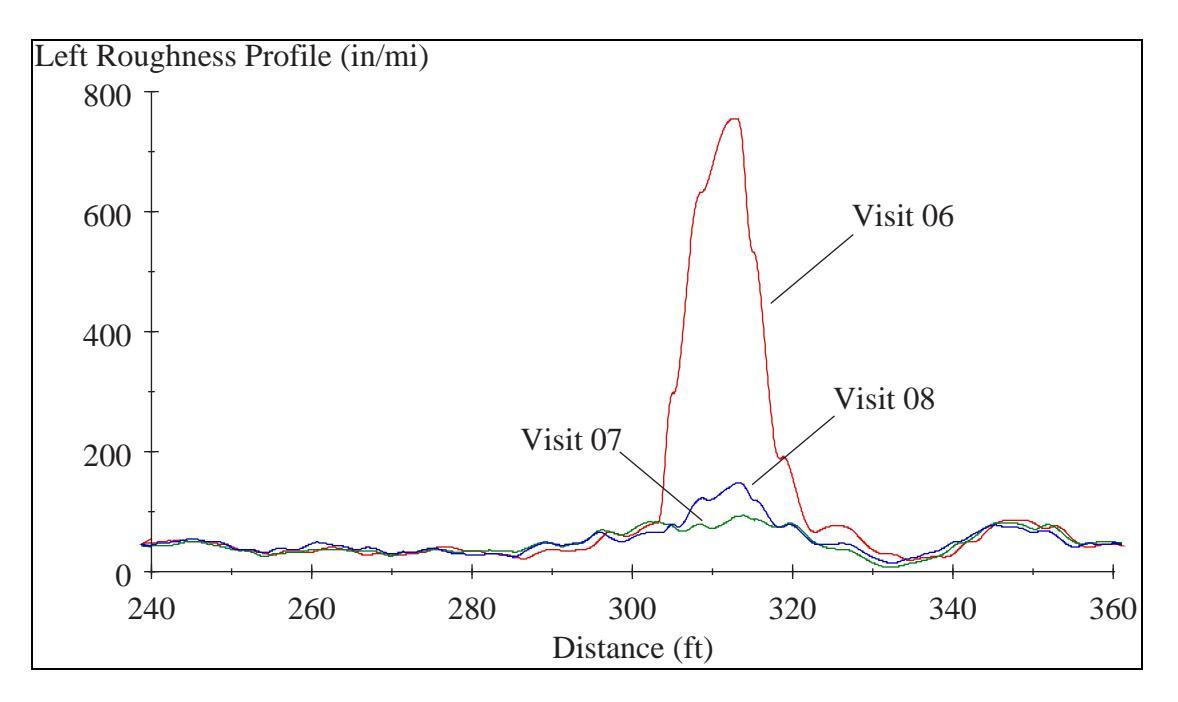
Figure 42. Roughness profile of section 0122, 10-ft base length.

Figure 42 shows how a roughness profile can help find and quantify isolated roughness. The figure shows the roughness profile of section 0122 using a 10 ft base length for visits 06, 07 and 08. With a 10 ft base length, isolated roughness is easy to identify. In visit 06, the peak roughness at the dip is about 755 in/mi. In the same location, the roughness is 88 in/mi. This is a difference of 667 in/mi over 10 ft. Since that value represents the roughness over just one fiftieth of the segment, it suggests that the single dip contributes about 13 in/mi to the overall IRI of the section. This is most of the difference between the IRI in visits 06 and 07.

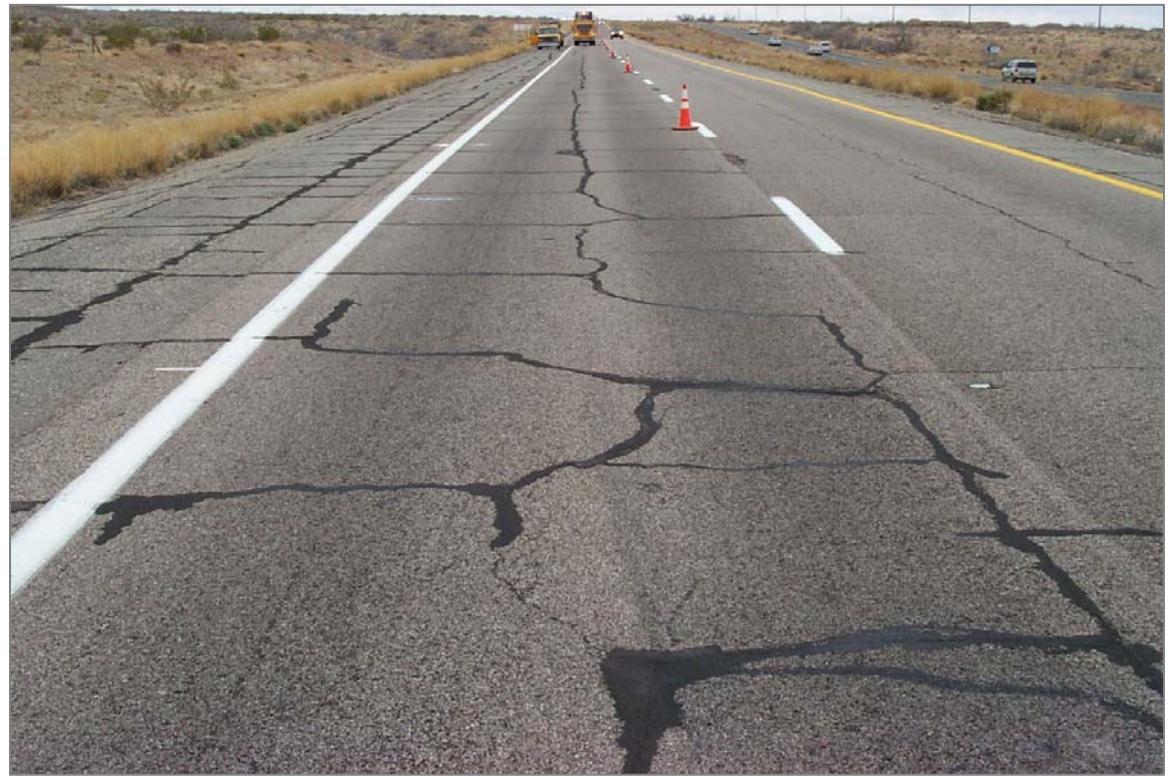
Figure 45. Section 0163 showing long dip in last 100 ft.

The long dip in the last 100 ft of the section appears clearly in Figure 45 below. This is certainly considered a rough feature by passing vehicles.
