Evaluation of Salvage and Replanted Native Plants on ADOT Projects

Final Report 587
June 2012

Arizona Department of Transportation
Research Center

Logan Simpson Design, Inc.
51 West Third Street, Suite 450
Tempe, AZ 85281

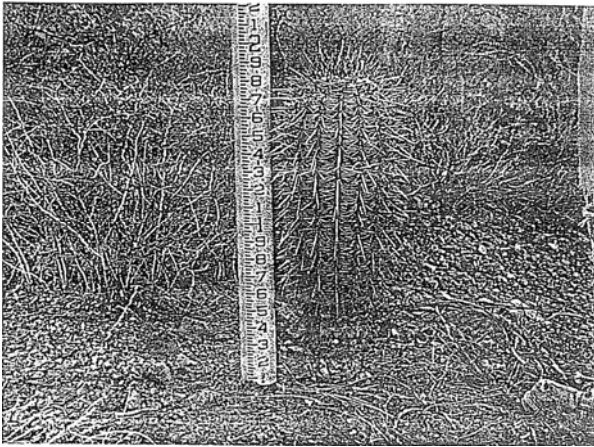
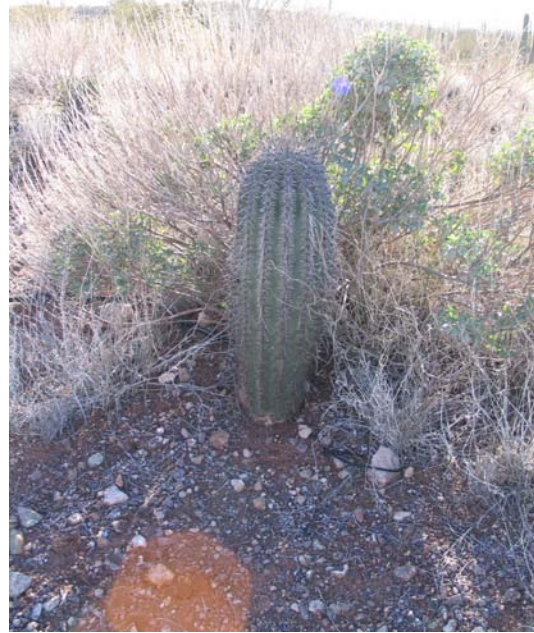
Above: Contractor's presalvage photo of saguaro tag #71, 2002.

Right: Saguaro in excellent condition at time of inventory, January 28, 2008. Original tag #71, LSD #166.

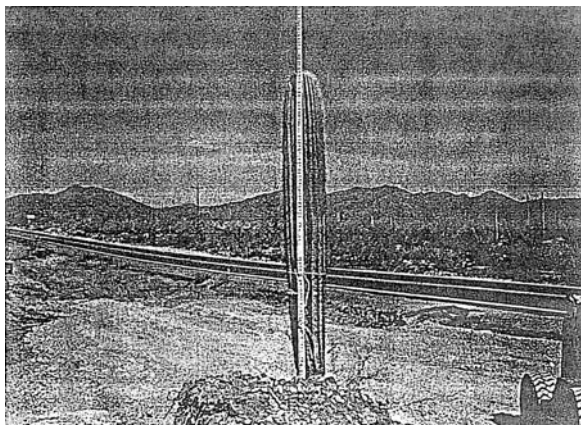
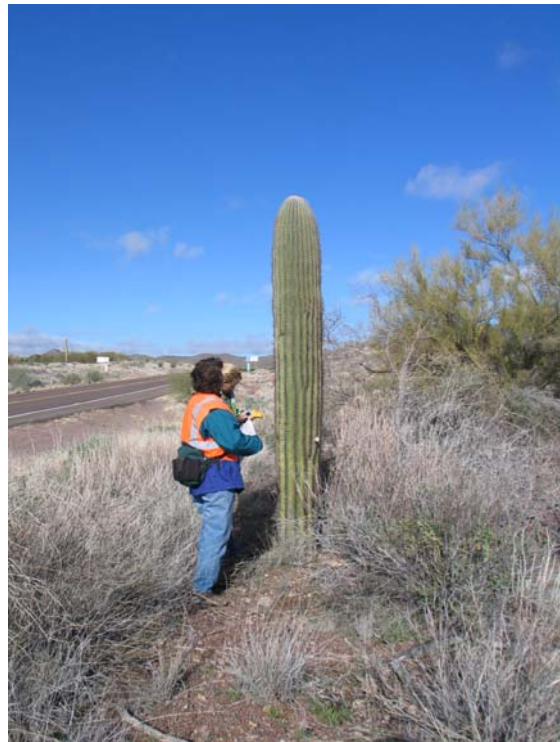
Above: Contractor's presalvage photo of saguaro tag #36.

Right: Saguaro in good condition at time of inventory, January 28, 2008. Original tag #36, LSD #100.

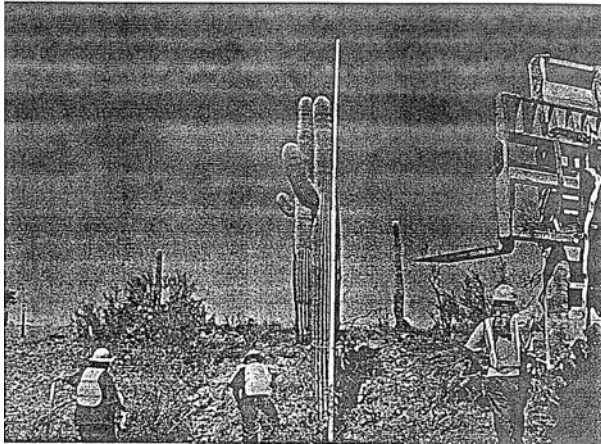
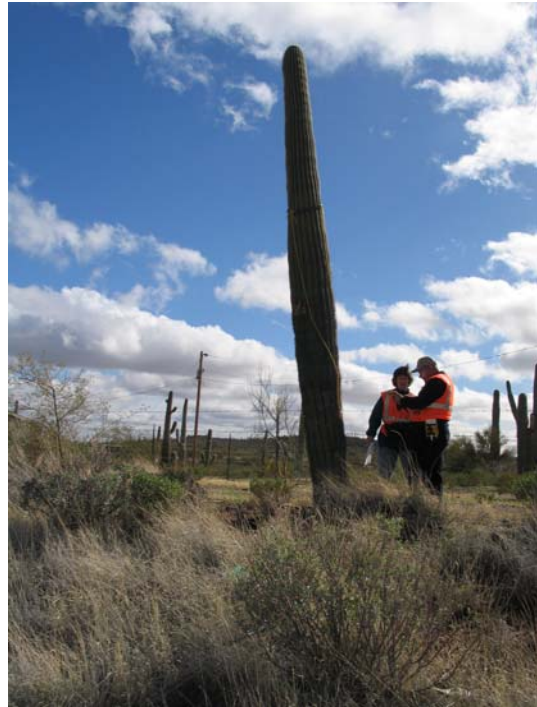
Above: Contractor's presalvage photo of saguaro tag #40.

Right: Saguaro in fair condition at time of inventory, January 28, 2008. Original tag #40, LSD #136.

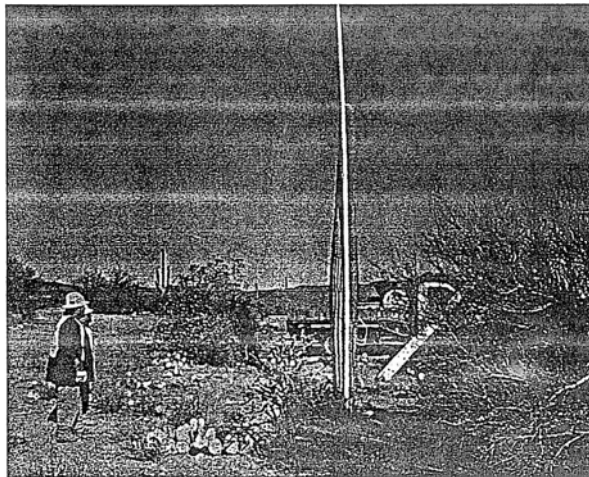
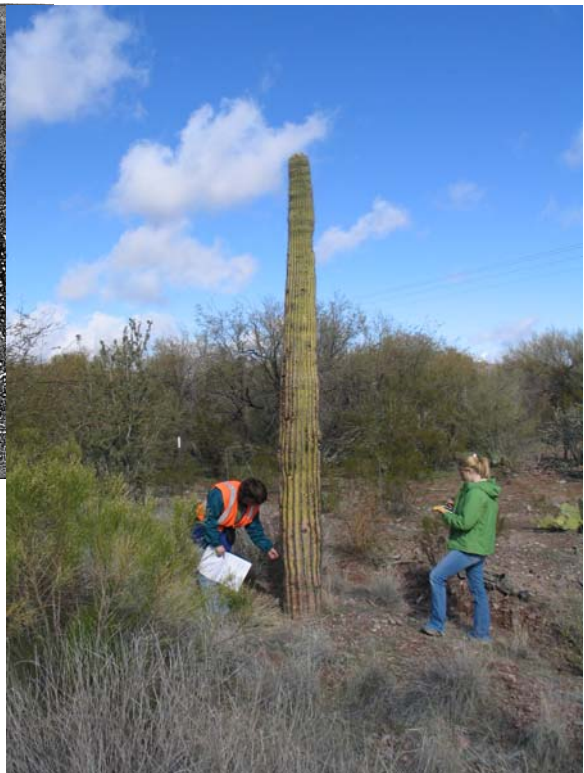
Above: Contractor's presalvage photo of saguaro tag #50.

Right: Saguaro in poor condition at time of inventory, January 28, 2008. Original tag #50, LSD #114.

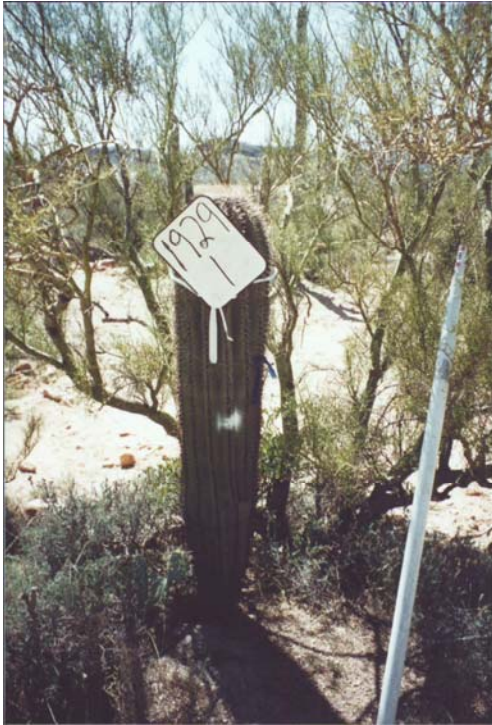
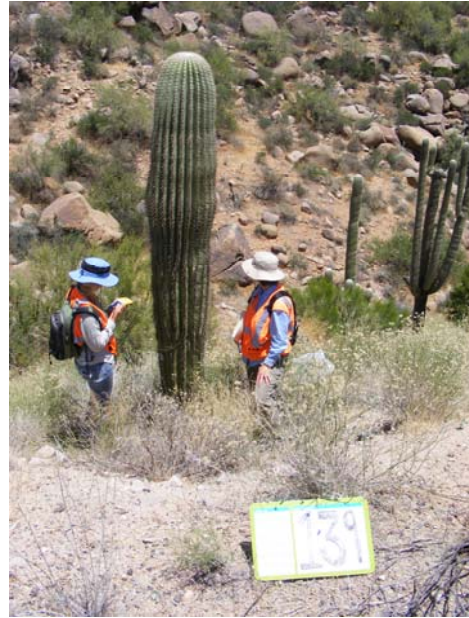
Left: Contractor's presalvage photo of saguaro tag #1929-1.

Above: Saguaro in excellent condition at time of inventory, June 19, 2008. Original tag #1929-1, LSD #139.

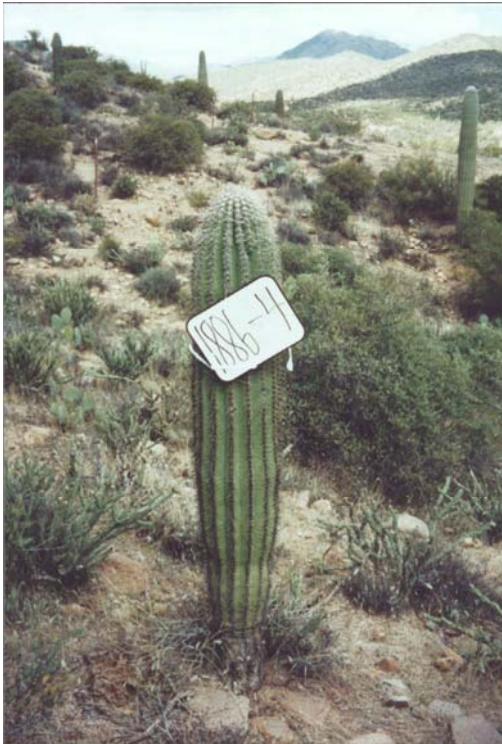
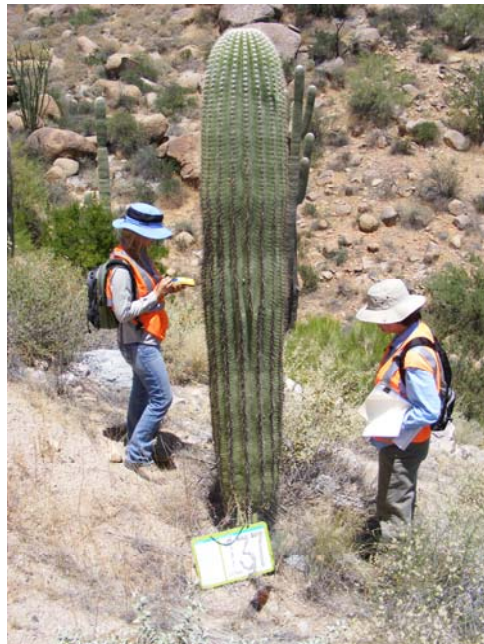
Above Left: Contractor's presalvage photo of saguaro tag #1886-4.

Above Right: Saguaro in good condition at time of inventory, June 19, 2008. Original tag #1886-4, LSD #137.

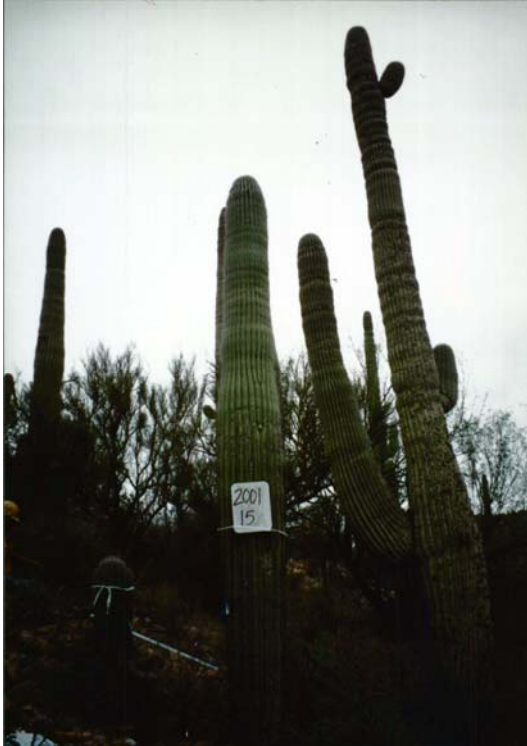
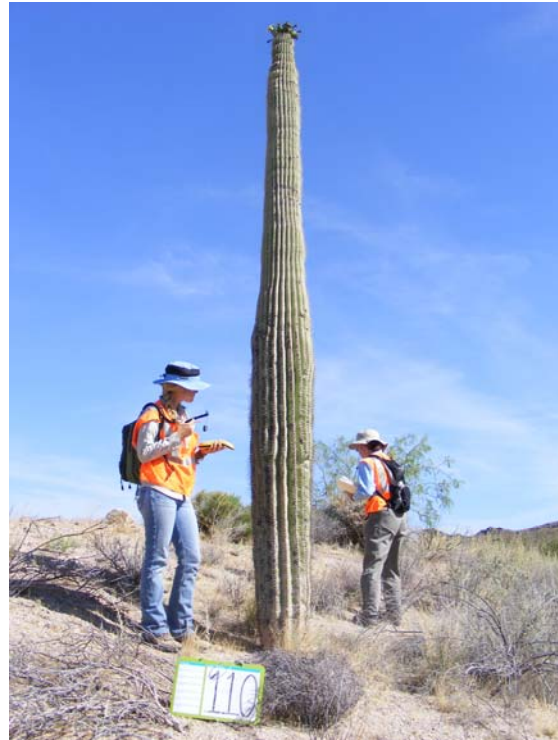
Above: Contractor's presalvage photo of saguaro tag #2001-15.
Right: Saguaro in fair condition at time of inventory, June 19, 2008.
Original tag #2001-15, LSD #110.

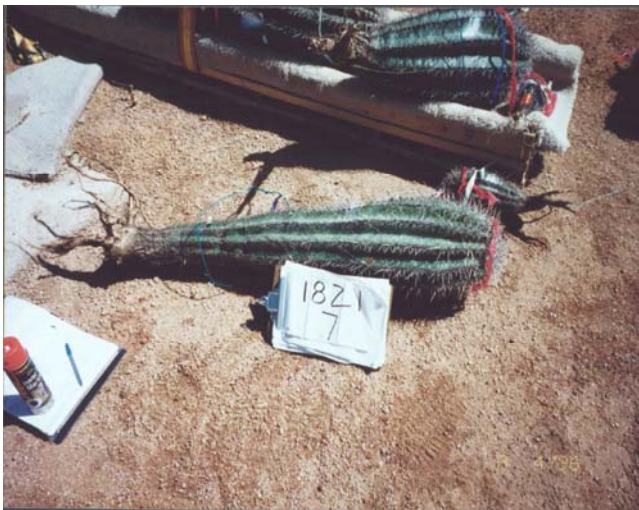
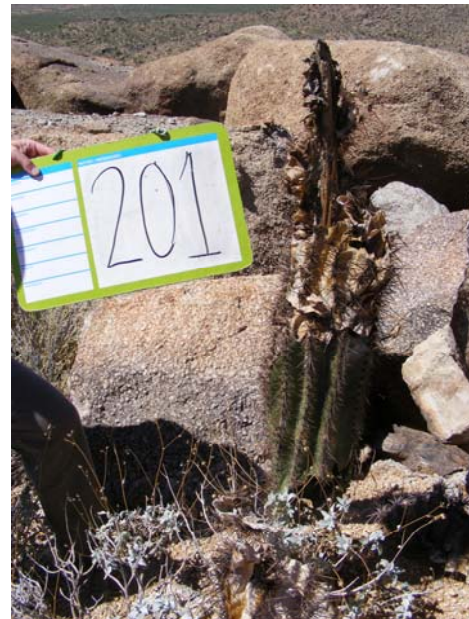
Above: Contractor's presalvage photo of saguaro tag #1821-7.
Right: Saguaro in poor condition at time of inventory, June 19, 2008.
Original tag #1821-7, LSD #201.

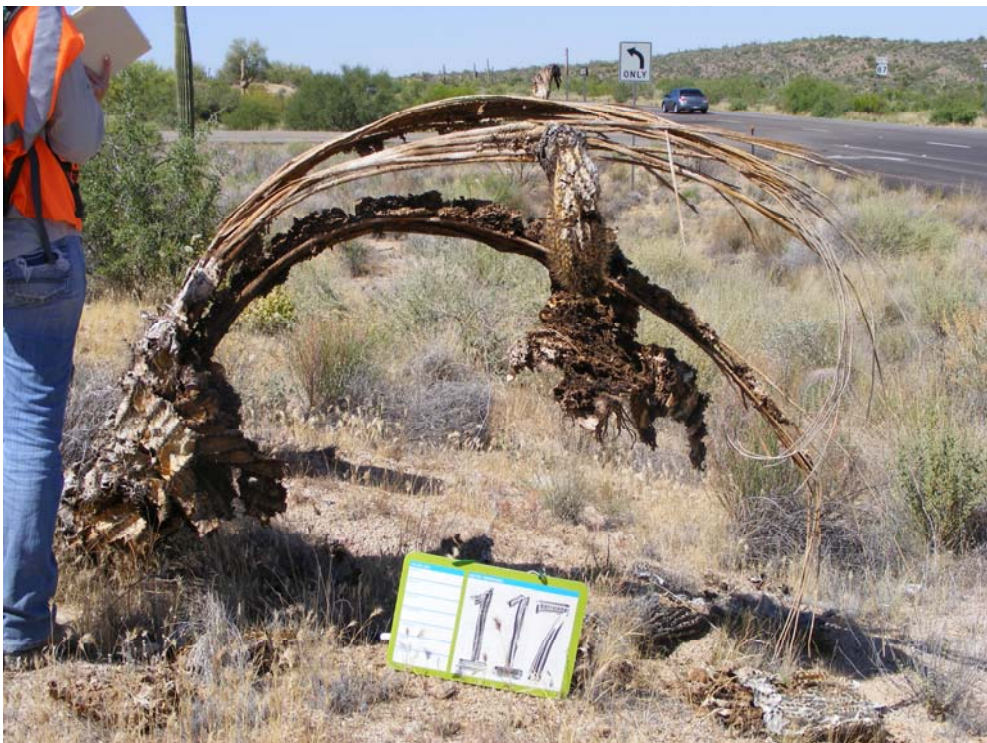
Below: Saguaro dead at time of inventory, June 19, 2008.
Original tag #1670-17, LSD

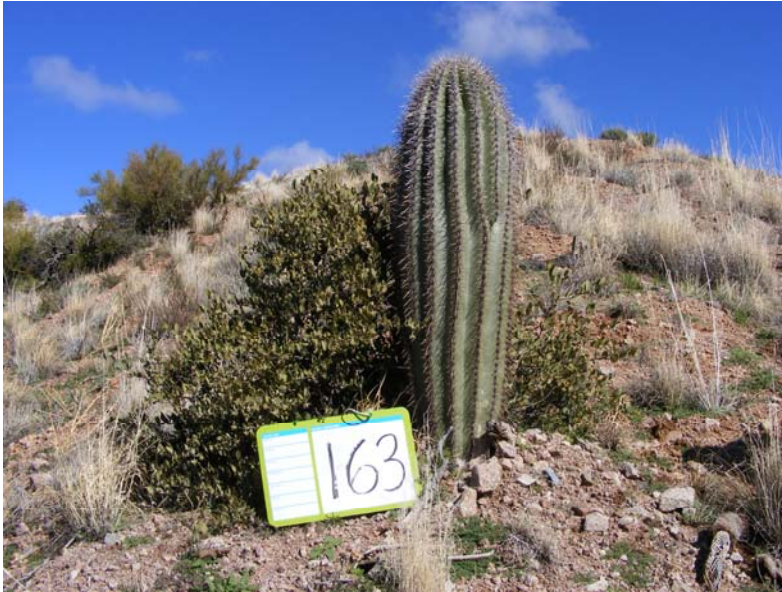
Left:
Saguaro in excellent condition at time of inventory, February 5, 2008.
Original tag #N/A, LSD #163.
NOTE: No Contractor's presalvage photo available.

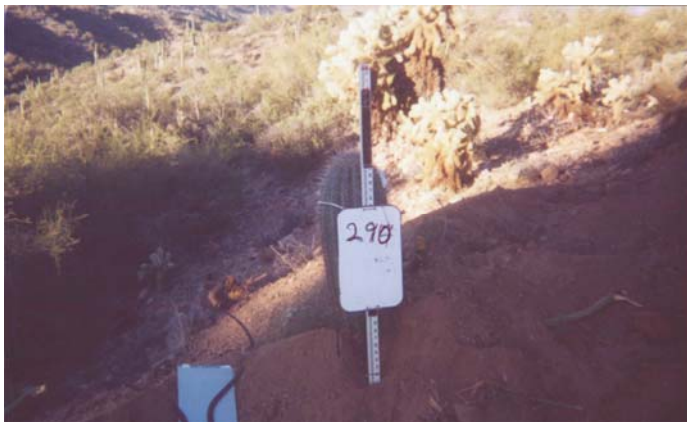
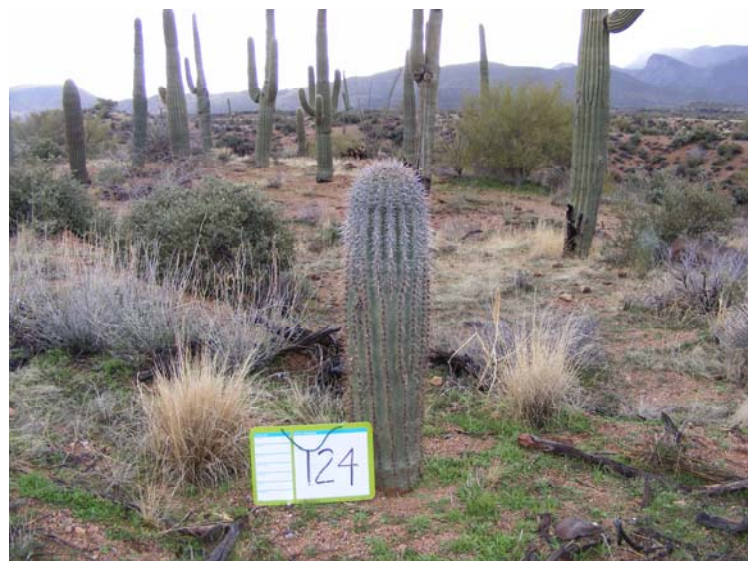
Left:
Contractor's presalvage photo of saguaro tag #290.

Right:
Saguaro in good condition at time of inventory, February 4, 2008.
Original tag #290, LSD #124.

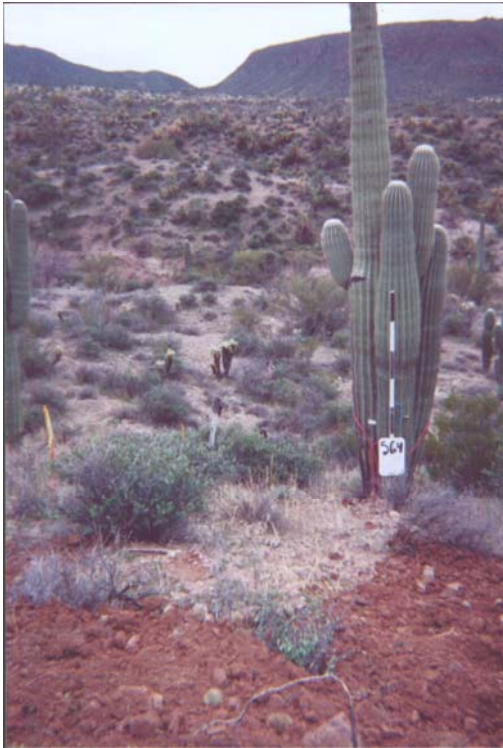
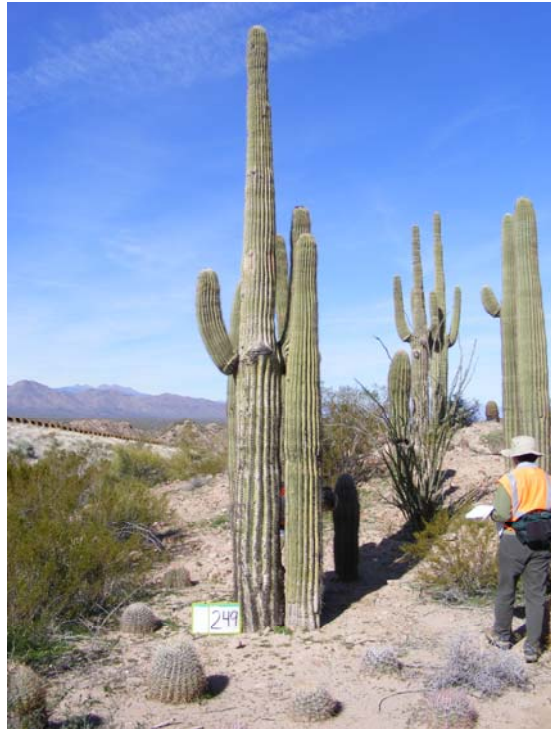
Above, Left: Contractor's presalvage photo of saguaro tag #564.
Right: Saguaro in fair condition at time of inventory, February 13, 2008.
Original tag #564, LSD #249.

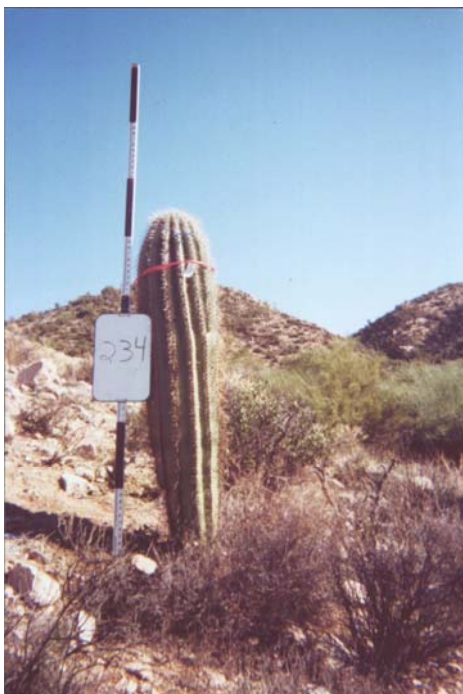
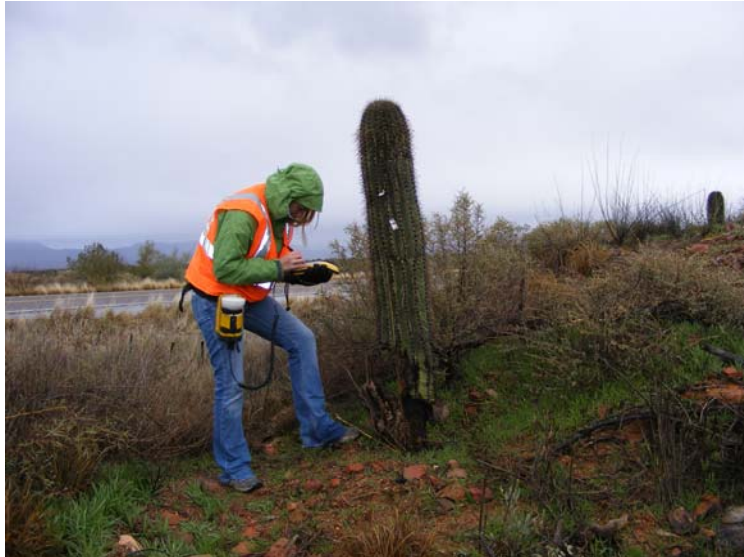
Left: Contractor's presalvage photo of saguaro tag #234.

Right: Saguaro in poor condition at time of inventory, February 4, 2008. Original tag #234, LSD #106.

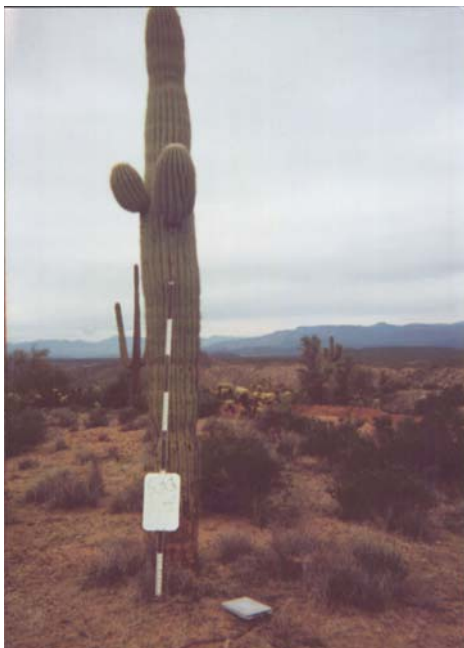
Above: Contractor's presalvage photo of saguaro tag #530.
Right: Saguaro dead at time of inventory, February 13, 2008. Original tag #530, LSD #246.

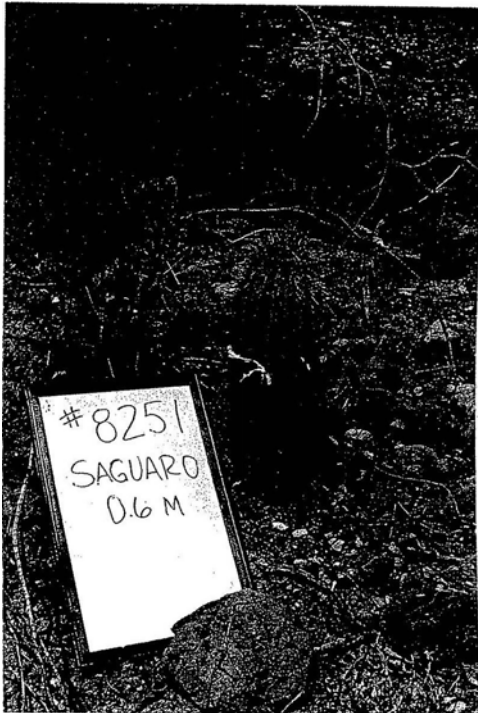
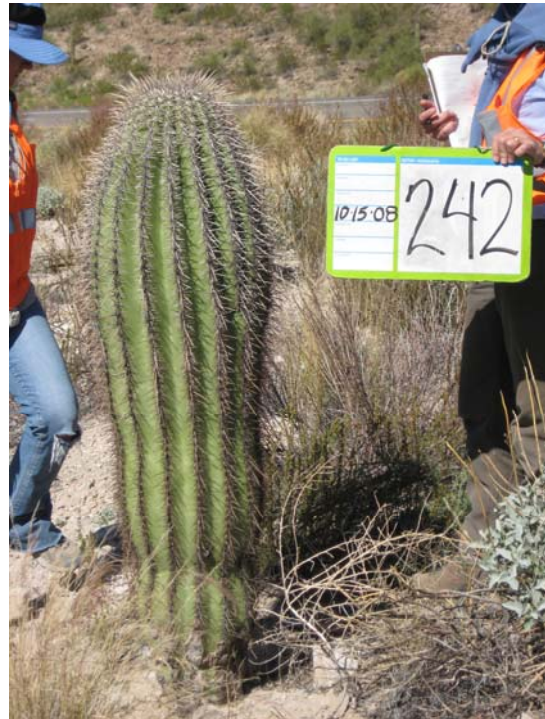
Left: Contractor's presalvage photo of saguaro tag #8251.
Right: Saguaro in excellent condition at time of inventory, October 15, 2008.
Original tag #8251, LSD #242.

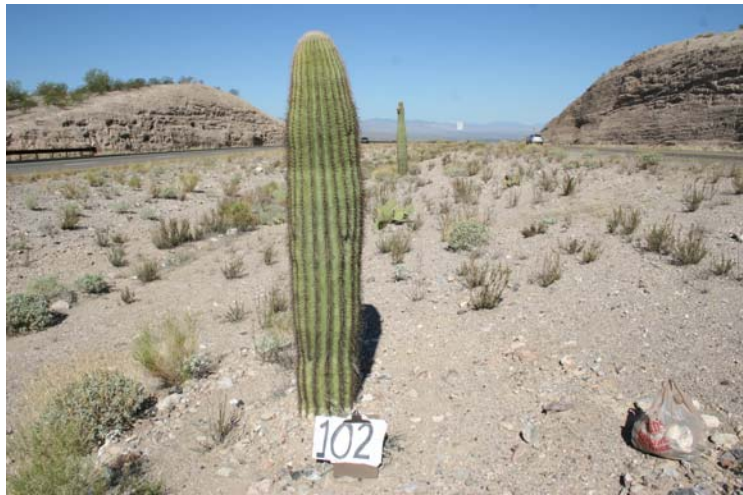
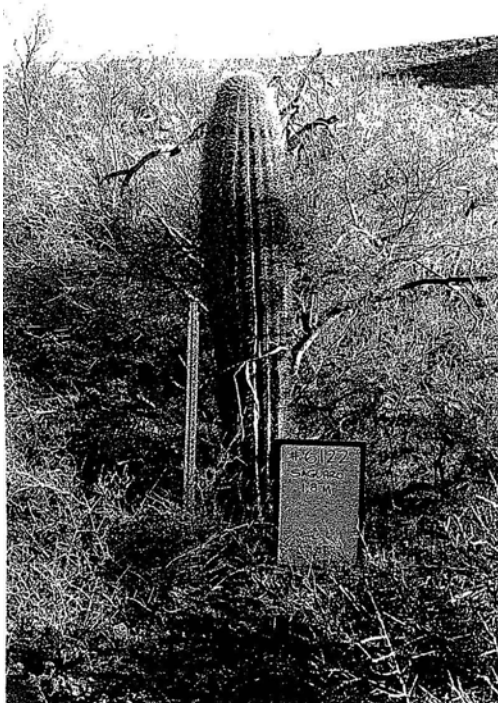
Left: Contractor's presalvage photo of saguaro tag #6122.
Above: Saguaro in good condition at time of inventory, October 9, 2008.
Original tag #6122, LSD #102.

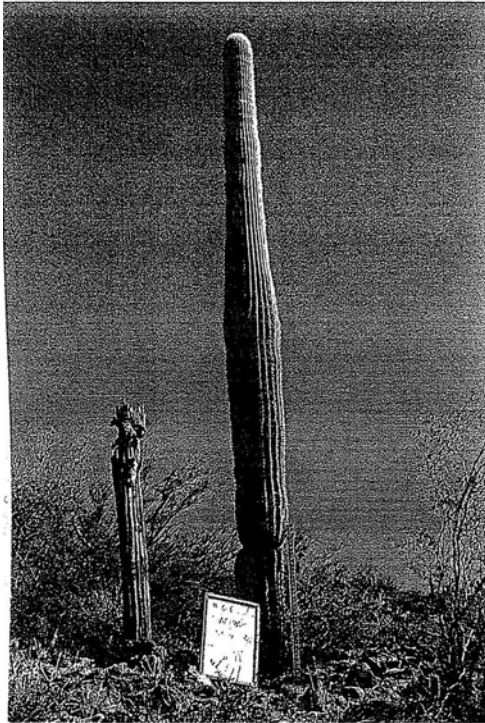
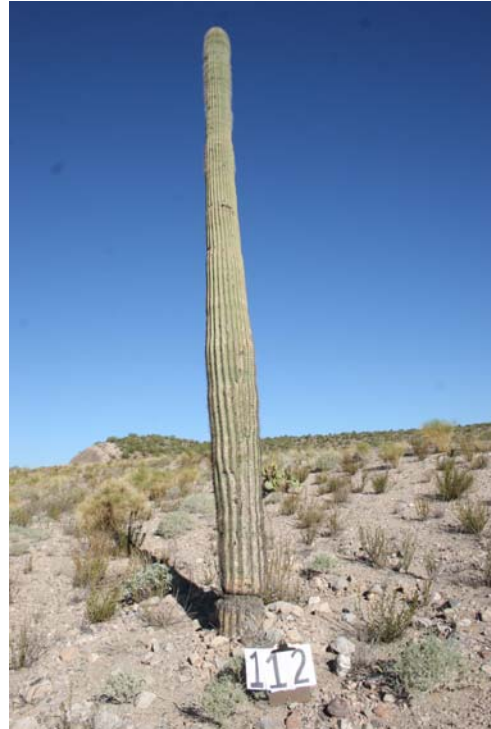
Above Left: Contractor's presalvage photo of saguaro tag #6655.
Above Right: Saguaro in fair condition at time of inventory, October 9, 2008.
Original tag #6655, LSD #112.

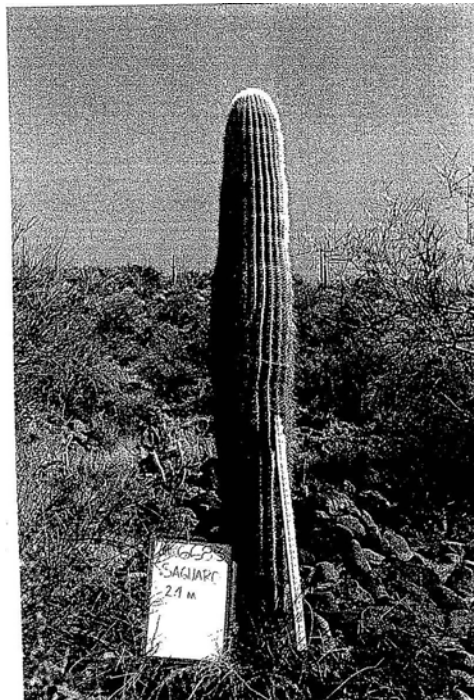
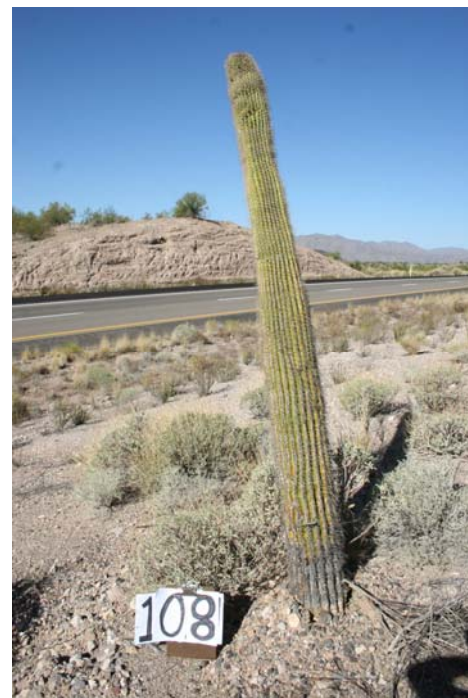
Above Left: Contractor's presalvage photo of saguaro tag #6683.
Above Right: Saguaro in poor condition at time of inventory, October 9, 2008.
Original tag #6683, LSD #108.

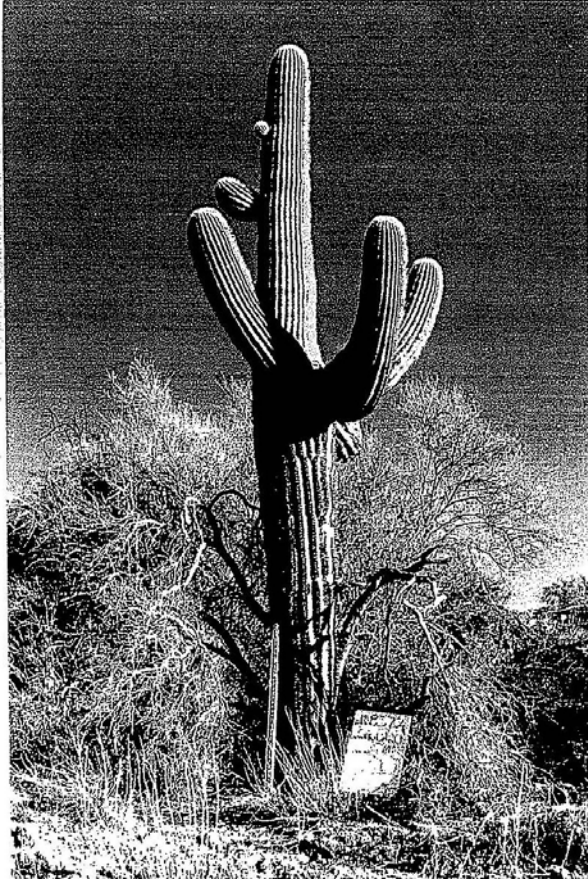
Left: Contractor's presalvage photo of saguaro tag #8372.
Below: Saguaro dead at time of inventory, October 9, 2008. Original tag #8372, LSD #135.
