Determination of Section 404 Permit and Habitat Mitigation Requirements

Final Report 589
September 2012

Arizona Department of Transportation
Research Center

Greg Martinsen, Timothy Wade, and Tricia Balluff
EcoPlan Associates, Inc.
701 West Southern Avenue, Suite 203
Mesa, Arizona 85210

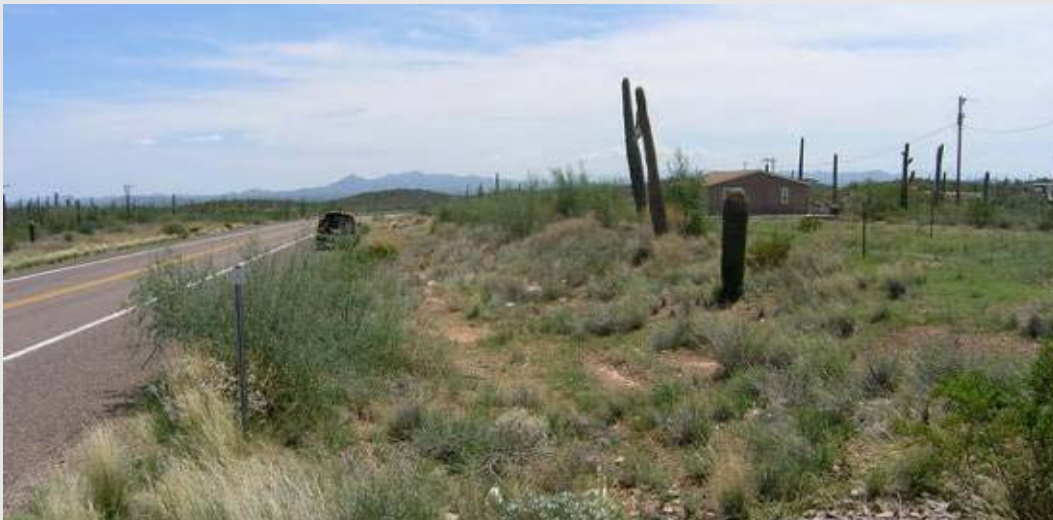
Conclusions: Clearly supplemental irrigation was provided to saguaros and nursery-grown trees for some period following their planting. Given their high survivorship, the mitigation effort was successful. Many blue paloverde and mesquite trees bore seed pods, and recruitment was high. Plants apparently incorporated within the reseeding mix, such as brittlebush, desert marigold, galleta grass, and purple three-awn, are thriving. Recruitment of perennial shrub species from the surrounding Sonoran desertscrub community also appeared to be high.

Figure 6. Relocated Saguaros at the Western End of the Covered Wells, Why–Tucson Highway (SR 86) Project Site.

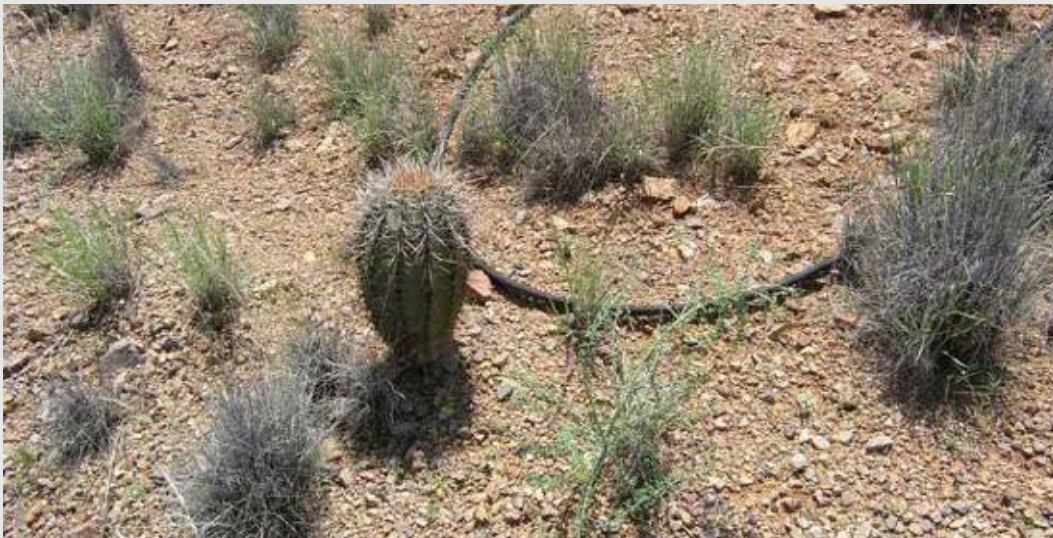
Figure 7. An Actively Growing Saguaro Near the Irrigation Tube at the Covered Wells, Why–Tucson Highway (SR 86) Project Site.

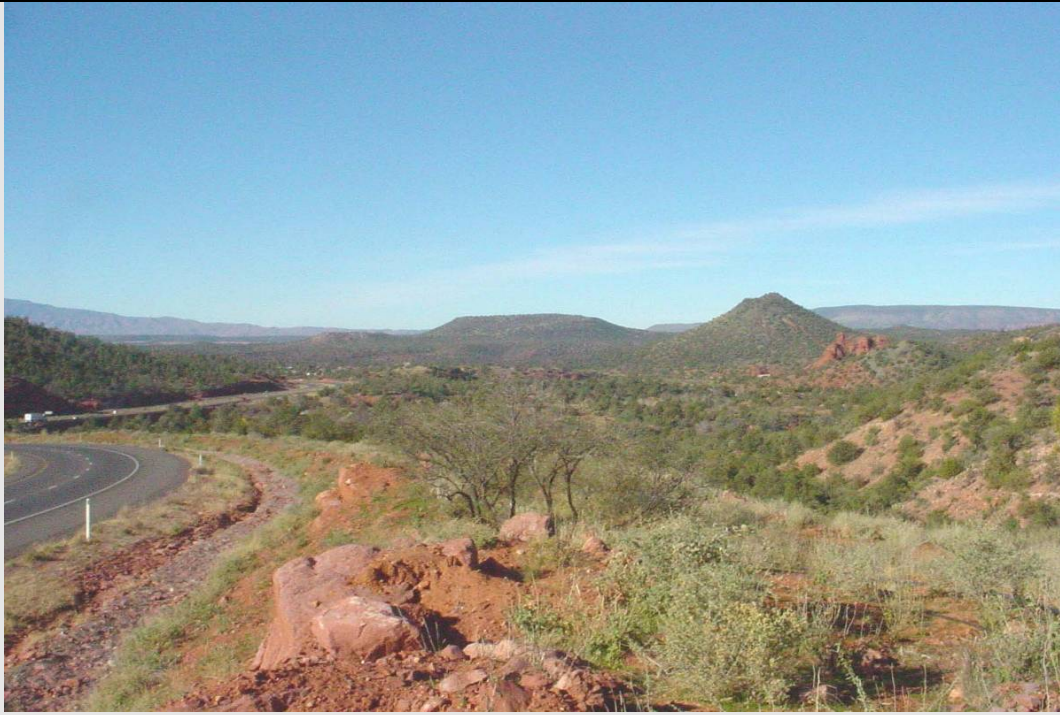
Figure 9. Revegetated Area Adjacent to and West of the SR 89A, Cornville Road to Sedona Project Site (Facing South).

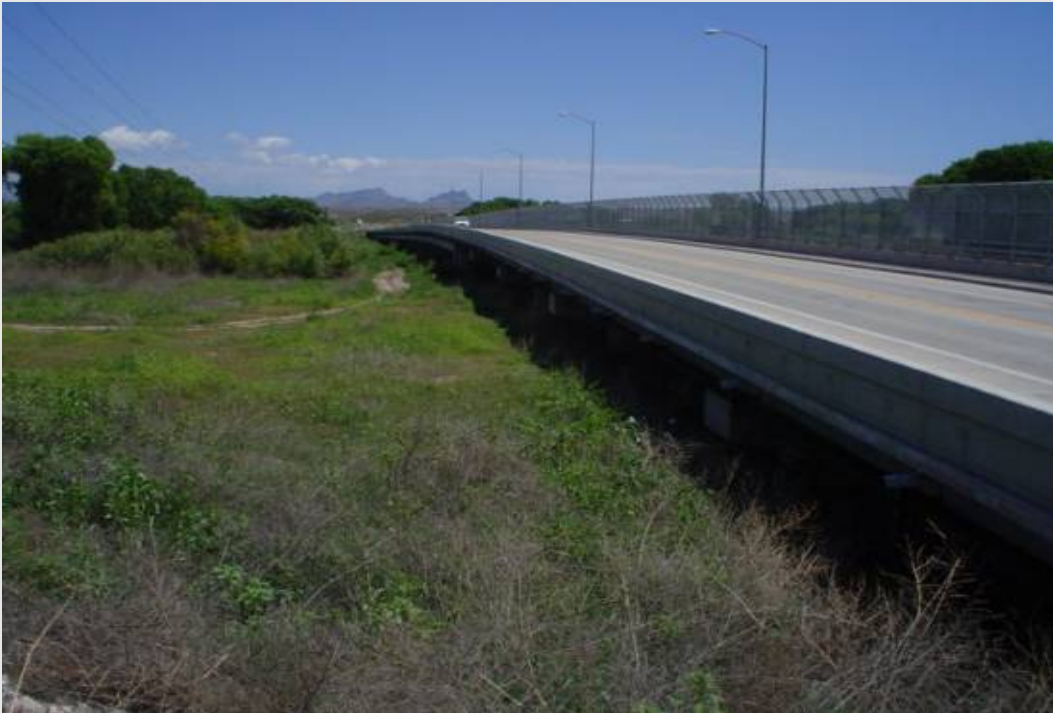
Site Visit: EcoPlan conducted a site visit on August 19, 2008. No pole plantings appeared to have been planted on the site (Figure 10). However, naturally recruited willow (*Salix* sp.), mesquite (*Prosopis* sp.), and tamarisk (*Tamarix* sp.) make the mitigation area appear healthier than before construction (Figure 11). There was evidence of postproject all-terrain vehicle use in the floodplain. There were no trees growing higher in the floodplain.

Conclusions: No conclusions can be drawn about the effectiveness of mitigation practices on this site because mitigation did not occur. However, riparian vegetation was developing in patches through natural recruitment near the river, likely due to the presence of perennial water.

Figure 10. The 40-Foot-Wide Mitigation Strip Along the West Side of the SR 75, Gila River Bridge #311 Project Site.

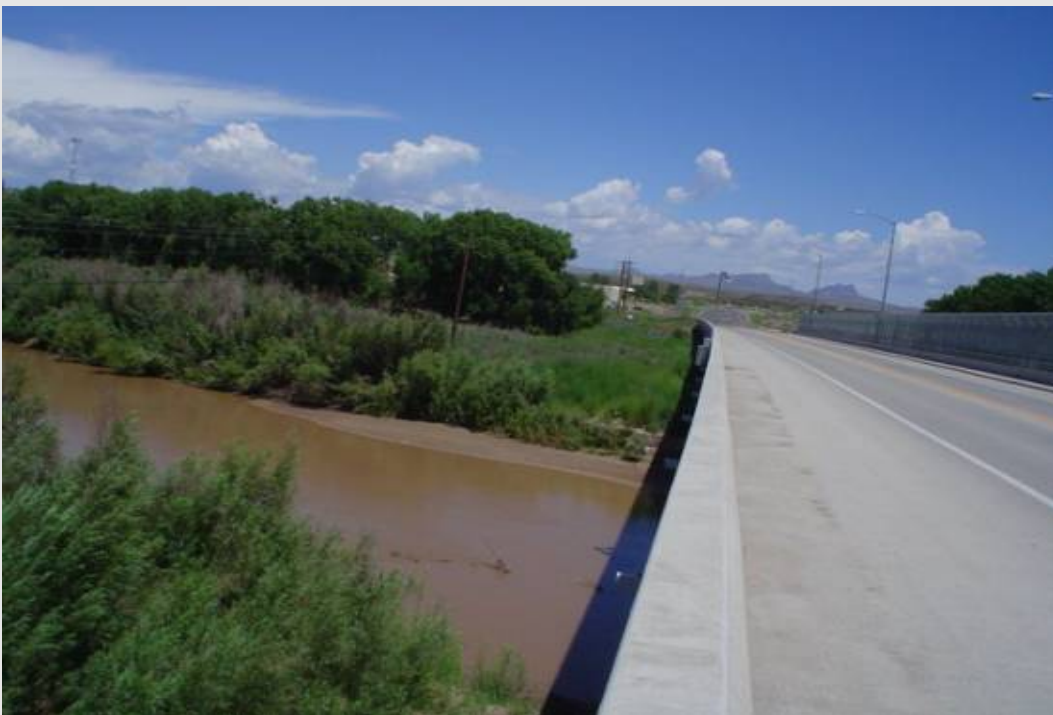
Figure 11. Dense, Naturally Recruited Riparian Trees Along the West Side of the SR 75, Gila River Bridge #311 Project Site.

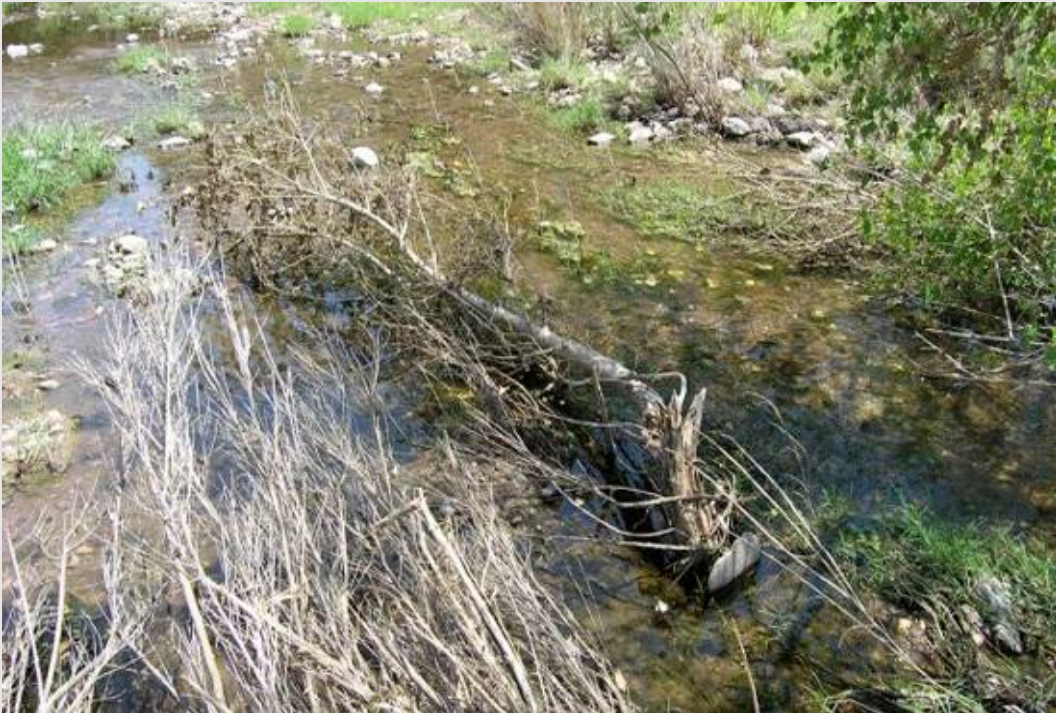
Figure 12. Pole Planting Knocked Down by Flooding at Peck Canyon Bridges Project Site, Between the Frontage Road and the I-19 Bridges.

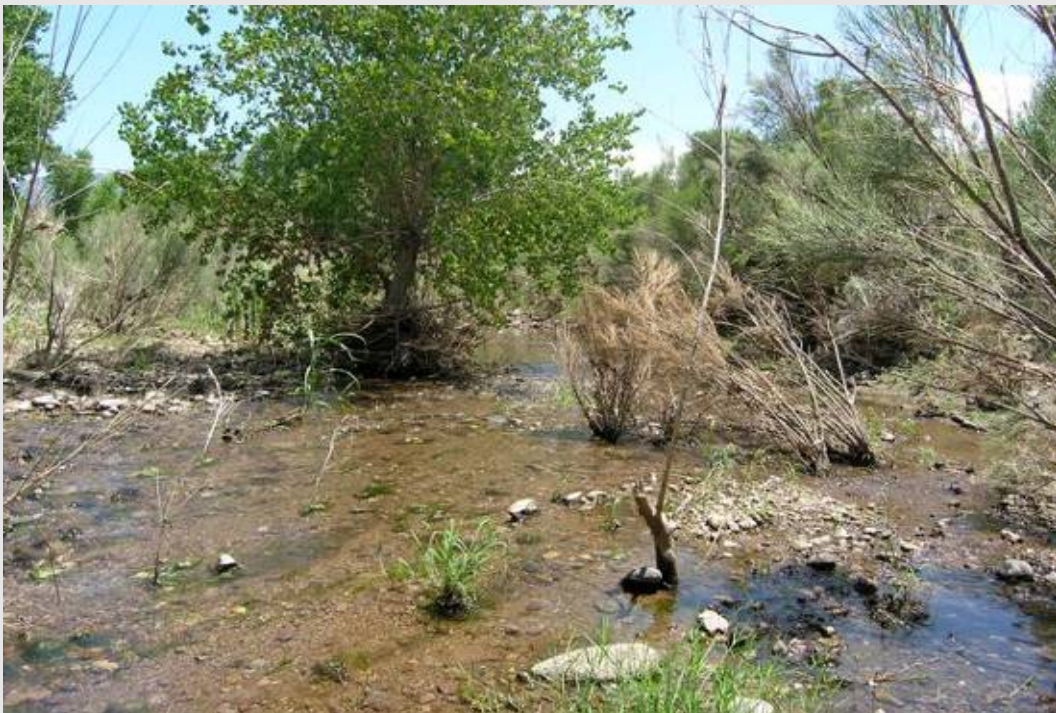
Figure 13. Growing and Dead Pole Plantings Downstream at the Peck Canyon Bridges Project Site.
