# **SECTION 1: BACKGROUND AND INVENTORY**

## **GILA BEND MUNICIPAL AIRPORT AIRPORT MASTER PLAN 2003**

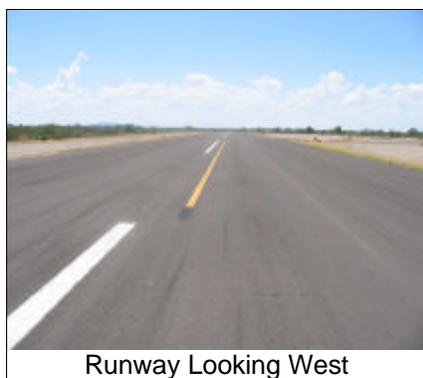
The Runway 4/22 surface has been classified as being in generally Fair condition. Random sealed surface cracking is in evidence to varying degrees along the runway. Recent pavement preservation in the form of crack sealing and slurry sealing has addressed these surface deficiencies for the short term.

In terms of structural integrity, Runway 4/22 is sound and has been classified as Good.

The runway shoulders are relatively clear of vegetation. They are appropriately graded and maintained to assure adequate drainage. Some erosion was noted along the shoulders and around culverts.

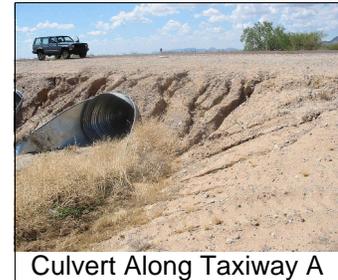
The surface condition of the 1985 section of Taxiway A is classified as Fair and the 1999 portions are considered to be in Good condition.

Taxiway A is structurally sound and has been classified as Good.

The taxiway shoulders are relatively clear of vegetation. They are appropriately graded and maintained to assure adequate drainage. However, some erosion was noted along the shoulders and around culverts.

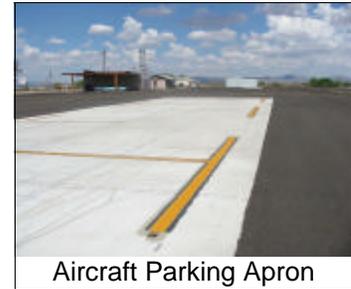
The existing Aircraft Parking Apron was originally constructed in four phases. The eastern most section was a part of the original 1965 airport development. It was built using a pavement section consisting of 2" of AC over 6" of ABC. The 1965 section was overlaid with 2" of AC in 1979, when the apron was also expanded toward the west. The 1979 section consisted of 2" of AC over 6" of ABC. The Apron was again expanded in 1985 using the same pavement section. The entire Apron was given a flush coat in 1986 and a seal coat in 1995. The Aircraft Parking Apron was completely reconstructed in 2002. The taxiway areas used a pavement section of 2" AC over 6" of ABC over compacted subbase material. Aircraft parking areas used a pavement section of 5" PCC over compacted subbase material. Structure and surface are Good.

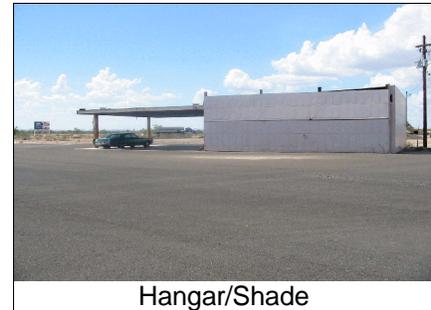
The existing Hangar/Shade is a 40' x 80' steel frame structure. One-half of this structure (40' x 40') has been enclosed as a hangar, with a steel bifold door and steel siding. The siding is of a nonstandard material salvaged from surplus military shelving. The remaining half of the structure (40' x 40') serves as a covered aircraft parking shade. The Hangar/Shade's structure is in Good condition. The nonstandard steel siding is in Poor condition,

exhibiting rust and loose panels. The hangar door is in Fair condition. This structure is owned by the Town of Gila Bend.

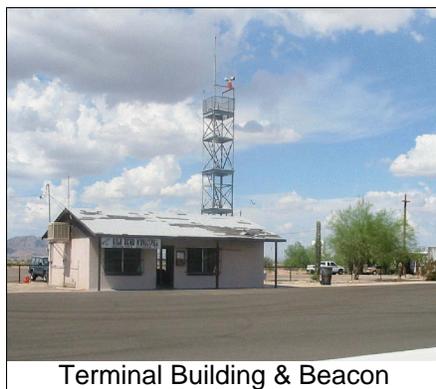
Terminal Building & Beacon

The existing Terminal Building is a concrete masonry structure with a wood frame shingled roof. It has approximately 24' x 25' under roof, and includes a pilot lounge, the airport's electrical equipment vault, a store room, and two restrooms. The building structure is in Good condition. The roof has

missing shingles and is in Poor condition. Interior appurtenances are in Poor condition. This structure is owned by the Town of Gila Bend.

The airport Rotating Beacon is located on a steel frame tower adjacent to the Terminal Building. The tower is approximately 40 feet high. The Unicom antenna is also mounted on the tower. The tower, beacon and antenna are in Good condition.

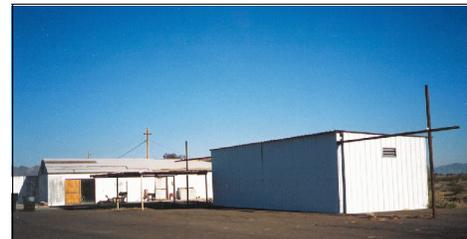
Storage Building, Vehicle Shade and Private Hangar

The Storage Building is a 24' x 40' wood frame structure located east of the Terminal Building at the northeast corner of the Aircraft Parking Apron. Its construction is not of standard materials and its structure appears to be in Poor condition. It is probable that this building could not be made to comply with current building codes. This structure is owned by the Town of Gila Bend.

A single privately owned hangar is located adjacent to the east edge of the Aircraft Parking Apron. This is a 38' wide by 30' deep "Tee" structure of steel frame construction, with corrugated steel siding and a sliding hangar door. The building is in Good condition.

A 20' x 20' vehicular parking shade is located immediately north of the Private Hangar. This structure is owned by the Town and is in Fair condition.

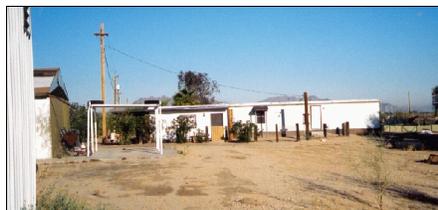
The Airport Manager's Residence is a 12' x 60' mobile home, in Fair condition. This building is owned by the Town and is currently occupied by the airport caretaker.

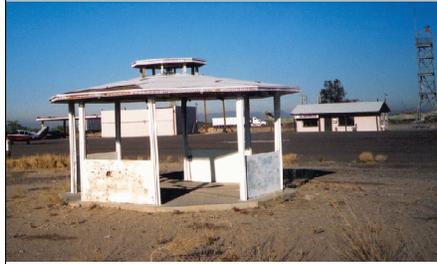
The Airport Gazebo

A small gazebo is located south of the Aircraft Parking Apron and north of Parallel Taxiway A. This structure is of nonstandard construction materials. It is built on a concrete slab. The slab is in Good condition, but the gazebo is in Poor condition.

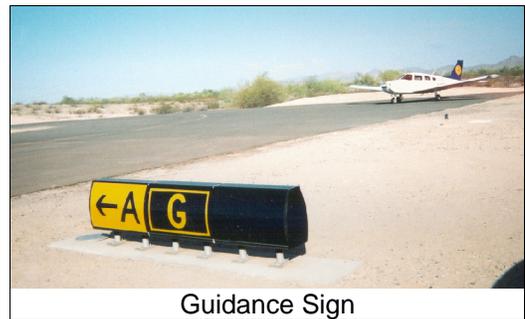
Guidance Sign

Runway 4/22 is equipped with Medium Intensity Runway Lights (MIRL). All taxiways are equipped with Medium Intensity Taxiway Lights (MITL) and guidance signs. All fixtures are base-mounted and all wiring is installed in conduit. The MIRL/MITL system and Taxiway Guidance Signs are in Good condition.

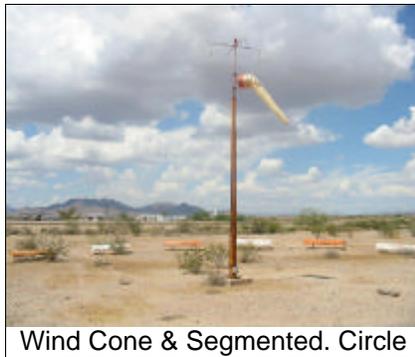
Wind Cone & Segmented. Circle

The existing lighted wind cone and segmented circle are in Good condition.
