FRICIONAL PROPERTIES OF HIGHWAY SURFACES

Final Report

1. Report No. FHWA-AZ-RD-75-1-146		2. Government Accession No.		3. Recipient's Catalog No.	
4. Title and Subtitle Frictional Properties of Highway Surfaces				5. Report Date August 1975

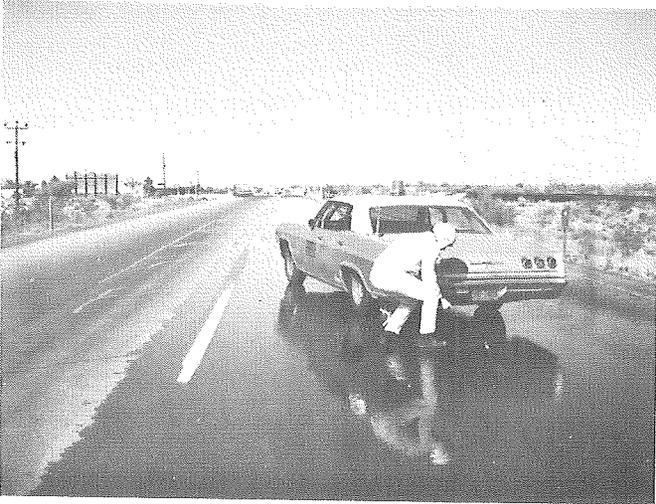
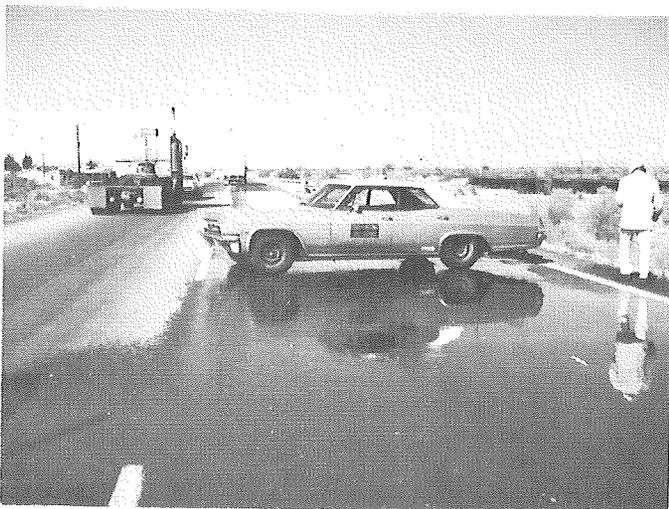
$$\begin{aligned} \text{RIGHT WHEEL PATH} &= \text{SDN}_{40} \frac{50}{60} \\ \text{LEFT WHEEL PATH} &= \text{SDN}_{40} \frac{60}{60} \end{aligned} \left. \begin{array}{l} \\ \\ \end{array} \right\} \begin{array}{l} 17\% \\ \text{Difference} \end{array}$$

← (A) Car skids at 30 MPH and rotates 25° counterclockwise

← (B) Car skids at 40 MPH and rotates 40° counterclockwise

← (C) Car skids at 50 MPH and rotates 95° counterclockwise

Figure 2 is an extreme case used to portray what might happen if one wheelpath was flushing and the other was not. The case shown in Figure 1 is common and although both wheelpaths have a satisfactory level of friction,

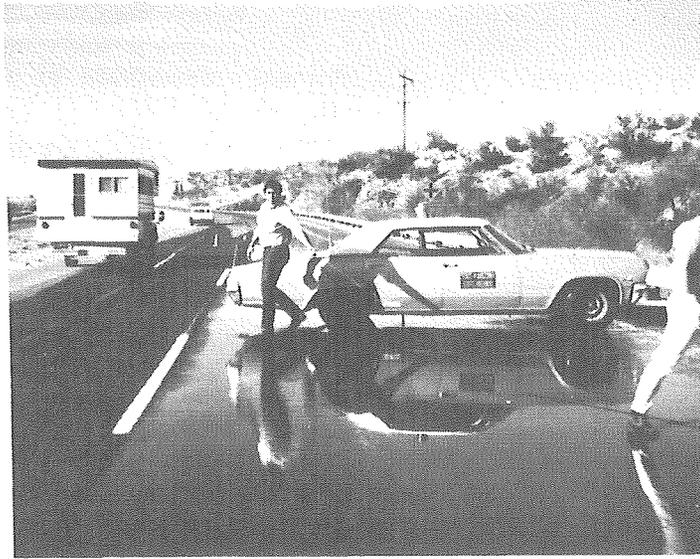
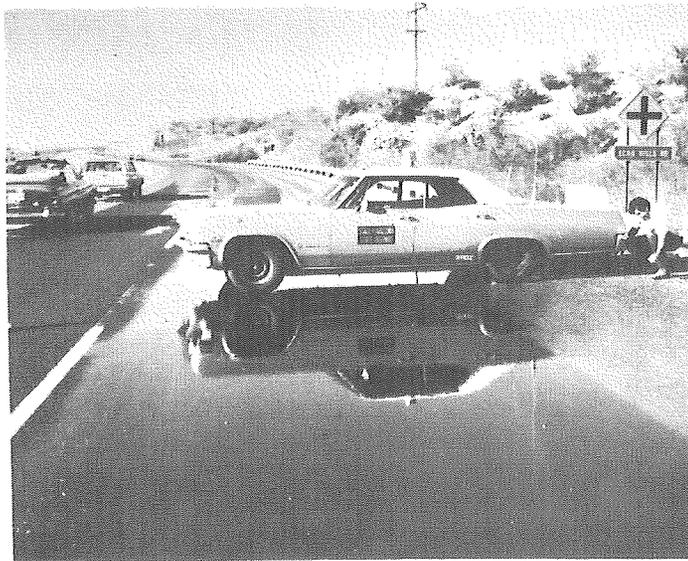
RIGHT WHEEL PATH = SDN<sub>40</sub> 67

39% Difference

LEFT WHEEL PATH = SDN<sub>40</sub> 41

(A)

Car skids at 40 MPH and rotates 90° clockwise

(B)

Car skids at 50 MPH and rotates at 270° clockwise

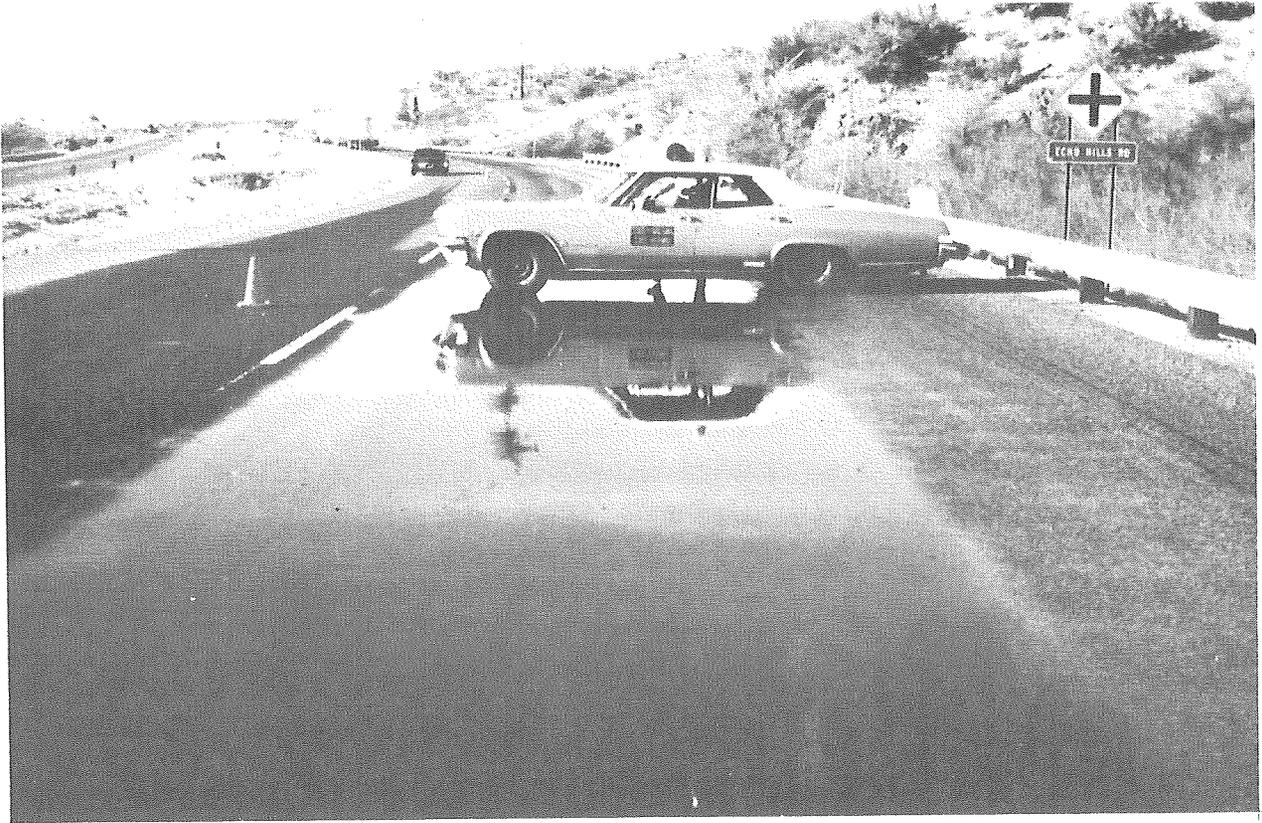
DIFFERENTIAL FLUSHING OR BLEEDING  
Figure 12

This condition is created if a portion of the lane is flushing while another is not. Such a condition can also occur if full lane repairs are not made or when

the contact of each ribbon falls inside the lane instead of at the edge. Maintenance operations can be one of the main contributors to such a problem. For example, if the chips do not adhere, or a slurry seal bleeds, in one ribbon and not the other, an extremely hazardous condition can exist.

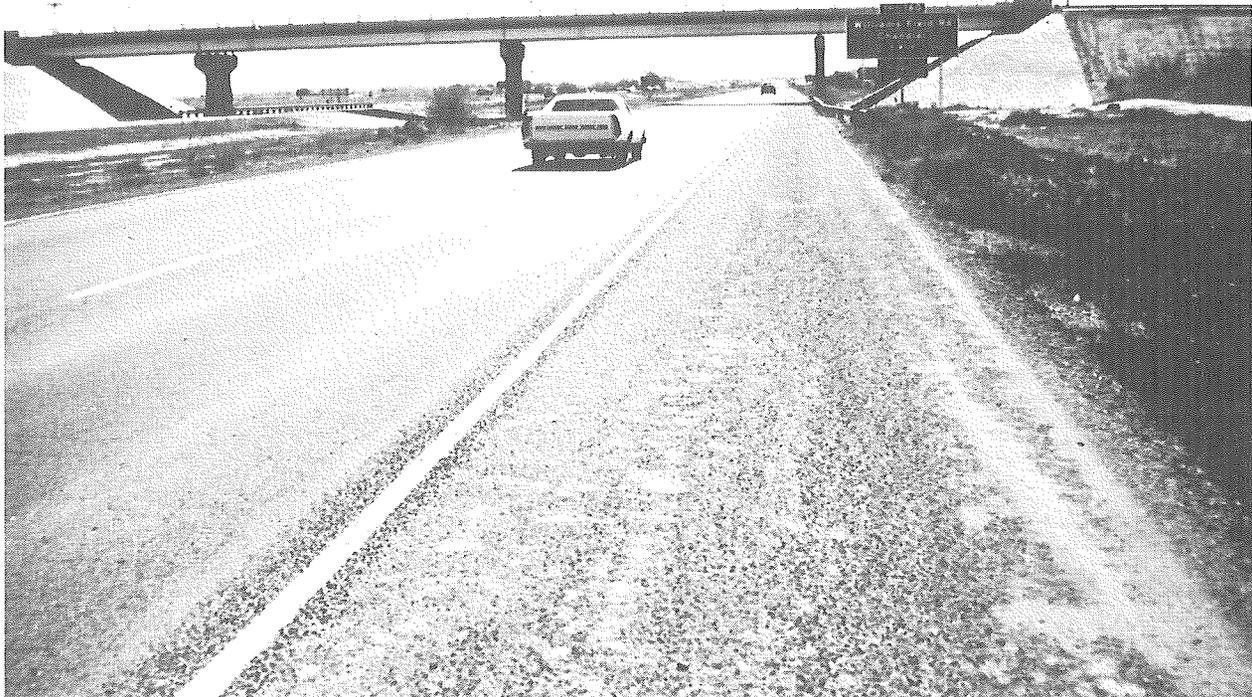
Figure 15

DISSIMILAR SURFACE TYPE FOR SHOULDER OR DISTRESS LANE

When a chip seal is used as the riding surface for the shoulder or distress lane, while the travel lane has a dissimilar surface such as Asphaltic Concrete (Figure 15), a differential friction condition is created when a vehicle rides on both surfaces simulataneously and attempts to stop. This condition can also exist when a concrete pavement has an asphaltic concrete shoulder (Figure 16). A preliminary report<sup>4</sup> has shown that in a major study of lane placement of vehicles, that sixty five percent of truck traffic rides partially on the distress lane. It was also established that of those trucks encroaching

In the past, the reason for using different shoulder material was a visual demarcation as well as a rumble strip. In the referenced study, it was shown that there was an eighty percent increase in encroachment when a bituminous surface treatment shoulder was used as compared to the AC shoulder. Obviously, this strengthens the conclusions that rough textured shoulders have not generally discouraged encroachment. It has also been noted that small, uniformly spaced grooves in the pavement will produce a much rougher ride with an audible high pitched sound. In the author's opinion, small grooves are much more successful and do not create a differential friction. Due to the amount of traffic riding on such a differential friction surface, major consideration should be given in future designs to using similar material for both the distress lanes and the travel lanes.

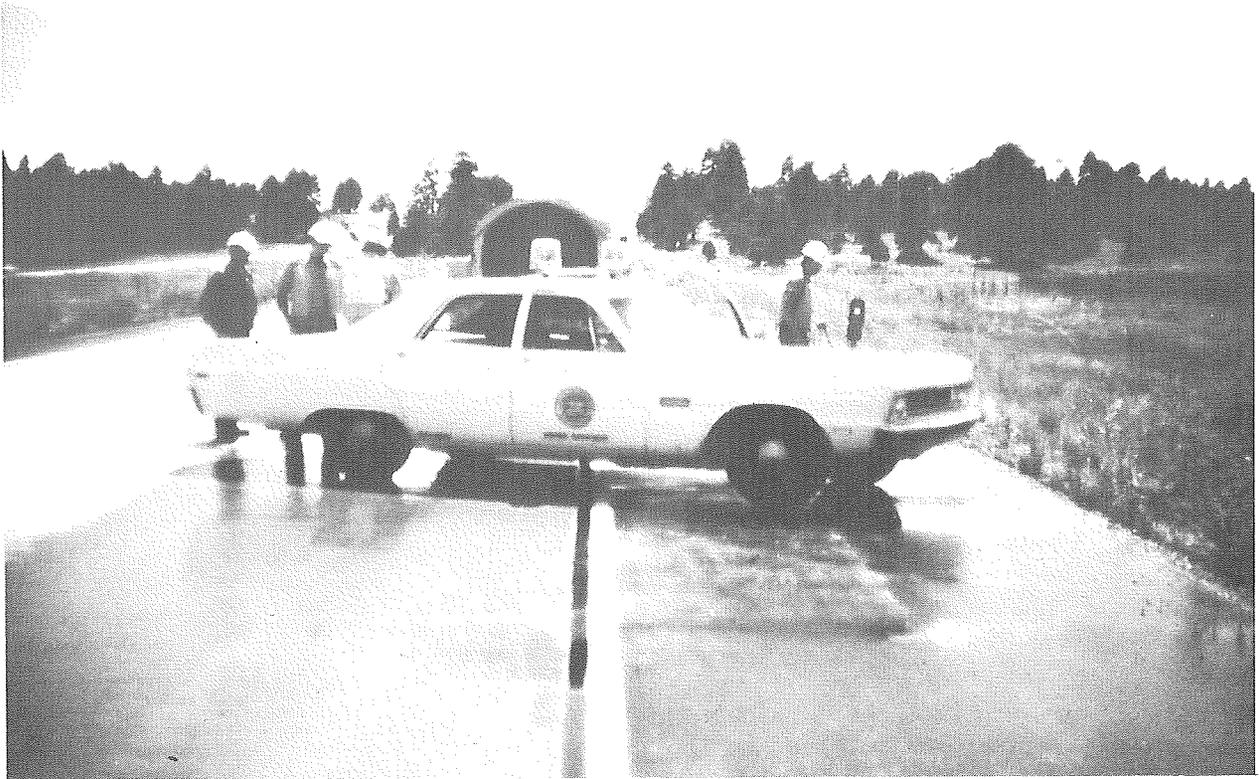
Figure 16

PCCP TRAVEL LANE WITH AC DISTRESS LANE

During construction, it would be desirable that the distress lane be constructed of the same surface type as the travel lanes. This is because there is a tendency for traffic at times to ride with one wheel in the distress lane. The use of a demarcation chip seal in combination with an ACFC travel lane may cause problems when the pavement is wet. The same problem may exist when using asphaltic concrete shoulders with concrete travel lanes.

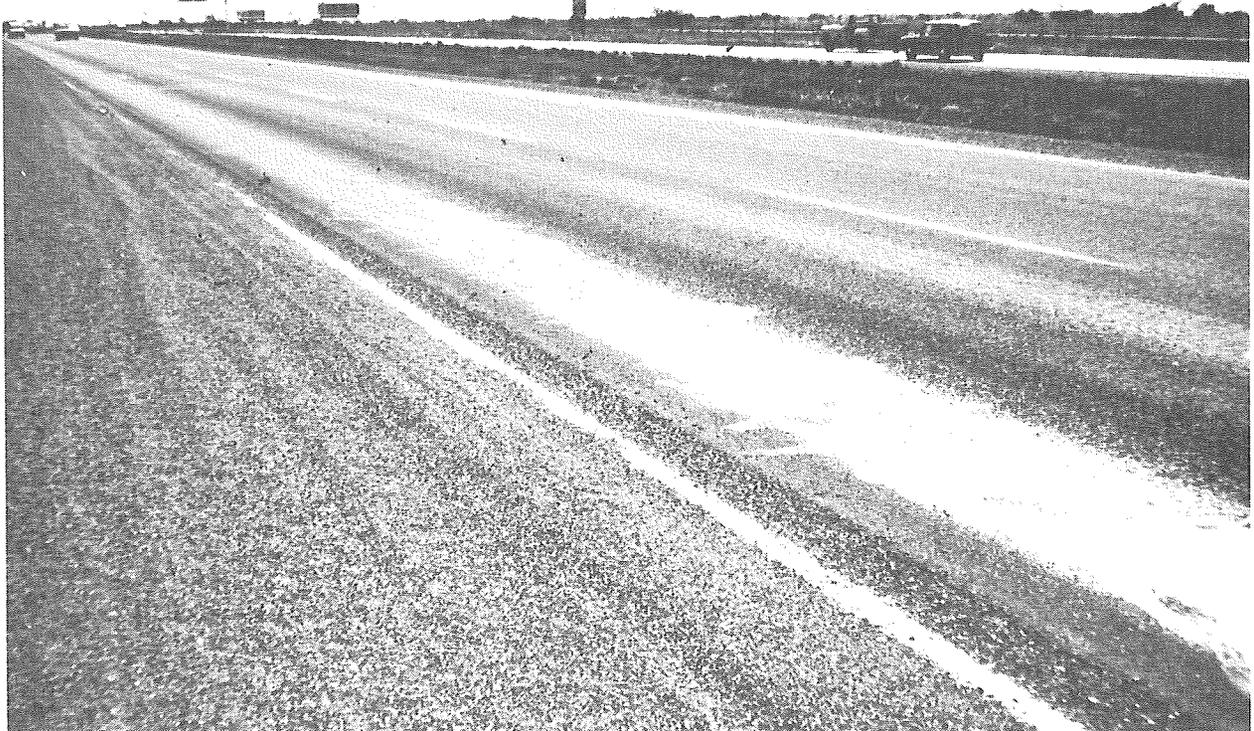
Figure 17

MAINTENANCE CRACK PATCHING

##### 5. Maintenance Crack Patching

This can be a major problem when the rate of crack patching in one wheeltrack is much greater than the other wheeltrack (Figure 17). If excessive amounts of asphalt are used, the

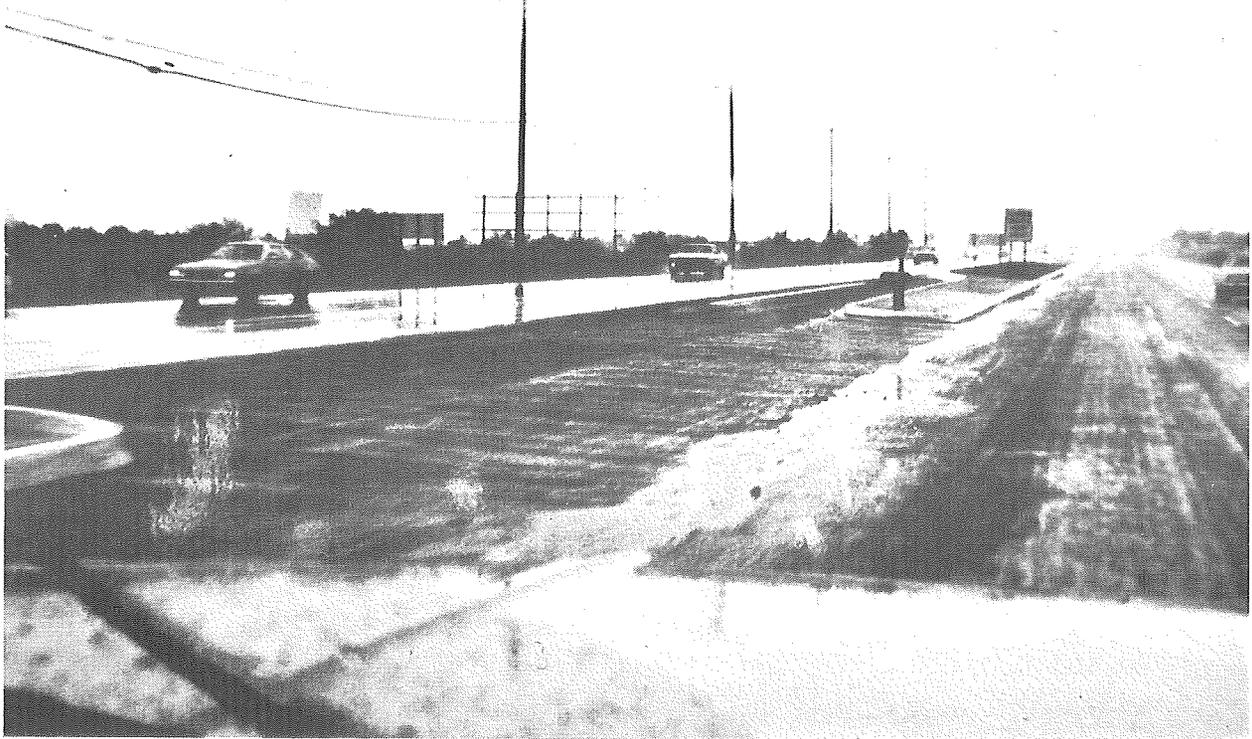
Figure 18

UNEQUAL DRAINAGE PROPERTIES

7. Unequal Water Layer Thickness

This differential friction condition can cause a major problem to the driving public. It is usually created by low spots or geometric problems which cause puddling or variation in water layer thickness. As one side of a car may be hydroplaning, an extreme differential may be created even though there is uniformity in the surface type. This condition can also occur if only a portion of the pavement is wet, such as might be created by water blowing across the road from roadside sprinklers.

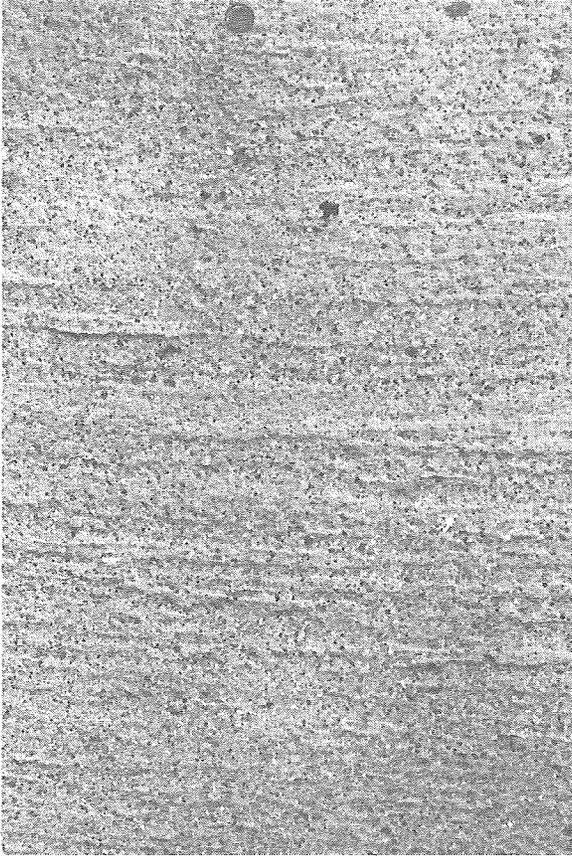
Figure C-2

BURLAP DRAG TEXTURE (4 ply, 10 oz (283.5g))

11-7-74

6-17-75

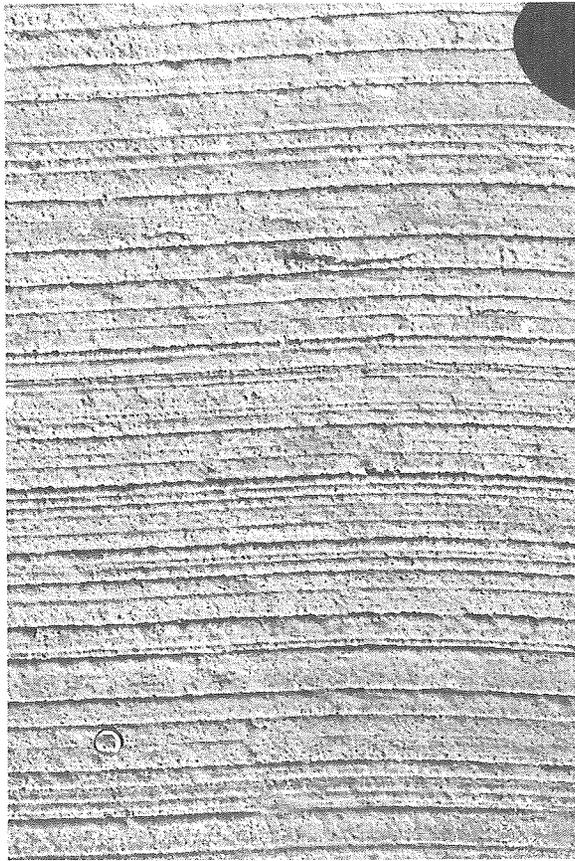
Figure C-3

BURLAP DRAG WITH NAILS TEXTURE

11-7-74

6-17-75

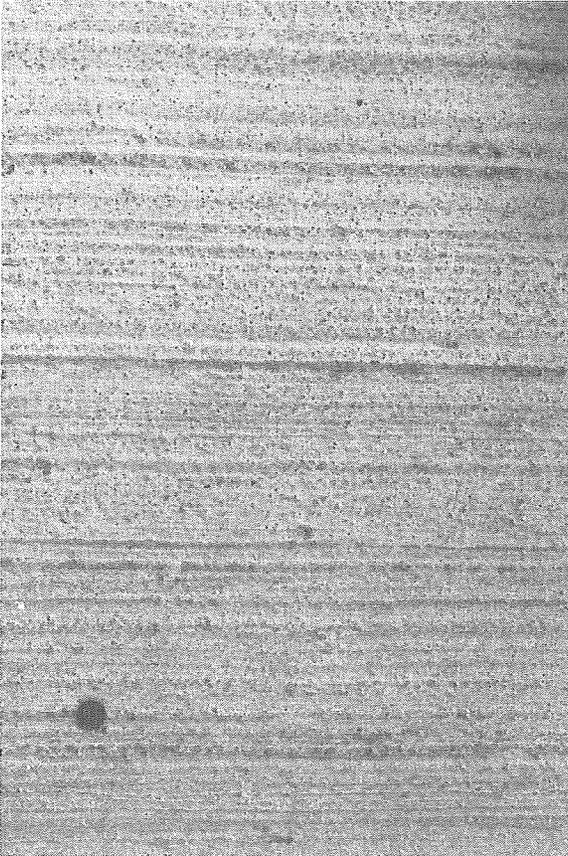
Figure C-6

BURLAP DRAG TEXTURE ( Threads Removed)

11-7-74

6-17-75
