ARIZONA DEPARTMENT OF TRANSPORTATION

REPORT NUMBER: FHWA-AZ88-202-II

SMALL SIGN SUPPORT ANALYSIS

**Phase II
Static, Pendulum and Full-Scale Crash Test Programs
Volume I (Report)**

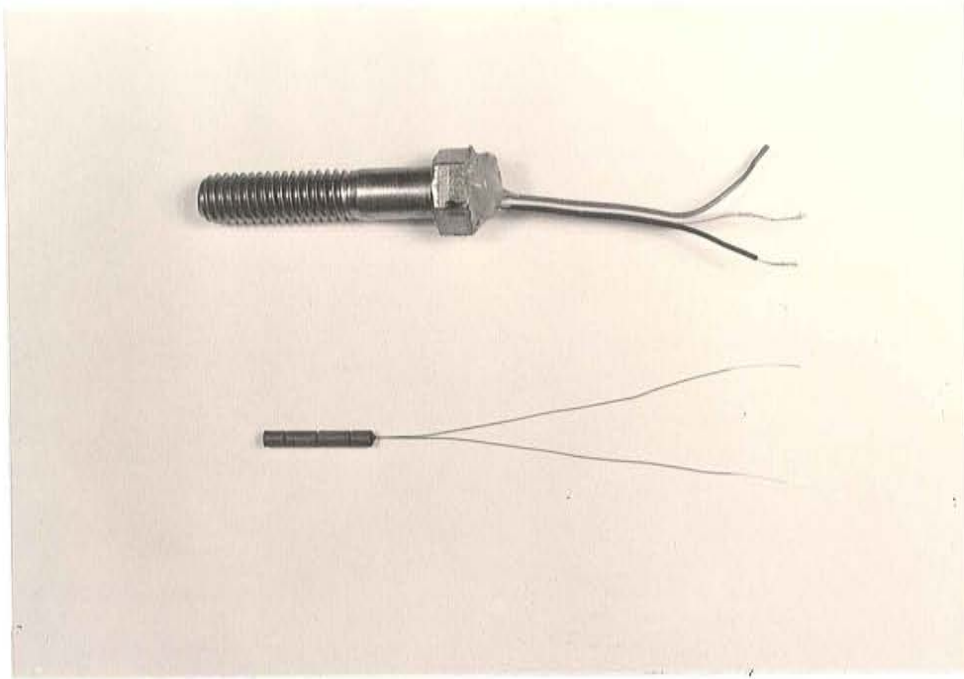
FIGURE 2.2. PHOTOGRAPH OF MTS STRAIN GAUGE AND ASSEMBLED STRAIN GAUGED BOLT.

The calibrated bolts were assembled by boring a 2.5mm hole through the shank of the bolt. A TML bolt strain gauge (Tokyo Sokki Kenkyujo Co. Ltd, Tokyo, Japan) was inserted and the hole filled with epoxy (Fig. 2.2). The initial tests of calibrated bolts using TML epoxy were not acceptable due to difficulties in curing and creep measured during calibration. As a result Micro-Measurements Division (MM); (Measurements Group Inc., Raleigh N.C.) AE-10 epoxy was substituted. Once the epoxy had cured, the bolt was calibrated in an MTS tension testing machine. The millivolt values read at each load step (2 kips) were plotted to develop the calibration curves (Appendix W).

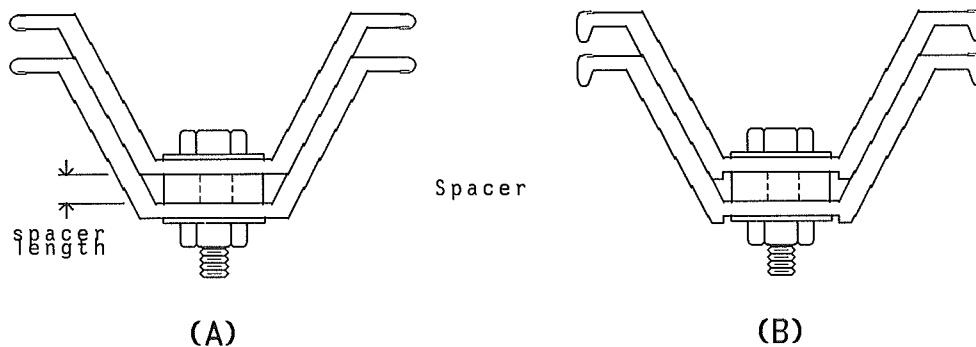
FIGURE 2.4. ILLUSTRATION OF (A) FRANKLIN AND (B) MARION NESTED SPLICES.

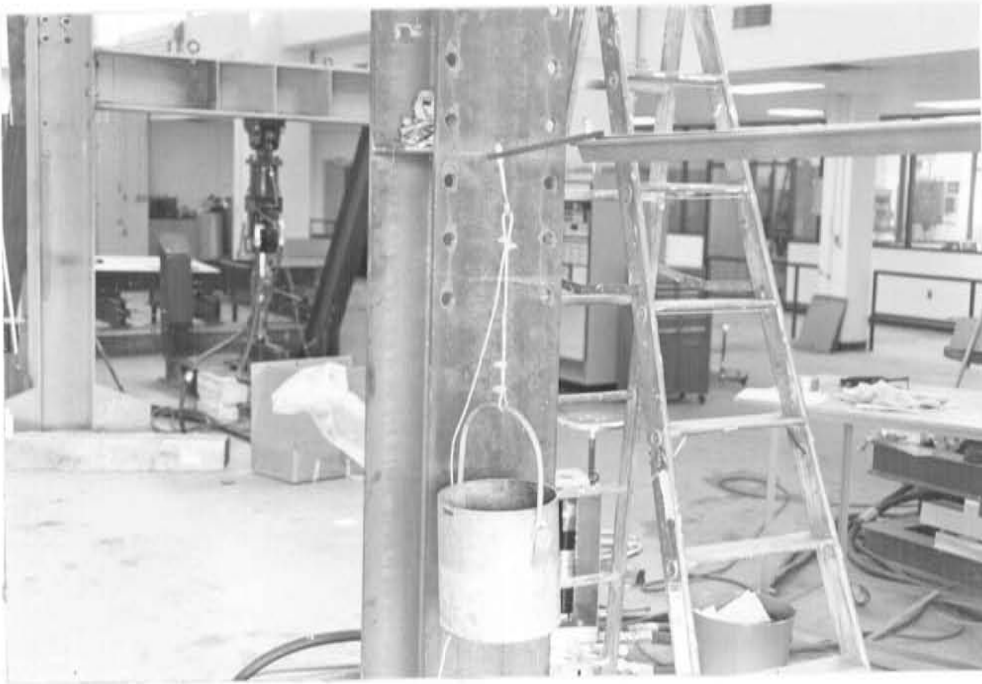
FIGURE 3.5. PHOTOGRAPH SHOWING COMBINED BENDING AND TORSION TEST APPARATUS.

Test procedures were similar to those described above (Section 3.2). Seventeen inch tests were not run because sign flutter is a wind rather than an impact load phenomenon. Calibrated bolts were loaded until a tension of 6 kips was measured. The data recorded included bolt and post strain. Data recorded for the field bolt test included the lateral

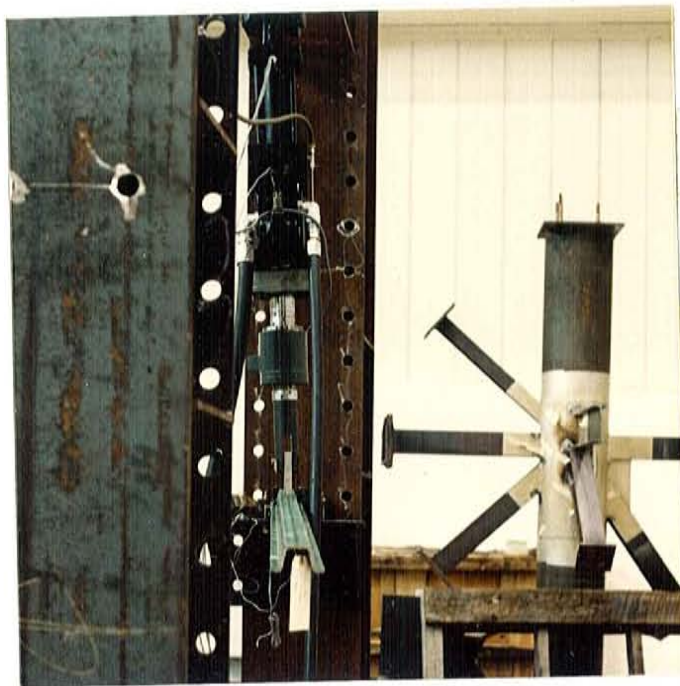
FIGURE 5.11. PHOTOGRAPH OF 18 INCH LATERAL TIP DEFLECTION MEASURED DURING A FACE TO FACE TEST IN THE NON-CRITICAL CONFIGURATION.

The stability problem was observed only in the 17 inch bending tests because the load source (MTS 20 kip actuator) was mounted to a beam through a universal joint to insure only axial compression is applied through the load cell. This joint provided a hinge at the beam (ie: no lateral restraint capacity), and the translation of the post occurred when the lateral load due to eccentricity (F_e) exceeded the lateral capacity of the splice (Fig. 5.15).

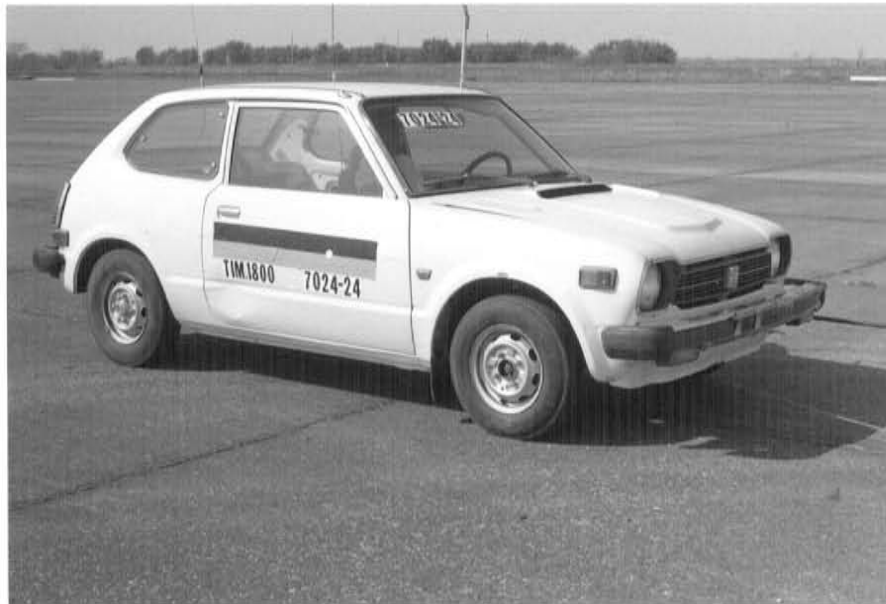
FIGURE 7.1. VEHICLE USED IN TESTS 7024-24,5.

The 1979 Honda shown in Figure 7.1 was directed into the sign installation (Fig. 7.2) using 3 - Marion 80 ksi 4 lb/ft u-posts with a cable reverse tow and guidance system. The test inertia mass of the vehicle was 1800 lbs (817 kg) and its gross static mass was 1970 lbs (894 kg). Impact point was such that the vehicle bumper contacted all three legs of the sign installation. The height from the ground to the lower edge of the bumper was 14.25 in (36.20 cm) and 18.75 (47.63 cm) to the top of the bumper. The vehicle was free-wheeling and unrestrained at impact.

The 1979 Honda shown in Figure 7.1 was directed into the sign installation (Fig.7.7) using 3 - Marion 80 ksi 4 lb/ft u-posts with a cable reverse tow and guidance system. This vehicle had been used in test 7024-24. The bumper was replaced, the dents pulled out and the crack in the windshield was marked. The test inertia mass of the vehicle was 1800 lbs (817 kg) and its gross static mass was 1970 lbs (894 kg). Impact point was such that the vehicle bumper contacted all three legs of the sign installation. The height from the ground to the lower edge of the bumper was 14.25 in (36.20 cm) and 18.75 (47.63 cm) to the top of the bumper. The vehicle was free-wheeling and unrestrained at impact.

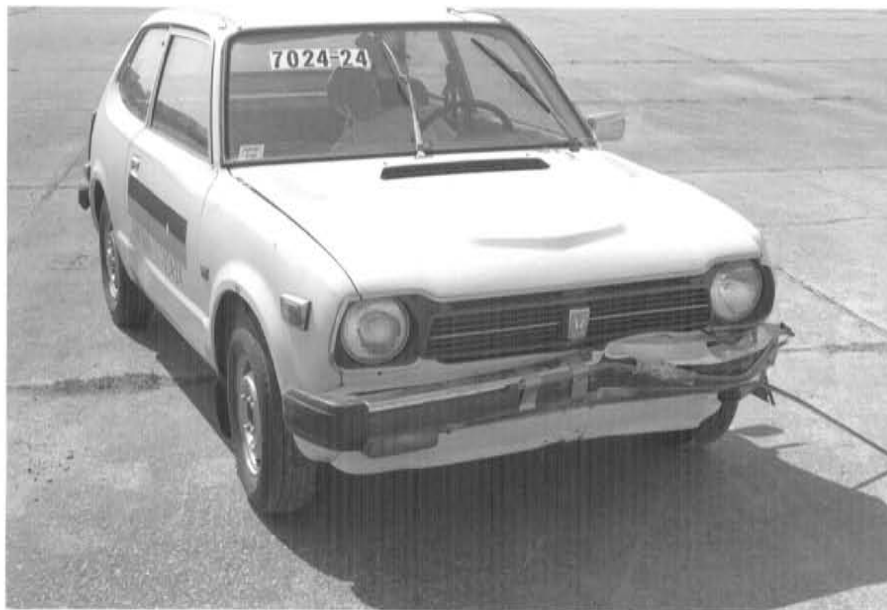
FIGURE 7.3. VEHICLE RESTING POSITION FOLLOWING TEST 7024-24.

The speed of the vehicle at impact was 20.6 mi/h (33.1 km/h). Approximately 0.062 seconds after impact, the right support fractured at bumper height and at 0.079 seconds, the center support broke away at the stub. The left support caused the left side of the vehicle to rise slightly before the support broke away from the stub at about 0.198 s. The vehicle lost contact with the sign installation at 0.313 seconds. Shortly thereafter, the sign panel fell to the ground and the vehicle rolled forward coming to rest over the stubs (Fig 7.3).

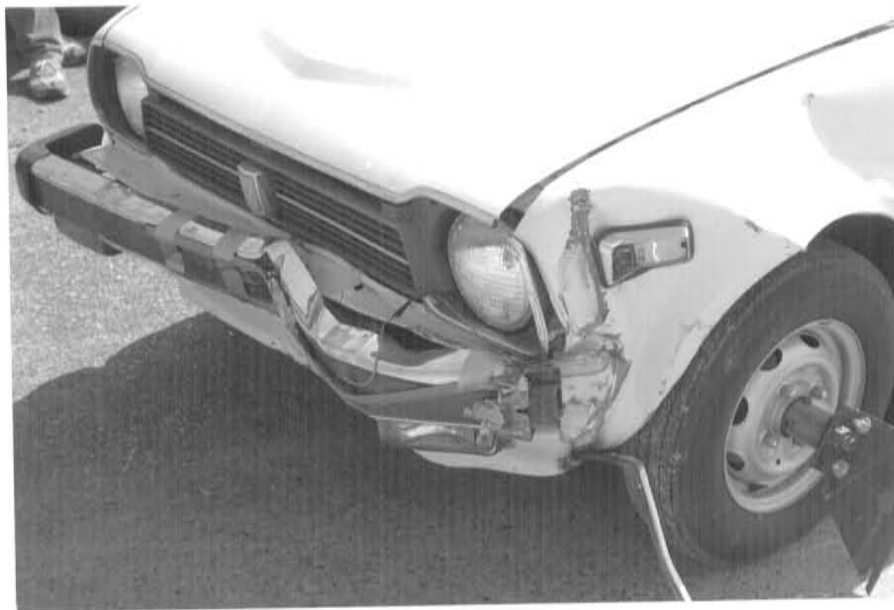
FIGURE 7.5. VEHICLE DAMAGE FOLLOWING TEST 7024-24.

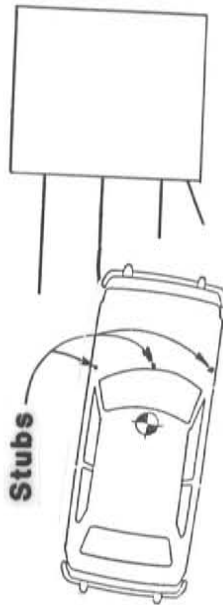
Test No.	7024-24	Impact Speed.	20.6 mi/h (33.1 km/h)
Date	3/02/87	Change in Velocity.	19.1 mi/h (30.7 km/h)
Test Article	Sign Installation	Change in Momentum	1566 lb-s
Support.	Three Marion	Occupant Impact Velocity	
	80 ksi, 4 lb-ft	Longitudinal.	21.9 ft/s (6.7 m/s)
	Supports	Lateral	None
Vehicle.	1979 Honda	Occupant Ridedown Accelerations	
Vehicle Weight		Longitudinal.	-2.7 g
Test Inertia	1800 lb (817 kg)	Lateral	N/A
Gross Static	1970 lb (894 kg)	Maximum Vehicle Crush	
Vehicle Damage Classification		Bumper Height	5.0 in (12.7 cm)
TAD.	12FD1		
SAE.	12FDEW1

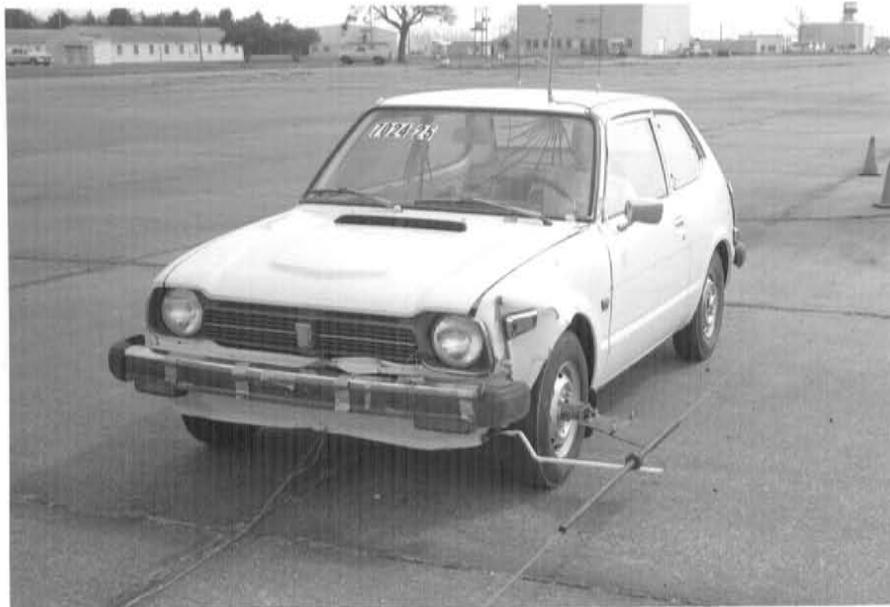
FIGURE 7.8. VEHICLE PRIOR TO TEST 7024-25.

The speed of the vehicle at impact was 62.6 mi/h (100.7 km/h). Shortly after impact, the center support fractured at bumper height and broke away from the stub. By 0.015 s after impact, the other supports had broken away from their stubs. The vehicle lost contact with the supports at approximately 0.065 seconds. As the vehicle continued forward, the sign installation went up and over the vehicle. The brakes were applied and the vehicle came to rest 230 ft (70 m) beyond impact point (Fig. 7.8).

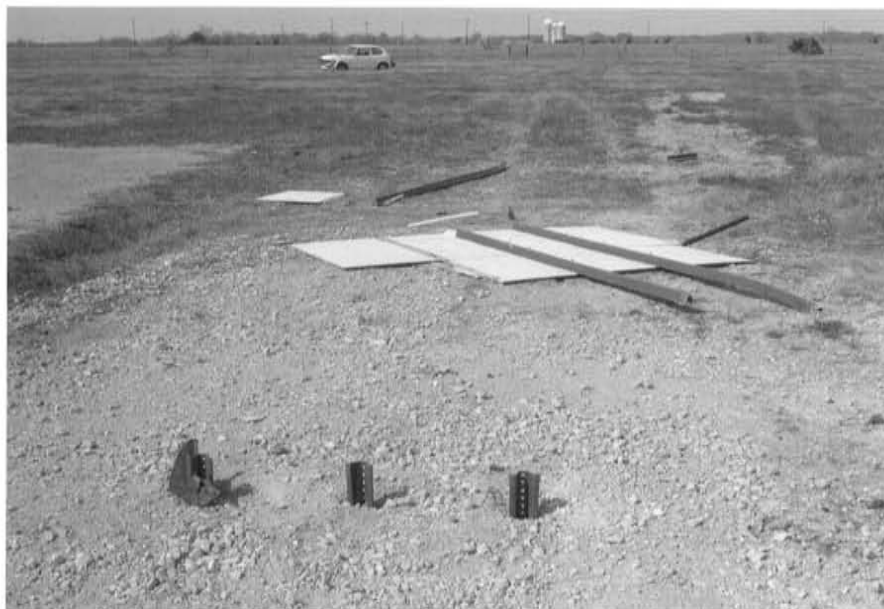
FIGURE 7.9. SIGN INSTALLATION FOLLOWING TEST 7024-25.

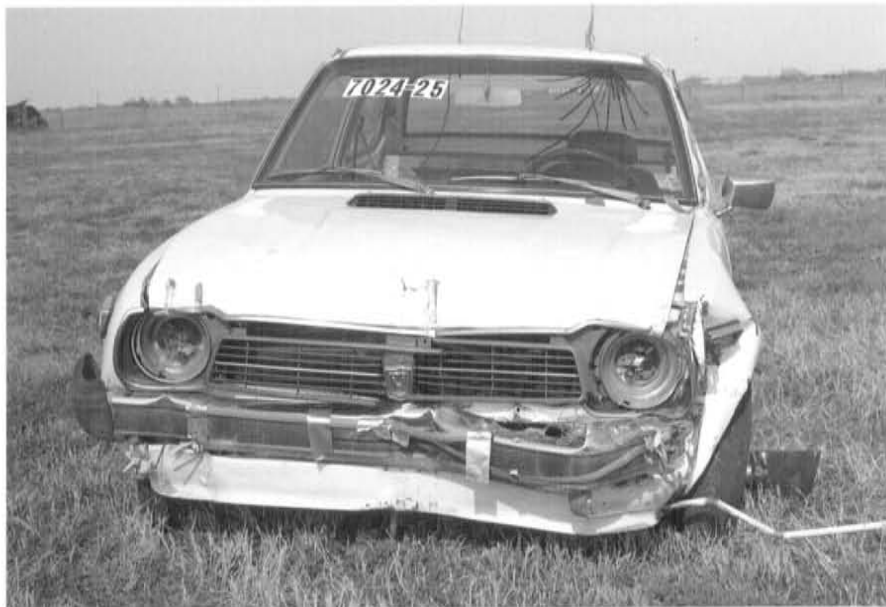
FIGURE 7.10. VEHICLE DAMAGE FOLLOWING TEST 7024-25.

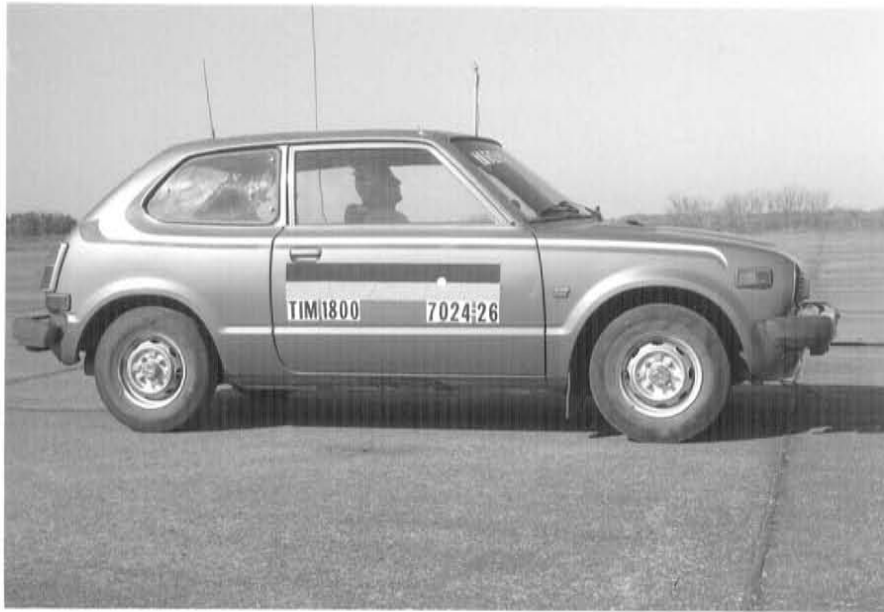
FIGURE 7.12. VEHICLE USED IN TESTS 7024-26,7.

The 1979 Honda shown in Figure 7.12 was directed into the sign installation (Fig. 7.13) using 3 - Marion 80 ksi 3 lb/ft u-posts with a cable reverse tow and guidance system. The test inertia mass of the vehicle was 1800 lbs (817 kg) and its gross static mass was 1973 lbs (896 kg). Impact point was such that the vehicle bumper contacted all three legs of the sign installation. The height from the ground to the lower edge of the bumper was 15.25 in (38.74 cm) and 20.00 in (50.80 cm) to the top of the bumper. The vehicle was free-wheeling and unrestrained at impact.

The 1979 Honda shown in Figure 7.12 was directed into the sign installation (Fig.7.18) using 3 - Marion 80 ksi 3 lb/ft u-posts with a cable reverse tow and guidance system. This vehicle had been used in test 7024-26. The bumper was repaired before this test. The test inertia mass of the vehicle was 1800 lbs (817 kg) and its gross static mass was 1973 lbs (896 kg). Impact point was such that the vehicle bumper contacted all three legs of the sign installation. The height from the ground to the lower edge of the bumper was 15.25 in (38.70 cm) and 20.00 (50.80 cm) to the top of the bumper. The vehicle was free-wheeling and unrestrained at impact.

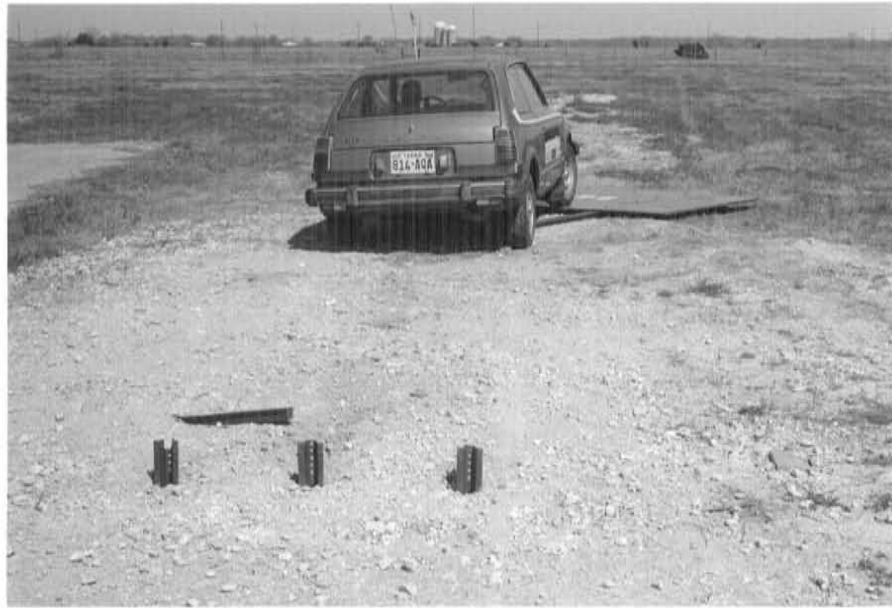
FIGURE 7.14. VEHICLE RESTING POSITION FOLLOWING TEST 7024-24.

The speed of the vehicle at impact was 21.7 mi/h (34.9 km/h). Approximately 0.054 seconds after impact, the left support fractured at bumper height and shortly thereafter, the others broke away from the stub. The vehicle lost contact with the sign supports at 0.310 seconds. As the vehicle continued forward, it again contacted the supports and eventually came to rest on the sign pannel (Fig.7.14).

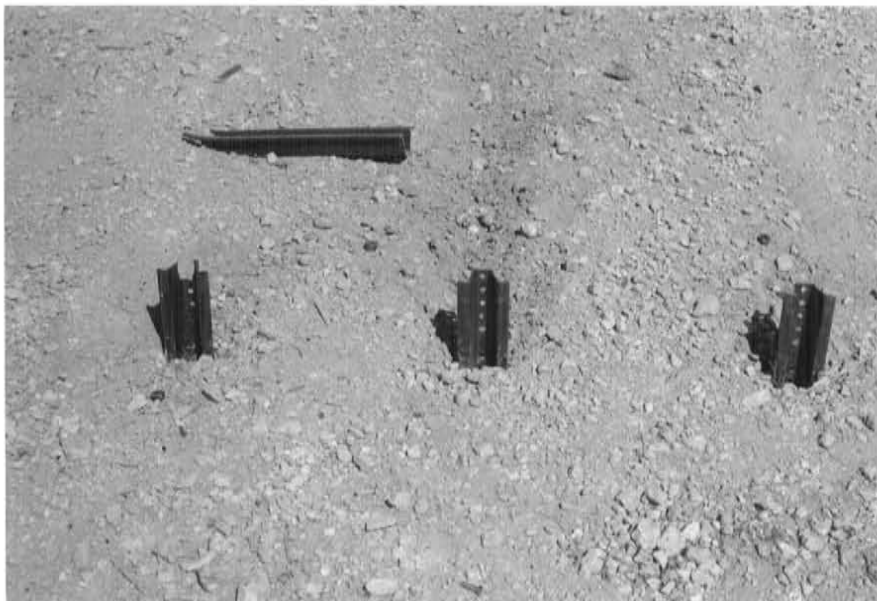
FIGURE 7.15. SIGN SUPPORTS FOLLOWING TEST 7024-24.

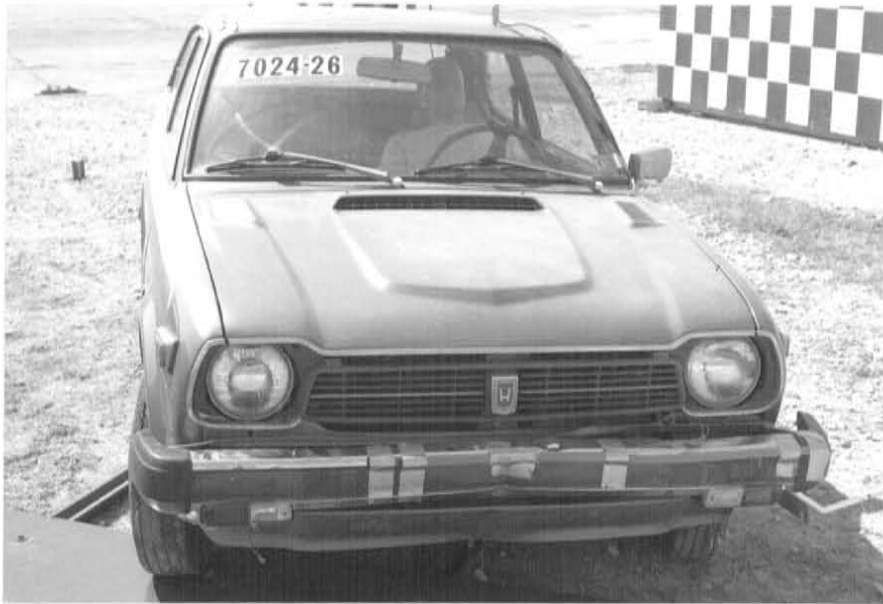
FIGURE 7.16. VEHICLE DAMAGE FOLLOWING TEST 7024-26.

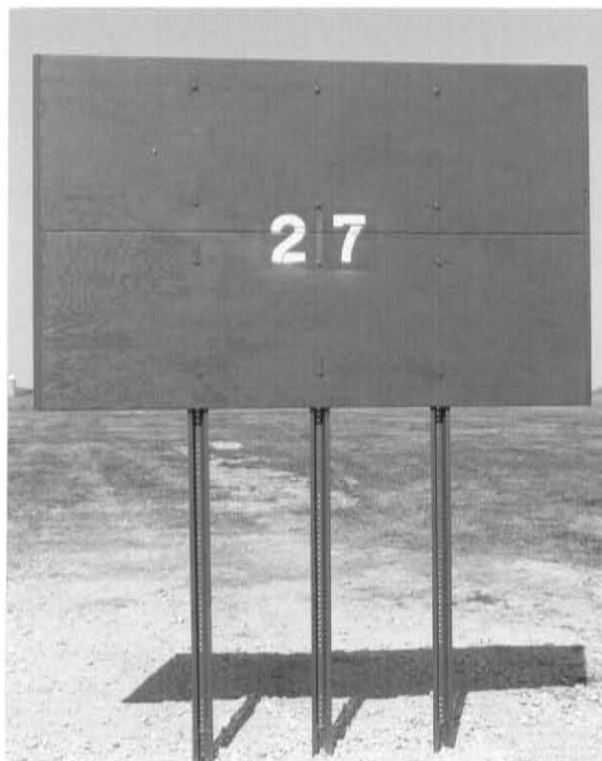
FIGURE 7.18. SIGN INSTALLATION USED IN TEST 7024-27.

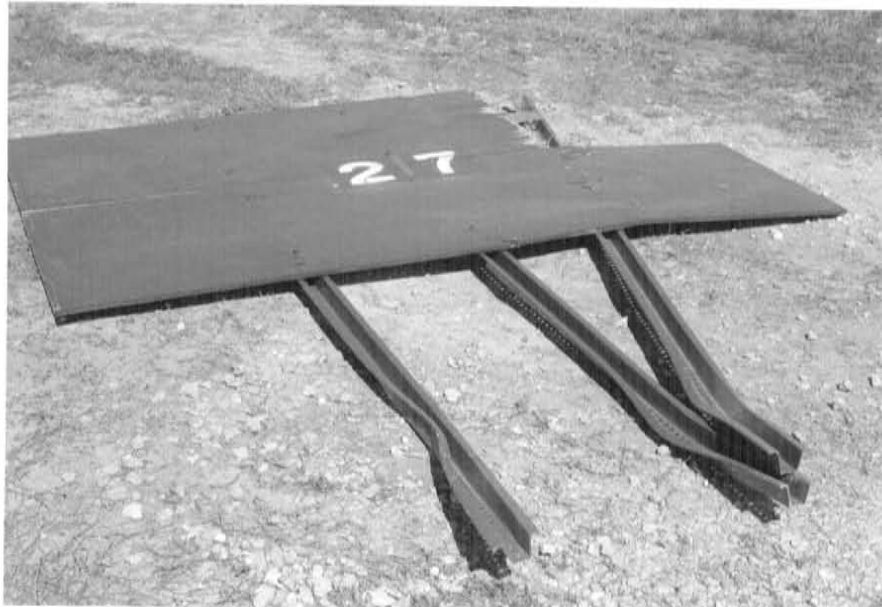
FIGURE 7.20. SIGN INSTALLATION FOLLOWING TEST 7024-27.

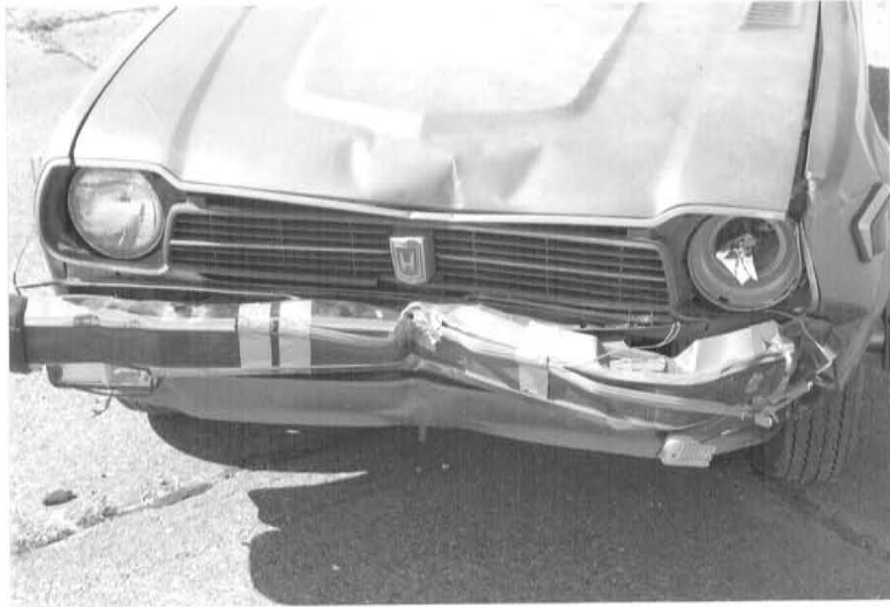
FIGURE 7.21. VEHICLE DAMAGE FOLLOWING TEST 7024-27.

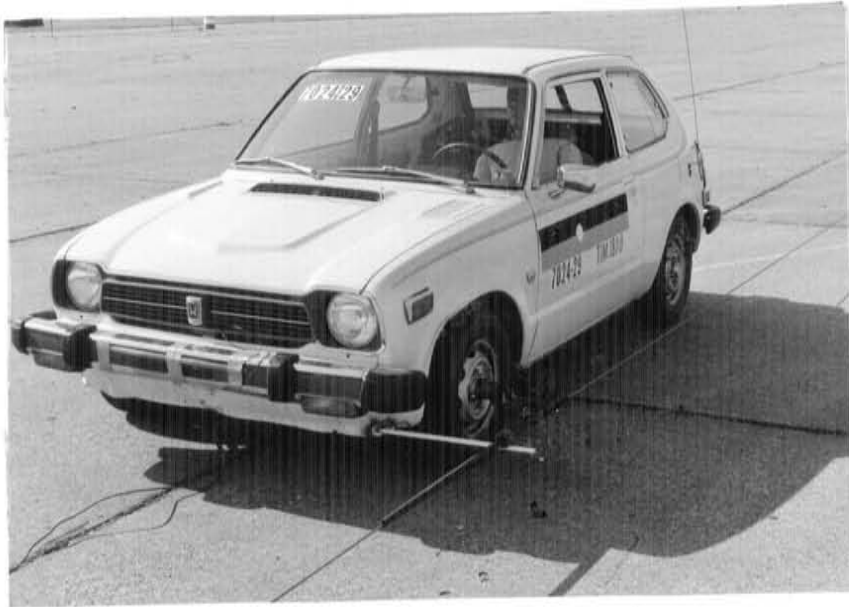
FIGURE 7.25. VEHICLE PRIOR TO TEST 7024-29

A 1979 Honda Civic (shown in Figure 7.25) impacted the sign installation (shown in Figure 7.26) at 18.7 miles per hour (30.1 km/h) using a cable reverse tow and guidance system. Test inertia mass of the vehicle was 1,800 lb (817 kg) and its gross static mass was 1,967 lb (892 kg). The height to the lower edge of the vehicle bumper was 14.5 inches (36.8 cm) and 19.5 inches (49.5 cm) to the top edge of the bumper.

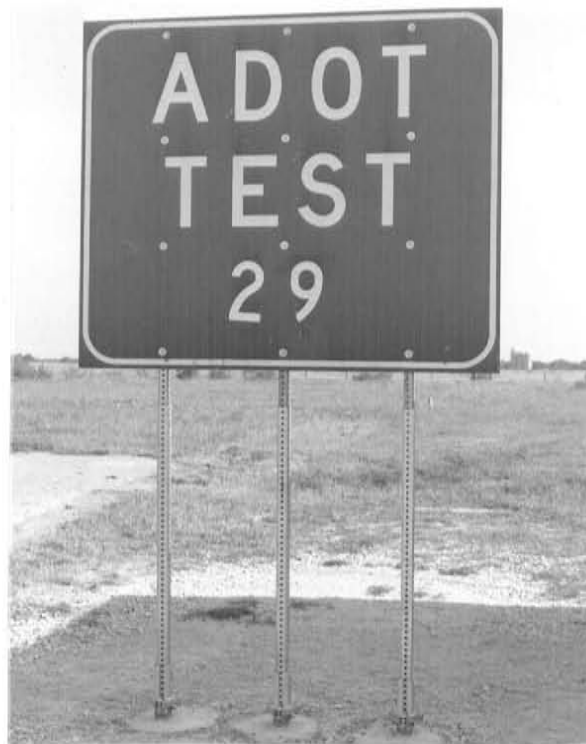
FIGURE 7.26. SIGN INSTALLATION USED IN TEST 7024-29.

The sign installation used in these tests consisted of a 6 ft wide x 5 ft high plywood sign panel mounted on three P2 Uni-Strut supports. These supports were attached to three triangular retrofit slip bases with 3/8 in grade 2 bolts, nuts, and flat washers. The lower slip base attachments were anchored in concrete footings at 21 in on center spacing. Teflon gaskets were used between the slip bases attached to the sign supports and the anchored slip bases. The support slip bases were attached to the anchored slip bases with 1/2 in grade 5 bolts, nuts, and flat washers. The bottom of the sign was mounted at 5 ft. Details of the installation assembly are shown in Figure 7.23 and the completed installation is shown in Figure 7.24.

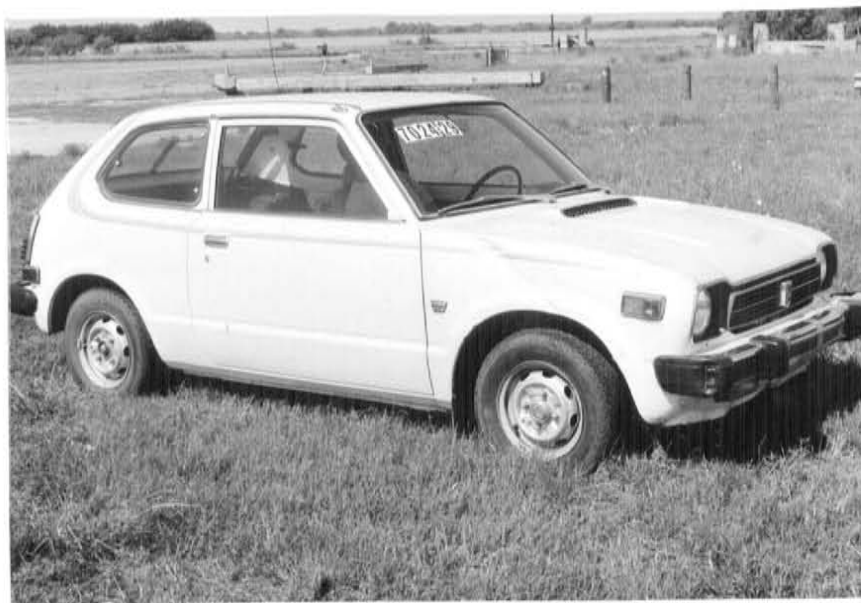
FIGURE 7.28. VEHICLE DAMAGE FOLLOWING TEST 7024-29.

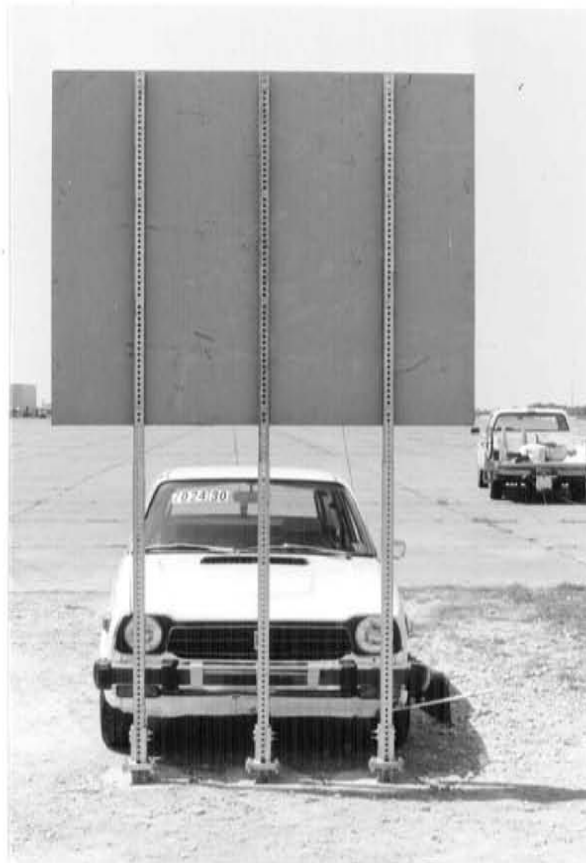
FIGURE 7.30. *VEHICLE PRIOR TO TEST 7024-30.*

A 1979 Honda Civic (shown in Figure 7.30) impacted the sign installation at 61.5 miles per hour (98.9 km/h) using a cable reverse tow and guidance system. Test inertia mass of the vehicle was 1,800 lb (817 kg) and its gross static mass was 1,967 lb (892 kg). The height to the lower edge of the vehicle bumper was 14.5 inches (36.8 cm) and 19.5 inches (49.5 cm) to the top edge of the bumper.

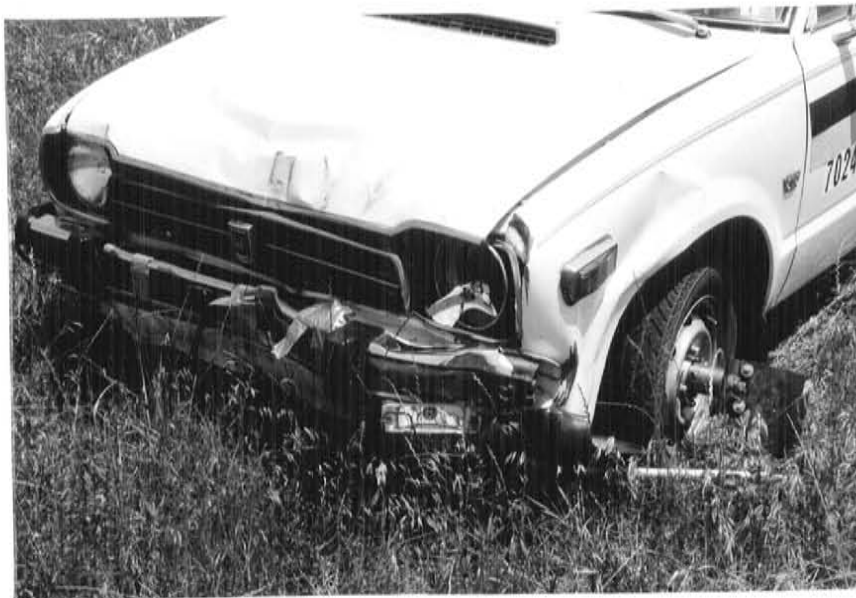
FIGURE 7.32. VEHICLE DAMAGE FOLLOWING TEST 7024-30.
