ARIZONA DEPARTMENT OF TRANSPORTATION

REPORT NUMBER: FHWA-AZ89-257

SLOPE EROSION CONTROL FOR URBAN FREEWAYS IN ARID CLIMATES

Volume I - Final Report

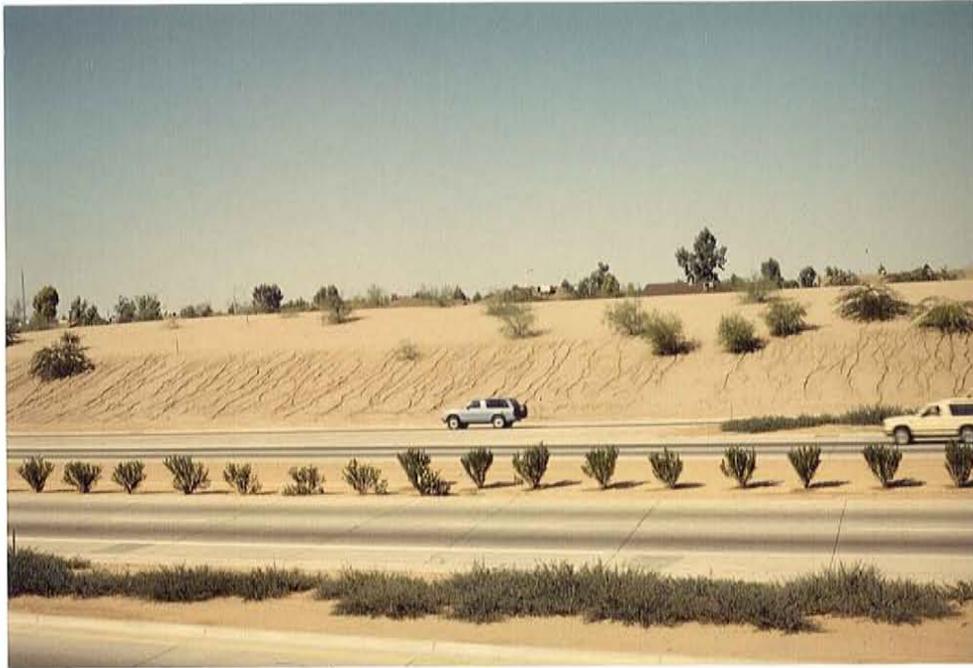
The study team took the opportunity to examine the slope damage and noticed several phenomena that provided insight into the slope erosion processes. When Plate 1 is examined, the visible erosion pattern is striking. Not only is the density of the rills high but their spacing is remarkably uniform. The rills also start at the same location on the slope. Plate 2 presents a side view showing the rill start point relative to slope curvature.

Plate 1. Slope Damage SR 360 West of Gilbert Road.

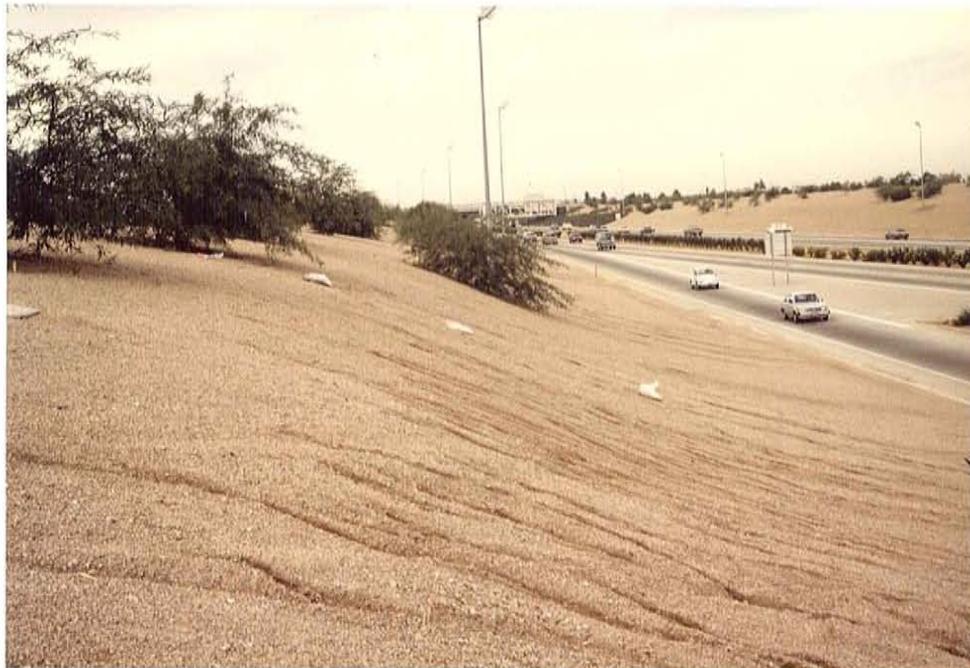
Plate 2. Profile of Slope Erosion Damage, West of Gilbert

The slopes in this section were protected with approximately 0.5 to 1.0 inches of granite slope protection, which when sampled was designated as SRG8 for later reference. The profile of the slope shown in Plate 2 is provided on Figure 2.

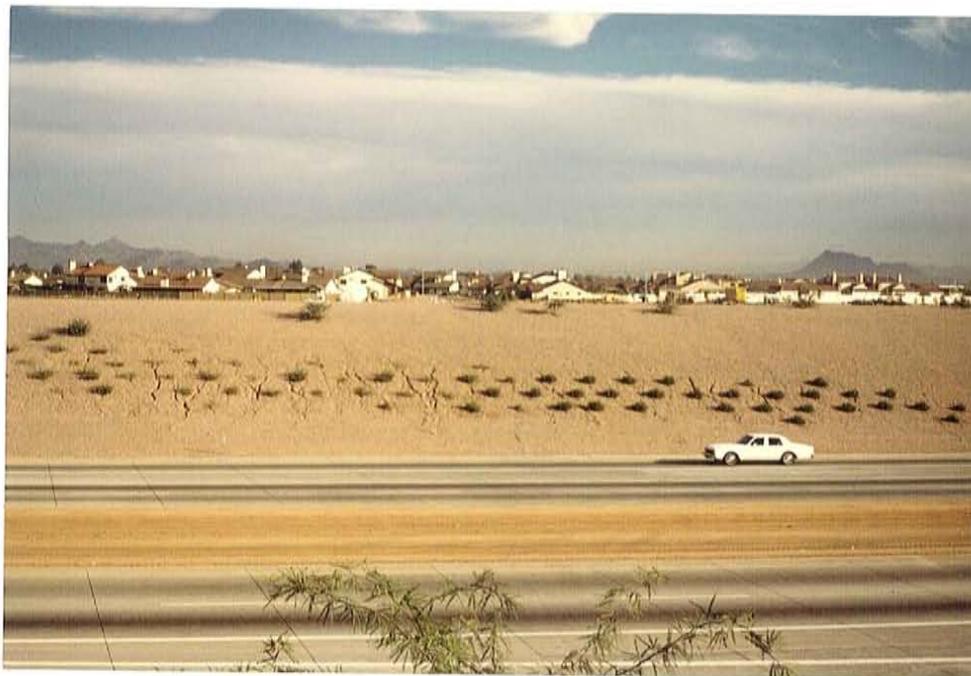
West of Val Vista Rd. on SR 360 is another example of slope damage as shown in Plate 3. When the plate is examined, it is apparent that the rills exist essentially only in the planted areas. Rills were not found on sections of the slopes where plants had not been placed. The surface protection on these sections as well as where Plate 3 was taken is a granite designated SRG1. This granite was placed in the spring and summer of 1986 and was not only approximately 2 inches thick but also contained larger particle sizes than did the SRG8 mate-

Plate 3. Dlope Damage SR 360 West of Val Vista Road.

rial. The observations at this location led the study team to suspect that the low density soil beneath the SRG1 material had allowed undermining of that material to occur. In other locations, where a higher density subgrade existed, such rill development was resisted by the SRG1 material.

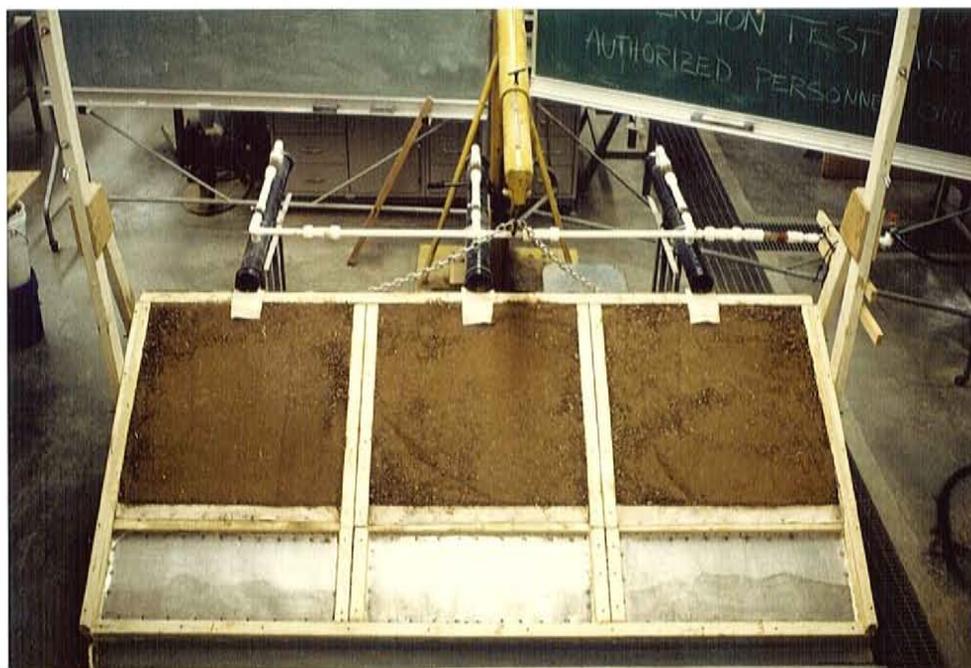
Plate 4. Front View of Erosion Test Cell

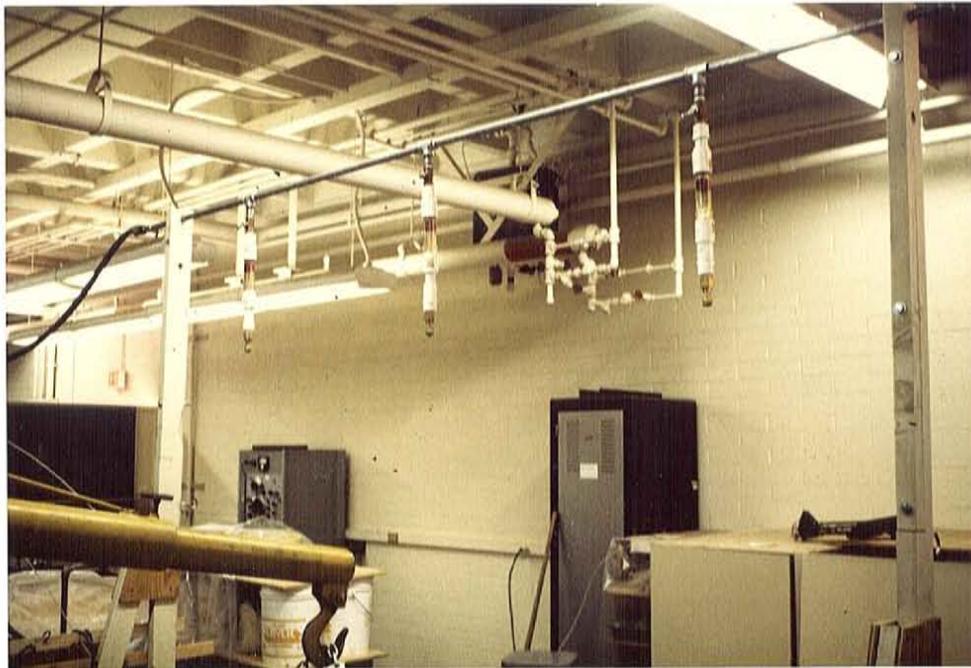
Plate 6. View of Spray Head and Flow Meter Assembly

To prevent sliding at the contact with the panel and the materials and to protect the test cell, Mirafi 6000 material was used to line the panel bottoms. At the lower end of the panel holding the material, holes covered with Mirafi 140N were used to allow subsurface flow similar to flow beneath the slope protection to occur without piping. This subsurface flow system also helped prevent artificially high pore pressures to develop.

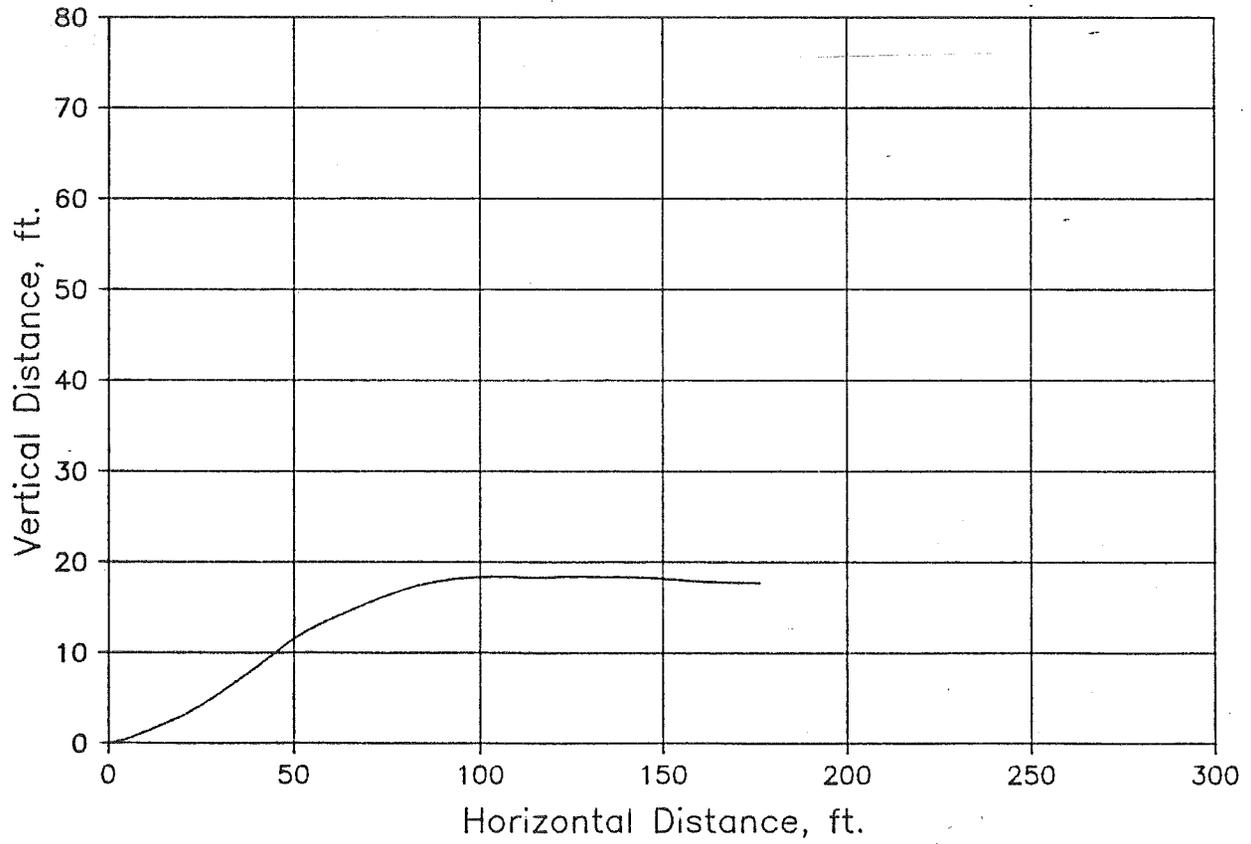
Figure 2. Profile of Slope West of Gilbert Rd.
at Plate No. 2 Location

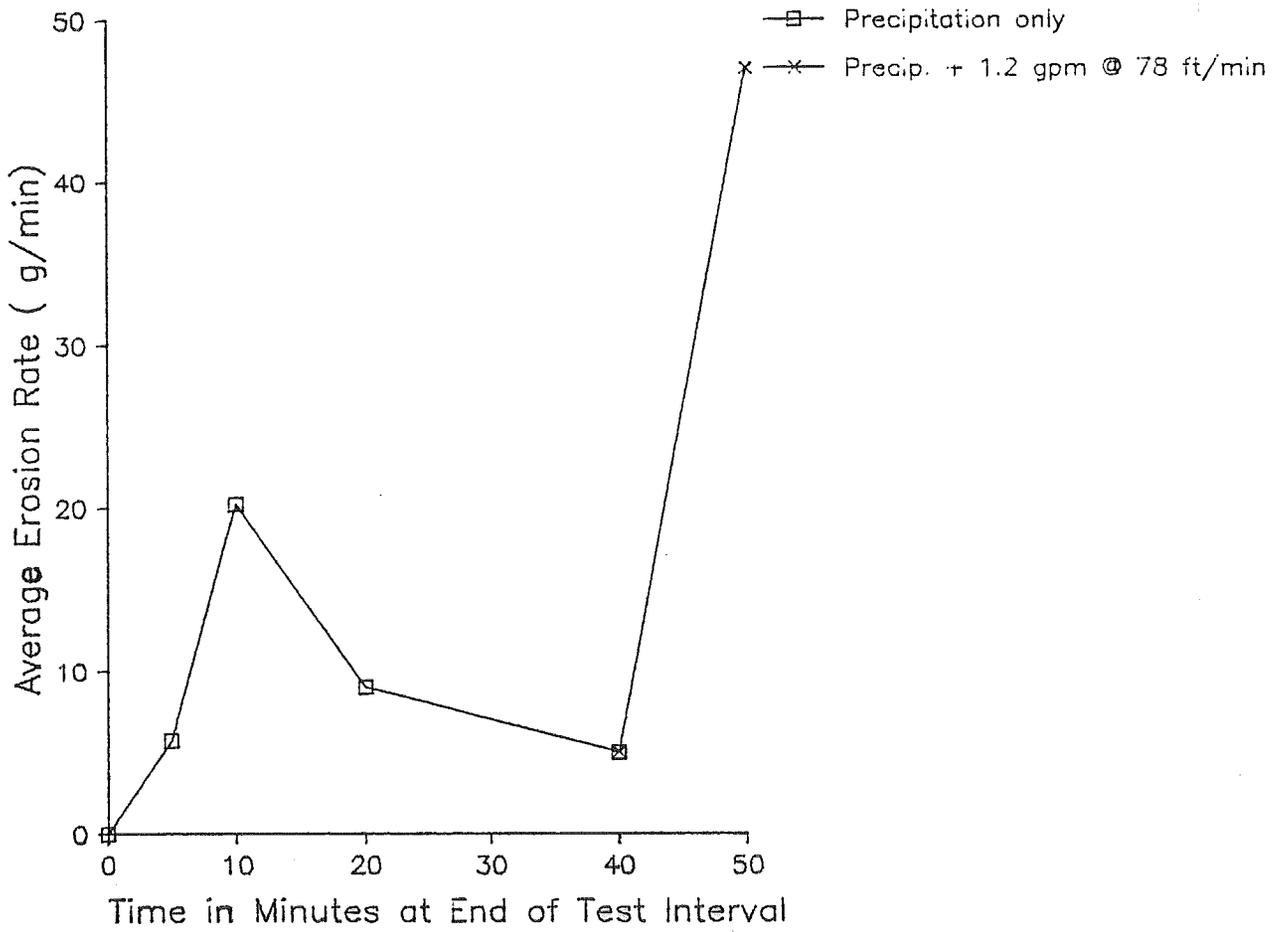
Figure 15. SRG1 Erosion Vs. Time, Combined Flow Conditions, for 2:1 Slope

When Figures 20 and 15 are compared it is apparent that when testing started with the same flow but at a higher velocity, the erosion rate increased. However, the armoring associated with the overland flow of 1.2 gpm and 78 ft/min was considerable. The rate of erosion of approximately 47 g/min associated with the first overland flow after 10 minutes is approximately 5 times greater than the rate of erosion for the second interval, with a velocity of 141 ft/min, after the same time

Data on Figures 15 and 20 also show that with successively higher flow events the rate of erosion first increases and then rapidly decreases as a more efficient form of surface protection is formed. However, at some point the erosion stresses will become large enough to transport the largest soil particles. When this severe erosion environment is brought to bear on the slope, the slope will fail.

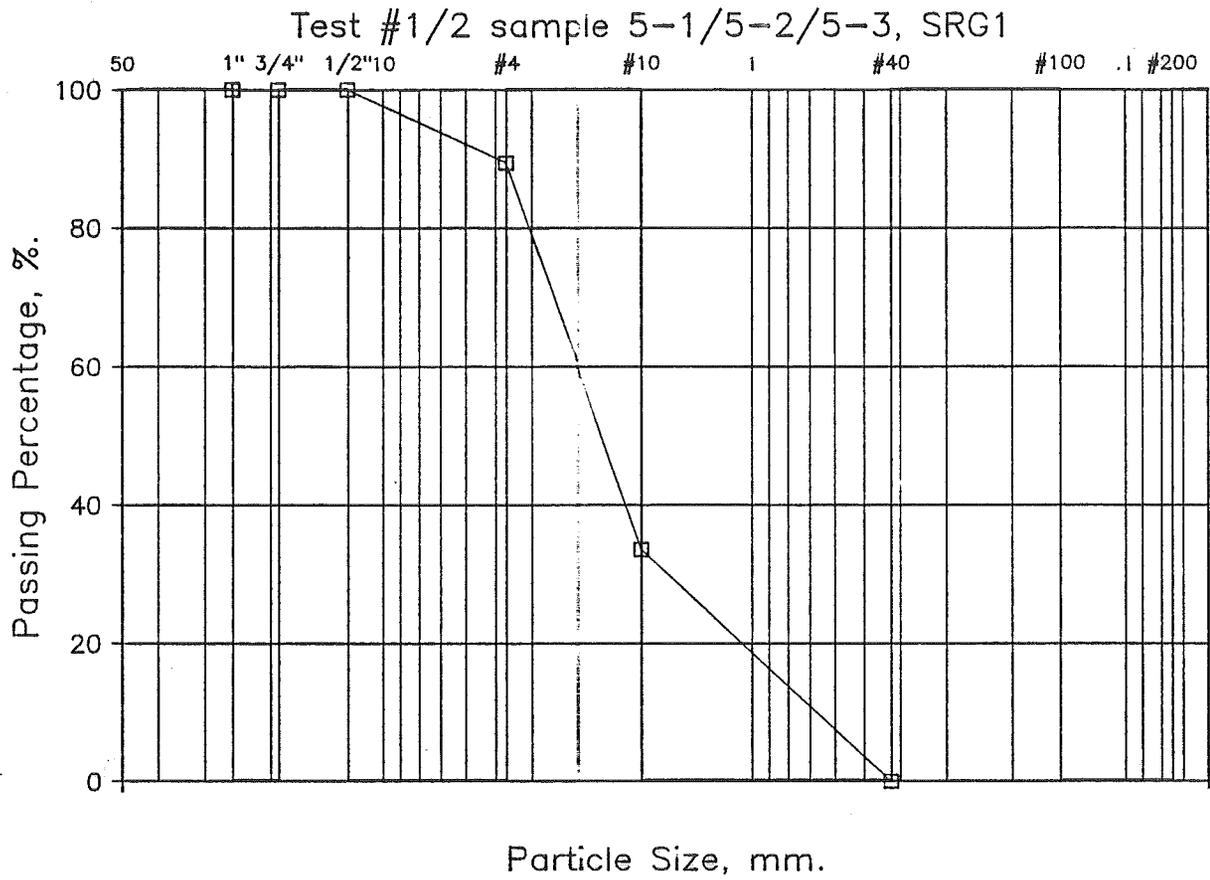
Figure 19. SRG1 Grain Size Analysis after 50 Minutes of Precipitation and 10 Minutes of Overland Flow

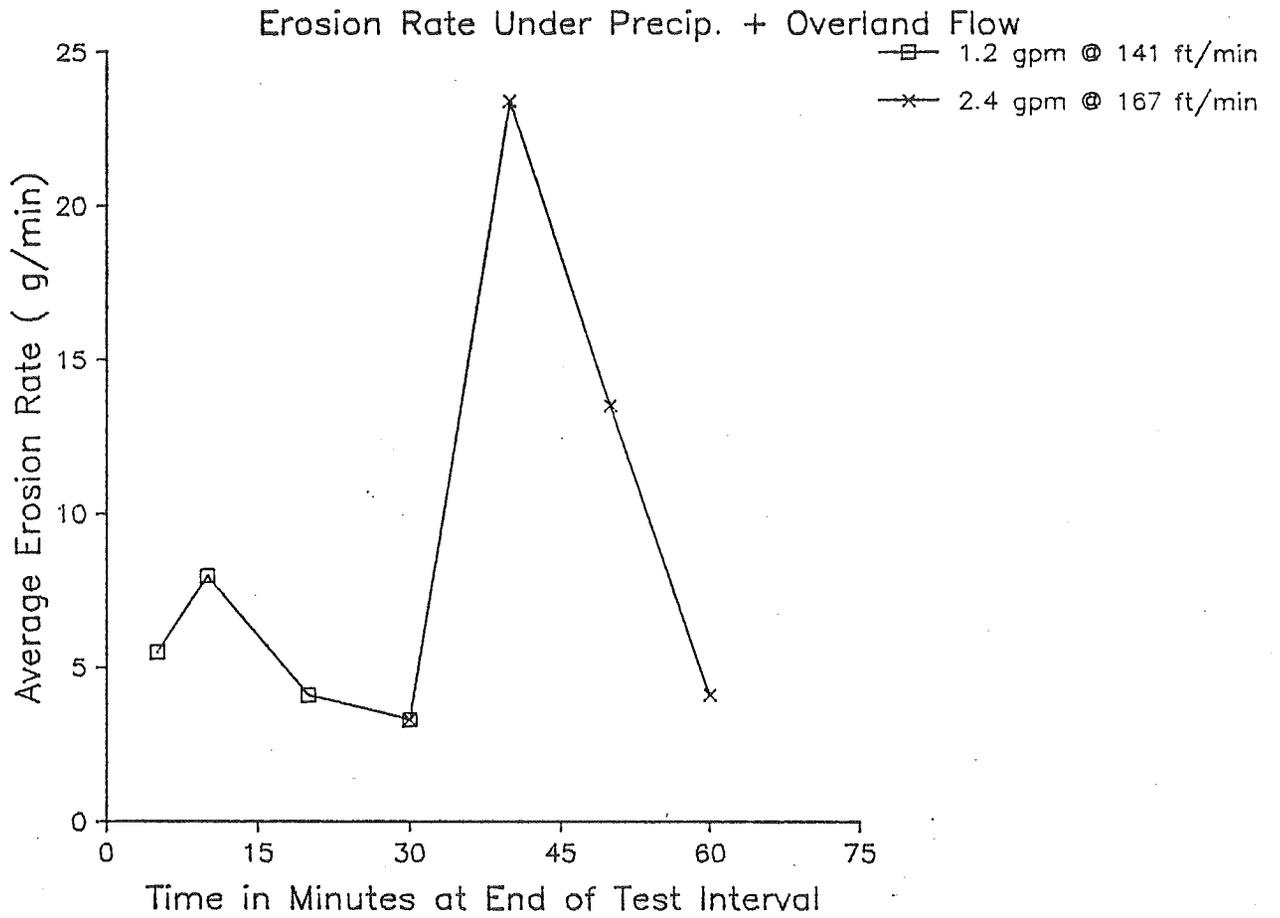
Figure 20. SRG1 Erosion Vs. Time for 2:1 slope and $Q = 1.2$ & 2.4 gpm (4.5 & 9.1 L/min)

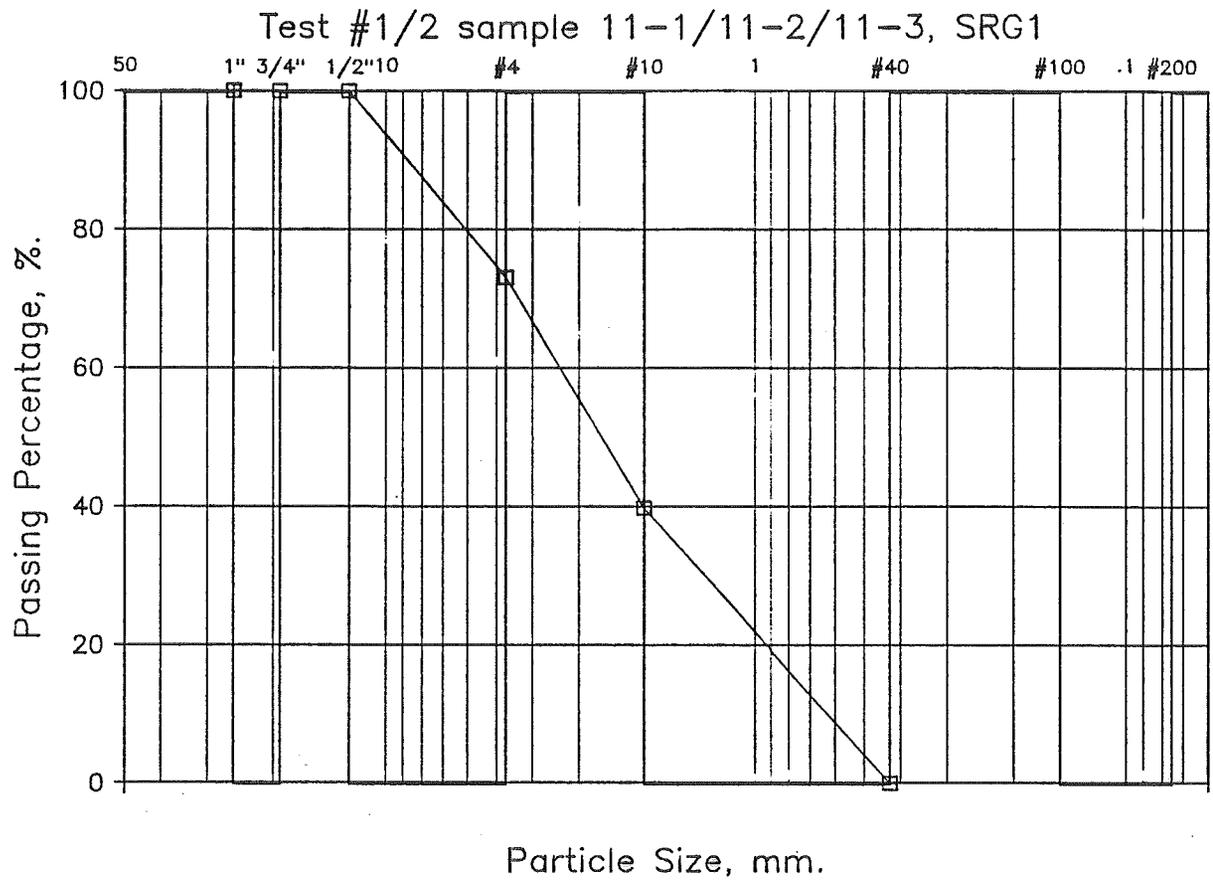
After 30 minutes of testing at the 1.2 gpm and 141 ft/min flow rates was completed the flow was increased. The volume was increased to 2.4 gpm and the flow velocity increased to 167 ft/min (50.9 m/min). The rate of erosion for the next 10 minute test interval increased to 23.4 g/min, (Figure 20). At this more severe erosion condition the percentage of plus number 4 size particles that were eroded increased to 27 percent of the collected combined sample (Figure 22).

Figure 22. SRG1 Grain Size Analysis, 10 minutes at 2.4 gpm (9.1 L/min) With a Velocity of 167 ft/min (50.9 m/min)

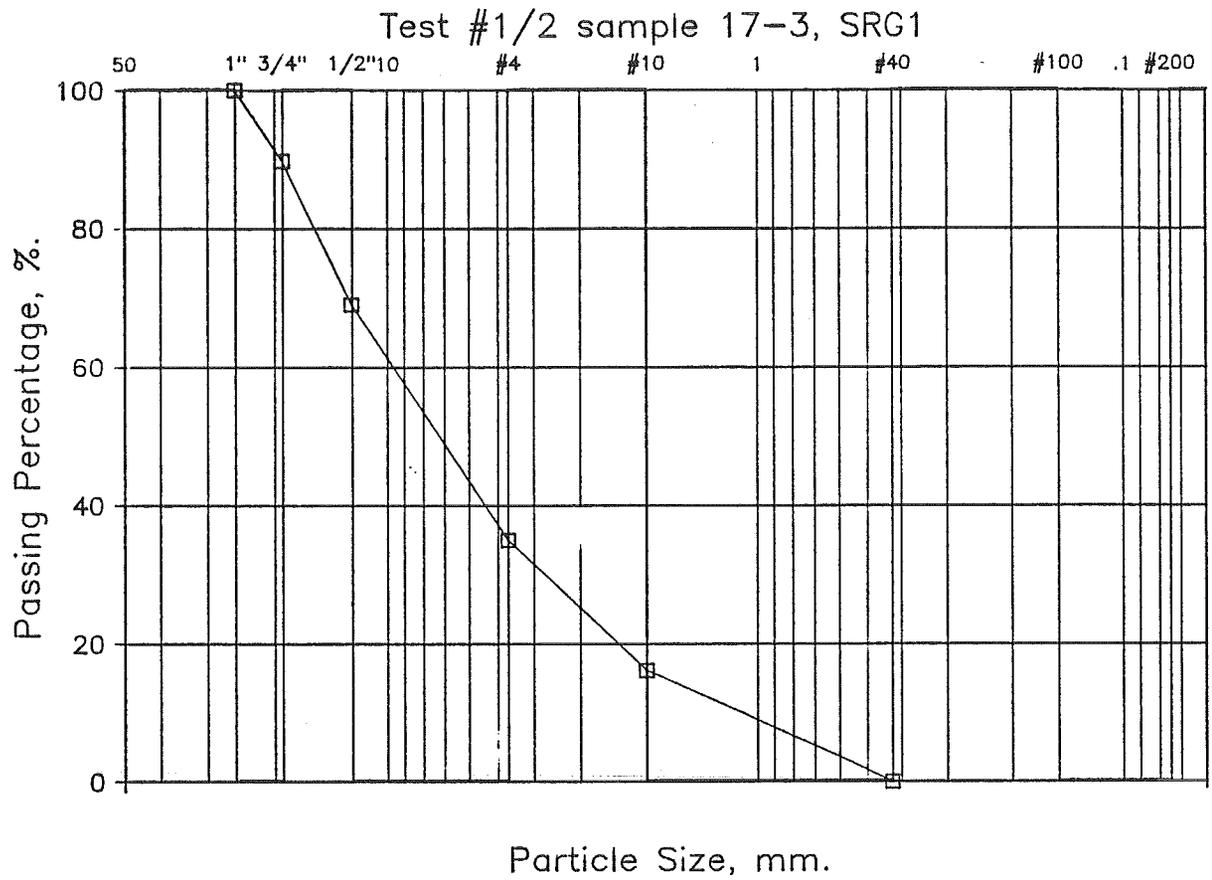
The removal of the armoring that had been formed during the prior testing began when the flow reached 6.0 gpm. As can be seen on Figure 27, the surface protection was being destroyed. Slope surface particles as large as 0.75 inches were being transported. In fact a straight channel had been cut in the SRG1, though the channel had not cut through to the Mirafi 6000 material.

Figure 27. SRG1 Grain Size Analysis, Panel 1, 10 Minutes of Combined Flow at 6.0 gpm (22.7 L/min)

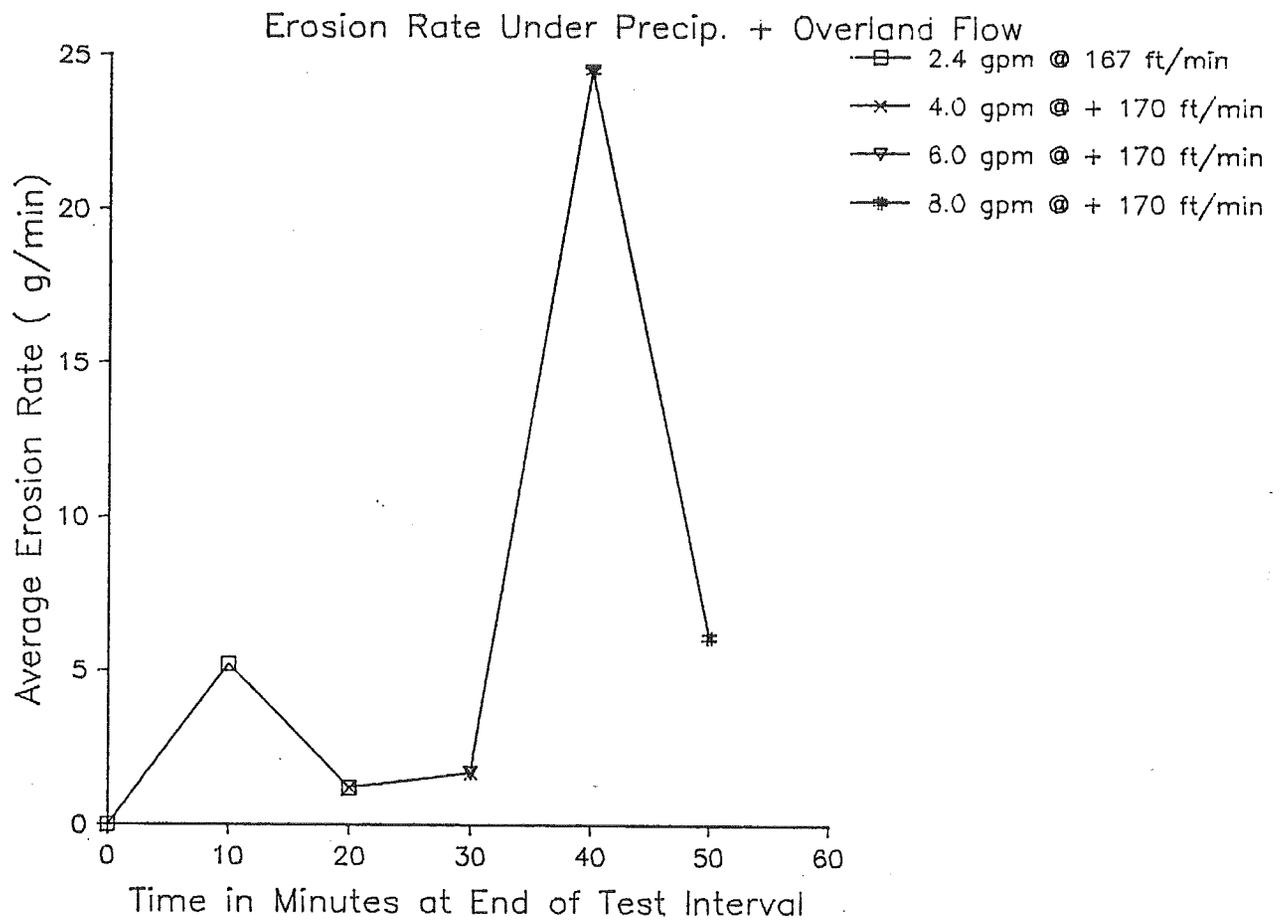
An example of the variability to be found on "identical" panel surfaces is depicted on Figure 30. The results of panel 3 present proof that for an advantageous arrangement of surface particles even SRG1 material is resistant to combined flows with an overland component of 8.0 gpm. It should be noted that considerable movement and surface erosion occurred prior to the development of this rather stable surface. The sample at the end of the 8.0 gpm 10 minute event contained no particles larger than the number 4 size. This indicates that the preceding flow events were responsible for the slope resistance (Figure 31).

Figure 30. SRG1 Test 2, Panel 3, Erosion Rate Vs. Time, 2:1 Slope

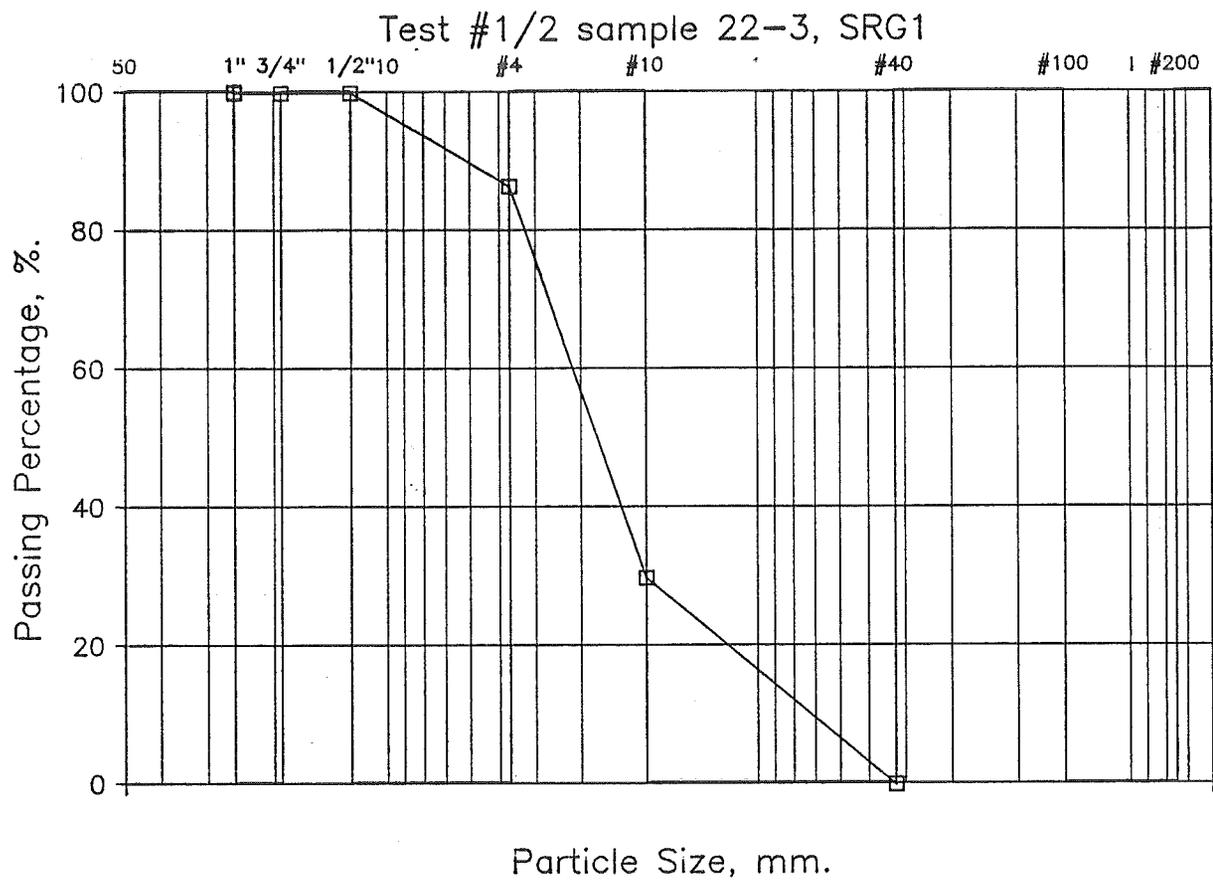
Figure 31. SRG1 Grain Size Analysis, Panel 3, Collected after 10 Minutes of Combined Flow With 8.0 gpm (30.3 L/min)

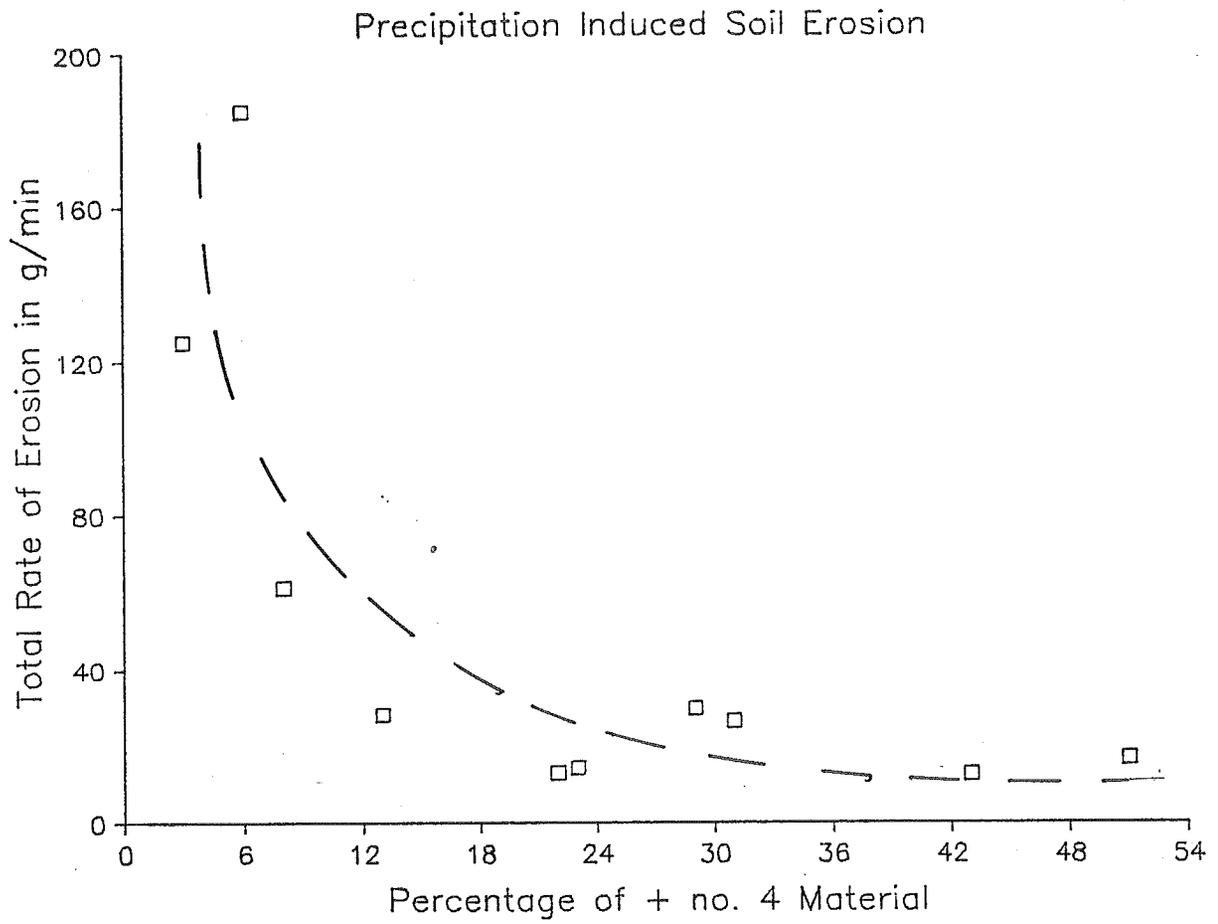
When rate of erosion caused by precipitation is plotted against the percentage of plus number 4 material in the soil for the SRP5 base soil, Figure 39 results. When the percentage of particles larger than the number 4 sieve is greater than 10

Figure 39. SRP5 Base Soil, Rate of Erosion Vs. Amount of Aggregate Larger than the No. 4 Sieve, 2:1 Slope, Precipitation Only

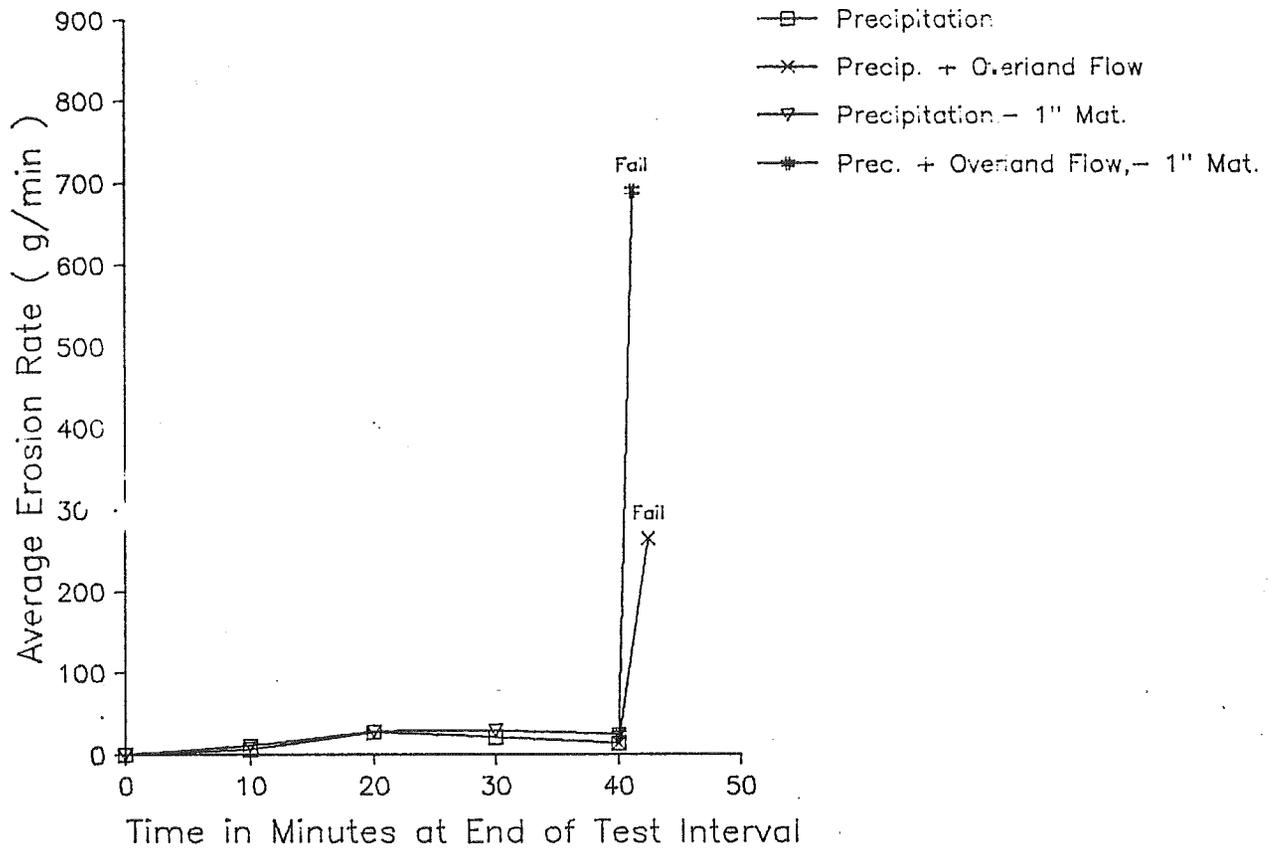
The difference in erosion potential is apparent when the combined flow testing is conducted (Figure 48). There is a three fold difference in erosion resistance when the combined flow starts. However, as Figure 48 indicates, both materials failed in less than 3 minutes into the combined flow testing period. The reason for the failure appeared to be related to the round shape of the coarse particles. SRS1 contains a large number of rounded CaCO_3 particles. These rounded particles tend to roll on the 2:1 slope. Once the rounded particles begin moving they do not stop as easily as the angular particles. The more spherical a particle becomes, the less efficiently the particle interlocks with others to form the surface armor. During the erosion tests particles were observed rolling down the slopes. As Figure 46 shows even for the SRS1 -1" slopes, particles 0.5 inches and larger were being collected at the low flow rates applied. Most of these particles once set in motion did not stop until the collection chamber was reached.

Figure 48. SRS1 & SRS1 -1", Erosion Rate Vs. Time, 2:1 Slope, Summary of Flow Conditions

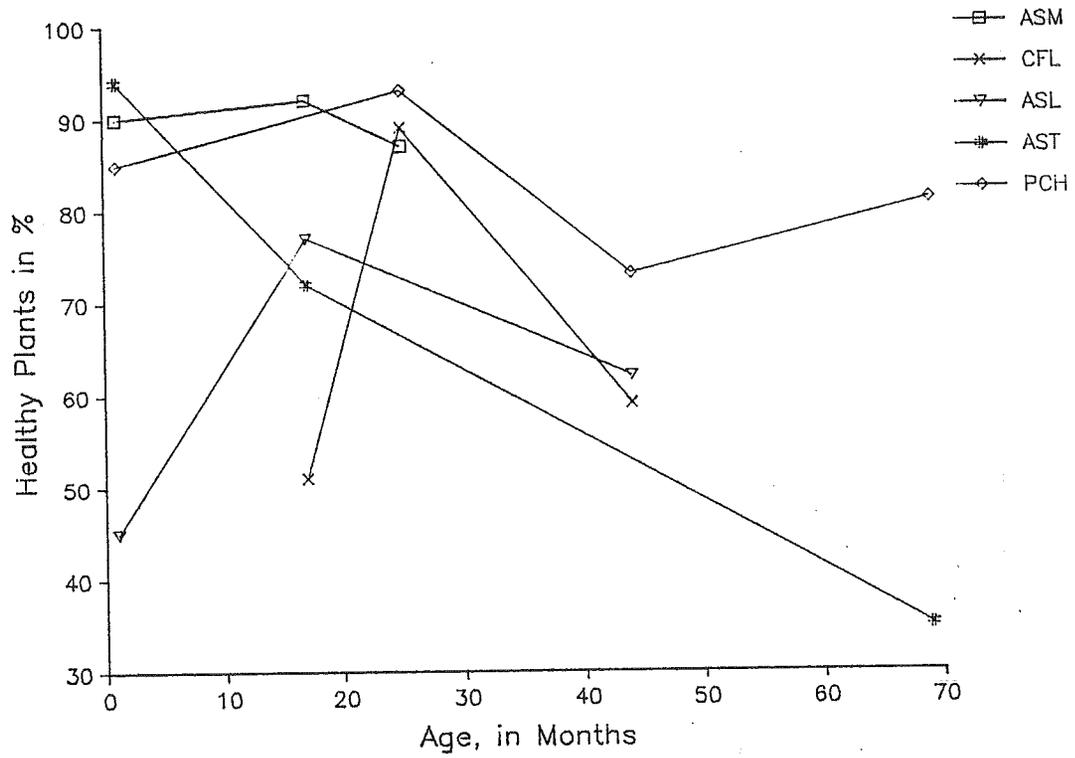
Although the differences are not age related, the recognition that the contracts do represent different environments is an important one. For whatever reasons, the contracts do represent a recognizable source of variation in the response of the plants to the freeway environment. Any future evaluations or sampling schemes should take these differences in contracts into consideration. In addition, if age of the plants is to be considered a parameter in any monitoring scheme then a baseline must be established.

Figure 51. Relation Between Contract Age and Health of Landscaping Plants

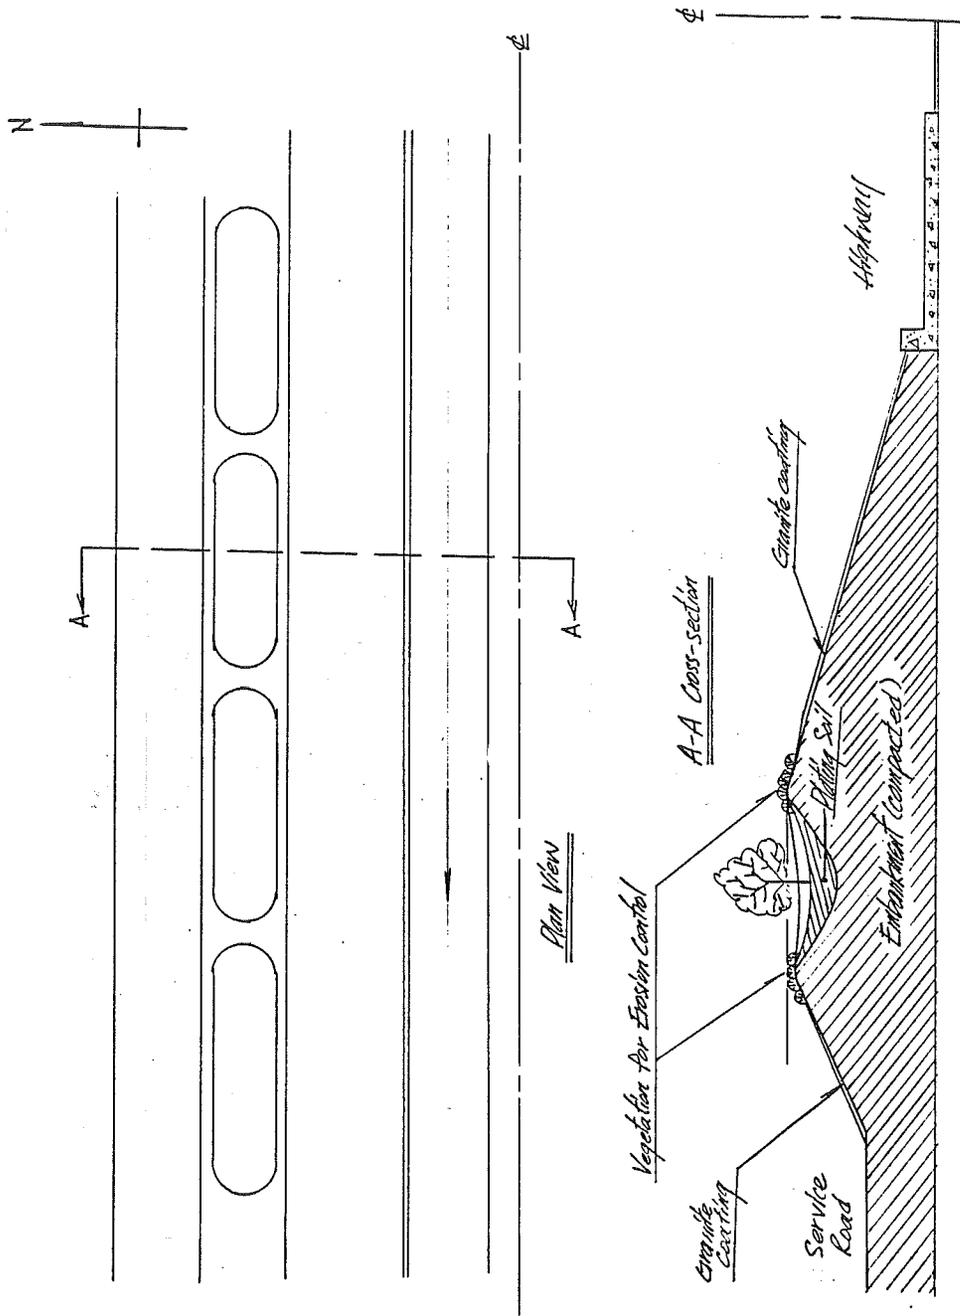
If more intense regrading is deemed feasible, then a somewhat radical change in landscape design should be evaluated. Figure 52 depicts an example of the design changes that might facilitate the separation of the engineering environment from the plant environment. In this design, the upper portion of the slope is graded so that the final surface is a gentle trough which does contains plating soil but not granite. The trough acts as a water catchment. Water collected in the trough will infiltrate into the plating soil, thus making it plant available and removing it from participating in overland flow. At appropriate intervals the reverse face or the freeway side would contain armored mini-spillways that would channel flow in such a way as to minimize erosion damage. Vegetation would be restricted to the upper portion of the slope. Tall shrubs in the trough would be visible but the ground surface would not. Unless weeds became a severe problem, they would not need to be removed except for cosmetic purposes. The shrubs would also provide a visibility barrier. The edges of the trough should be planted with a ground cover that can

Figure 52. Design of a Test Section Which Combines Engineering Environment with Plant Environment

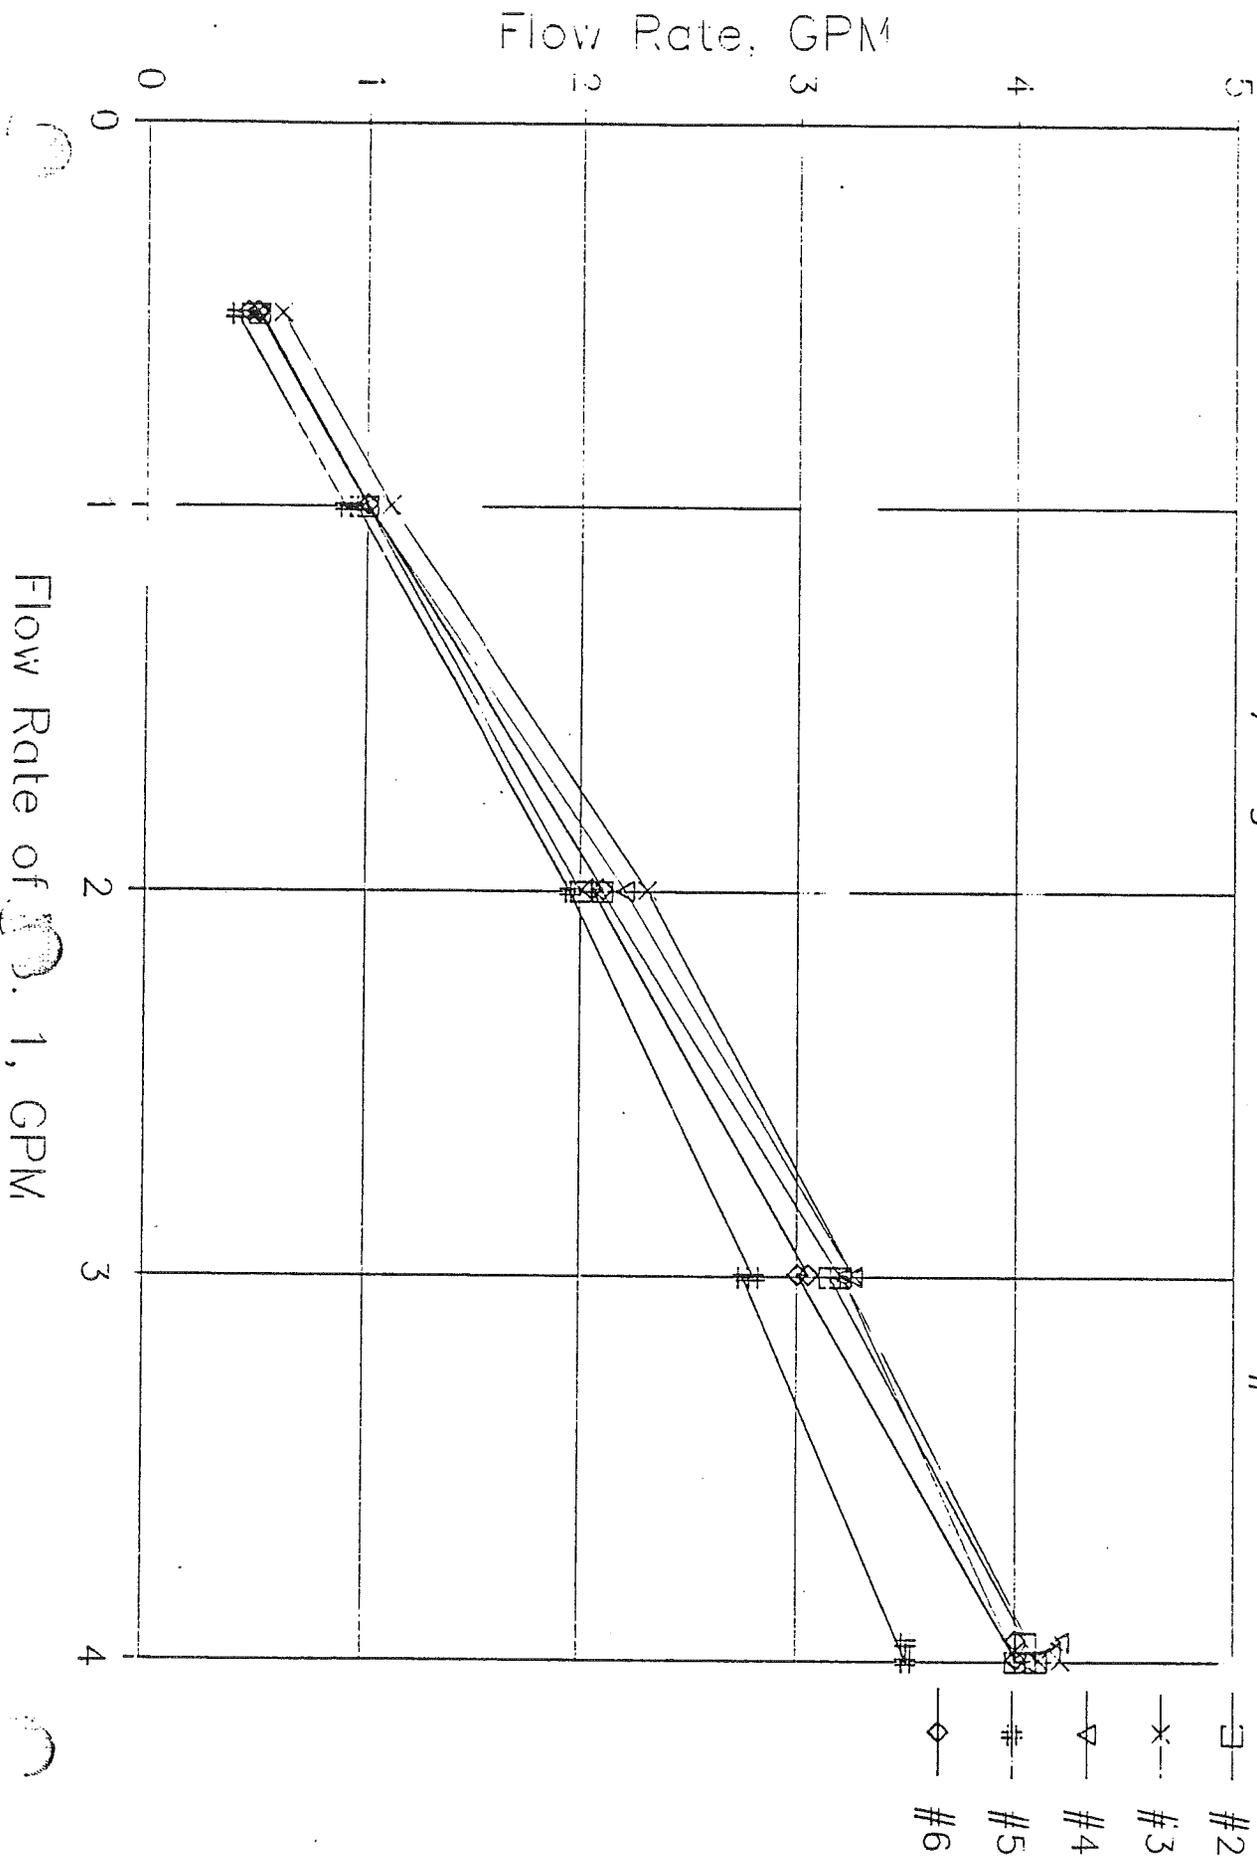
Flow-meter Calibration

2-27-87 / Against to Flow-meter #1
