ARIZONA DEPARTMENT OF TRANSPORTATION

REPORT NUMBER: FHWA-AZ92-329

EVALUATION OF BRIDGE APPROACH RAILS

Final Report

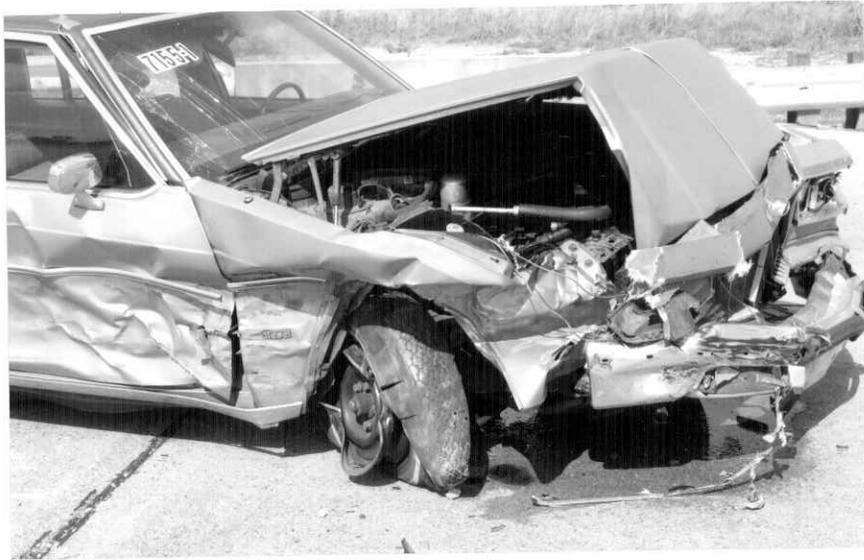
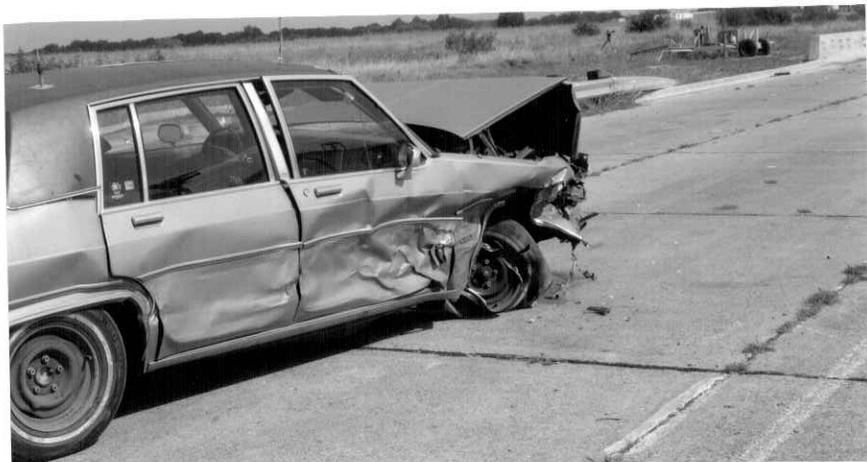
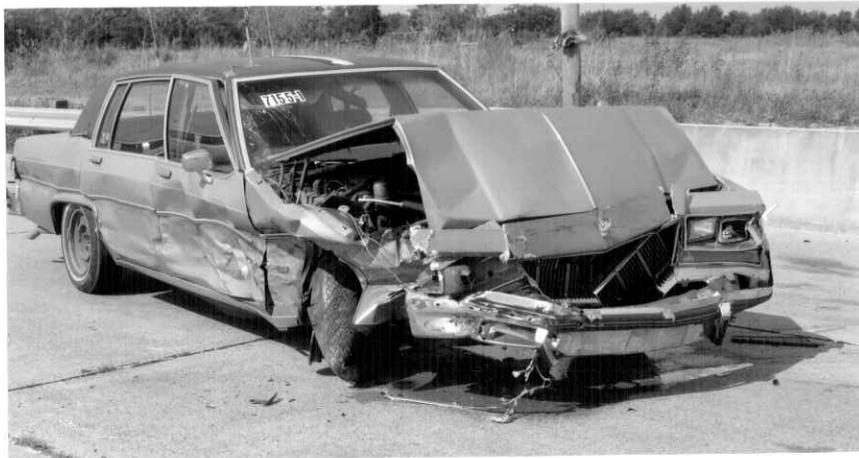
Figure 7. Vehicle after test 7155-1

Damage to the vehicle is shown in Figure 7. The maximum crush was 18.0 inches (45.7 cm) at the right front corner of the vehicle. The right front wheel and control arm were bent and pushed rearward 13.0 inches (33.0 cm). The entire front end of the vehicle was shifted to the left 5.0 inches (12.7 cm).

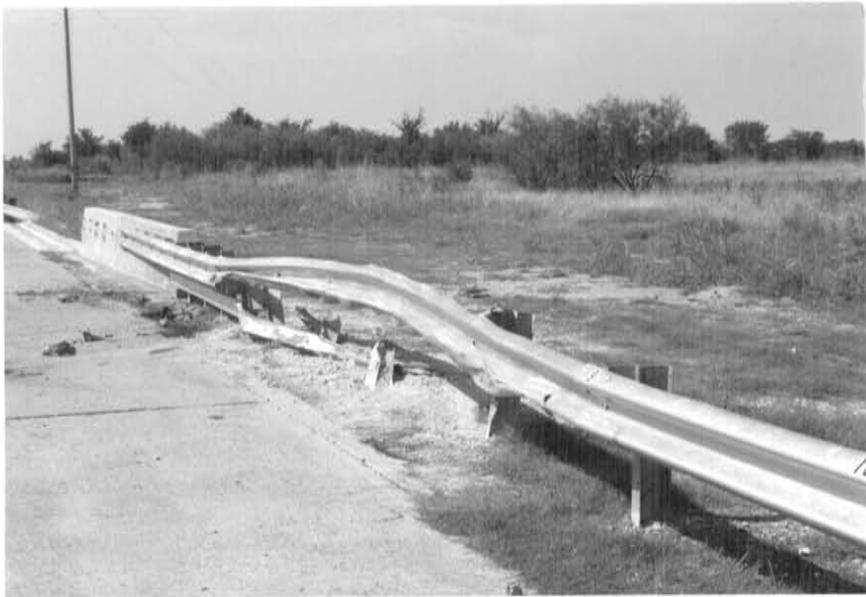
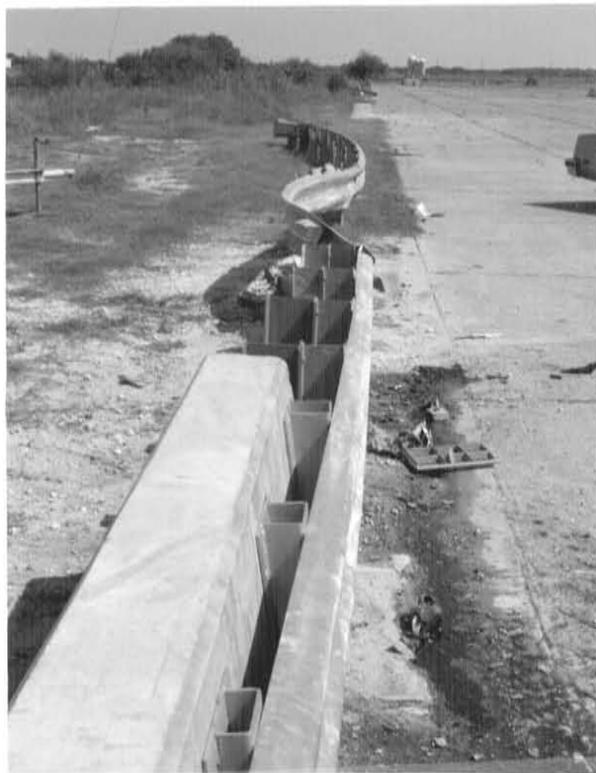
Figure 18. Arizona guardrail transition to concrete half barrier after test 7155-2

As shown in Figure 18, the guardrail and transition systems experienced considerable damage. There was residual deformation to the rail in the area of the first seventeen posts.

The maximum permanent rail deformation was 22.0 inches (55.9 cm) and maximum lateral dynamic rail deflection was observed to be 34.9 in (88.7 cm).

In summary, this test was judged to be a failure. The installation contained but failed to redirect the impacting vehicle. The vehicle was brought to an abrupt stop after snagging on the rubrail end and first transition post (post 7).

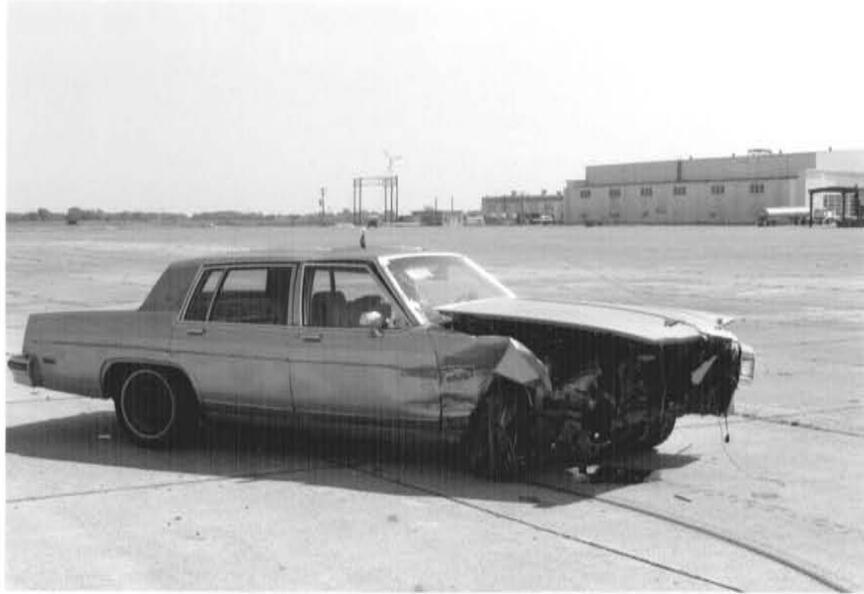
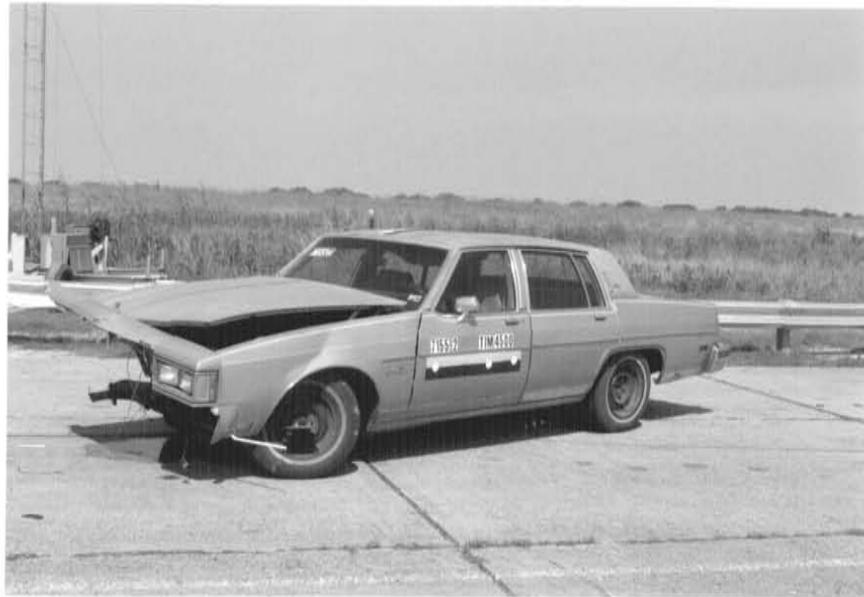
Figure 19. Vehicle after test 7155-2

Damage to the vehicle is shown in Figure 19. The maximum crush was 21.0 inches (53.3 cm) at the right front corner of the vehicle. The right front wheel and control arm were severely bent and pushed rearward 8.0 inches (20.3 cm). The entire front end of the vehicle was shifted to the left 2.0 inches (5.1 cm). Additionally, the right front tire was aired, the subframe was bent, and the windshield was broken.

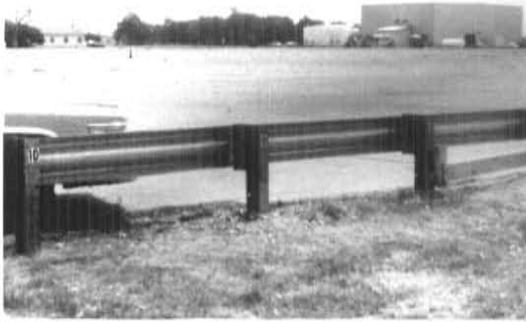
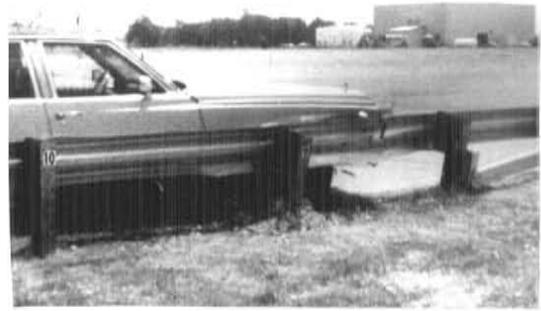
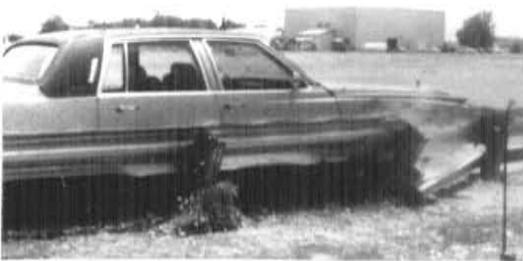
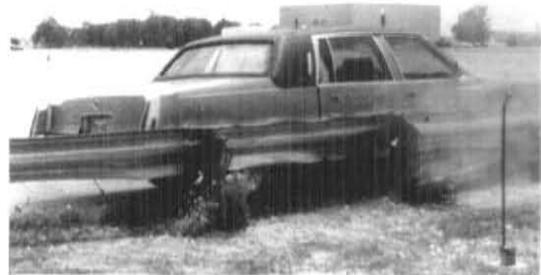
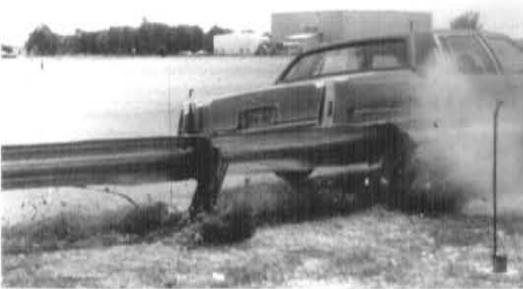
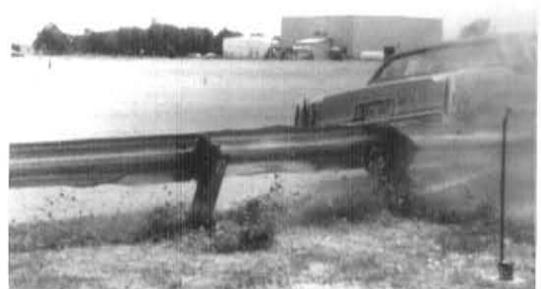
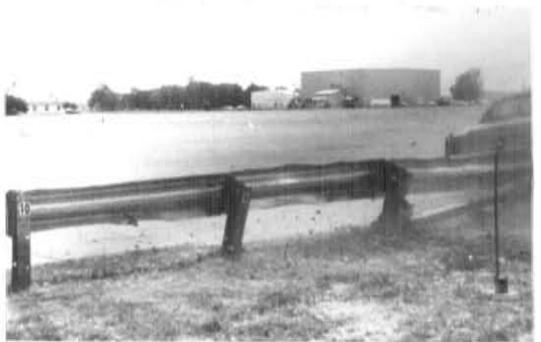
Figure 29. Sequential photographs of test 7155-3.

and the vehicle came to rest 203 feet (61.9 m) from the point of impact. Sequential photographs of the test are shown in Figure 29.

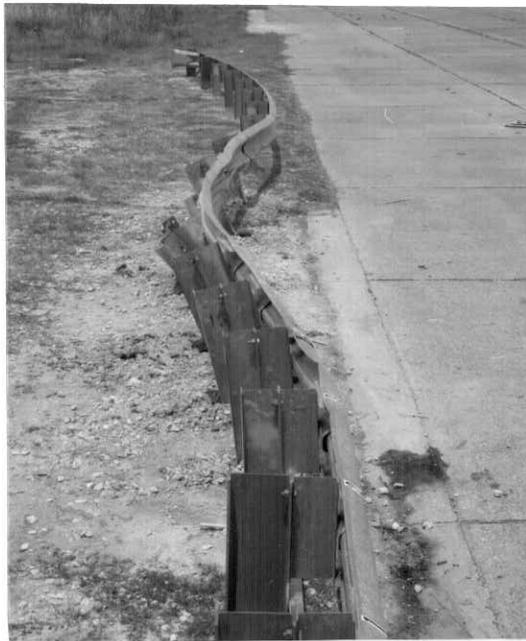
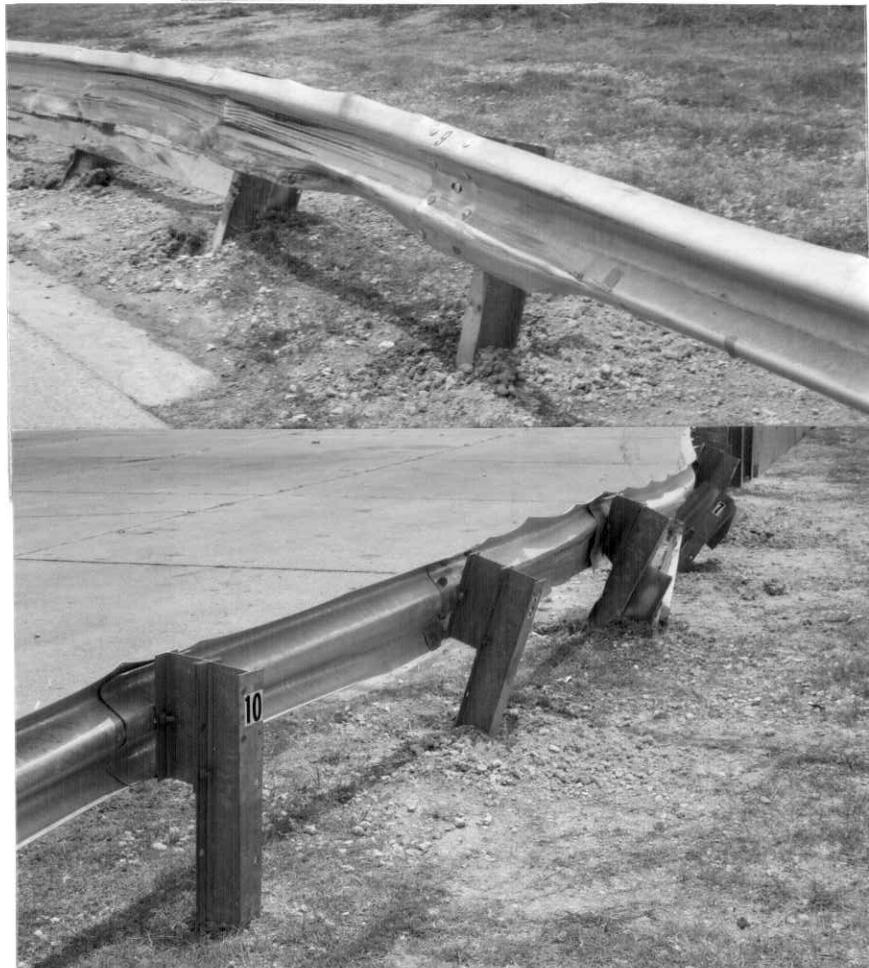
Figure 30. Arizona guardrail transition to concrete barrier after test 7155-3.

Damage to the installation is shown in Figure 30. The maximum lateral dynamic rail deflection was observed to be 28.2 inches (71.6 cm), and the maximum permanent rail deformation was measured to be 27.0 inches (68.6 cm). As designed, several of the guardrail posts detached from the W-beam rail allowing the vehicle to push them over more readily. Although some wheel contact was observed on post 8, there was no significant snagging on the post or rubrail end. The vehicle was in contact with the installation for a total length of 31.0 feet (9.5 m).

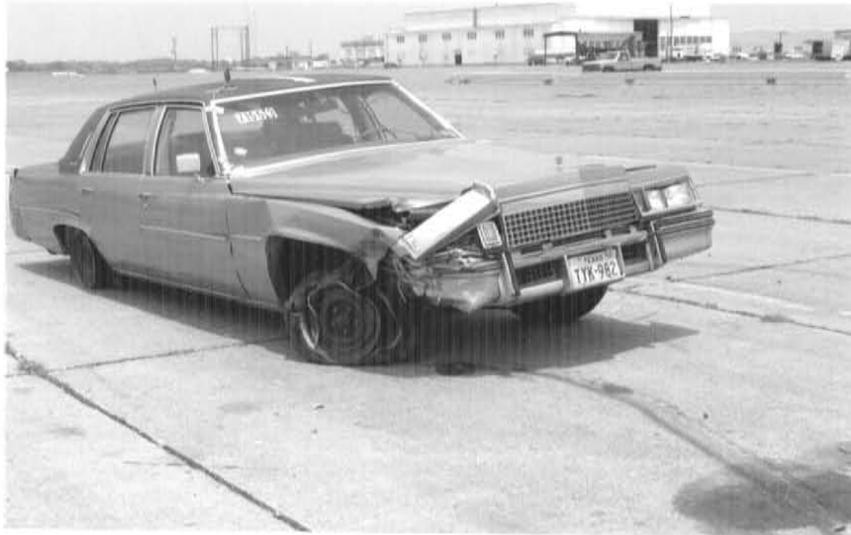
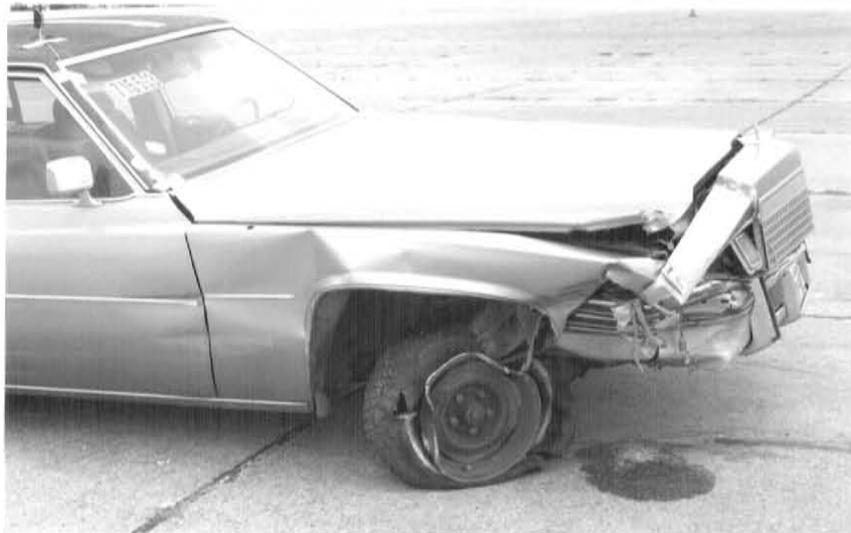
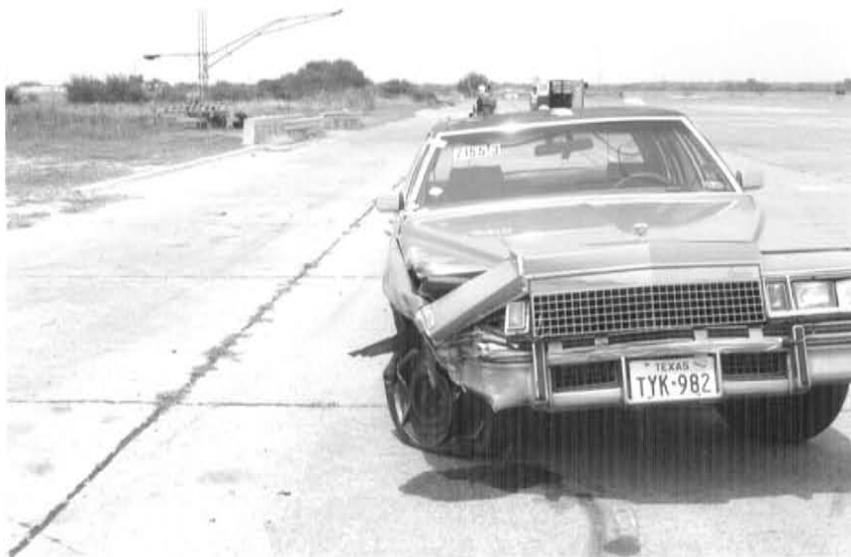
Figure 31. Vehicle after test 7155-3.

As shown in Figure 31, damage to the vehicle was relatively minor. The damage was primarily confined to the right front fender area. The maximum crush was 15.0 inches (38.1 cm) at the lower right front corner of the vehicle. The right front wheel was pushed rearward only 0.5 inches (1.3 cm). The front end of the vehicle was shifted to the left 3.0 inches (7.6 cm). Additionally, the right side tires were aired and the wheels were bent.

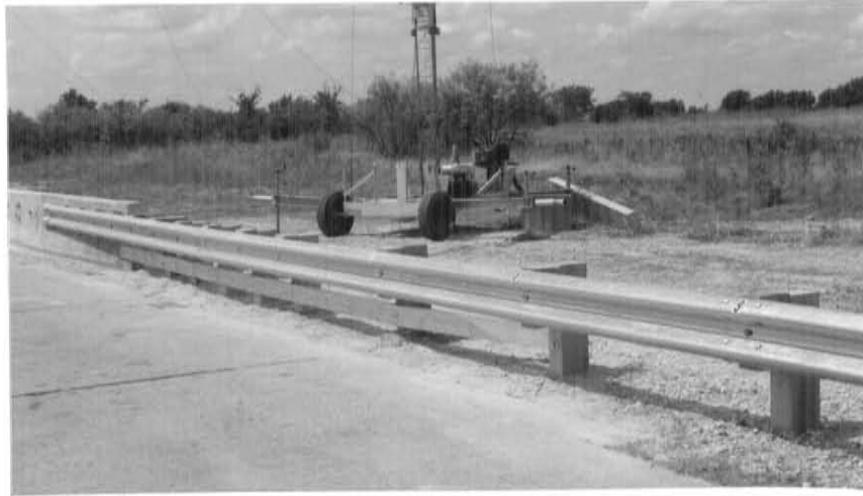
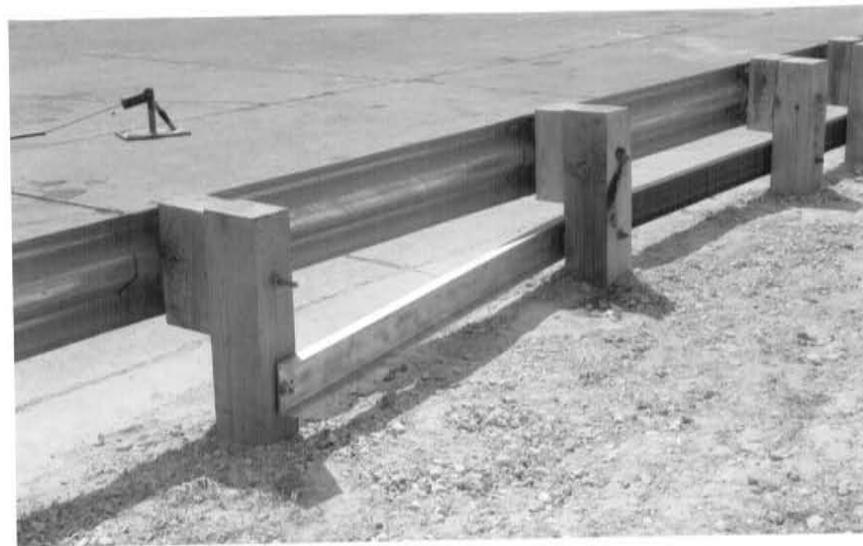
Figure 38. Arizona guardrail transition to concrete barrier before test 7155-4.

Details of the wood post design are shown in Figure 37. The completed test installation is shown in Figure 38.

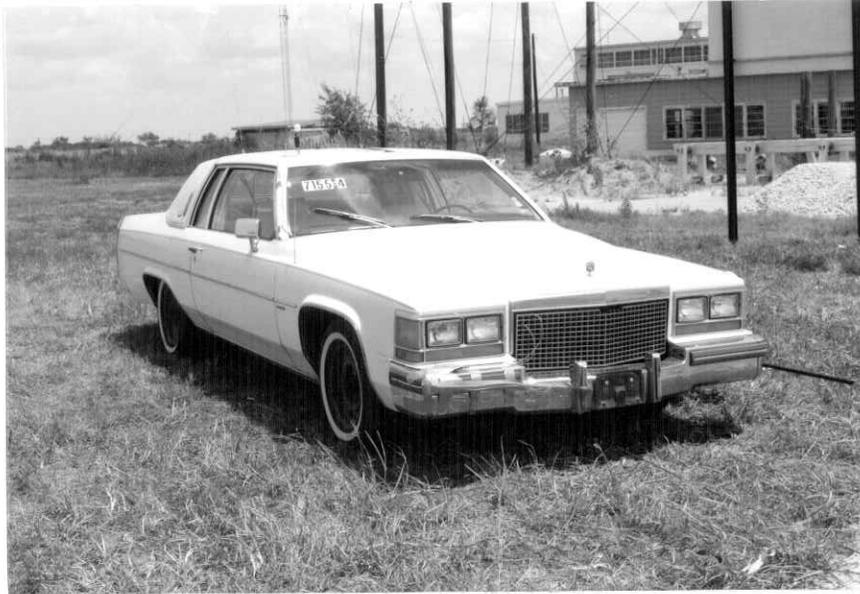
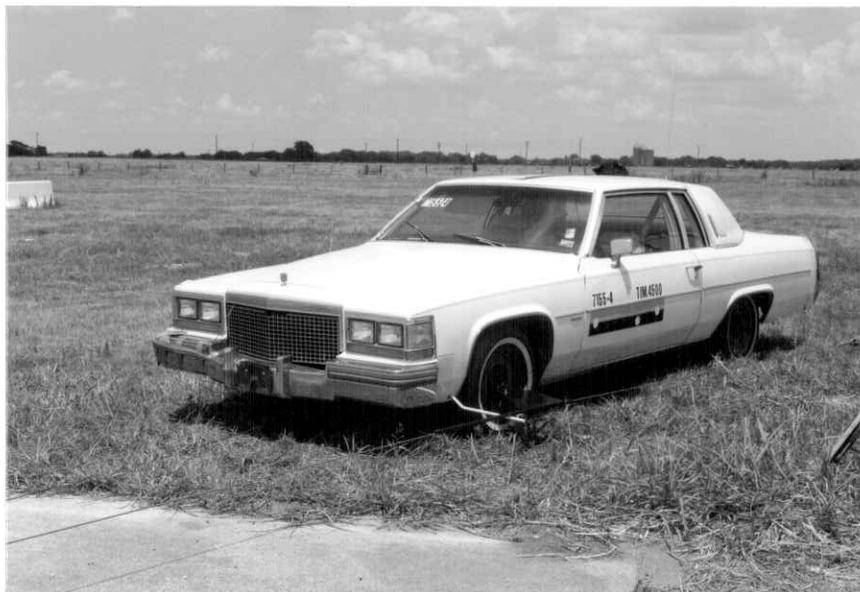
Figure 39. Vehicle before test 7155-4.

A 1981 Cadillac Coupe Deville (shown in Figure 39) impacted 7.0 ft (2.1 m) upstream from the end of the concrete bridge rail at 61.5 miles per hour (98.9 km/h) and at an angle of 24.0 degrees using a cable reverse tow and guidance system. Test inertia mass of the vehicle was 4,500 pounds (2,041 kg). The lower edge of the vehicle's bumper was at a height of 12.0 inches (30.5 cm) and the distance to the upper edge of the bumper was 20.0 inches (50.8 cm). Other dimensions and information pertaining to the test vehicle are given in Figure 40.

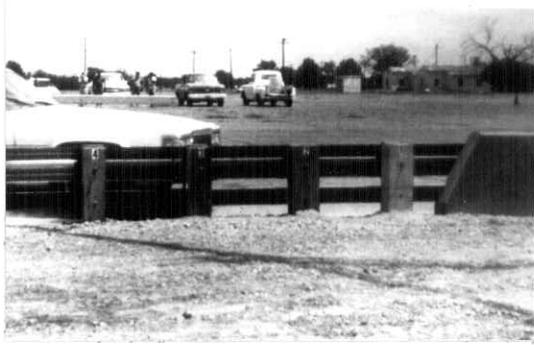
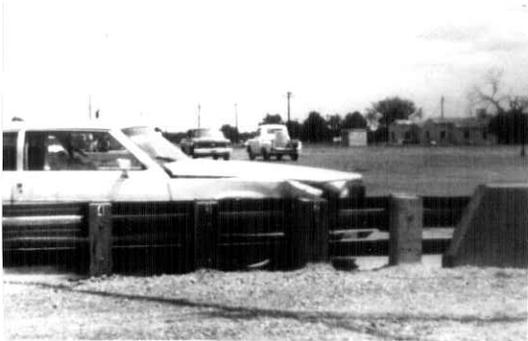
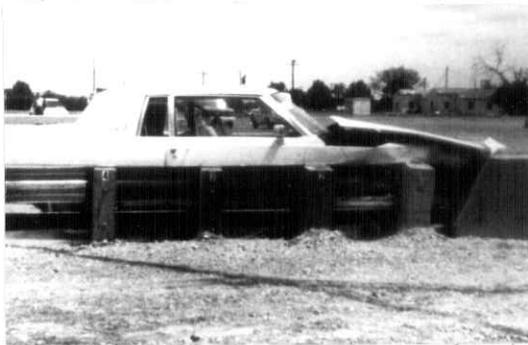
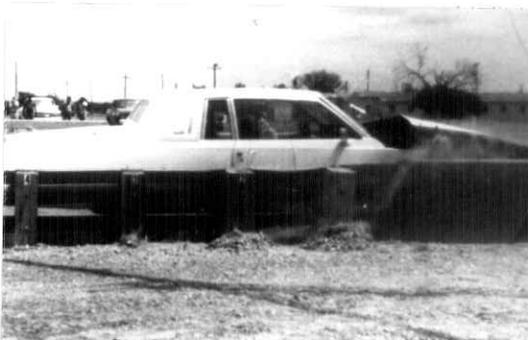
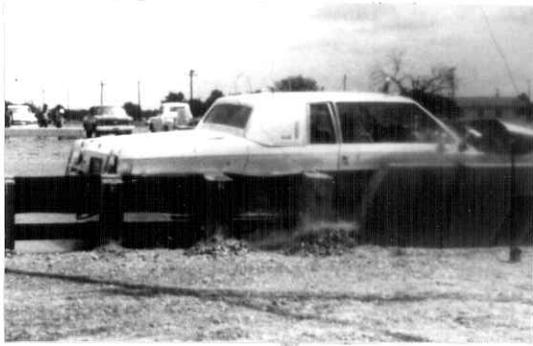
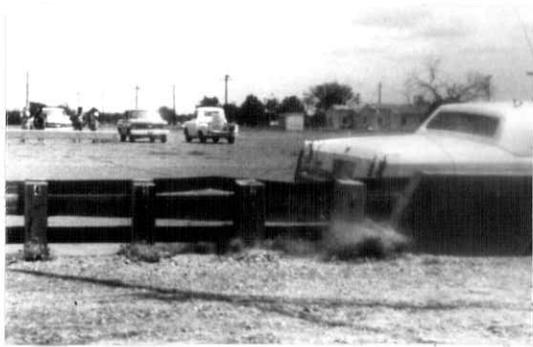
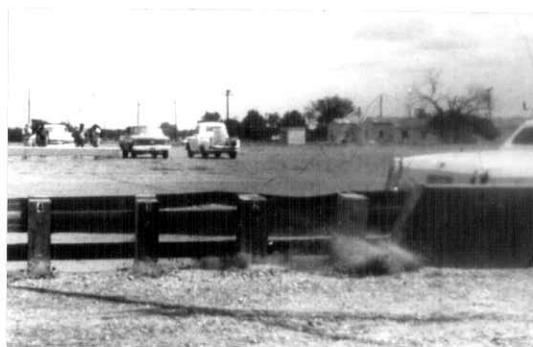
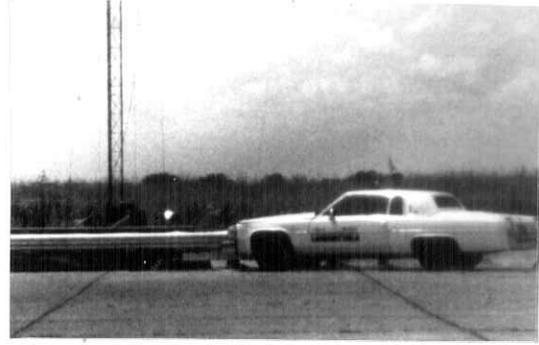
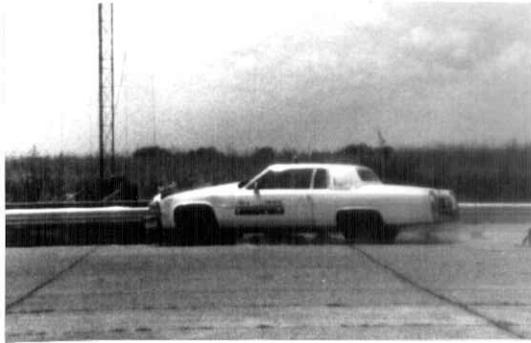
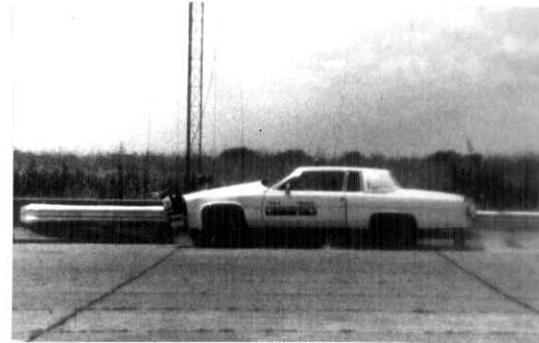
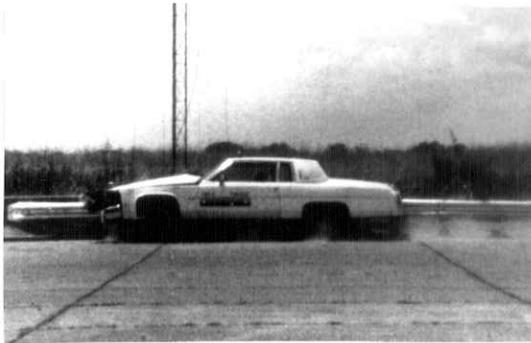
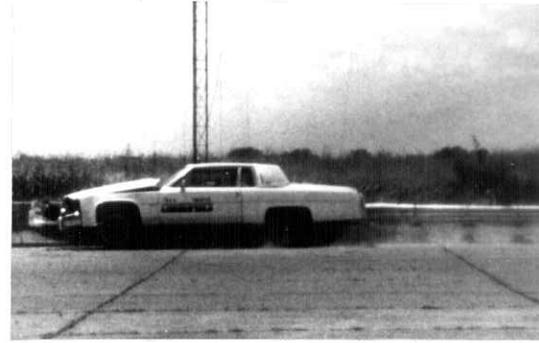
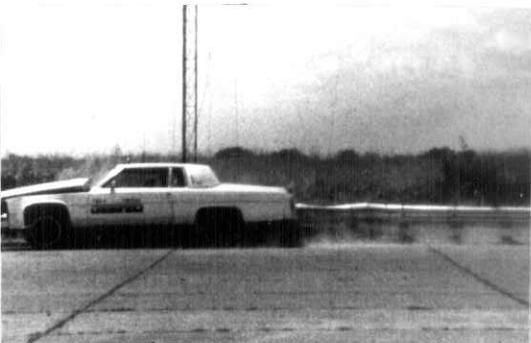
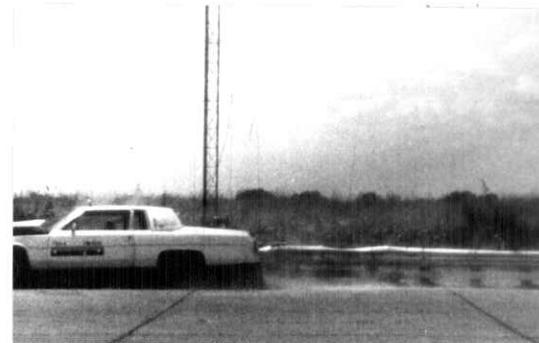
Figure 41. Sequential photographs of test 7155-4.

The vehicle was free wheeling and unrestrained just prior to impact. The performance of this system was very similar to the steel post system evaluated in Test 1. There was some evidence wheel contact with the first guardrail post adjacent to the concrete barrier and with the end of the concrete barrier itself. However, the presence of the rubrail prevented any significant vehicular decelerations from occurring. As seen in Test 1, the vehicle made contact with the first steel blockout on the face of the concrete barrier as the W-beam rail deformed around it. In spite of this contact, the vehicle was smoothly redirected without any abrupt ridedown decelerations. When the vehicle lost contact with the installation, it was traveling at a speed of 43.7 miles per hour (70.3 km/h) and at an angle of 8.2 degrees. Shortly thereafter, the brakes were applied, the vehicle yawed clockwise and came to rest 180.0 feet (54.9 m) from the point of impact. It should be noted that a secondary impact with an old test installation occurred downstream from the impact location. Sequential photographs of the test are shown in Figure 41.

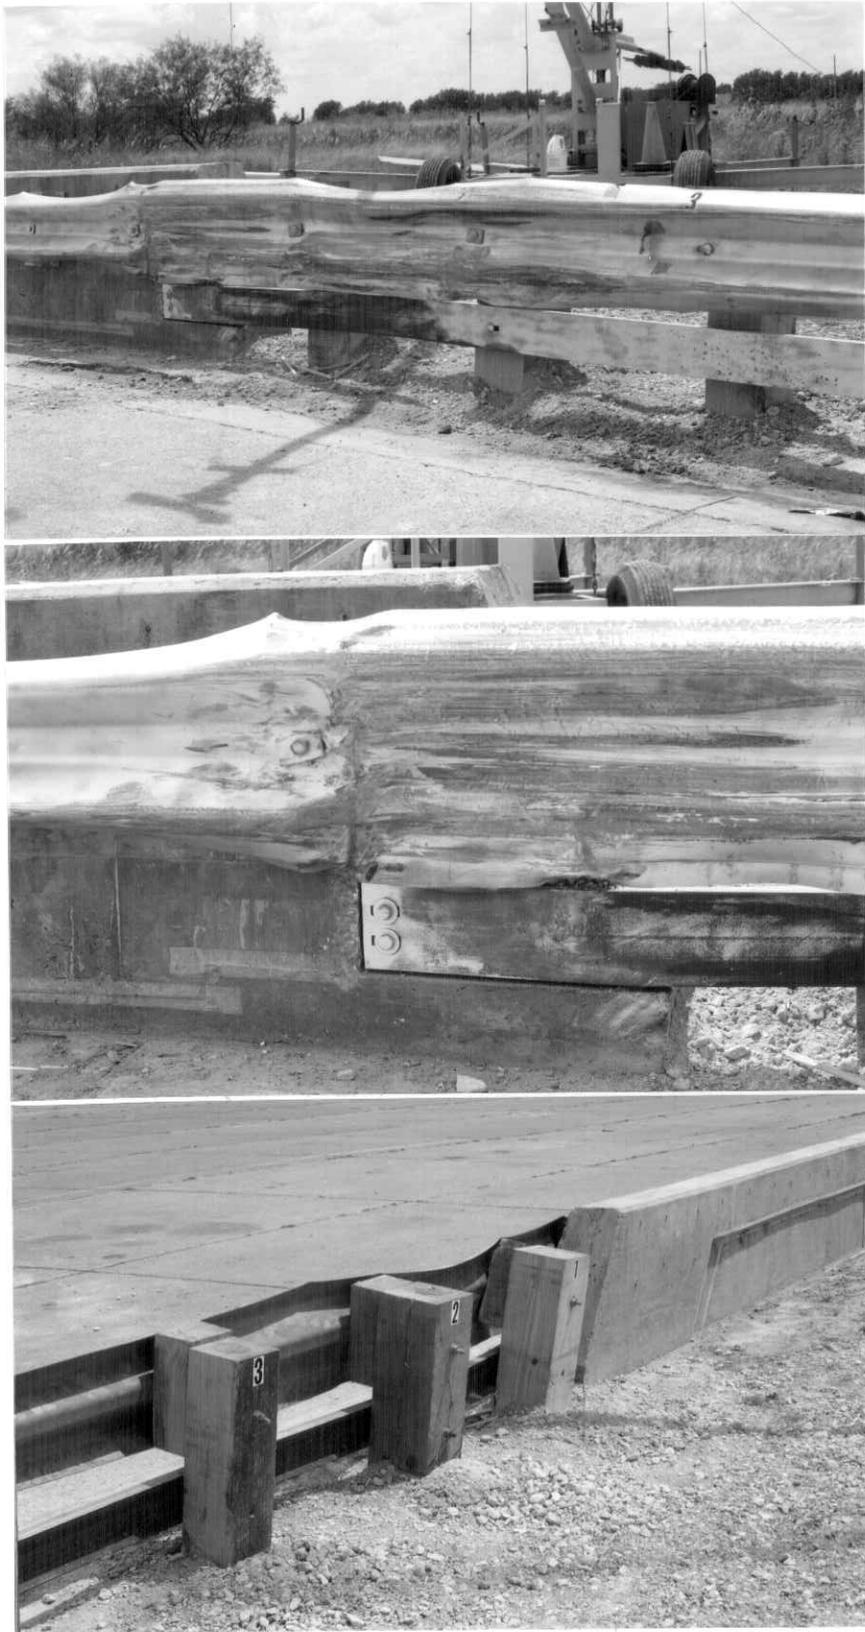
Figure 42. Arizona guardrail transition to concrete barrier after test 7155-4.

As shown in Figure 42, the installation received only minor damage. The maximum permanent rail deformation was 7.5 inches (19.1 cm) and maximum lateral dynamic rail deflection was observed to be 8.3 inches (21.0 cm). Once again, the concrete insert anchors to which the steel blockouts were attached performed well and showed no visible signs of distress. The vehicle was in contact with the installation for a total length of 14.8 feet (4.5 m).

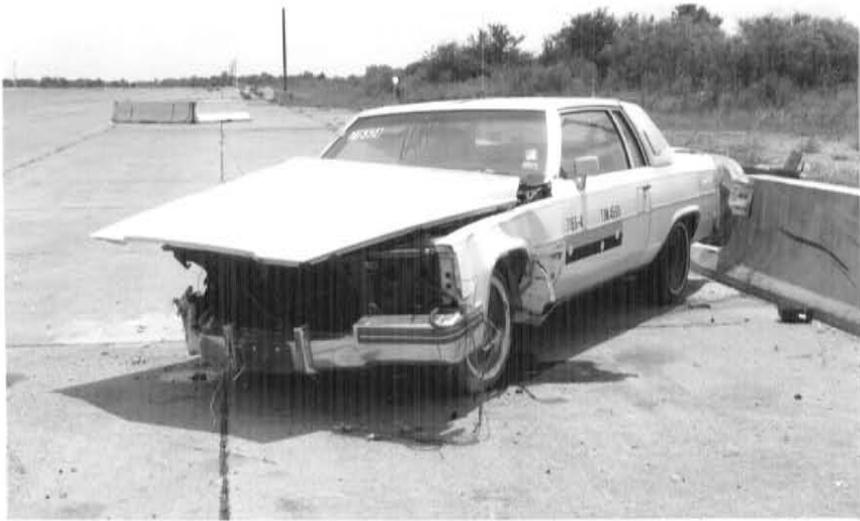
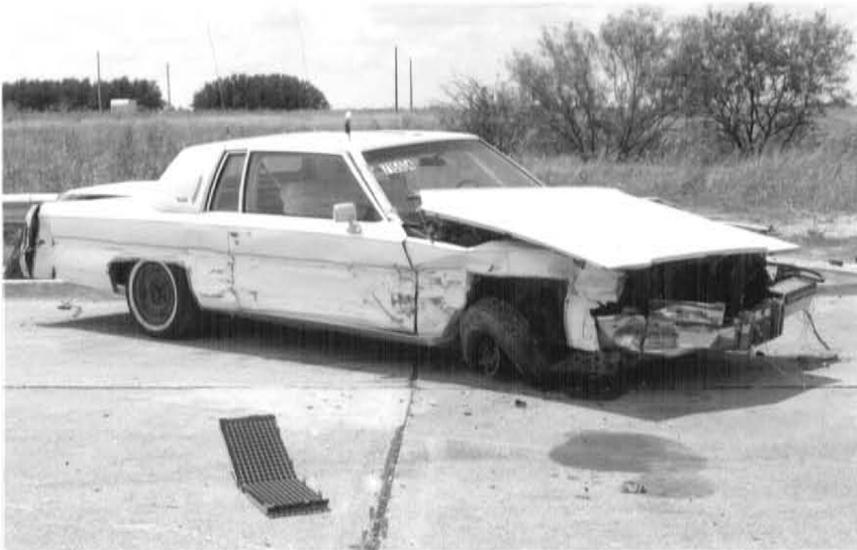
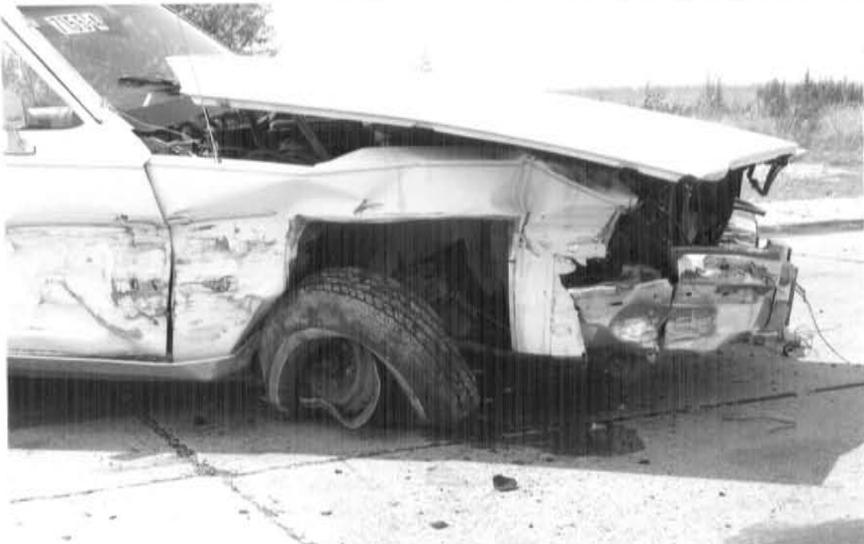
Figure 43. Vehicle after test 7155-4.

Damage to the vehicle is shown in Figure 43. The damage was moderate for a test of this severity. The maximum crush was 17.0 inches (43.2 cm) at the right front corner of the vehicle. The right front wheel and control arm were pushed rearward 11.0 inches (27.9 cm), and the entire front end of the vehicle was shifted to the left a distance of 6.0 inches (15.2 cm).

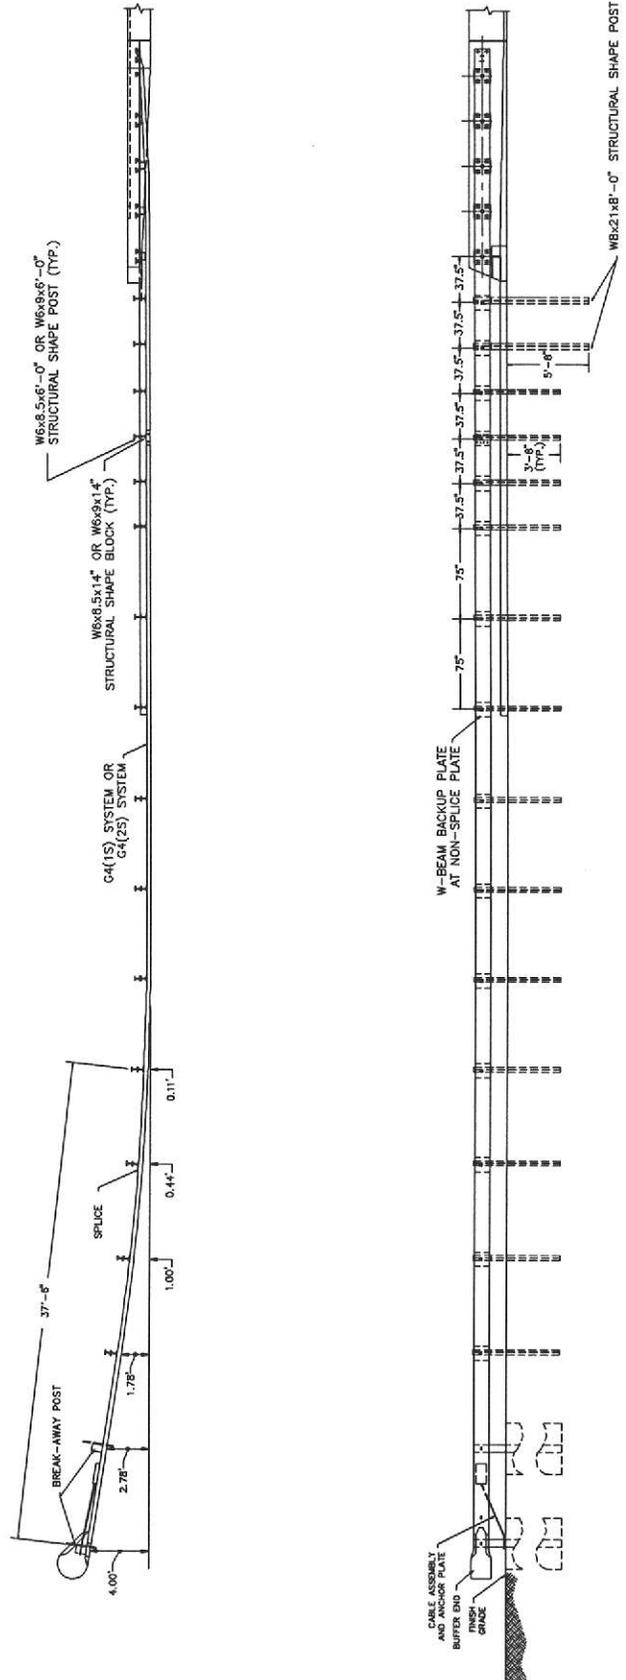
Figure 49. ADOT steel post transition with curb

from the end of the concrete rail along the transition. The face of the curb was aligned in a vertical plane with the traffic face of the W-beam guardrail. Post size, post spacing, and blockout depth were all the same as steel post designs previously tested in this study. As in Test 3, the rectangular plate washers were removed from all but the first two posts adjacent to the parapet.

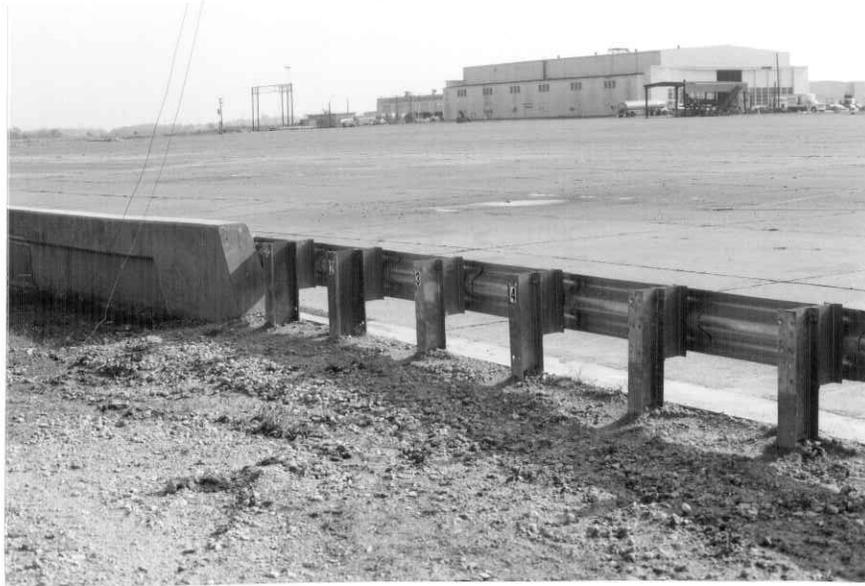
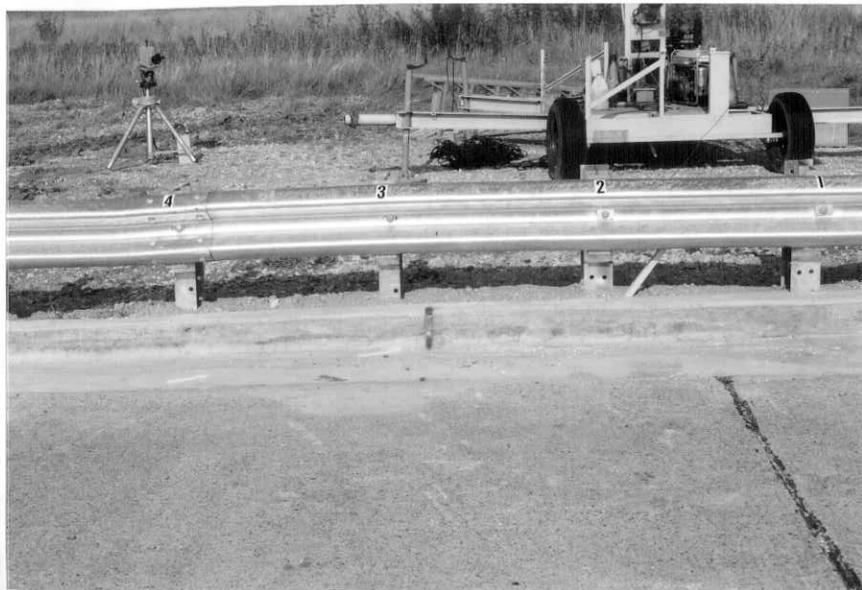
Figure 50. Arizona guardrail transition to concrete barrier before test 7155-5.

Details of the curb transition are given in Figure 49, and the completed test installation before Test 5 is shown in Figure 50.

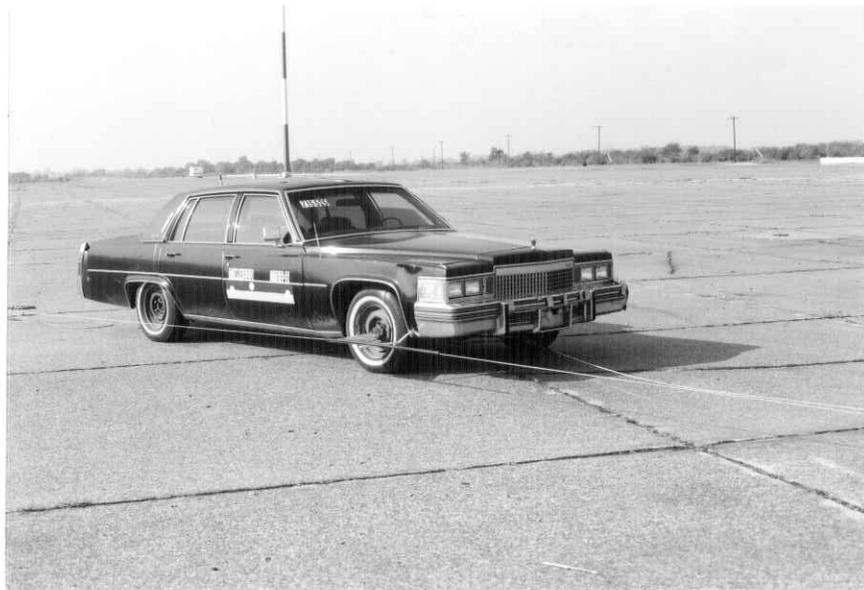
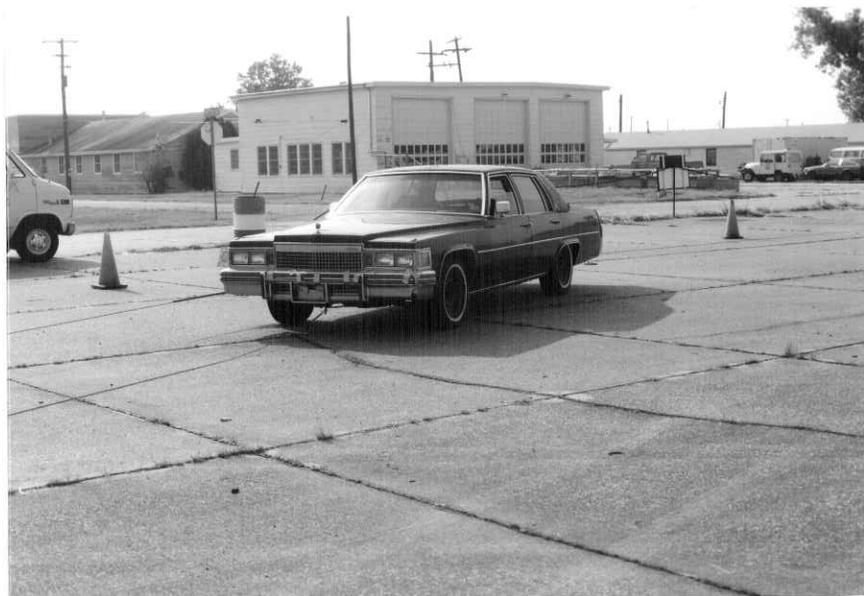
Figure 51. Vehicle before test 7155-5.

A 1979 Cadillac Sedan Deville (shown in Figure 51) impacted 7.0 ft (2.1 m) upstream of the end of the concrete bridge rail at 62.8 miles per hour (101.0 km/h) and at an angle of 26.0 degrees using a cable reverse tow and guidance system. Test inertia mass of the vehicle was 4,500 pounds (2,041 kg). The lower edge of the vehicle's bumper was at a height of 13.5 inches (34.3 cm) and the upper edge was at a height of 23.0 inches (58.4 cm). Other dimensions and pertinent information on the vehicle are given in Figure 52.

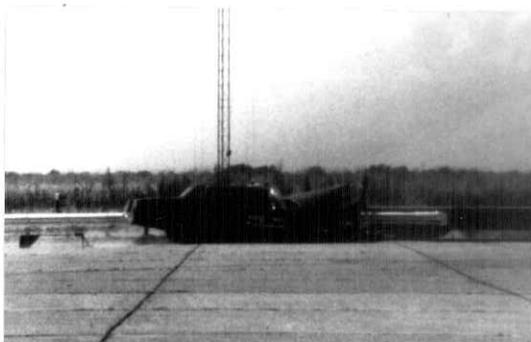
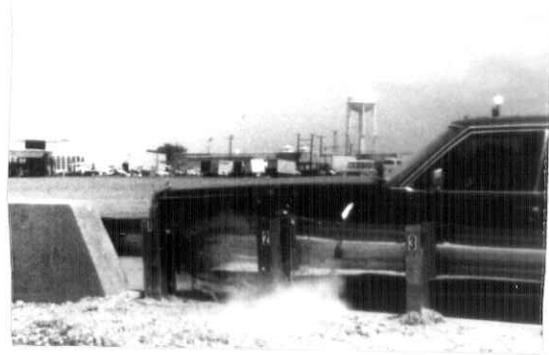
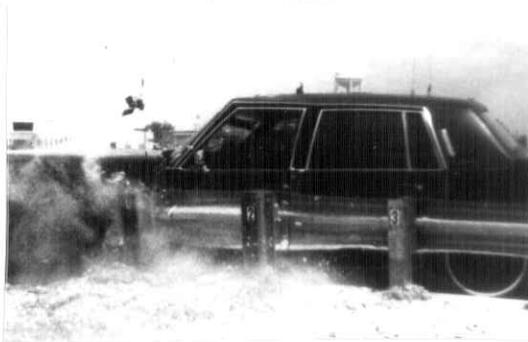
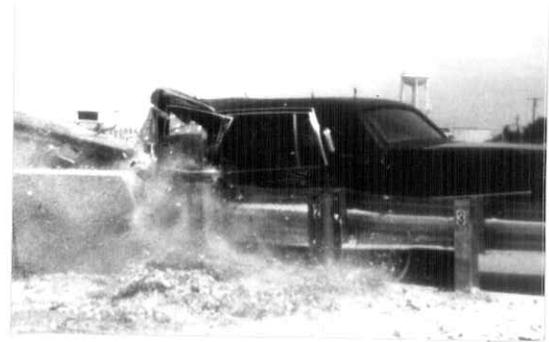
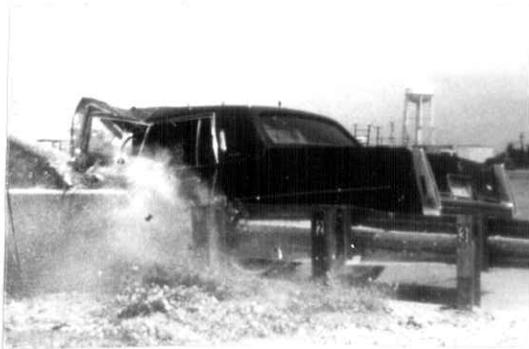
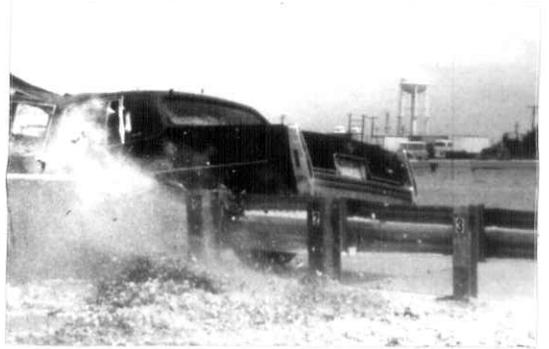
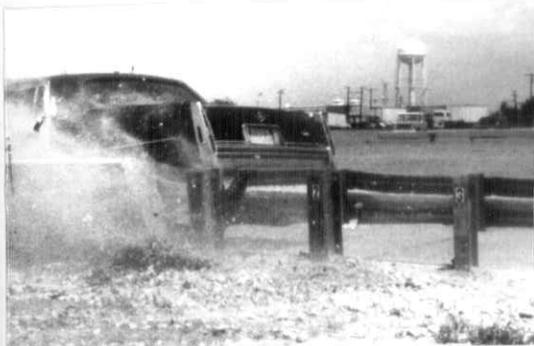
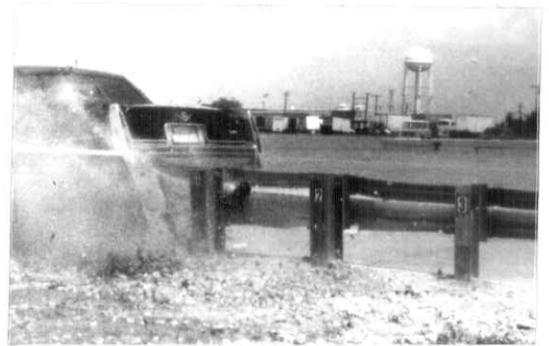
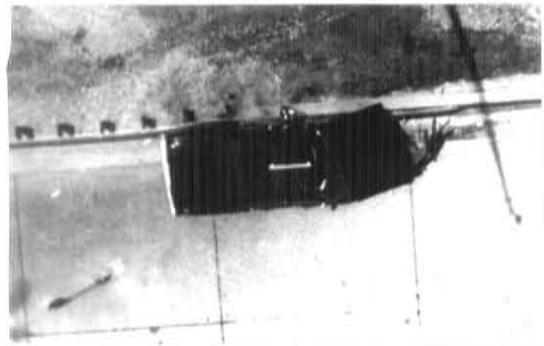
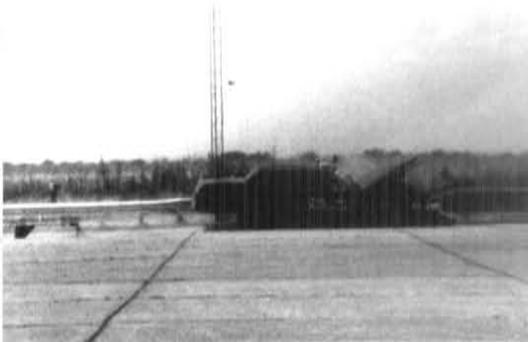
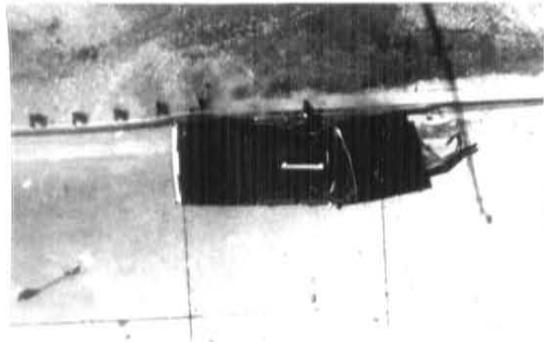
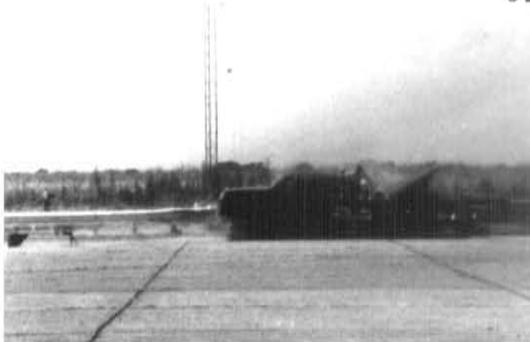
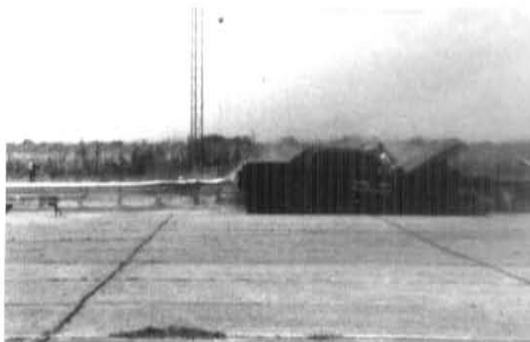
Figure 53. Sequential photographs of test 7155-5.

The vehicle was free wheeling and unrestrained just prior to impact. The vehicle immediately jumped the curb and thus had an upward trajectory as it impacted the W-beam guardrail. The guardrail was raised vertically allowing the bumper of the vehicle to ride underneath the guardrail and impact the W8x21 post adjacent to the concrete barrier. The blockout on this post partially collapsed and the W-beam yielded locally, wrapping itself around the end of the concrete rail. This allowed the front frame of the vehicle to impact the end of the bridge rail. Shortly thereafter, the left front wheel snagged on the end of the bridge rail causing the entire front end of the vehicle to nose down and shift toward the barrier. The vehicle experienced significant decelerations, but continued to move along the barrier. The vehicle finally lost contact with the installation at 0.444 second traveling 29.9 miles per hour at an angle of 4.9 degrees. Shortly thereafter, the brakes were applied, the vehicle yawed clockwise and came to rest 127.5 feet (38.9 m) from the point of impact. Sequential photographs of the test are shown in Figure 53.
