ARIZONA DEPARTMENT OF TRANSPORTATION

REPORT NUMBER: FHWA-AZ92-329

EVALUATION OF BRIDGE APPROACH RAILS

Final Report

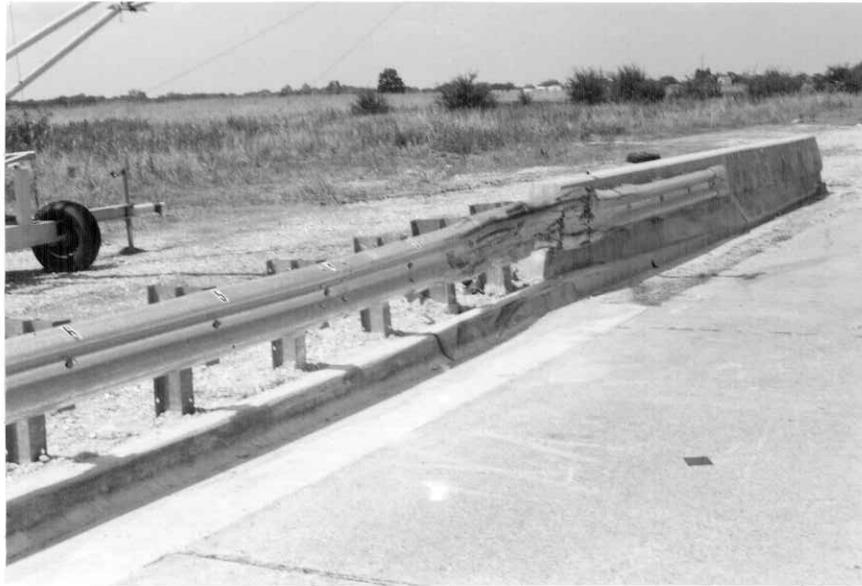
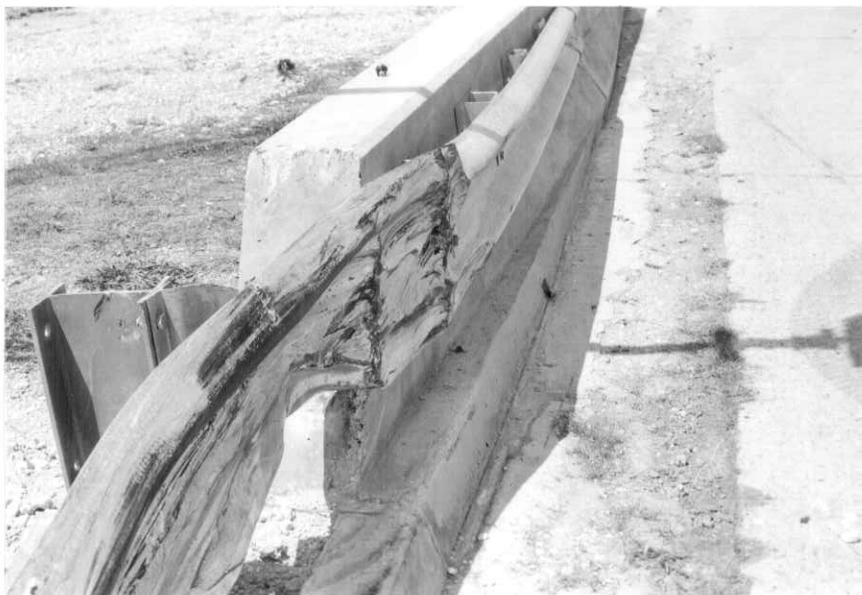
Figure 54. Arizona guardrail transition to concrete half barrier after test 7155-5.

As shown in Figure 54, the area of damage to the installation was limited to the first two guardrail posts and the end of the concrete bridge rail. The maximum permanent rail deformation was 11.8 inches (29.8 cm) and the maximum lateral dynamic rail deflection was

observed to be 12.7 inches (32.3 cm). The W-beam yielded around the end of the concrete rail and the first steel blockout on the face of the concrete barrier. Even under this severe impact, the concrete anchor inserts and blockouts were undamaged. In addition, the curb showed no visible signs of distress. The vehicle was in contact with the installation for a total length of 12.5 feet (3.8 m).

In summary, this test was judged to be a failure. The installation failed to smoothly redirect the impacting vehicle. There was significant snagging of the vehicle frame and wheel on the end of the concrete barrier and the first steel blockout on the concrete bridge rail. There was also severe deformation and intrusion into the occupant compartment of the vehicle.

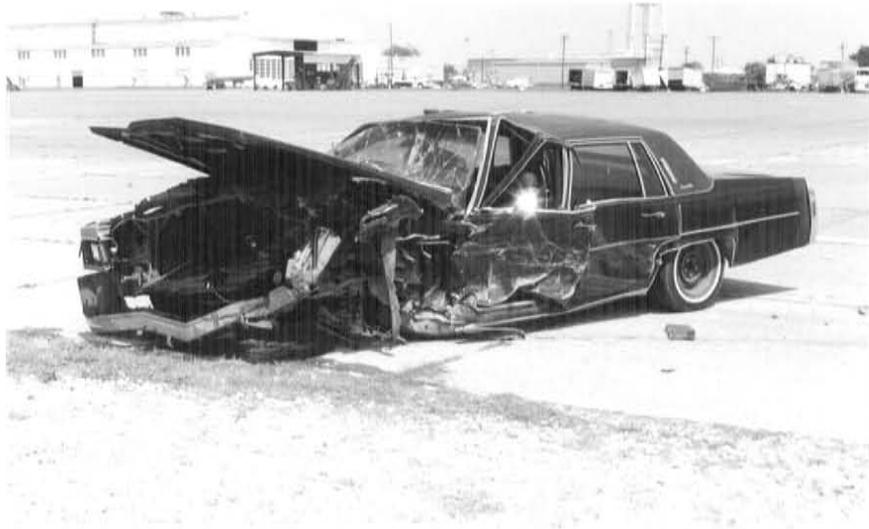
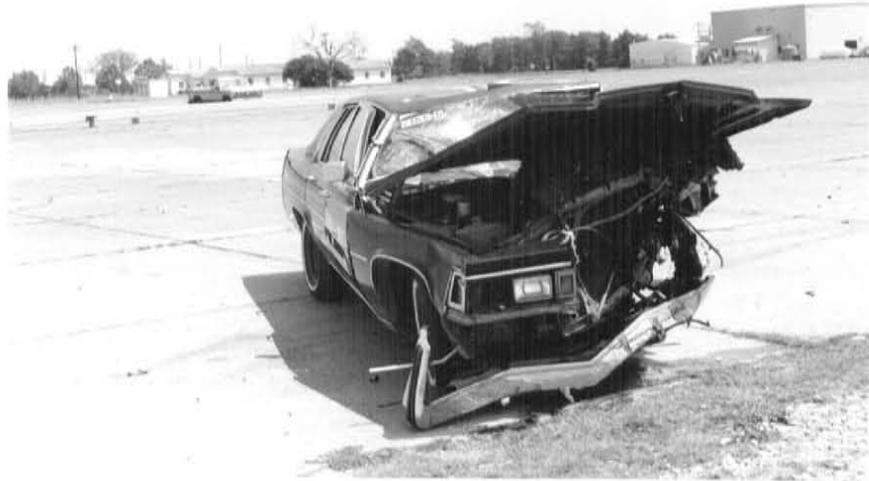
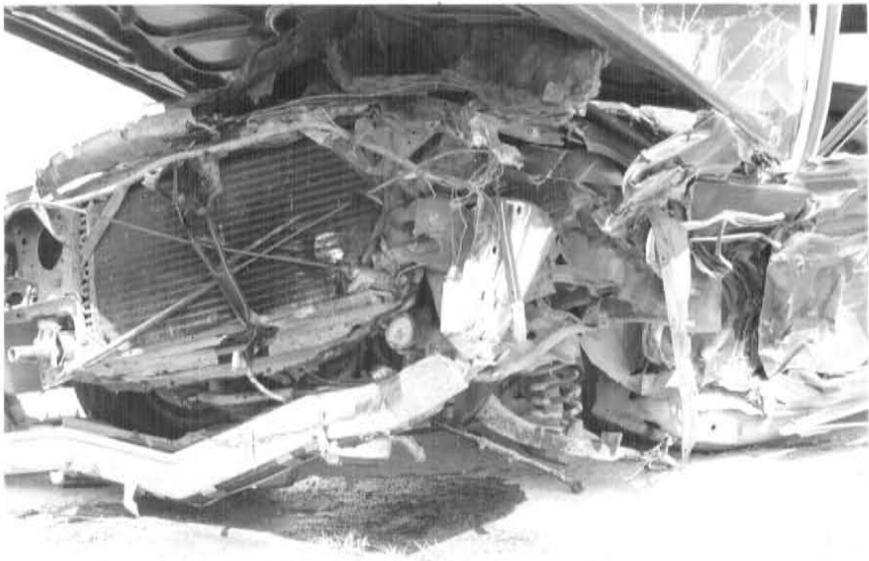
Figure 55. Vehicle after test 7155-5.

As shown in Figure 55, the vehicle was severely damaged. The maximum crush recorded on the vehicle was 22.0 inches (55.9 cm). The left front wheel and spindle assembly was separated from the vehicle at the ball joint attachment points on the control arm. The entire front end of the vehicle was shifted to the left 4.0 inches (10.2 cm). Additionally, the subframe was damaged and the roof and A-pillar were buckled. There was significant intrusion and deformation of the occupant compartment with the steering wheel nearly contacting the driver's seat.

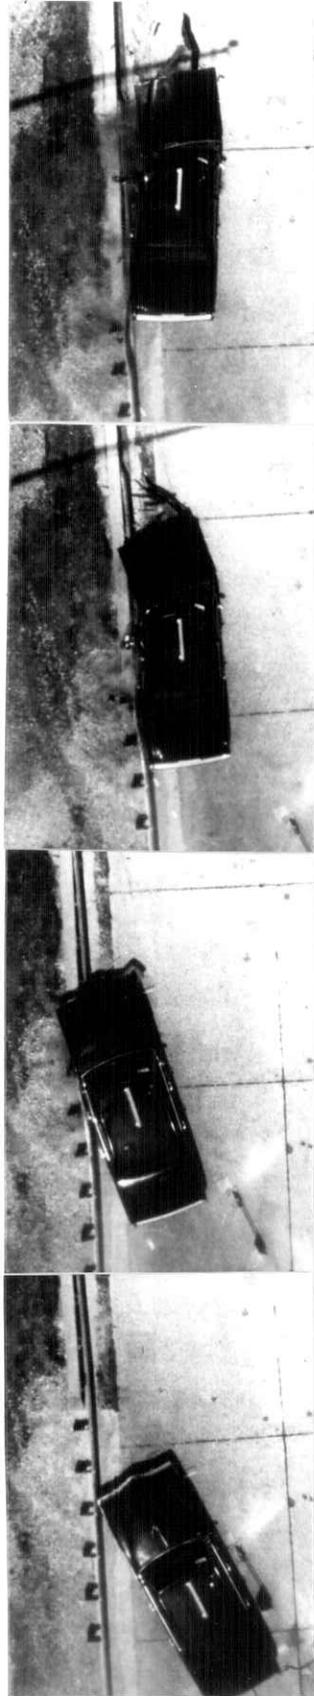
Figure 56. Summary of results for test 7155-5.

Test No.	7155-5	Impact Speed	62.8 mi/h (101.0 km/h)
Date	08/23/90	Impact Angle	26.0 deg
Test Installation	Arizona Guardrail Transition to Concrete Half Barrier	Exit Speed	29.9 mi/h (48.1 km/h)
Length of Transition	87.5 ft (26.7 m)	Exit Angle	4.9 deg
Vehicle	1979 Cadillac Sedan Deville	Vehicle Accelerations (Max. 0.050-sec Avg)	
Vehicle Weight		Longitudinal	-17.4 g
Test Inertia	4500 lb (2041 kg)	Lateral	-13.3 g
Vehicle Damage Classification		Occupant Impact Velocity	
TAD	11LFQ-7	Longitudinal	40.3 ft/s (12.3 m/s)
CDC	11LFAW3	Lateral	25.3 ft/s (7.7 m/s)
Maximum Vehicle Crush	22.0 in (55.9 cm)	Occupant Ridedown Accelerations	
Max. Dyn. Rail Deflection.	12.7 in (32.3 cm)	Longitudinal	-10.1 g
Max. Perm. Rail Deflection	11.8 in (29.8 cm)	Lateral	-18.4 g

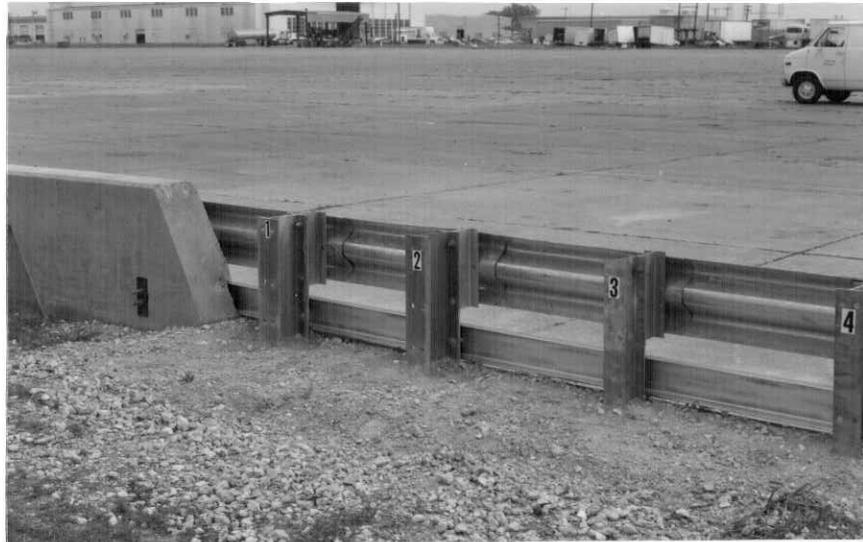
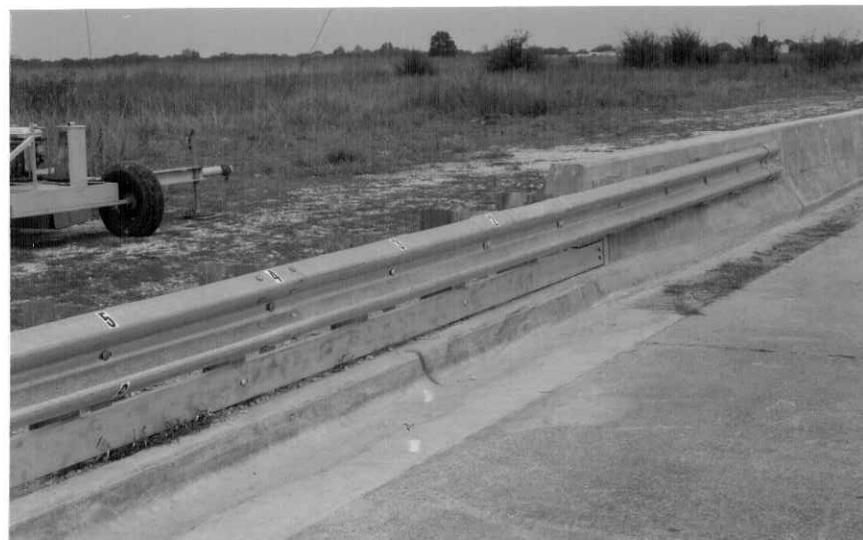
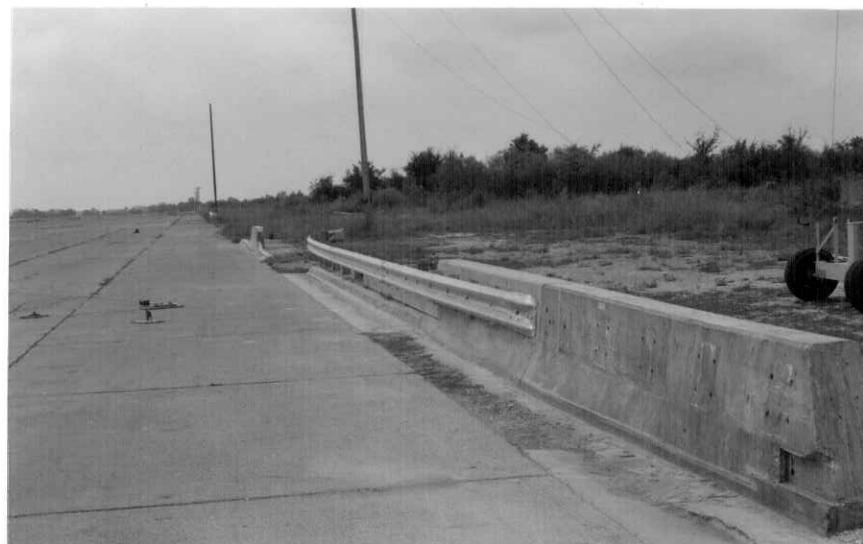
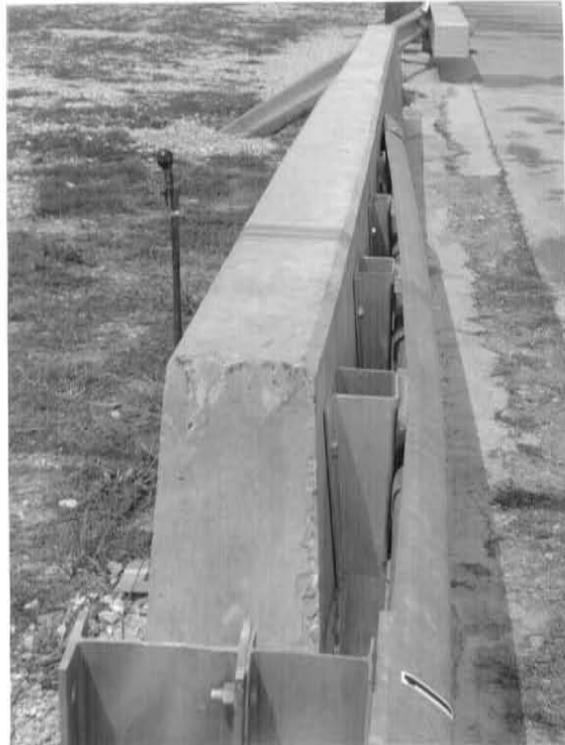
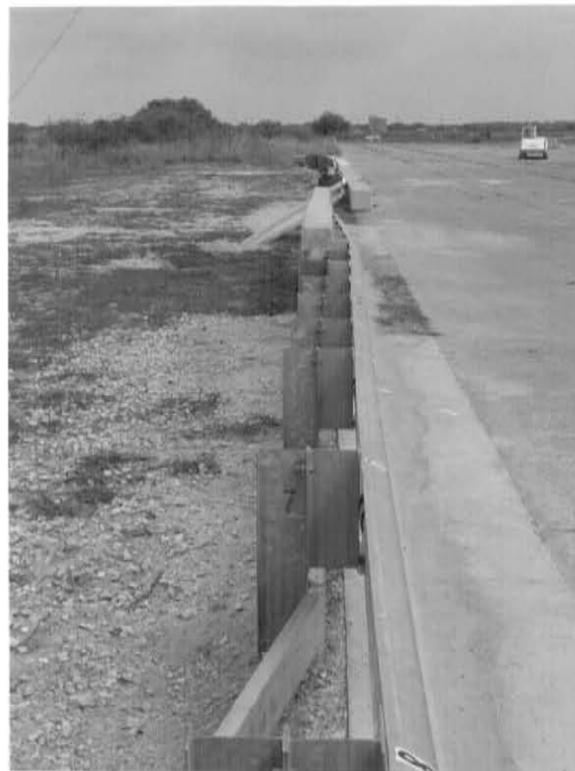
Figure 62. Arizona guardrail transition to concrete barrier before test 7155-6.

Due to the poor performance observed in Test 5, the curb transition design was modified. The retrofit modification included the addition of a channel rubrail similar in design to the previously tested steel post system. The rubrail was inset into a section cut out of the concrete rail in order to eliminate termination problems and allow the rubrail to be attached to the flanges of the steel posts in the transition. In lieu of the rubrail terminal anchor, the retrofit rubrail was through bolted to the concrete barrier. The purpose of the rubrail was to prevent the wheel of the vehicle from snagging on the end of the concrete barrier after it climbs the curb. In addition, W-beam backup plates were added behind the steel blockouts on the face of the concrete bridge rail to help reduce the localized yielding in these areas and thus reduce the potential for snagging of the vehicle frame. As in the previous test, rectangular plate washers were only used on the first two posts adjacent to the concrete parapet. Figure 61 shows details of the modified transition design, and the completed test installation is shown in Figure 62.

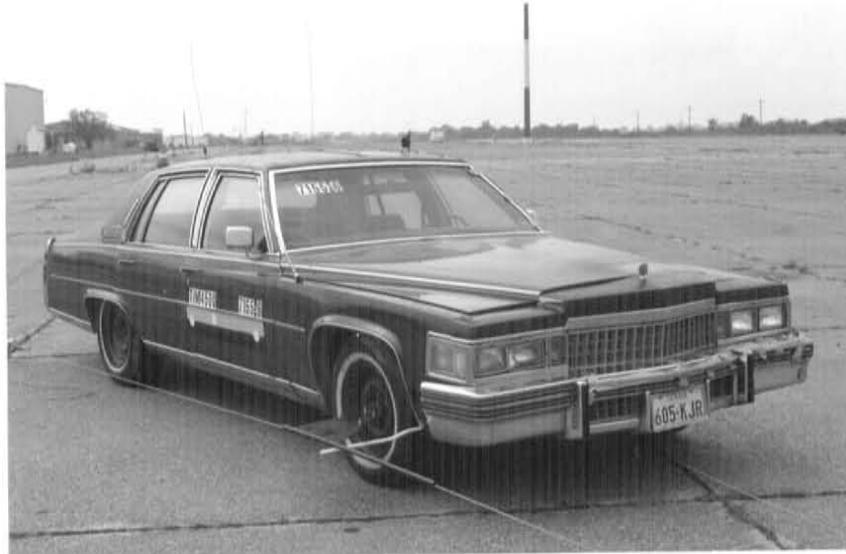
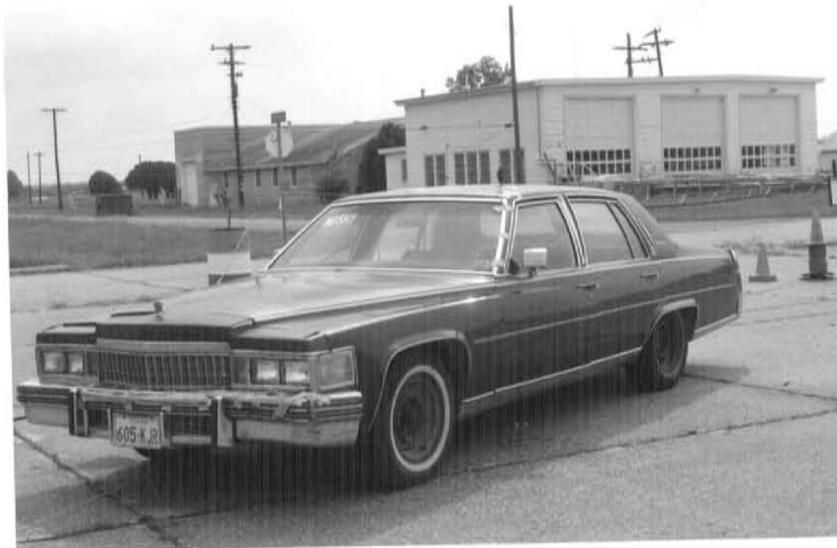
Figure 63. Vehicle before test 7155-6.

A 1979 Cadillac Fleetwood (shown in Figure 63) impacted the transition 7.0 ft (2.1 m) upstream from the end of the concrete bridge rail at 59.5 miles per hour (95.8 km/h) and at an angle of 25.4 degrees using a cable reverse tow and guidance system. Test inertia mass of the vehicle was 4,500 pounds (2,041 kg). The height to the lower edge of the vehicle's bumper was 12.0 inches (30.5 cm) and the height to the upper edge was 21.8 inches (55.2 cm). Other dimensions and information on the vehicle are given in Figure 64.

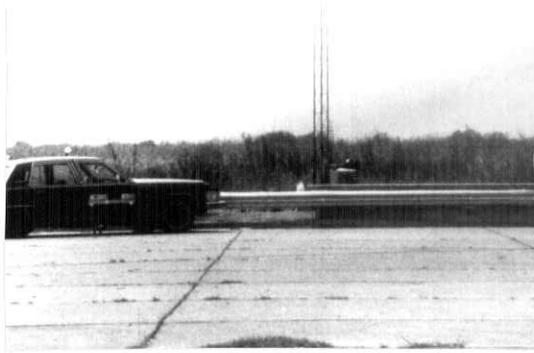
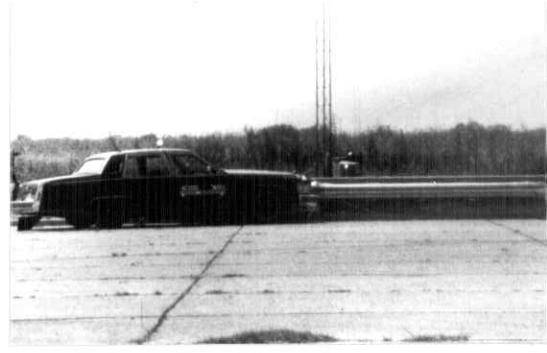
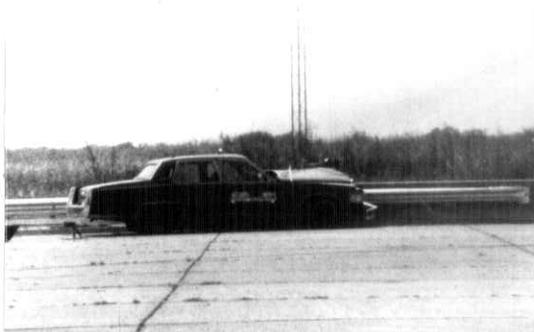
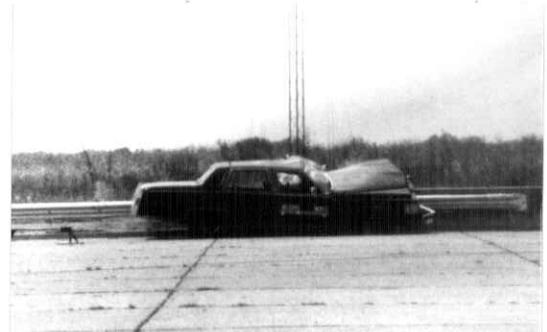
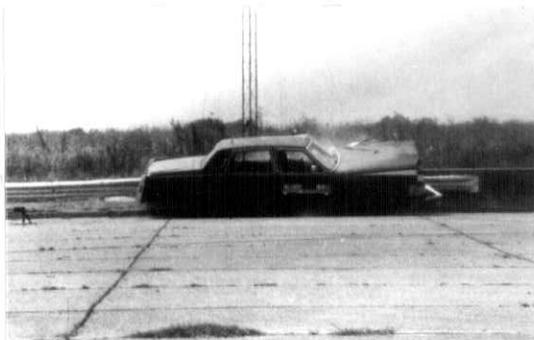
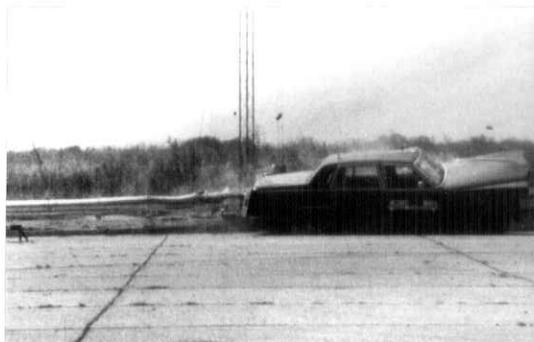
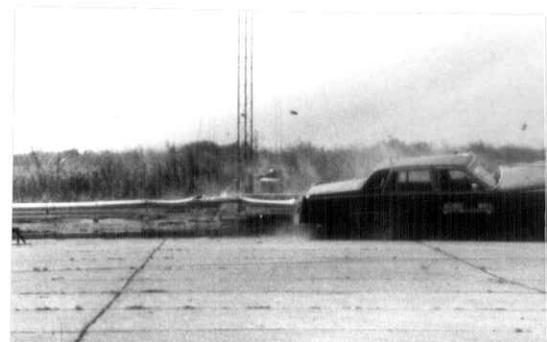
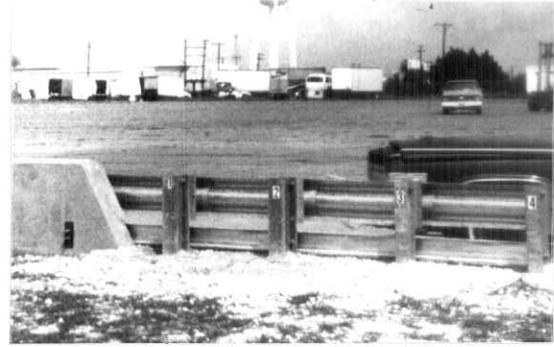
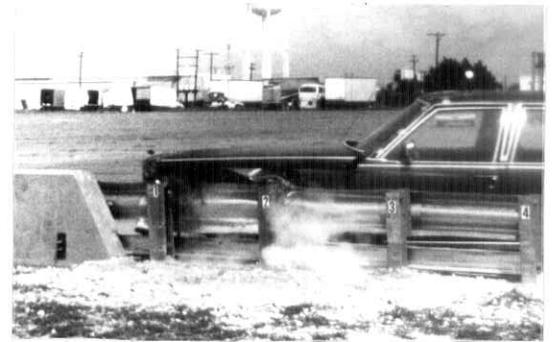
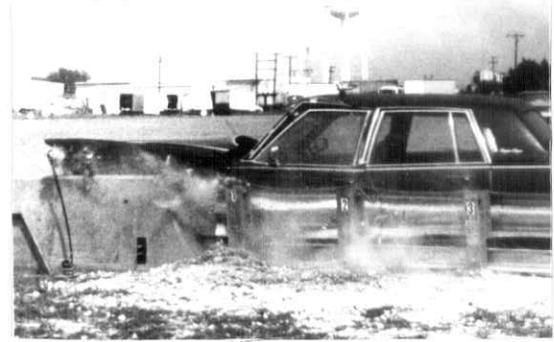
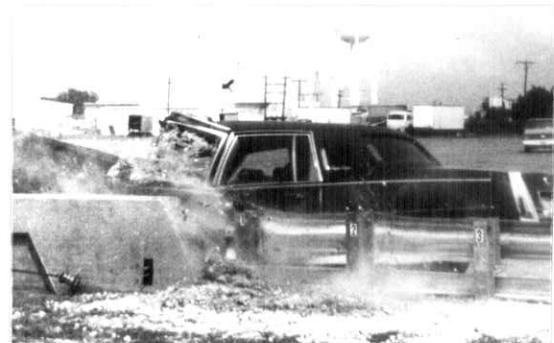
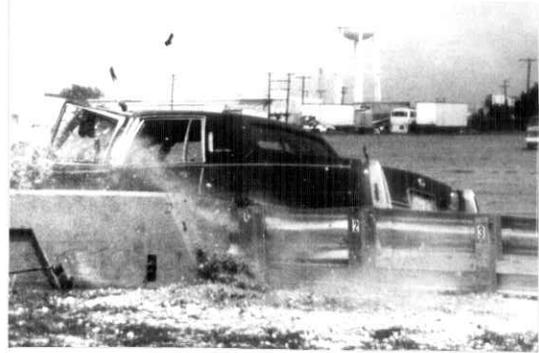
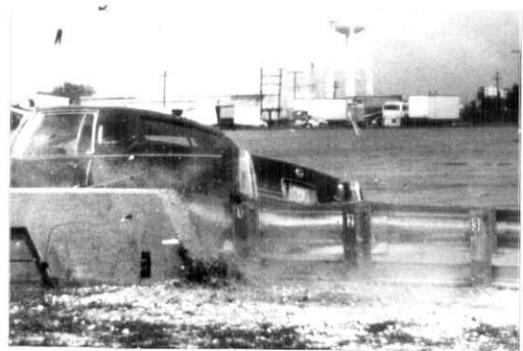
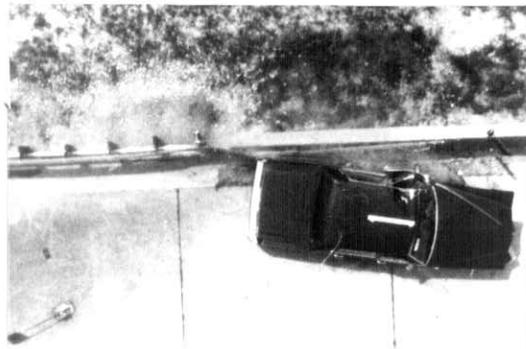
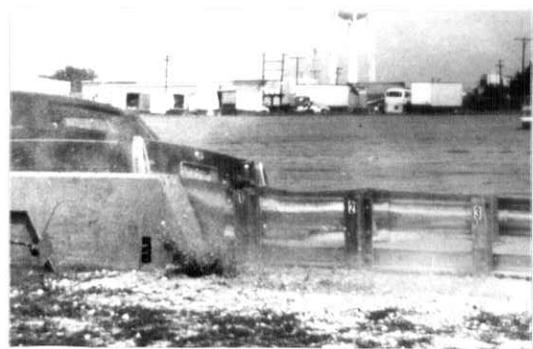
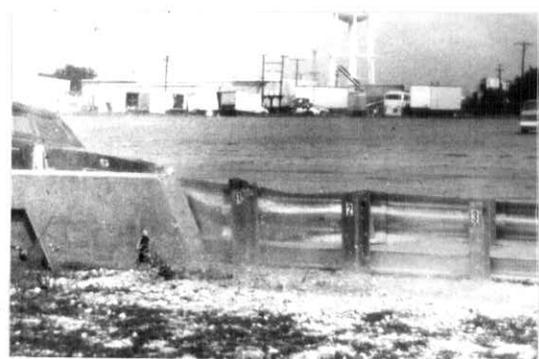
Figure 65. Sequential photographs for test 7155-6.

The vehicle was free wheeling and unrestrained just prior to impact. Upon impact, the vehicle climbed the curb and engaged the guardrail. The vertical motion imparted to the vehicle by the curb caused the wheel of the vehicle to ride up onto the rubrail, thus minimizing its effectiveness and raising the effective barrier loading height. Higher barrier loading increased bending moments at the base of the steel posts and increased barrier deflections. The combined lateral, longitudinal, and vertical loading transmitted to the posts caused total collapse of the W6x9 blockout on the first post adjacent to the end of the concrete wingwall. Thus, the effective blockout depth at this post was reduced to zero, resulting in a further increase in barrier rail deflection. This increase in deflection allowed

the W-beam rail to wrap around the end of the concrete barrier and the first steel blockout on the concrete rail. Subsequently, the vehicle frame and wheel were permitted to snag on the end of the concrete bridge rail and the first blockout. The vehicle lost contact with the installation while traveling at 33.9 miles per hour and at an angle of 4.7 degrees. Shortly thereafter, the brakes were applied, the vehicle yawed clockwise and came to rest 113.0 feet (34.5 m) from the point of impact. Sequential photographs of the test are shown in Figure 65.

In summary, this test was judged to be a failure. The installation failed to smoothly redirect the impacting vehicle. Significant snagging on the end of the concrete barrier was

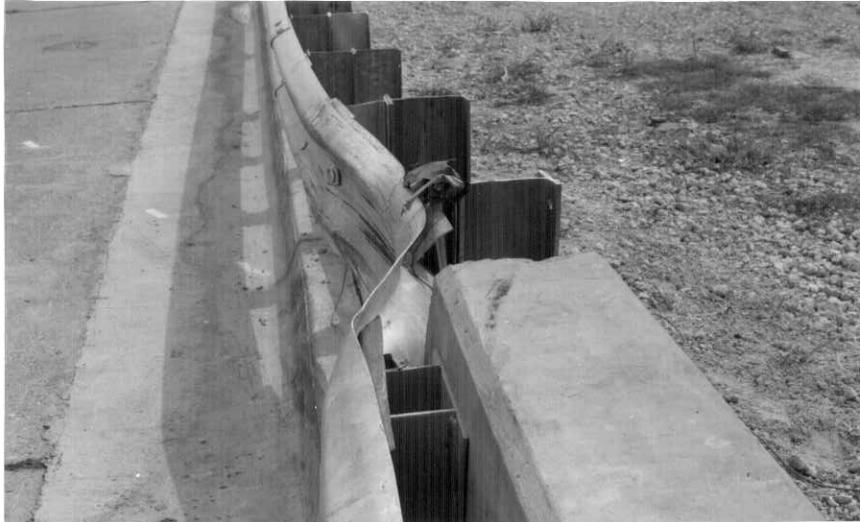
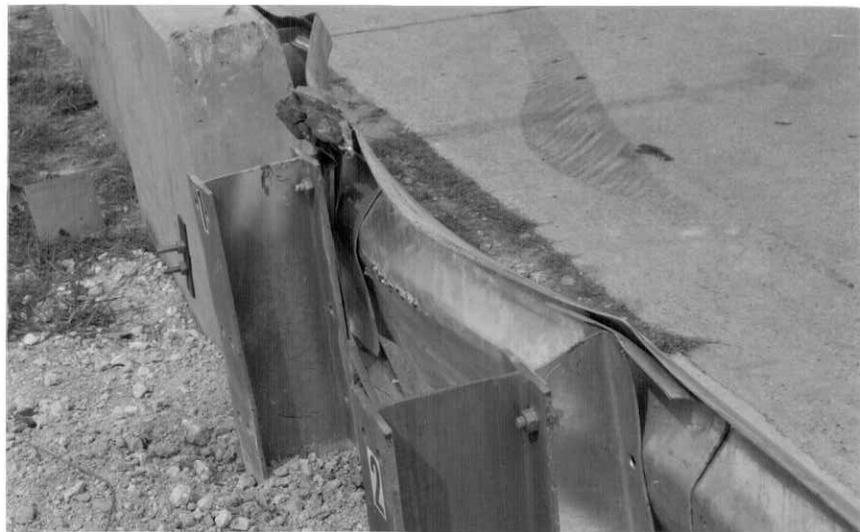
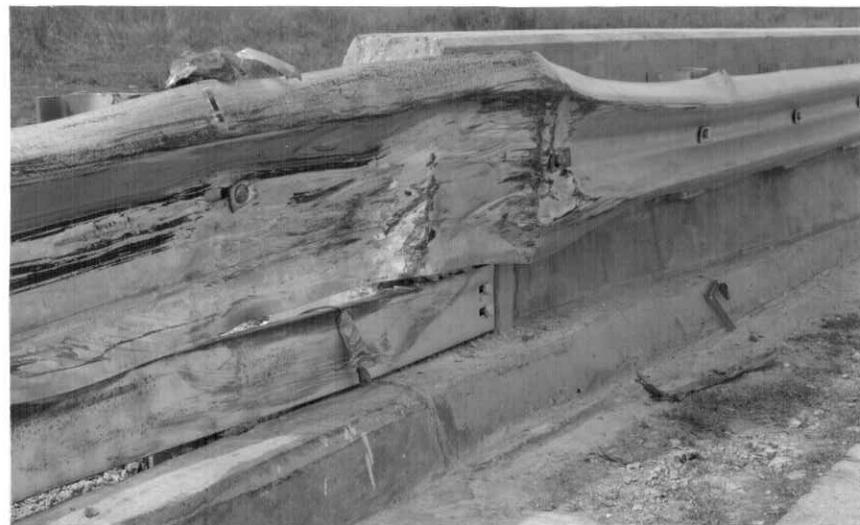
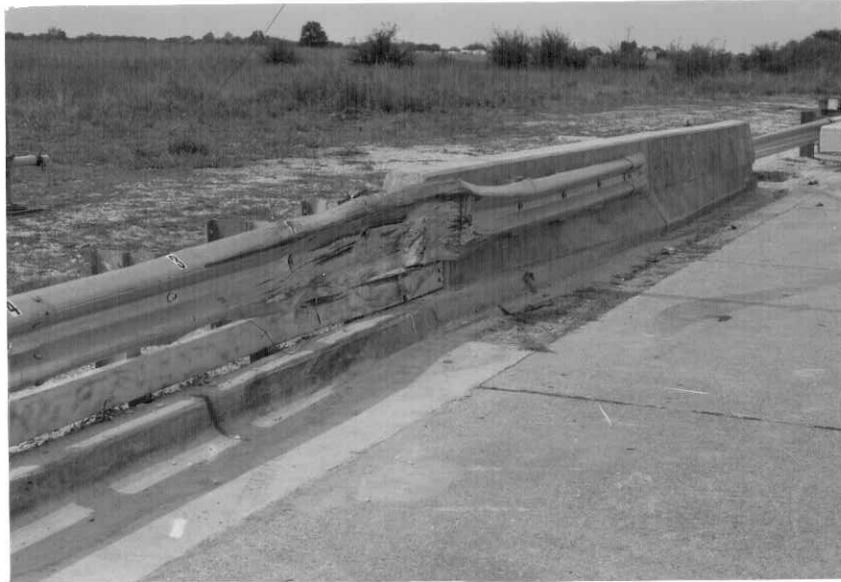
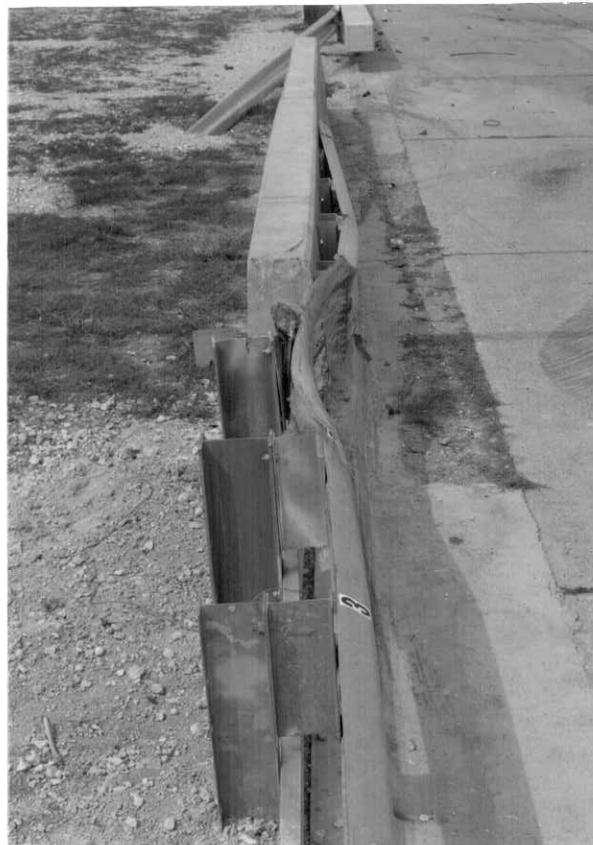
Figure 66. Arizona guardrail transition to concrete barrier after test 7155-6.

Damage to the transition installation is shown in Figure 66. The maximum permanent rail deformation was 10.4 inches (26.4 cm). As mentioned above, the lift imparted to the vehicle by the curb rendered the rubrail ineffective. The blockout on the first post adjacent to the end of the concrete barrier completely collapsed, allowing additional deflection to occur. The W-beam backup plate on the first steel blockout on the concrete barrier was not sufficient to prevent localized yielded in the rail from occurring. There were no signs of distress in the curb or around the concrete anchor inserts. The vehicle was in contact with the installation for a total length of 12.0 feet (3.7 m).

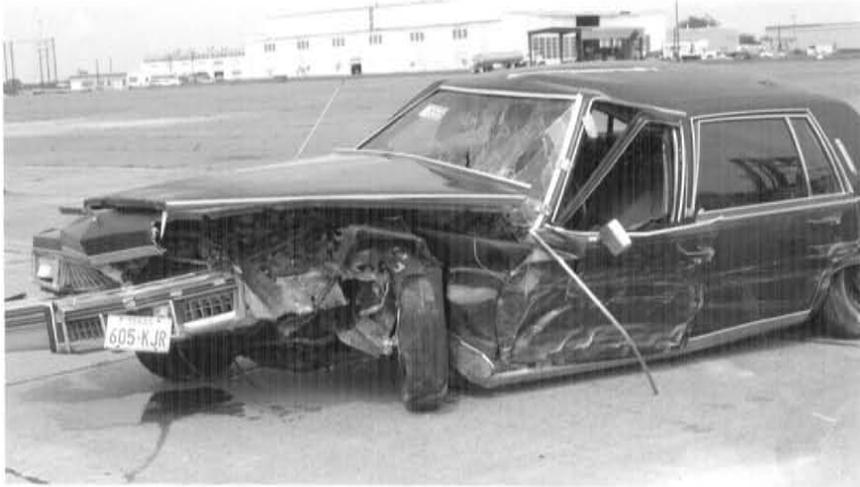
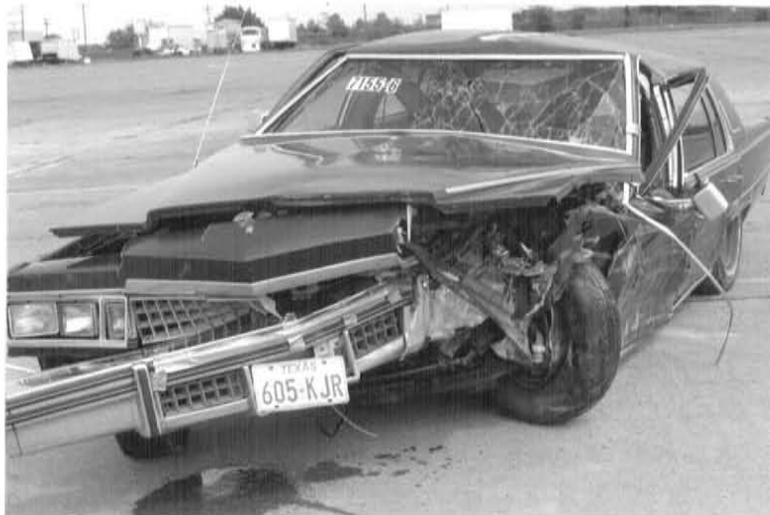
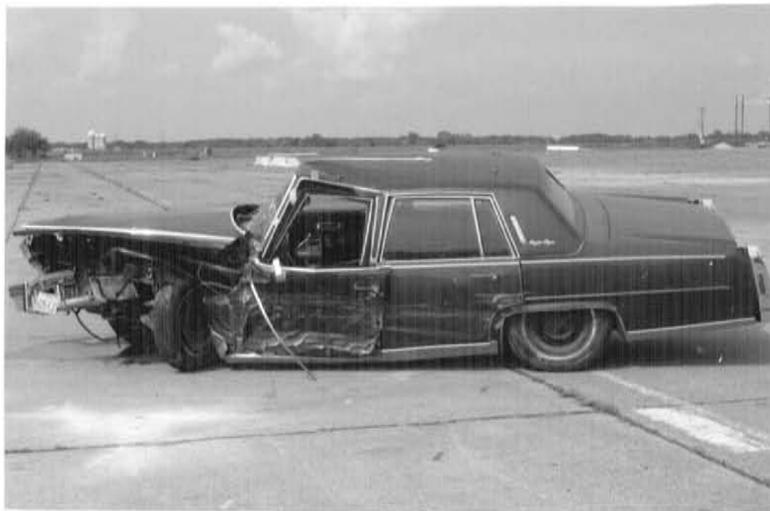
Figure 67. Vehicle after test 7155-6.

As shown in Figure 67, the vehicle sustained severe damage. The maximum crush recorded for the vehicle was 28.0 inches (71.1 cm). The left front wheel was pushed rearward 26.0 inches (66.0 cm), causing significant penetration of the occupant compartment. The entire front end of the vehicle was shifted to the left 3.0 inches (7.6 cm). Additionally, the A-pillar, roof, and door were all severely bent and buckled.

observed. This snagging caused severe damage to the vehicle as well as significant intrusion into the passenger compartment.

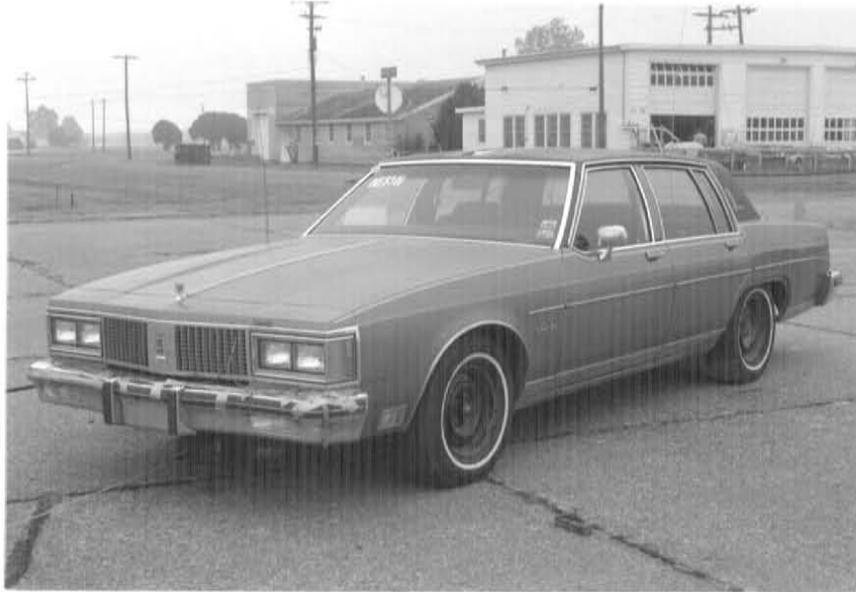
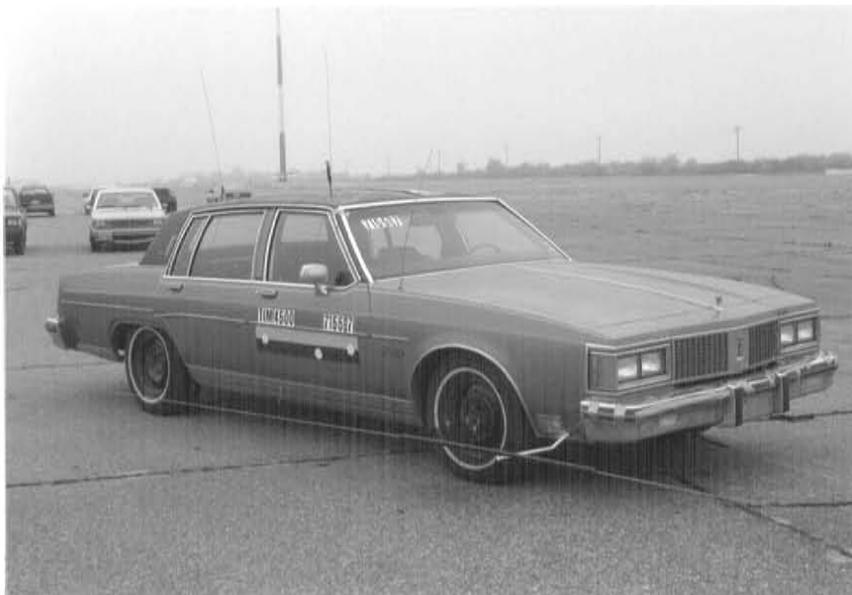
Figure 75. Vehicle before test 7155-7.

A 1984 Oldsmobile Ninety-Eight (shown in Figure 75) impacted 7.0 ft (2.1 m) upstream of the end of the concrete bridge rail at 59.5 miles per hour (95.8 km/h) and at

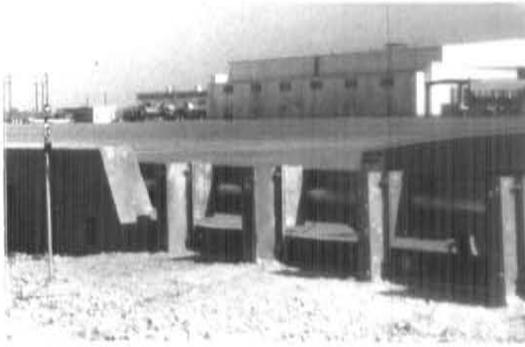
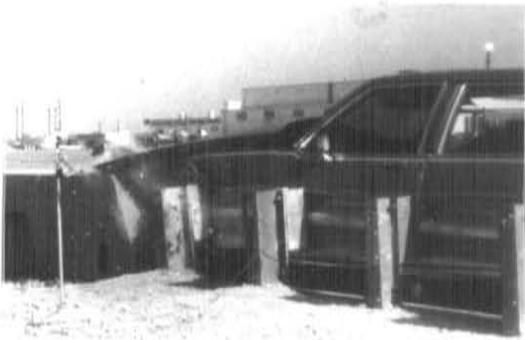
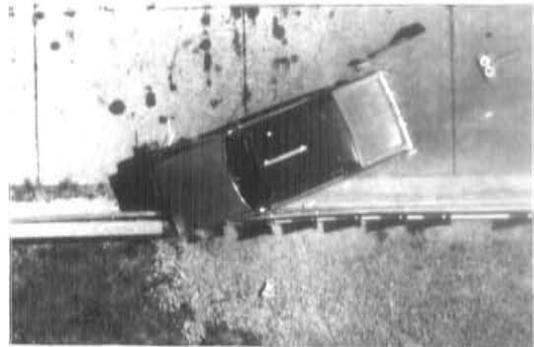
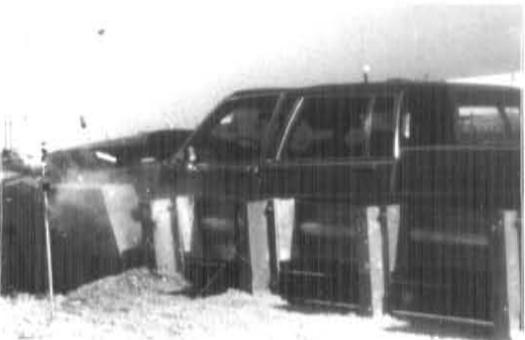
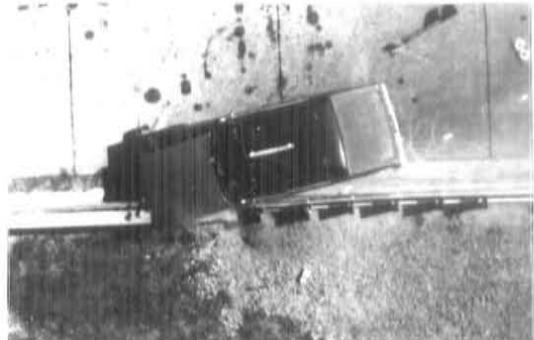
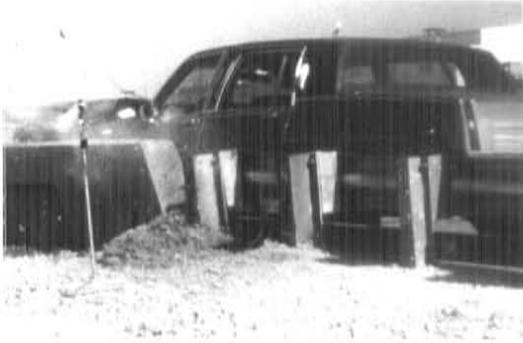
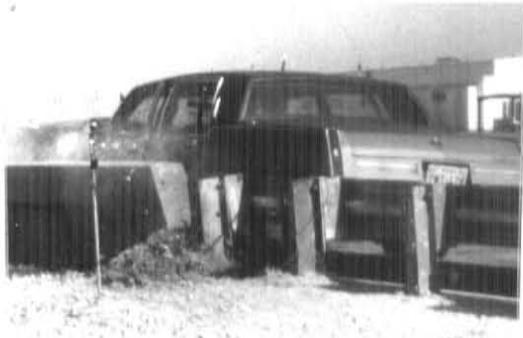
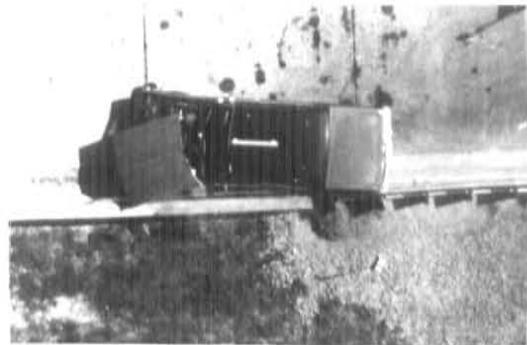
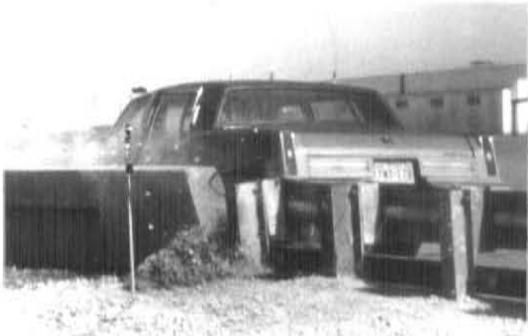
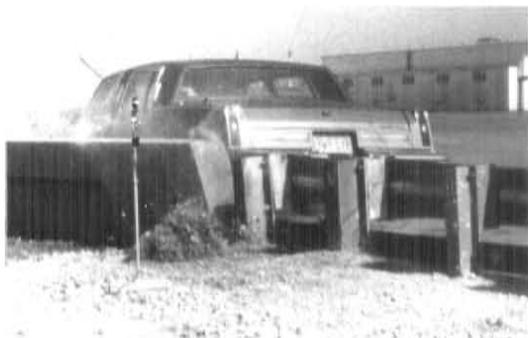
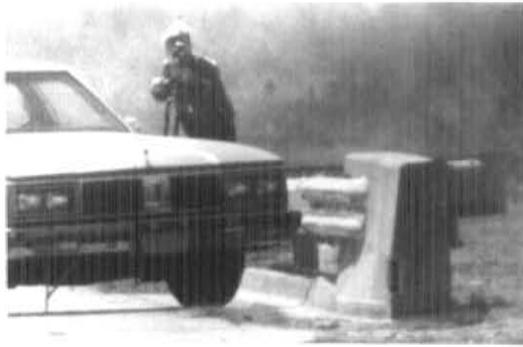
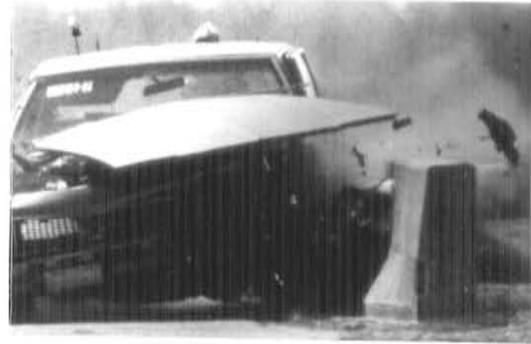
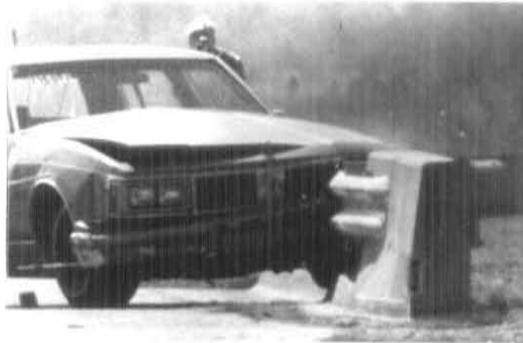
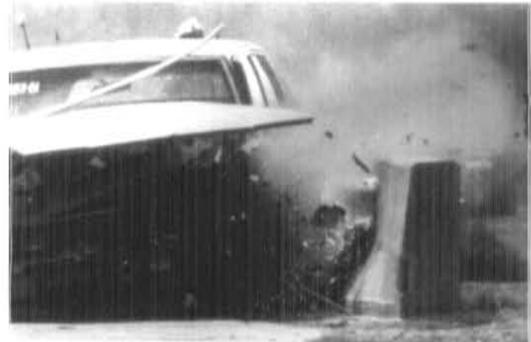
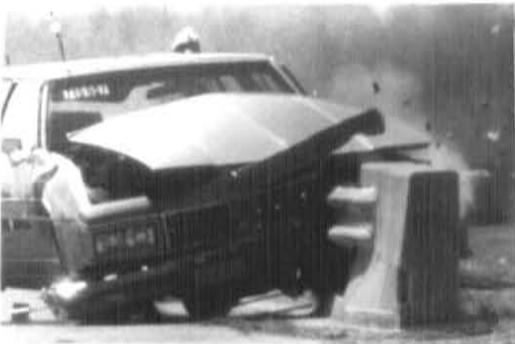
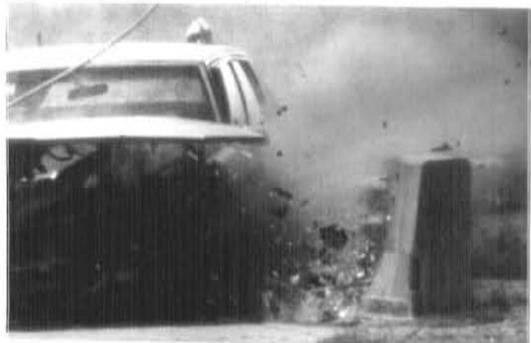
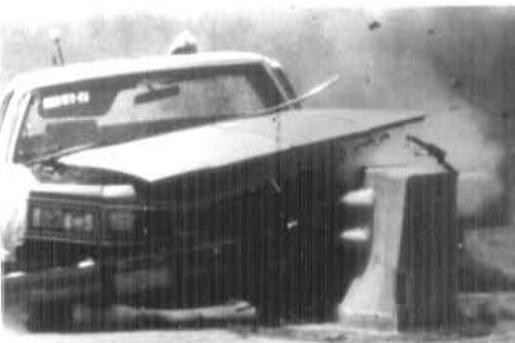
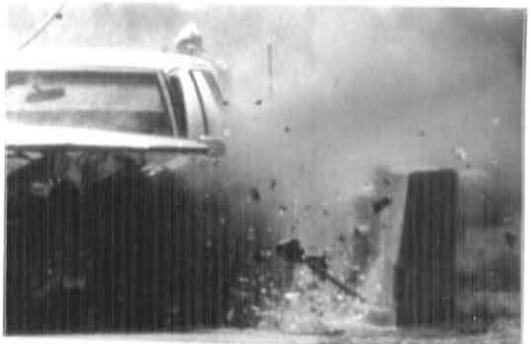
Figure 77. Sequential photographs for test 7155-7.

The vehicle was free wheeling and unrestrained just prior to impact. As in tests 5 and 6, the vehicle's left front tire quickly climbed the concrete curb. The vehicle was then smoothly redirected with only moderate deflection of the metal beam barrier. Although the amount of wheel snag on the barrier system was minor, the left front tire was blown-out. The test vehicle exited the barrier system at an angle of only 6.6 degrees and drag forces associated with the blown front tire caused the vehicle to quickly steer back to the roadside. Sequential photographs of the test are shown in Figure 77.

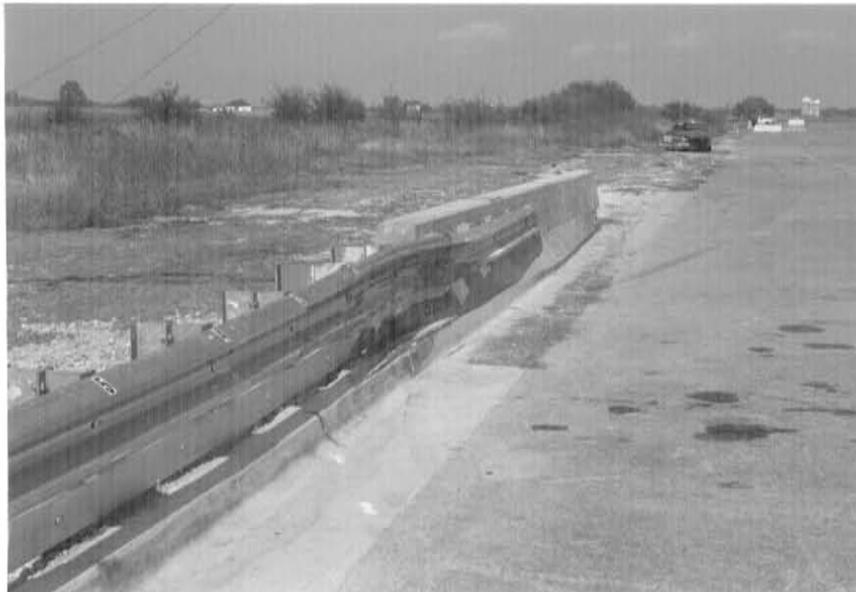
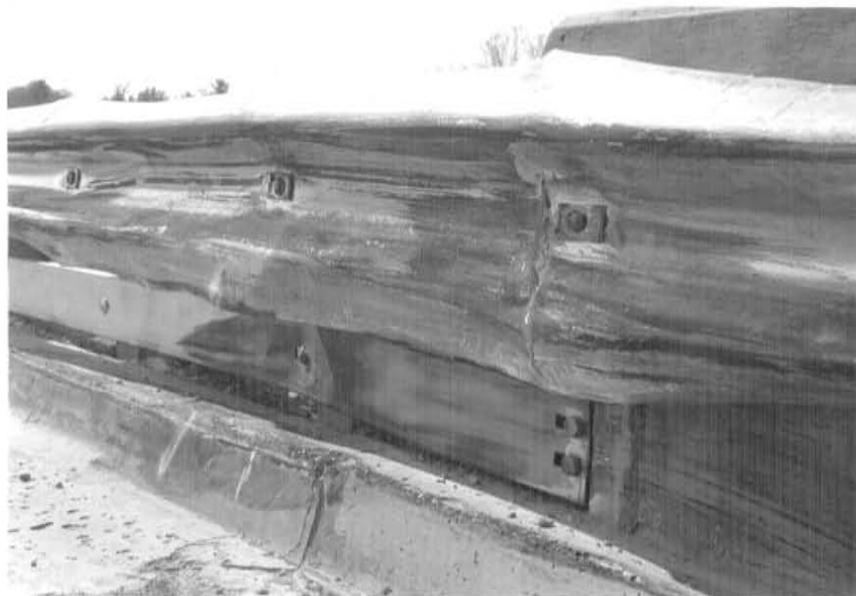
Figure 78. Arizona guardrail transition to concrete half barriers after test 7155-7.

The installation received minor damage as shown in Figure 78. Permanent barrier deflection was limited to 4.5 in. (11.4 cm). The vehicle was in contact with the installation for a total length of 13.0 feet (4.0 m).

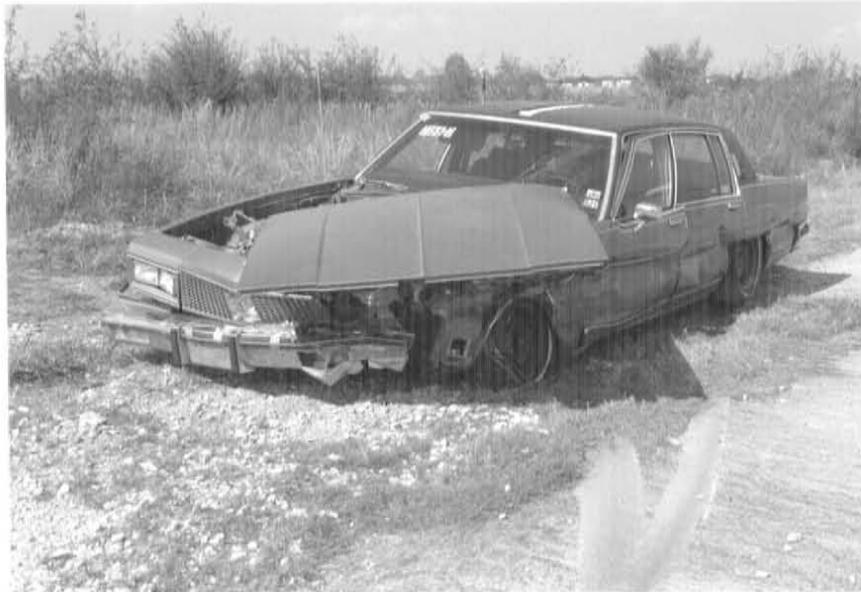
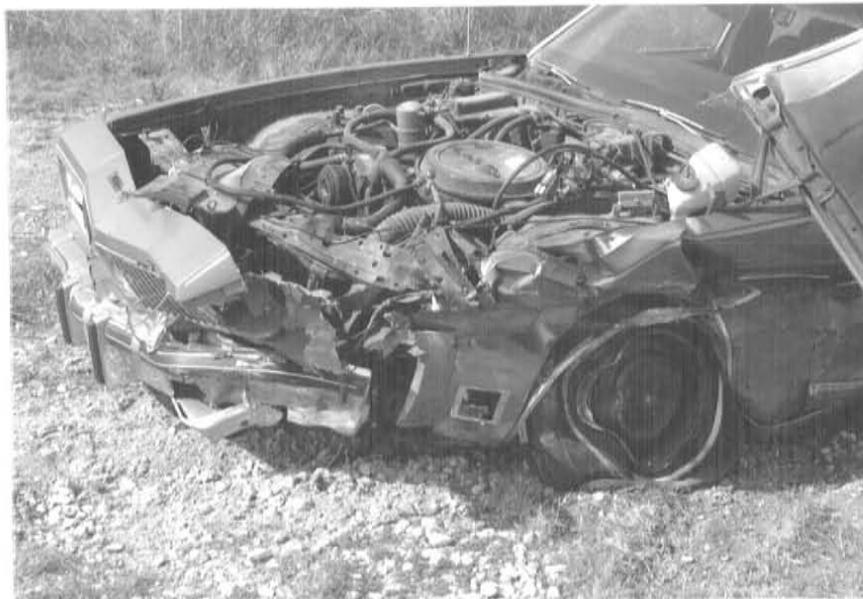
Figure 79. Vehicle after test 7155-7.

The vehicle received relatively minor damage for a test of this severity, as shown in Figure 79. Maximum vehicle crush was limited to 15.0 inches (38.1 cm) at the left front corner of the vehicle. The left front wheel was pushed rearward 7.0 inches (17.8 cm). The entire front end of the vehicle was shifted to the right 5.0 inches (12.7 cm). Additionally, the entire left side of the vehicle was scraped and dented. Damage to other areas included a bent roof, floor pan, hood, and a broken windshield.

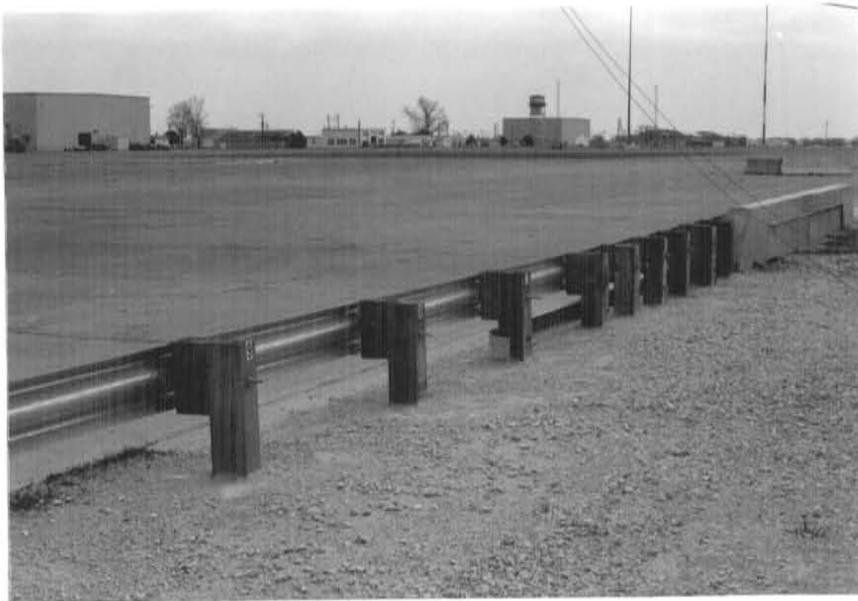
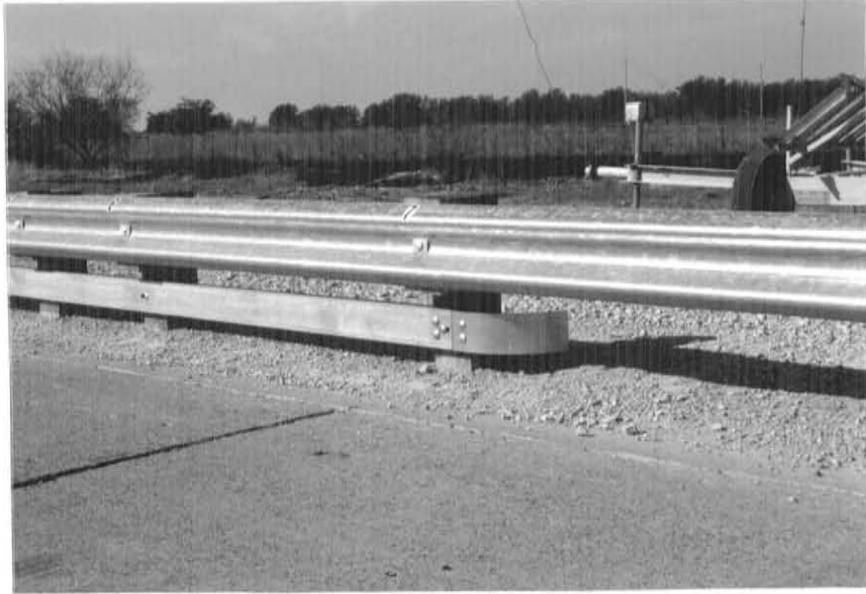
Figure 86. Arizona guardrail transition to concrete half barriers before test 7155-8.

The purpose of this test was to evaluate the upstream end of the unmodified wood post transition with channel rubrail. As discussed in an earlier section, the wood post system was predicted to have better impact performance than the steel post transition which failed in Test 2. The wider 8"x8" post to which the rubrail was attached had the potential for shielding the exposed end of the rubrail from vehicle contact. Therefore, although significant wheel snagging on the guardrail post was predicted, if the wheel was not allowed to spear on the end of the rubrail, the hazard would not be as severe and the test would have a chance to pass. In addition, the blockouts on the G4(2W) guardrail had a depth of 8 inches compared to the 6 inches provided by the steel post system. This increase in blockout distance reduces the degree of snagging on the intermediate guardrail posts and further improved the chances of this system performing satisfactorily. Details of the standard wood post transition are shown in Figure 85. The completed test installation is shown in Figure 86.
