ARIZONA DEPARTMENT OF TRANSPORTATION

REPORT NUMBER: FHWA-AZ92-329

EVALUATION OF BRIDGE APPROACH RAILS

Final Report

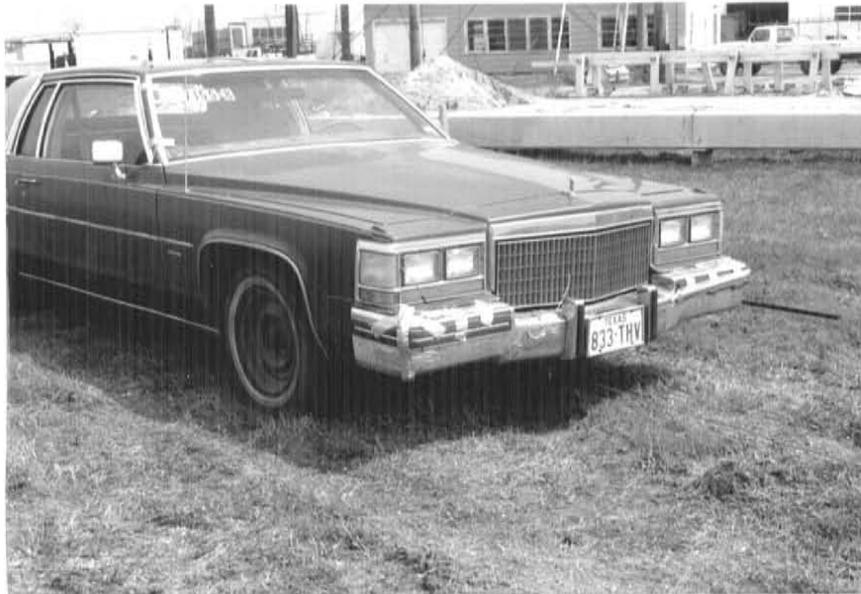
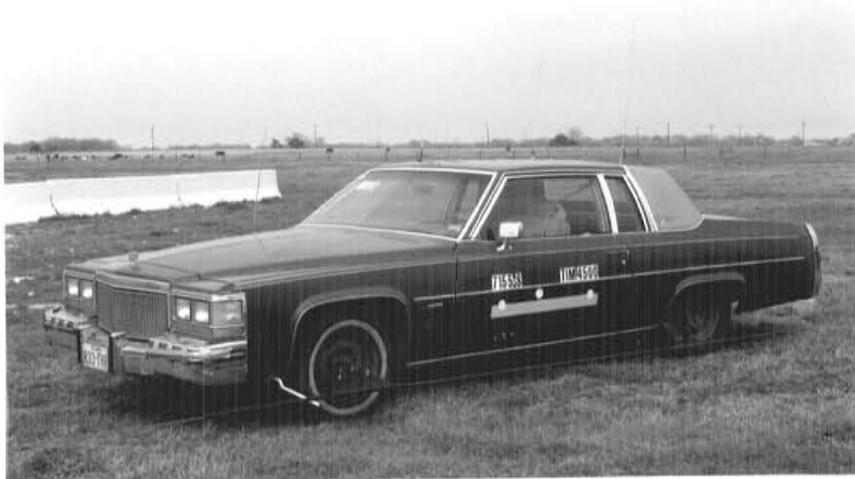
Figure 87. Vehicle before test 7155-8.

A 1980 Cadillac Coupe DeVille (shown in Figure 87) impacted 10.0 ft (3.0 m) upstream from the end of the rub-rail at 59.6 miles per hour (95.8 km/h) and at an angle of 24.5 degrees using a cable reverse tow and guidance system. Test inertia mass of the

vehicle was 4,500 pounds (2,041 kg). The height to the lower edge of the vehicle bumper was 13.0 inches (33.0 cm) and the height to the upper edge was 21.0 inches (53.3 cm). Other dimensions and information pertaining to the vehicle are given in Figure 88.

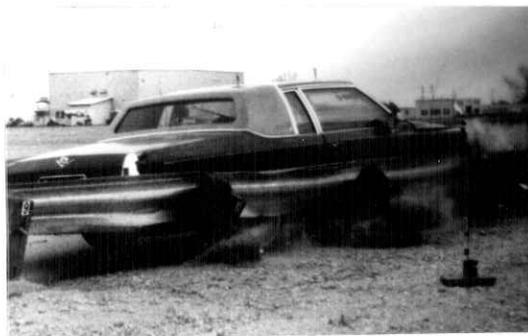
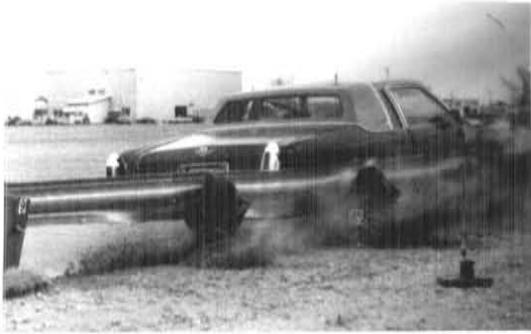
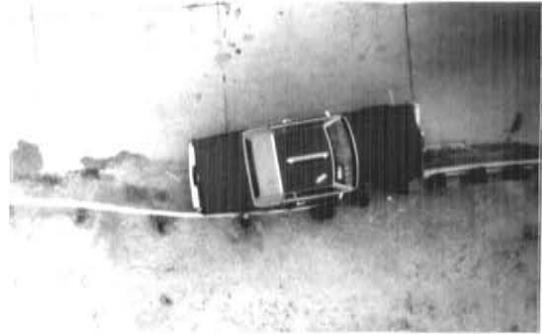
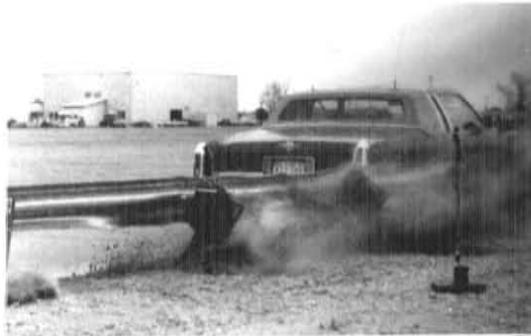
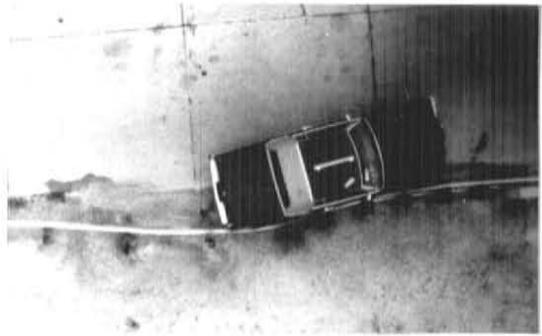
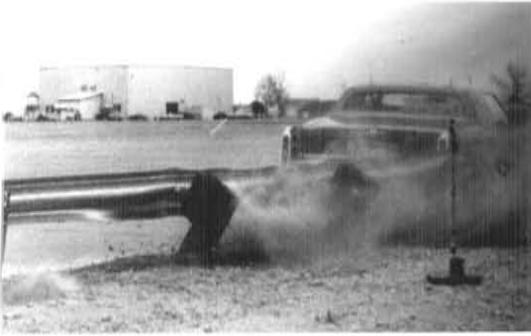
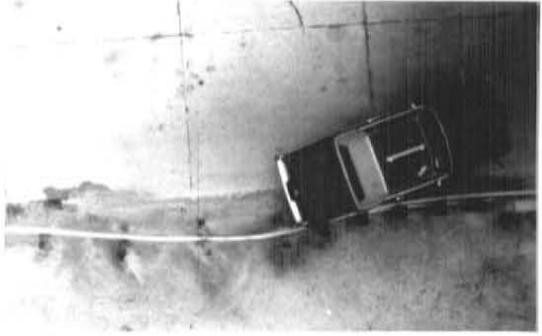
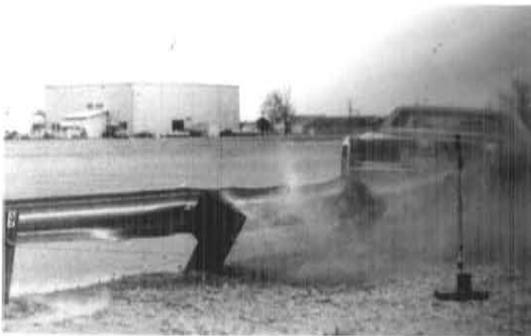
Figure 89. Sequential photographs of test 7155-8.

The vehicle was free wheeling and unrestrained just prior to impact. Upon impact, the barrier began to deform in a manner similar to that observed in Test 2. There was some evidence of pocketing behind the first post of the transition (post 7). This was due to the fact that this post was restrained at the top by the W-beam and at the bottom by the rubrail and, thus, could not rotate as freely as the guardrail posts prior to the transition. However, the post was able to deflect an appreciable amount out of the path of the impacting vehicle and the pocketing was not as pronounced as that seen in Test 2. Although there was wheel contact on the first transition post (0.134 seconds after impact), the wheel did not engage the end of the rubrail. The vehicle became parallel to the installation at 0.199 seconds and lost contact with the installation at 0.600 second while traveling 37.6 miles per hour and at an angle of 18.0 degrees. Shortly thereafter, the brakes were applied, the vehicle yawed counterclockwise and came to rest 135.0 feet (41.2 m) from the point of impact. It should be noted that there was no evidence of wheel contact on the guardrail post immediately upstream of the transition, indicating that the 8 inch blockout was sufficient enough to prevent such behavior from occurring. The sequential photographs of the test are shown in Figure 89.

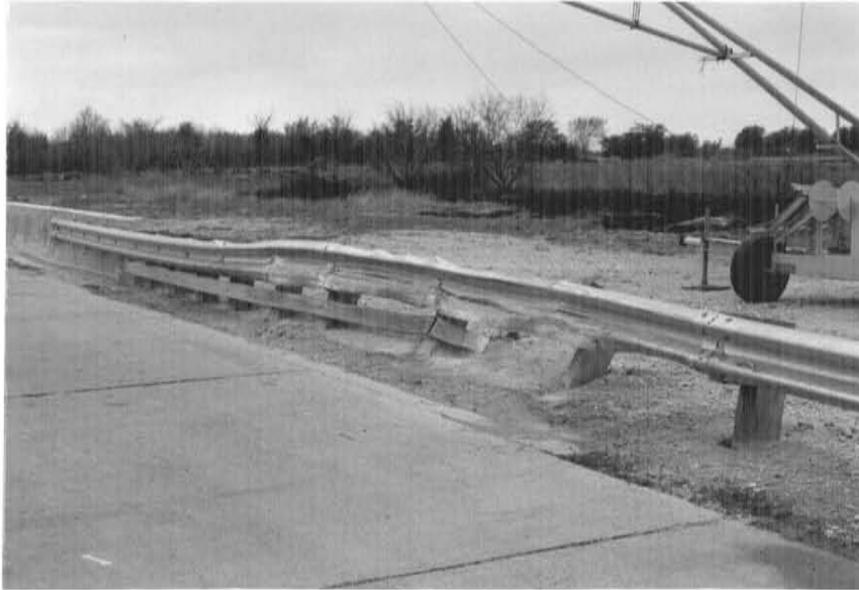
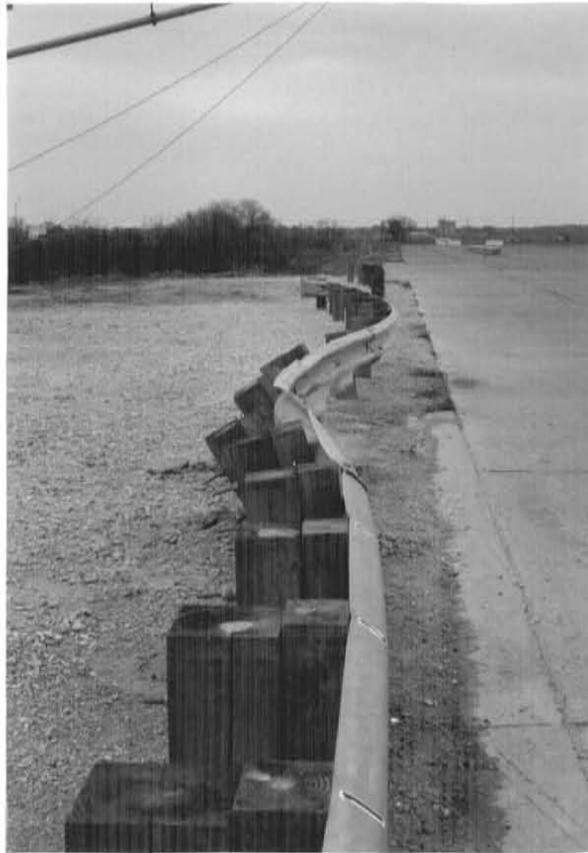
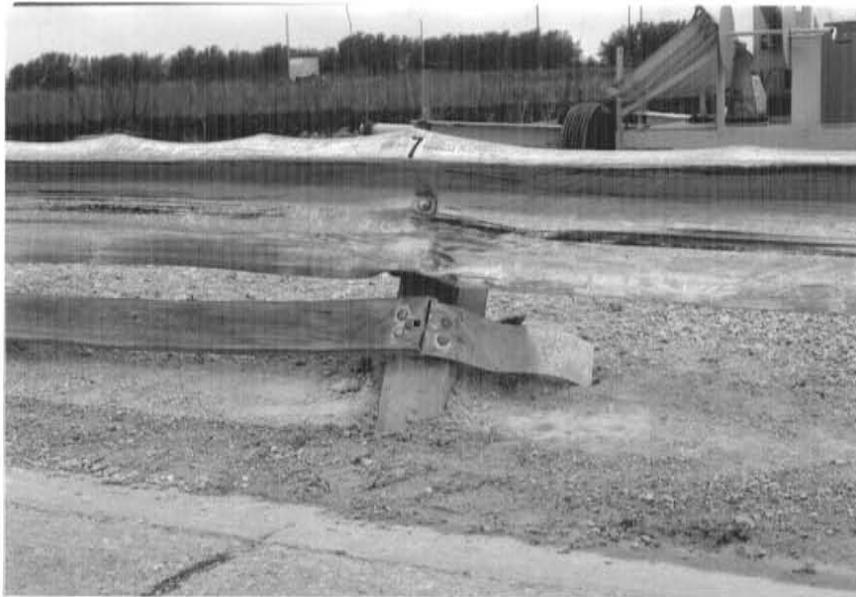
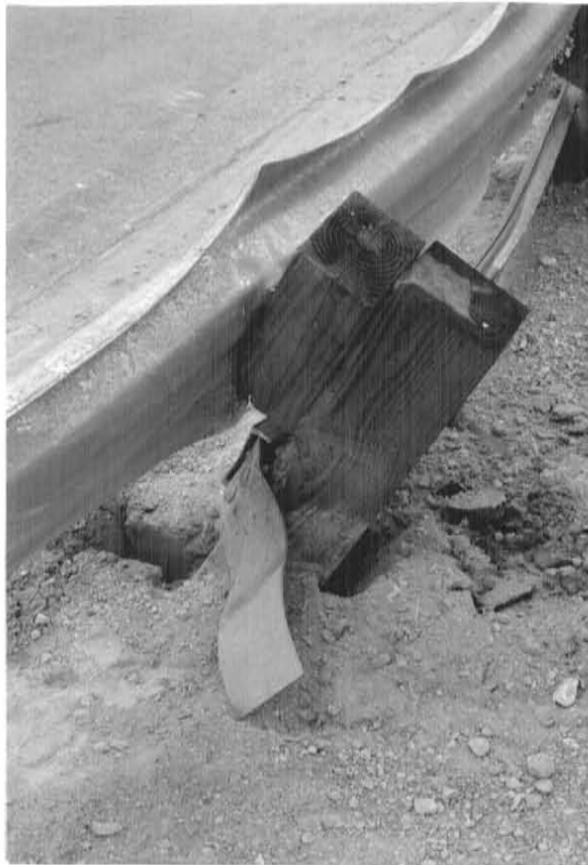
Figure 90. Arizona guardrail transition to concrete barrier after test 7155-8.

Damage to the barrier is shown in Figure 90. Maximum dynamic rail deflection during impact was 28.8 in (0.7 m), and the maximum permanent rail deformation was measured to be 25.3 inches (64.1 cm). The vehicle was in contact with the installation for a total length of 23.7 feet (7.2 m).

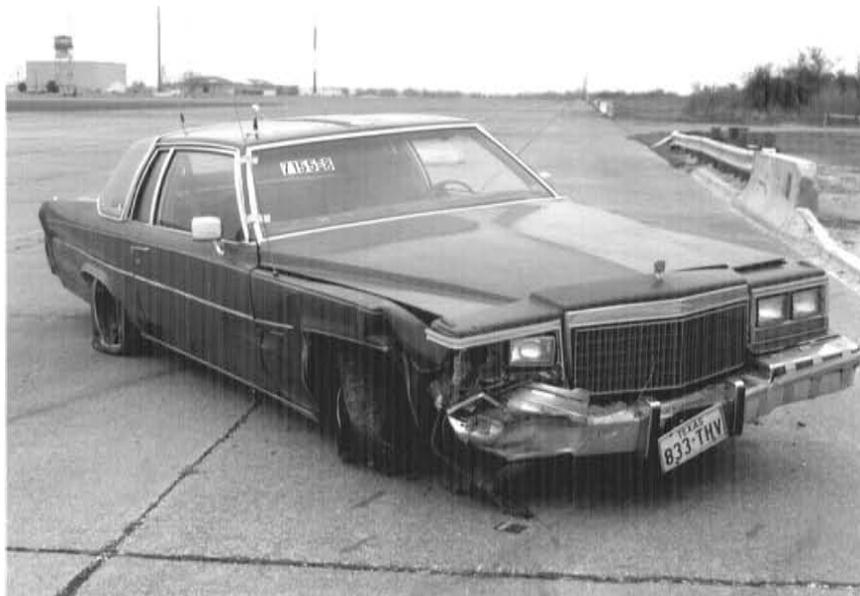
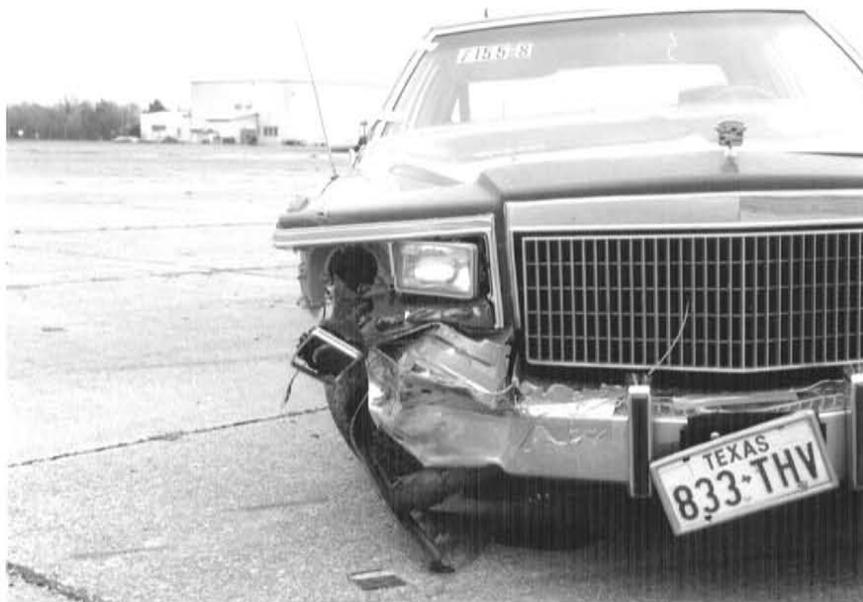
Figure 91. Vehicle after test 7155-8.

As shown in Figure 91, damage to the vehicle was minor for an impact of this severity. The maximum crush recorded on the vehicle was 10.0 inches (25.4 cm) at the right front corner. The right front wheel was pushed rearward 8.0 inches (20.3 cm) and the control arm was bent. Additionally, both the front and rear wheels were bent and the tires were aired out.

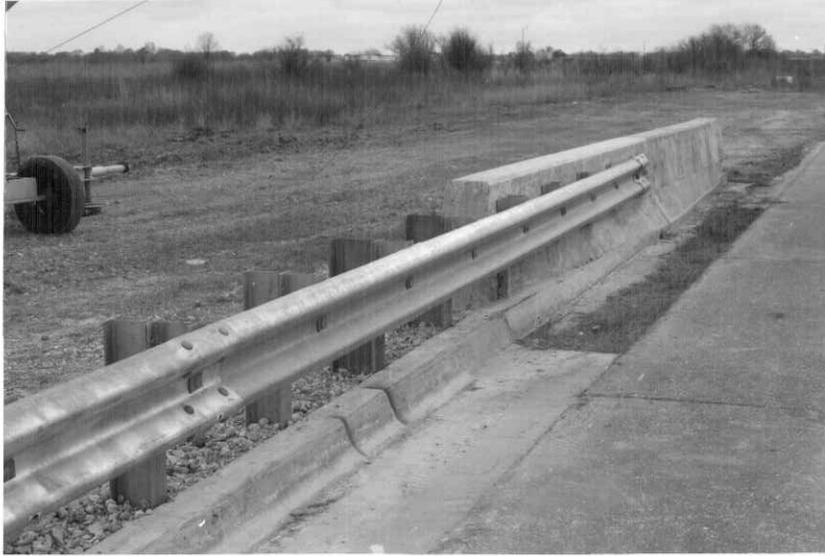
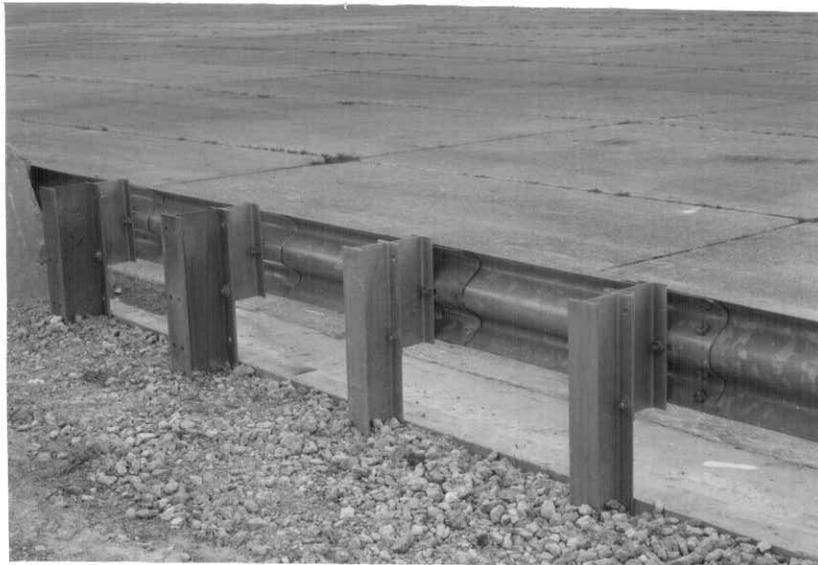
Figure 97. Arizona guardrail transition to concrete barrier before test 7155-9.

Details of the standard steel post transition with 6 inch curb are shown in Figure 49. The completed test installation for test 7155-9 is shown in Figure 97.

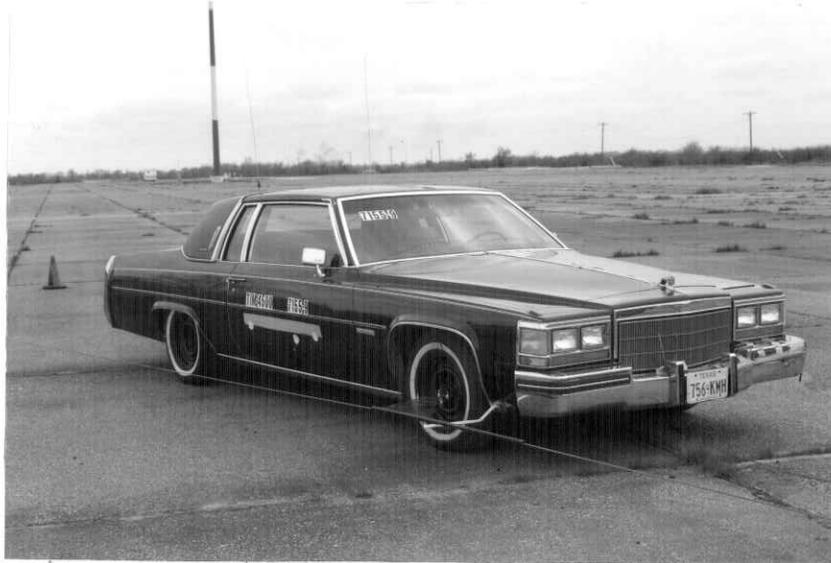
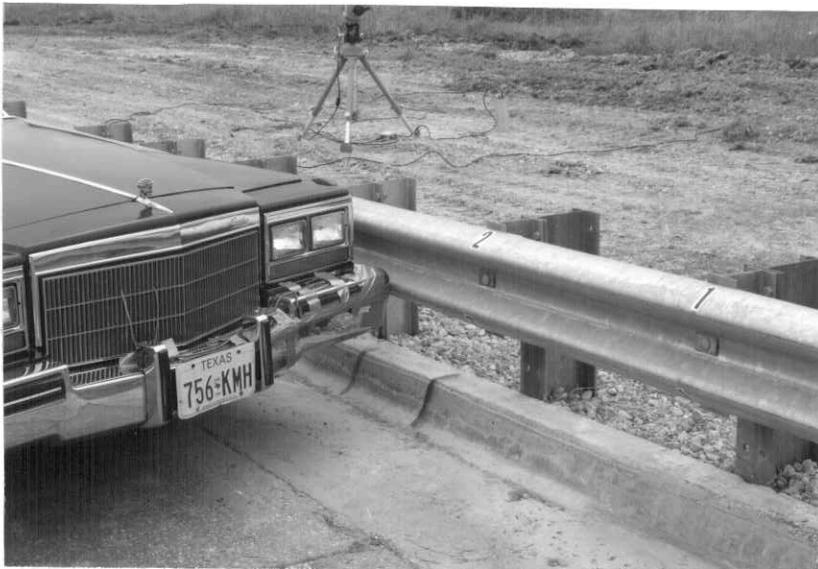
Figure 98. Vehicle before test 7155-9.

A 1982 Cadillac Coupe DeVille (shown in Figure 98) impacted 5.5 ft (1.7 m) upstream of the concrete bridge parapet at 59.7 miles per hour (96.0 km/h) and at an angle of 21.5 degrees using a cable reverse tow and guidance system. Test inertia mass of the vehicle was 4,500 pounds (2,041 kg). Dimensions and other pertinent information on the vehicle are given in Figure 99.

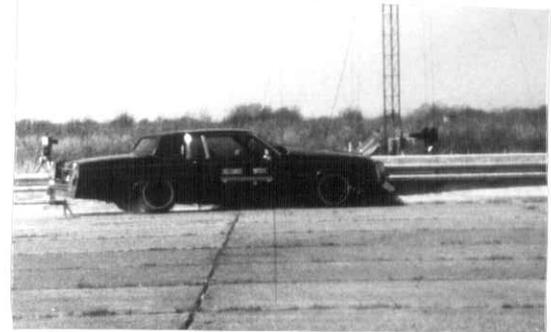
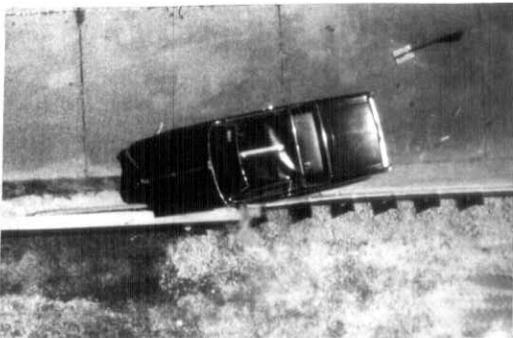
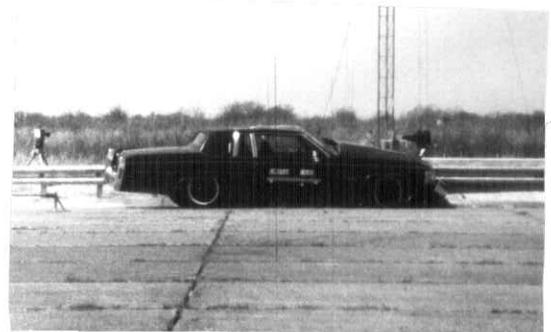
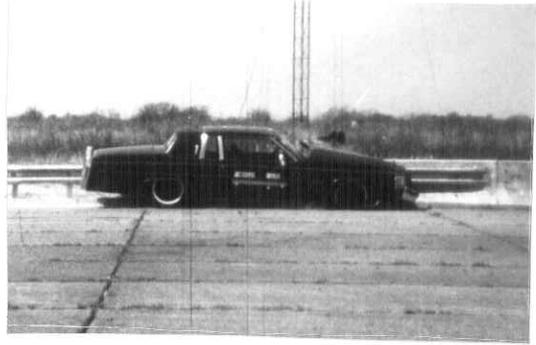
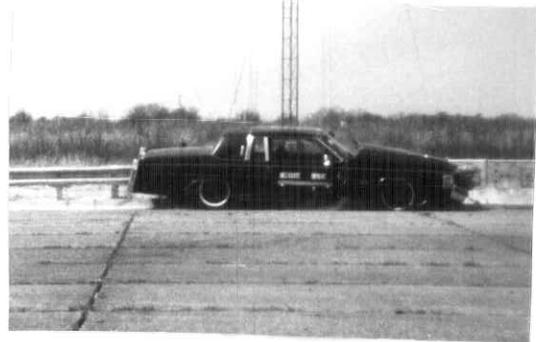
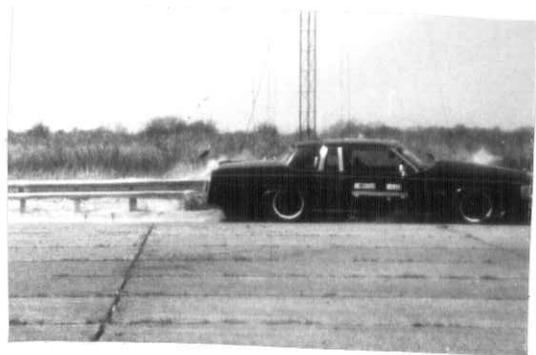
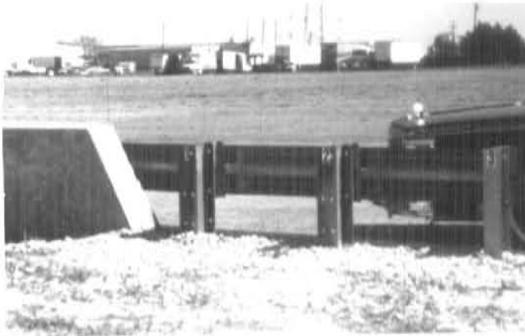
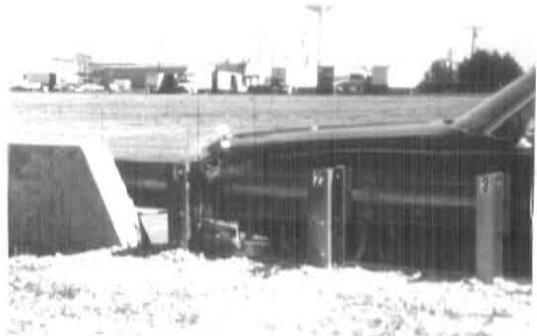
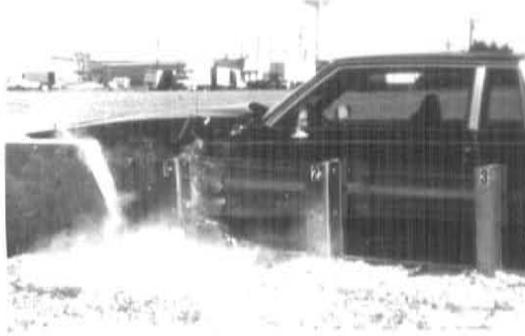
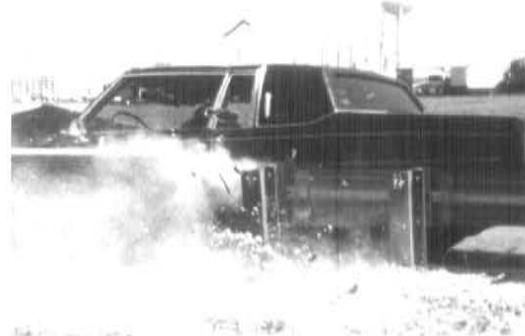
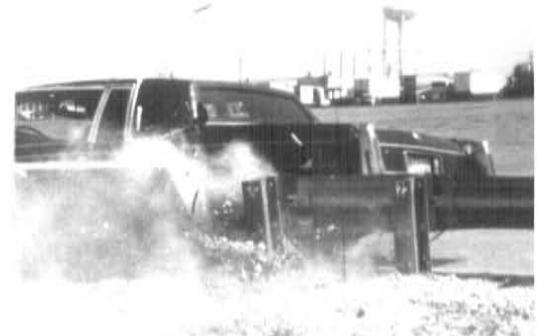
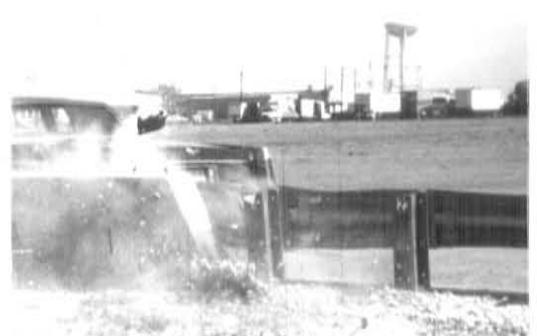
Figure 100. Sequential photographs of test 7155-9.

The vehicle was free wheeling and unrestrained just prior to impact. The left front tire of the vehicle climbed the curb as the vehicle engaged the guardrail. Although yielding of the W-beam around the end of the concrete barrier and first steel blockout on the face of the barrier allowed some vehicle snagging to occur, the vehicle was smoothly redirected. The vehicle lost contact with the installation at 0.364 second traveling 41.2 miles per hour (66.3 km/h) at an angle of 3.7 degrees. After exiting the installation, the brakes were applied and the vehicle came to rest 160.0 feet (48.8 m) from the point of impact. Sequential photographs of the test are shown in Figure 100.

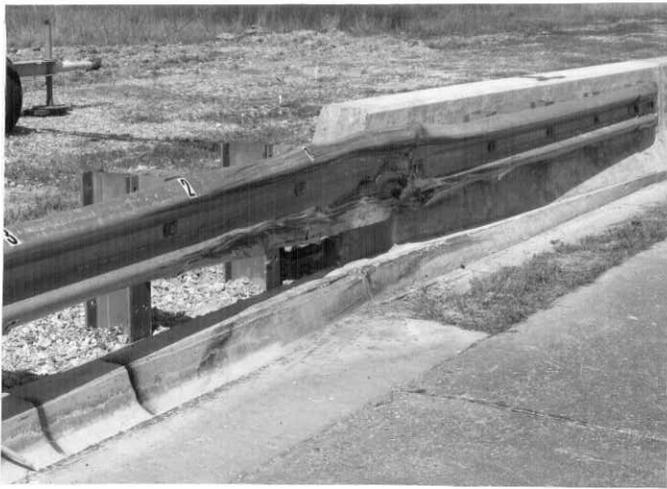
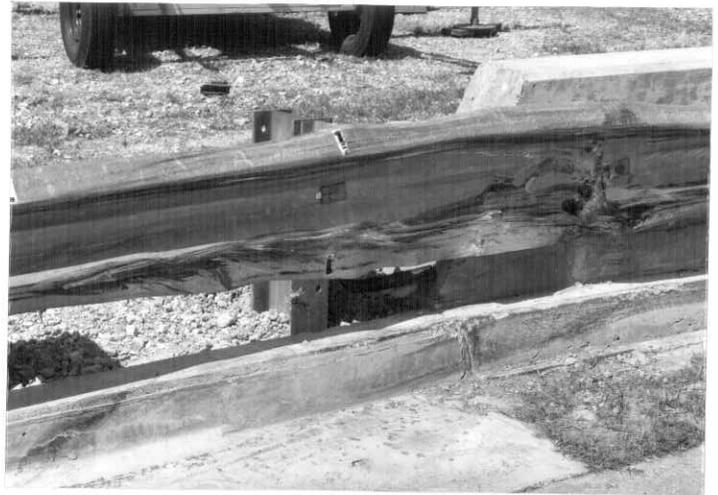
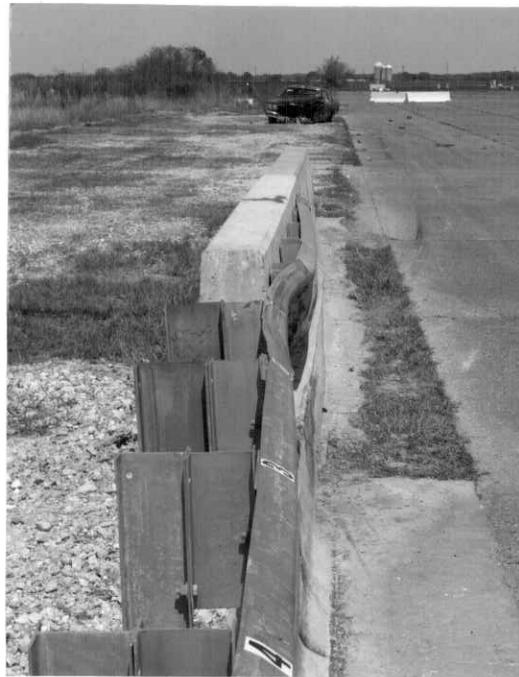
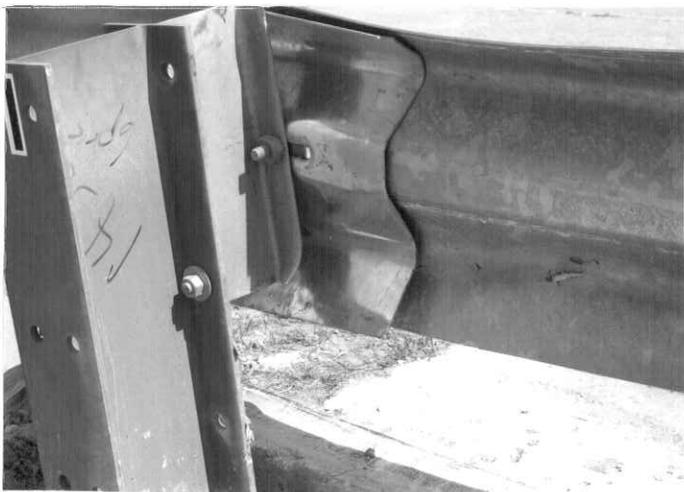
Figure 101. Arizona guardrail transition to concrete barrier after test 7155-9.

Residual damage to the installation is shown in Figure 101. The maximum permanent rail deformation was 3.5 inches (8.9 cm). The W-beam rail yielded locally around the end of the concrete parapet. The rail also yielded about the first steel blockout on the face of the parapet resulting in permanent deformation of the blockout as shown in Figure 101. The W6x9 steel blockouts on the first two posts from the end of the parapet retained their shape, and there was no observable damage or distress to the curb or the concrete anchor inserts. The vehicle was in contact with the installation for a total length of 12.7 feet (3.9 m).

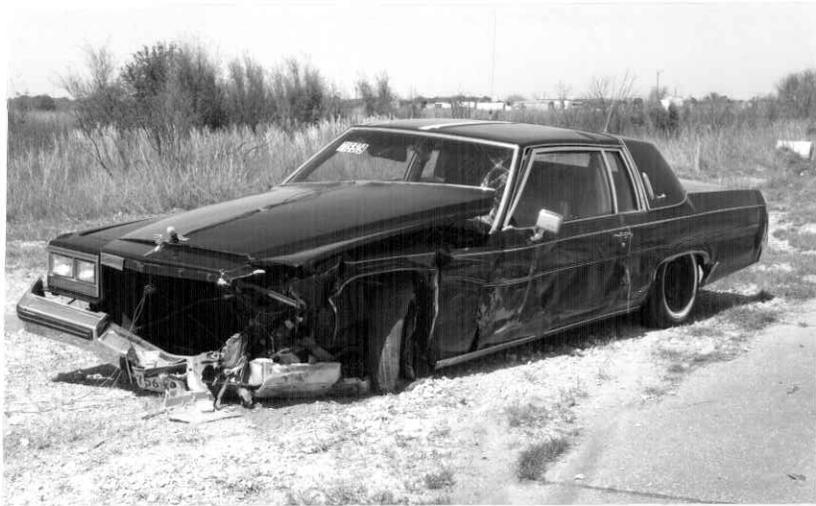
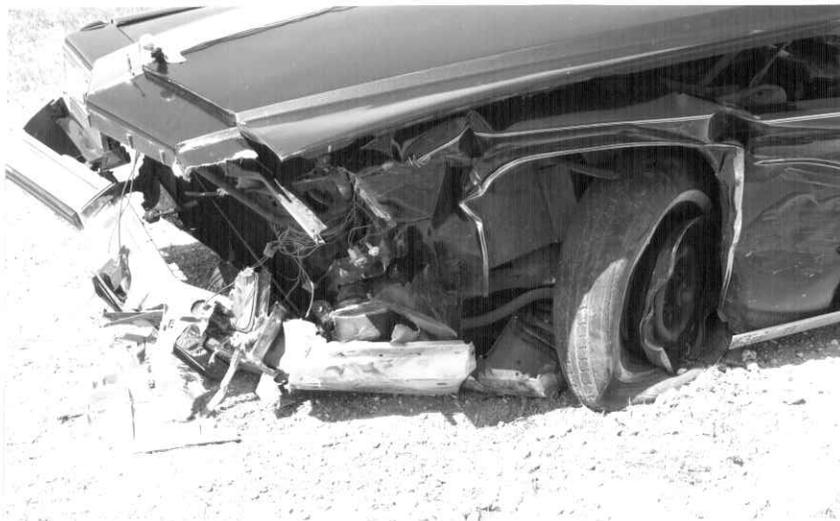
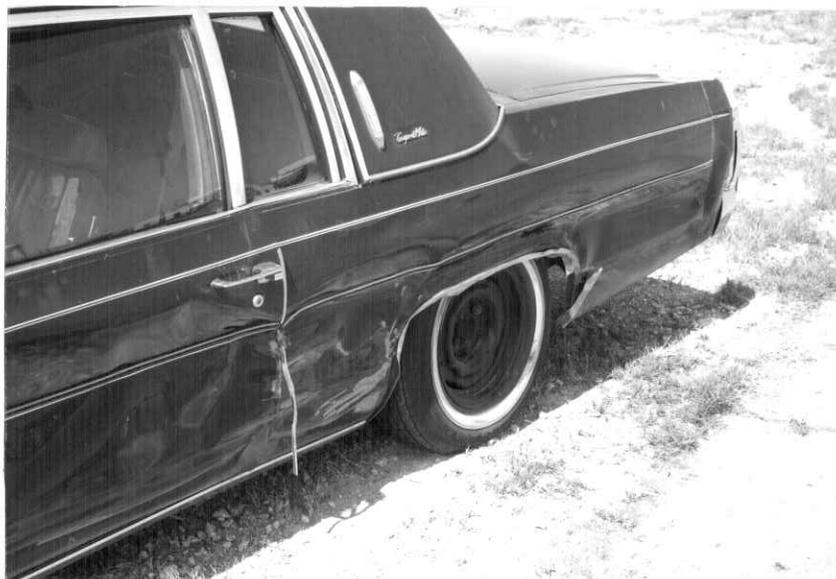
Figure 102. Vehicle after test 7155-9.

Damage received by the vehicle is shown in Figure 102. The maximum recorded crush was 12.0 inches (30.5 cm) at the left front corner of the vehicle. The left front wheel was pushed rearward 3.5 inches (8.9 cm) causing some minor deformation of the floor pan. The left side of the vehicle was dented and scraped, and the windshield was broken. The left rear tire and wheel were undamaged.
