# Performance Evaluation of Arizona's LTPP SPS-5 Project: Strategic Study of Rehabilitation of Asphalt Concrete Pavements

Arizona Department of Transportation Research Center

# **Performance Evaluation of Arizona's LTPP SPS-5 Project: Strategic Study of Rehabilitation of Asphalt Concrete Pavements**

**SPR-396-5  
June 2015**

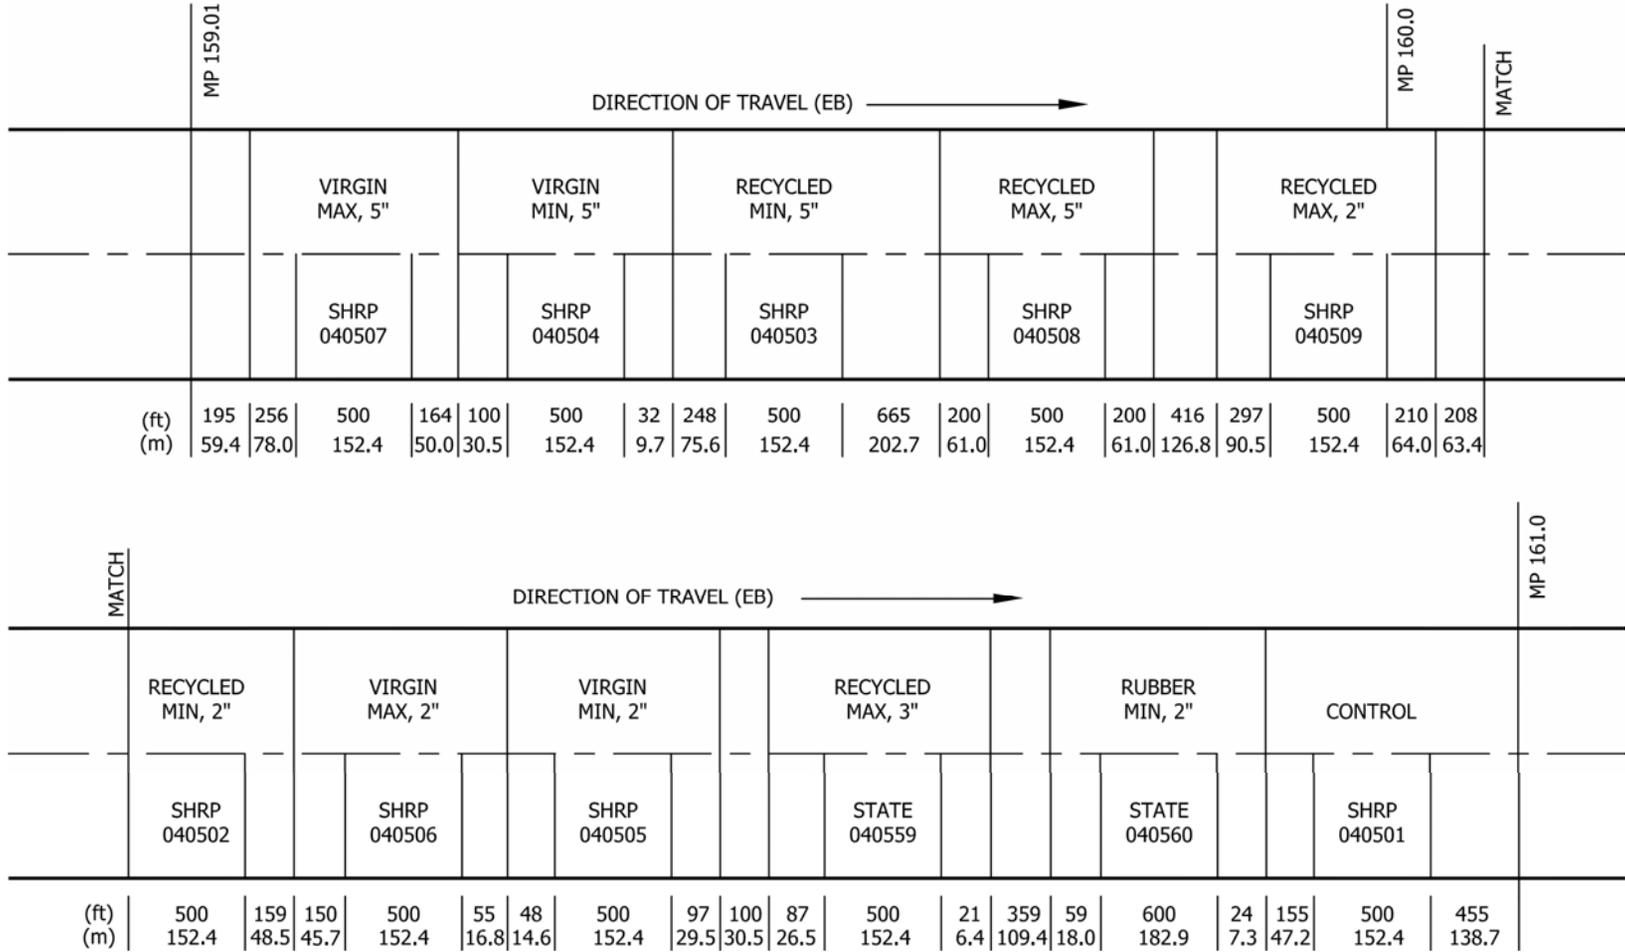
**Figure 2. Layout of the SPS-5 Project**

**SHRP SPS-5 TEST SECTION LAYOUT  
040500 CASA GRANDE, ARIZONA  
I-8 EASTBOUND**

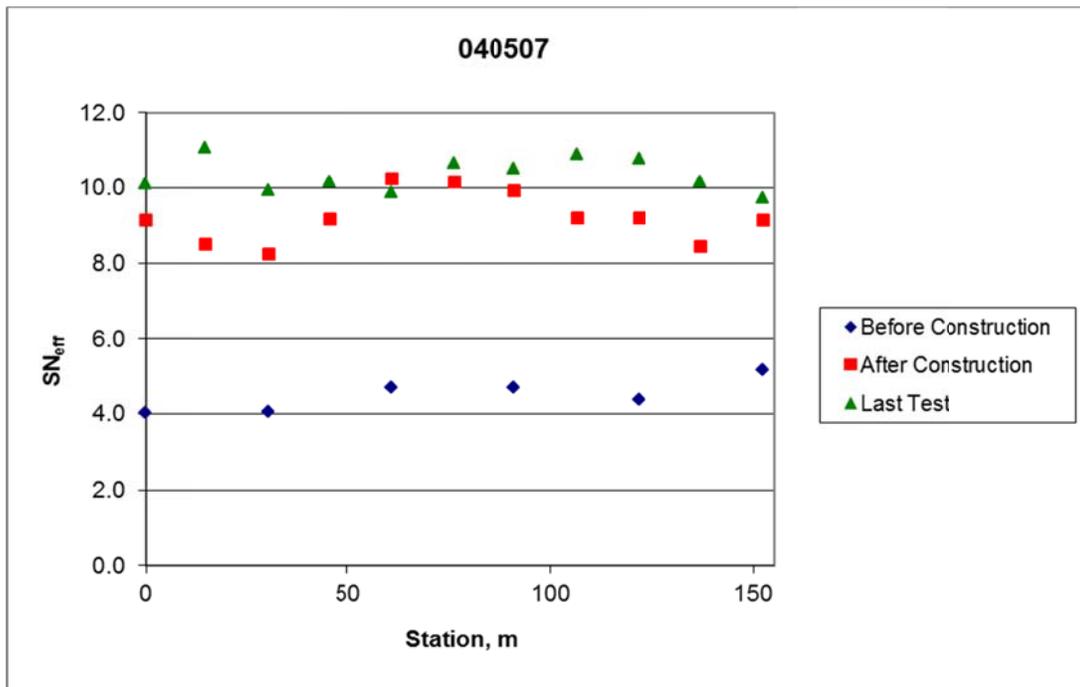
Figure 6.  $SN_{eff}$  versus Station, Section 040507

Figures 6 and 7 show  $SN_{eff}$  for this section versus station and time. The  $SN_{eff}$  values in these figures are temperature-corrected using the methodology described in the previous section.

The plot of immediate postconstruction SN<sub>eff</sub> values versus station shows a similar trend to the immediate postconstruction M<sub>r</sub> versus station plot, indicating that SN<sub>eff</sub> and M<sub>r</sub> are not fully independent, at least for that test date. The preconstruction SN<sub>eff</sub> is 4.60, which is reasonable considering the pavement structure. The average postconstruction SN<sub>eff</sub> is 10.7, which is considerably higher than would be expected given the pavement structure. As with the subgrade, the pavement structure at this section is much stiffer than expected. The SN<sub>eff</sub> versus date plot does not indicate deterioration of the pavement.

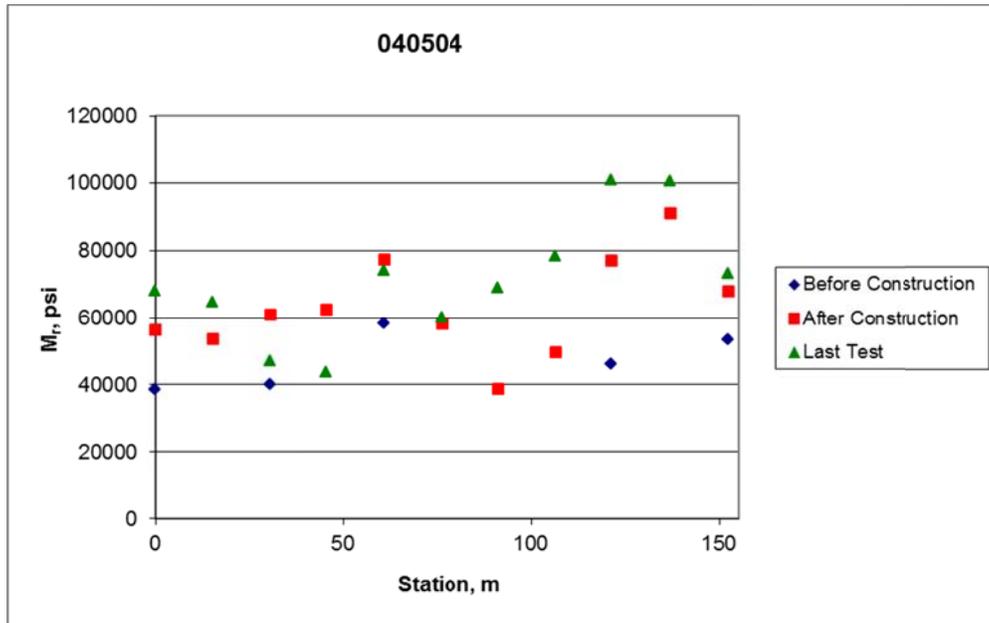
**Figure 8. Subgrade Resilient Modulus versus Station, Section 040504**

$M_r$  calculated using the AASHTO 1993 procedure is shown in Figures 8 and 9. Figure 8 shows  $M_r$  versus station for the preconstruction, postconstruction, and final tests. Figure 9 shows the average  $M_r$  for each test date.

As with Section 040507, the preconstruction  $M_r$  of 47,000 psi is high, but within the reasonable range for the material type. After construction,  $M_r$  increases to approximately 80,000 psi, which is lower than was seen at Section 040507, but still above the typical range for a subgrade material.

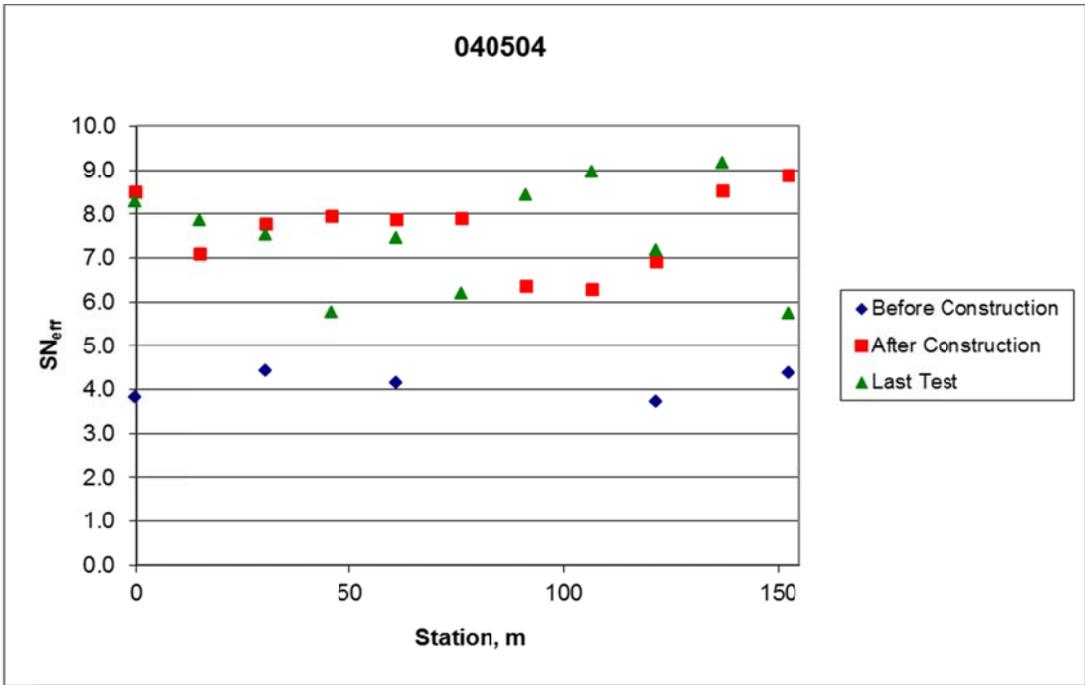
Figure 10. SN<sub>eff</sub> versus Station, Section 040504

The immediate postconstruction  $M_r$  and  $SN_{eff}$  plots both exhibit a sag around Station 100. The correlation between the plots for the last test is less apparent. The preconstruction  $SN_{eff}$  is 4.08, which is reasonable for the pavement structure. The average postconstruction  $SN_{eff}$  of 8.81 is considerably higher than expected, indicating that whatever phenomenon is affecting the response of Section 040507 is also affecting Section 040504. There appears to be a slight decrease in  $SN_{eff}$  in the final FWD test performed on December 10, 2003.

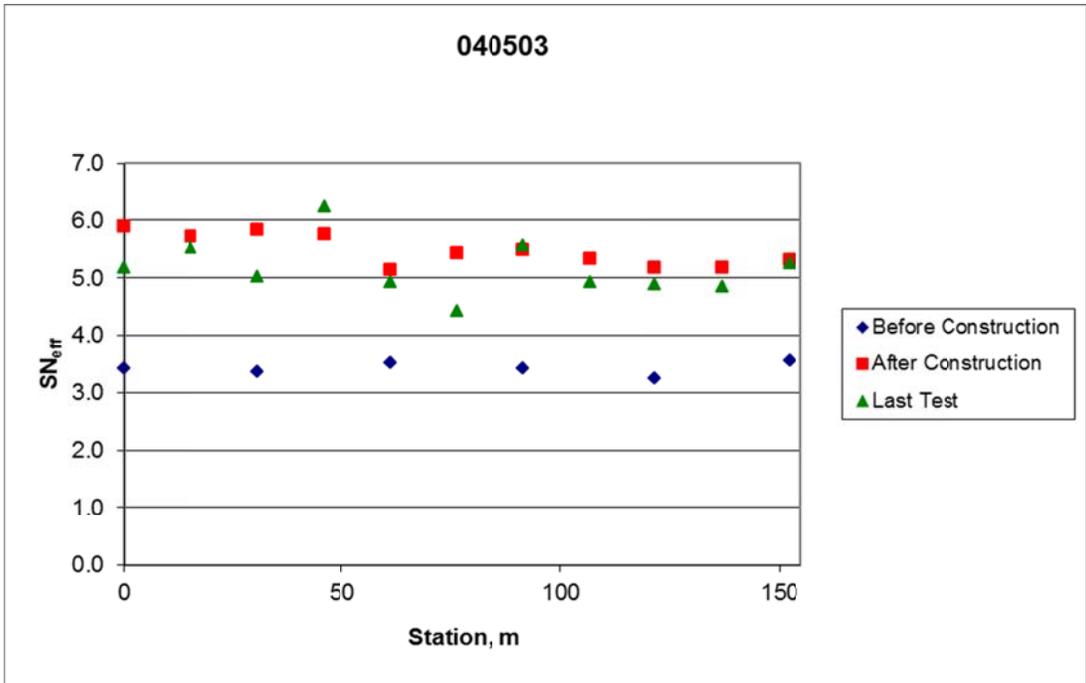
Figure 14. SN<sub>eff</sub> versus Station, Section 040503

Figures 14 and 15 show  $SN_{eff}$  for this section versus station and time. The  $SN_{eff}$  values in these figures are temperature-corrected using the methodology described earlier in this chapter.

The  $SN_{eff}$  versus station plot does not show the same trend as the  $M_r$  versus station plot, indicating that  $SN_{eff}$  and  $M_r$  are independent. The immediate postconstruction  $SN_{eff}$  is 5.47, which is reasonable for the pavement section. However, it increases to a peak of 7.50 on October 18, 1994, which is higher than would be considered reasonable. It then decreases back to a value consistent with the immediate postconstruction value. This is a similar trend as is visible in the  $M_r$  versus time plot.

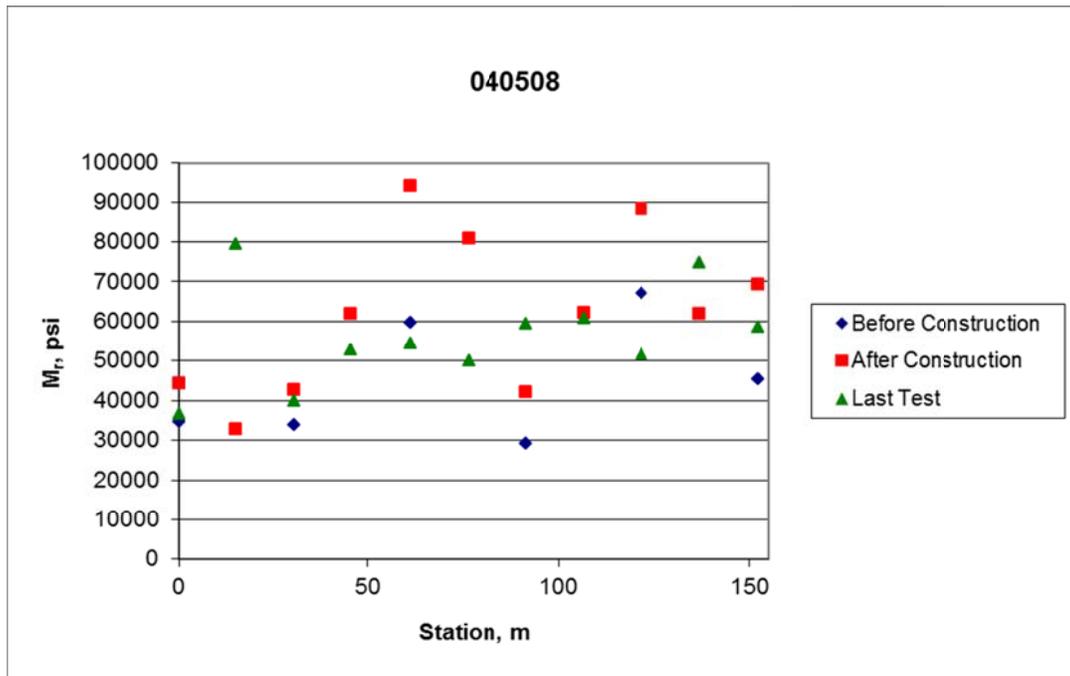
Figure 16.  $M_r$  versus Station, Section 040508

The  $M_r$  versus station plot shows a high degree of variability and a weak trend, with  $M_r$  increasing from the beginning to the end of the section. Unlike in most of the other sections, the preconstruction data also exhibits a high degree of variability. The  $M_r$  versus date plot shows an increase in  $M_r$  that persists for a longer duration than is observed at the other sites.  $M_r$  then declines to a level that is more typical for a subgrade material.

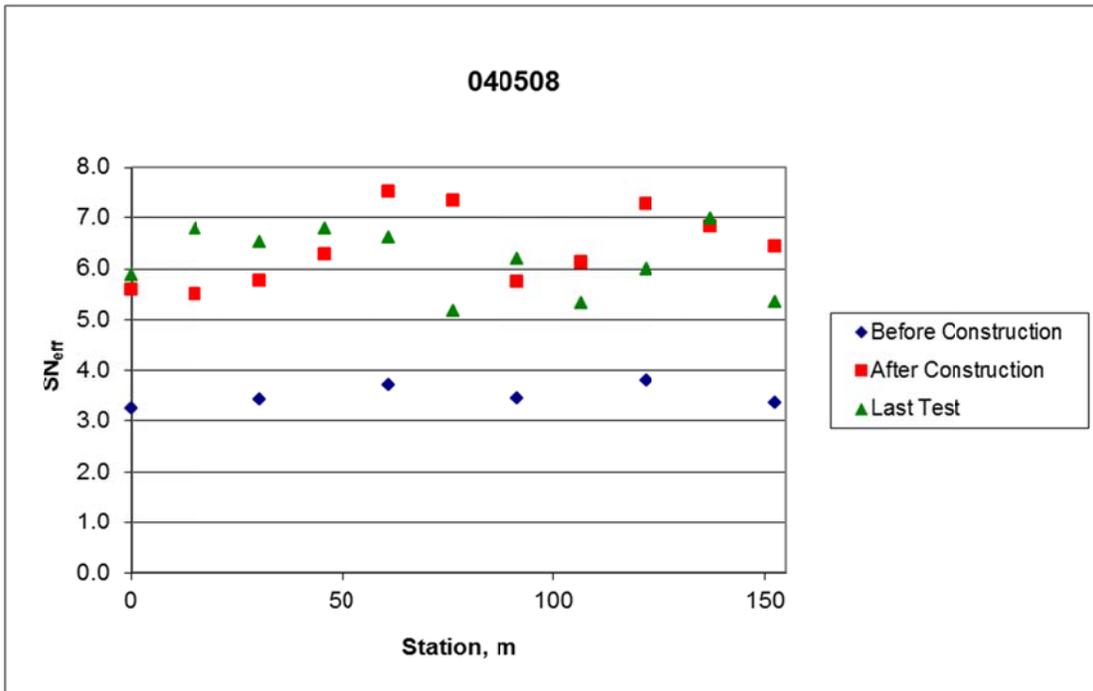
Figure 18.  $SN_{eff}$  versus Station, Section 040508

Figures 18 and 19 show  $SN_{eff}$  for this section versus station and time. The  $SN_{eff}$  values in these figures are temperature-corrected using the methodology described earlier in this chapter.

The SN<sub>eff</sub> versus station plot shows less variability than the M<sub>r</sub> versus station plot, although for the immediate postconstruction and final data sets, the high and low points are coincident. The SN<sub>eff</sub> versus date plot shows an initial increase and then a gradual decrease. The peak SN<sub>eff</sub>, at six years after construction, is 8.20, which is higher than would be expected given the pavement section. The SN<sub>eff</sub> calculated from the final test at this section is 6.15, which is still somewhat higher than would be expected.

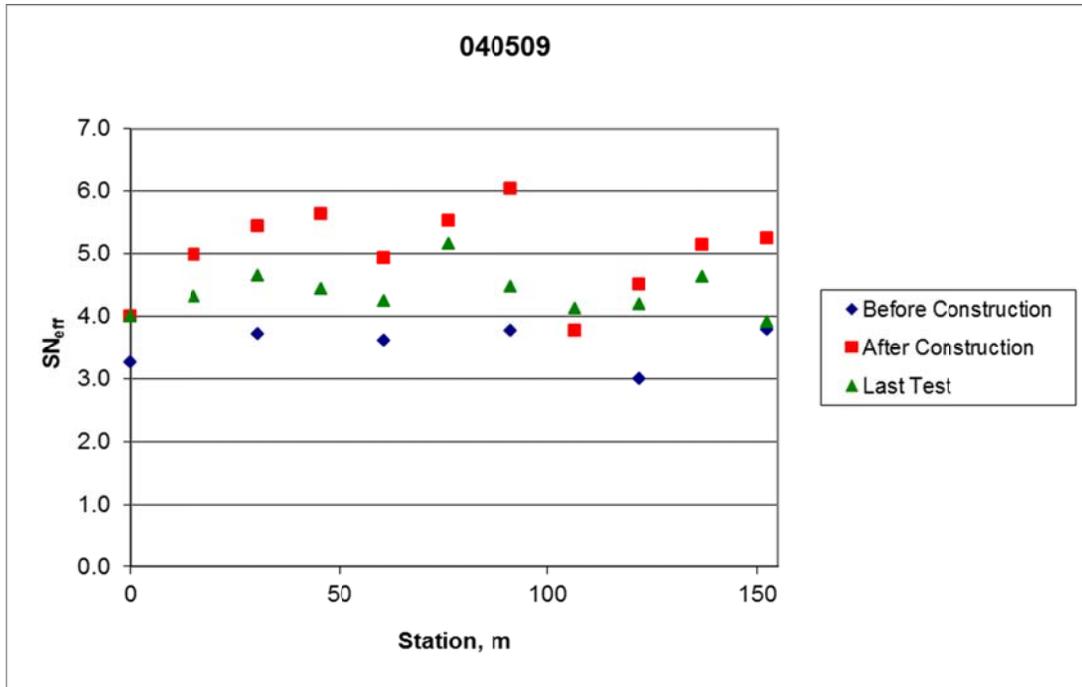
Figure 22. SN<sub>eff</sub> versus Station, Section 040509

Figures 22 and 23 show  $SN_{eff}$  for this section versus station and time. The  $SN_{eff}$  values in these figures are temperature-corrected using the methodology described earlier in this chapter.

The trends seen in the SN<sub>eff</sub> versus station plot are not the same as those seen in the M<sub>r</sub> versus station plot, indicating that SN<sub>eff</sub> and M<sub>r</sub> are independent. However, the SN<sub>eff</sub> versus date and M<sub>r</sub> versus date

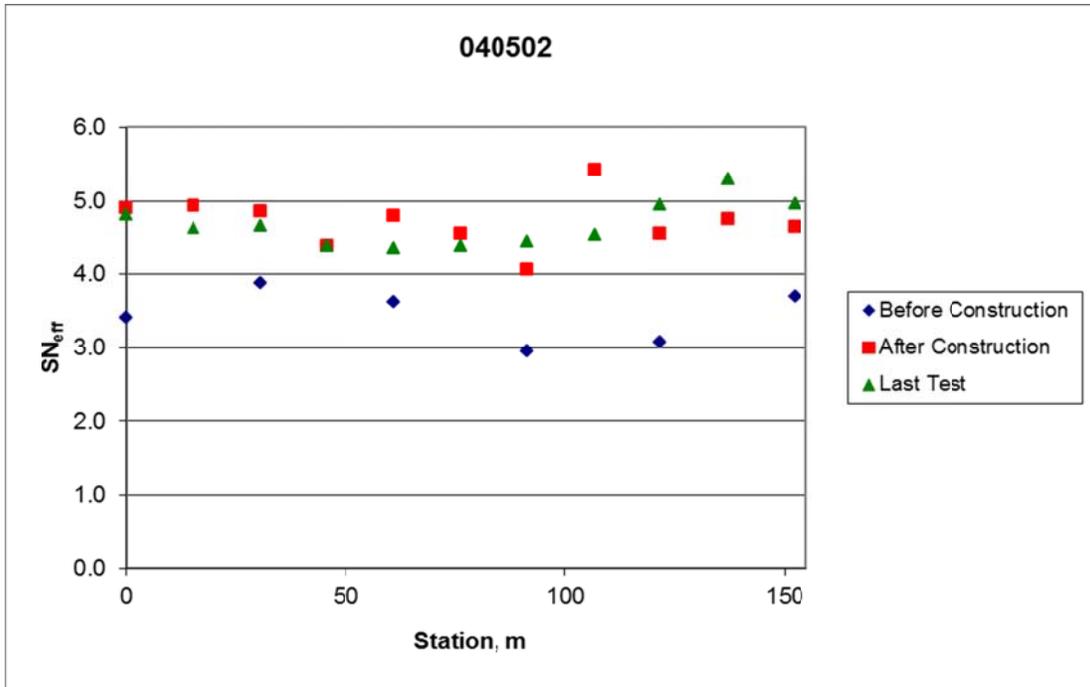
Figure 26. SN<sub>eff</sub> versus Station, Section 040502

Figures 26 and 27 show  $SN_{eff}$  for this section versus station and time. The  $SN_{eff}$  values in these figures are temperature-corrected using the methodology described in the previous section.

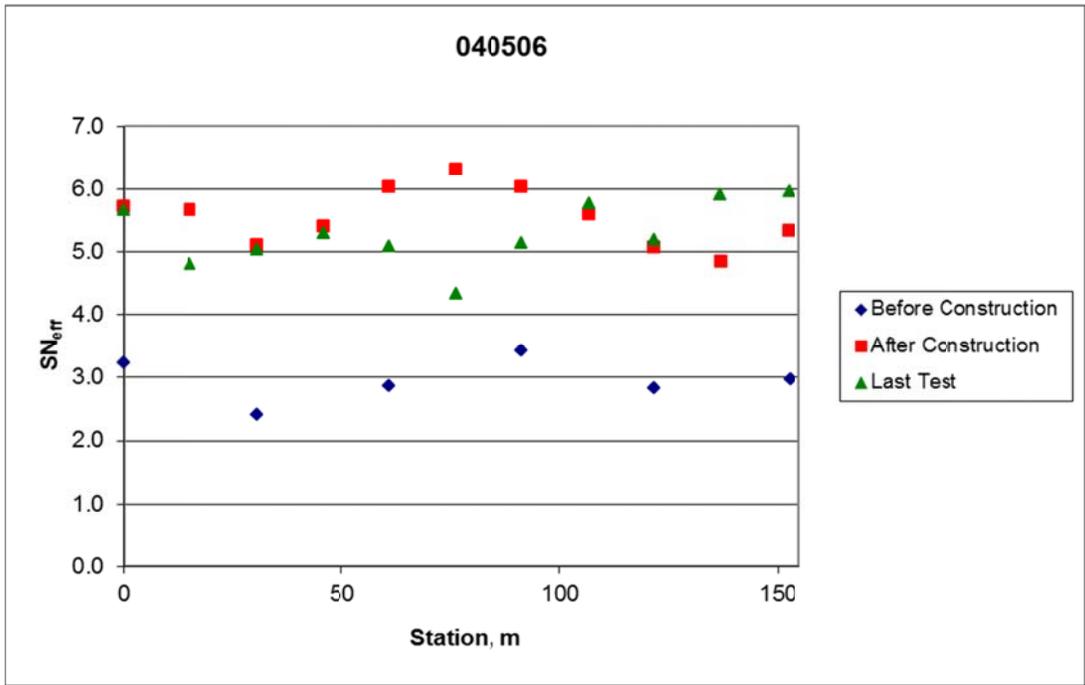
Figure 30. SN<sub>eff</sub> versus Station, Section 040506

Figures 30 and 31 show  $SN_{eff}$  for this section versus station and time. The  $SN_{eff}$  values in these figures are temperature-corrected using the methodology described earlier in this chapter.

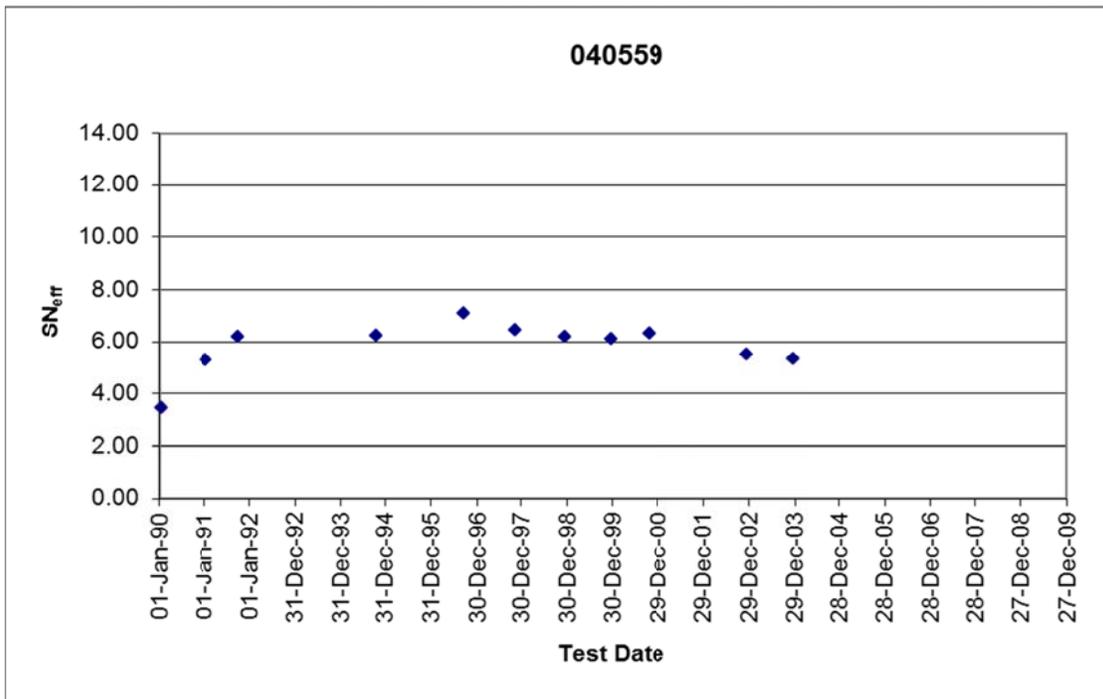
Figure 39. SN<sub>eff</sub> versus Date, Section 040559

Figures 38 and 39 show  $SN_{eff}$  for this section versus station and time. The  $SN_{eff}$  values in these figures are temperature-corrected using the methodology described earlier in this chapter.

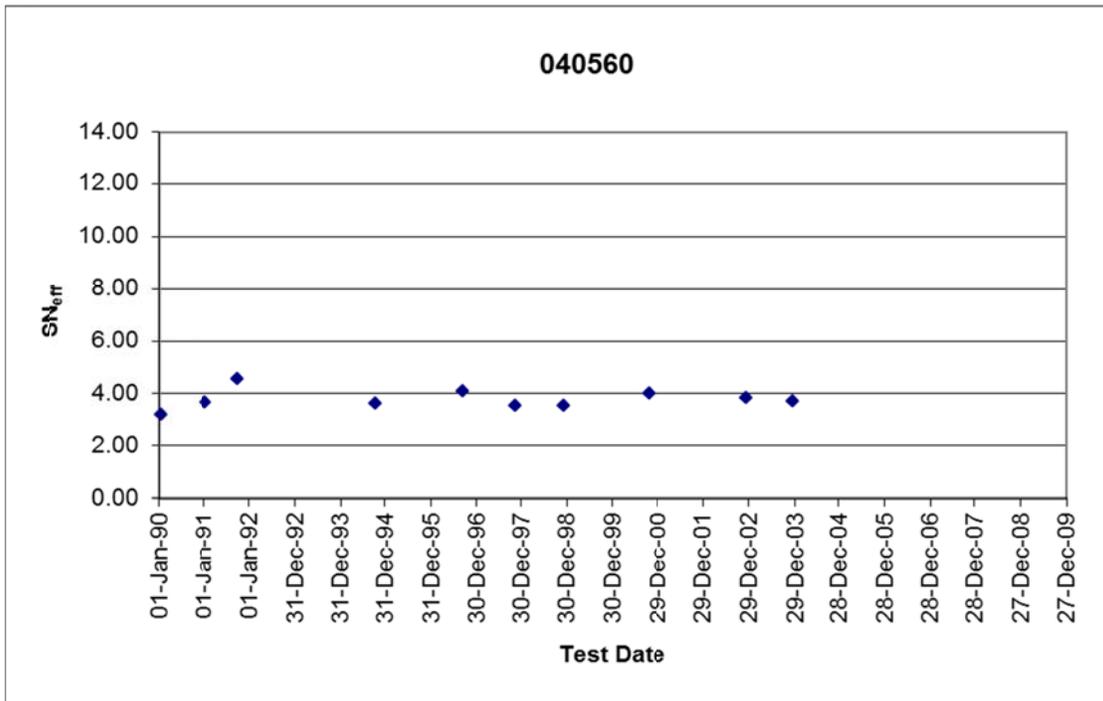
Figure 43. SN<sub>eff</sub> versus Date, Section 040560

Figures 42 and 43 show  $SN_{eff}$  for this section versus station and time. The  $SN_{eff}$  values in these figures are temperature-corrected using the methodology described earlier in this chapter.

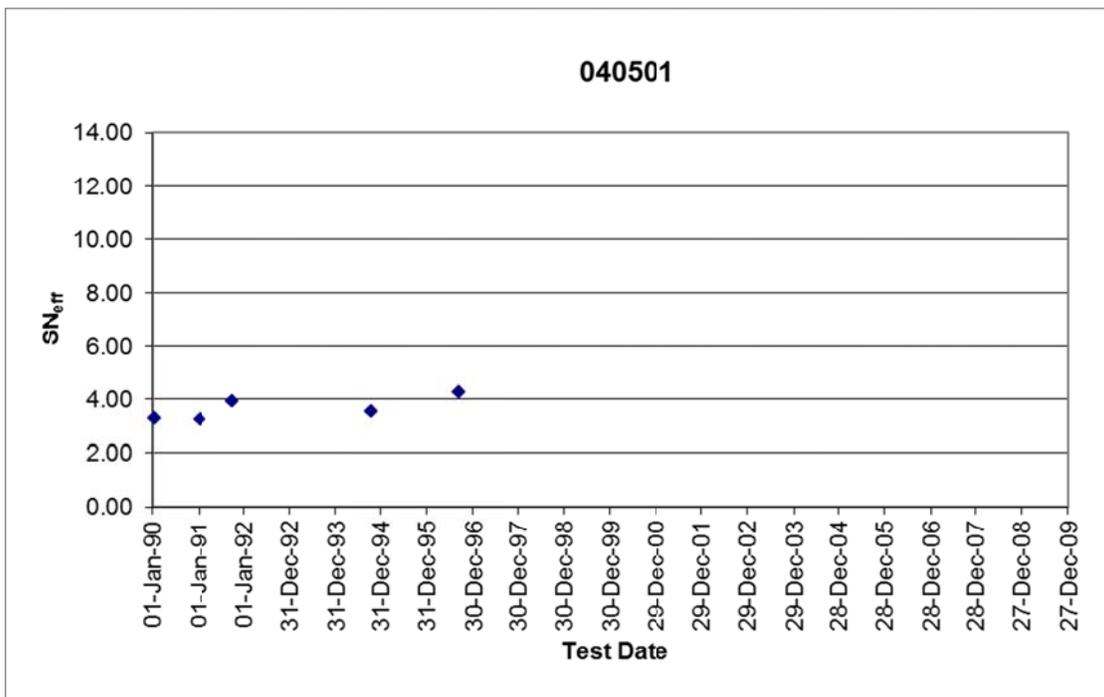
Figure 47. SN<sub>eff</sub> versus Date, Section 040501

Figures 46 and 47 show  $SN_{eff}$  for this section versus station and time. The  $SN_{eff}$  values in these figures are temperature-corrected using the methodology described earlier in this chapter.

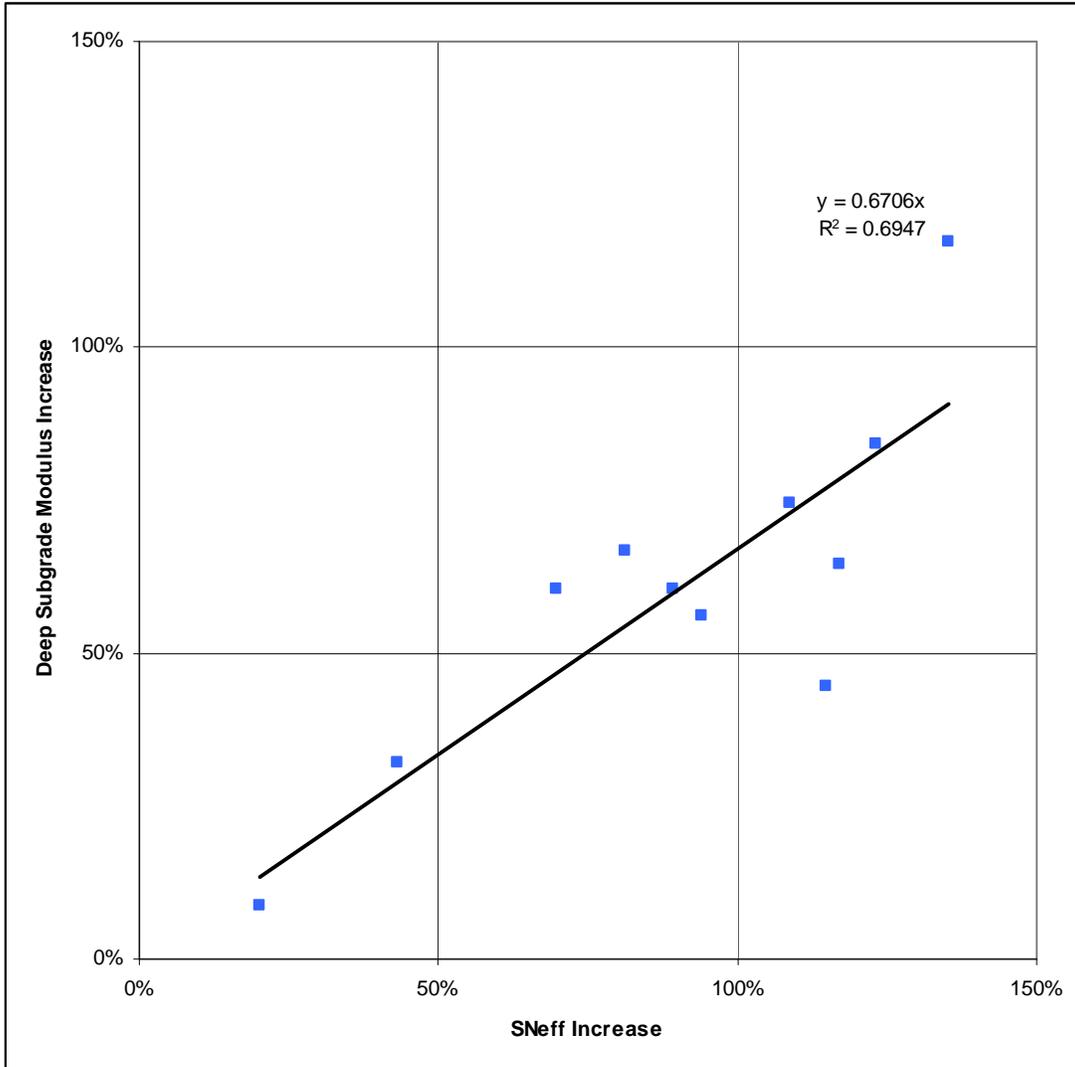
**Figure 48. Subgrade Modulus Increase versus  $SN_{eff}$  Increase**

The increase in pavement thickness shows poor correlation to the increase in deep subgrade modulus. The increase in  $SN_{eff}$  has better correlation to the increase in deep subgrade modulus, as shown in Figure 48.

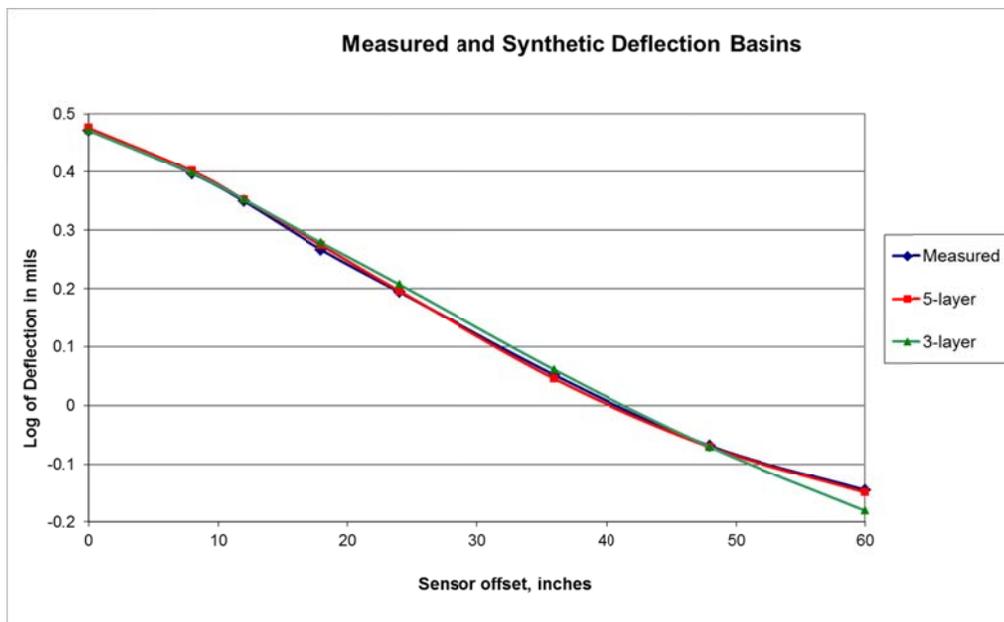
Figure 49. Measured versus Synthetic Deflection Basins

Figure 49 compares the measured deflection basin to the synthetic deflection basins calculated for the five- and three-layer models. The four- and two-layer models were omitted for clarity because the deflection basins for the five- and four-layer models are quite similar, as are the deflection basins for the three- and two-layer models.

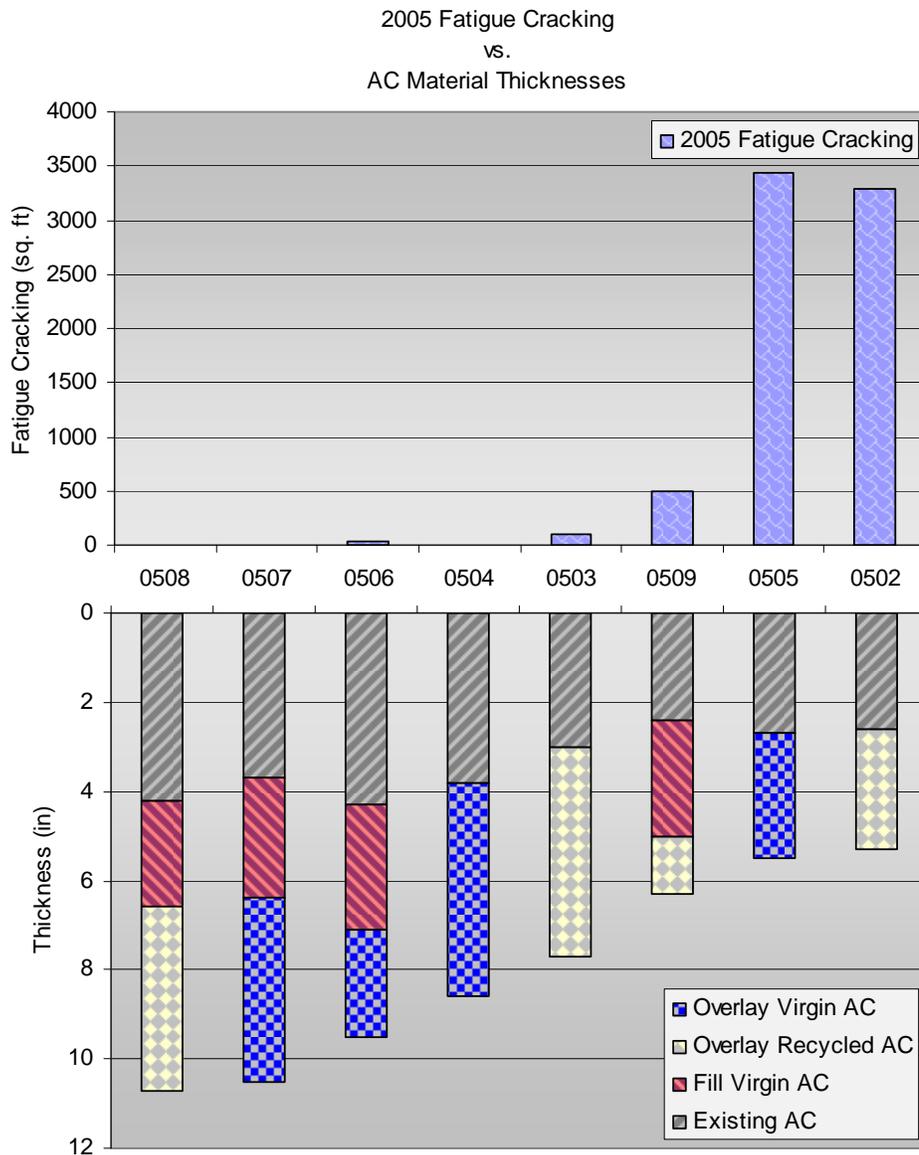
**Figure 69. Fatigue Cracking and AC Material Thicknesses**

In the experimental design of the SPS-5 project, the milled layer was to be replaced with the same overlay material used in the section before overlay placement. From an LTPP perspective, this thickness is not considered to be part of the overlay thickness. However, this additional material does appear to affect the structural performance of the sections. Fatigue cracking, the standard measure of pavement performance, seems to have a direct correlation with the thickness of the AC material. Figure 69 shows that sections where the total thickness of all AC layers (new and existing) was greater than 6 inches had a greater resistance to fatigue cracking than sections with total AC layer thicknesses less than 6 inches (based on limited observations of the eight core sections). Sections 040505 and 040502, in which the total AC material thickness was less than 6 inches, incurred fatigue cracking in over half the total area of the sections.

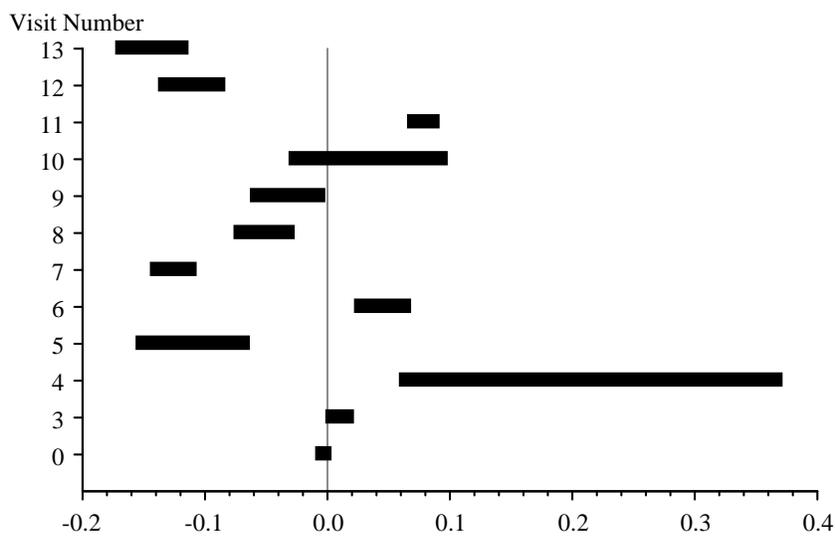
Figure 70. Consistency in Longitudinal Distance Measurement

Figure 70 shows the disagreement in longitudinal distance measurement for each visit using the original basis set as a reference. In the figure, a range of disagreement for each visit exists because up to nine repeat profile measurements were made. The variation between repeat measurements within a visit appears as the width of each bar in the figure. Since the longitudinal distance measurement was based on the rotation of a drive wheel, the variations were most likely caused by variations in speed, lateral wander, and tire inflation pressure (Karamihas et al. 1999). If tire inflation pressure were the dominant cause, the disagreement would grow more positive with each successive repeat measurement as the tire heated up because the tire-rolling radius would increase, and the profiler would register less wheel rotation for the same travel distance. This occurred in visits 04 through 09, but the effect was rarely greater than 0.10 percent of the overall distance. Also, the field procedures require the operator to warm the tire before taking measurements. Visits with very consistent longitudinal distance measurement are attributed to proper tire warm-up.

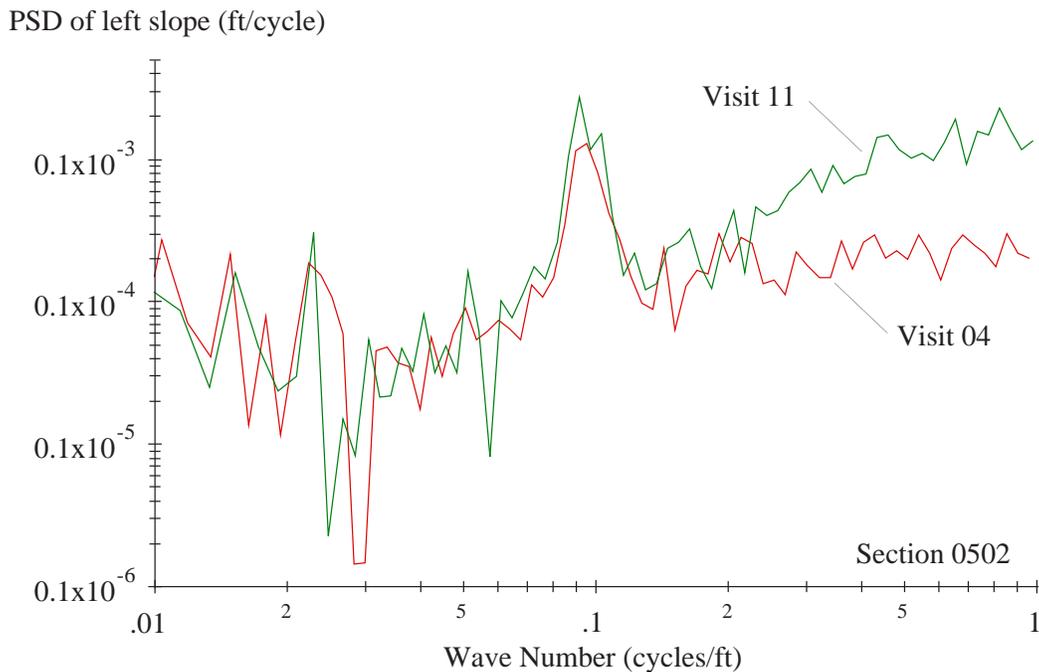
**Figure 82. PSD of Section 040502 Profiles (Left Side)**

- The peak at about 0.092 cycle/ft indicates a tremendous amount of roughness with a wavelength of about 10.9 ft. The vertical axis is on a log scale, so the peak at this wavelength is actually more significant than it looks. In fact, the roughness concentrated at wavelengths near 10.9 ft is responsible for more than half of the IRI of the visit 04 profile. This content was present in the first visit after rehabilitation, which indicates that the roughness was built in rather than a result of deterioration. An inspection of right profile PSD plots shows that this periodic content is much more dominant on the left side than the right.

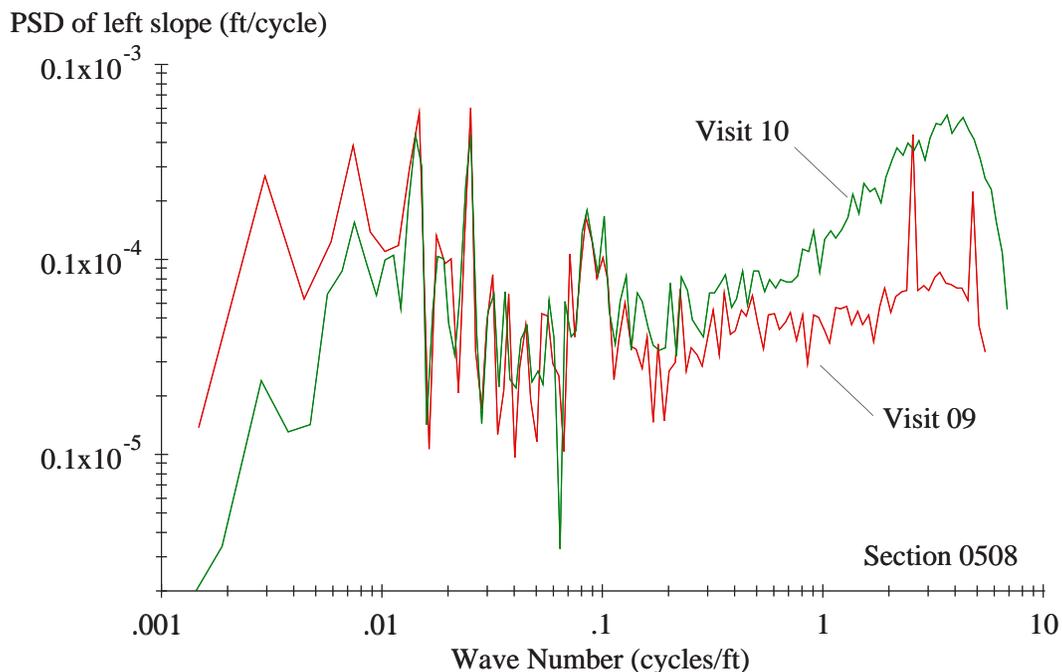
**Figure 83. PSD of Section 040508 Profiles (Left Side)**

- The PSD plot for visit 09 includes a spike at a wave number of about 2.6 cycles/ft and at double that value. This is also an artifact of the measurement process, but the source is unclear. The spikes were present in all of the profiler measurements, which include all of the measurements made in visit 04 through visit 09. However, the spikes did not occur at the same wave number in each visit or in each repeat measurement within a given visit. The wave number where the left-most spike occurred ranged from about 2.04 cycles/ft to 2.72 cycles/ft.

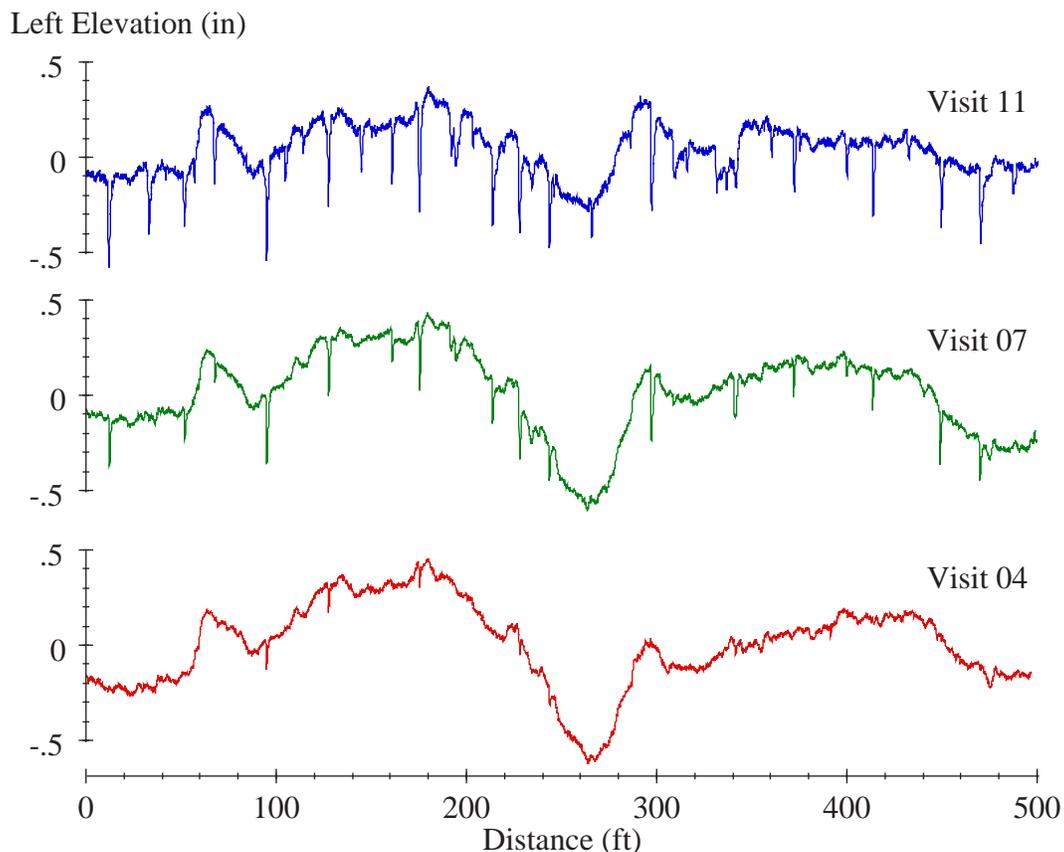
**Figure 84. Raw Profiles of Section 040509**

Although the raw profile plots in Figure 84 provide very useful information about the nature of the roughness on Section 040509, a filtered plot may provide much more detail. In particular, a closer look at the narrow dips may help study their progression. Figure 85 shows a small segment of the profile after it has been high-pass filtered. An anti-smoothing moving average filter was applied with a base length of 25 ft. The anti-smoothing is performed by applying a smoothing filter and then subtracting it from the original profile. Without the filter, the overall trend in the profile masks the dip, such that it is barely visible in the trace from visit 04. When the profile is filtered, the dip and its growth with time are much more obvious.

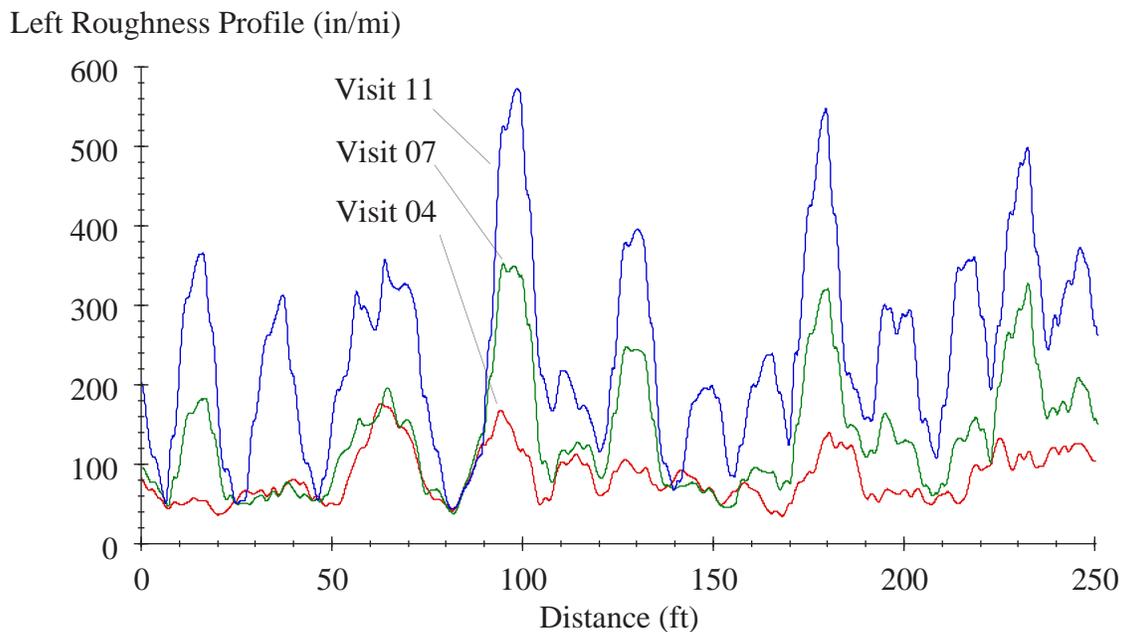
**Figure 88. Roughness Profiles of Section 040509 (10-ft Base Length)**

Figure 88 shows how a roughness profile can help find localized roughness and quantify its impact on the overall roughness of a section. The figure shows the roughness profile of Section 040509 using a 10-ft base length for visits 04, 07, and 11. With a 10-ft base length, isolated roughness is easy to identify. For example, the dips that appear at 175.5 ft increase in roughness significantly with time. In visit 11, the peak value of the roughness profile in the vicinity of the dip is 546 inches/mi. Since that value represents the roughness over just 1/50 of the segment, it suggests that the single dip contributes more than 10 inches/mi to the overall IRI of the section.

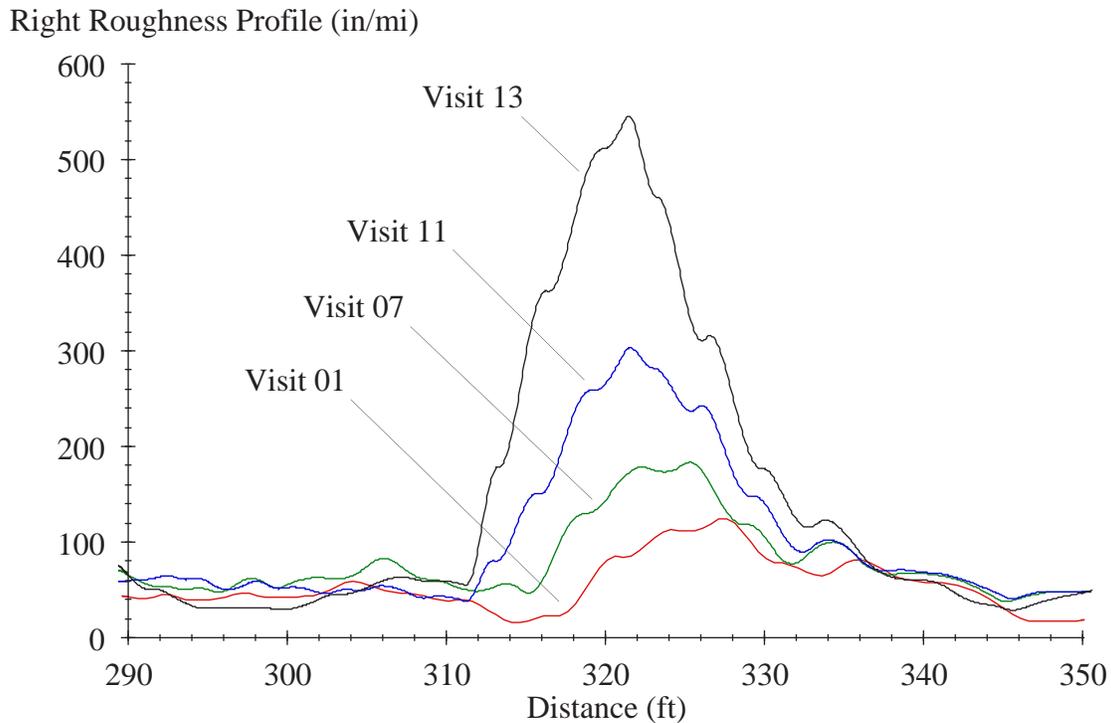
**Figure D-1. Roughness Profiles of Section 040506 (10-ft Base Length)**

All of the narrow dips listed above occurred in locations where distress surveys indicated the presence of transverse cracks.
