Arizona Department of Transportation Research Center

# **Performance Evaluation of Arizona's LTPP SPS-9 Project: Strategic Study of Rehabilitation of Flexible Pavement Binder Factors**

**SPR-396-9A  
June 2015**

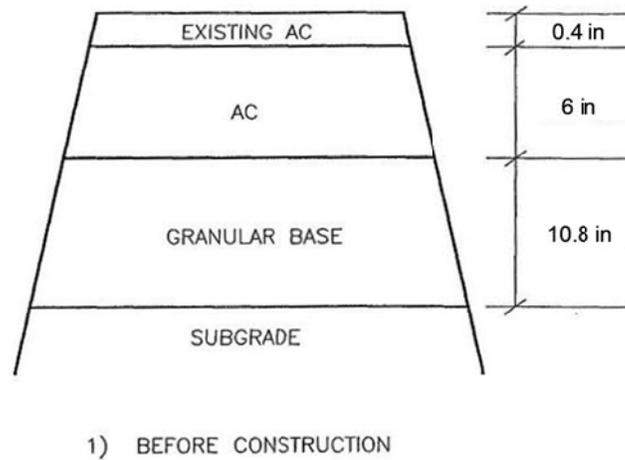
**Figure 1. Existing Pavement Structure for the SPS-9A Project**

Each test section was resurfaced in March 1995. The resurfacing treatment consisted of milling 4 inches from the existing pavement, placing a 4-inch standard (1.5-inch maximum aggregate) asphalt concrete (AC) layer, and then overlaying with 3 inches of the experimental surfaces, as shown in Figures 1 and 2. The test sections were located entirely on a shallow fill of native material. The subgrade and embankment material are coarse-grained silty sands with gravel and cobbles.

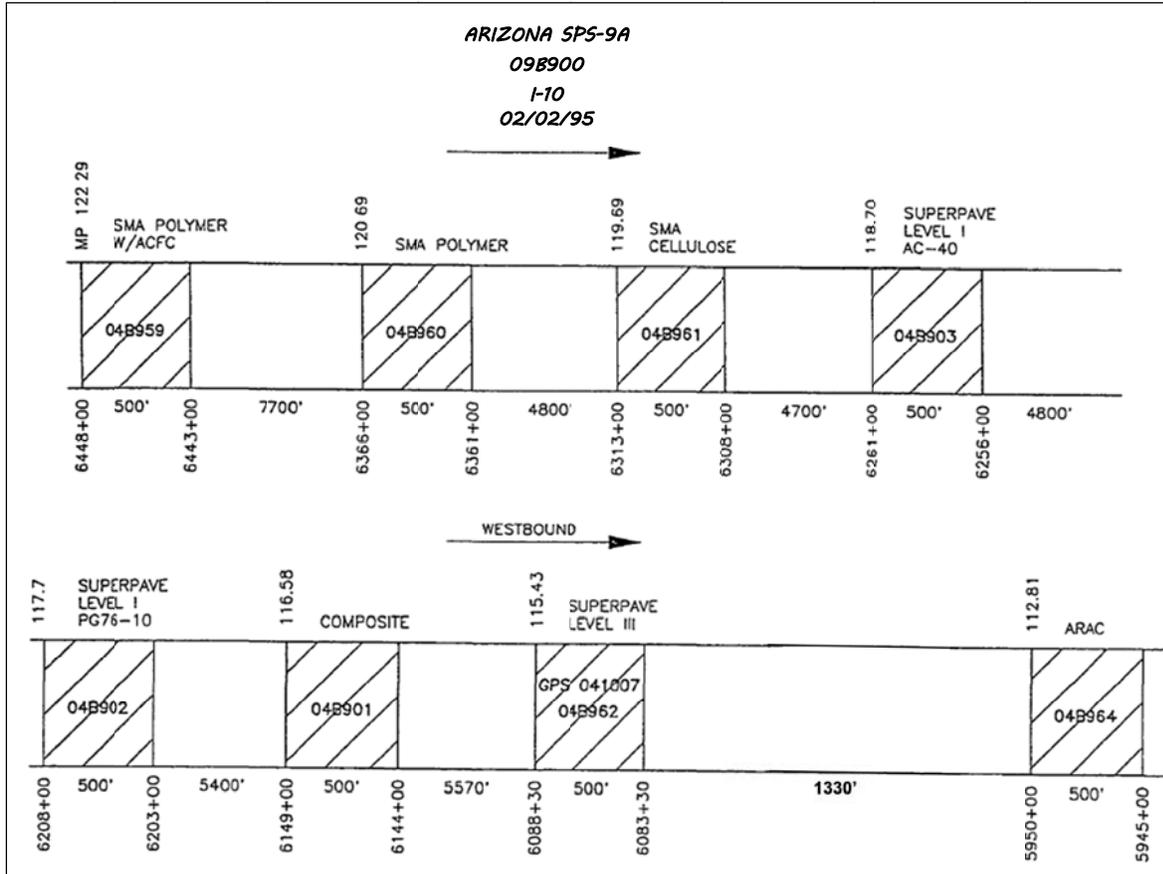
Figure 3. Layout of the SPS-9A Test Sections

The site extended from milepost (MP) 112.81 to MP 122.29 on westbound I-10. The site is located at latitude 33°27'45" and longitude -112°28'10", with an approximate elevation of 1059 ft. The terrain surrounding the test section is slightly rolling and the roadway is straight. Figures 3 through 5 illustrate the test sections located within the SPS-9A project.

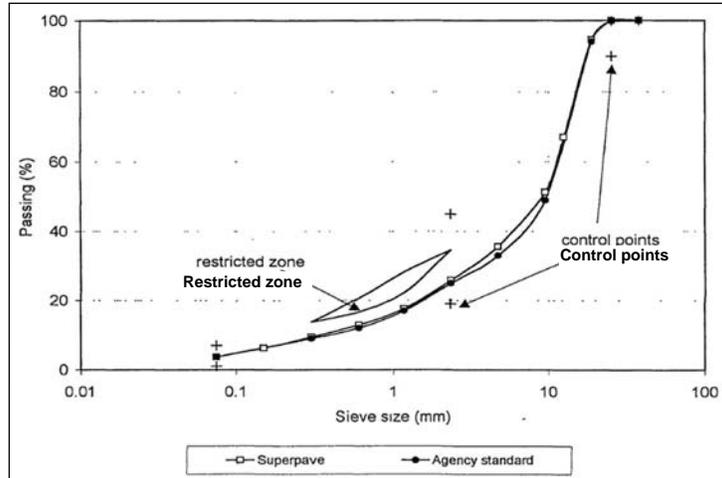
**Figure 6. Gradations of Superpave Aggregate and Agency Standard Aggregate (FHWA 1998)**

The gradations for the Superpave and standard agency aggregate are shown in Figure 6. As previously mentioned, some mixture and other data were not available for all test sections.

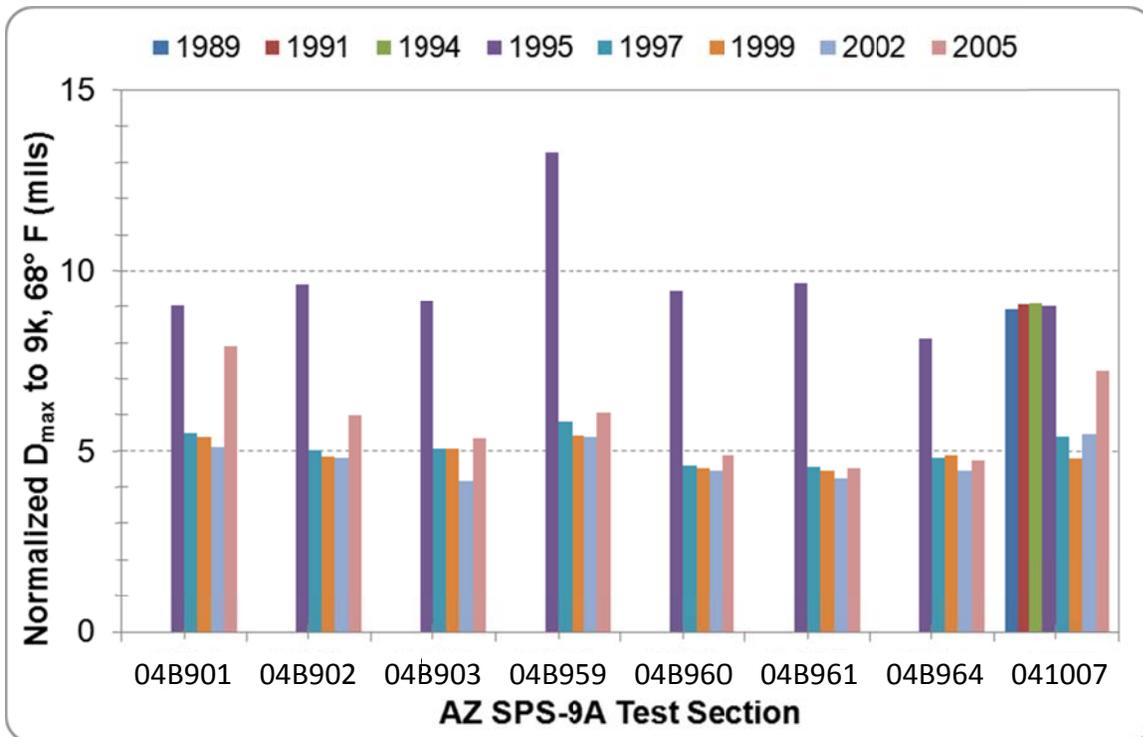
Figure 7. Average Normalized  $D_{max}$  by Test Section

The normalized average maximum deflection ( $D_{max}$ ) ( $D_0$ , measured at the center of the FWD load plate, normalized to a load level of 9000 pounds and an AC mix temperature of 68 °F) typically indicates the total stiffness of the pavement structure (surface and base) and the underlying subgrade. Increases in the normalized average maximum deflection (or  $D_{max}$ ) observed over time may be due to weakening of the pavement structure or weakening of the subgrade.

Figure 7 shows  $D_{max}$  results for each test section from the first round of testing to the last. Except for Section 041007, the first round of testing for all sections was performed in 1995. When this testing was performed, the top lift of the AC layer had not been placed, resulting in the relatively high deflections that were observed throughout the project. The second test was performed in 1997—21 months after construction. As expected,  $D_{max}$  reduced significantly compared to the first round of testing.

The deflection at the center plate shows an improvement in pavement strength between testing conducted in 1995 and 1997 as a result of adding the structural layer in 1995 after the first round of testing was completed. All of the sections remained structurally sound during the 1997, 1999, and 2002 testing. The researchers observed a decline in pavement structure in the last round of testing in 2005, mainly due to the weakening in the AC layer, since the subgrade didn't change significantly over time.

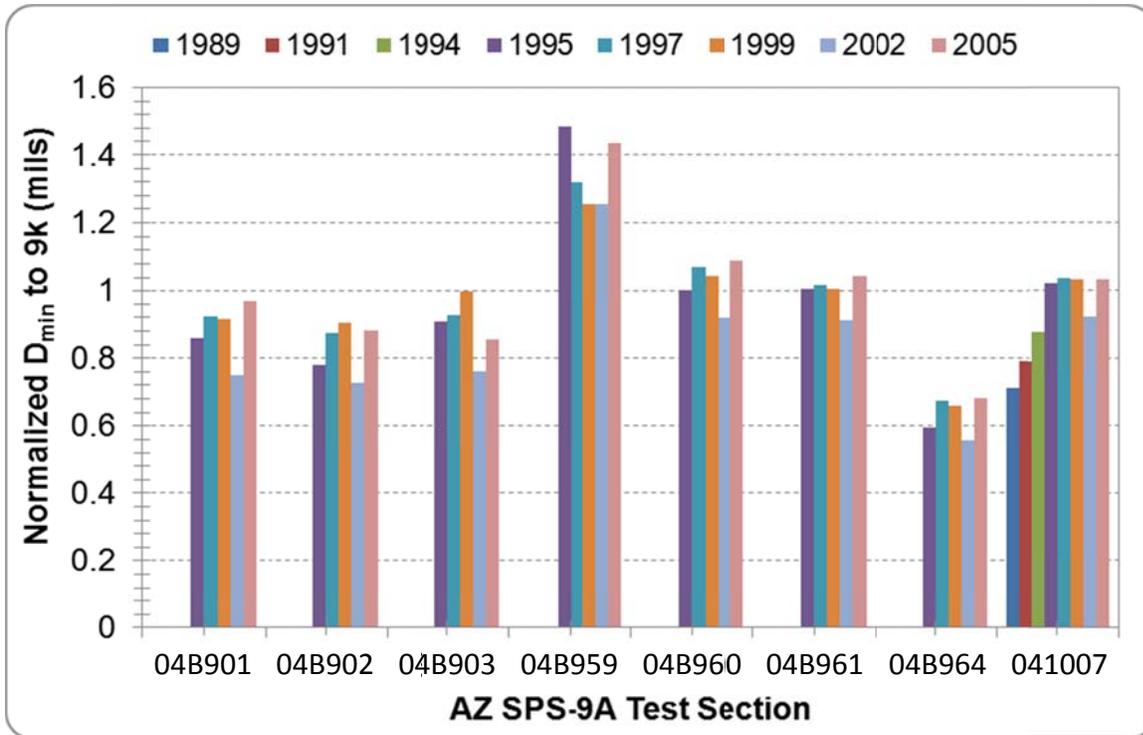
Figure 8. Average Normalized  $D_{min}$  by Test Section

The minimum deflection ( $D_{min}$ ) was observed in the sensor farthest from the loading plate, which for LTPP can be either sensor No. 7 or sensor No. 8, depending on the configuration used. The  $D_{min}$  readings also normalized to standard 9000 pounds, but no temperature correction factor was applied. The  $D_{min}$  readings were indicative of the subgrade characteristics. Figure 8 shows the  $D_{min}$  measurement from the first round of testing to the last round of testing. In general, subgrade modulus did not change much throughout the test sites. Section 04B964 had the strongest subgrade and Section 04B959 had the weakest subgrade. Interestingly, subgrade strength increased with time in Section 041007.

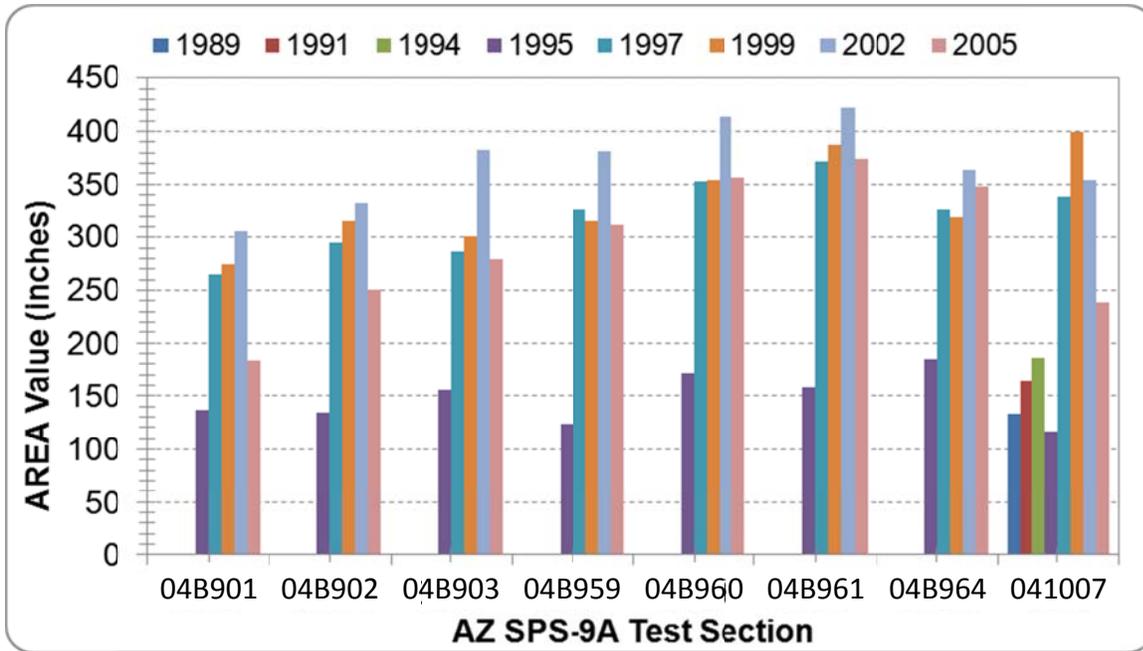
Figure 9. AREA Values by Test Section

Figure 9 shows the average AREA value of the SPS-9A test sections from the first round of testing to the last round of testing. As shown in the figure, a significant increase in AREA value between first and second round of testing was observed, which coincides with the  $D_{max}$  observation.

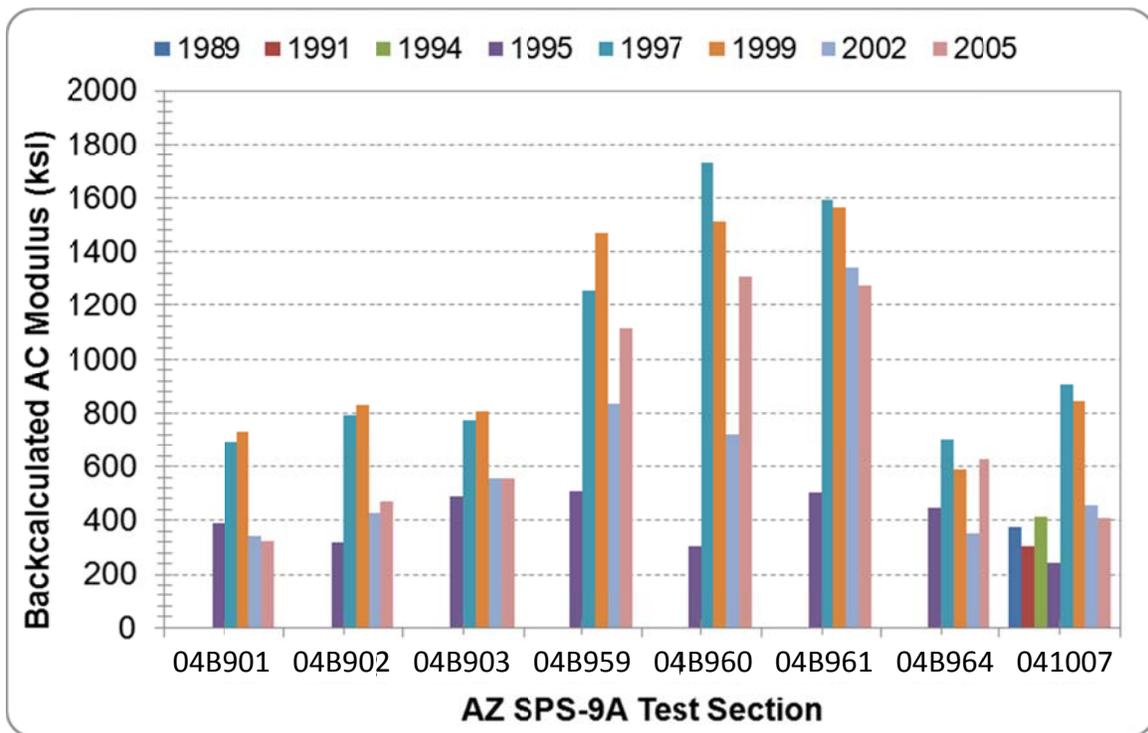
Figure 10. Backcalculated AC Modulus by Test Section

In general, backcalculated AC modulus decreased as the pavement aged (Figure 10). In some cases the AC modulus increased with time, which could be due to aging of the asphalt binder. The decrease in AC moduli value is probably due to the appearance of distress and the resulting weakening in overall pavement strength.

- After construction in 1995, little variation in the AC moduli was observed in most sections. The first significant drop was observed in 2002 in all sections, however, the AC moduli bounced back in the 2005 testing. A similar trend was observed among the three core LTPP test sections. The Superpave mix design sections showed higher AC moduli values compared to the agency standard mix section. No significant difference was found between the PG 76-10 and PG 70-10 sections. The three SMA sections showed the highest AC moduli value among all test sections.

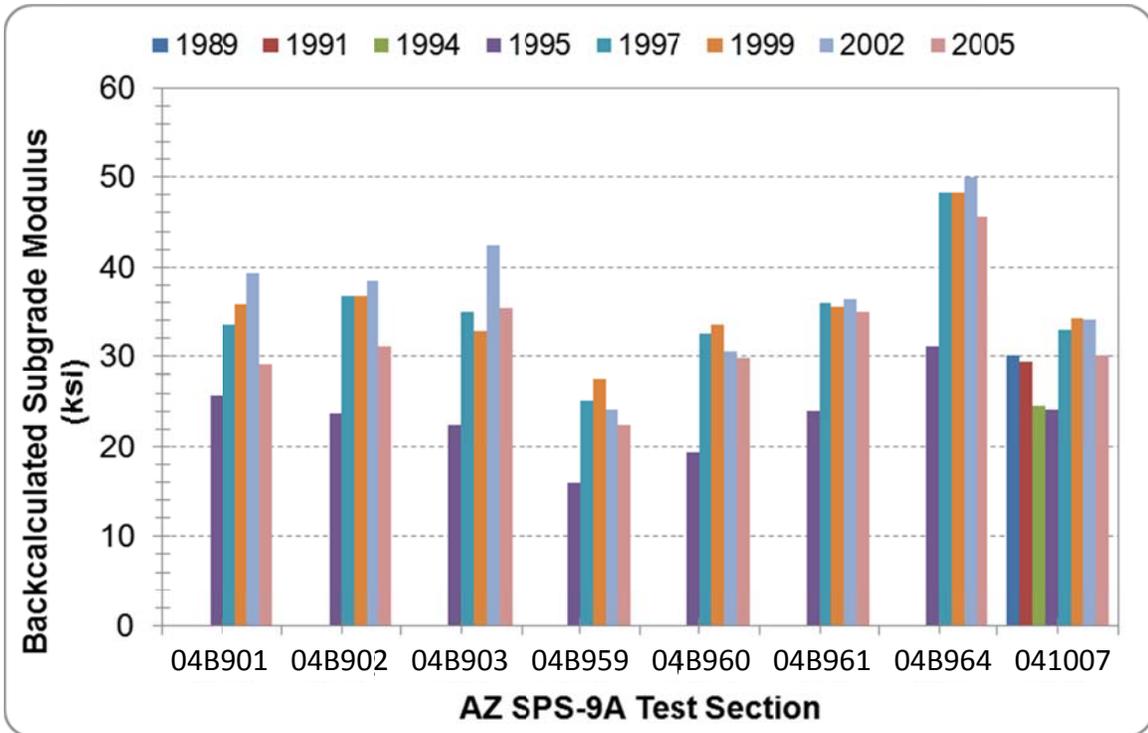
Figure 11. Backcalculated  $M_R$  by Test Section

Figure 11 shows the backcalculated subgrade modulus values. The variation in the Evercalc backcalculated subgrade modulus within each section is similar to the previous backcalculated subgrade modulus using the American Association of State Highway and Transportation Officials (AASHTO) procedure except Section 041007. In general, uniform subgrade modulus was observed at the test site during the test period. The average backcalculated subgrade modulus of all sections is 32 ksi. The highest coefficient of variation (COV) of the subgrade modulus was 21 percent in Section 04B903; the lowest COV was 14 percent in Section 041007.

- The trend of the Evercalc backcalculated subgrade moduli was similar to the trend observed in the subgrade moduli using the AASHTO procedure. In general, uniform subgrade modulus was observed at the test site during the test period. The average backcalculated subgrade modulus of all sections was 32 ksi. The COV of subgrade modulus within each test section ranged from 14 percent to 21 percent.

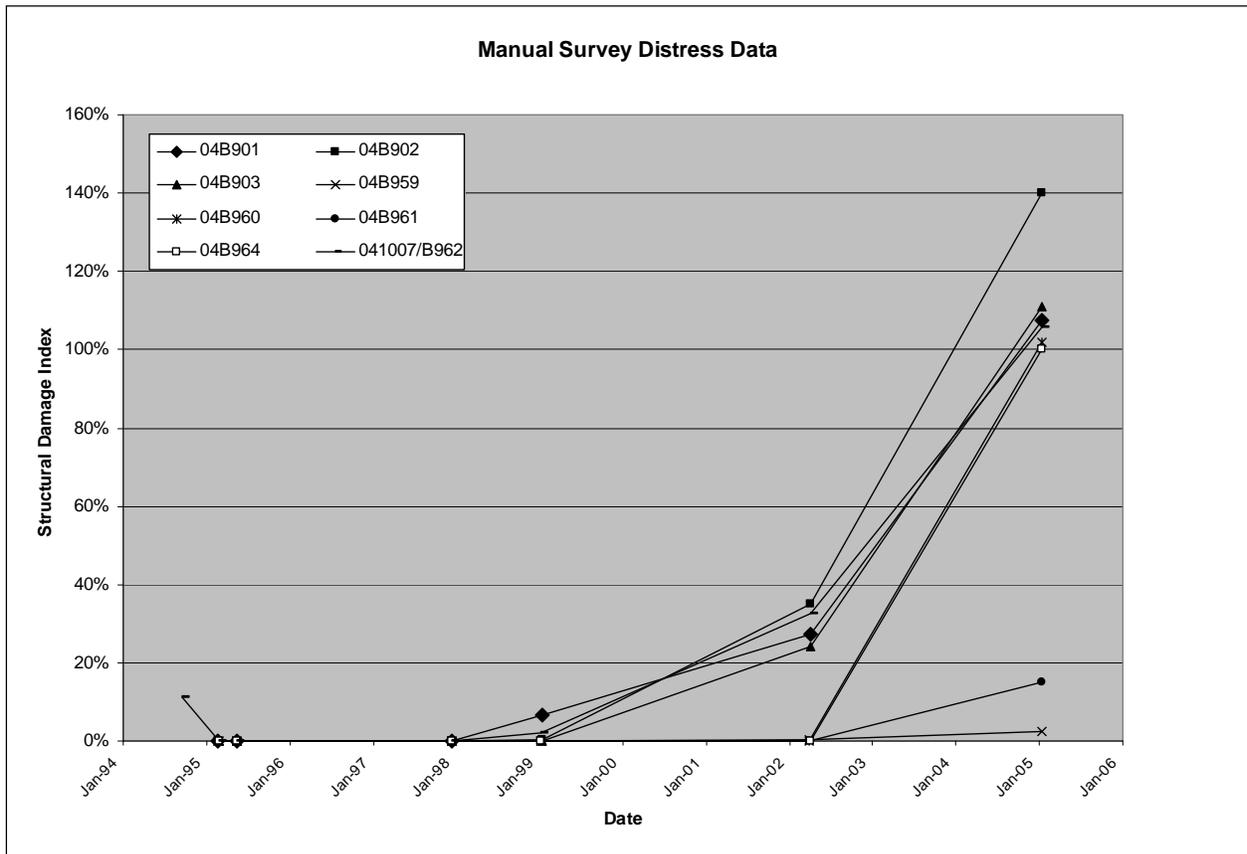
**Figure 12. Structural Damage Trends for SPS-9A Test Sections**

Figure 12 shows the structural damage trends for each section. The performance trends are relatively consistent and within the expected range of variation. All sections (except 04B959 and 04B961) showed a rapid accumulation of structurally related distresses approximately 10 years after construction.

The Marshall mix (Section 04B901) contained a smaller percentage of asphalt binder than the Superpave mixes (Sections 04B902 and 04B903). Higher asphalt binder contents typically produce better resistance to fatigue cracking; however, all three sections accumulated similar amounts of fatigue cracking. Compared to the rest of the SPS-9A project, Section 04B959 (SMA polymer with ACFC) and Section 04B961 (SMA cellulose) exhibited significantly smaller amounts of structural damage accumulation.

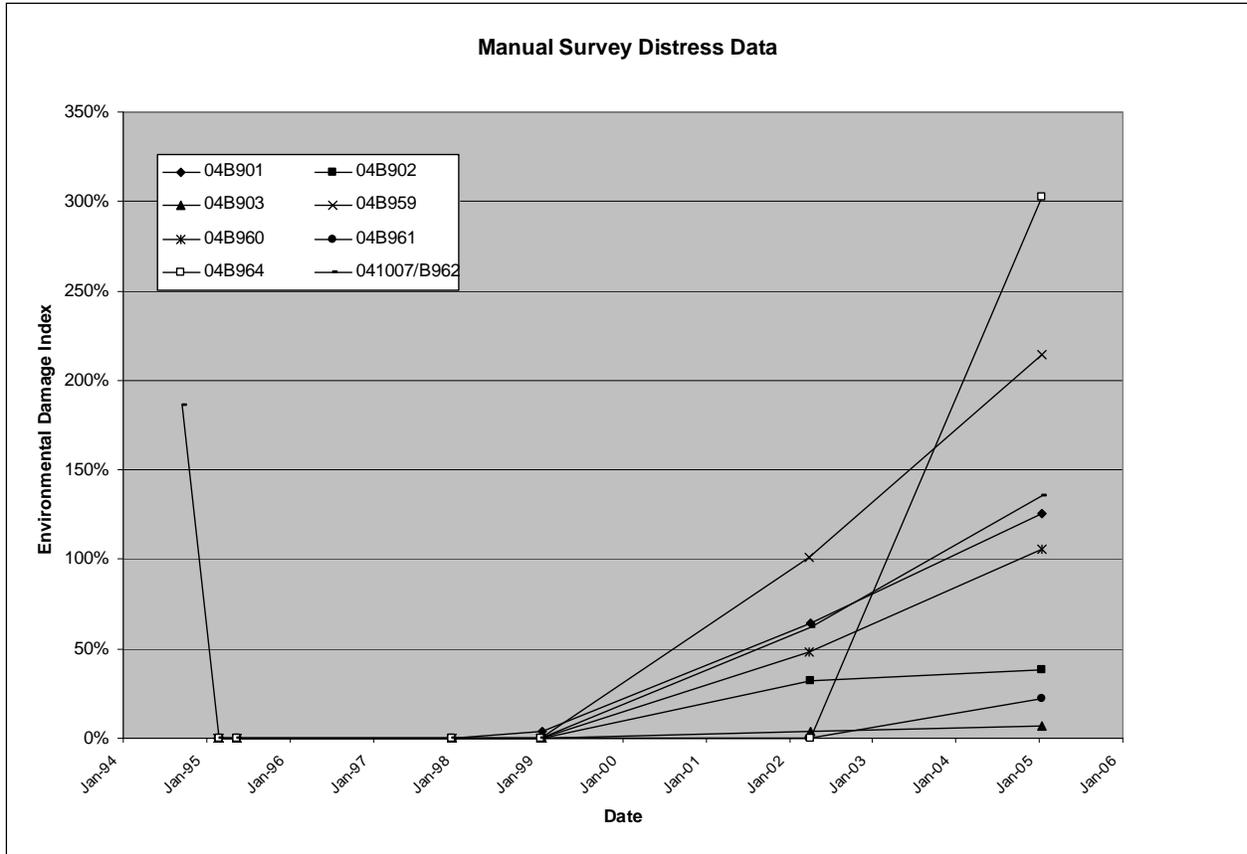
Figure 13. Environmental Damage Trends for SPS-9A Test Sections

Figure 13 shows the overall environmental damage trends for each section. The performance trends are relatively consistent and within the expected range of variation.

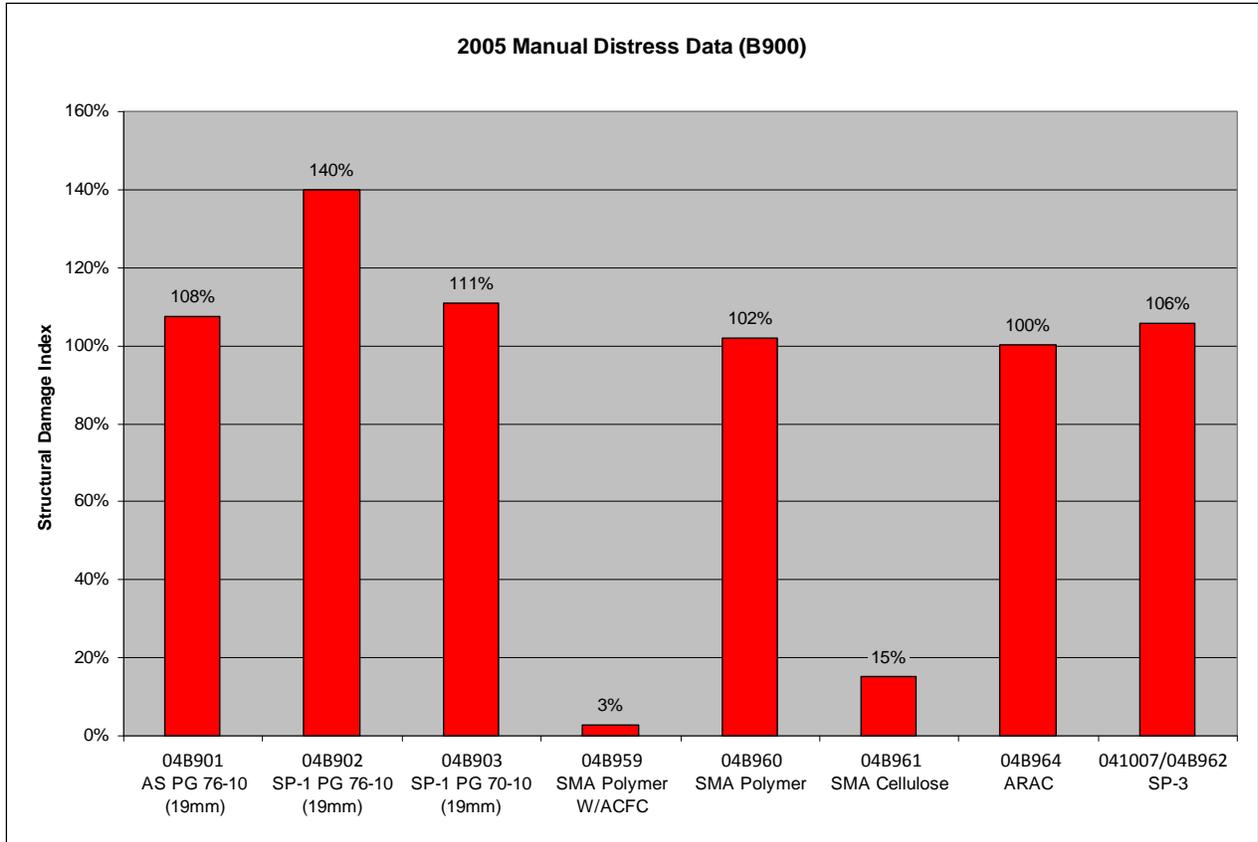
**Figure 14. Structural Damage Index and Pavement Structure Summary**

In-depth analyses and comparisons were conducted for all of the SPS-9A test sections. Figure 14 summarizes the structural damage index and pavement structure for each section; Figure 15 summarizes the environmental damage index and pavement structure. Both damage indices reported are based on the data collected in January 2005 (just before going out of study).

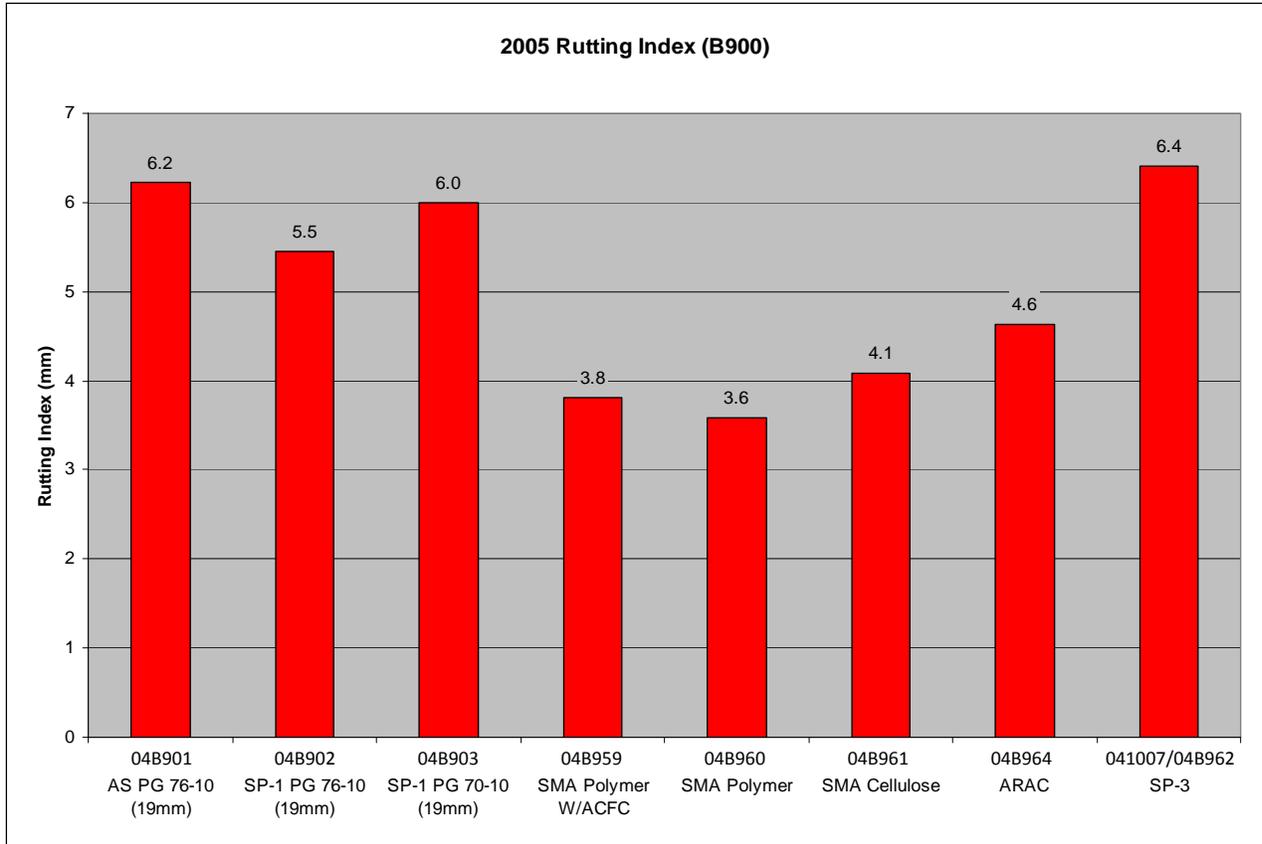
**Figure 16. Rutting Index and Pavement Structure Summary**

Figure 16 summarizes the rutting and pavement structure for each section. Significant variation in rutting performance between the sections did not exist. All sections exhibited less than 7 mm of rutting after over seven years in service, which is well below the level required to trigger improvements in most pavement management systems. Therefore, rutting was not the driving factor in the overall condition of the pavement.

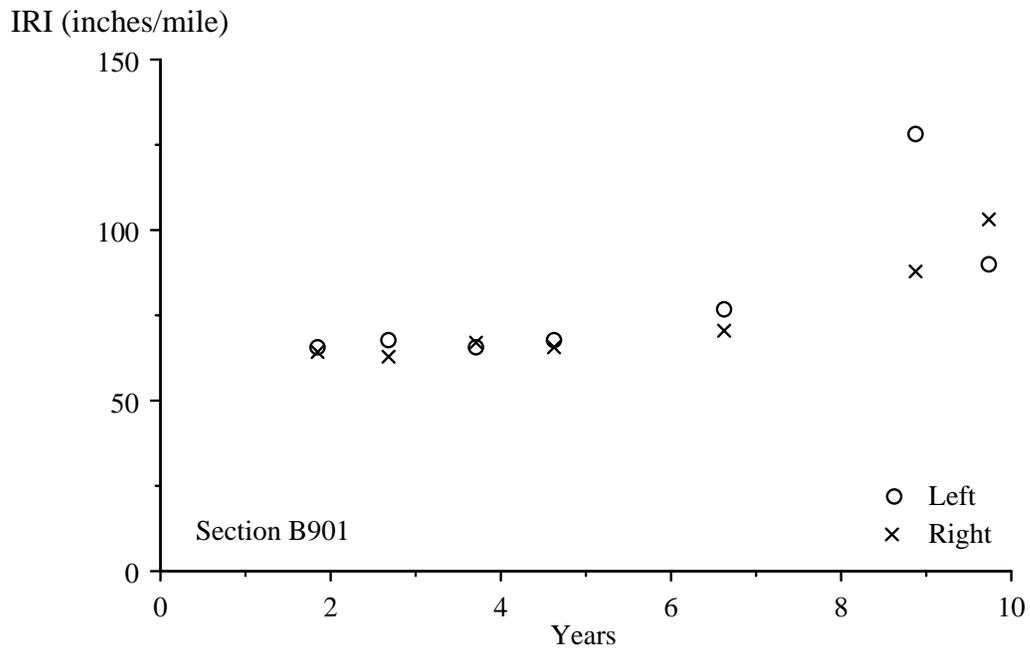
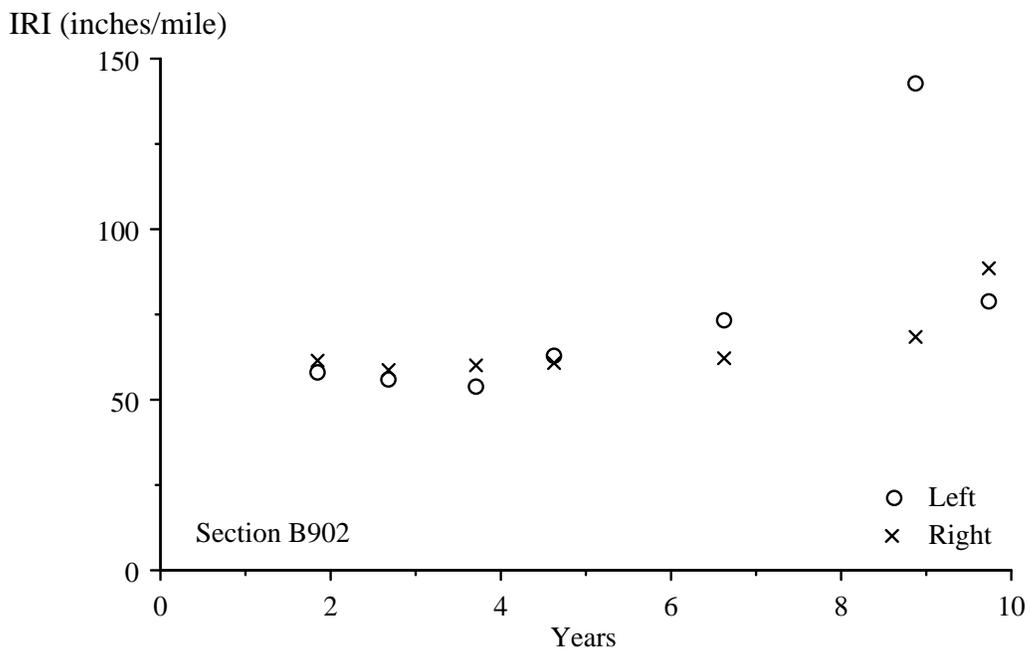
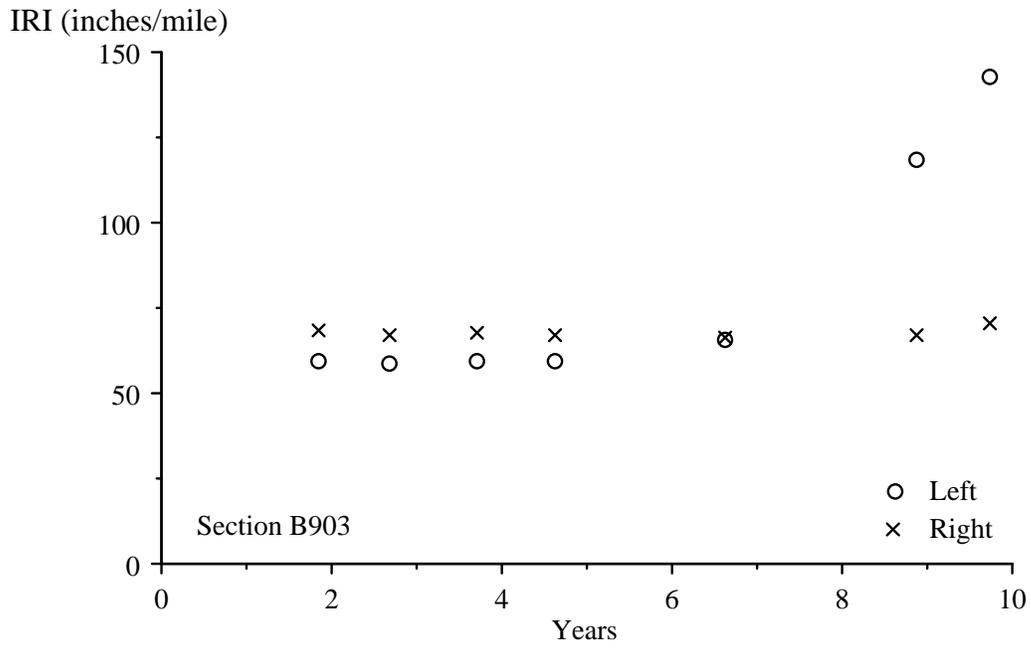
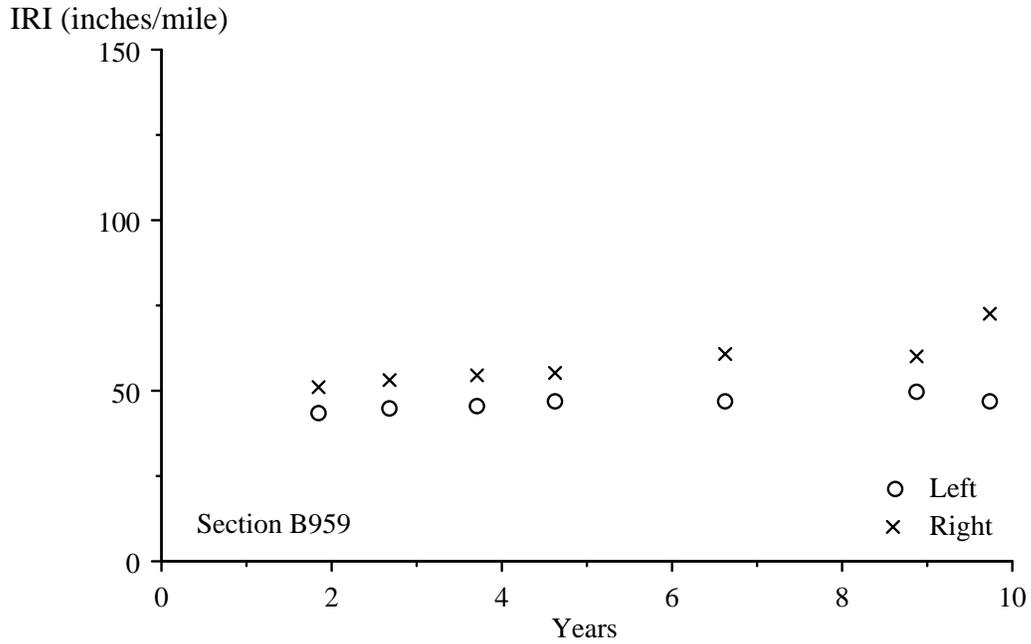
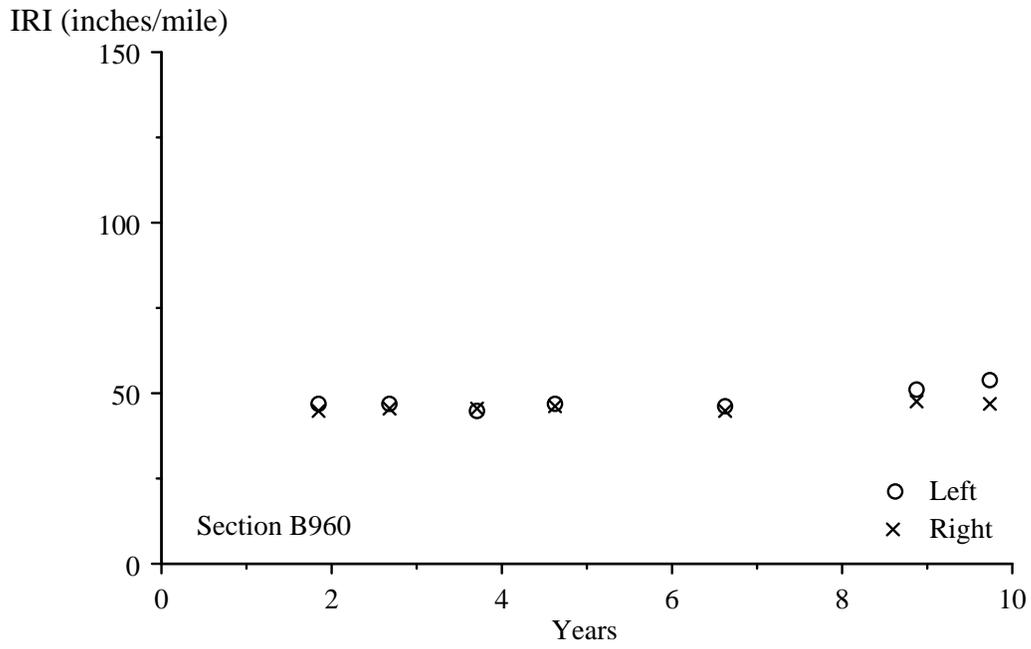
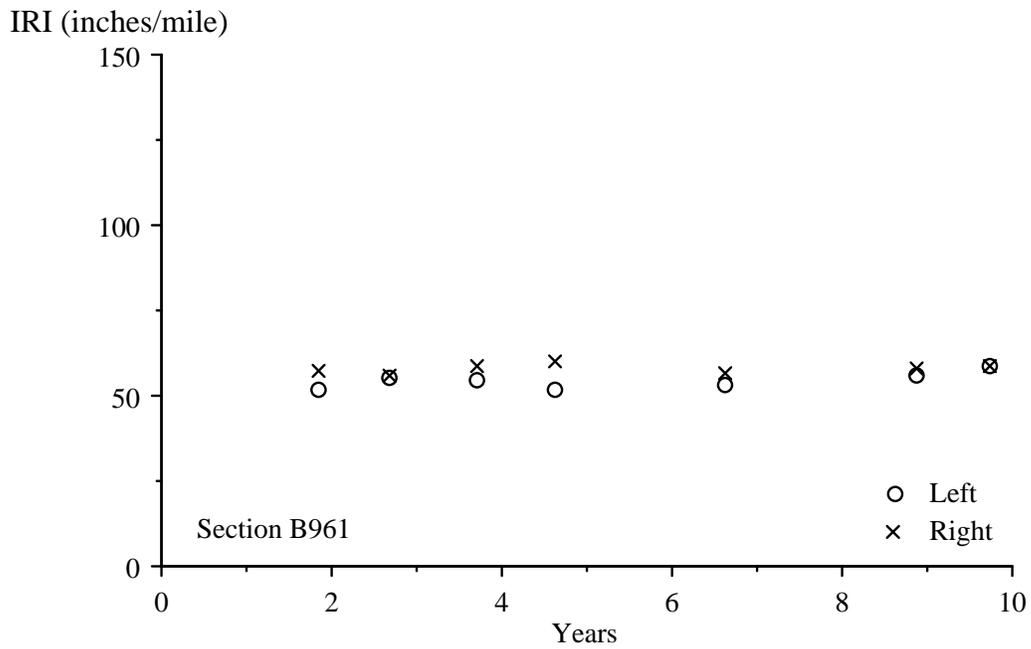
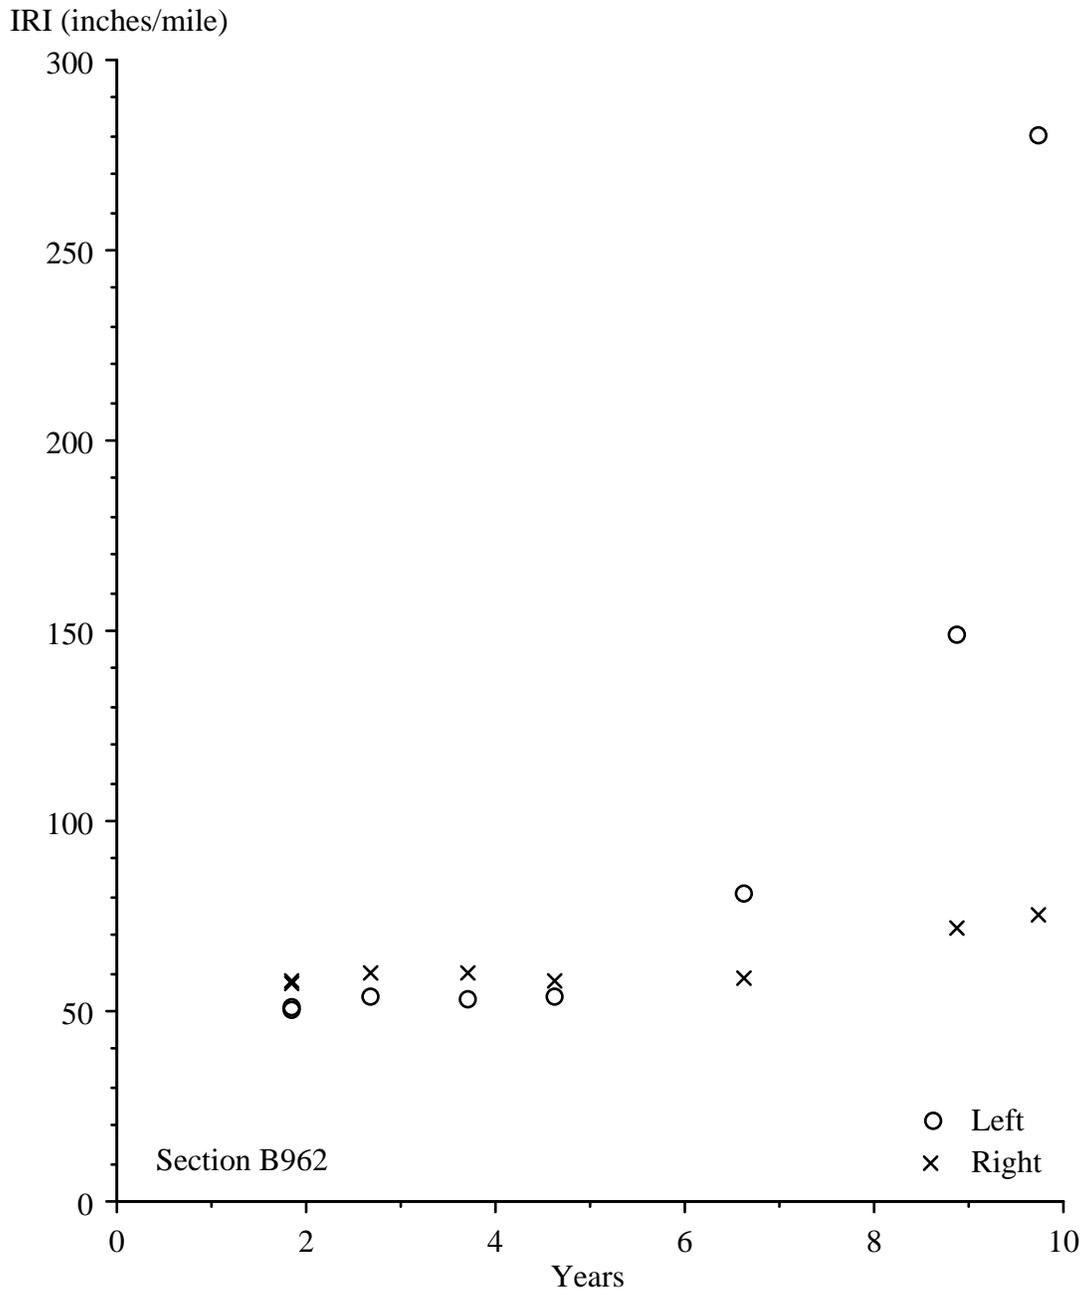
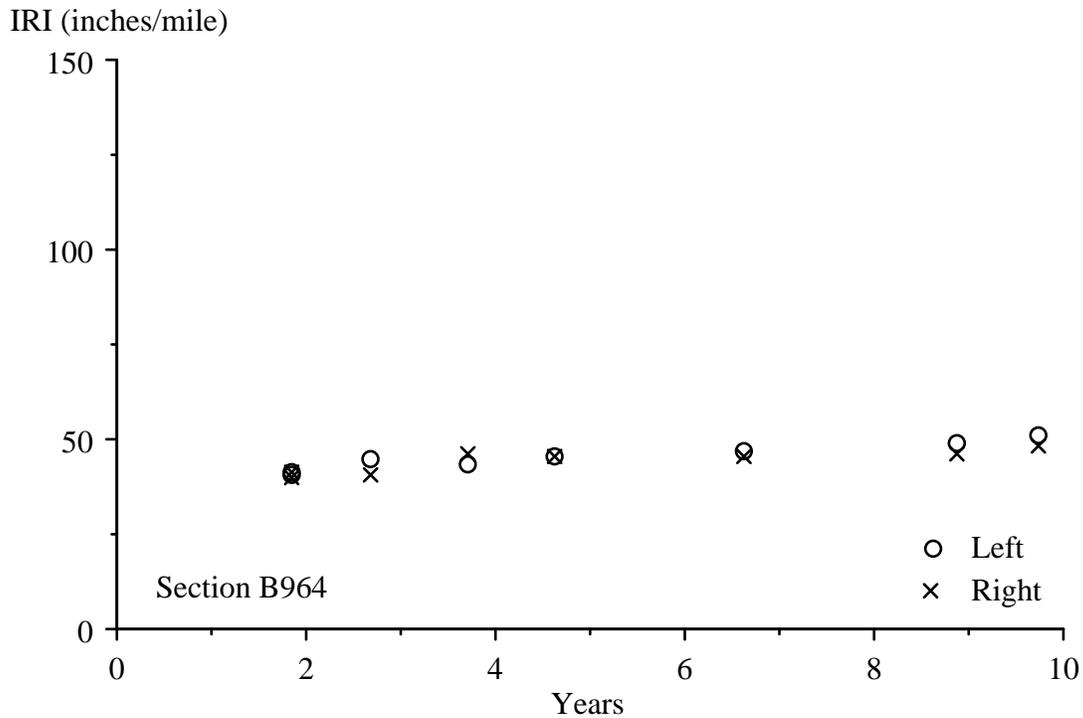
Figures 17 through 24 provide a snapshot of the roughness history of each pavement section. The remainder of this chapter characterizes the profile content that made up the roughness and explains the profile features that contributed to roughness progression.
