Performance Evaluation of Arizona's LTPP SPS-9 Project: Strategic Study of Flexible Pavement Mix Design Factors

SPR-396-9B
January 2016

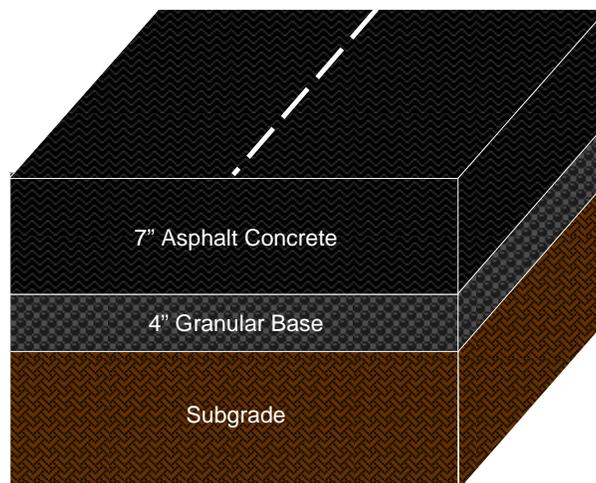
Figure 1. Structural Layers of SPS-9B (040900 and 04A900)

All five SPS-9B test sections had the same thickness design; each consisted of approximately 7 inches of asphalt concrete laid over 4 inches of granular base placed on top of subgrade. Figure 1 depicts a structural cross section of the sites as originally constructed.

Note: Layer thicknesses are approximate. Sites 040902 and 04A902 received a 0.5-inch slurry seal in 2002 (not shown).

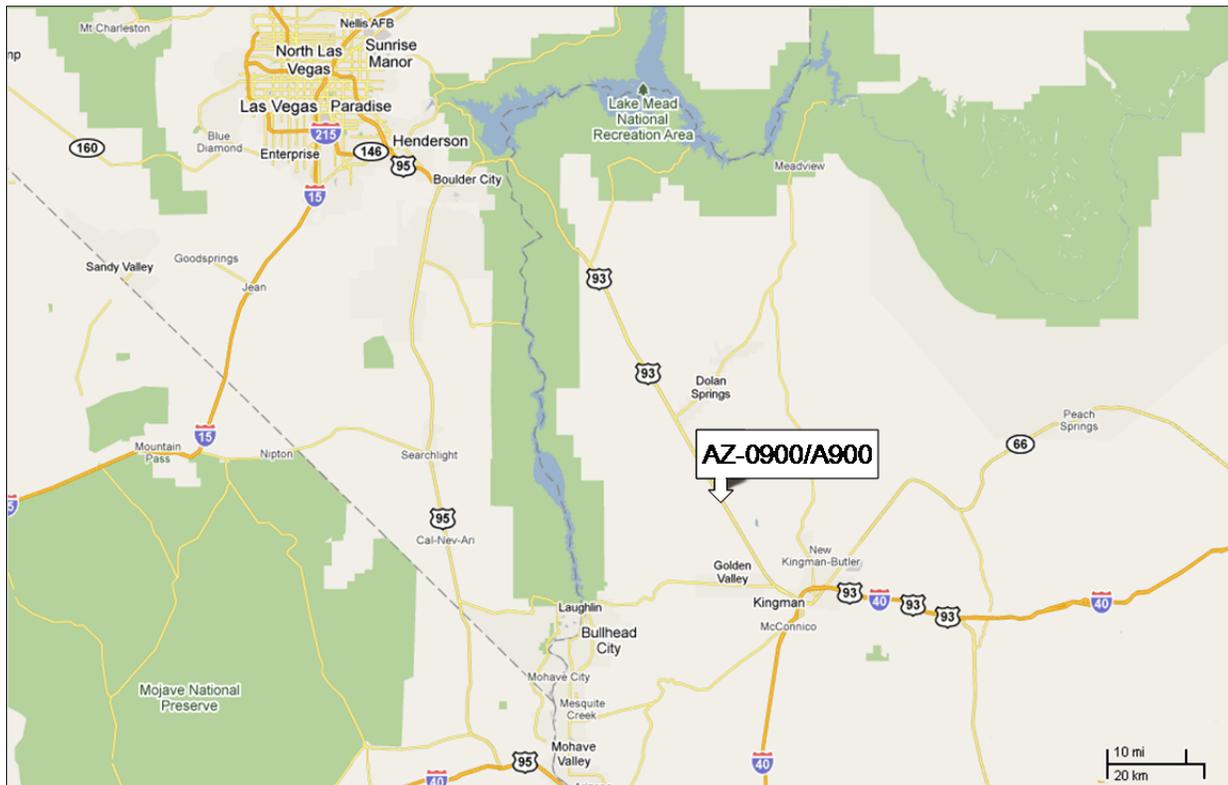
**Figure 2. Location of SPS-9B Test Sections 040900 and 04A900
(Courtesy of Google Maps)**

The test pavements were constructed on northbound U.S. Route 93 in Mohave County, Arizona, from November 1992 to August 1993. The site extends from milepost 53.23 to milepost 46.43, which is north of Kingman and south of the Nevada/Arizona border. The terrain surrounding the test section is slightly rolling, and the roadway is straight with grades reaching 3 percent in some areas. The soil is covered with various desert-type brush and small trees. Low foothills surround the test section in the distance. The approximate elevation of the test section is 3523 ft, with a latitude of 35° 23' and longitude of -114° 15'. The location and layout of the SPS-9B project are shown in Figures 2 through 4. The five SPS-9B test sections were constructed concurrently with the SPS-1 project. The performance of the SPS-1 project is discussed in a separate report (Puccinelli et al. 2012).

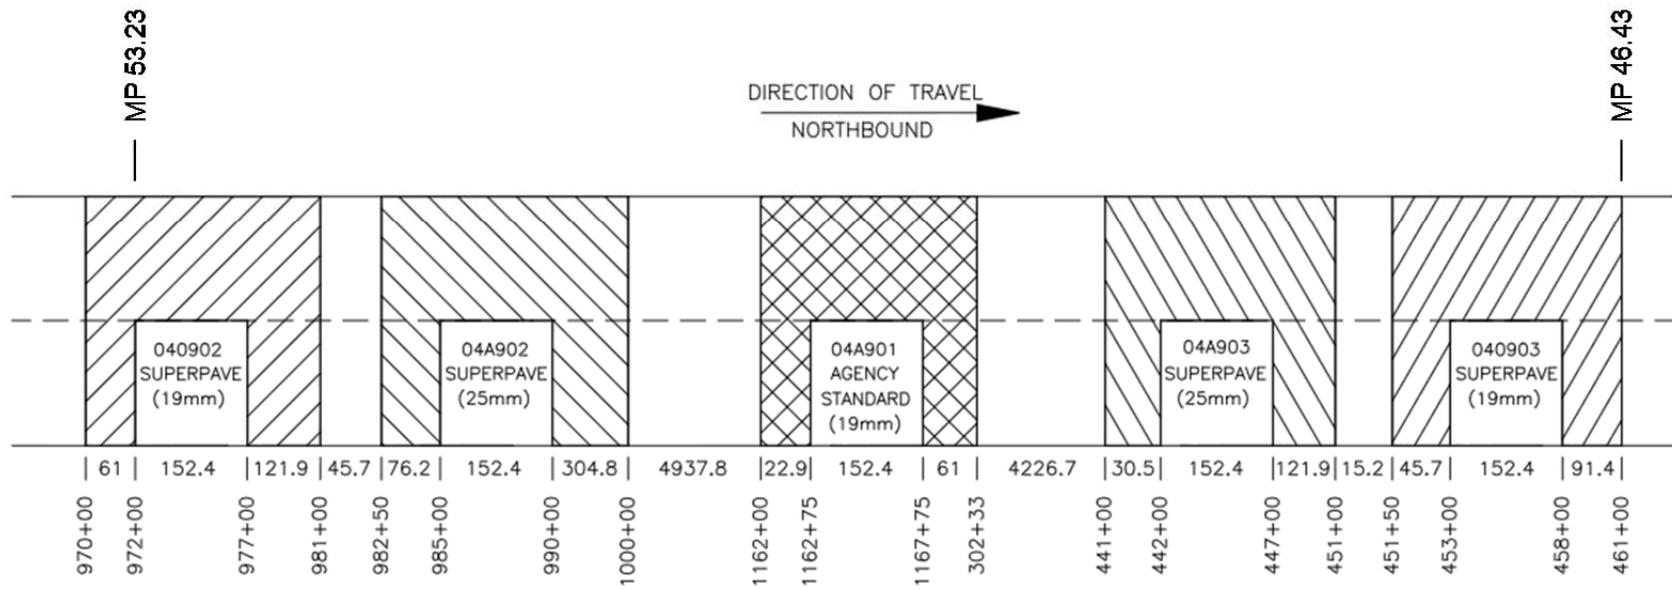
SPS-9 TEST SECTION LAYOUT
 040900 & 04A900
 KINGMAN, ARIZONA
 US-93 NORTHBOUND
 09/28/00

NOTES: STATIONS IN FEET (Per Plans)
 DISTANCES IN METERS

EQUATION 1167+93.75 Bk = 300+51.82 Ahd

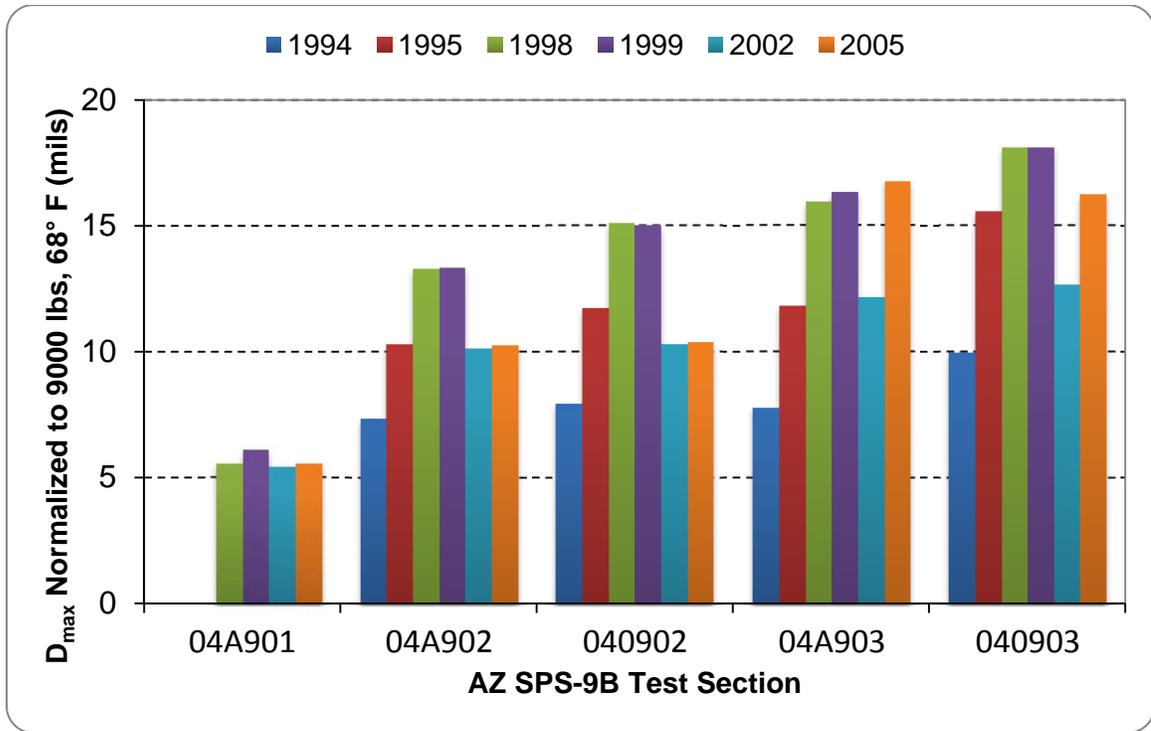
Figure 5. Average Normalized D_{max} by Test Section

The normalized average maximum deflection (D_0 , measured at the center of the FWD load plate, normalized to a load level of 9000 pounds and an AC mix temperature of 68° F) typically indicates the total stiffness of the pavement structure (surface and base) and the underlying subgrade. Increases in the normalized average maximum deflection (or D_{max}) observed over time may be due to weakening of the pavement structure, weakening of the subgrade, or both.

Figure 5 shows D_{max} results for each test section from the first round of testing to the last. Except for Section 04A901, the first round of testing for all sections was performed in February 1994. The first round of tests for section 04A901 was performed in January 1998. The last round of testing for all sections was performed in April 2005.

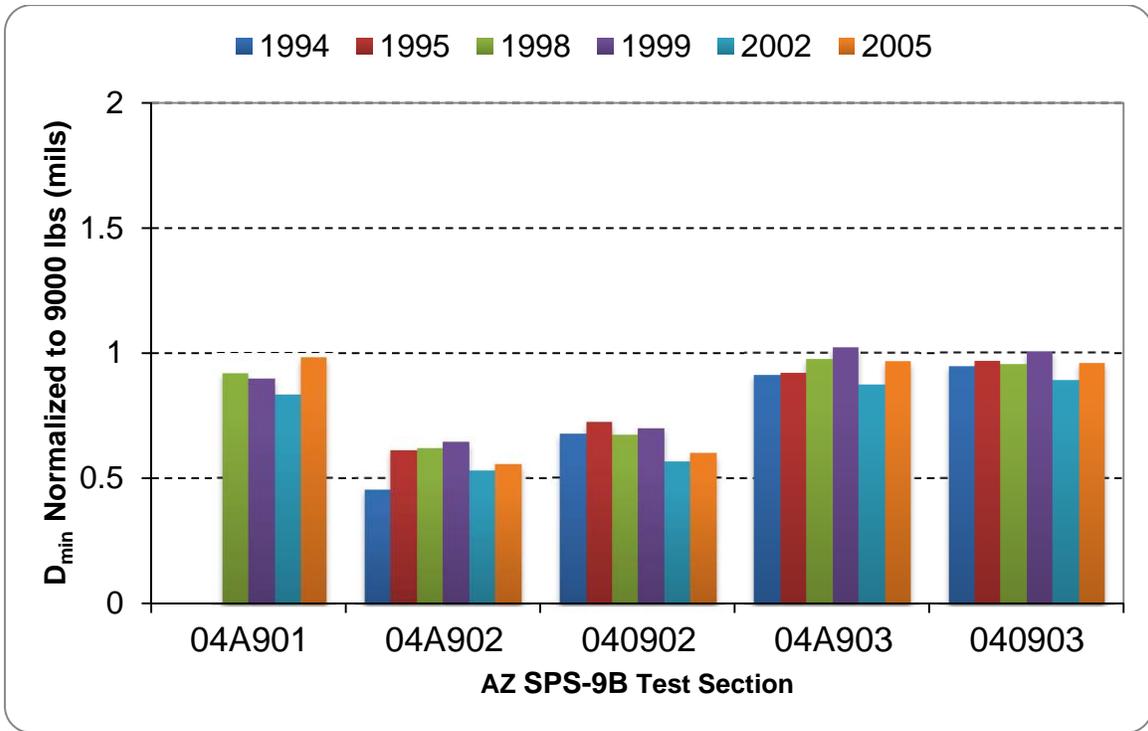
Figure 6. Average Normalized D_{min} by Test Section

The minimum deflection (D_{min}) is observed in the sensor farthest from the loading plate, which for LTPP can be either sensor No. 7 or sensor No. 8, depending on the configuration used. D_{min} readings are also normalized to a standard 9000 pounds, but no temperature correction factor is applied. D_{min} readings are indicative of the subgrade characteristics. Figure 6 shows the D_{min} measurement from the first round of testing to the last. Four rounds of testing were conducted on Section 04A901, and six rounds of testing were conducted on the remaining sections. Similar deflection responses were observed in Sections 04A901, 04A903, and 040903, where the deflection value was higher than that measured in Sections 04A902 and 040902. The average D_{min} in Sections 04A901, 04A903, and 040903 was about 0.9 mils, and the average D_{min} in Sections 04A902 and 040902 was about 0.6 mils.

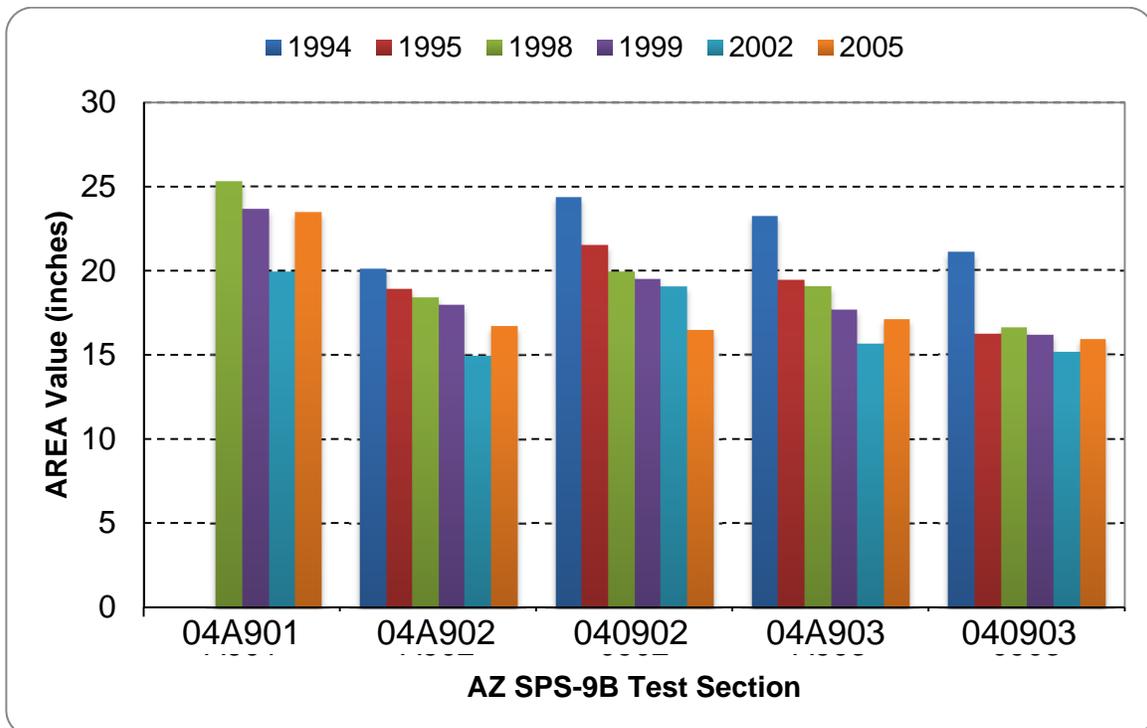
Figure 7. AREA Values by Test Section

Figure 7 shows the average AREA values for the SPS-9B test sections over the years. As expected, the overall trend in AREA value was a decrease over time. This is because the structure strength decreased as distresses developed in the pavement.

Sections 04A902 and 04A903 were both constructed using Superpave Level I mix with 25-mm nominal aggregate size, but the AREA values are larger in Section 04A903 than in Section 04A902. In addition, the minimum deflection in 04A902 is smaller than in 04A903. This implies that the subgrade is stronger in 04A902 than in 04A903. Thus, the structure strength above the subgrade in 04A902 is much weaker than in 04A903. By contrast, Section 040903 has generally lower AREA values than Section 040902, indicating that 040903 is a stronger pavement overall.

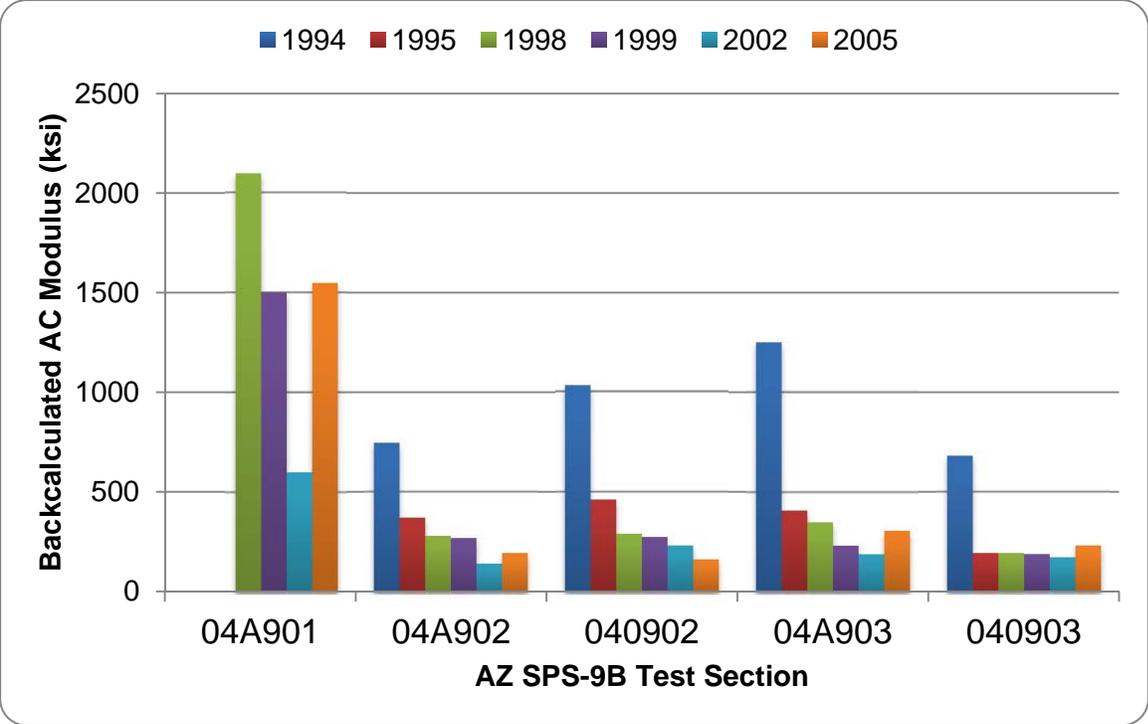
Figure 8. Backcalculated AC Modulus by Test Section (Evercalc Method)

Table 12 provides the statistics on the backcalculated moduli for the test sections. (The information in Table 12 is also shown graphically in Figures 8 and 9.) In general, backcalculated AC modulus decreased as pavement age increased, potentially caused by the progression of pavement distresses over time. Except in Section 04A901, there is a significant trend in AC moduli decreasing over time. In the case of 04A902, the AC moduli decreased after the first round of testing, and the values bounced back at the last round of testing. The values also bounced back in Section 040902, but in the second to last round of testing. The resulting trend coincides with other parameters discussed in the previous section. A similar decreasing trend can also be observed in the subgrade moduli among all the test sections. This type of decreasing trend in subgrade modulus did not occur using the AASHTO backcalculation procedure, which showed uniform subgrade modulus over time. The discrepancy could be caused by the assumption used in the Evercalc analysis, which combines the base and subgrade layers into one layer. If the subgrade fines penetrate into the base layer, the base modulus will weaken with time, and thus the combined subgrade (subgrade and base) modulus will decrease. In general, Sections 04A901, 04A902,

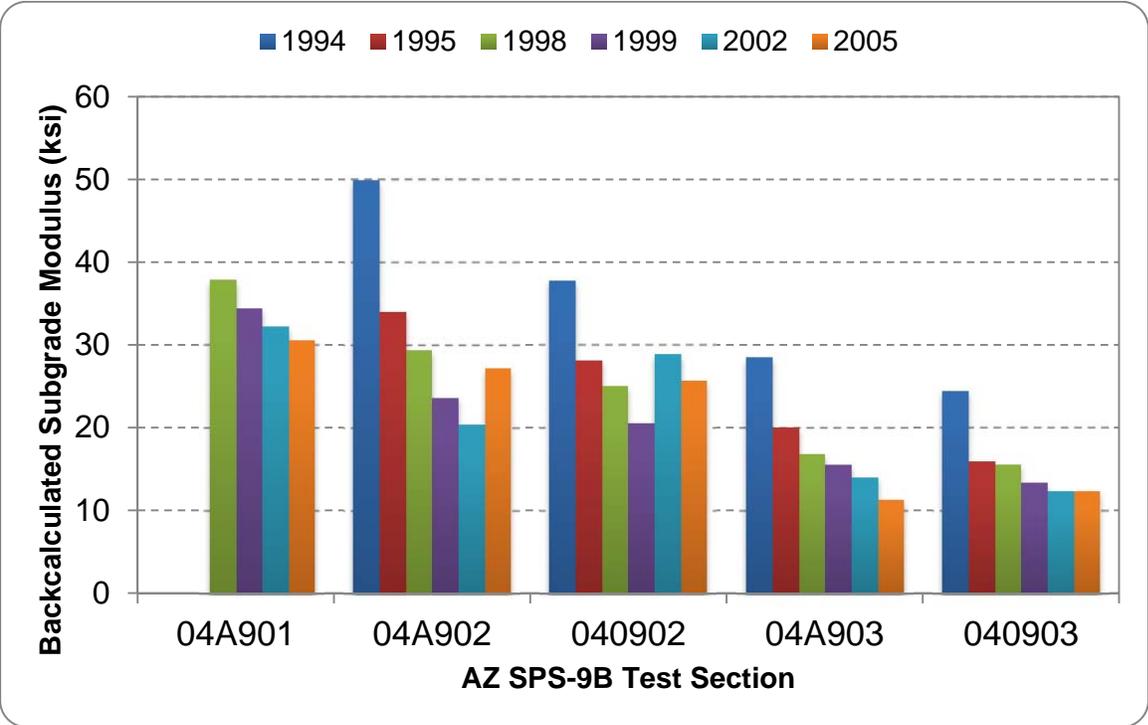
Figure 9. Backcalculated Subgrade Resilient Modulus by Test Section (Evercalc Method)

A clear declining trend in the average subgrade resilient modulus can be observed in Sections 04A901, 04A902, and 04A903 between the first round of testing and the last. There was little or no change in Sections 040902 and 040903. The decline in subgrade modulus could be due to a gradual increase and leveling off of the subgrade moisture content after construction.

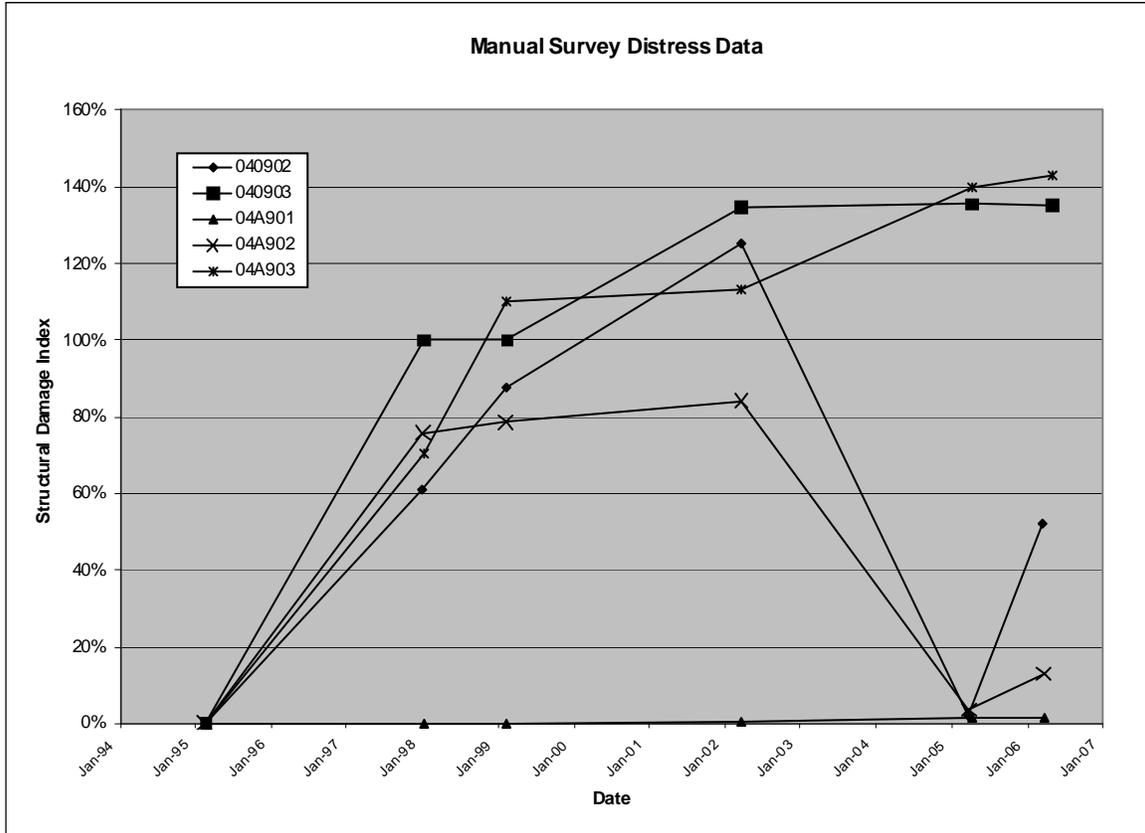
Figure 10. Structural Damage Trends for SPS-9B Test Sections

Figure 10 shows the structural damage trends for each section, and Figure 11 shows the environmental damage trends. The performance trends are relatively consistent and within the expected range of variation. The drop in structural damage after May 2002 for Sections 040902 and 04A902 indicates that the slurry seal masked the underlying deterioration. The drop in environmental damage in 2006 was due to fatigue cracking spreading to non-wheelpath areas that were previously rated as longitudinal and transverse cracking.

The Superpave sections contained a higher percentage of asphalt cement, which typically produces higher resistance to fatigue cracking. However, all Superpave sections showed a rapid accumulation of structurally related damage at early stages of the pavement life, approximately three years after construction. The accumulation typically slowed in later years.

Compared with the rest of the SPS-9B project, Section 04A901 exhibited significantly smaller amounts of structural and environmental damage accumulation, as shown in Figures 10 and 11. The pavement structure for Section 04A901 used the standard agency mix, which was used over a larger area extending beyond the test section limits.

In 2002, a slurry seal was applied to Sections 040902 and 04A902. As shown in Figure 10, the slurry seal did improve the surface characteristics of the road. It appears to have had a significant effect on Section 04A902, based on a comparison of the structural distress three years after initial construction with the distress three years after the slurry seal. However, the data may be misleading because the sections experienced significantly decreased traffic loads after 2001 due to increased security over the Hoover Dam (see Table 8). Accounting for the reduced traffic loads, Section 040902 actually experienced nearly the same amount of structural damage three years after the slurry seal as it had three years after initial construction. This is most likely due to reflective cracking from prior damage. Though the slurry seal improved the road surface, the seal was applied after cracking was present, which was too late to be effective as a preventive maintenance treatment. The purpose of such an application is to slow crack initiation by reducing oxidation and weathering. Oxidation of the asphalt binder increases the brittleness of the binder and promotes raveling and cracking. Slurry seals do not increase the structural capacity of the pavement and are not thick enough to prevent existing cracks from reflecting through the treatment. If cracks are present in the existing pavement, a slurry seal will quickly reflect this cracking, thereby diminishing the expected resistance to oxidation and weathering.

Timing of surface applications is critical to the effectiveness of the treatments. Figure 10 shows that all Superpave sections already had a significant amount of cracking in 1998. Applying the slurry seal when there is not much cracking and the cracks are low in severity may result in slower deterioration and improved effectiveness of the treatment.

As previously mentioned, Sections 040902 and 040903 are replicate sections; however, 040902 received a slurry seal treatment in 2002. Figures 10 and 11 show a noticeable difference in the performance trends of these replicates. Section 040902 has significantly less structural damage than Section 040903, but it also has significantly more environmental damage. The slurry seal treatment and the subjective nature of distress surveys most likely account for this discrepancy. Prior to receiving the slurry seal in 2002, Section 040902 had high-severity fatigue cracking throughout the entire section. When the slurry seal was applied, it masked the distress. In 2006, there was a significant amount of longitudinal cracking along the border of the inner wheelpath, which was most likely the beginning stages of fatigue cracking (structural distress) reflecting through the pavement. However, the longitudinal cracking was located

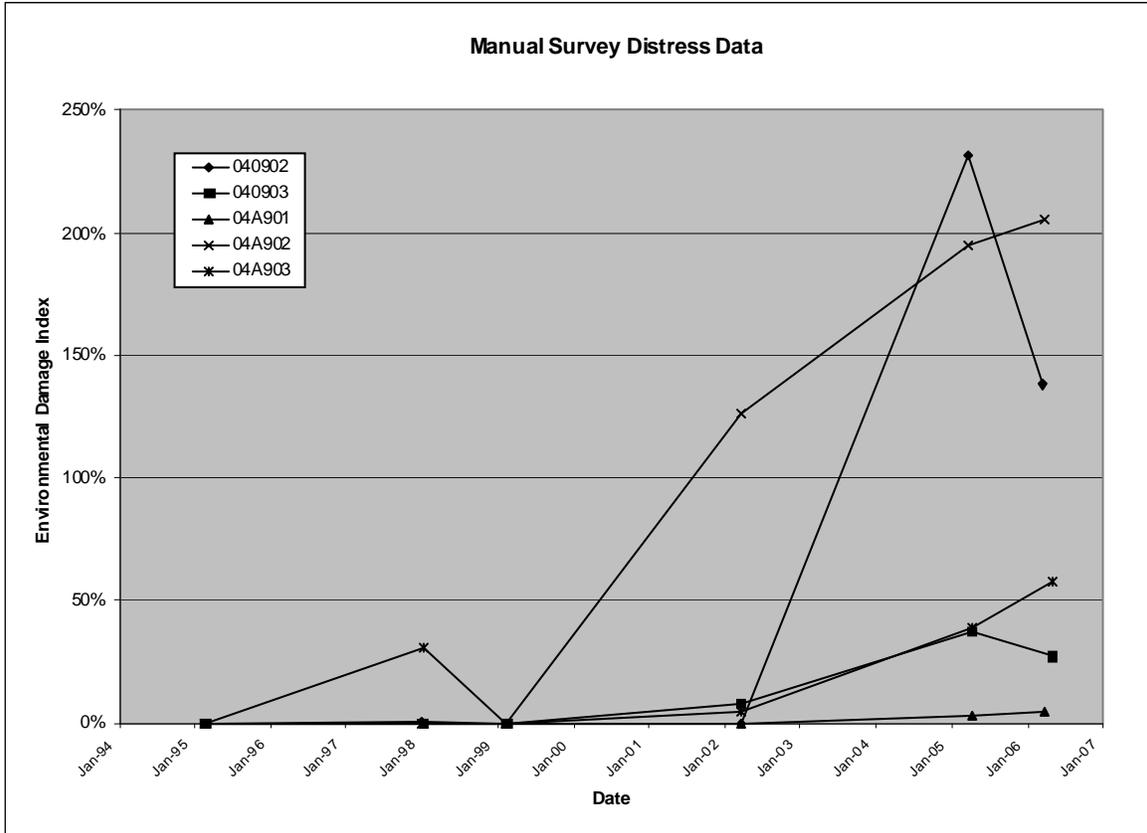
Figure 11. Environmental Damage Trends for SPS-9B Test Sections

As noted above, the performance trends for environmental damage are relatively consistent and within the expected range of variation (see Figure 11). Section 04A902 experienced the most environmental damage. The slurry seal applied in 2002 did not appear to have a significant impact on the performance of the Superpave sections (04A902 and 040902). Although slight decreases were somewhat discernible for surveys within a year of the slurry seal, environmental distresses clearly increased in magnitude approximately three years after the slurry seal was applied. There is no clear indication that the slurry seal provided any abatement in environmental distress.

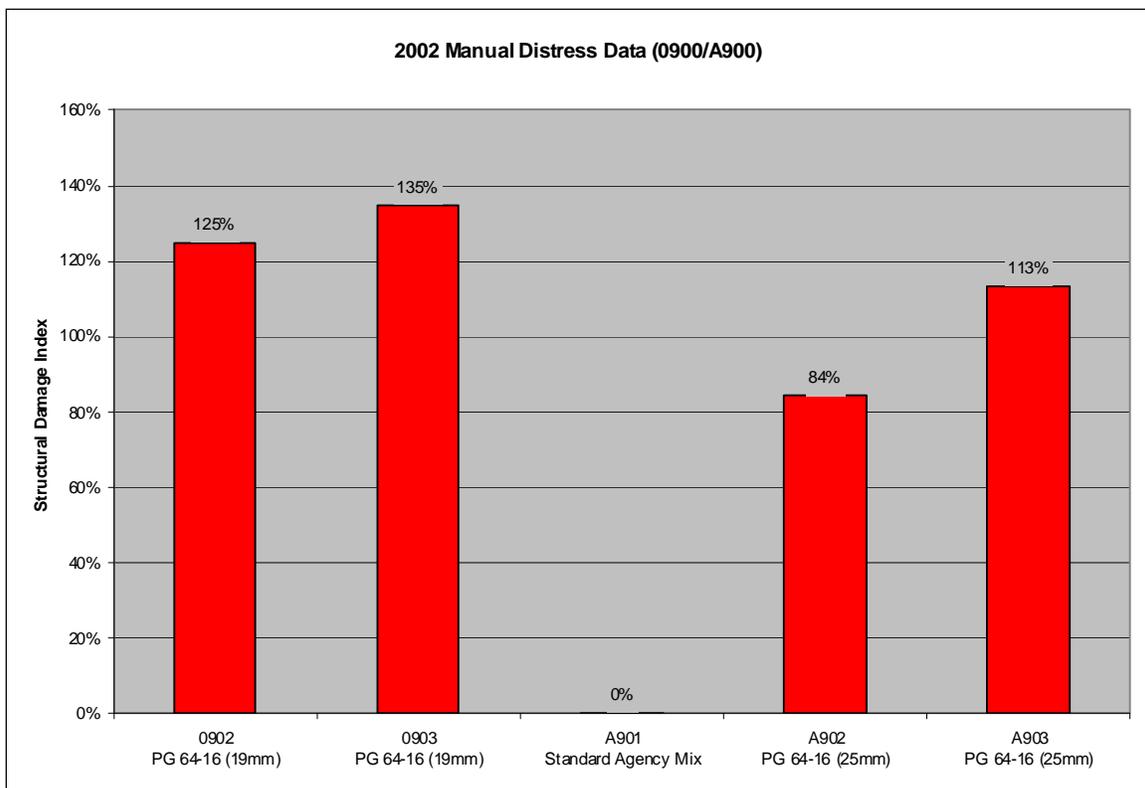
Figure 12. Structural Damage Index Summary

The researchers conducted in-depth analyses and comparisons of all the SPS-9B test sections. Figure 12 summarizes the structural damage index and pavement structure for each section; Figure 13 summarizes the environmental damage index and pavement structure. Both damage indices are based on the data collected in March and April 2002 (before slurry seal application).

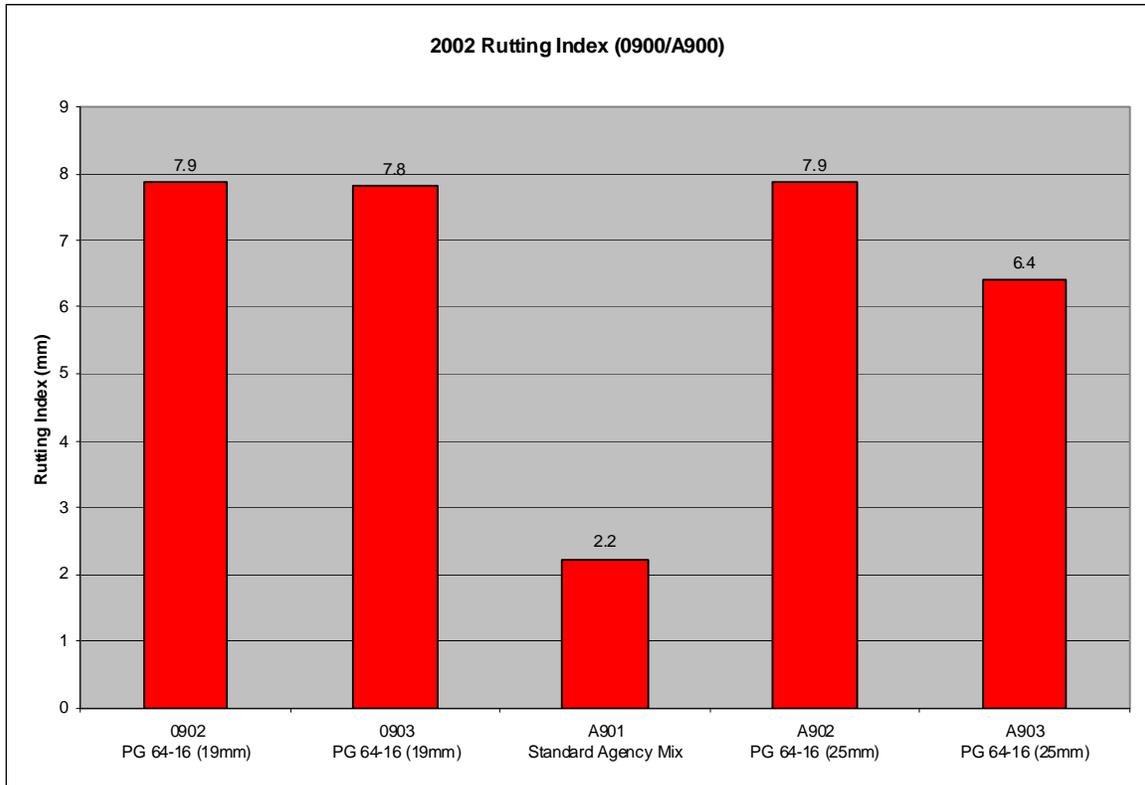
Figure 14. Rutting Index Summary

Figure 14 summarizes the amount of rutting in each section as of March or April 2002. The Superpave sections experienced higher amounts of rutting than the agency mix section (04A901). Comparing the performance of the Superpave mixes, Sections 04A902 and 04A903 (25-mm gradation) performed slightly better than Sections 040902 and 040903 (19-mm gradation). However, all sections exhibited less than 9 mm of rutting after over seven years in service, which is well below the level required to trigger improvements in most pavement management systems. Therefore, rutting was not the driving factor in the overall condition of the pavement.

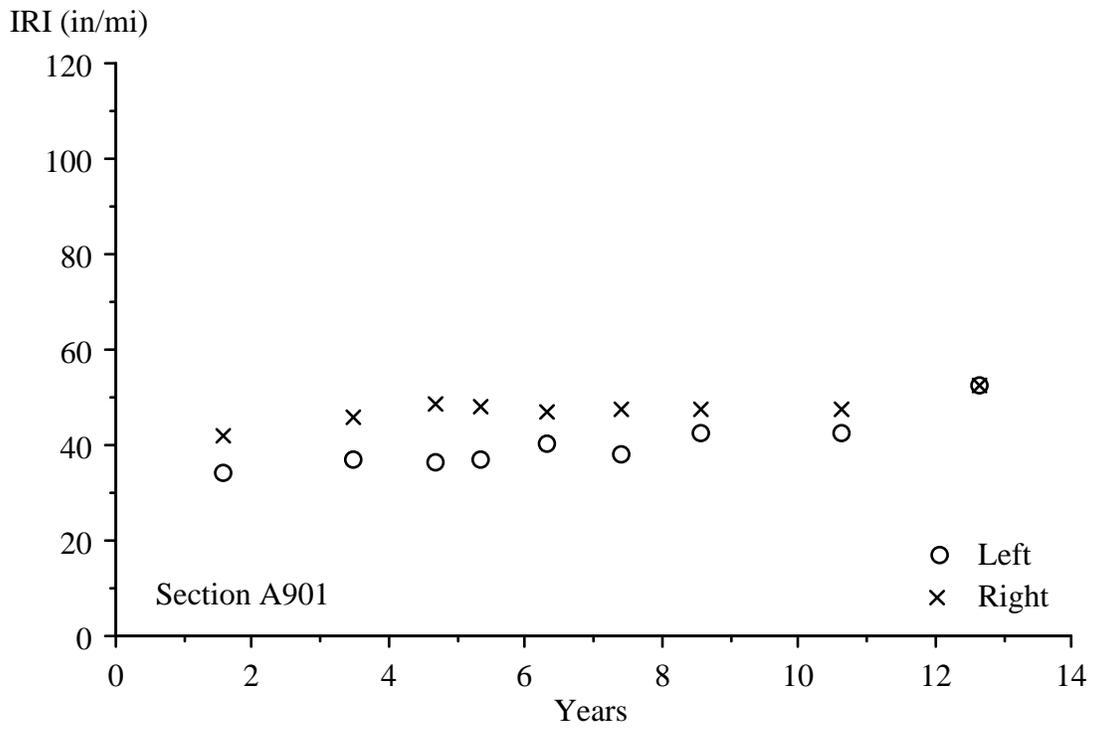
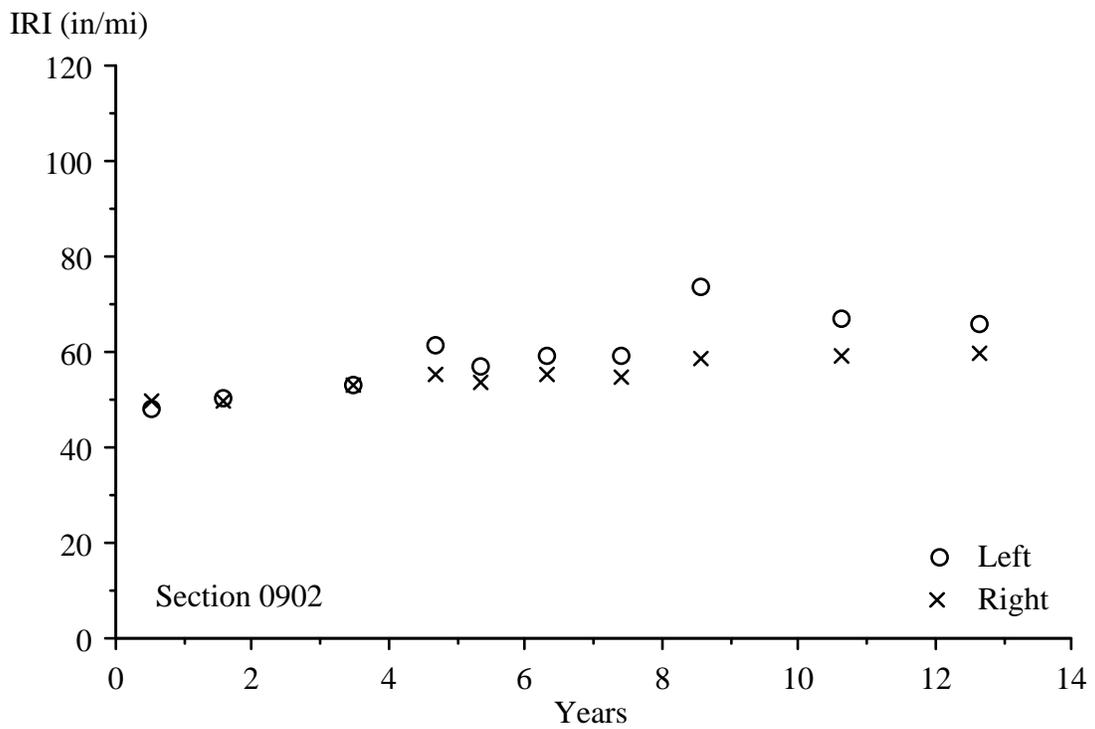
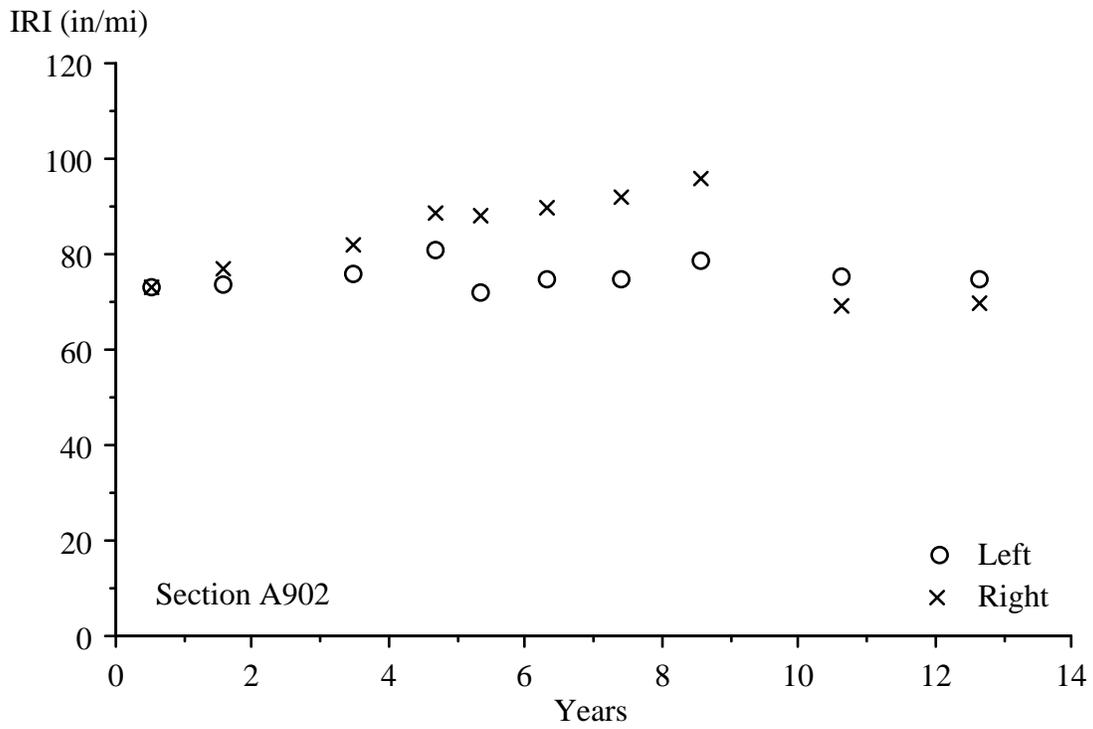
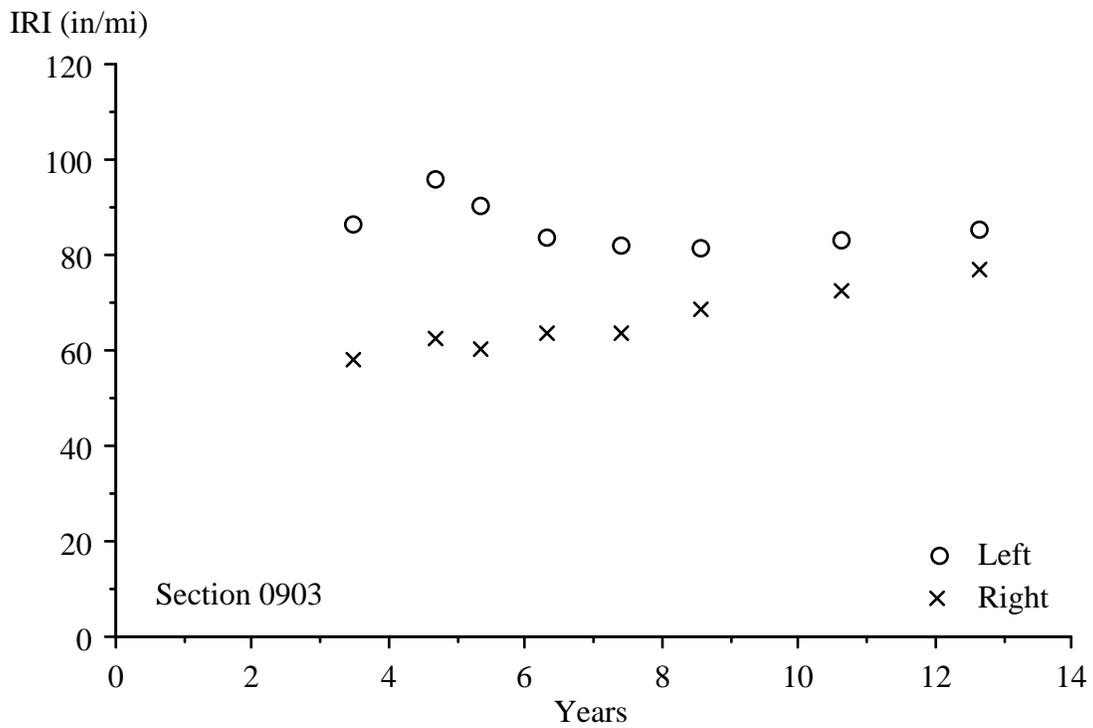
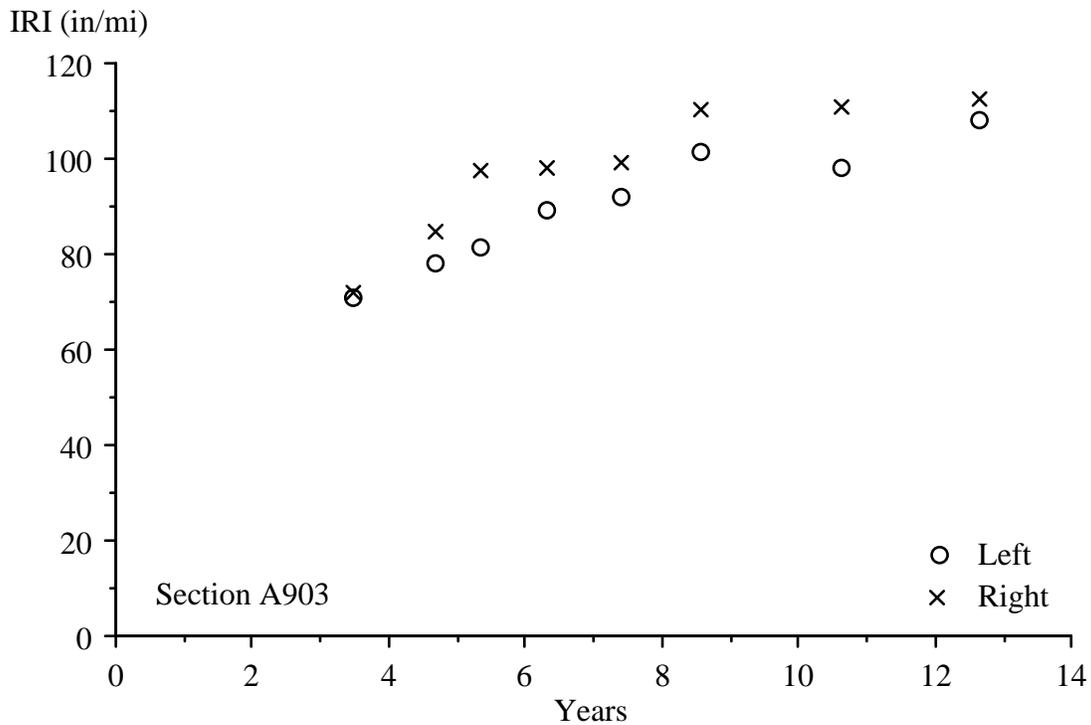
Figures 15 through 19 provide a snapshot of the roughness history of each pavement section. The remainder of this chapter characterizes the profile content that made up the roughness and explains the profile features that contributed to roughness progression.

The summaries below provide the most important observations made about each test section. To help provide context for these summary statements, Figure 23 shows the range of left and right IRI for each section. Note that the highest IRI value for some of the sections did not occur in the final visit. (See the appendix or Figures 15 through 19.)

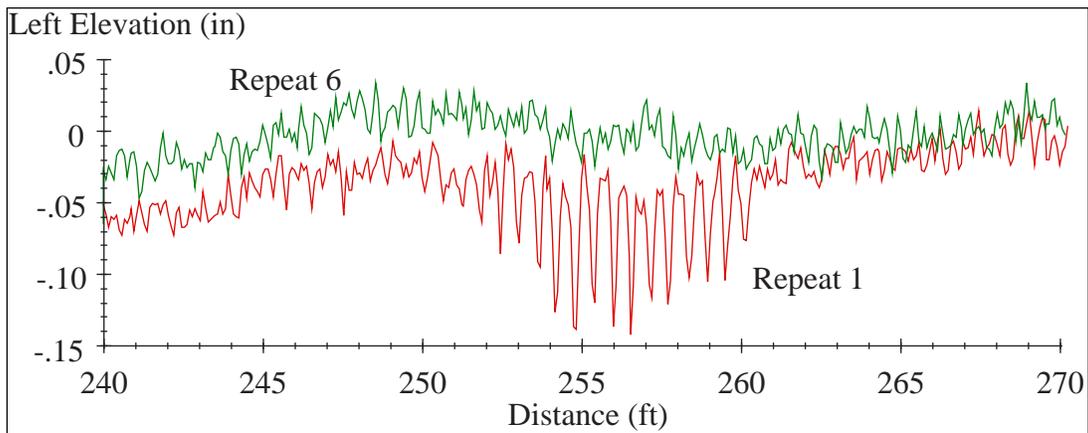
Figure 20. Periodic Chatter in Elevation Profiles from Section 04A901, Left Side

The unfiltered elevation profile plots included two areas with strong periodic chatter about 250 to 280 ft and 440 to 465 ft from the start of the section in some repeat measurements from all visits. The chatter usually appeared as a series of narrow dips about 0.1 inch deep and 0.7 ft apart. (In many areas, the chatter approximated a sinusoid.) In visits 04 and 11, many of the repeat measurements included the chatter in the locations above, as well as most of the first half of the section. Figure 20 shows an example of the chatter (and its hit-or-miss nature) from visit 04.

The chatter in the profile corresponds to a narrow scuff that runs along the left wheelpath over most of the section and runs off to the edge near the end. It is present in the photos and appears as a long series of indents about a third of the width of the lane edge stripe. (See Figure 21.)

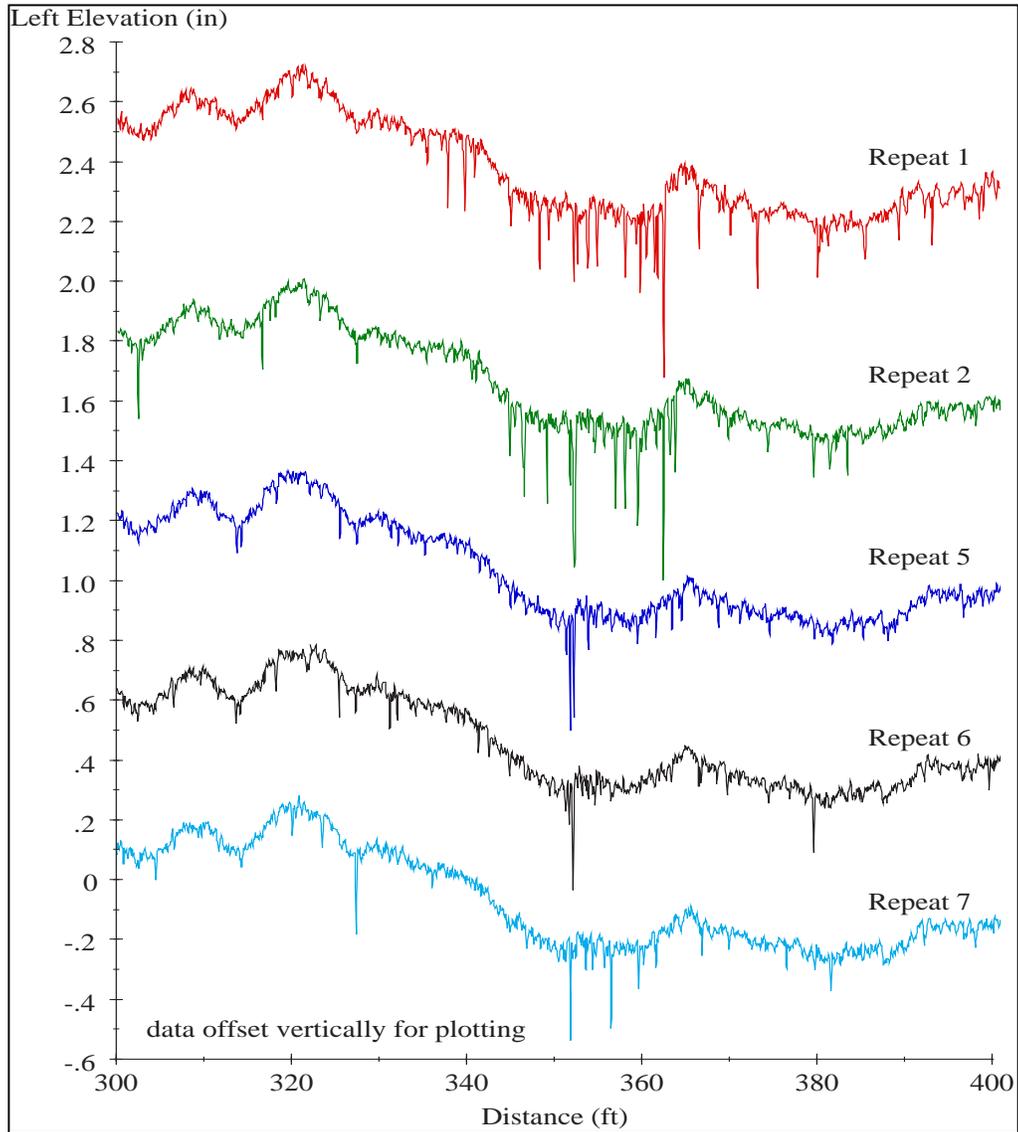
Figure 22. Narrow Downward Spikes in Elevation Profile, Section 040903, Visit 13

Profiles were fairly consistent across visits 03 through 05. Profile plots in the long-, medium-, and short-wavelength ranges were very consistent in visits 06 through 13. However, profiles from visits 11 and 13 included narrow downward spikes up to 0.5 inches deep that appeared throughout the section. The spikes often appeared in the same location in more than one of the repeat measurements. Fewer spikes appeared in the left side profiles than on the right, and the spikes that did appear often occurred in more than one repeat measurement. Figure 22 shows the density and shape of the spikes over 100 ft of the section in visit 13. In some locations, the spikes appear in only one repeat measurement of the five, but in others the spikes appear in multiple repeats.
