SURFACE FRICTION STUDY OF ARIZONA HIGHWAYS
FINAL REPORT

1. Report No. Report No. 3	2. Government Accession No.	3. Recipient's Catalog No.	
4. Title and Subtitle SURFACE FRICTION STUDY OF ARIZONA HIGHWAYS		5. Report Date July 1972

6. Performing Organization Code	
7. Author(s) John C. Burns Rowan J. Peters		8. Performing Organization Report No.	
9. Performing Organization Name and Address Materials Division (Research) 1745 West Madison Phoenix, Arizona 85007		10. Work Unit No.

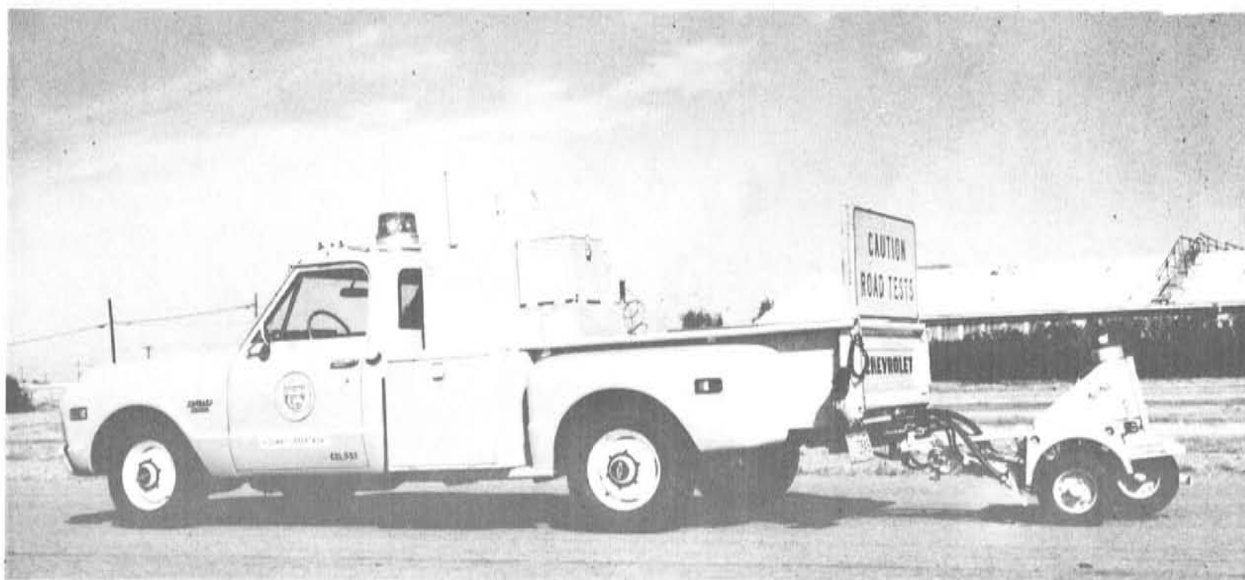
Figure 7

COMPLETE SURFACE FRICTION TEST UNIT

The towing vehicle, which has now become a part of the skid test unit, is a one-ton truck which carries a 300 gallon water supply and all of the support equipment (Figure 7).

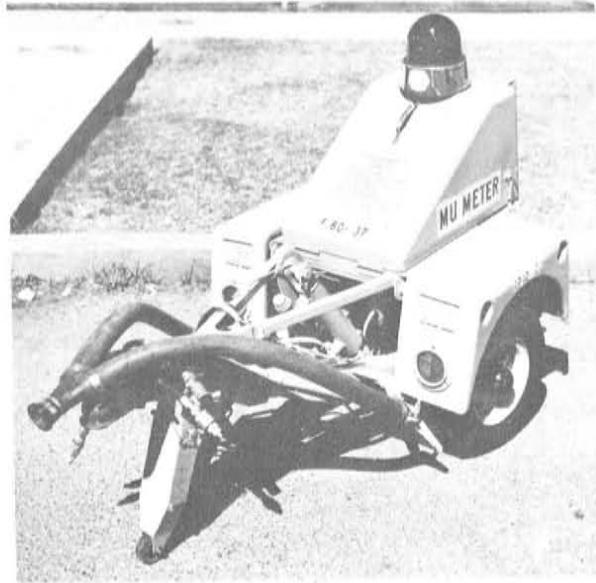
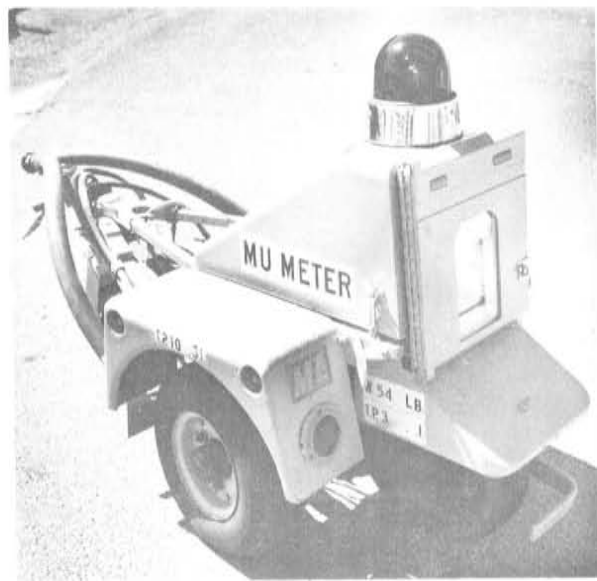
Figure 8

ARIZONA HIGHWAY DEPARTMENT'S
MODIFIED MU-METER

With the modifications of the Mu-Meter complete (Figure 8), the unit is highly maneuverable, and it is now possible to conduct numerous tests without stopping or interfering with traffic flow. Using this system, approximately 250 lane miles of highway can be tested in one eight-hour day. The normal test speed is 40 MPH with higher speeds possible between test sites. In addition, an automatic speed control on the truck insures the desired test speed.

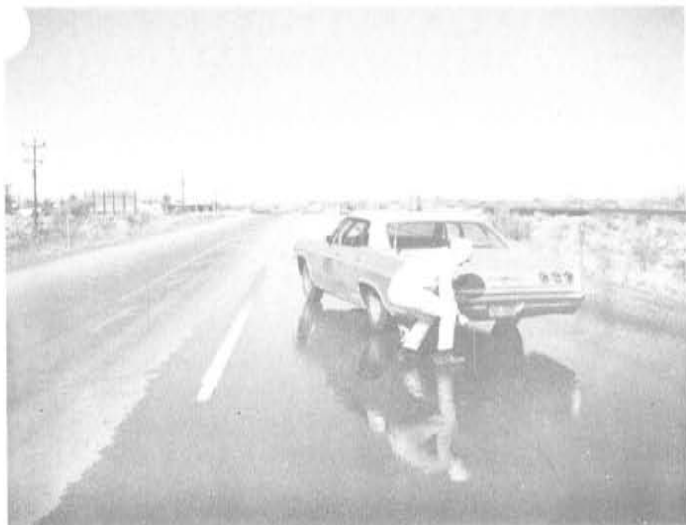
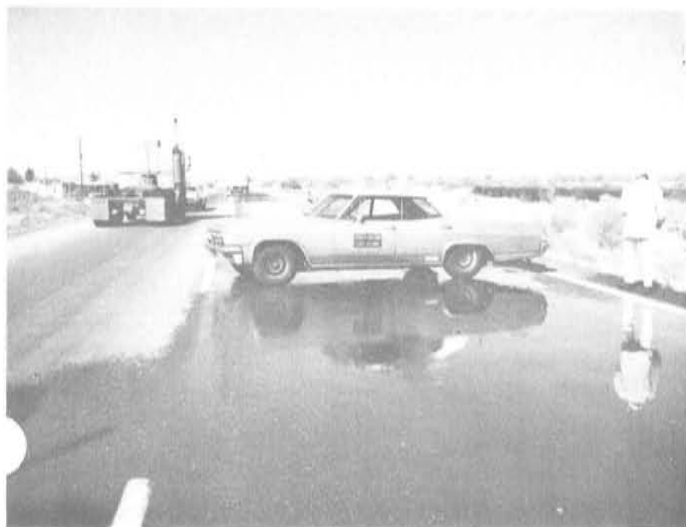
Figure 35

RIGHT WHEEL PATH = SDN₄₀ 50
LEFT WHEEL PATH = SDN₄₉ 60 } 17% Difference

← (A) Car skids at 30 MPH and rotates 25° counterclockwise

← (B) Car skids at 40 MPH and rotates 40° clockwise

← (C) Car skids at 50 MPH and rotates 95° counterclockwise

During our testing, a condition was noted that we feel warrants special attention and further investigation. The condition occurs when the two wheelpaths in which a vehicle rides have a different coefficient of friction. We are aware that there will usually be a small difference, but this is not the condition we are describing. The differential wheelpath friction (DWPF) we are considering is one in which a vehicle may be riding on two different surface types, two different ribbons of asphaltic concrete or concrete pavement, or a condition where one wheelpath is flushed or polished while the other is not. To our surprise, a very small difference in the wheelpath frictions will cause a car to spin out of control when braking. An example of two conditions are shown in Figures 35 and 36. In Figure 35, the wet stopping distance number at 40 MPH (SDN_{40}) was 50 for the right wheelpath and 60 for the left wheelpath, which is only a 17 percent difference. In picture A, the car skidded at 30 MPH and rotated 25° counterclockwise. In picture B, the car skidded at 40 MPH and rotated 40° counterclockwise. In picture C, the car skidded at 50 MPH and rotated 95° counterclockwise. When the direction of skidding was reversed, the same values were recorded with the

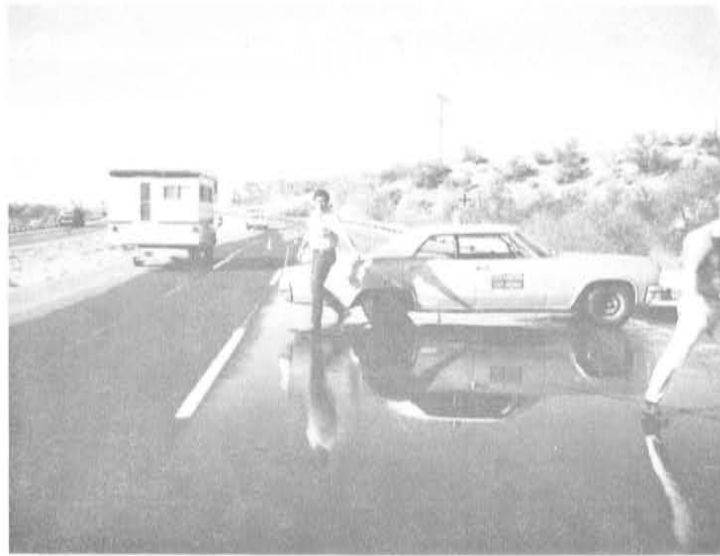
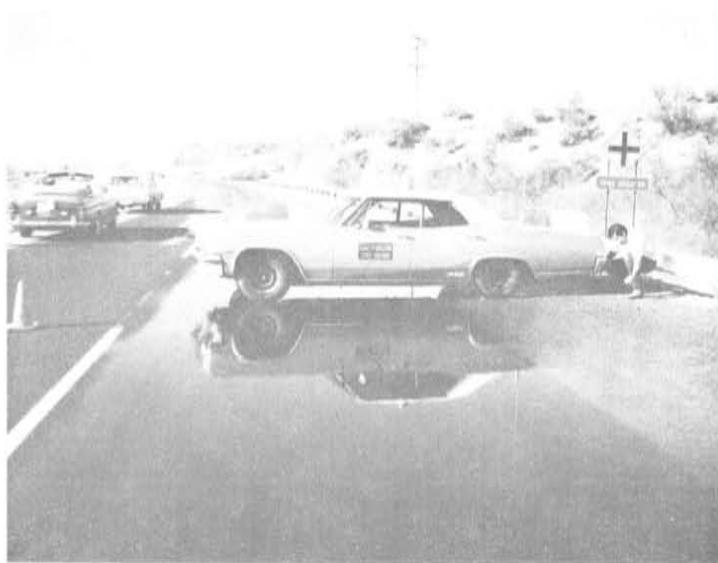
RIGHT WHEEL PATH = $SDN_{40} \frac{67}{40}$
LEFT WHEEL PATH = $SDN_{40} \frac{41}{40}$ } 39% Difference

(A)
Car skids at 40 MPH and rotates 90° clockwise

(B)
Car skids at 50 MPH and rotates at 270° clockwise

Figure 36 is an extreme case used to portray what might happen if one wheelpath were flushing while the other was not. However, the first case is one that is fairly common and, although both wheelpaths have a satisfactory level of friction, a hazardous condition occurs due to their difference. As the speed increases, the effects increase dramatically. Under such conditions, the normal driver tends to remove his foot from the brake as he begins to rotate. When he does, his car is propelled in the direction the vehicle is turned, perhaps off the road or into the oncoming traffic lane.

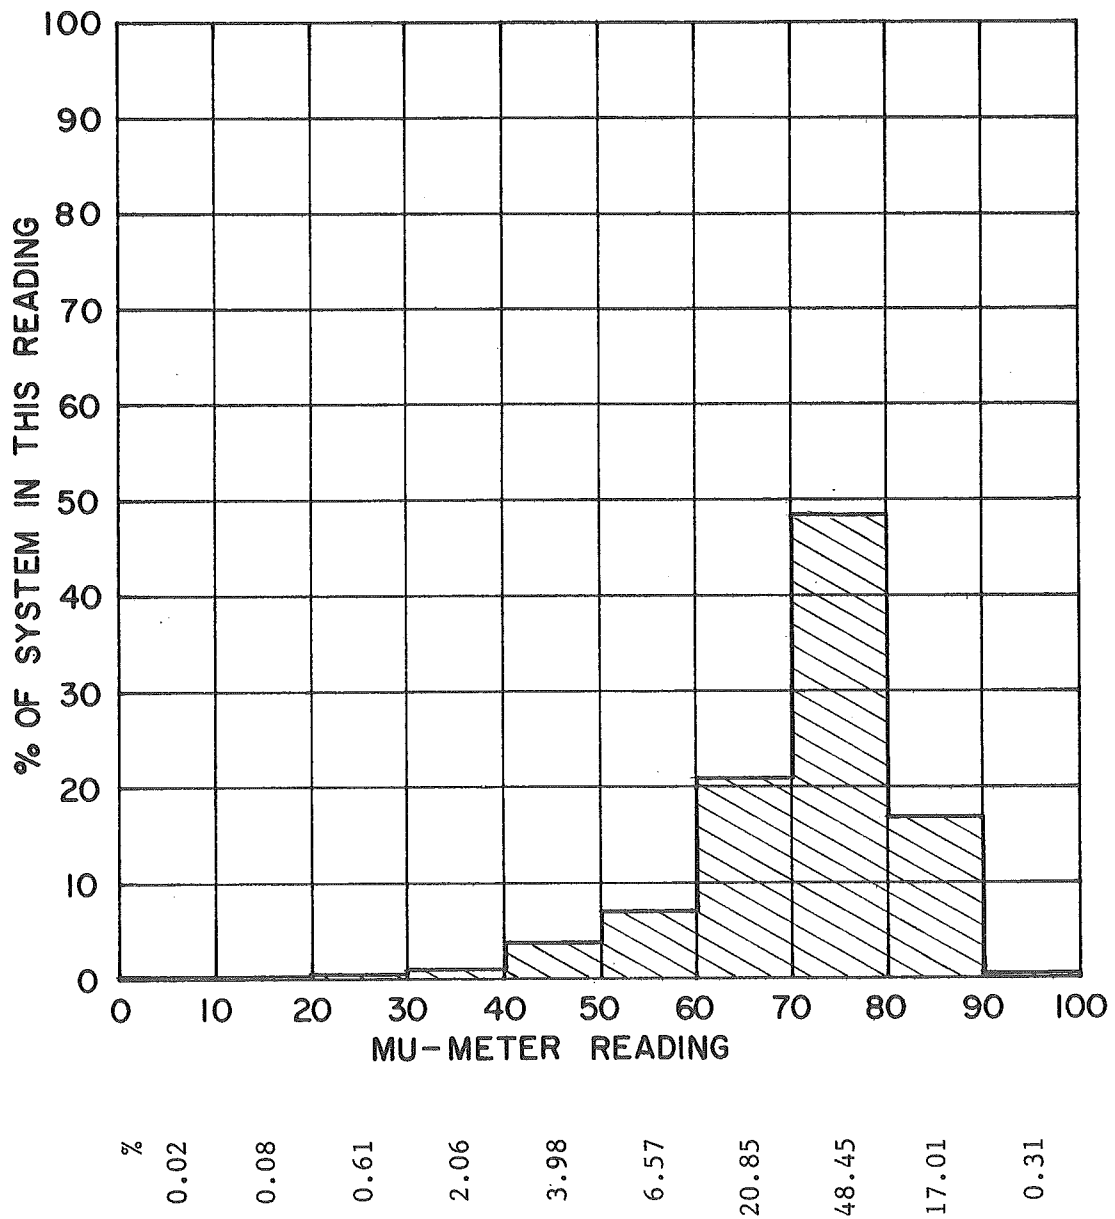
Figure 37

INTERSTATE, STATE AND U.S.
HIGHWAYS IN ARIZONA

As part of the study, an analysis of the percent of the highway system falling into each friction range was made (Figure 37). These and following interpretations are made from the highway inventory previously mentioned. The results showed that only 2.8 percent of the Arizona highway system fell below a skid number of 40. This figure must be considered when evaluating the accident analysis. It was found that approximately 50 percent of the highway system fell within the Mu-Meter frictional range of 71 to 80. These results indicate that the skid resistance level of the Arizona highway system is predominantly very good and that the present pavement designs and aggregate types are producing satisfactory skid resistant surfaces.

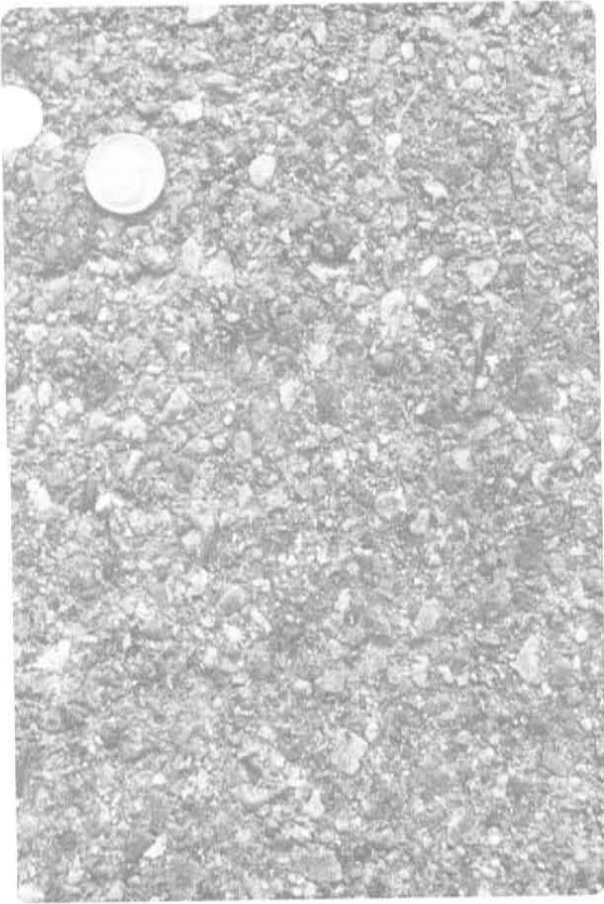
Figure 40

I-10-M.P. 175.2, N.B. INSIDE LANE
 SURFACE - 3/8 INCH DENSE GRADED ASPHALTIC CONCRETE
 AGGREGATE SUPPLY - GILA RIVER PIT #6651
 BINDER - AC 85-100
