ARIZONA DEPARTMENT OF TRANSPORTATION

REPORT NUMBER: FHWA-AZ88-202-1

SMALL SIGN SUPPORT ANALYSIS

Phase I Crash Test Program

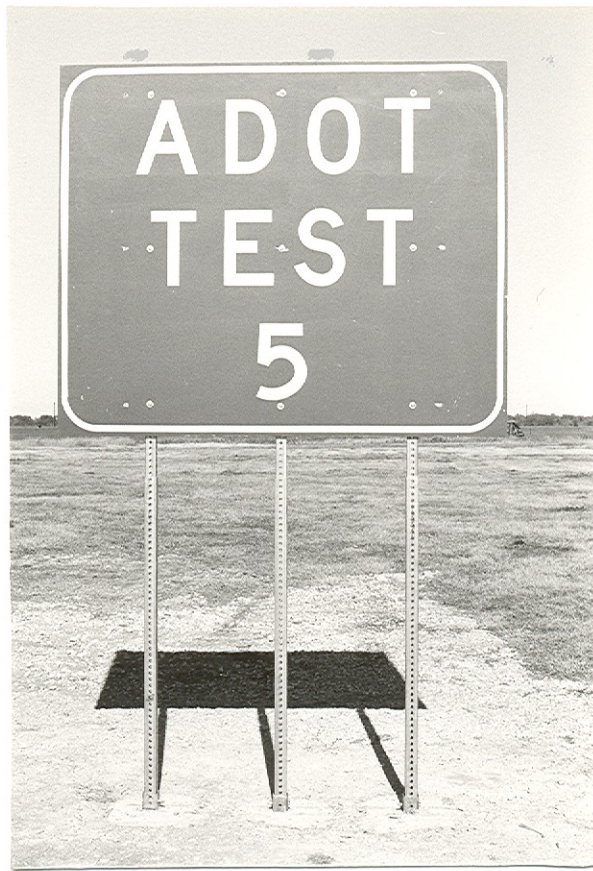
FIGURE A-7. SIGN INSTALLATION, TEST 5
(SAME AS TEST 6)

In tests 5 and 6, a 6 ft wide by 5 ft high by 5/8 inch thick plywood (MDO) panel was mounted on three 1 3/4 inch square sign posts, with the lower edge of the panel approximately 5 ft above ground. Post spacing was 21 inches rather than the 25 inches called for in the plans (first sheet, Figure A-6). The smaller spacing was used so that the test vehicle would strike all three posts (vehicle width was approximately 51 inches). Three fasteners were used to attach the panel to each of the three posts. Attachment hardware was as shown on the second sheet of Figure A-6. Hardware specifications are given in the notes of Figure A-4. It is noted that a bolt for this specification is equivalent to an SAE Grade 1 bolt.

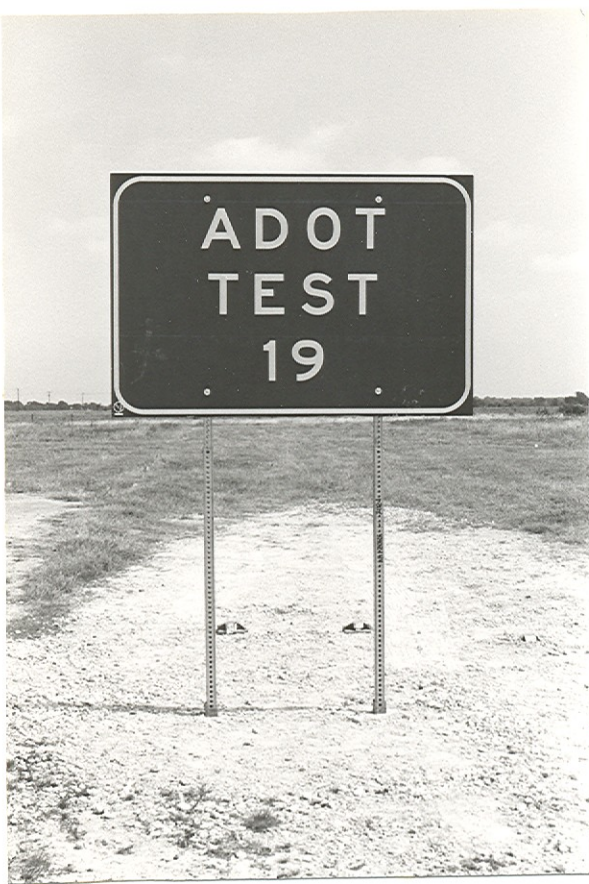
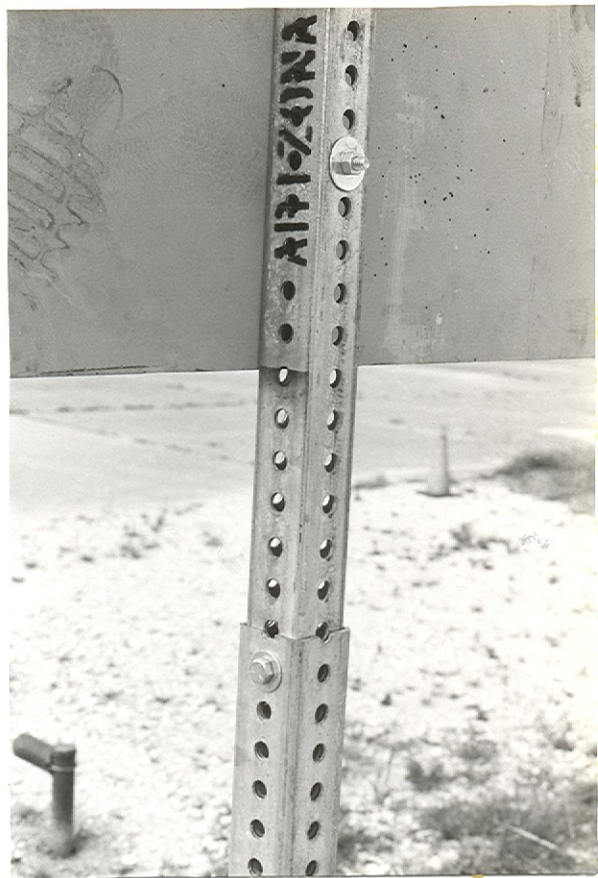
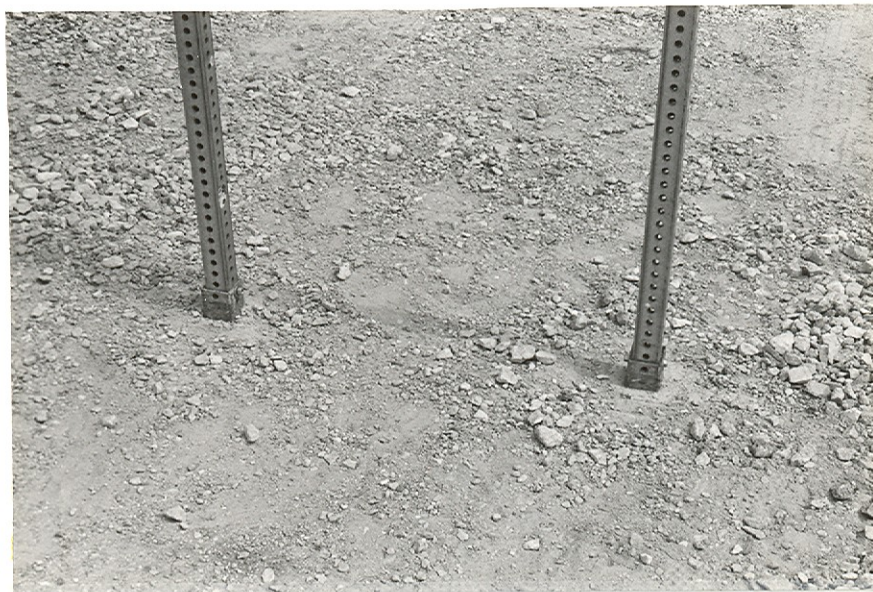
FIGURE A-8. SIGN INSTALLATION, TEST 19
(SAME AS TEST 20)

In tests 19 and 20, a 6 ft wide by 4 ft high by 5/8 inch thick plywood (MDO) panel was mounted on two 1 3/4 inch square sign posts, with the lower edge of the panel approximately 5 ft above ground. Post spacing was 40 inches rather than the 43 inches called for in the plans (first sheet, Figure A-6). The smaller spacing was requested by ADOT. Two fasteners were used to attach the panel to each post. Attachment hardware was as shown on the second sheet of Figure A-6. In tests 19 and 20, the bolts were SAE Grade 5 and the nuts were Grade 8.

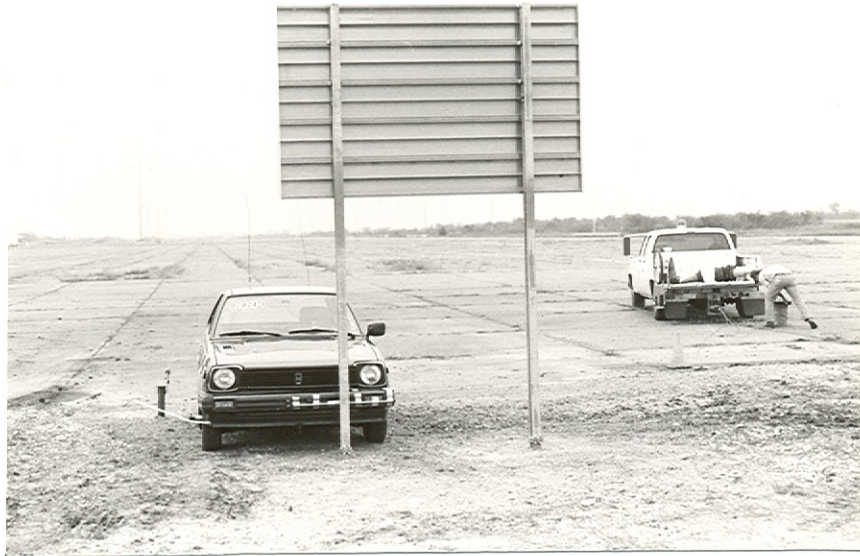
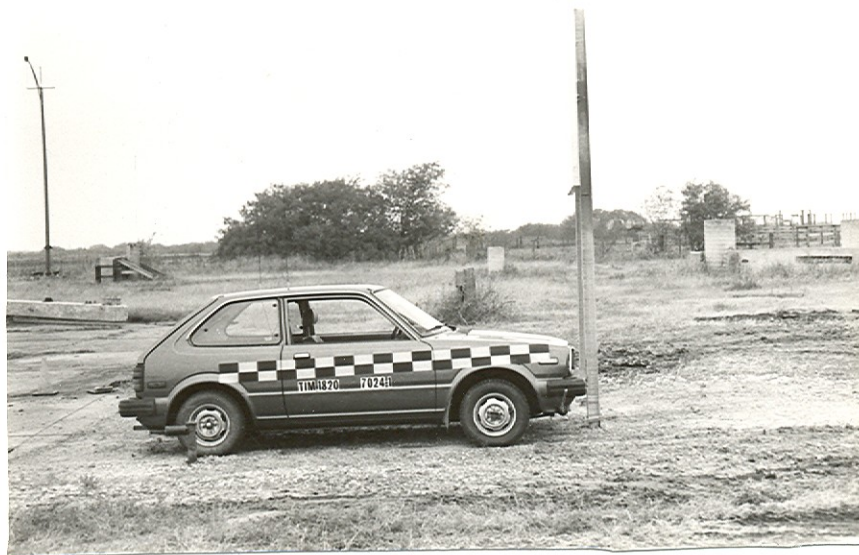
FIGURE A-23. RELATIVE POSITIONS OF SIGN INSTALLATION AND TEST VEHICLE FOR TEST 1.

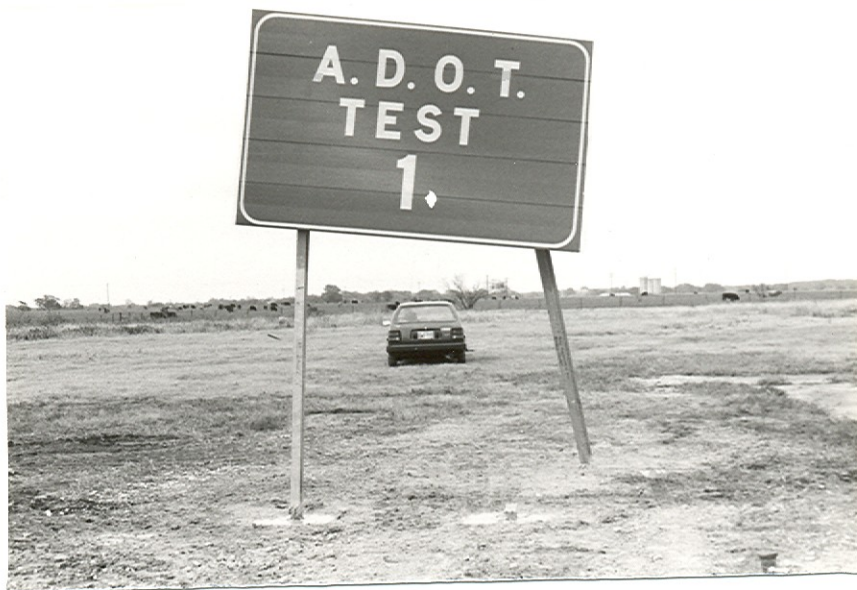
FIGURE A-24. SIGN INSTALLATION AFTER TEST 1.

Photographs of the sign installation after the test are shown in Figures A-24 and A-25. Damage to the vehicle was minimal as shown in Figure A-26. The left front quarter was deformed and was crushed 1.0 in. at bumper height. Sequential photographs of the test are shown in Figure A-27.

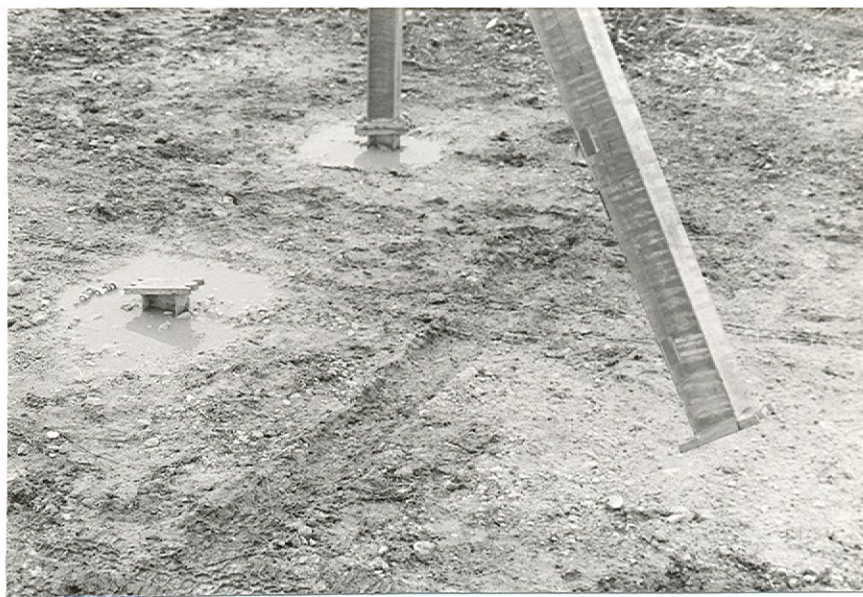
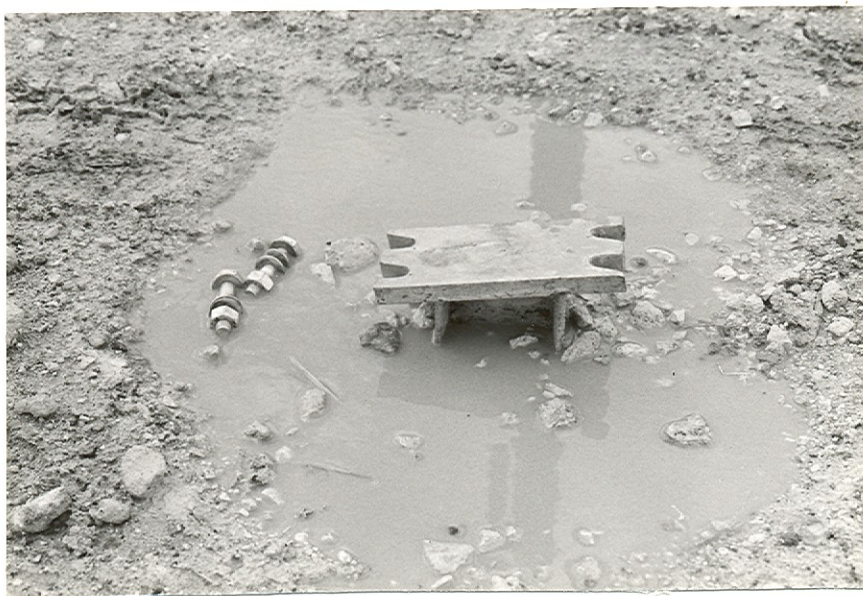
FIGURE A-25. BREAKAWAY BASE AFTER TEST 1.

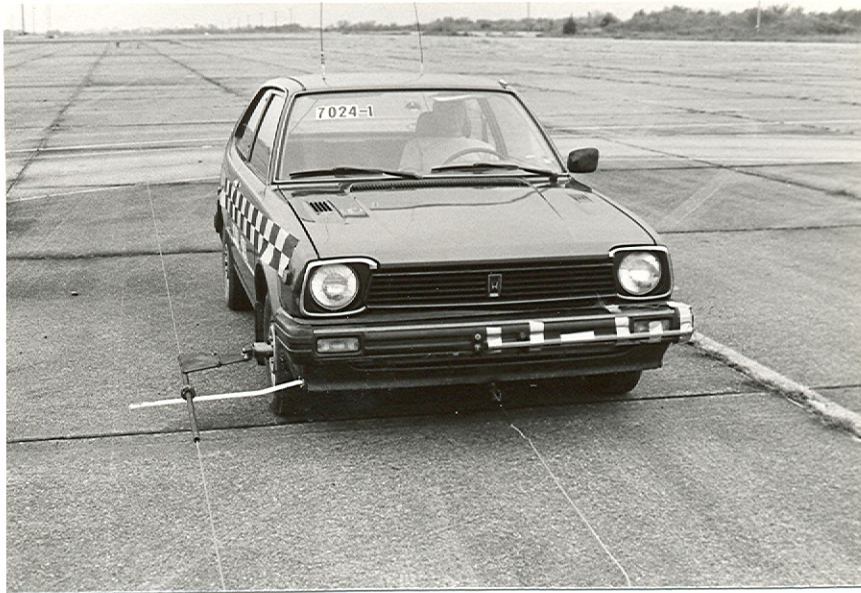
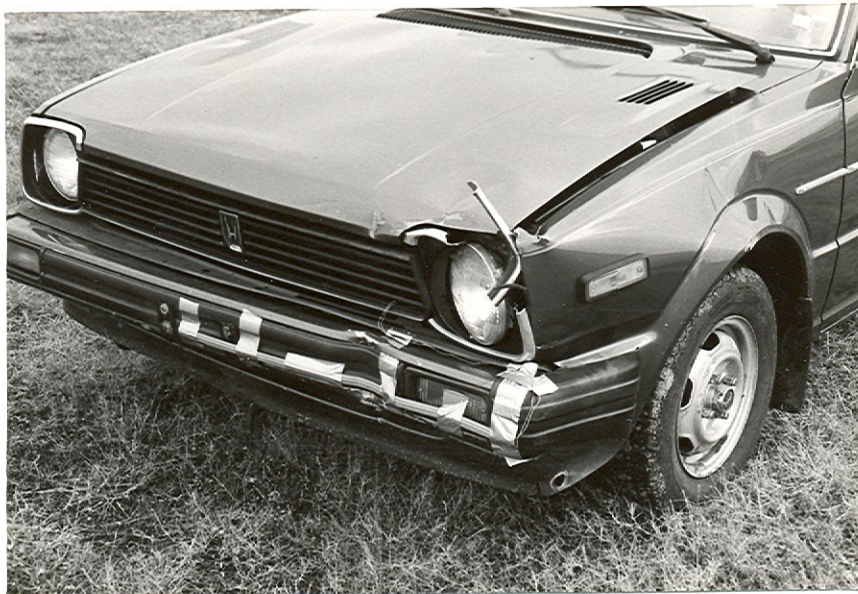
FIGURE A-26. TEST VEHICLE BEFORE AND AFTER TEST 1.

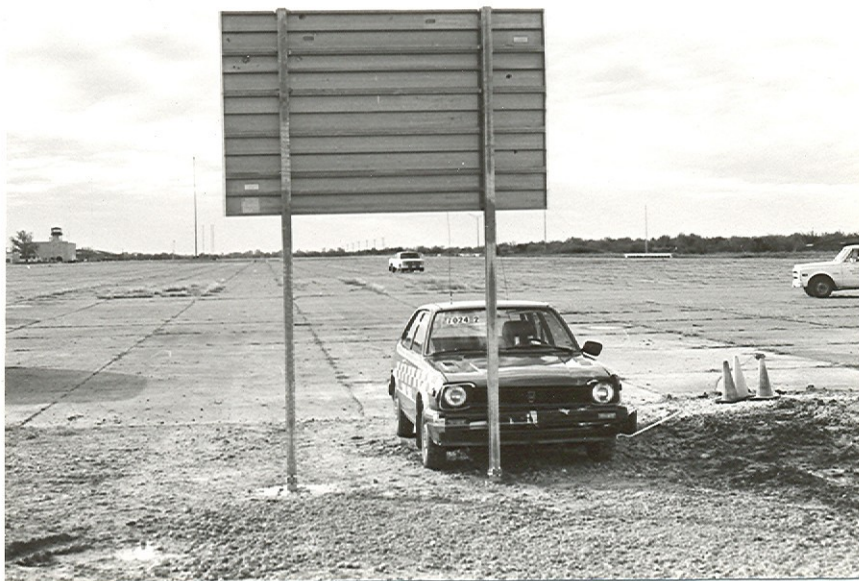
FIGURE A-30. RELATIVE POSITIONS OF SIGN INSTALLATION AND TEST VEHICLE FOR TEST 2.

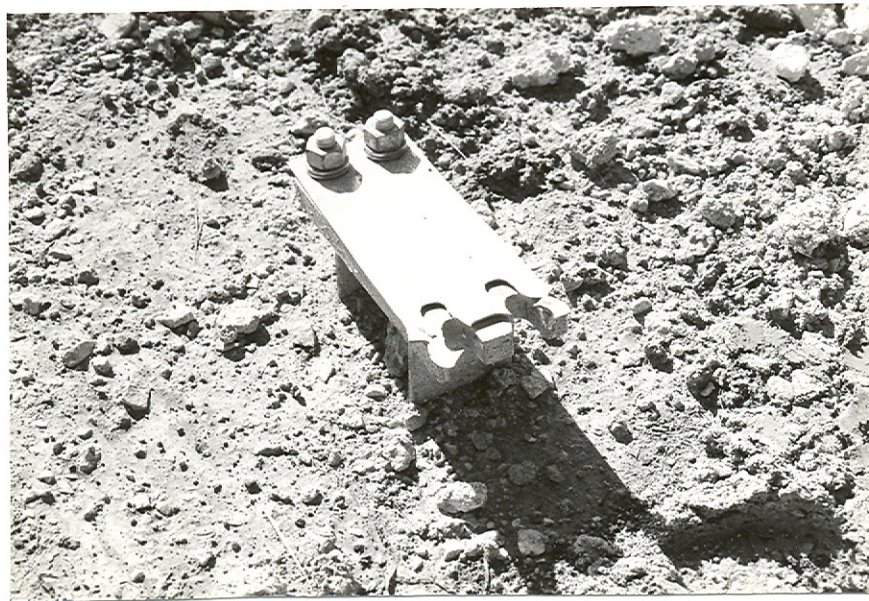
FIGURE A-31. BREAKAWAY BASE AFTER TEST 2.24-2.

Photographs of the sign after the test are shown in Figures A-31 and A-32. The vehicle received minimal damage as shown in Figure A-33. The right front quarter received 2.0 in. crush at bumper height and 2.0 in. at hood height. Sequential photographs of the test are shown in Figure A-34.

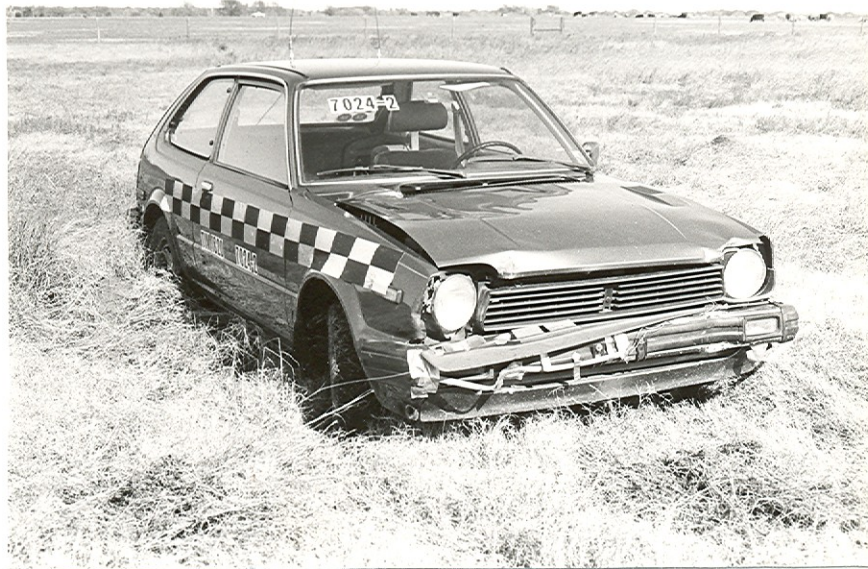
FIGURE A-33. TEST VEHICLE AFTER TEST 2.

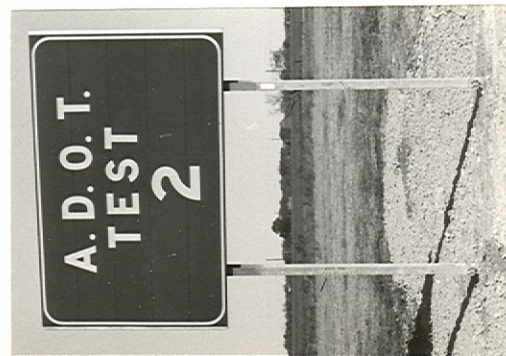
FIGURE A-35. SUMMARY OF RESULTS FOR TEST 2.

A summary of test results is provided in Figure A-35. Change in the vehicle's velocity during the impulse period was 2.1 mph and change in momentum was 174 lb-sec. There was no occupant impact during the impulse period.

Test No.	7024-2	Impact Speed.	59.3 mph (95.4 kph)
Date	11/8/84	Change in Velocity.	2.1 mph (3.4 kph)
Test Article	Multi-leg Sign Support of S4x7.7 post	Change in Momentum	174 lb-sec
Vehicle.	1980 Honda Civic	Occupant Impact Velocity	
Vehicle Weight		Longitudinal.	No Contact
Test Inertia	1,820 lb (826 kg)	Lateral	No Contact
Gross Static	1,985 lb (901 kg)	Occupant Ridedown Accelerations	
Vehicle Damage Classification		Longitudinal.	N/A
TAD.	12FR1	Lateral	N/A
SAE.	12FREN2	Maximum Vehicle Crush	
		Bumper Height	2.0 in. (5.1 cm)
		Hood Height	2.0 in. (5.1 cm)

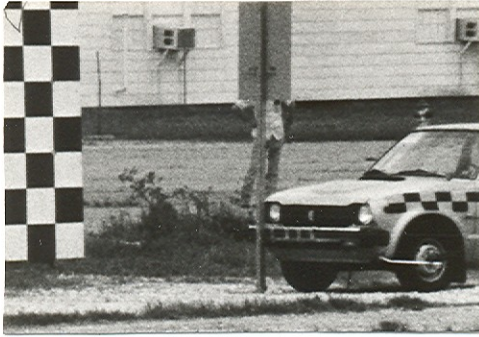
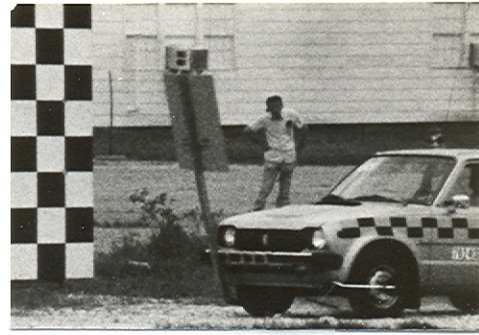
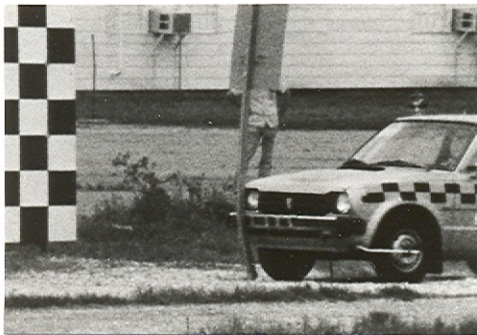
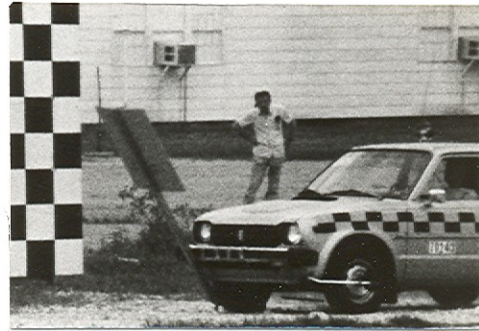
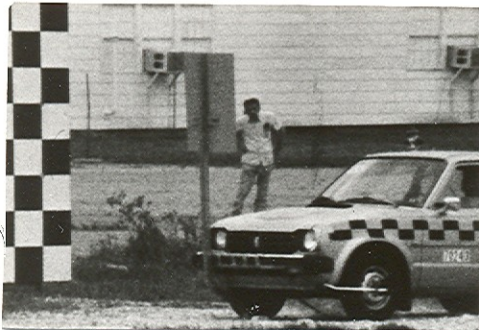
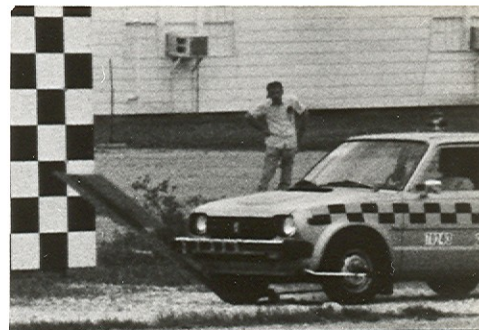
FIGURE A-37. SEQUENTIAL PHOTOGRAPHS FOR TEST 3.

Approximately 0.025 sec after impact the support fractured at bumper height. The vehicle lost contact with the sign installation at 0.110 sec. Sequential photographs of the test are shown in Figure A-37. The support was fractured (but not completely separated) at the base and 16 in. above the ground as shown in Figure A-38. As shown in Figure A-39 the vehicle sustained minor scrapes to the bumper.

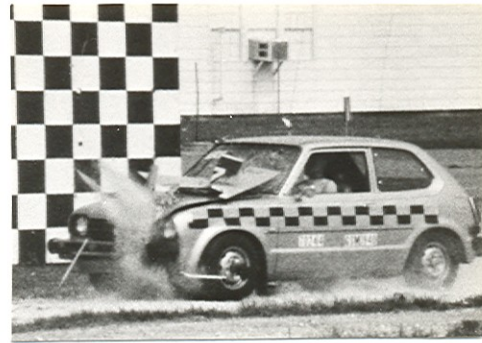
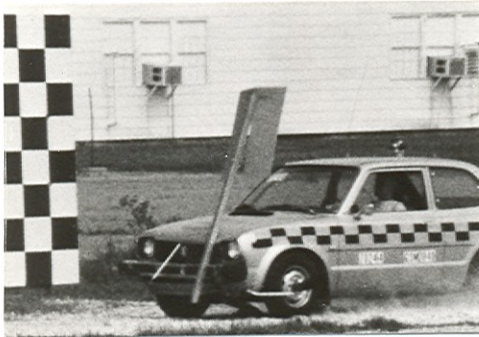
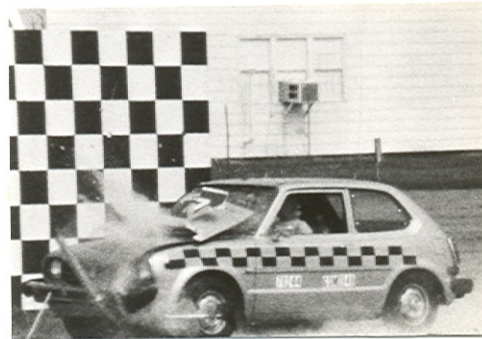
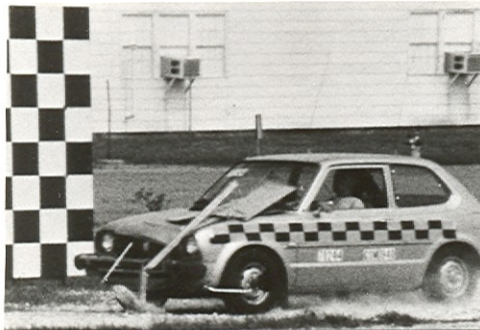
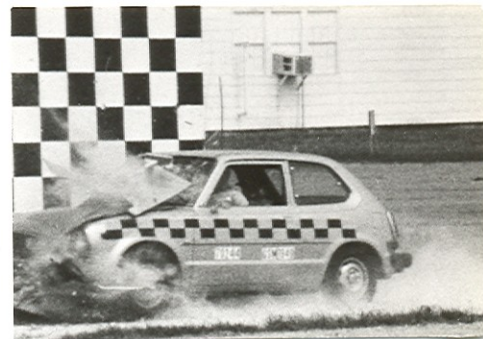
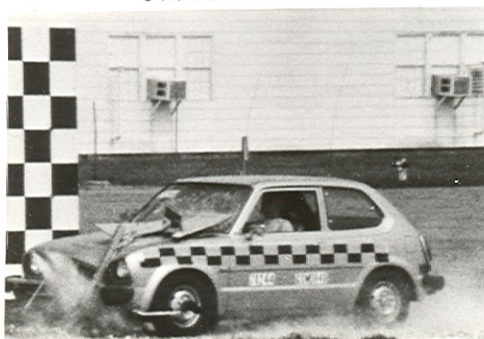
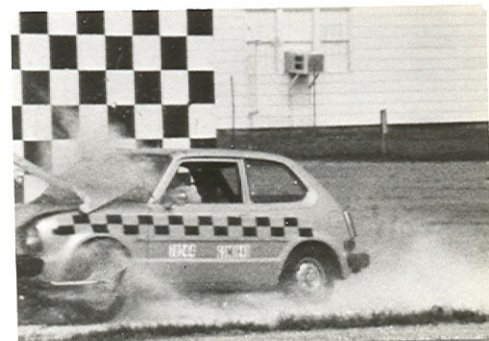
FIGURE A-42. SEQUENTIAL PHOTOGRAPHS FOR TEST 4.

Approximately 0.010 sec after impact the sign panel split at the lower bolt connection and at 0.013 sec the support began to fracture at bumper height. At 0.035 sec the bottom of the sign panel hit the hood and shortly thereafter (0.043 sec) broke away from the support. The top of the sign panel then hit the windshield at 0.050 sec. Loss of contact occurred at 0.148 sec. As the vehicle left the test site the brakes were applied. The brakes locked up and the vehicle yawed in counterclockwise rotation. The wheels dug into the soft soil causing the vehicle to roll one and three-quarter revolutions. The vehicle subsequently came to rest on its right side. Sequential photographs of the test are shown in Figure A-42.

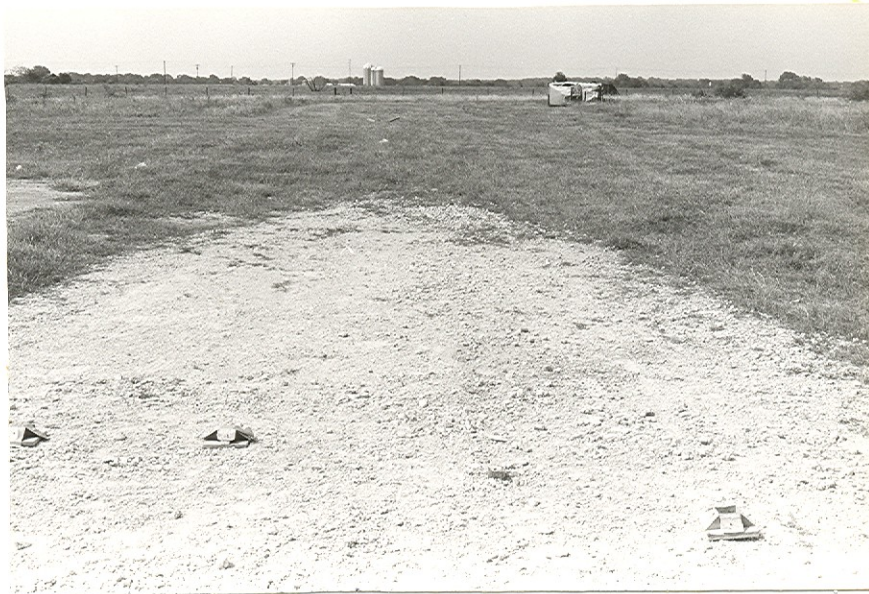
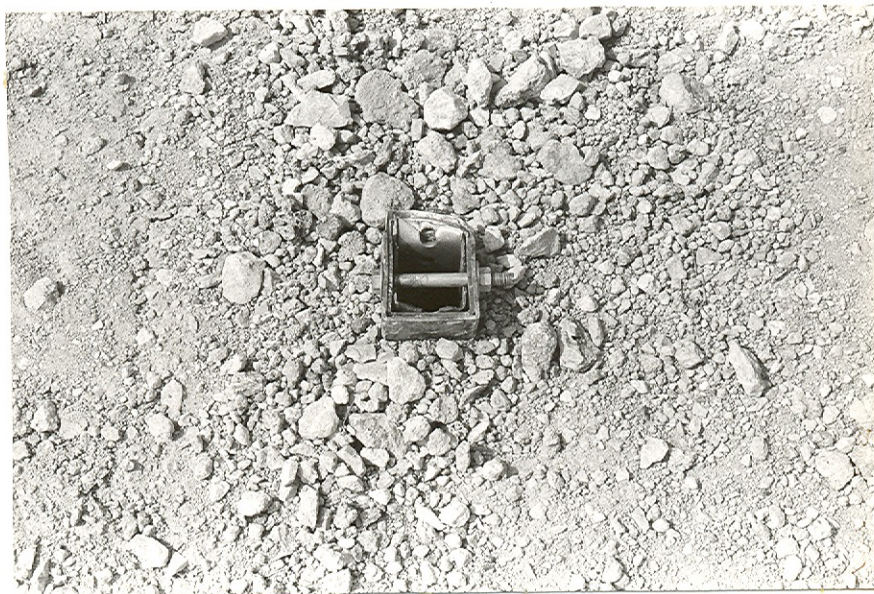
FIGURE A-43. TEST SITE AFTER TEST 4.

The support broke away at the base and was deformed as shown in Figures A-43 and A-44. The vehicle sustained a maximum crush of 3.0 in. at bumper height and the hood was scraped and dented. The windshield was cracked but not penetrated when the sign panel hit it. All other damage was due to post-test rollover. Photos of the vehicle after the test are shown in Figure A-45.

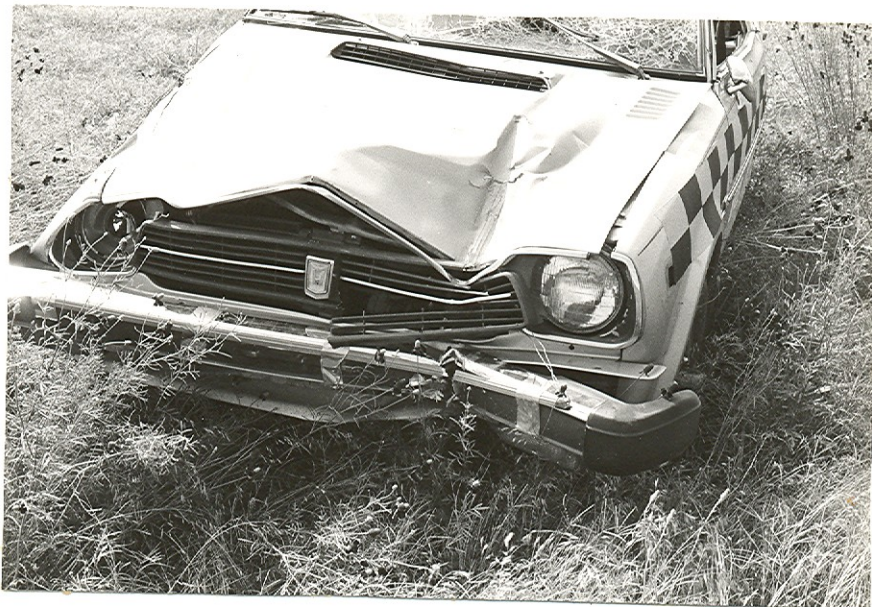
FIGURE A-45. VEHICLE AFTER TEST 4.

The vehicle remained upright and stable throughout the impact phase and up to the time of brake application. Rollover of the vehicle was considered to be totally due to unsymmetrical brake application in combination with soft soil and not induced by impact with the sign.

As noted in Table 4, the vehicle in test 4 rolled subsequent to impact with the test article. However, analysis of the test film showed that the rollover was not attributable to the impact. Rather it was due to vehicle yawing that resulted from unsymmetrical braking, leading to tire rutting and the tripping of the vehicle. While the rollover cannot be attributed to the impact, it does point out the relative instability of the 1800 lb vehicle. As shown, rollover of this vehicle can occur on relatively flat, traversable, grassy sod, quite similar to actual roadside conditions.

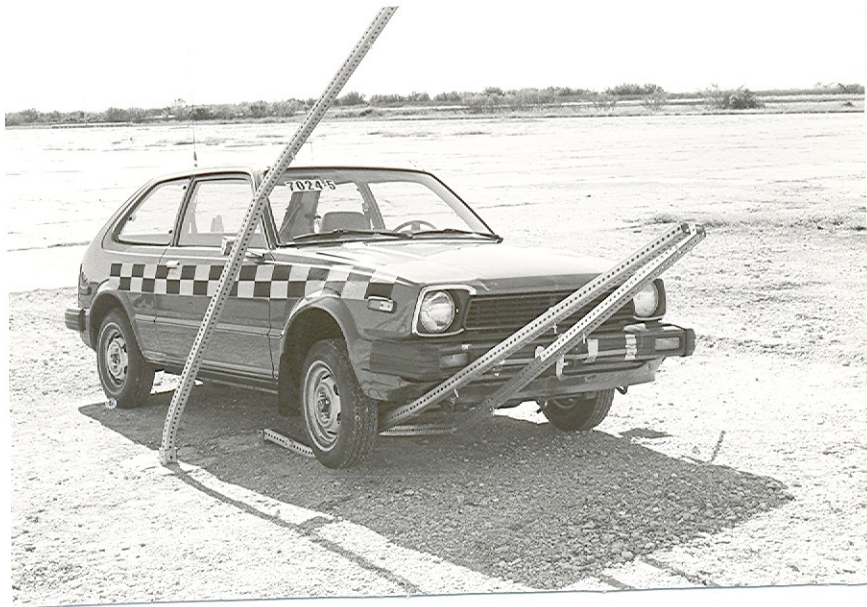
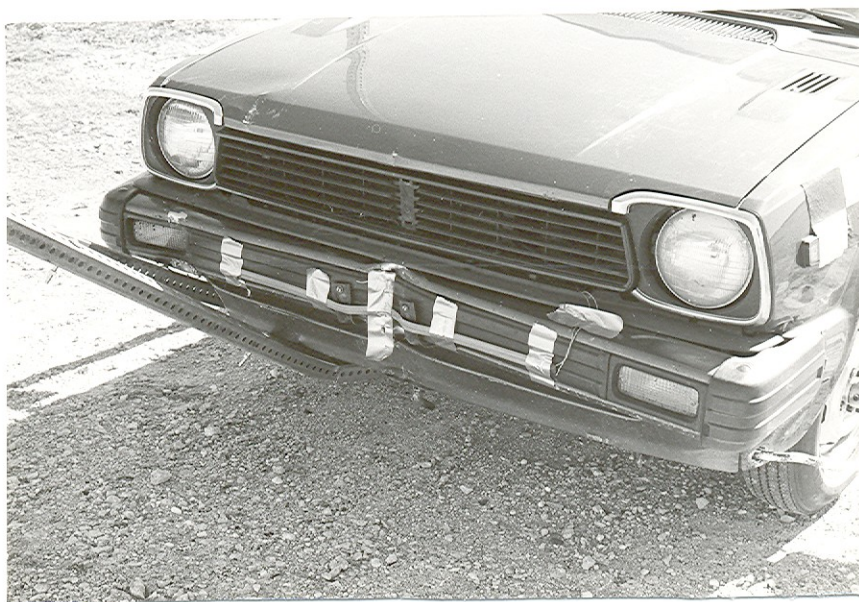
FIGURE A-50. TEST VEHICLE AFTER TEST 5.

The front of the vehicle was deformed as shown in Figure A-50. The right front quarter received 4.0 in. crush at bumper height. The center was crushed 2.0 in. at bumper height. The windshield was slightly cracked just below the mirror. Sequential photographs of the test are shown in Figure A-51.

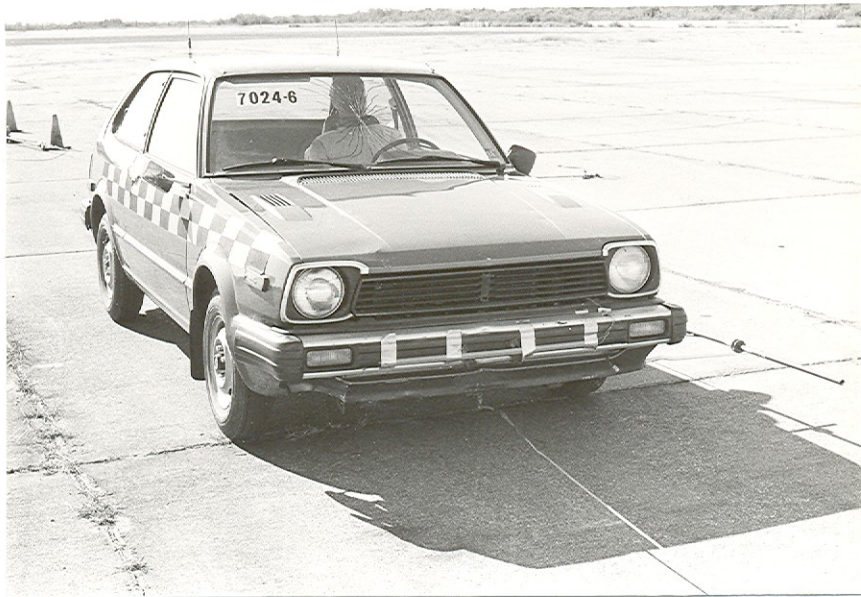
(cracks in windshield from Test 5)

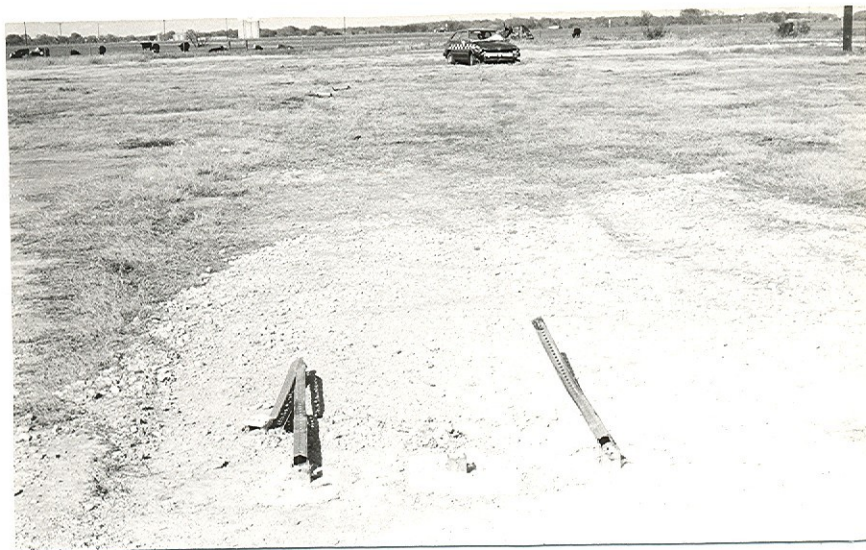
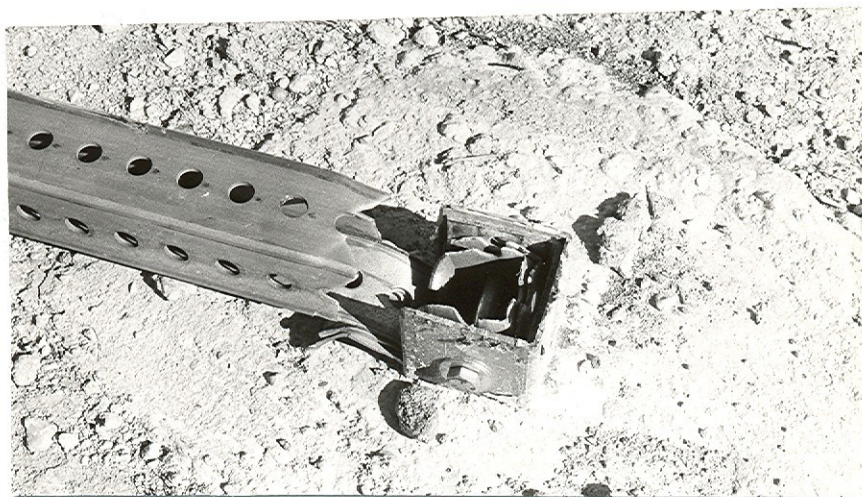
FIGURE A-55. SIGN INSTALLATION AFTER TEST 6.
(BASE)

Almost immediately after impact (0.002 sec), the supports began bending. At 0.022 sec the supports began to fracture and, as the vehicle continued forward, the supports deformed around the front of the vehicle. At 0.072 sec the sign panel hit the windshield knocking it loose from the upper molding. At 0.090 sec the dummy's head came through the opening between the windshield and the roof of the vehicle and by 0.162 sec the dummy's head was completely out of the vehicle. The vehicle exited the test area carrying the sign panel and parts of the supports. The vehicle came to rest approximately 156 ft behind and 18 ft to the right of the impact point.

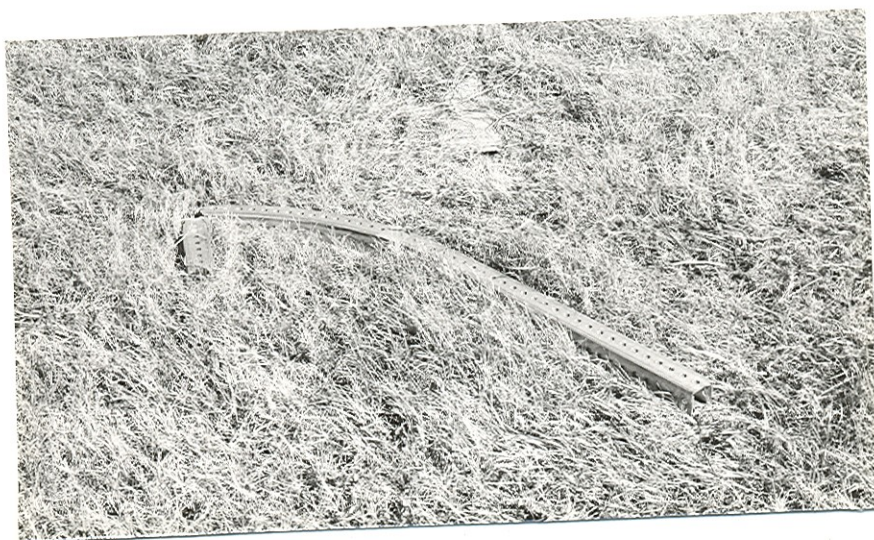
FIGURE A-56. SIGN INSTALLATION AFTER TEST 6.
(SUPPORTS AND SIGN PANEL)

Center Support

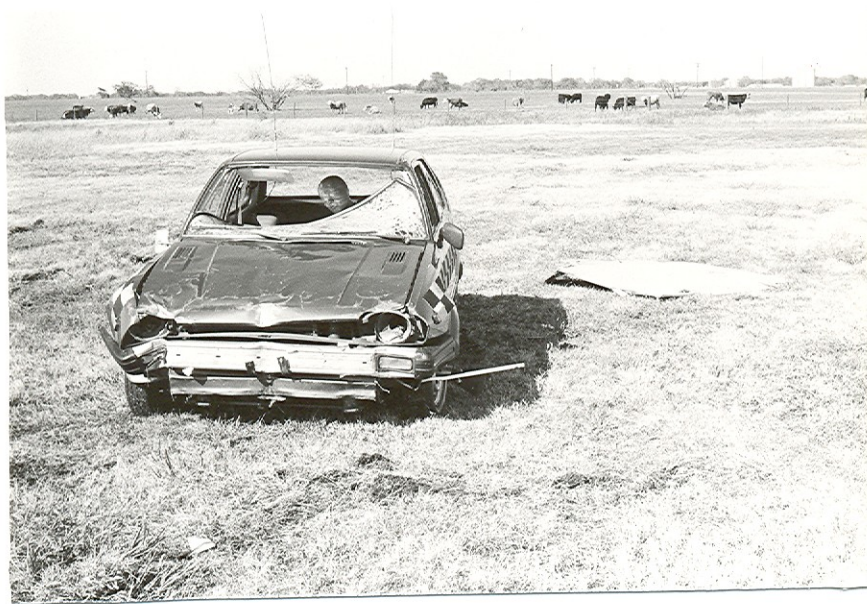
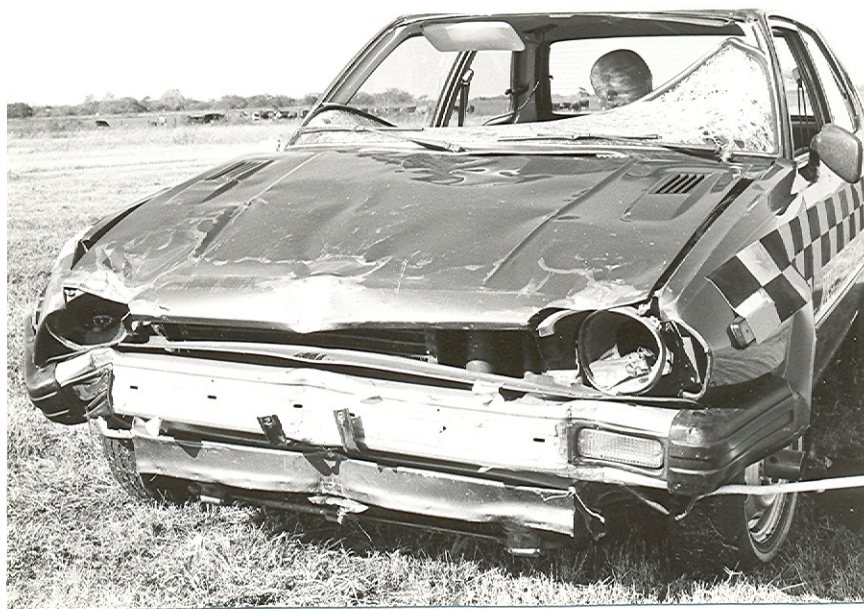
FIGURE A-57. TEST VEHICLE AFTER TEST 6.

The front of the vehicle was deformed and the windshield was broken as shown in Figure A-57. The right front quarter received 4.0 in. crush at bumper height. The center was crushed 1.0 in. at bumper height and 1.5 in. at hood height. Sequential photographs of the test are shown in Figure A-58.
