Report Number 11
HPR-1-13(224)

PREVENTION OF REFLECTIVE CRACKING IN ARIZONA MINNETONKA - EAST (A Case Study)

May 1976

Final Report

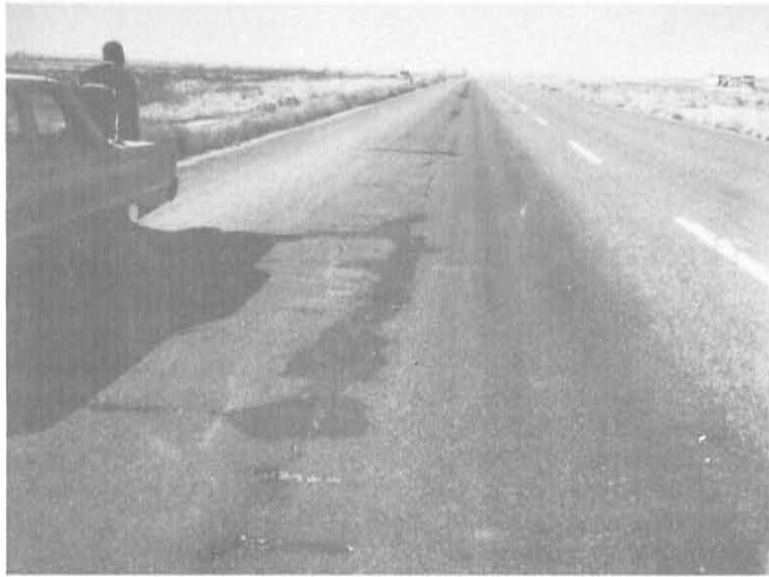
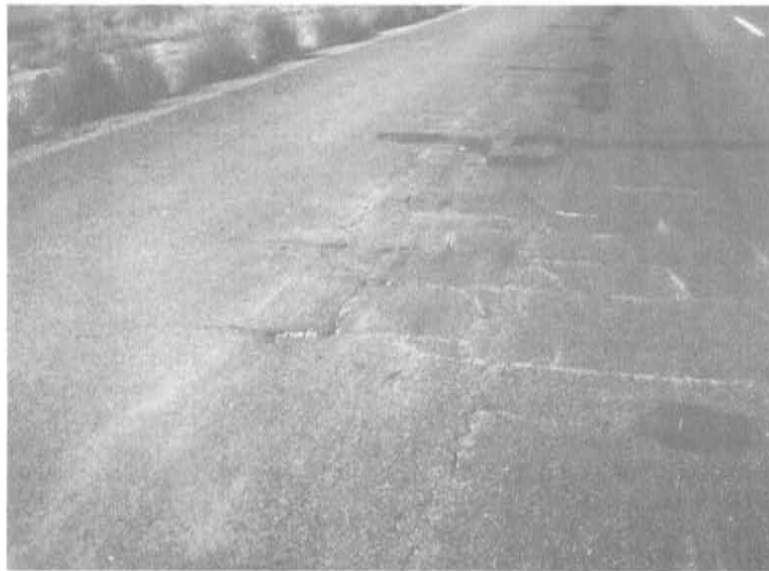
Figure 2. Typical Roadway Cracking, Minnetonka-East,
Photos taken during design phase, February, 1969

Maximum	Minimum	Average
Rutting (Inches)	1.500	0.000	0.564
Benkelman Beam (Inches)	0.074	0.002	0.035
Condition Survey	Extensive cracking, including block (flexural) and shrinkage (thermal) cracks. Spalling and rutting were also noted.

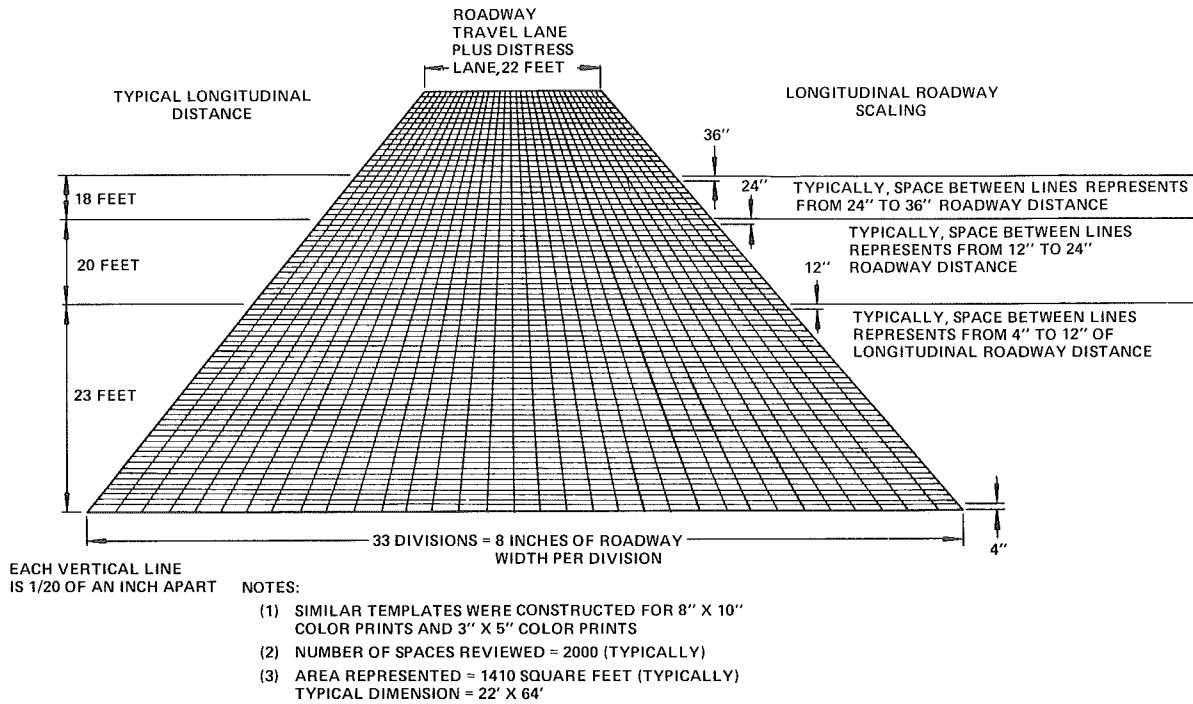
Figure 8. Template – Crack Count Survey, Glass Template Used, For 5" x 7" Color Print Crack Interpretation (Note 1)

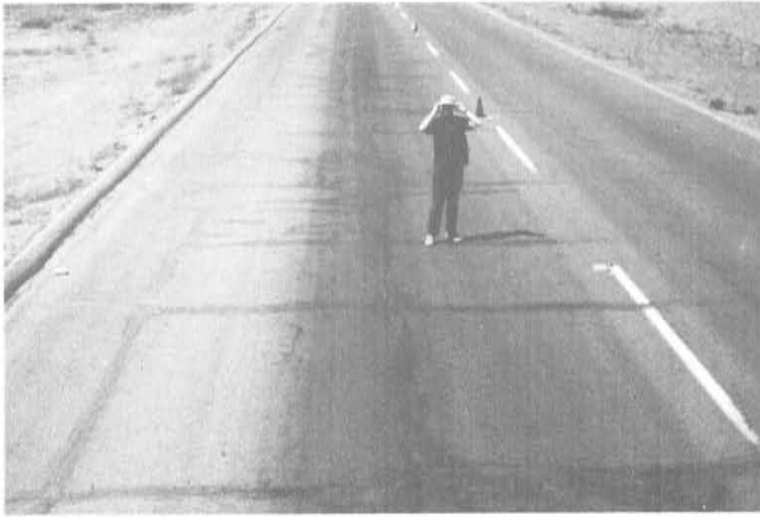
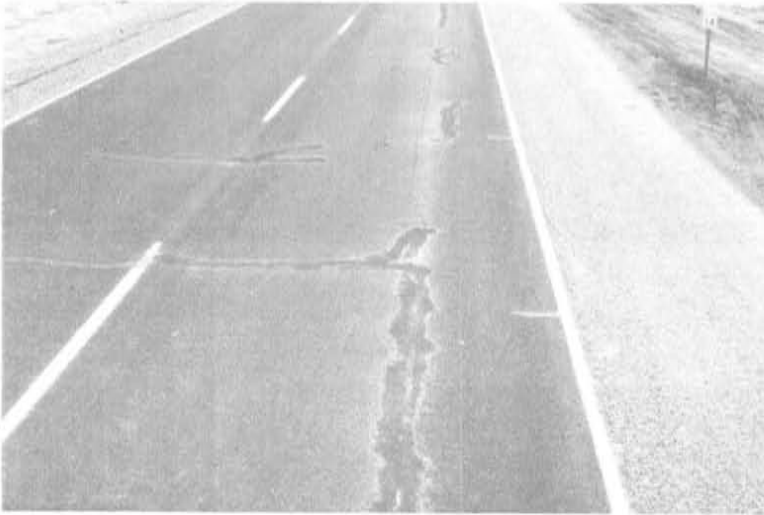
March 25, 1971
23.1% Cracking Before Overlay

March 24, 1972
23.7% Cracking Before Overlay

Feb. 6, 1973
2.9% Cracking or 12.2% Reflected
Cracking After Overlay

Figure 10. Typical History of Cracking, Control Section:
Sta 449+50-75 Eastbound

Feb. 26, 1974
3.6% Cracking or 15.2% Reflected
Cracking After Overlay

March 13, 1975
8.7% Cracking or 36.7% Reflected
Cracking After Overlay

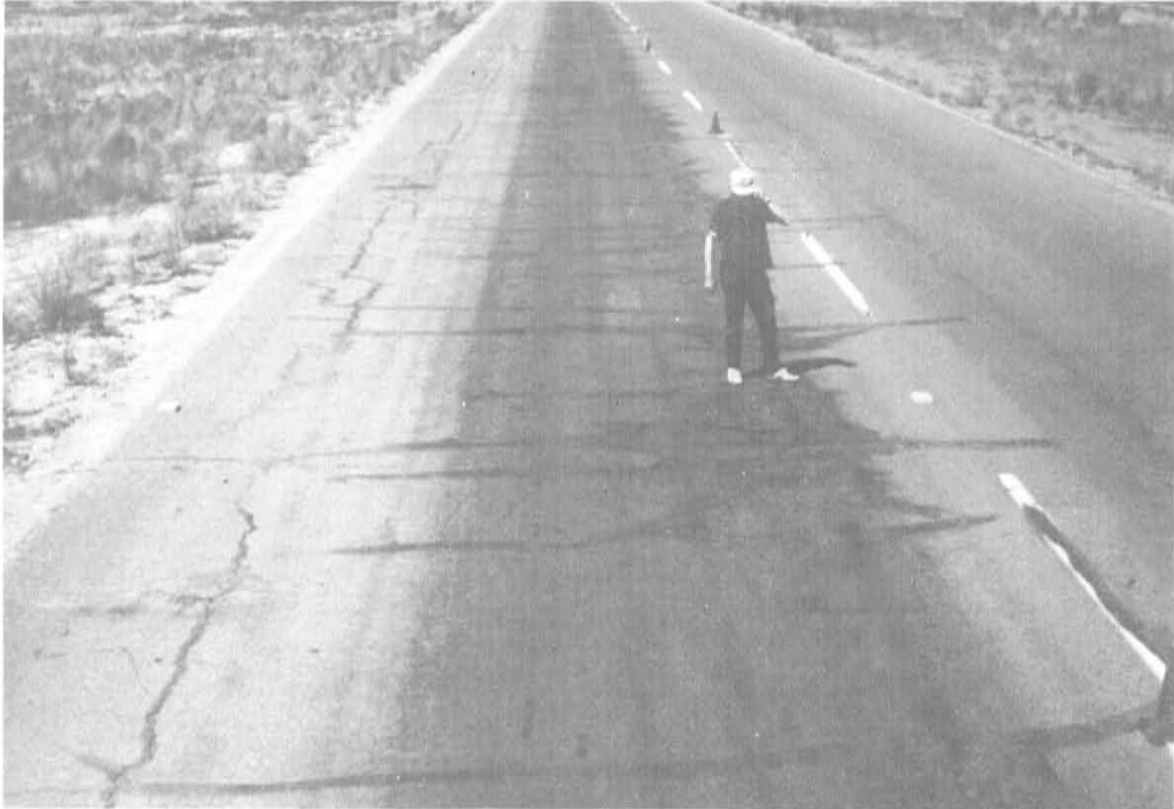
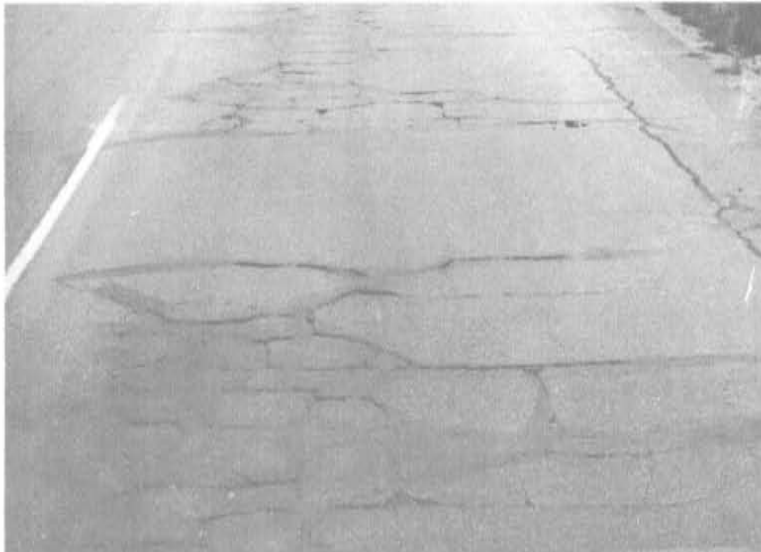
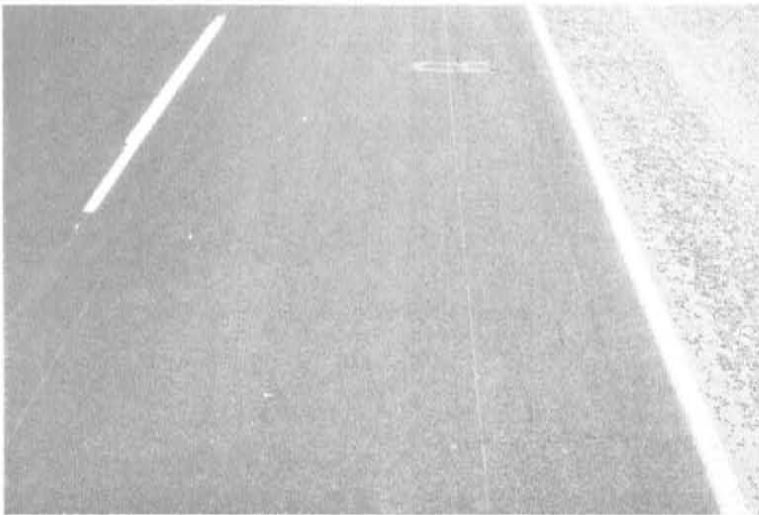
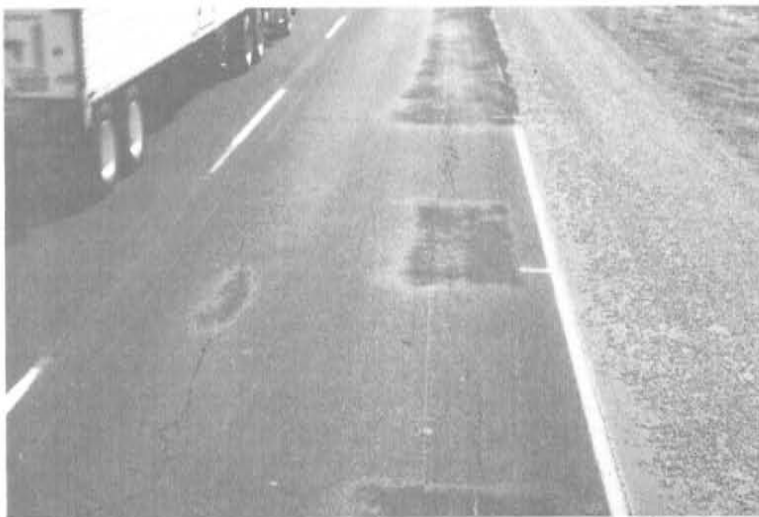
March 25, 1971, 23.1% Cracking Before Overlay

March 24, 1972
31.1% Cracking Before Overlay

Figure 11. Typical Photo History of Cracking, LA 40/50,
Sta 386+75-387

Feb. 6, 1973
.5% Cracking or 1.6% Reflected
Cracking After Overlay

Feb. 26, 1974
2.6% Cracking or 8.4% Reflected
Cracking After Overlay

March 13, 1975
7% Cracking or 22.5% Reflected
Cracking After Overlay

LA 40/50
STATION 386 + 75 - 387 (SEE FIGURE 11, PHOTO 1)

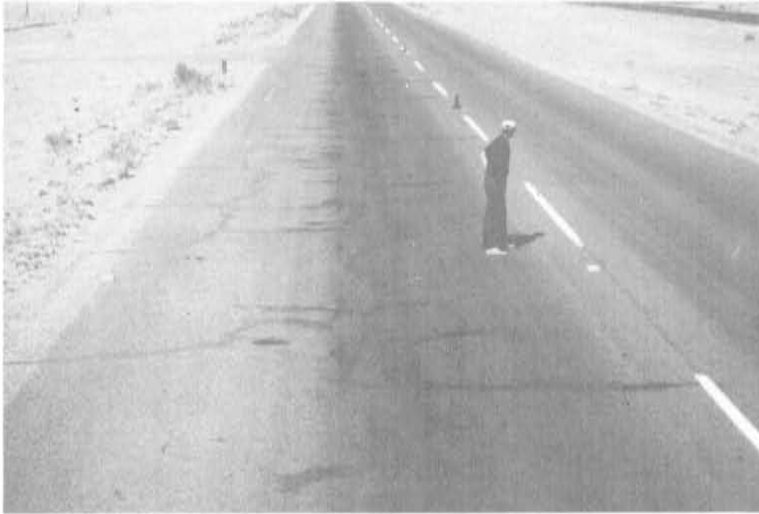
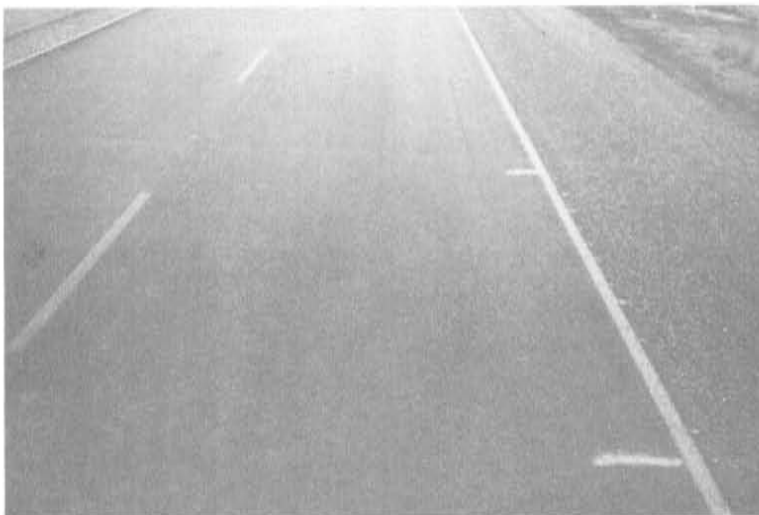
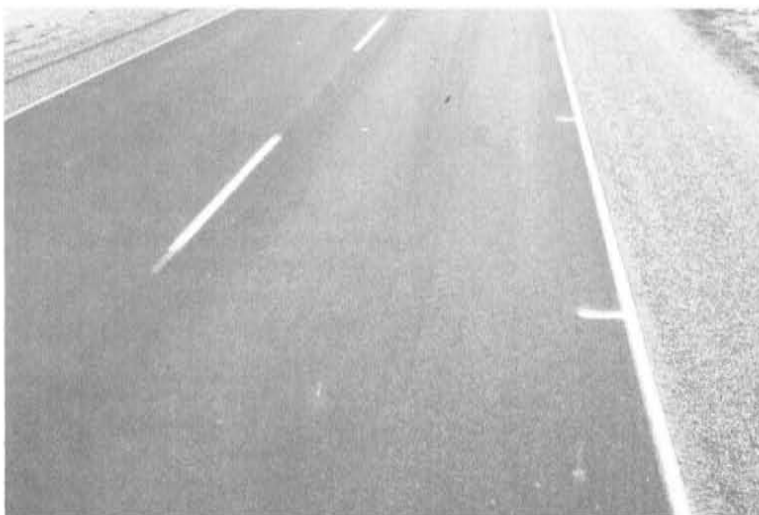
March 25, 1971
13.8% Cracking Before Overlay

Feb. 6, 1973
0% Cracking After Overlay

March 13, 1975
0% Cracking or 0% Reflected
Cracking After Overlay

Figure 12. Typical Photo History of Cracking, Asphalt
Rubber Between AC Overlay and ACFC, T.S. #3,
Sta 317+75-318

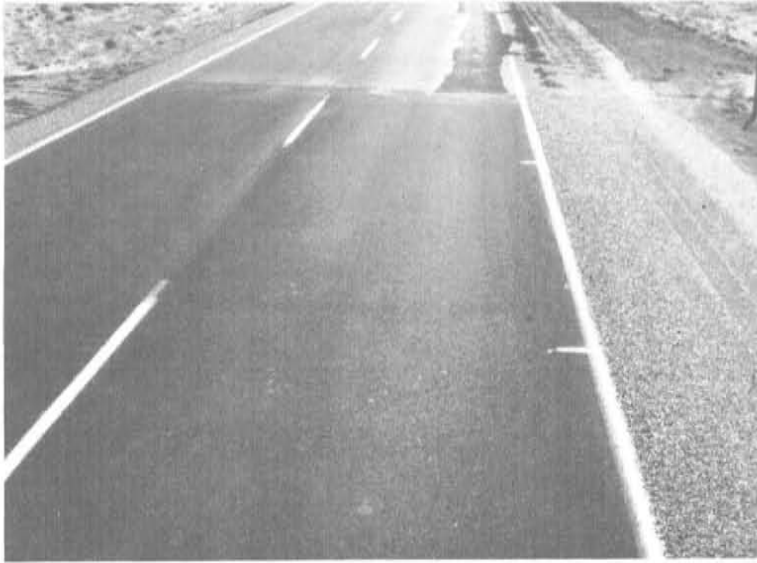
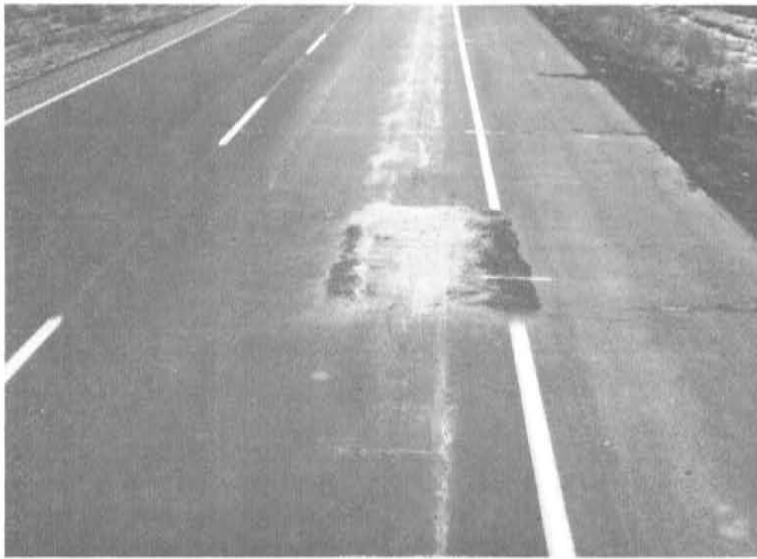
March 13, 1975
1-1/4" AC With 1/2" ACFC

March 13, 1975
2" AC With No ACFC

Figure 13. Influence of Surface Texture on Cracking, Interface Between Control Section (Containing ACFC and Rumble Rock), and Test Section (Containing No ACFC or Rumble Rock).

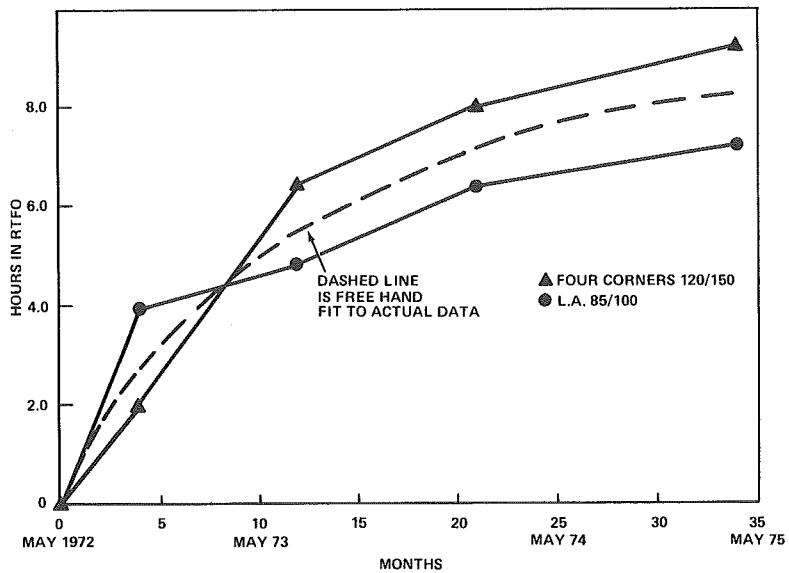
Figure 24. RTFO Time vs. Field Time (To Achieve Equivalent Micro-Viscosities @ 77°F)
