ARIZONA DEPARTMENT OF TRANSPORTATION

Report Number
1979-GW1

PREVENTION OF REFLECTIVE CRACKING MINNETONKA-EAST (1979 ADDENDUM REPORT)

August 1979

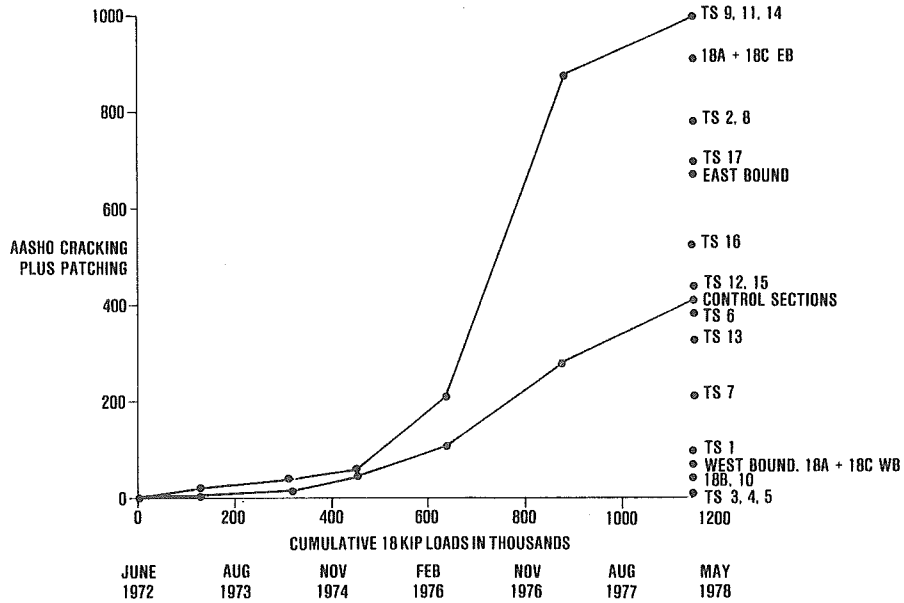
FIGURE 4

Through regression analysis, percent cracking multiplied by 13.8 equals AASHTO lineal feet plus class 2 and 3 area of cracking in 1000 square feet of pavement. From this it was possible to plot AASHTO cracking plus patching versus cumulative 18kip traffic loads. Figure 4 shows this relationship and lists the order of ranking from poor to good. Test section 9, 11, 14 which are Four Corners 120/150 asphalt, emulsion treated base and petroset flush-in have all had their

entire travel lane removed and replaced with patching material as of March 1978. Whereas those test sections shown on Table 2 have had virtually no patching. Interestingly the trend line curves tend to be concave upward.

**AASHO CRACKING PLUS PATCHING
VS. 18 KIP LOADS**

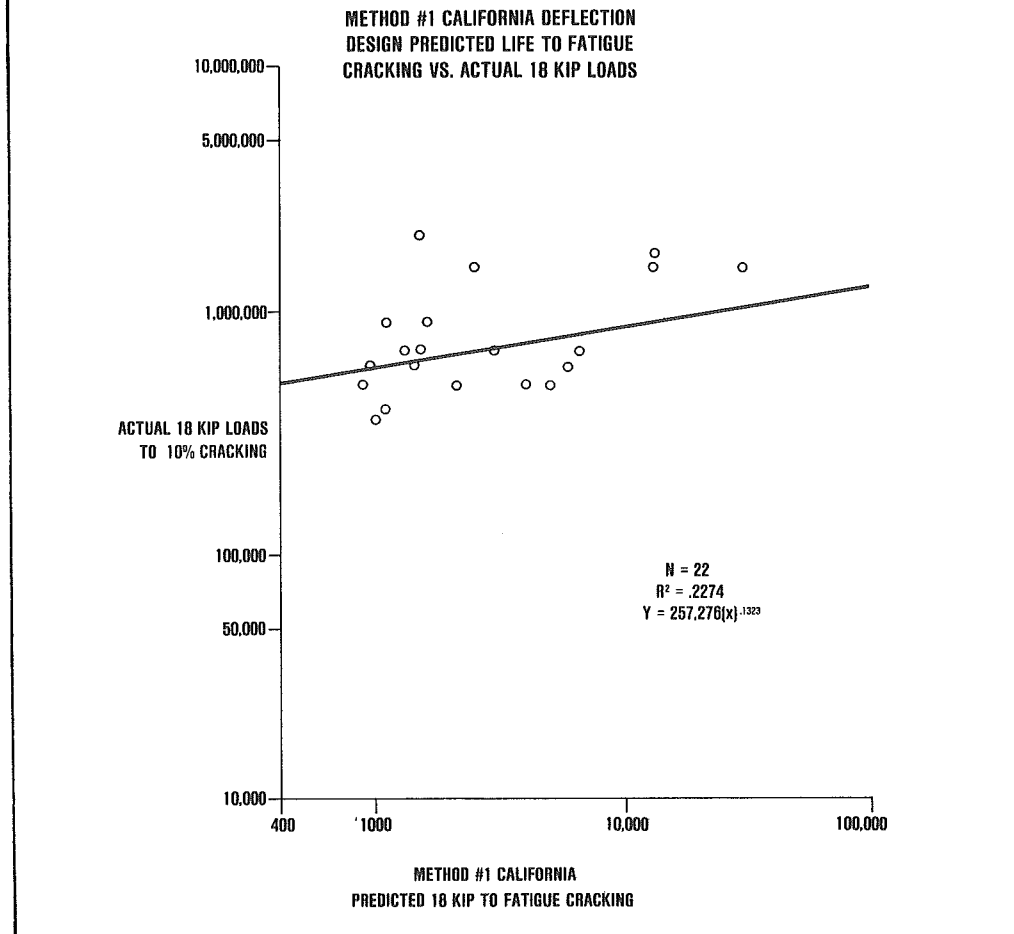
FIGURE 12

Deflection of the existing old road is measured. By knowing this deflection and thickness of the old road, it was possible to compute the overlay thickness needed to reach some desirable number of 18 kip loads to failure. In this case failure was vaguely defined as fatigue cracking failure. As can be seen, the existing pavement lasted considerably longer than estimated. Solutions for different percent cracking at failure were derived. As can be seen below the 10 percent cracking gave the best fit correlation value.

Figure 12 gives calculated expected life to 10 percent cracking estimated from this method versus actual life.

N	R ²	A	B
1% cracking	22	.1270	152,000.	.1064
5% cracking	22	.1990	205,000.	.1281
10% cracking	22	.2274	257,000.	.1323
20% cracking	22	.1692	517,000.	.0886
30% cracking	22	.1148	743,000.	.0689
40% cracking	22	.0644	1,031,000.	.0506
