REPORT NUMBER: AZ92-377-1

CONSTRUCTION REPORT FOR ARIZONA'S SHRP SPS-4 EXPERIMENT

Construction Report

August 1992

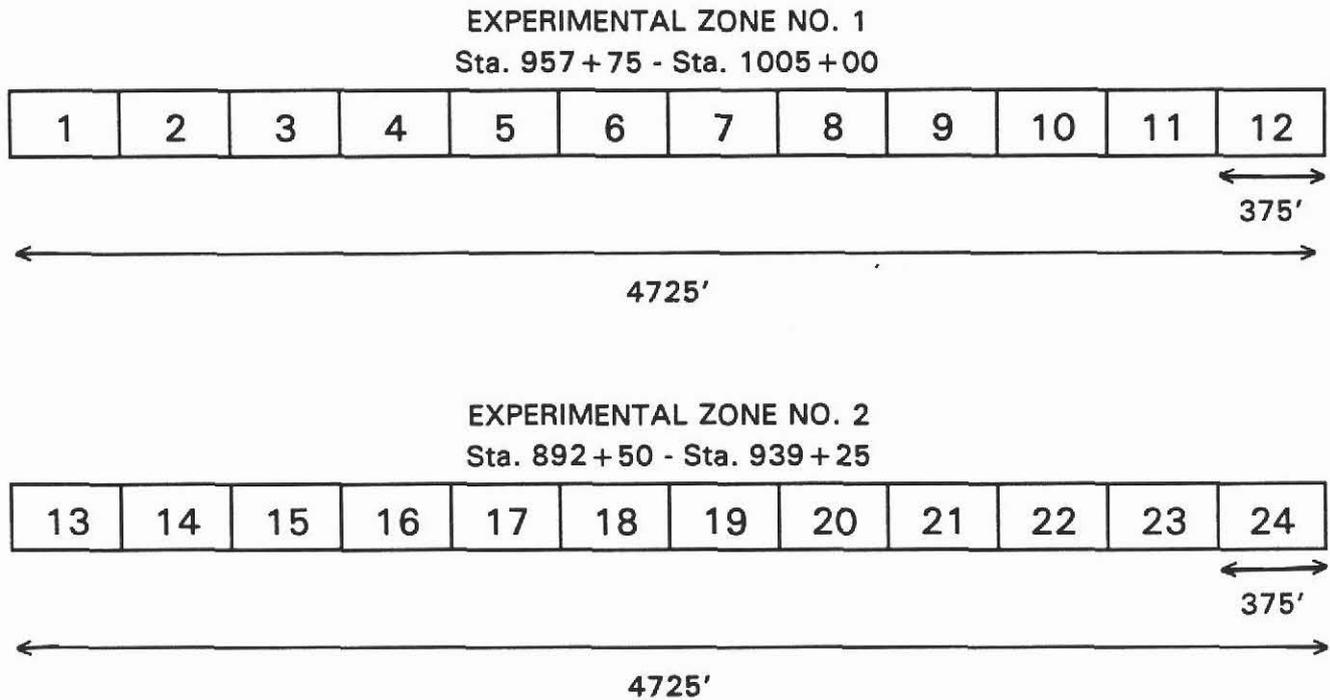
Figure 2 - Experimental Zones

Figure 2 shows the layout of Experimental Zones No. 1 and No. 2. This drawing provides the experimental field plan. Each test section was approximately 375 feet in length and contains 25 joints. Two control sections (Section Nos. 3 and 17) were unsealed, and approximately 600 feet

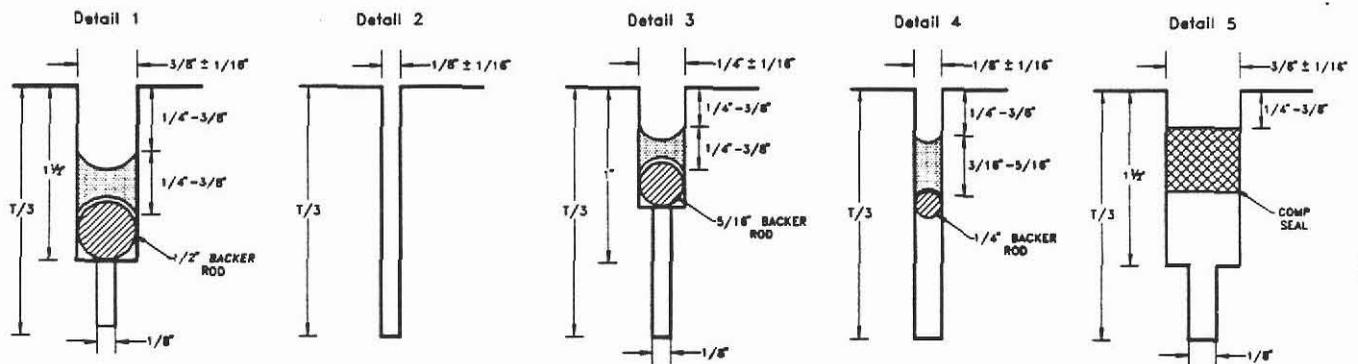
Figure 3 - Joint Details

The primary cut for all joints was specified as the thickness of the slab (T) divided by three (T/3), with a width of 1/8 inches. The width and depth of the secondary cut was established specifically for each sealant. Five joint details were formulated to receive the various joint sealants. Detail 2 was used for the two unsealed test sections. Joint details are provided in Figure 3.

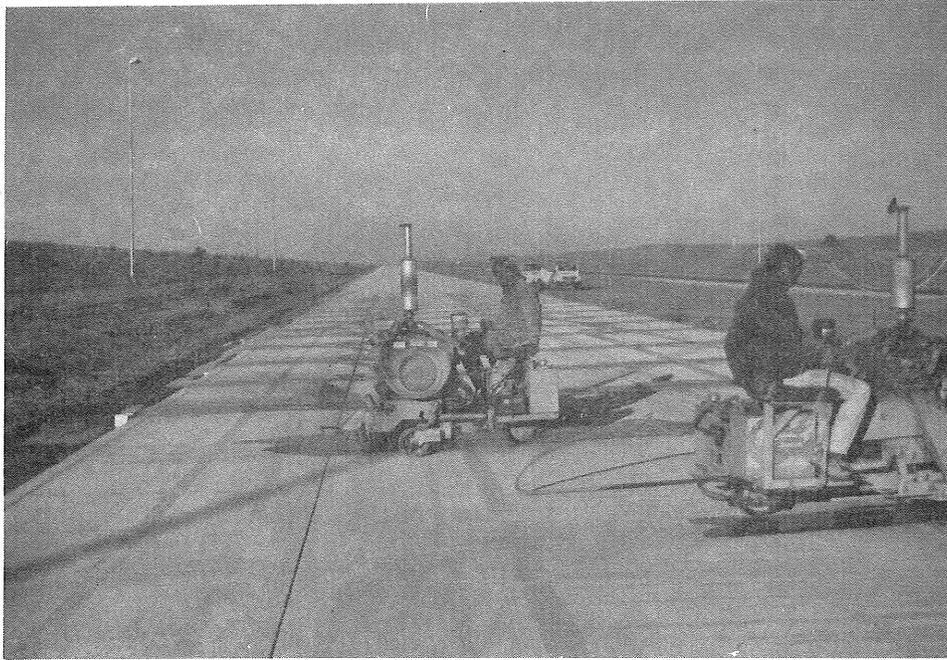
Figure 5 - Primary Saw Cutting Using Riding Saws

The plain concrete pavement for this project was placed on February 13, 1991. The contractor began sawing the 4.333-inch (T/3) deep primary cut as soon as the concrete attained an age at which extensive raveling did not occur. Primary cutting was performed on February 13, and 14, 1991. Secondary cuts were sawn on February 15, 1991. All joints were cut using riding saws (Figure 5). The various sealant reservoirs were formed after all primary transverse joints were cut for a section.

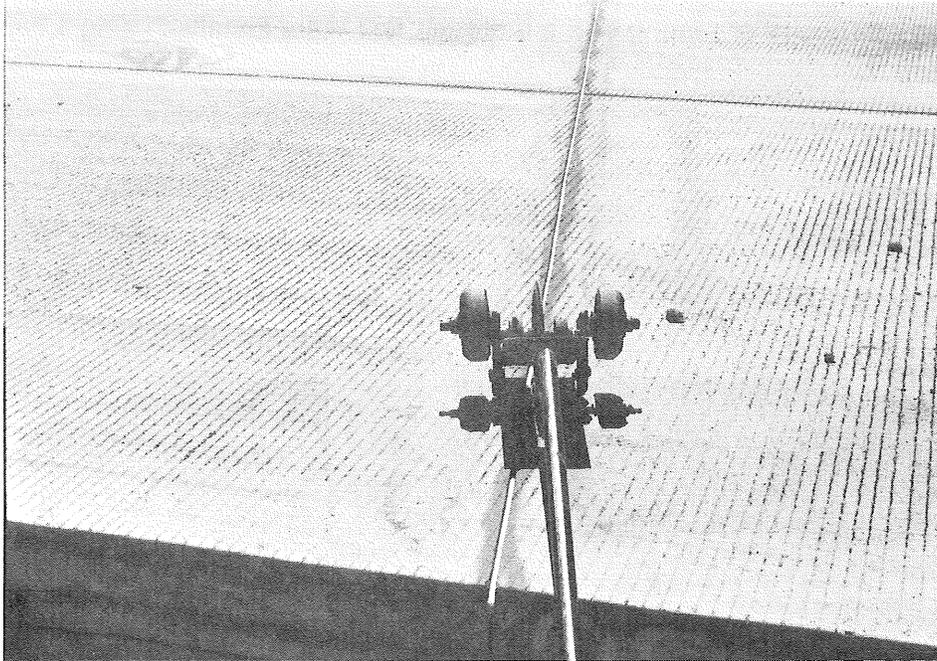
Figure 7 - Tool Used to Place Backer Rod

should not be a cause of concern as long as they have the proper size. All backer rods were placed without any difficulty or tearing of the material, and were installed using a backer rod tool as shown in Figure 7.

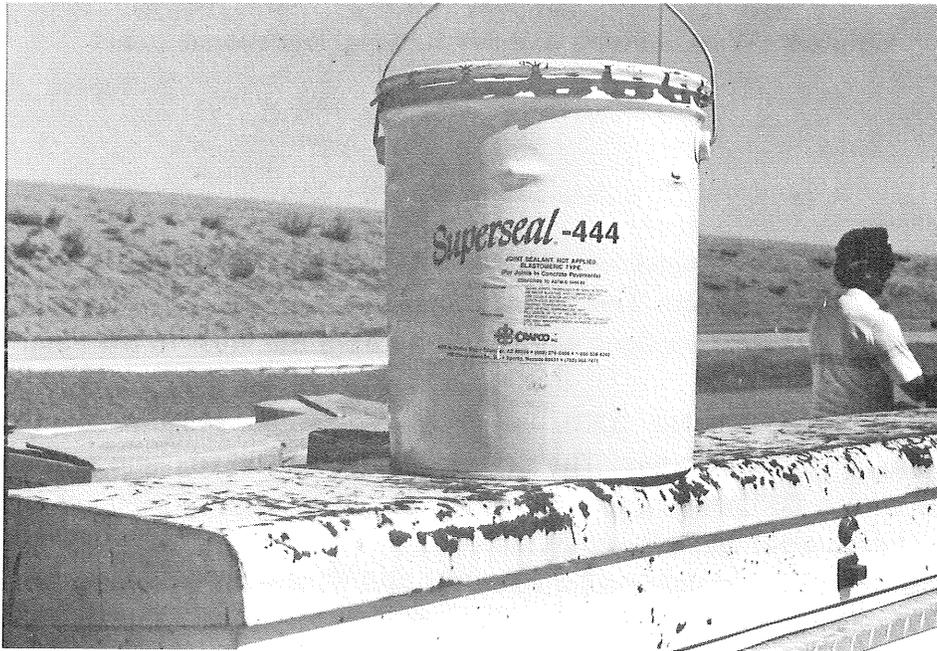
Figure 8 - Container of Crafcro Superseal - 444 Joint Sealant.

The Crafcro 221 and 444 (Lot No. 323), Figure 8, hot-poured sealants were placed using equipment and personnel from Crafcro. The Crafcro 444 was installed using a Crafcro applicator (E-Z pour model) with a 200 gallon capacity (Figure 9). Because of equipment problems, Test Section No. 23 (Crafcro 444) was placed by the contractor (Figure 10). The temperature of the Crafcro 444 at time of placement varied from 255°F to 260°F, and the air temperature varied from 69°F to 79°F. The temperature of the Crafcro 221 at time of placement varied from 400°F to 410°F, and the air temperature varied from 72°F to 74°F. A significant amount of bubbles was observed on the surface of the joints for both sealants at the time of placement.

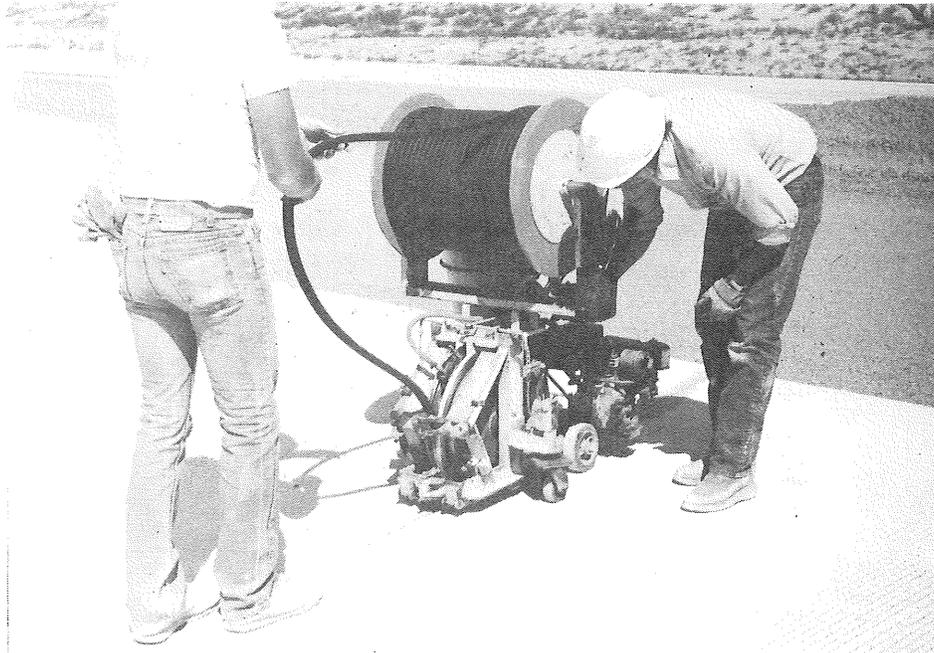
Figure 11 - Installation of Compression Seal Using A Delastall Auto Installer.

The Delastic V-687 (Lot No. 0190160) and Watson Bowman WB-687 and WB-812 compression seals were installed using a Delastall Auto Installer (Figure 11). The compression seal was initially started by hand and then installed with a machine. The last foot of the compression seal was also installed by hand. Final placement of the compression sealer was performed using hand methods (Figure 12). The Delastic V-687 was installed at air temperatures between 72°F to 81°F.

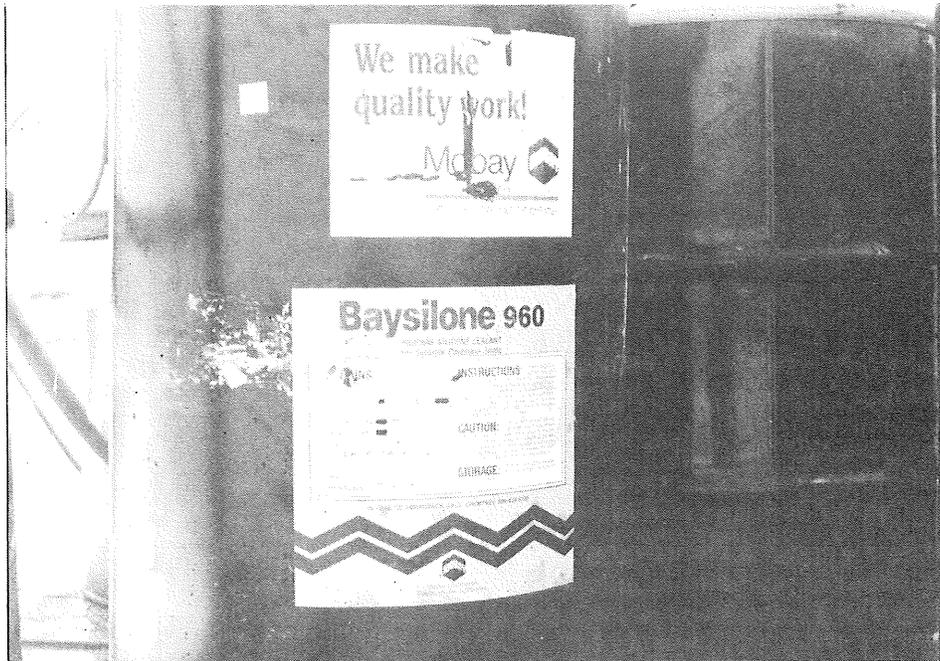
Figure 13 - Container of Mobay Baysilone 960 Joint Sealant

The Crafcoc Silicone S.L., Dow 890 S.L. (Lot No. ET110047), Dow 888 S.L., and Mobay Baysilone S.L. (Lot No. 56191), Figure 13, self-leveling sealants were placed with a standard joint sealant pump at a pressure varying from 60 to 75 psi, Figure 14. The longitudinal joints in which Dow 890 S.L. was used in the transverse joints (Joint Details 3 and 4) were sealed first. This was necessary because a smaller tip was required for sealing the transverse joints than the longitudinal joints. A standard hot-pour tip was modified to produce this smaller tip, Figure 15. No skinning of the surface of the longitudinal joints was observed before sealing of the transverse joints was completed. Air temperatures at the time of sealant application varied from 61°F to 73°F. A few bubbles were observed on the surfaces of the sealants in sections 6, 10, 16, 18, and 19.

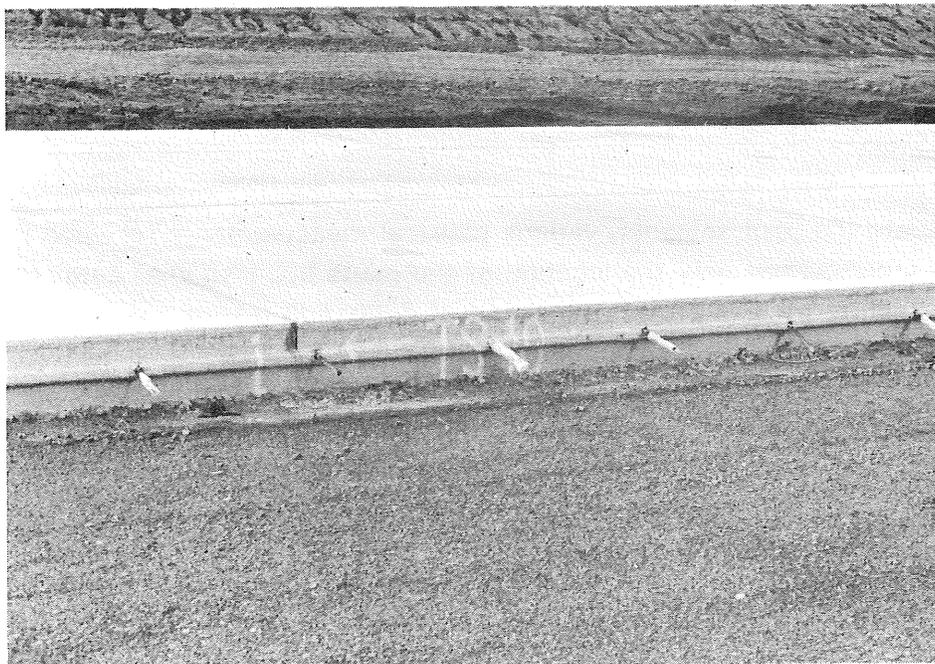
Figure 16 - Subgrade and Aggregate Base Prior to Storms

The PCC for this highway project was placed in widths less than full roadway. This placement method left the adjacent subgrade exposed to the environment (Figure 16). Normally, this is not a problem since the adjacent pavement will be placed after a short period of time. For this specific roadway, several storms occurred before the adjacent concrete was placed. The runoff water from the storms caused some undermining of the subgrade and aggregate base beneath the existing concrete pavement. This condition can be seen in Figure 17. Corrective action was taken by the Contractor to rehabilitate this erosion condition.

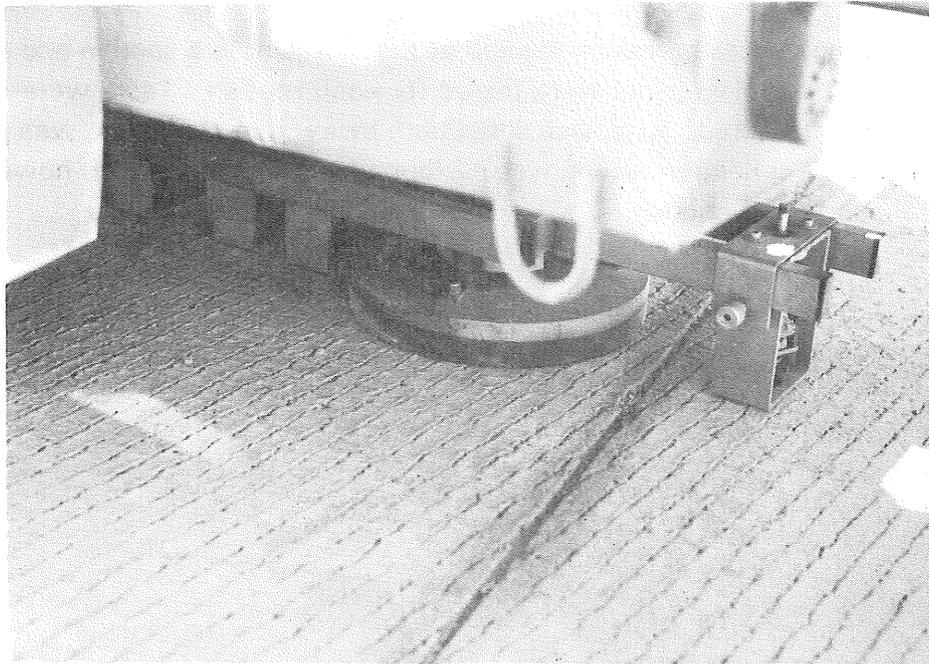
Figure 19 - FWD Load Applied Adjacent to Joint

FWD testing was conducted at three load levels ranging from approximately 9,000 lbs to 17,000 lbs. Data were reduced by normalizing deflections to a 9,000-lb load. Load transfer efficiency was obtained by dividing the measured deflection across the joint from the load by the measured deflection at the load, and applying a bending correction obtained from midslab deflection testing.
