REPORT NUMBER: FHWA-AZ94-386

TEST AND EVALUATION OF ARIZONA SLIP-AWAY BASE LUMINAIRE SUPPORTS

Final Report

Roger P. Bligh, P.E.
Hayes E. Ross, Jr., P.E.
D. Lance Bullard, Jr.
Texas Transportation Institute
The Texas A&M University System
College Station, Texas 77843-3135

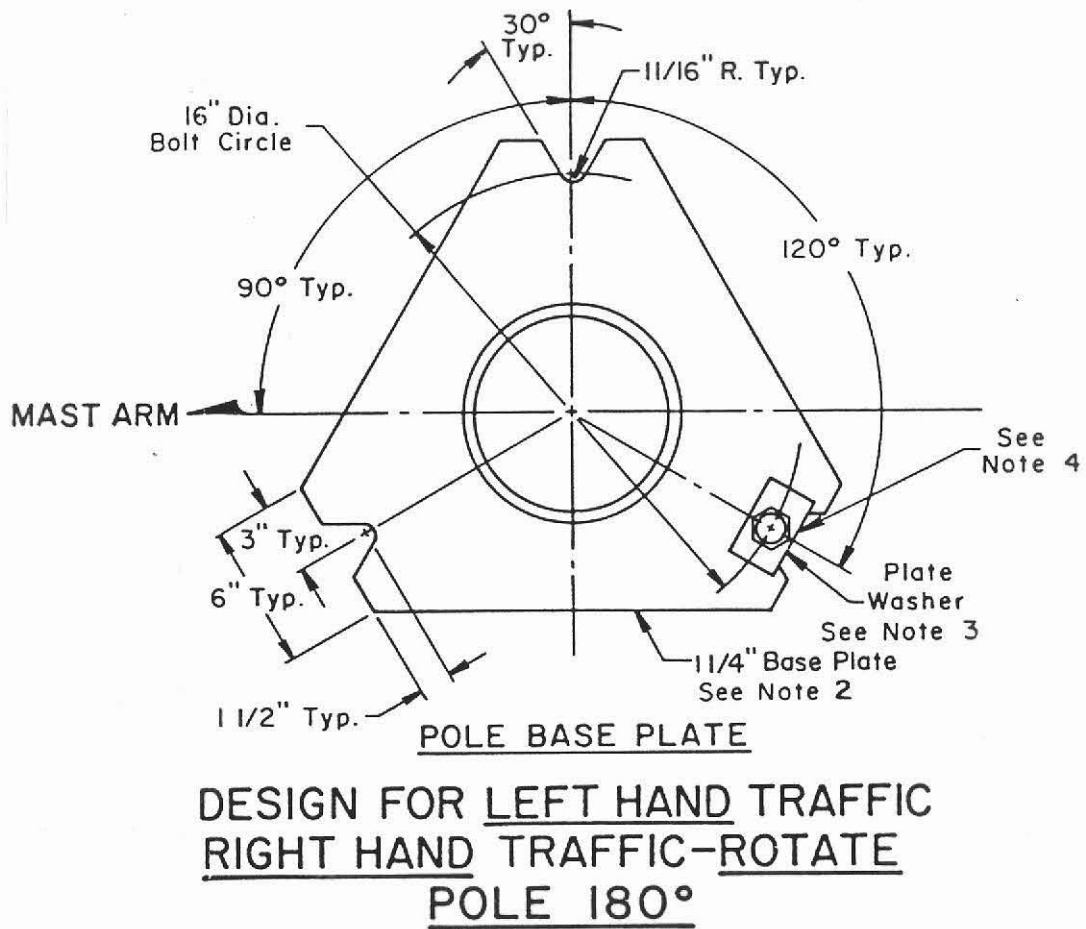
Figure 2. Plan view of slip-plate base.

The base plate of the luminaire support pole, shown in Figure 2, was a three-bolt, omnidirectional design with a 0.4 m (1.3 ft) diameter bolt circle. The base plates were constructed from 69.9 mm (2.8 in) thick steel plate. Placed between the foundation and support pole slip-away base plates and on both ends of the slip-plate bolts were 7.9 mm (.3 in) x 92.1 mm (3.6 in) x 57.2 mm (2.3 in) plate washers. A 28-ga keeper plate was used to aid in retaining the slip-base bolts. The slip-base bolts were torqued to 281.8 N-m (208 ft-lb) in accordance with ADOT standards.

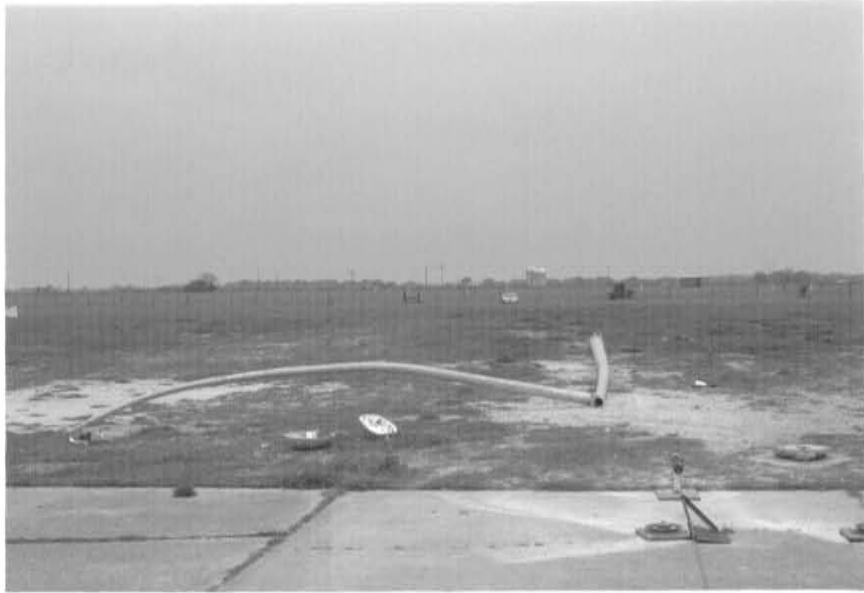
As shown in Figure 9, the luminaire support sustained considerable damage. Both the support pole and mast arm were bent and would require replacement, as would the luminaire which became detached from the mast arm and shattered on the ground surface. As shown in Figure 10, damage to the foundation base plate caused from contact with the vehicle's undercarriage was relatively minor and would not necessitate repair.

Figure 9. Slip-away base luminaire support installation after test 472360-1.

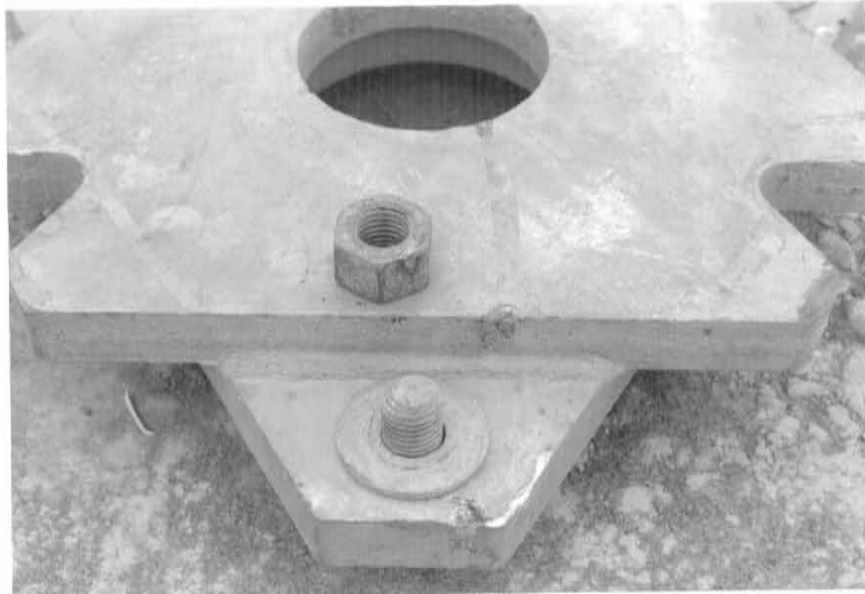
Figure 10. Damage to slip-base (test 472360-1).

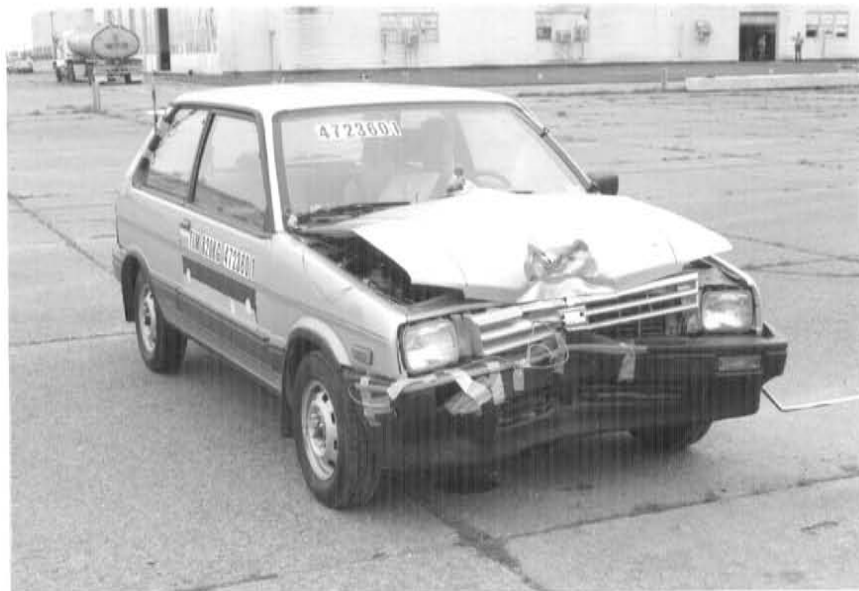
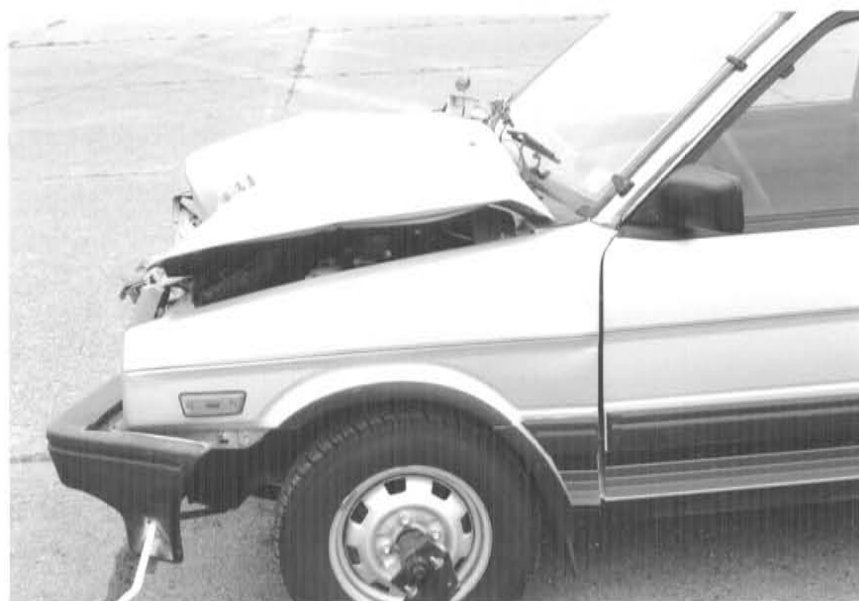
Exterior body damage sustained by the vehicle during the impact is shown in Figure 11. There was damage to the front bumper, grill, hood, and radiator. A maximum crush of 240 mm (9.4 in) was recorded at the front center of the vehicle. As shown in Figure 12, the front stabilizer bar and oil pan were bent from contact with the front anchor bolt of the foundation base plate assembly. There was no deformation or intrusion into the occupant compartment of the vehicle.

Figure 11. Vehicle after test 472360-1.

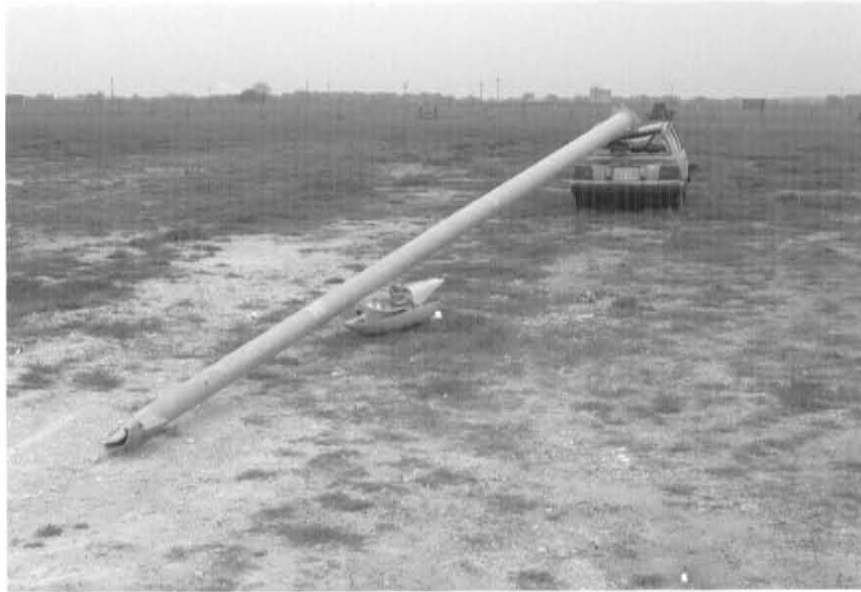
As can be seen in Figure 22, the support sustained minimal damage from the impact. The mast arm became detached from the luminaire pole due to contact with the ground, and the top of the pole was deformed.

Figure 22. Slip-away base luminaire support installation after test 472360-2.

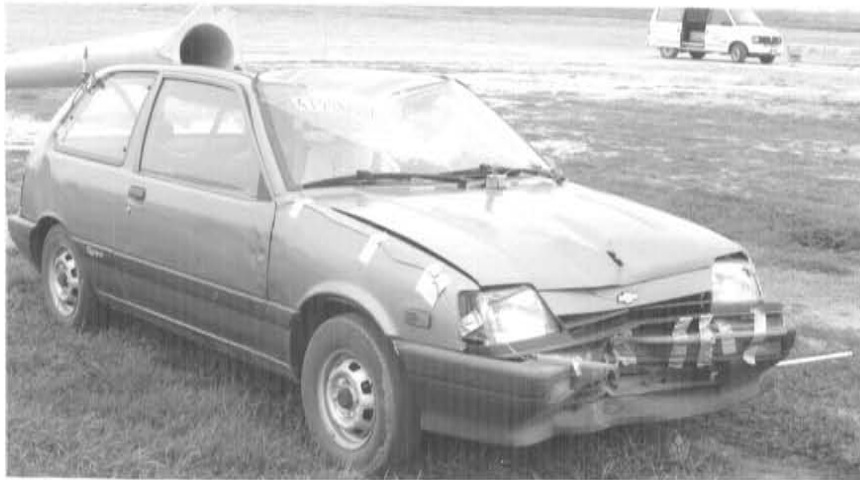
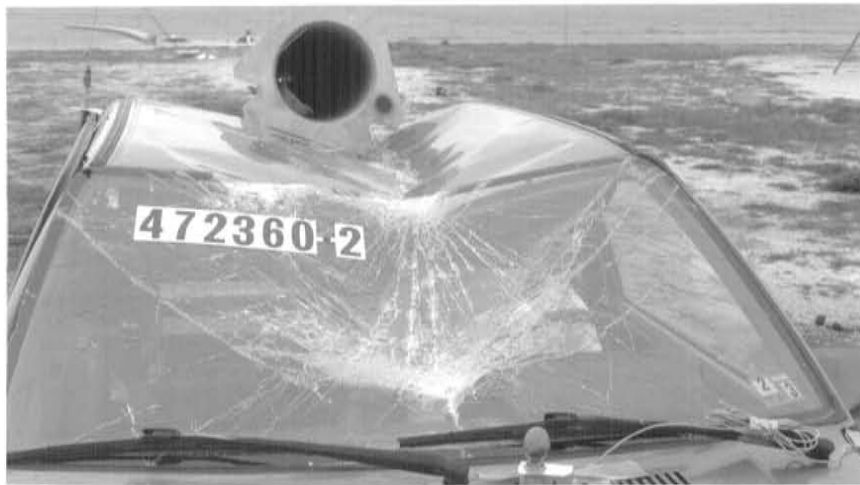
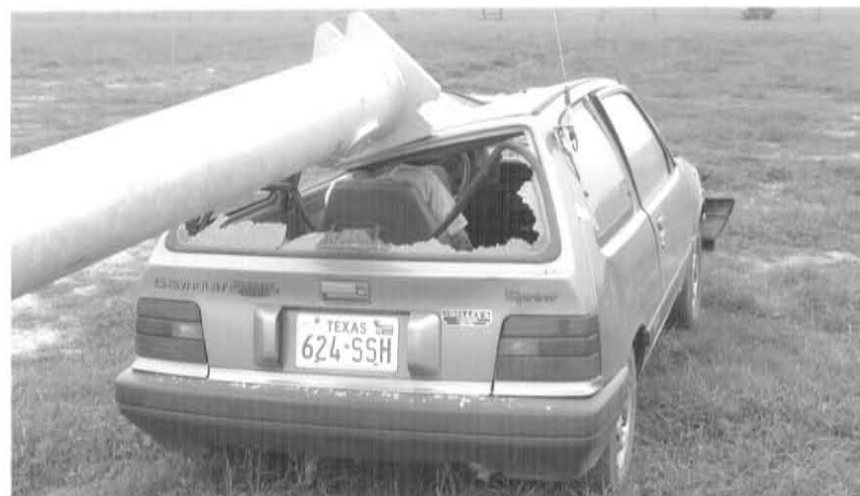
Figure 23 shows the damage to the test vehicle. The vehicle received a maximum crush of 200 mm (7.9 in) at the front center of the vehicle. The crush sustained to the roof spanned an area of 1000 mm (39.4 in) wide x 1500 mm (59.1 in) long, with the maximum depth of penetration measured to be 165 mm (6.5 in) at the aft edge of the roof. The crush sustained by the roof was sufficient enough to cause the A, B, and C pillars to be bent inward on both sides

Figure 23. Vehicle after test 472360-2.

of the vehicle. Additionally, the vehicle sustained damage to the front bumper, grill, hood, and rear hatch.

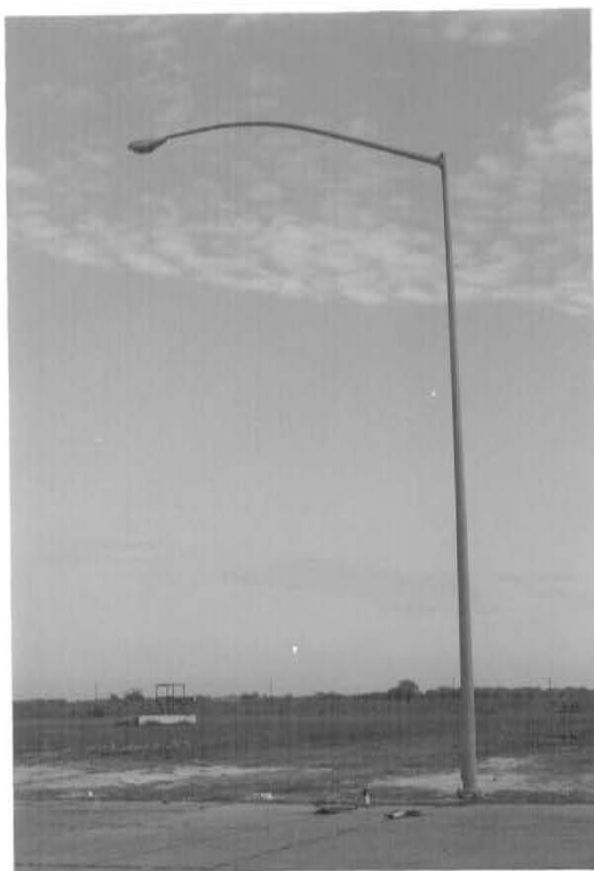
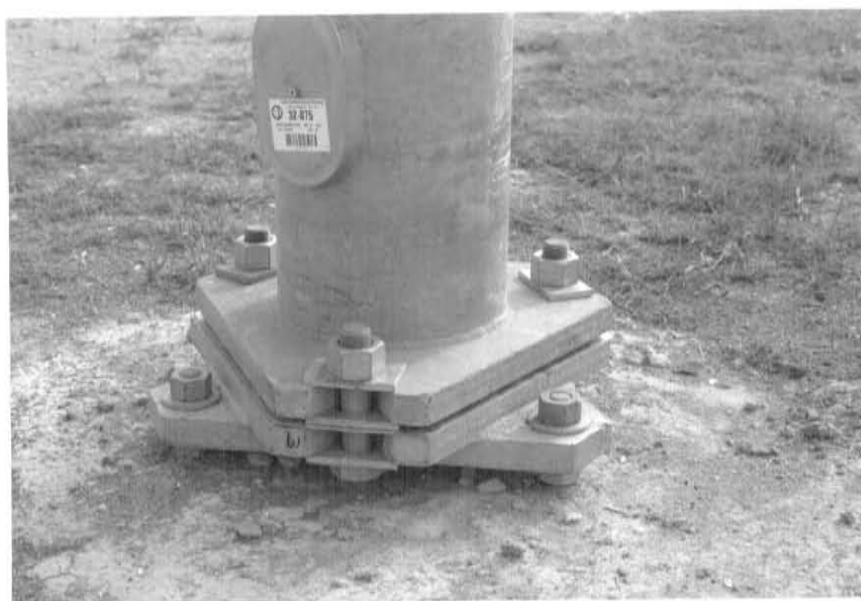
Since the 13.7-m (45-ft) luminaire pole was found to be deficient, it was decided to evaluate the impact performance of the next most critical system which is ADOT's standard 12.2-m (40-ft) constant tapered pole. Except for the length, the support pole was similar in design and construction to the previously tested 13.7-m (45-ft) pole. As with the prior test installation, a 6.1 m (20.0 ft) tapered mast arm and luminaire were attached to the luminaire pole. The pole base plate, foundation base plate, and concrete footing were identical to those used in the previous test installation as detailed in Figures 2 and 3. The three slip-base bolts were torqued to a value of 281.8 N-m (208 ft-lb) in accordance with ADOT standards. The total weight of the system, which included the pole, pole base plate, mast arm, and luminaire, was measured to be 385.6 kg (850 lb). Photographs of the completed test installation are shown in Figure 29.

Figure 29. 12.2-m (40-ft) Arizona slip-away base luminaire support.

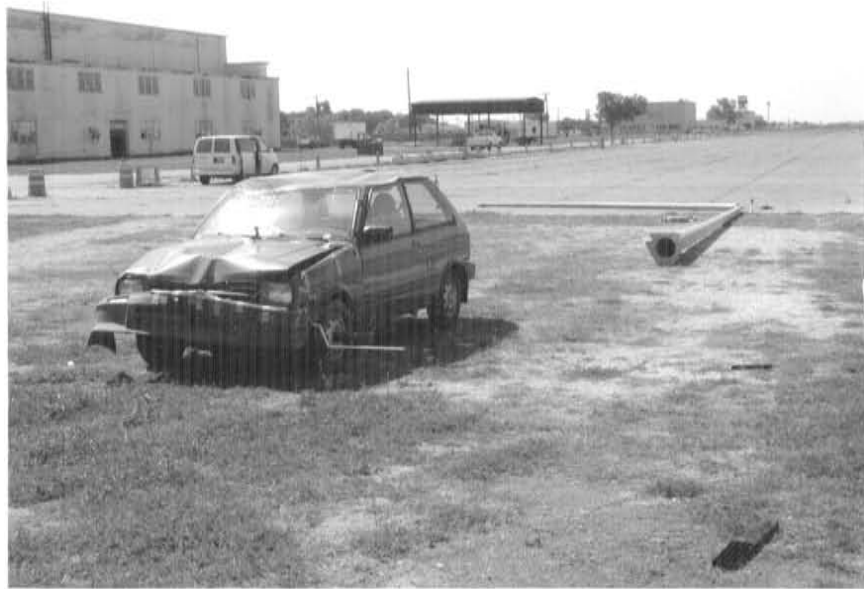
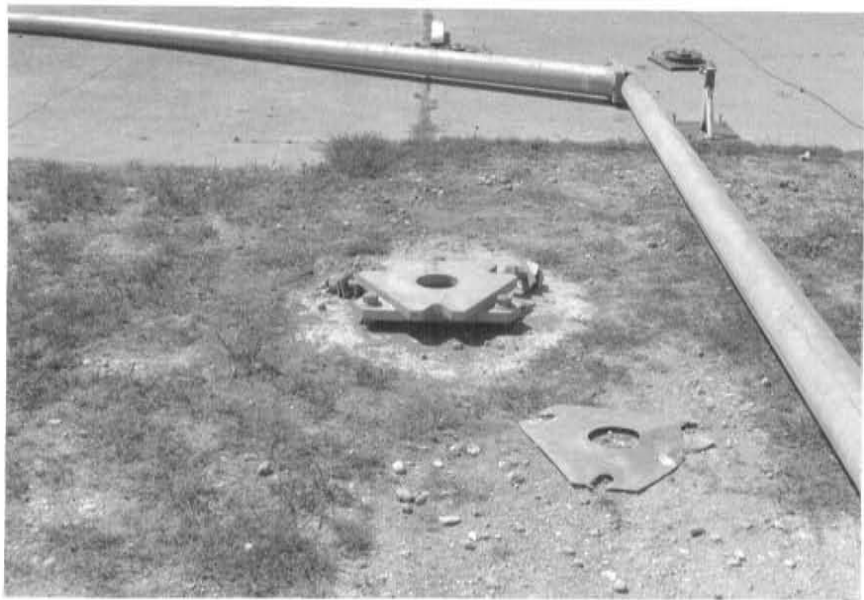
The post-test positions of the luminaire support and test vehicle are shown in Figure 34. With the exception of the luminaire, which released from the mast arm and shattered on the ground, the luminaire support was essentially undamaged. Exterior body damage sustained by the vehicle is shown in Figure 35. The vehicle received a maximum crush of 55 mm (2.2 in) at the front center of the vehicle and 120 mm (4.7 in) on the roof. There was also damage to the front bumper, grill, hood, windshield, and rear hatch. Damage to the roof is shown in Figure 36.

Figure 34. Slip-away base luminaire support installation after test 472360-3.

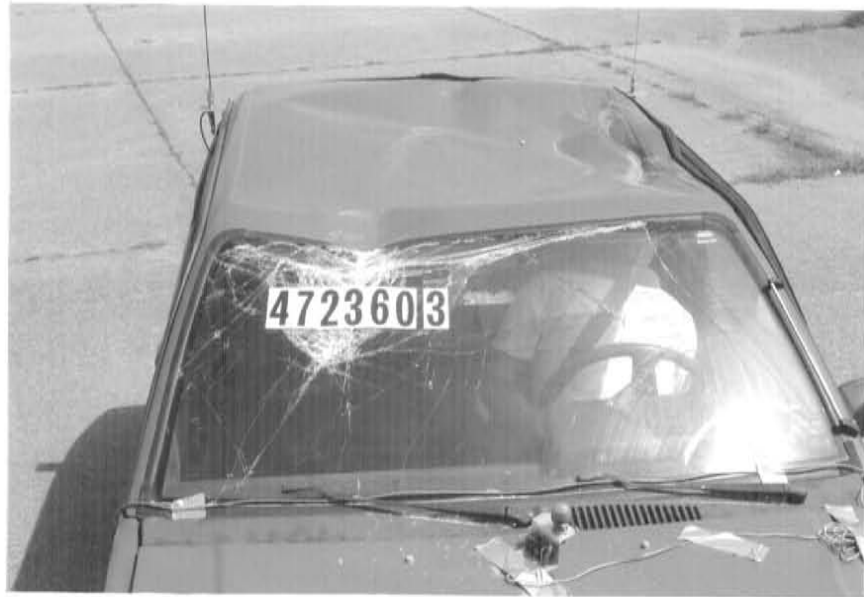
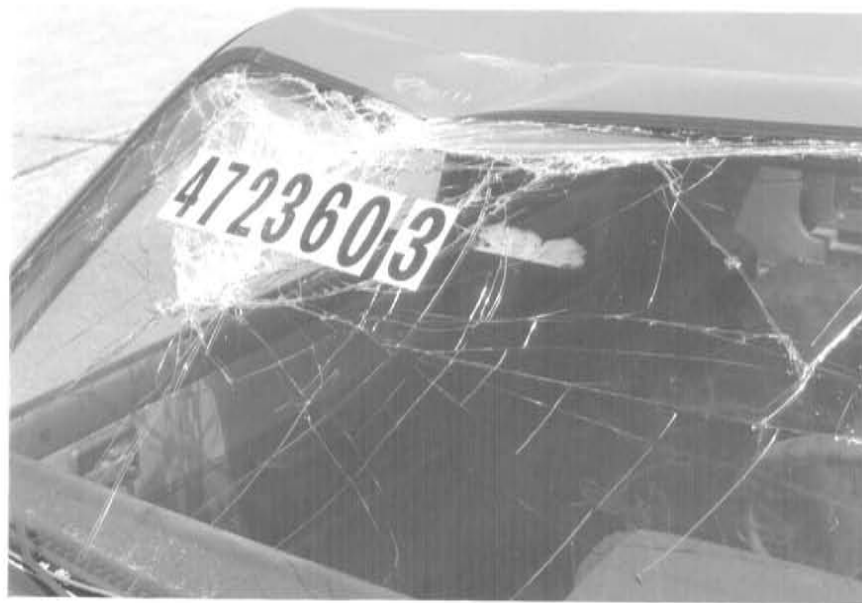
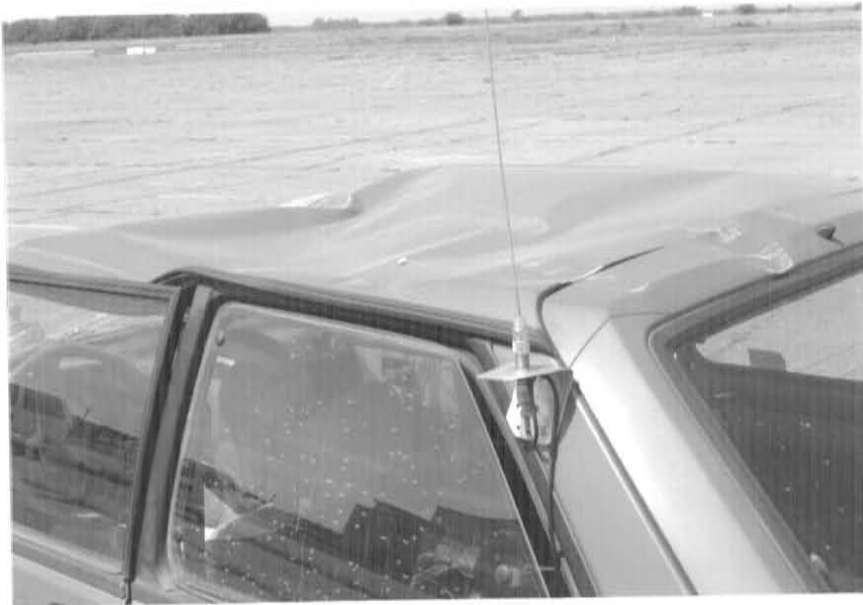
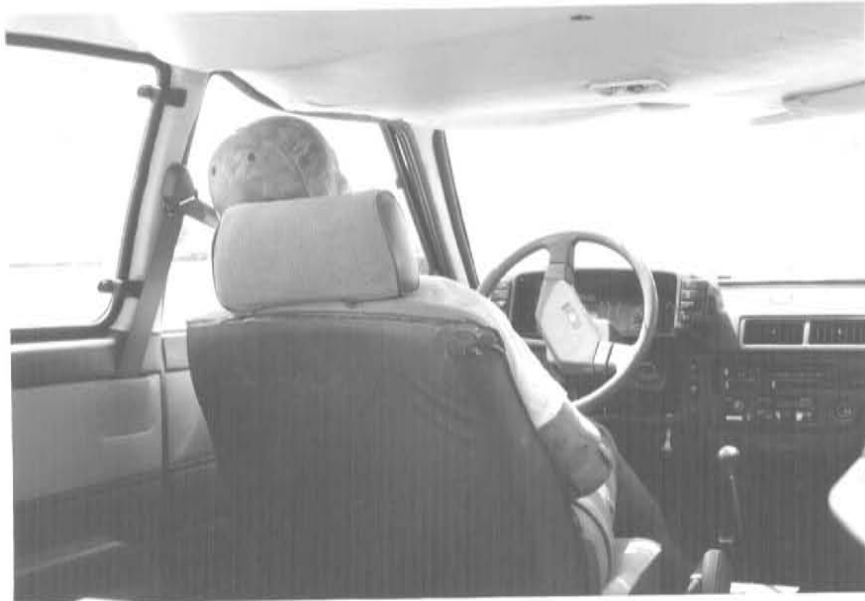
Figure 36. Damage sustained to roof of vehicle (test 472360-3).

Figure 36. Damage sustained to roof of vehicle (continued).

In a similar review of the test conducted on the 12.2-m (40-ft) luminaire support, FHWA concurred with the researchers that the system was acceptable. The maximum roof crush of

120 mm (4.7 in.) was within the acceptable range as defined by previously accepted systems, and the extent of damage was much more localized than in the previous test of the 13.7-m (45-ft) system. A copy of the response letter from FHWA which cites these opinions is included as Appendix A of this report.

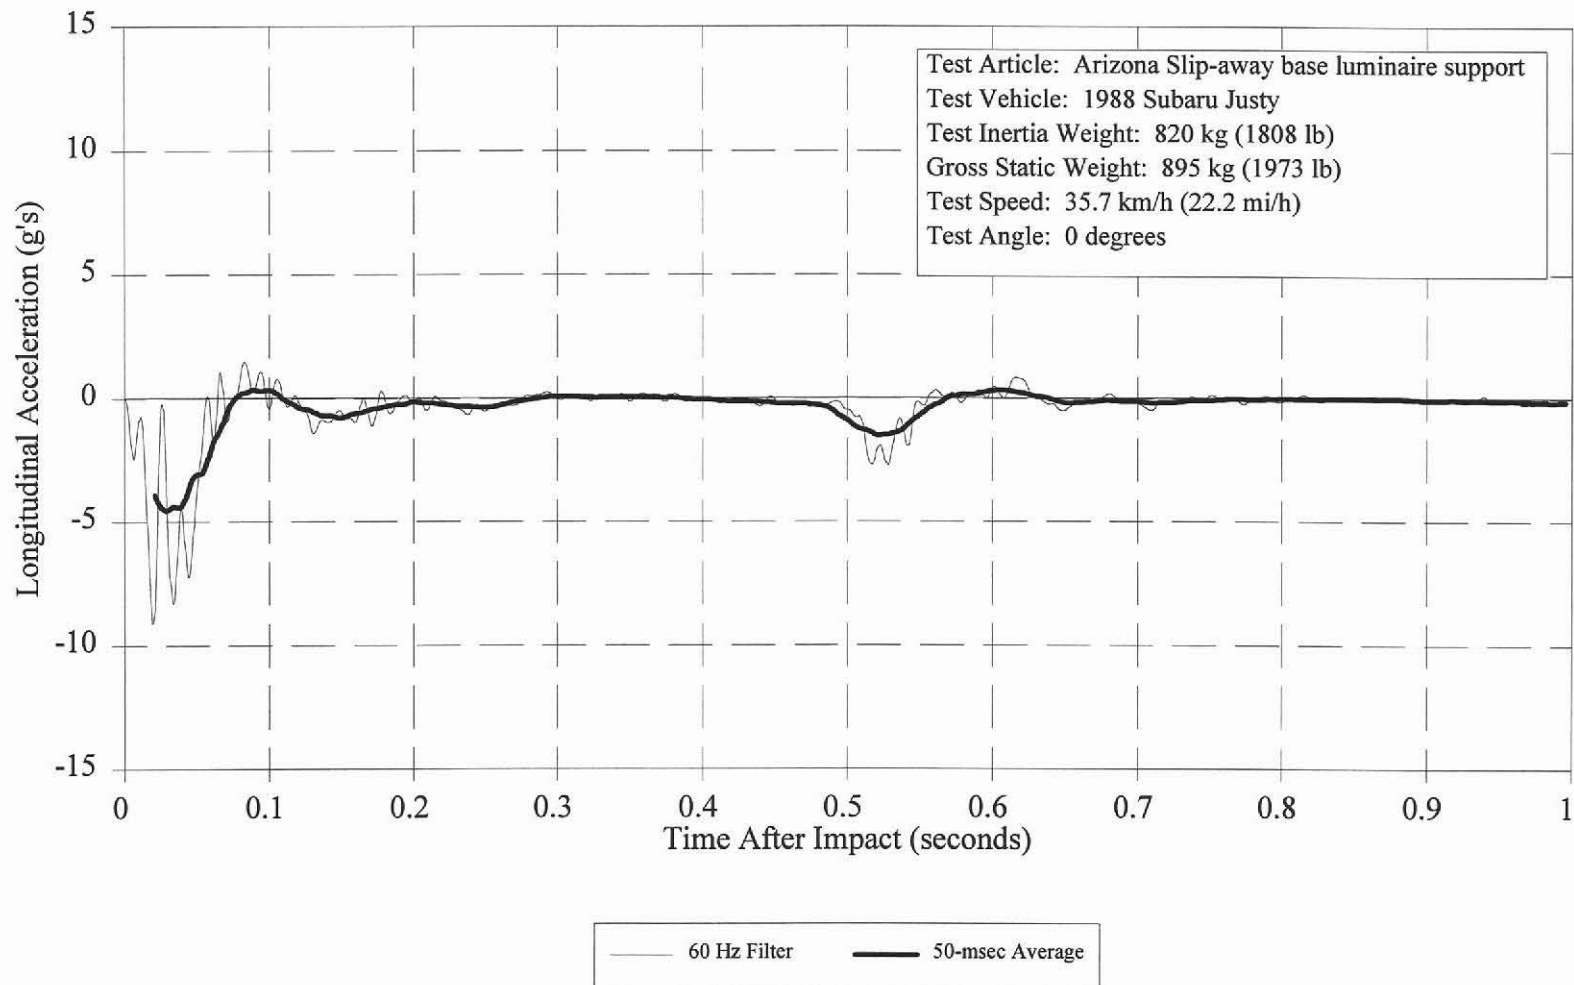
Data from the accelerometer located at the center-of-gravity were digitized for evaluation of occupant risk and were computed as follows. In the longitudinal direction, occupant impact velocity was 2.8 m/s (9.3 ft/s) at 0.280 s, the highest 0.010-s average ridedown acceleration was -2.4 g between 0.523 and 0.533 s, and the maximum 0.050-s average acceleration was -4.6 g

Figure 39. Vehicle longitudinal accelerometer trace for test 472360-3.

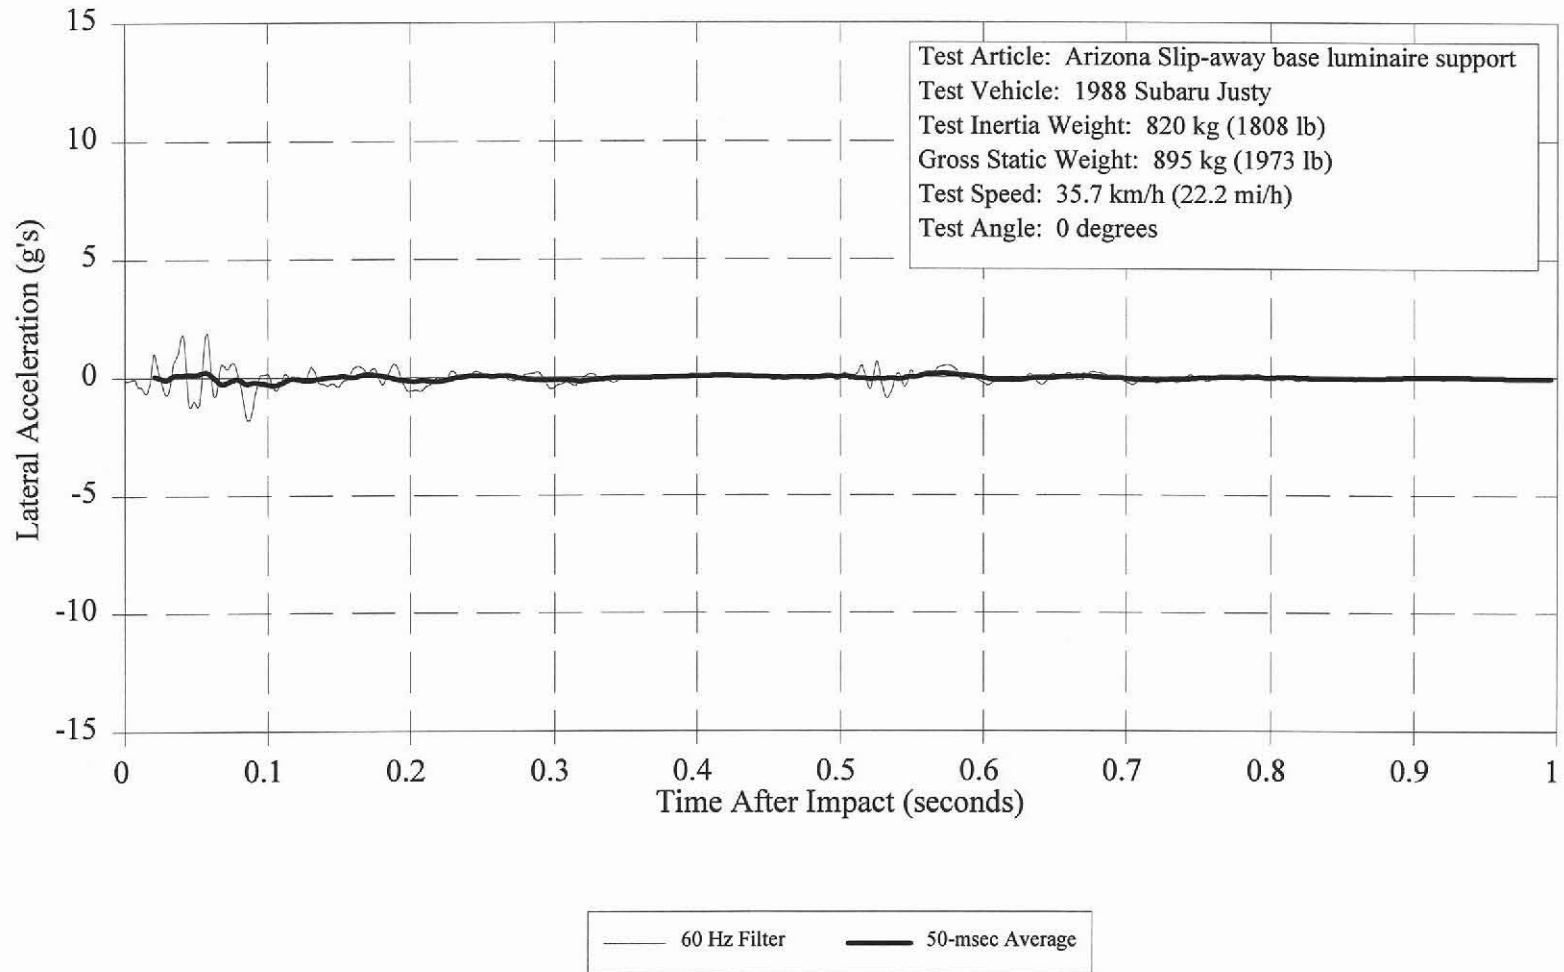
Figure 40. Vehicle lateral accelerometer trace for test 472360-3.
