Evaluation of the Effectiveness of Wildlife Guards and Right of Way Escape Mechanisms for Large Ungulates in Arizona

Arizona Department of Transportation Research Center

SPR-729

September 2020

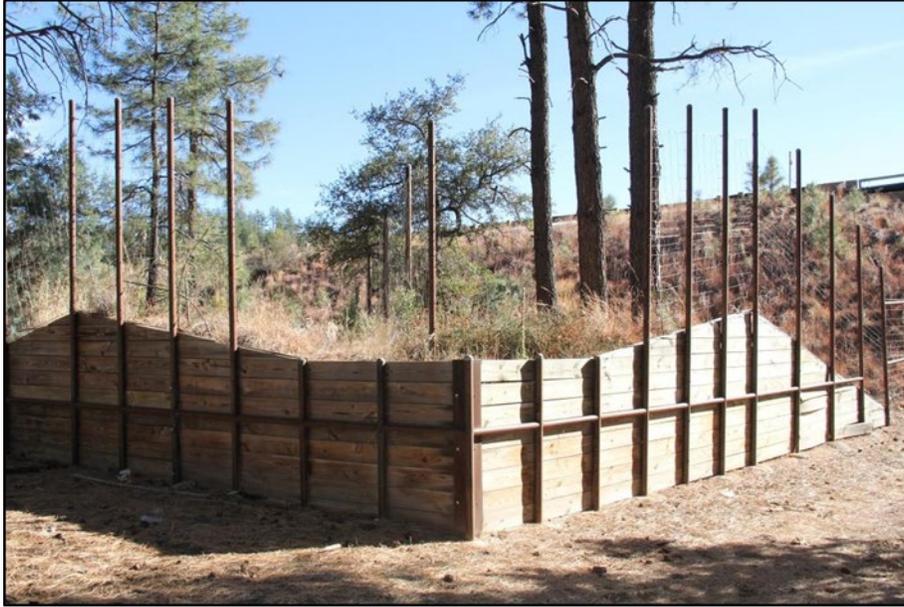
Figure 1. Wooden Escape Ramp

Wooden plank escape ramps used on the first phase of SR 260 presented maintenance issues as boards warped, allowing ramp fill material to erode and compromise the structure. These maintenance concerns prompted AGFD to work with ADOT to modify the escape ramp design, ultimately leading to a robust concrete retaining wall design that was implemented for the next phases of SR 260 and have so far withstood erosion. However, the effectiveness of these concrete structures as one-way escape mechanisms for elk and deer has not been evaluated.

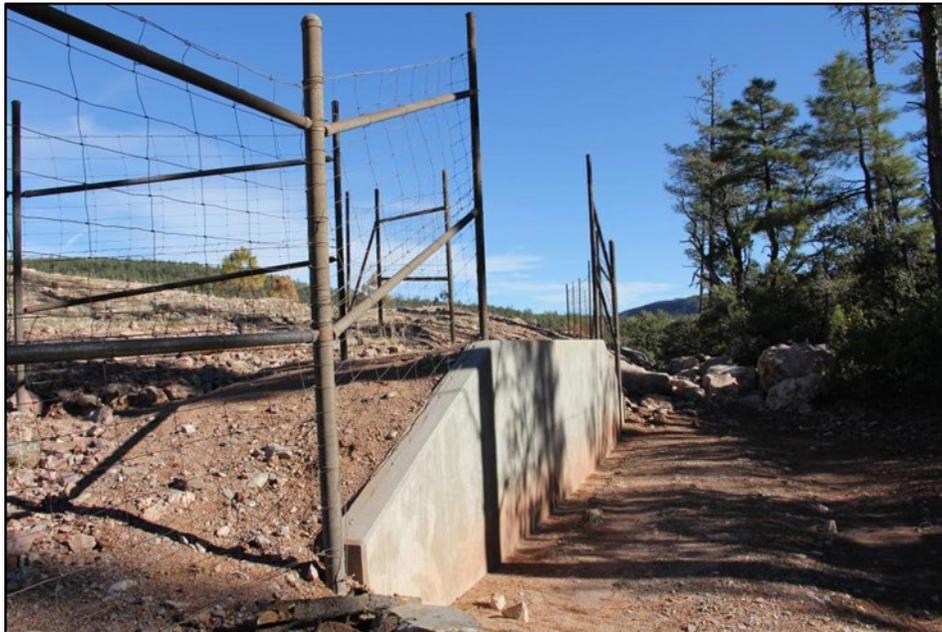
Figure 2. Concrete Escape Ramp

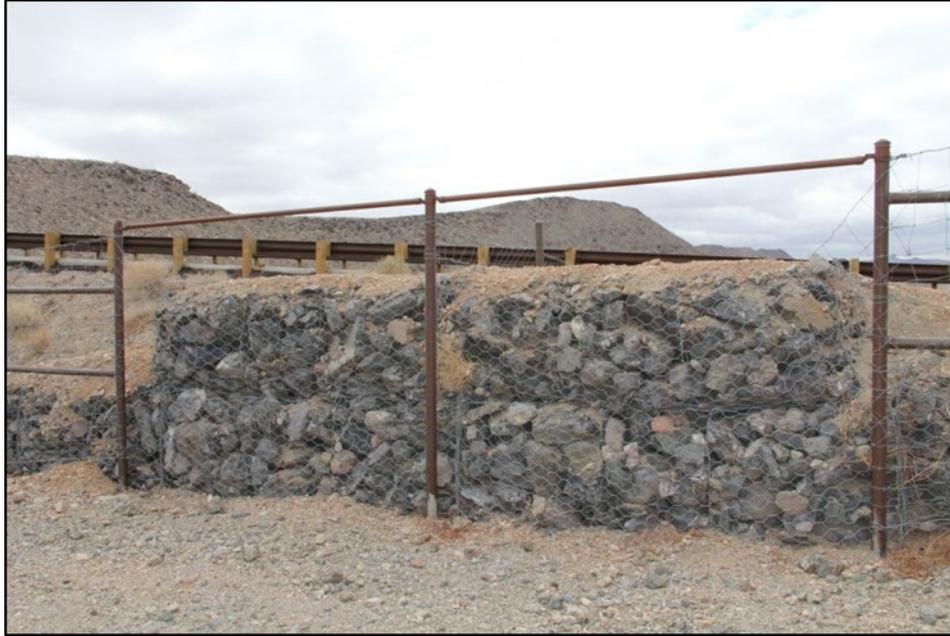
Figure 3. Gabion Basket Escape Ramp

In 2003, ADOT began experimenting with gabion basket escape ramp structures as an alternative to costly concrete designs along U.S. 93 (McKinney and Smith 2007). Gabion basket escape ramps consist of stacked wire mesh baskets filled with rocks (see Figure 3). Although the first gabion baskets were inexpensive, preliminary data indicated that the escape mechanism design was inadequate for preventing bighorn sheep from accessing the ROW, and researchers recommended increasing the ramp height in the future. The heightened versions were installed as escape mechanisms for bighorn sheep on U.S. 93 and for elk and mule deer on I-17. At both locations, soil retention partially failed, exposing the wire mesh along the leading edge of the ramp. This presented a maintenance problem and posed a danger to ungulates as their legs could become caught if they attempted to use the deteriorated escape mechanism (Gagnon et al. 2016, Gagnon et al. 2017a). To address soil retention issues, the gabion basket escape ramps installed on SR 260 in 2013 used a revised design to prevent backfill from sloughing off, incorporating fine wire mesh and landscape fabric into the approved design drawings. The installation was completed in fall 2013, and the updated design has yet to be evaluated.

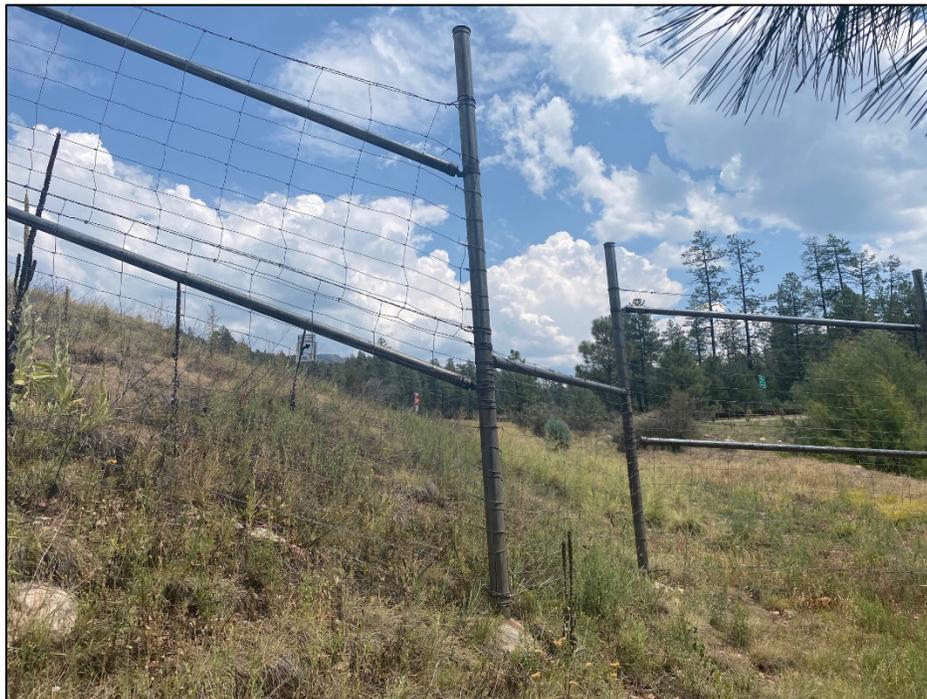
Figure 4. Slope Jump Escape Mechanism

a slope with the uphill side of the slope jump toward the highway and the downhill side away from the highway (see Figure 4). The premise of slope jumps is to take advantage of existing topography where physics would easily allow a deer or elk to jump down the slope (over a lowered segment of fence) and out of the ROW, but where the animal would have difficulty gaining enough momentum to jump up the slope (over the fence) and into the ROW (Gallagher et al. 2005). Presently, there are no empirical data regarding slopes and heights that effectively prevent ungulates from entering the ROW via slope jumps or using them to escape. The slope jumps along Arizona highways (SR 260 and I-17) are the first of their kind to be implemented; as such, they provide an opportunity to test the effectiveness of this design and determine its utility for future ADOT projects.

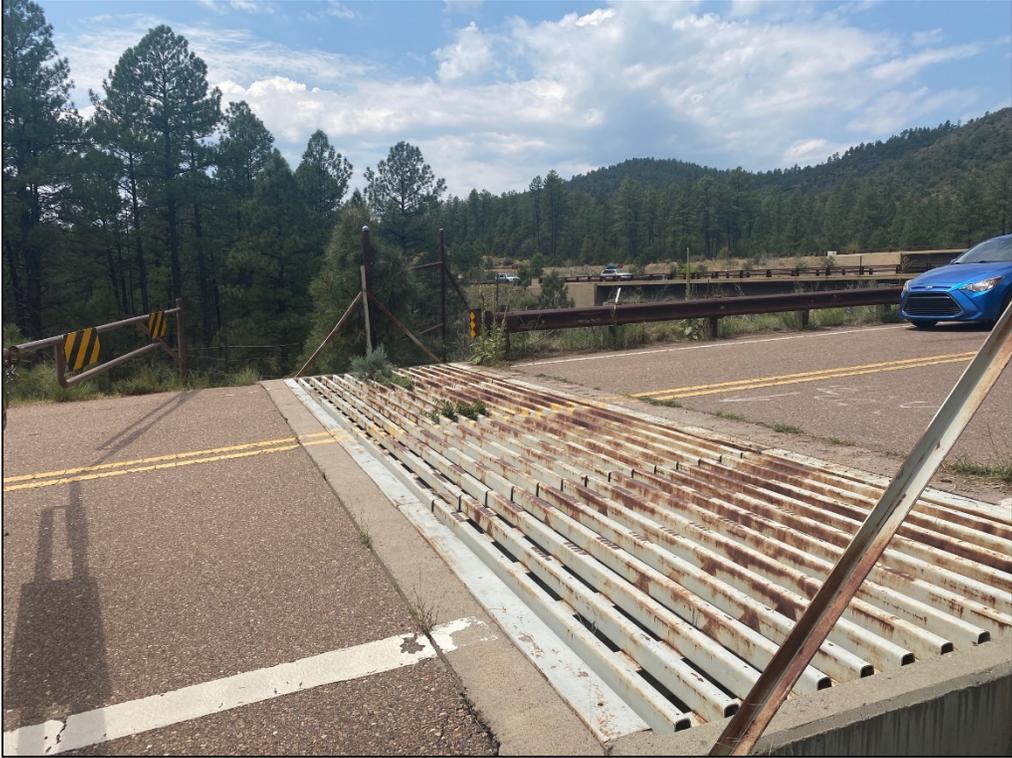
Figure 5. ADOT Standard Cattle Guard

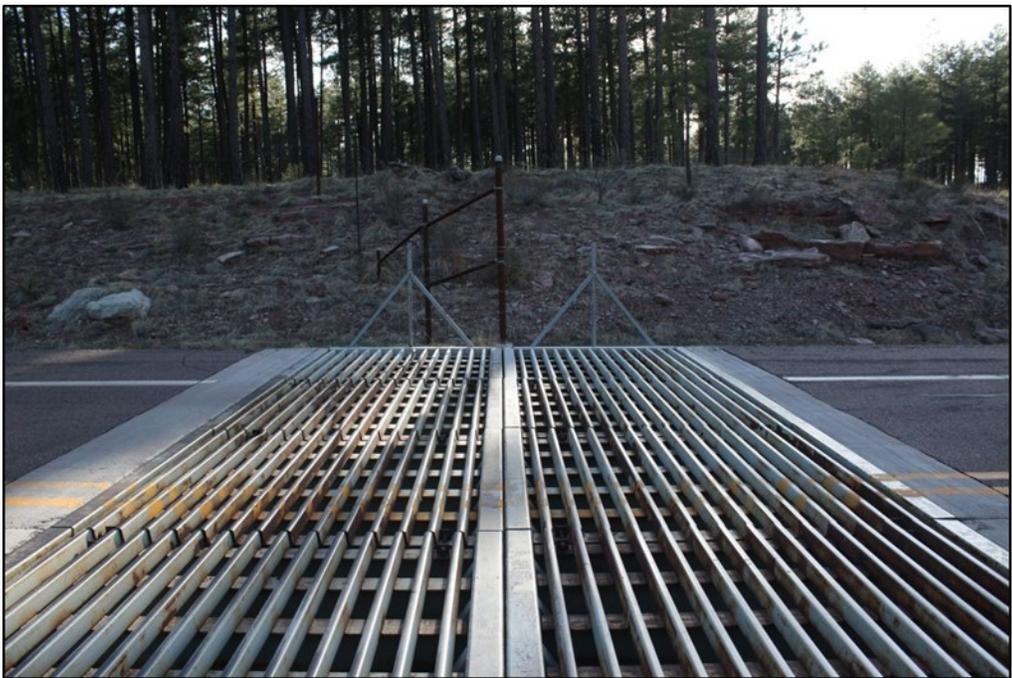
Figure 6. Two ADOT Standard Guards Installed Side-by-Side to Create a Double Cattle Guard

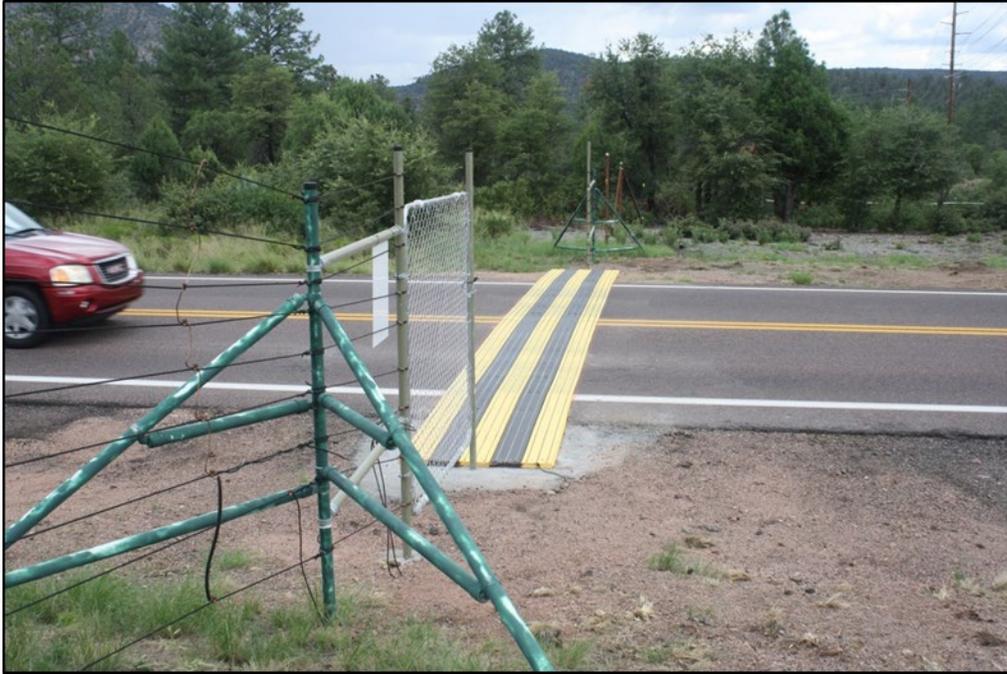
Figure 7. Electrified Mat

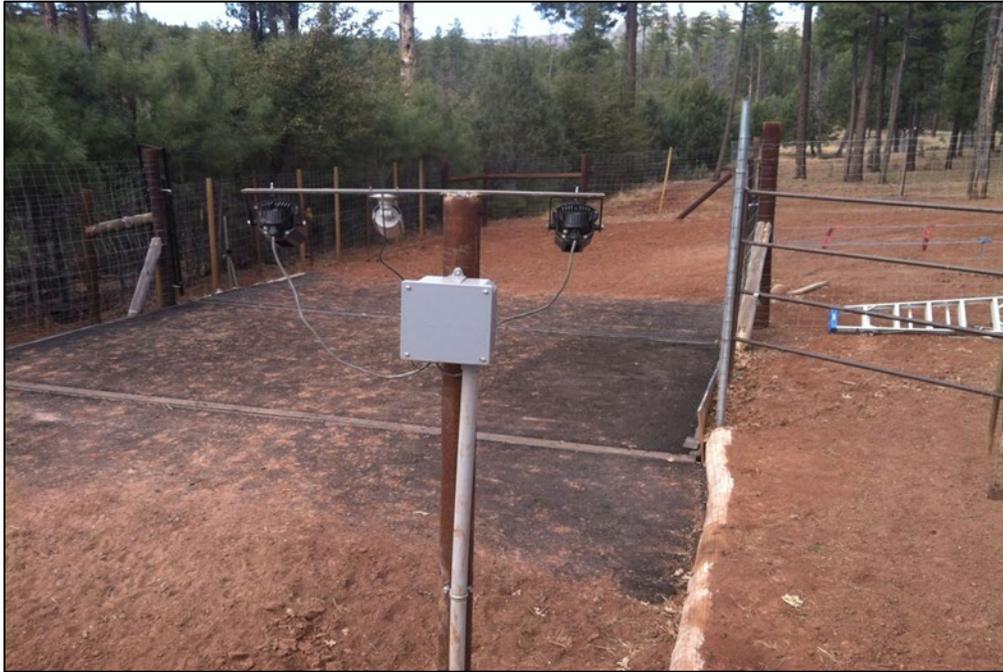
Figure 10. Video Surveillance Camera Orientation at a Wildlife Guard Treatment

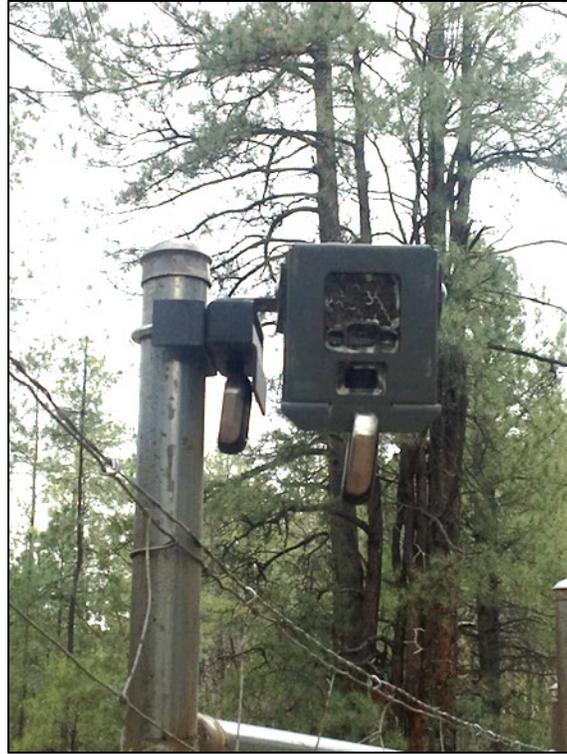
Figure 15. Camera Box Mounted to Wildlife Fencing

Researchers used Reconyx HyperFire still cameras, which use a motion sensor to detect animals and have a night vision feature to capture images in low lighting. Cameras were positioned to begin capturing images as animals approached the escape mechanisms from either inside or outside of the ROW (see Figure 16). Once an animal was detected, the camera captured a burst of three images each second until the animal left the camera's field of view. Because of the limitations of battery life and image storage capacity, cameras were checked approximately every six weeks to replace batteries, collect image data, verify that camera orientation was correct, and ensure that vandalism or theft had not occurred. Images were backed up twice to avoid loss in the event of storage equipment failure. If a camera was stolen or vandalized, researchers replaced the camera as soon as possible to minimize disruption in data collection.

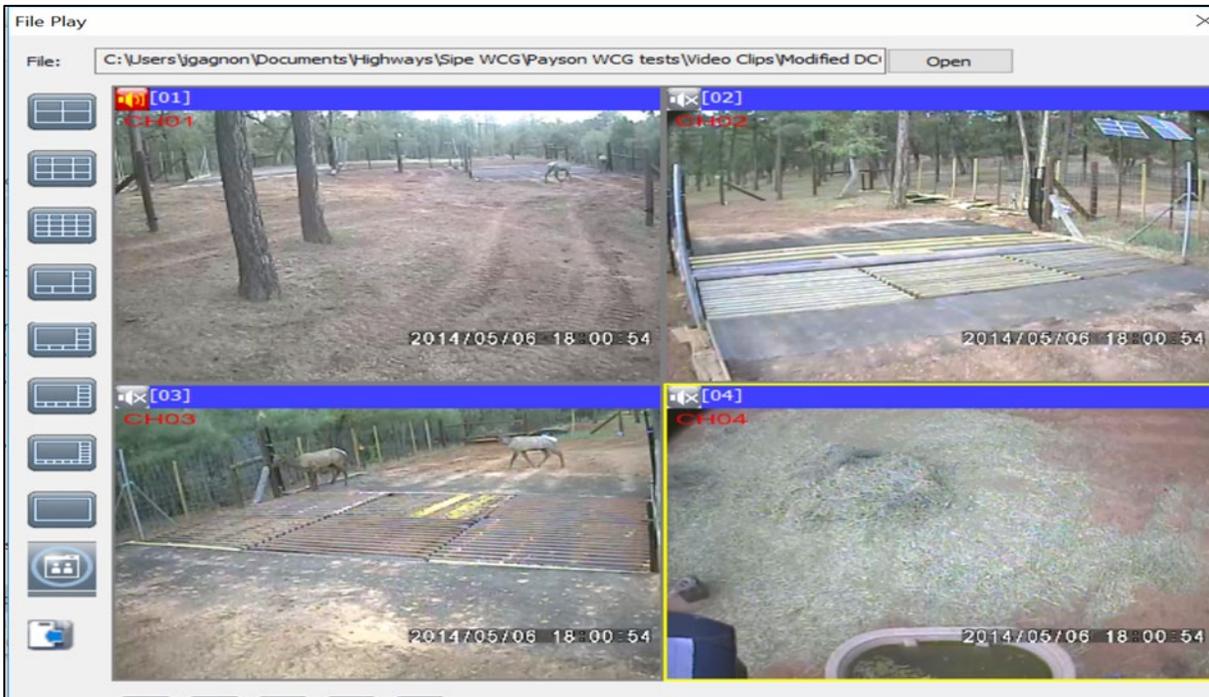
Figure 18. Video Camera Orientations Showing, top to bottom and left to right, (1) Entry Point into Test Site, (2 and 3) Wildlife Guard Treatments, and (4) Bait and Water

Four cameras were oriented to collect video when elk entered the test site and to document interactions with wildlife guards within the enclosure as elk attempted to reach bait and water on the other side of the wildlife guards at the back of the enclosure (see Figure 18). Infrared illuminators were activated via photocell to allow researchers to document elk activity during nighttime and low-light conditions. Cameras continued to record activity while elk were present and for two minutes after they left the enclosure. Cameras were checked approximately every two weeks to ensure correct camera and photo-beam orientation and to switch out the digital video recorder for image review.

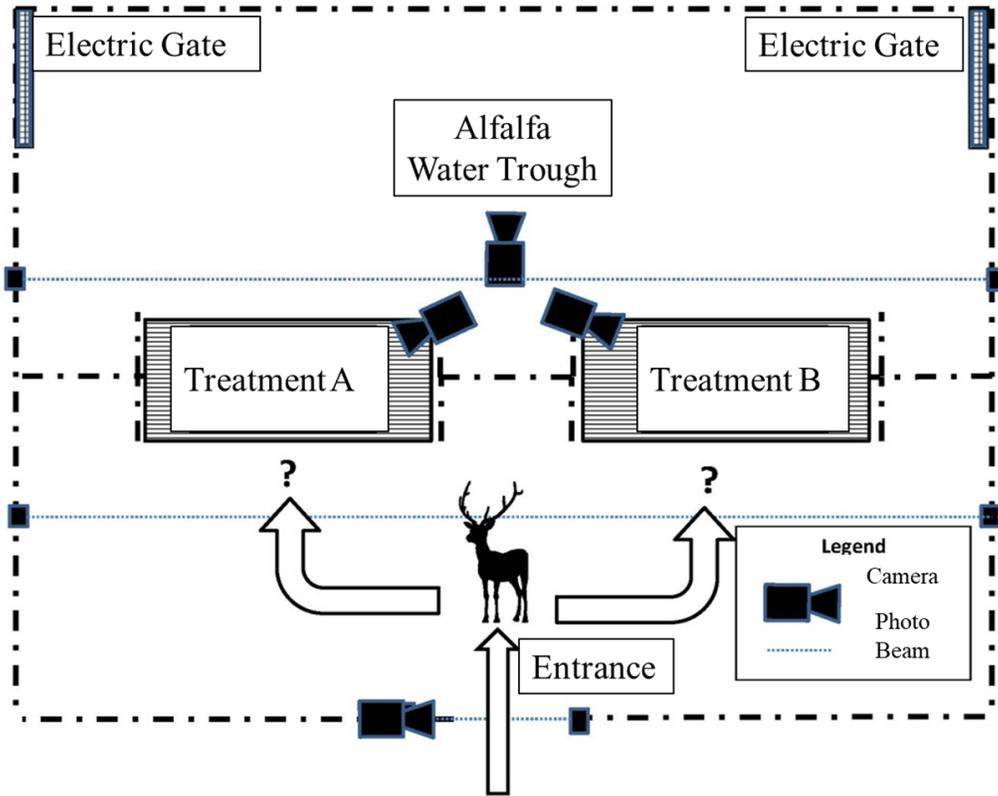
Figure 19. Layout of the Elk Wildlife Guard Test Site and Video Cameras at Risser Ranch

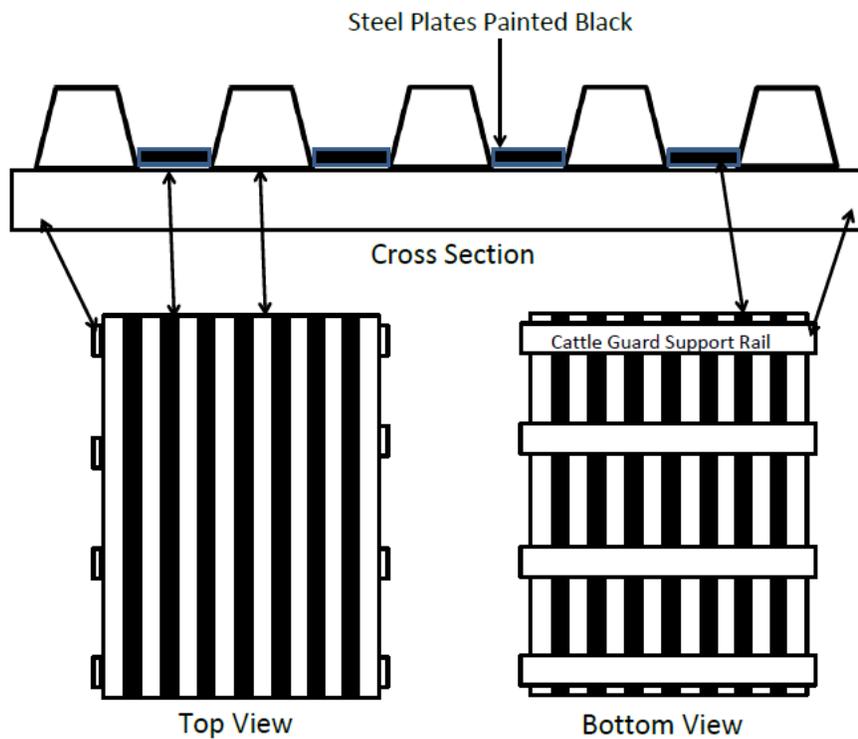
Figure 20. Cattle Guard Modified to Prevent Elk Injury, Showing Cross Section, Top, and Bottom Views

The evaluation and comparison of various combinations of wildlife guard types ended up being limited by the difficulty in implementing potential modifications to the guards and asphalt at the test site; thus, only selected comparisons were made. In addition, the test site evaluation of ADOT standard single and double cattle guards used modified versions of the guards created by CrossTek LLC. In these modified guards, welded black plates were placed inside the cattle guards to keep elk from falling all the way through the grates (potentially leading to injury) while still visually mimicking a cattle guard (see Figure 20).

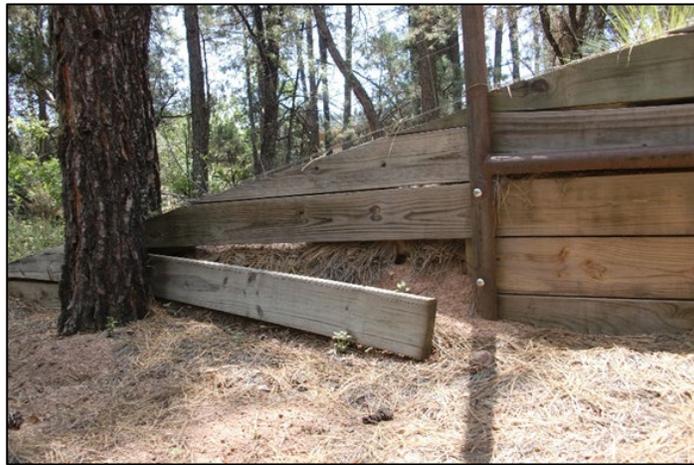
Figure 21. Escape Mechanism in Need of Maintenance

The research team collected photographic examples of maintenance and design concerns associated with various escape mechanisms and wildlife guards used in Arizona. One example is shown in Figure 21. In addition to maintenance and design issues, the research team also sought out examples of escape mechanisms and wildlife guards from other states. These examples were combined and used to help inform current maintenance decisions and recommendations for possible future design changes that would maximize wildlife use and minimize maintenance needs. These issues are discussed in detail in Chapter 4.

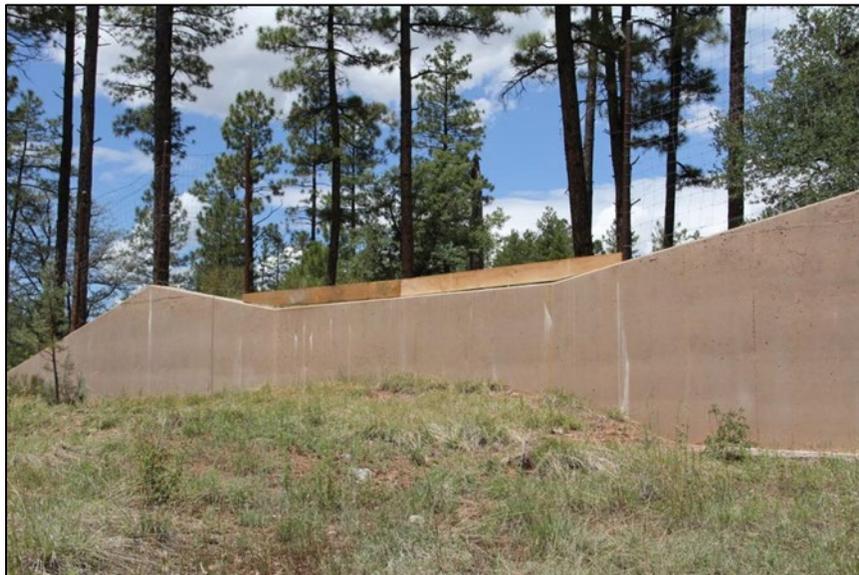
Figure 23. Board Added Along the Top of an Escape Ramp to Increase Its Height

In seven locations, researchers modified the height of existing escape mechanisms during the study. These locations included areas where elk had been documented to easily enter the ROW via an escape mechanism (see Figure 22) or where heights of escape mechanisms appeared too low (less than 60 inches) to effectively preclude elk from entering the ROW. The research team made modifications that included adding boards along the top edge of the escape mechanism (see Figure 23) or removing dirt mounds at the base of the escape mechanism to increase the height an elk would have to jump to enter the ROW. Three of these locations were on SR 260 and four were on I-17. After the modifications, monitoring was resumed at the new heights. In some instances, multiple modifications were made to the same escape mechanism to find the optimal height that would allow elk to escape the ROW relatively easily but discourage them from entering the ROW.

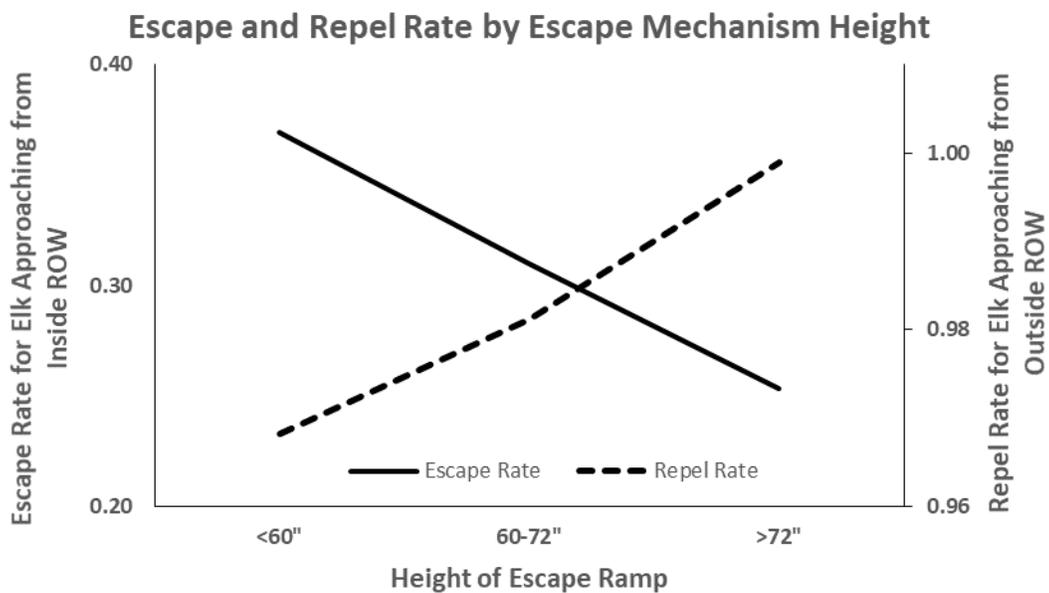
Figure 24. Comparison of Elk Escape Rates and Repel Rates by Escape Ramp Height

Escape Ramp Height (inches)	Approaches from Inside ROW	Escapes	Escape Rate	Approaches from Outside ROW	Times Repelled	Repel Rate
< 60	712	263	0.37	2545	2464	0.97
60-72	129	40	0.31	903	886	0.98
> 72	158	40	0.25	928	927	1.00

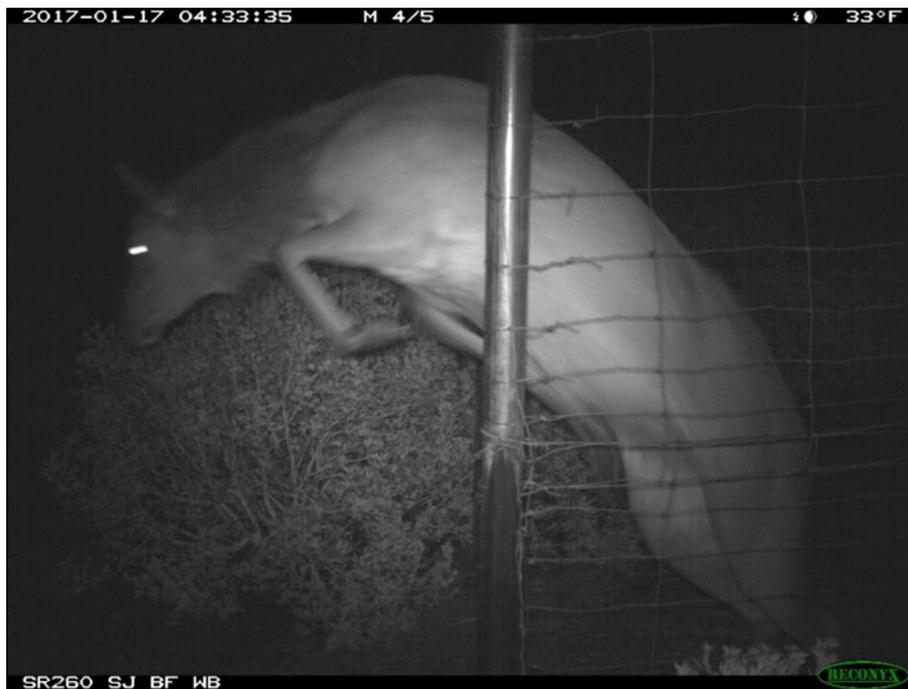
Figure 25. Elk Successfully Exiting the ROW Using a Slope Jump

Slope Jumps. The research team documented 24 elk escapes from the ROW out of 278 approaches to slope jumps within the ROW (see Figure 25), which is a 0.09 escape rate. Of 1289 elk that approached from outside the ROW, four entered the ROW and 1285 were repelled, for a repel rate of 1.00. Since 23 of the 24 escapes occurred at a single slope jump where the slope was minimal or nearly flat and only one escape occurred at a slope jump with a slope, the research team did not have enough data to determine an optimal slope. Although the slope jumps deterred elk from entering the ROW, they did not sufficiently facilitate elk in exiting the ROW. The lack of elk use of slope jumps led the research team to discontinue monitoring slope jumps after March 2018.

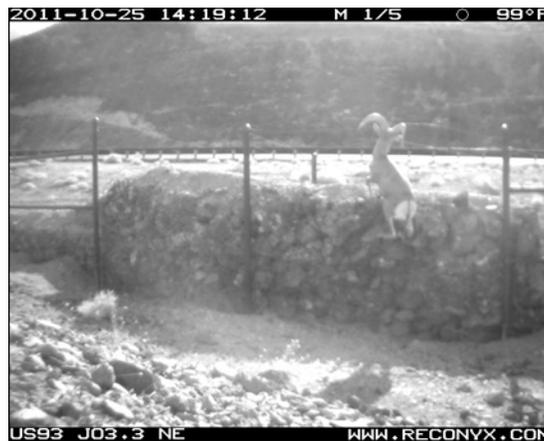
Figure 30. Wire Preventing Bighorn Sheep from Using an Escape Ramp to Enter the ROW

Modifications were made to escape ramps between 2011 and 2015 to determine the impact on the ramps' effectiveness. During the bighorn sheep crossing project along U.S. 93 from 2011 to 2015, the research team noted the presence of sheep in the ROW as well as unexpected sheep-vehicle collisions (Gagnon et al. 2017a). The team suspected that sheep were entering the ROW via escape mechanisms and installed cameras at select escape mechanisms to record these entries. After confirming that sheep were accessing the ROW at these locations (see Figure 28), the research team stretched wire across the opening of the ramp to deter sheep from jumping into the ROW while still allowing sheep to exit the ROW by passing under or over the wire (see Figure 29). Continued monitoring of the escape ramps with wire showed that sheep still tried to jump up and were stopped by the wire, presumably because they could not see it (see Figure 30). To help accentuate the wire, the research team added polyvinyl chloride (PVC) pipe to the wire (see Figure 31). The research team presented these preliminary findings to ADOT, and ADOT Maintenance staff added an adjustable horizontal metal crossbar to the escape ramp in place of the wire/PVC (see Figure 32).

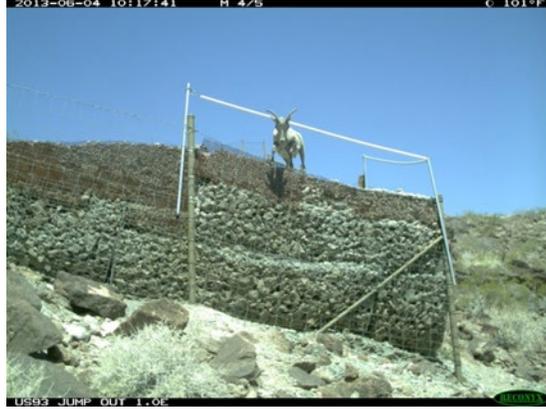
Figure 31. Bighorn Sheep Using an Escape Ramp with PVC that Accentuates the Wire

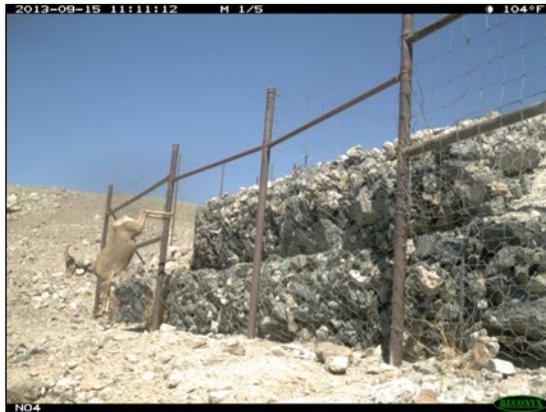
Figure 32. Bighorn Sheep Using an Escape Ramp with a Bar

The current study monitored the performance of this final version of the escape ramps (with the metal bar added). Data collected before and after the modifications allowed for a comparison of escape ramp effectiveness with and without a barrier (wire, PVC, or metal bar).

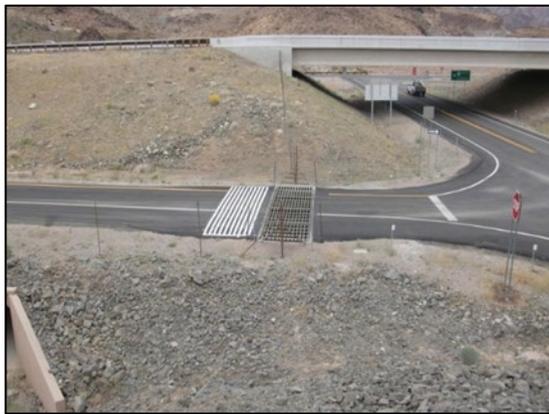
Figure 34. Painted Stripes Mimicking an Additional Cattle Guard

From 2011 to 2015, the research team and ADOT Maintenance staff noted that sheep were entering and exiting the ROW via the single cattle guards (a non-ADOT standard cattle guard) at the on- and off-ramps of the Kingman Wash traffic interchange (TI) by either jumping the cattle guard or walking the ledge along the edge of the cattle guard (see Figure 33). In an attempt to reduce access to the ROW by sheep, ADOT painted stripes on the ROW side of the cattle guards to mimic a double cattle guard and discourage sheep from jumping over the cattle guard and onto the painted stripes (see Figure 34). The research team added cameras to two of the cattle guards in 2012. A previous study conducted by the research team on bighorn sheep along U.S. 93 found that these painted stripes did not deter sheep from crossing the single cattle guards (Gagnon et al. 2017a; see Figure 35).

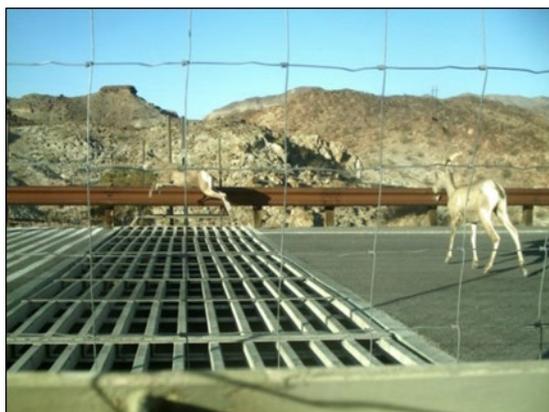
Figure 35. Bighorn Sheep Jumping a Cattle Guard at Kingman Wash TI Despite Painted Stripes

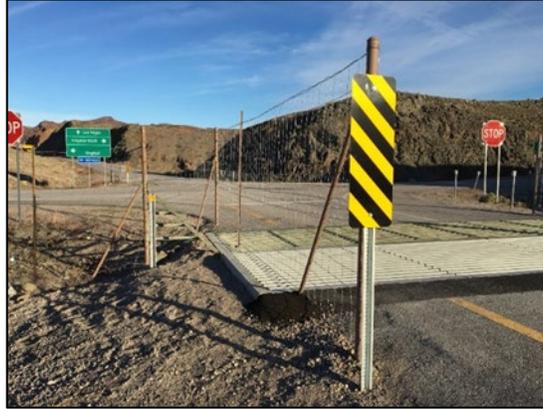
Figure 36. Double Cattle Guard with Fencing

In 2015 ADOT modified the wildlife guards at the four on- and off-ramps at Kingman Wash TI, installing a second single cattle guard alongside the initial cattle guard to create a double cattle guard (like those used for elk along SR 260) and added a fence to block access to the ledge that the sheep had used to cross the cattle guard (see Figure 36).

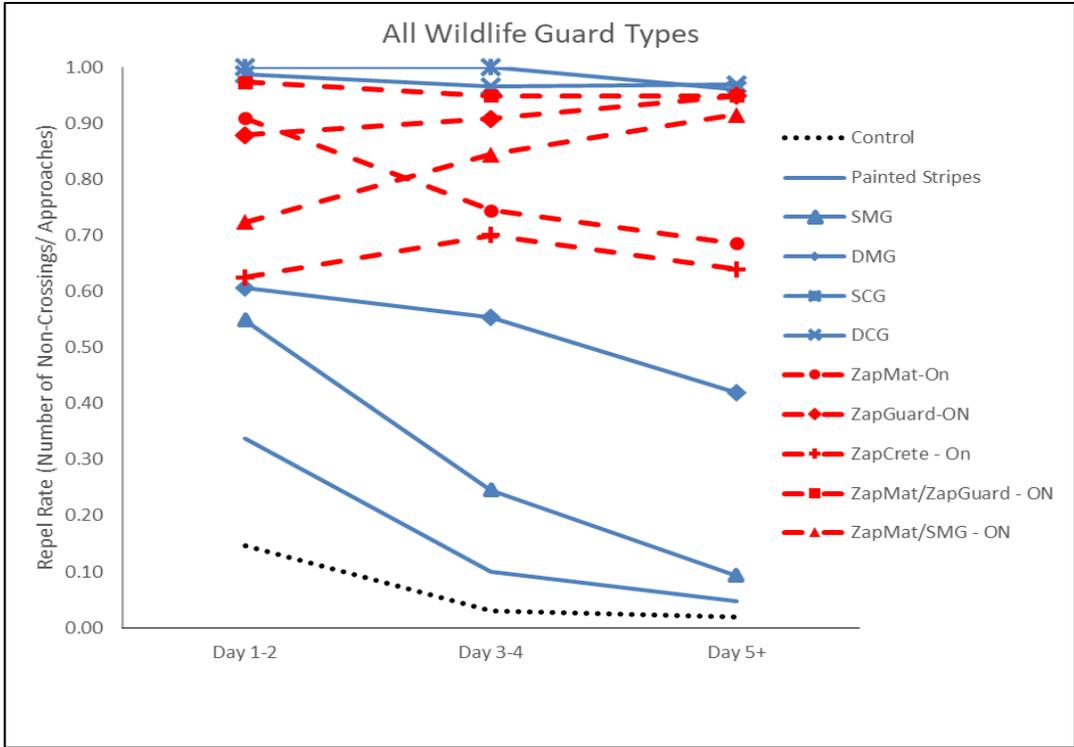
Figure 37. Elk Repel Rates Over Time for Wildlife Guards at the Controlled Test Site

Researchers analyzed the effectiveness of each wildlife guard type over time (days 1 to 2, 3 to 4, and beyond) (see Figure 37). The electrified wildlife guards had higher repel rates in most instances than the nonelectrified versions (see Figure 38). Of the nonelectrified wildlife guards (see Table 14), the single and double cattle guards maintained a consistently high repel rate over time, while the painted stripes and single modified cattle guard showed a reduction in repel rate to less than 0.10 within four days (see Figure 39). All types that included electrified components (see Table 14) achieved a repel rate greater than 0.60, and in some cases these types increased in effectiveness over time. The most effective electrified configuration over time was the ZapMat combined with the ZapGuard. Both the ZapGuard alone, and the ZapCrete and single modified cattle guard combined, increased the repel rate to more than 0.90 (see Figure 40).

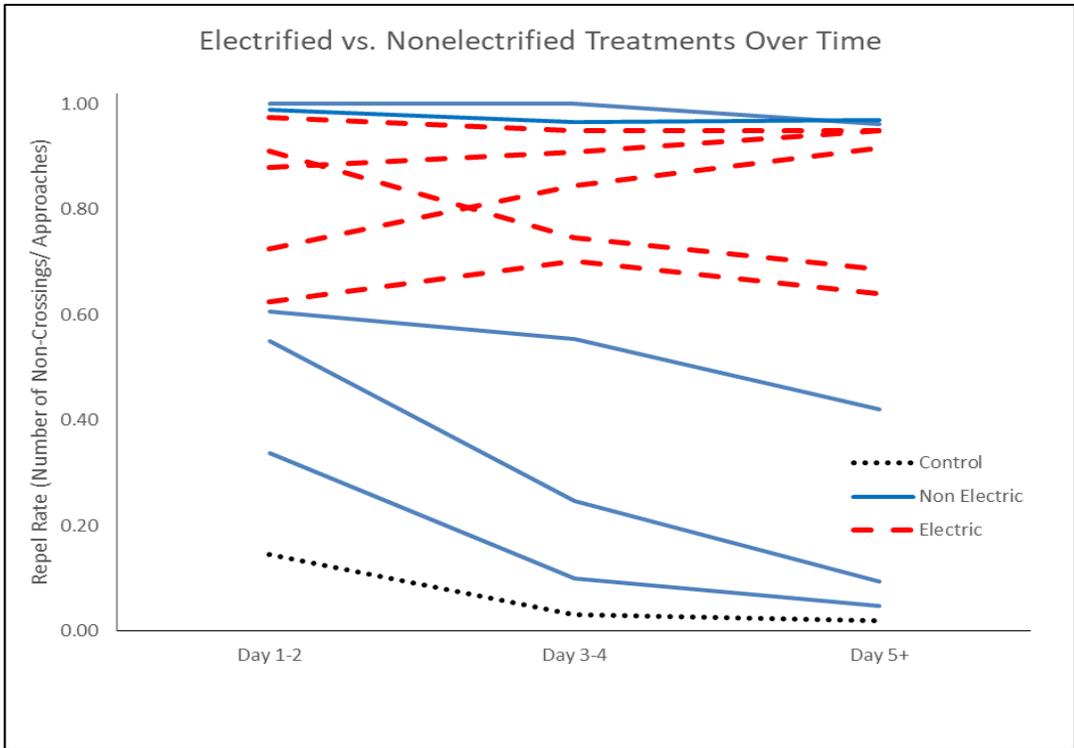
Figure 38. Elk Repel Rates Over Time for Electrified and Nonelectrified Wildlife Guards

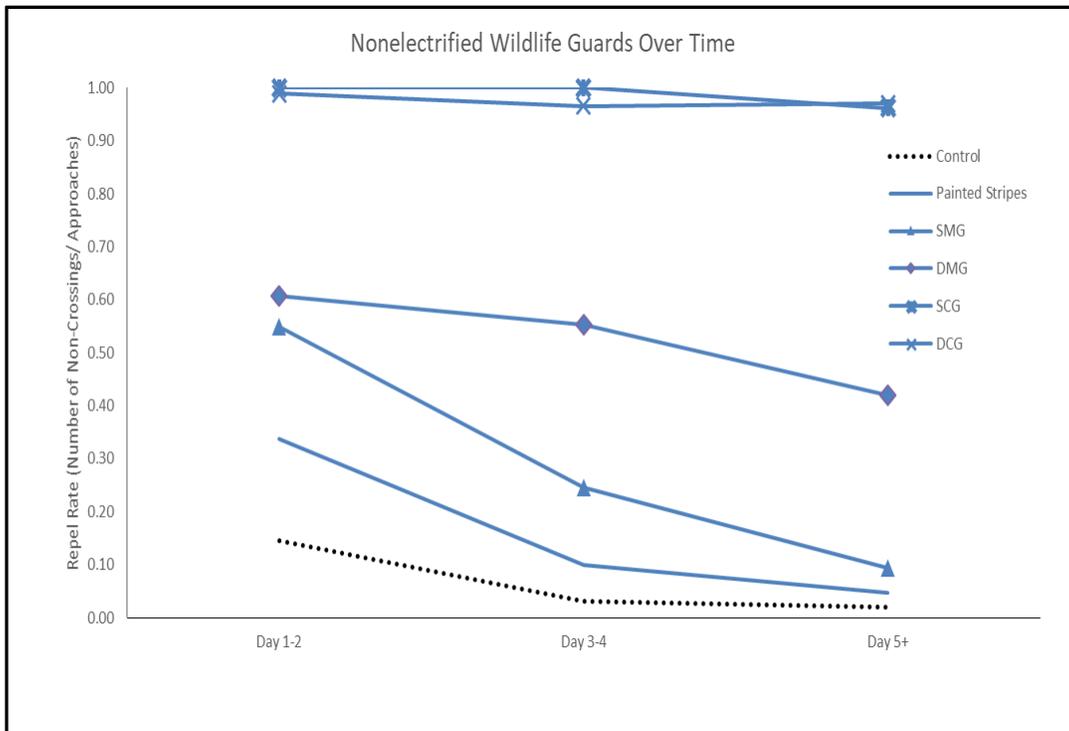
Figure 39. Elk Repel Rates Over Time for Nonelectrified Wildlife Guards

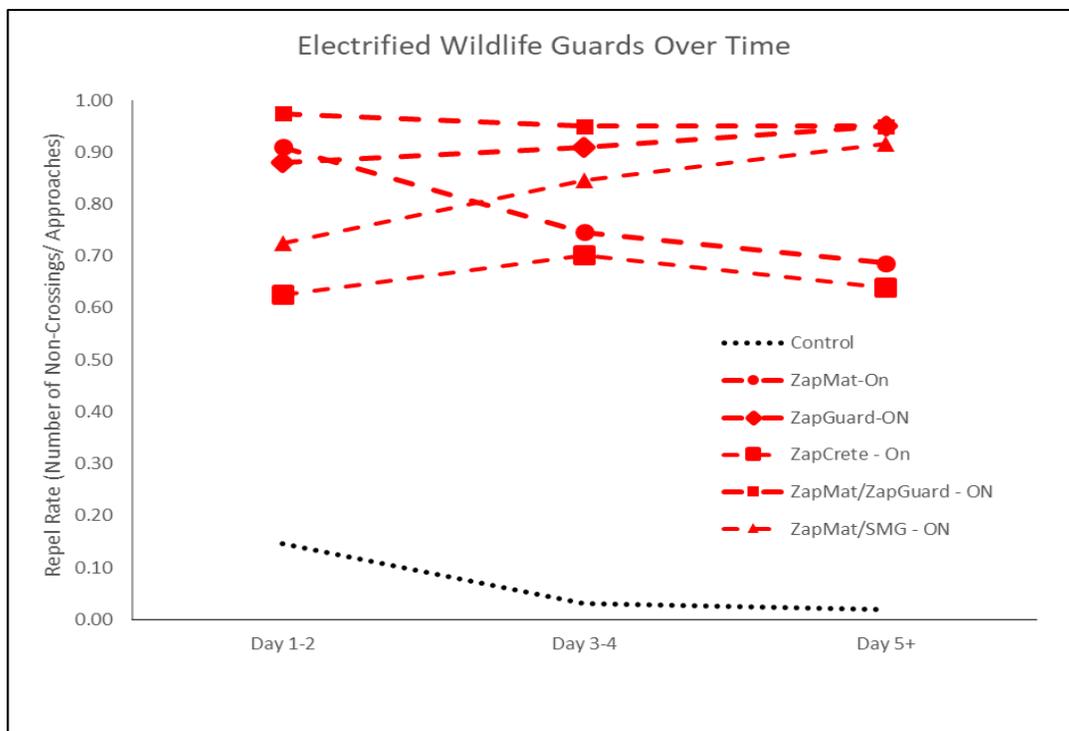
Figure 40. Elk Repel Rates Over Time for Electrified Wildlife Guards

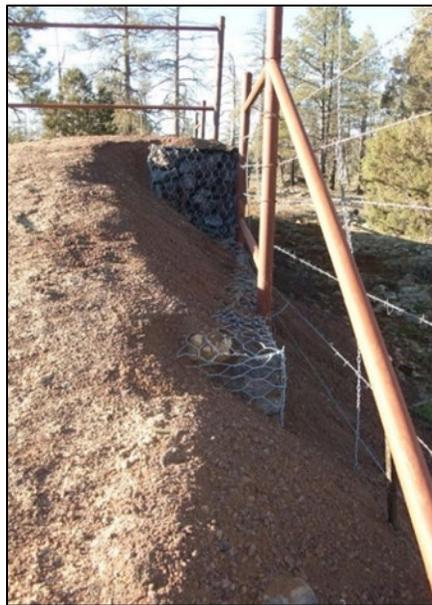
Figure 41. Escape Ramp with a Noncompatible Substrate and No Soil Retention Method

For escape mechanisms, a key maintenance concern was inadequate soil retention. Causes included no method of retaining soil, retention failure due to excessively porous soil, failure of soil retention material, noncompatible substrate on the ramp surface, and soil and debris buildup at the base of a ramp from flood events. Design concerns included ramps short enough to allow wildlife to easily enter the ROW, and obstacles that may hinder wildlife use of ramps (see Figures 41 to 47).

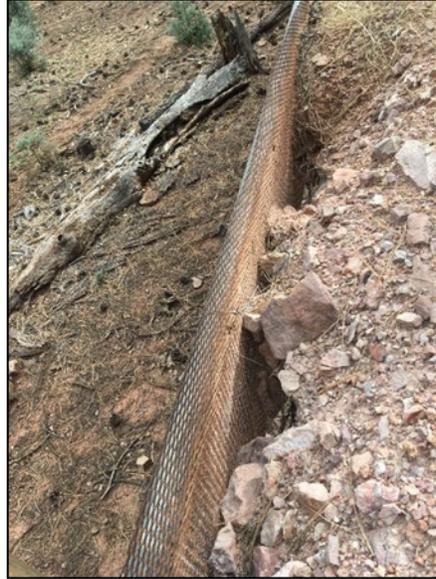
Figure 42. Soil Loss Around an Expanded Metal Mesh Retainer

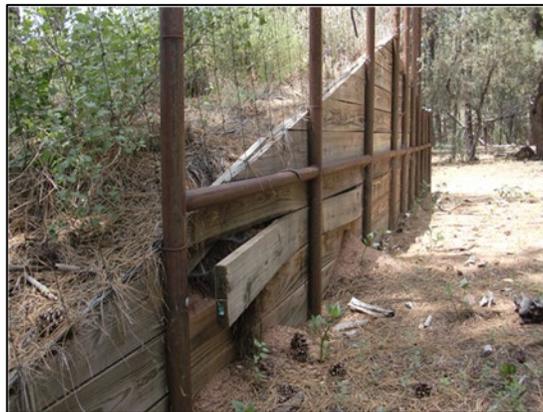
Figure 43. Soil Loss from Failing Wooden Plank Retaining Wall

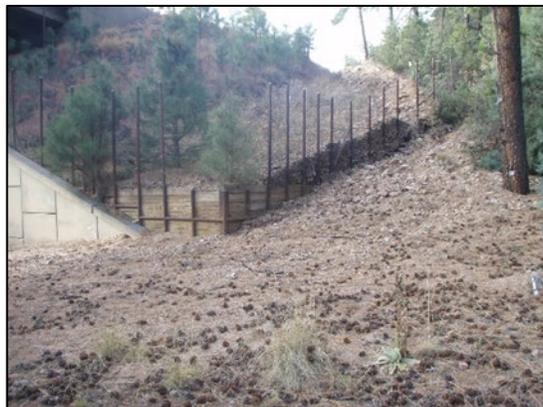
Figure 44. Ramp Placed Near Drainage, Allowing Buildup of Water-Deposited Sediment

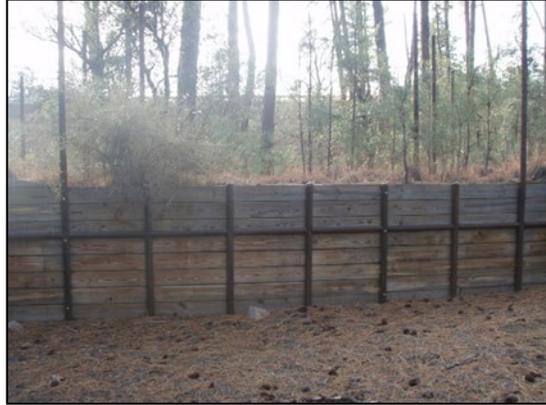
Figure 45. Retaining Wall Too Short to Keep Elk from Entering the ROW (Height Less Than 48 Inches)

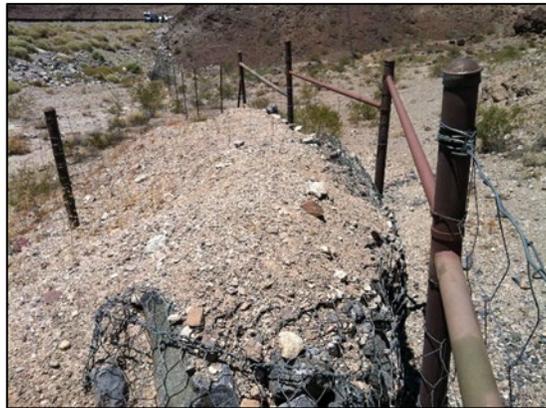
Figure 46. Erosion, Lack of Soil Retention, and Short/Buried Guide Fence

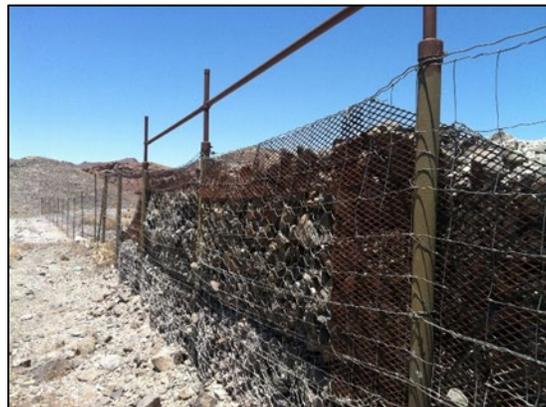
Figure 47. Retaining Mesh Above Lip of Ramp, Creating Potential Escape Obstacle

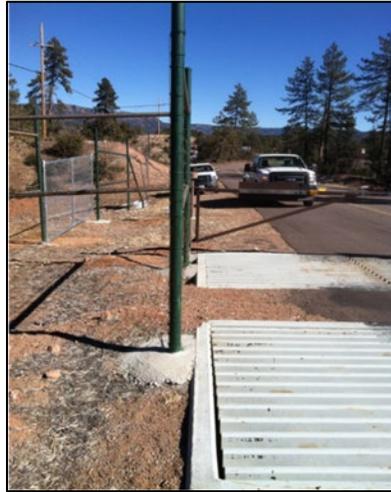
Figure 48. Large Distance Between Double Cattle Guards and Short Fence

The research team also documented maintenance and design concerns regarding wildlife guards during field visits in Arizona. These concerns included excessive spacing between the two cattle guards in a double cattle guard; areas within the wildlife guard where animals could walk, either related to design or to dirt filling the cattle guard; and materials unsuitable for heavy traffic (see Figures 48 to 51).

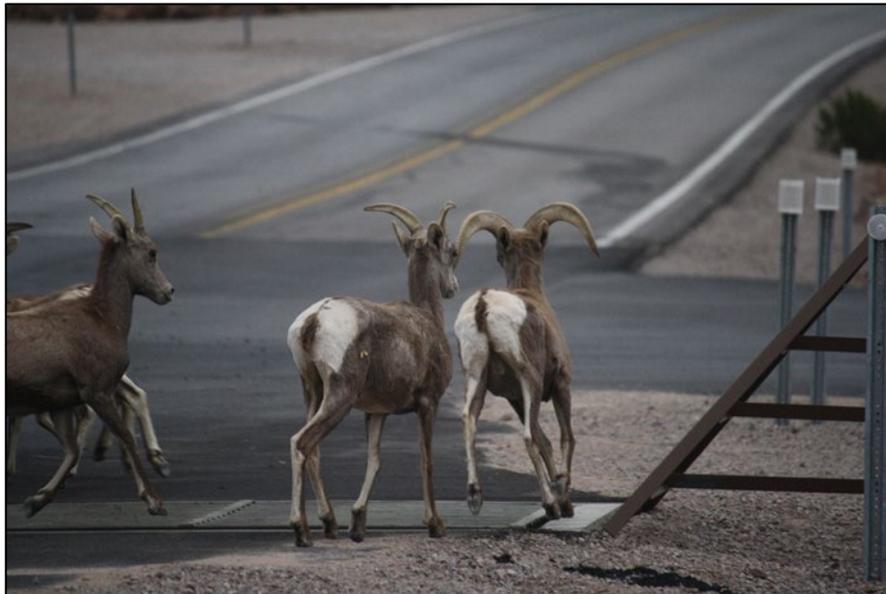
Figure 49. Ledge Allowing Animals to Access the ROW via a Wildlife Guard

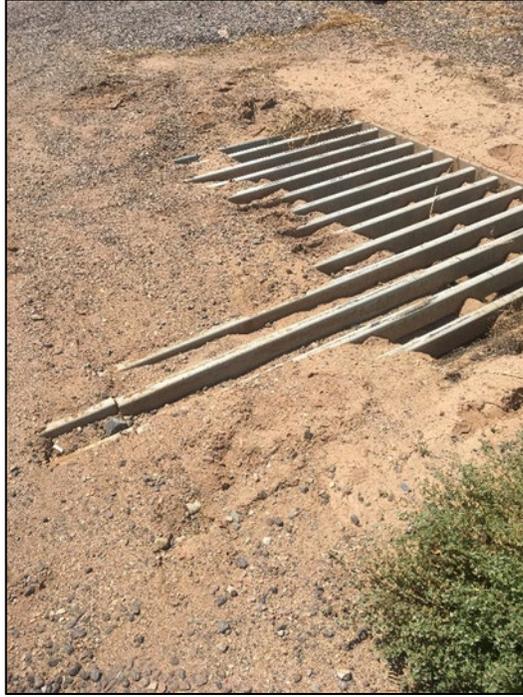
Figure 50. Cattle Guard Partially Filled in with Dirt

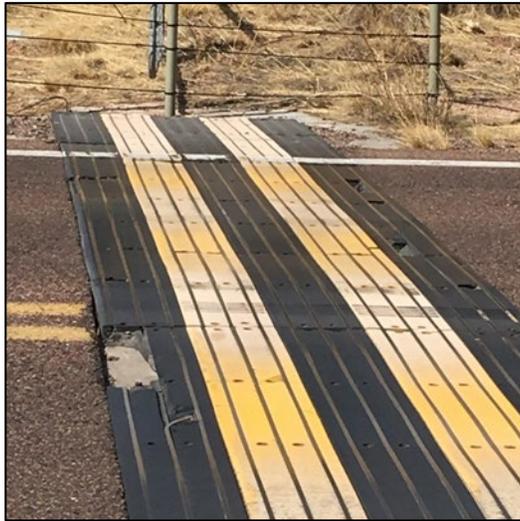
Figure 51. Electrified Mat Material Damaged by Traffic Over Time

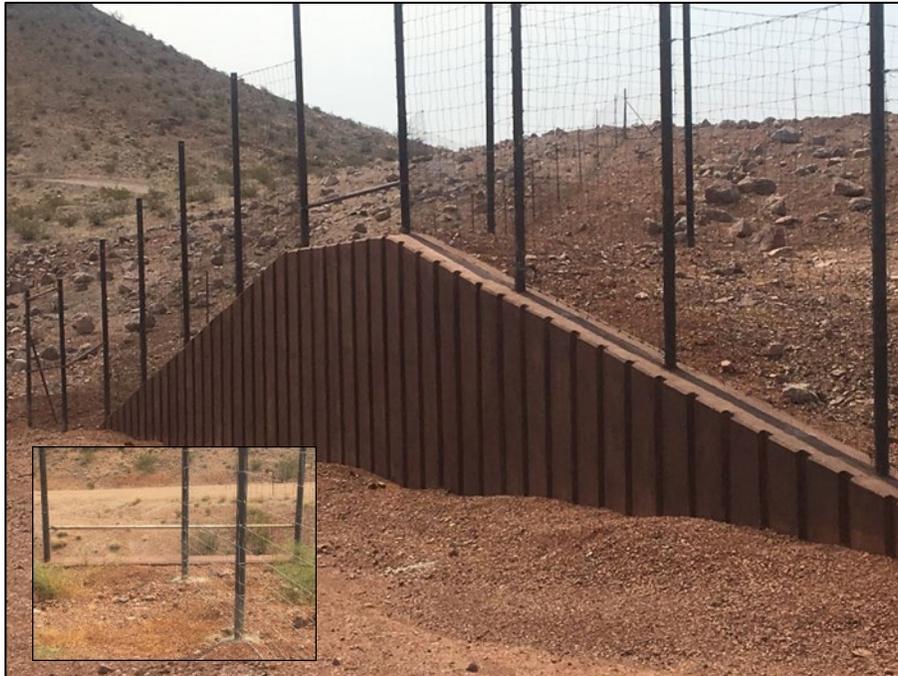
Figure 52. Escape Ramp with Horizontal Bar to Limit Bighorn Sheep Access from Outside the ROW; Inset Photograph Shows Horizontal Bar Detail

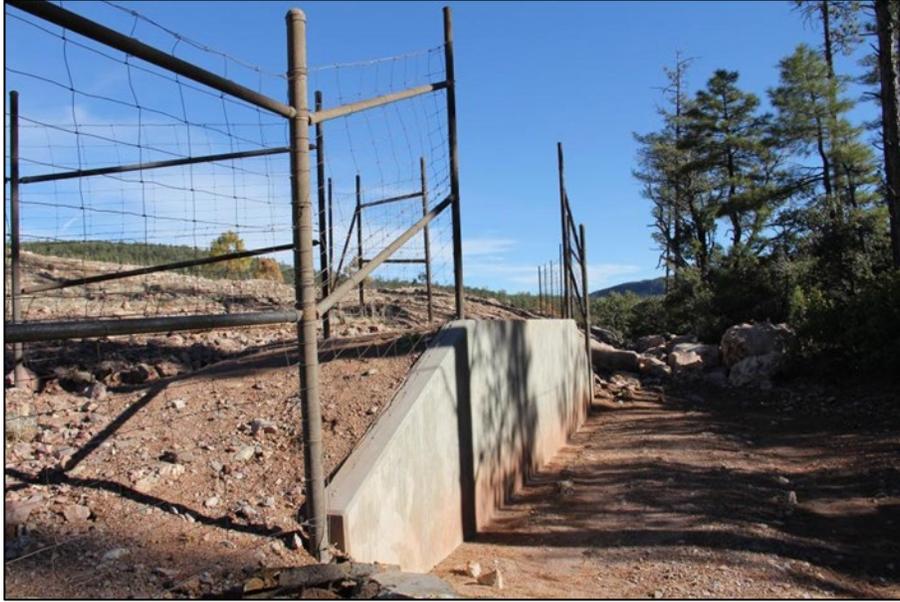
Figure 53. Escape Ramp Using Concrete to Retain Soil Along State Route 260 in Arizona
