Evaluation of the Effectiveness of Wildlife Guards and Right of Way Escape Mechanisms for Large Ungulates in Arizona

Arizona Department of Transportation Research Center

SPR-729

September 2020

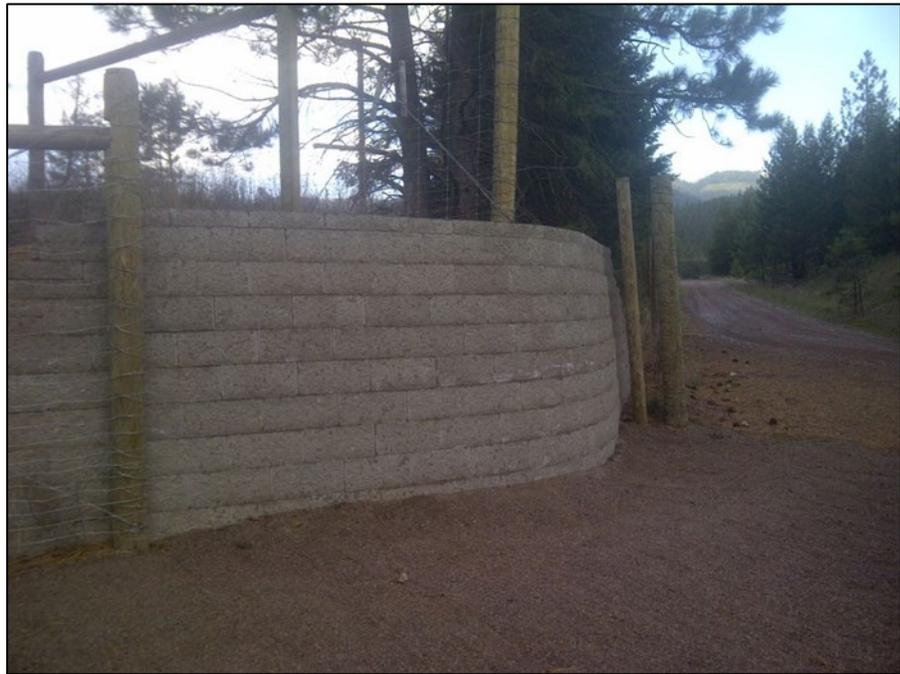
Figure 54. Montana Example of Escape Ramp Using Landscape Blocks to Retain Soil on U.S. Route 93

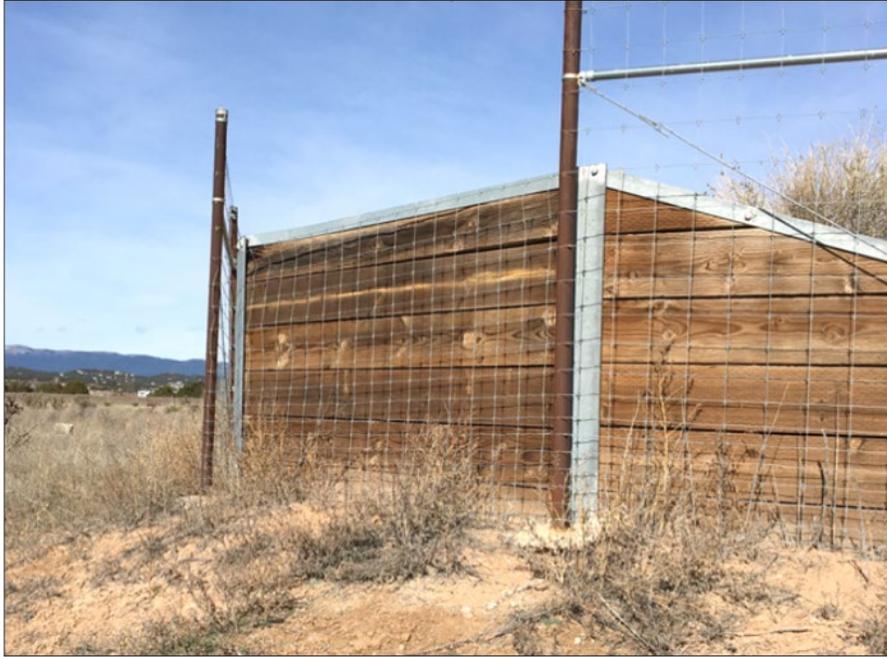
Figure 55. New Mexico Example of Escape Ramp Using Properly Treated and Supported Lumber to Retain Soil Along Interstate 40

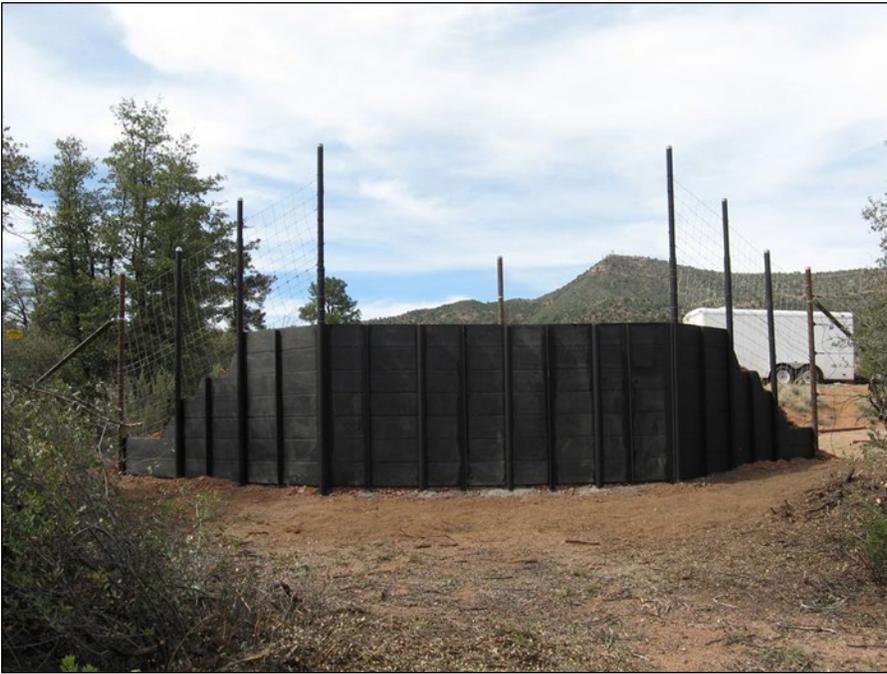
Figure 56. Escape Ramp Using Composite Material to Retain Soil Along State Route 260 in Arizona

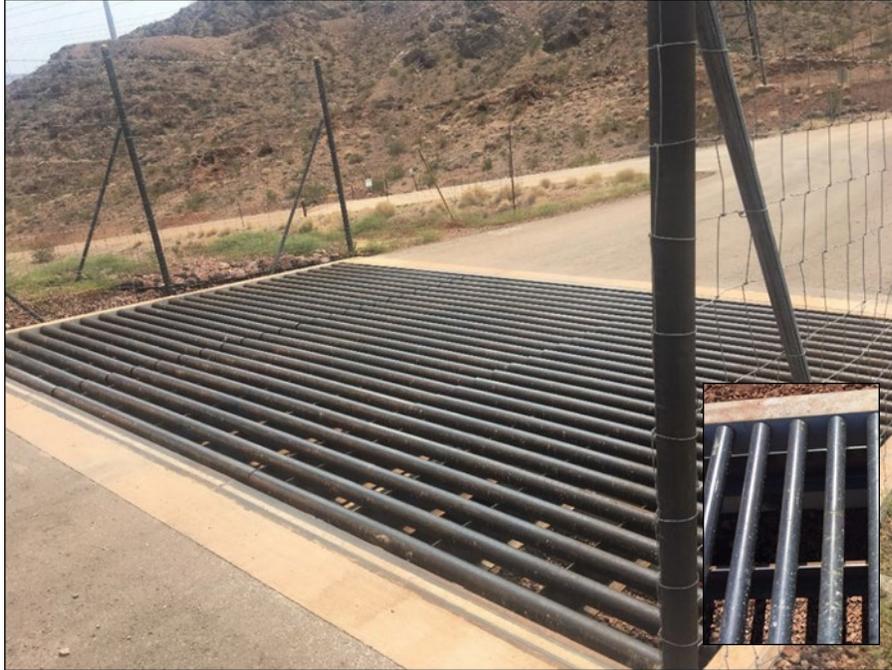
Figure 57. Wildlife Guard with Round Bars to Deter Wildlife Located on an Arizona-Nevada Joint Project Along Interstate 11; Inset Photograph Showing Round Bar Detail

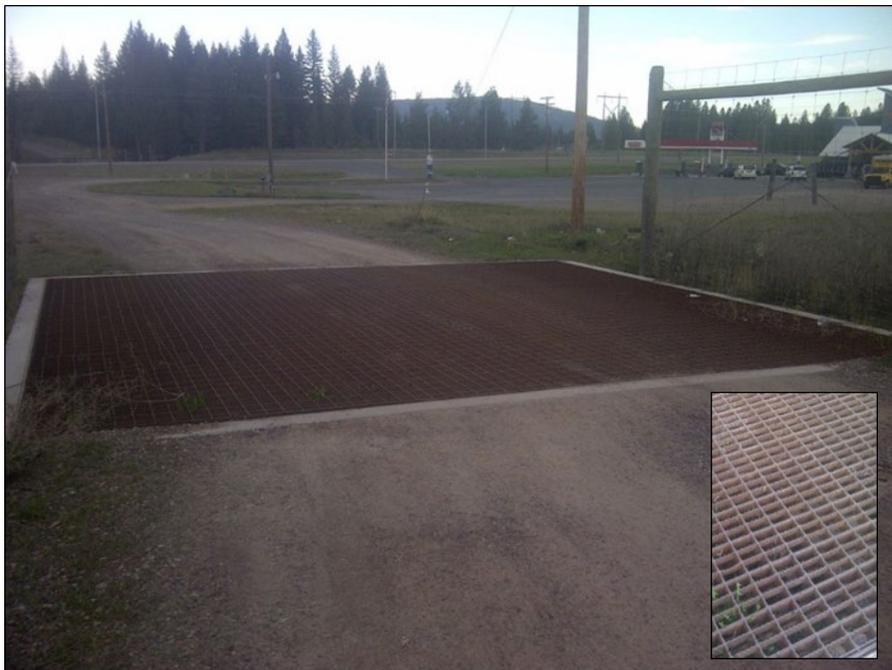
Figure 58. Montana Example of Grate-Style Wildlife Guard Along U.S. Route 93; Inset Photograph Showing Grate Detail

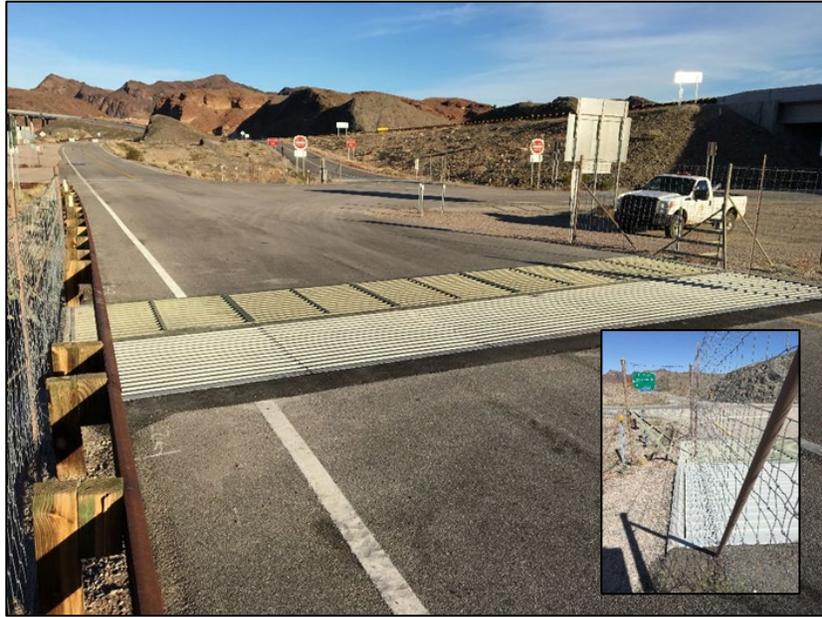
Figure 59. Wide Wildlife Guard to Deter Jumping, with Guardrail or Fence to Prevent Walking on the Vault Edge, Along U.S. 93; Inset Photograph Showing Fencing Detail

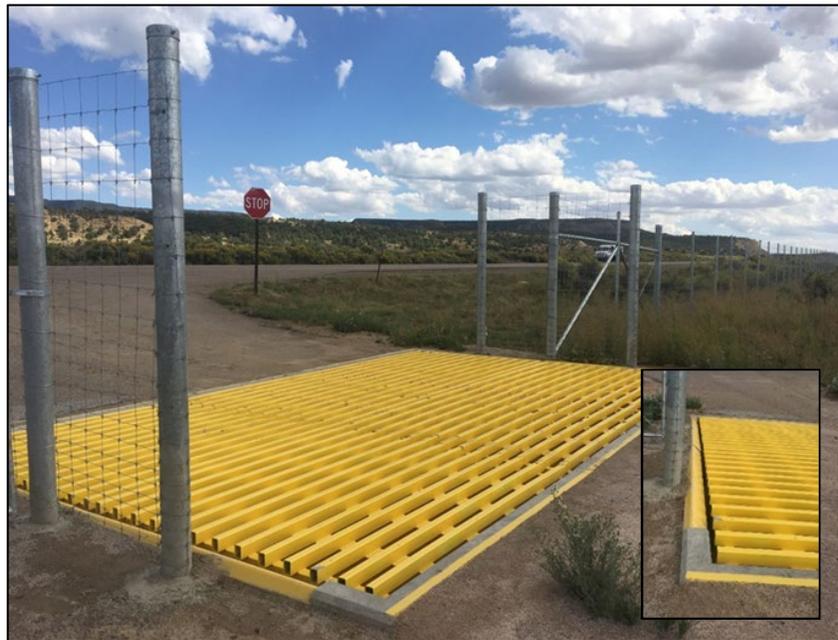
Figure 60. New Mexico Example of Wide Wildlife Guard to Deter Jumping, with Angle Iron Welded to the Vault Edge to Reduce Walking on the Vault Edge, Along U.S. Route 550; Inset Photograph Showing Welded Angle Iron Detail

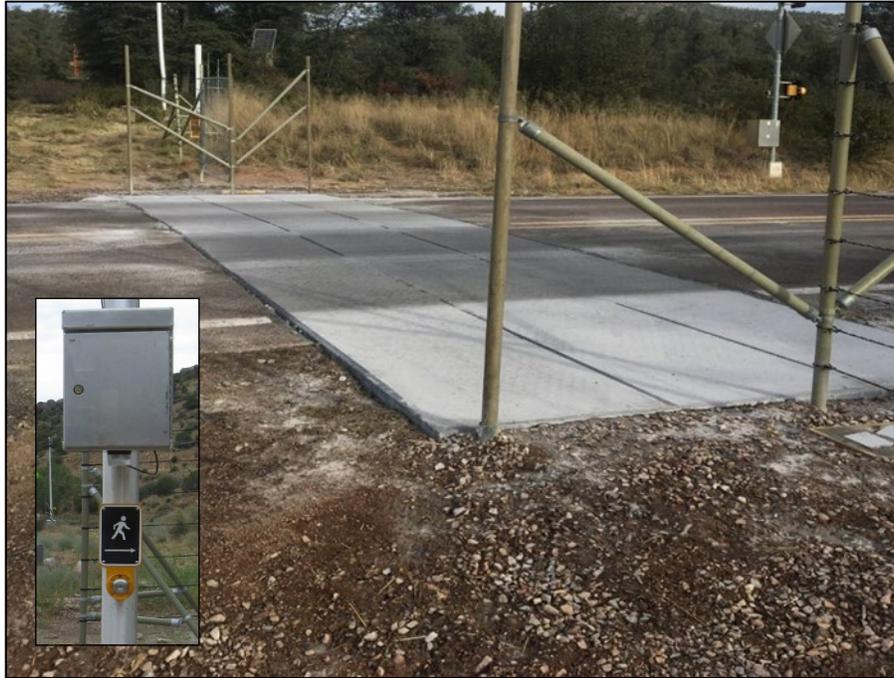
Figure 61. Electrified Concrete Wildlife Guard with Push-Button Power Delay for Pedestrian Crossing Along State Route 260; Inset Photograph Showing Push-Button Detail
