Evaluation of Pedestrian Hybrid Beacons on Arizona Highways

SPR-756

September 2019

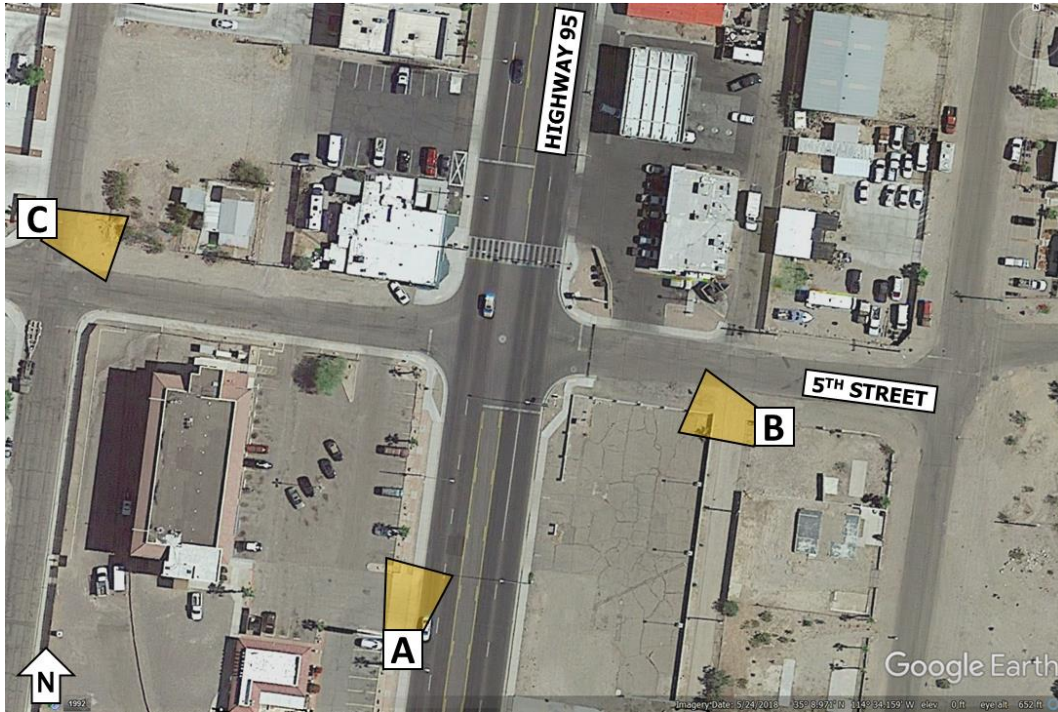
Figure 1. Example of Camera Positioning from Study Site BH-01.

Figure 1 shows an example of the camera positioning for a study site. The main camera is positioned on the major street to capture the PHB, the crosswalk approaches, and the major-street approaches. Secondary cameras are used to capture the minor-street approaches and are positioned to capture the view of the departing vehicles.
