# Structures Geotechnical Engineering Report

## CRAYCROFT RD TI OP STR #594 & #595

I-10 Temporary Bridge at Craycroft Road, Tucson, Arizona

Terracon Project No. 65155090R1

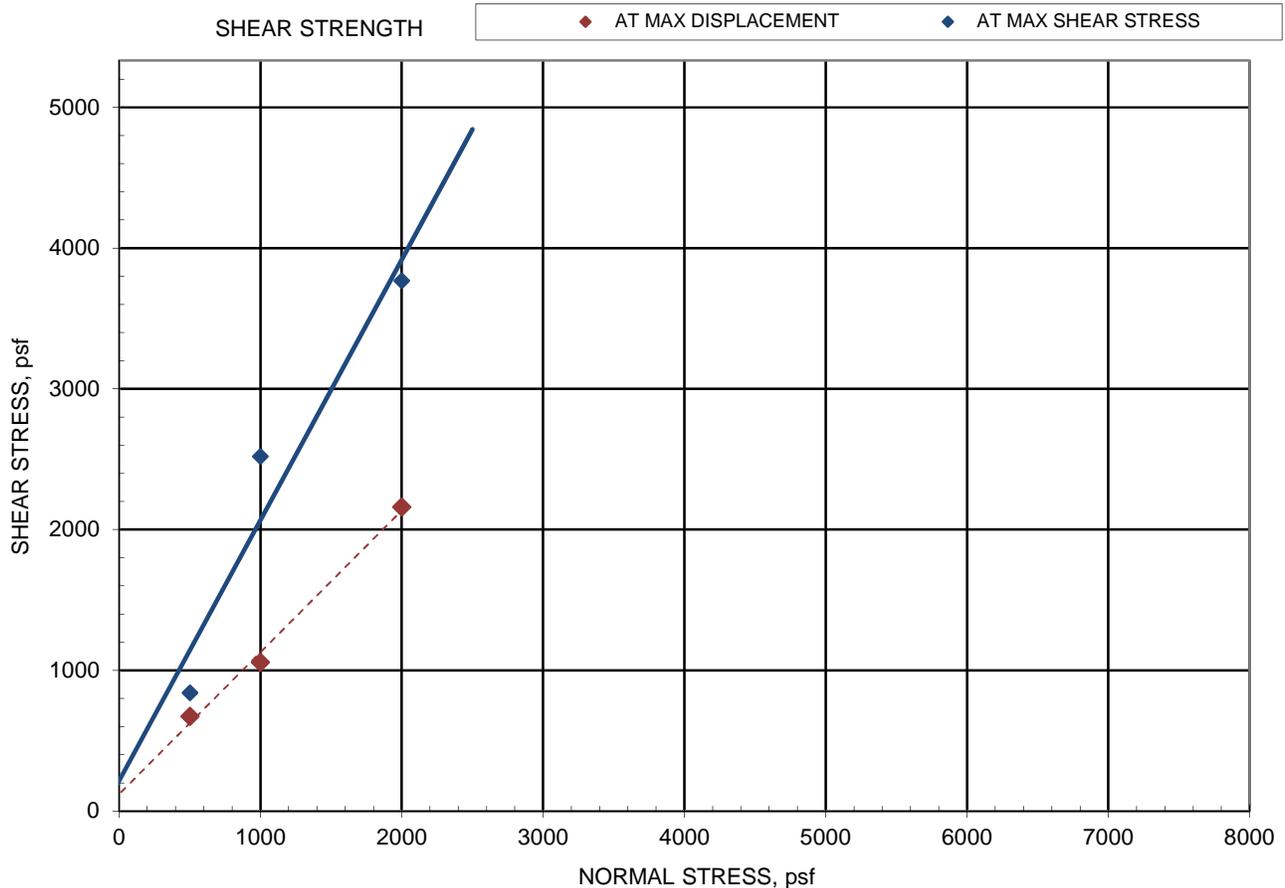
**DIRECT SHEAR TEST OF SOILS UNDER CONSOLIDATED  
DRAINED CONDITIONS ASTM D3080**

FRICION ANGLE	COHESION
<b>AT MAX SHEAR STRESS</b>	<b>61.6</b>	<b>216</b>
Specs:		
<b>AT MAX DISPLACEMENT</b>	<b>45.2</b>	<b>120</b>
Specs:

**Note:** The friction angle presented is applicable only to the load ranges and sample conditions tested

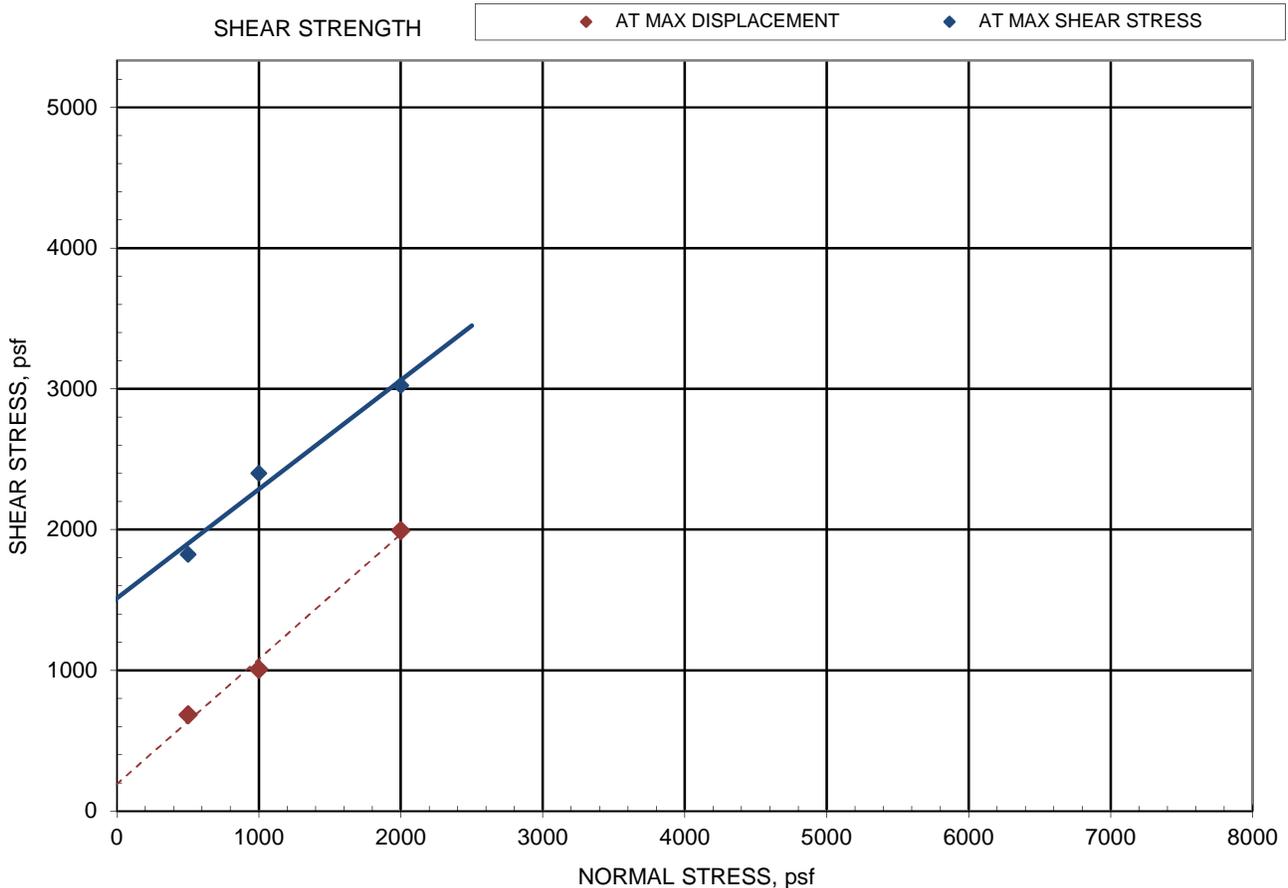
**DIRECT SHEAR TEST OF SOILS UNDER CONSOLIDATED  
DRAINED CONDITIONS ASTM D3080**

**PROJECT:** I-10 Temporary Bridge at Craycroft Road  
**LOCATION:** Tucson, Arizona  
**MATERIAL:** Composite Sample, Clayey Sand  
**SAMPLE SOURCE:** B1@0-5'; B1@5'; B1@14'

FRICTION ANGLE	COHESION
<b>AT MAX SHEAR STRESS</b>	<b>37.8</b>	<b>1512</b>
Specs:		
<b>AT MAX DISPLACEMENT</b>	<b>41.6</b>	<b>192</b>
Specs:
