Roadway Geotechnical Engineering Report

CRAYCROFT RD TI OP STR #594 & #595
I-10 Temporary Bridge at Craycroft Road, Tucson, Arizona

ADOT TRACS No.: 010 PM 267 H8774 01C

Terracon Project No. 65155090R1

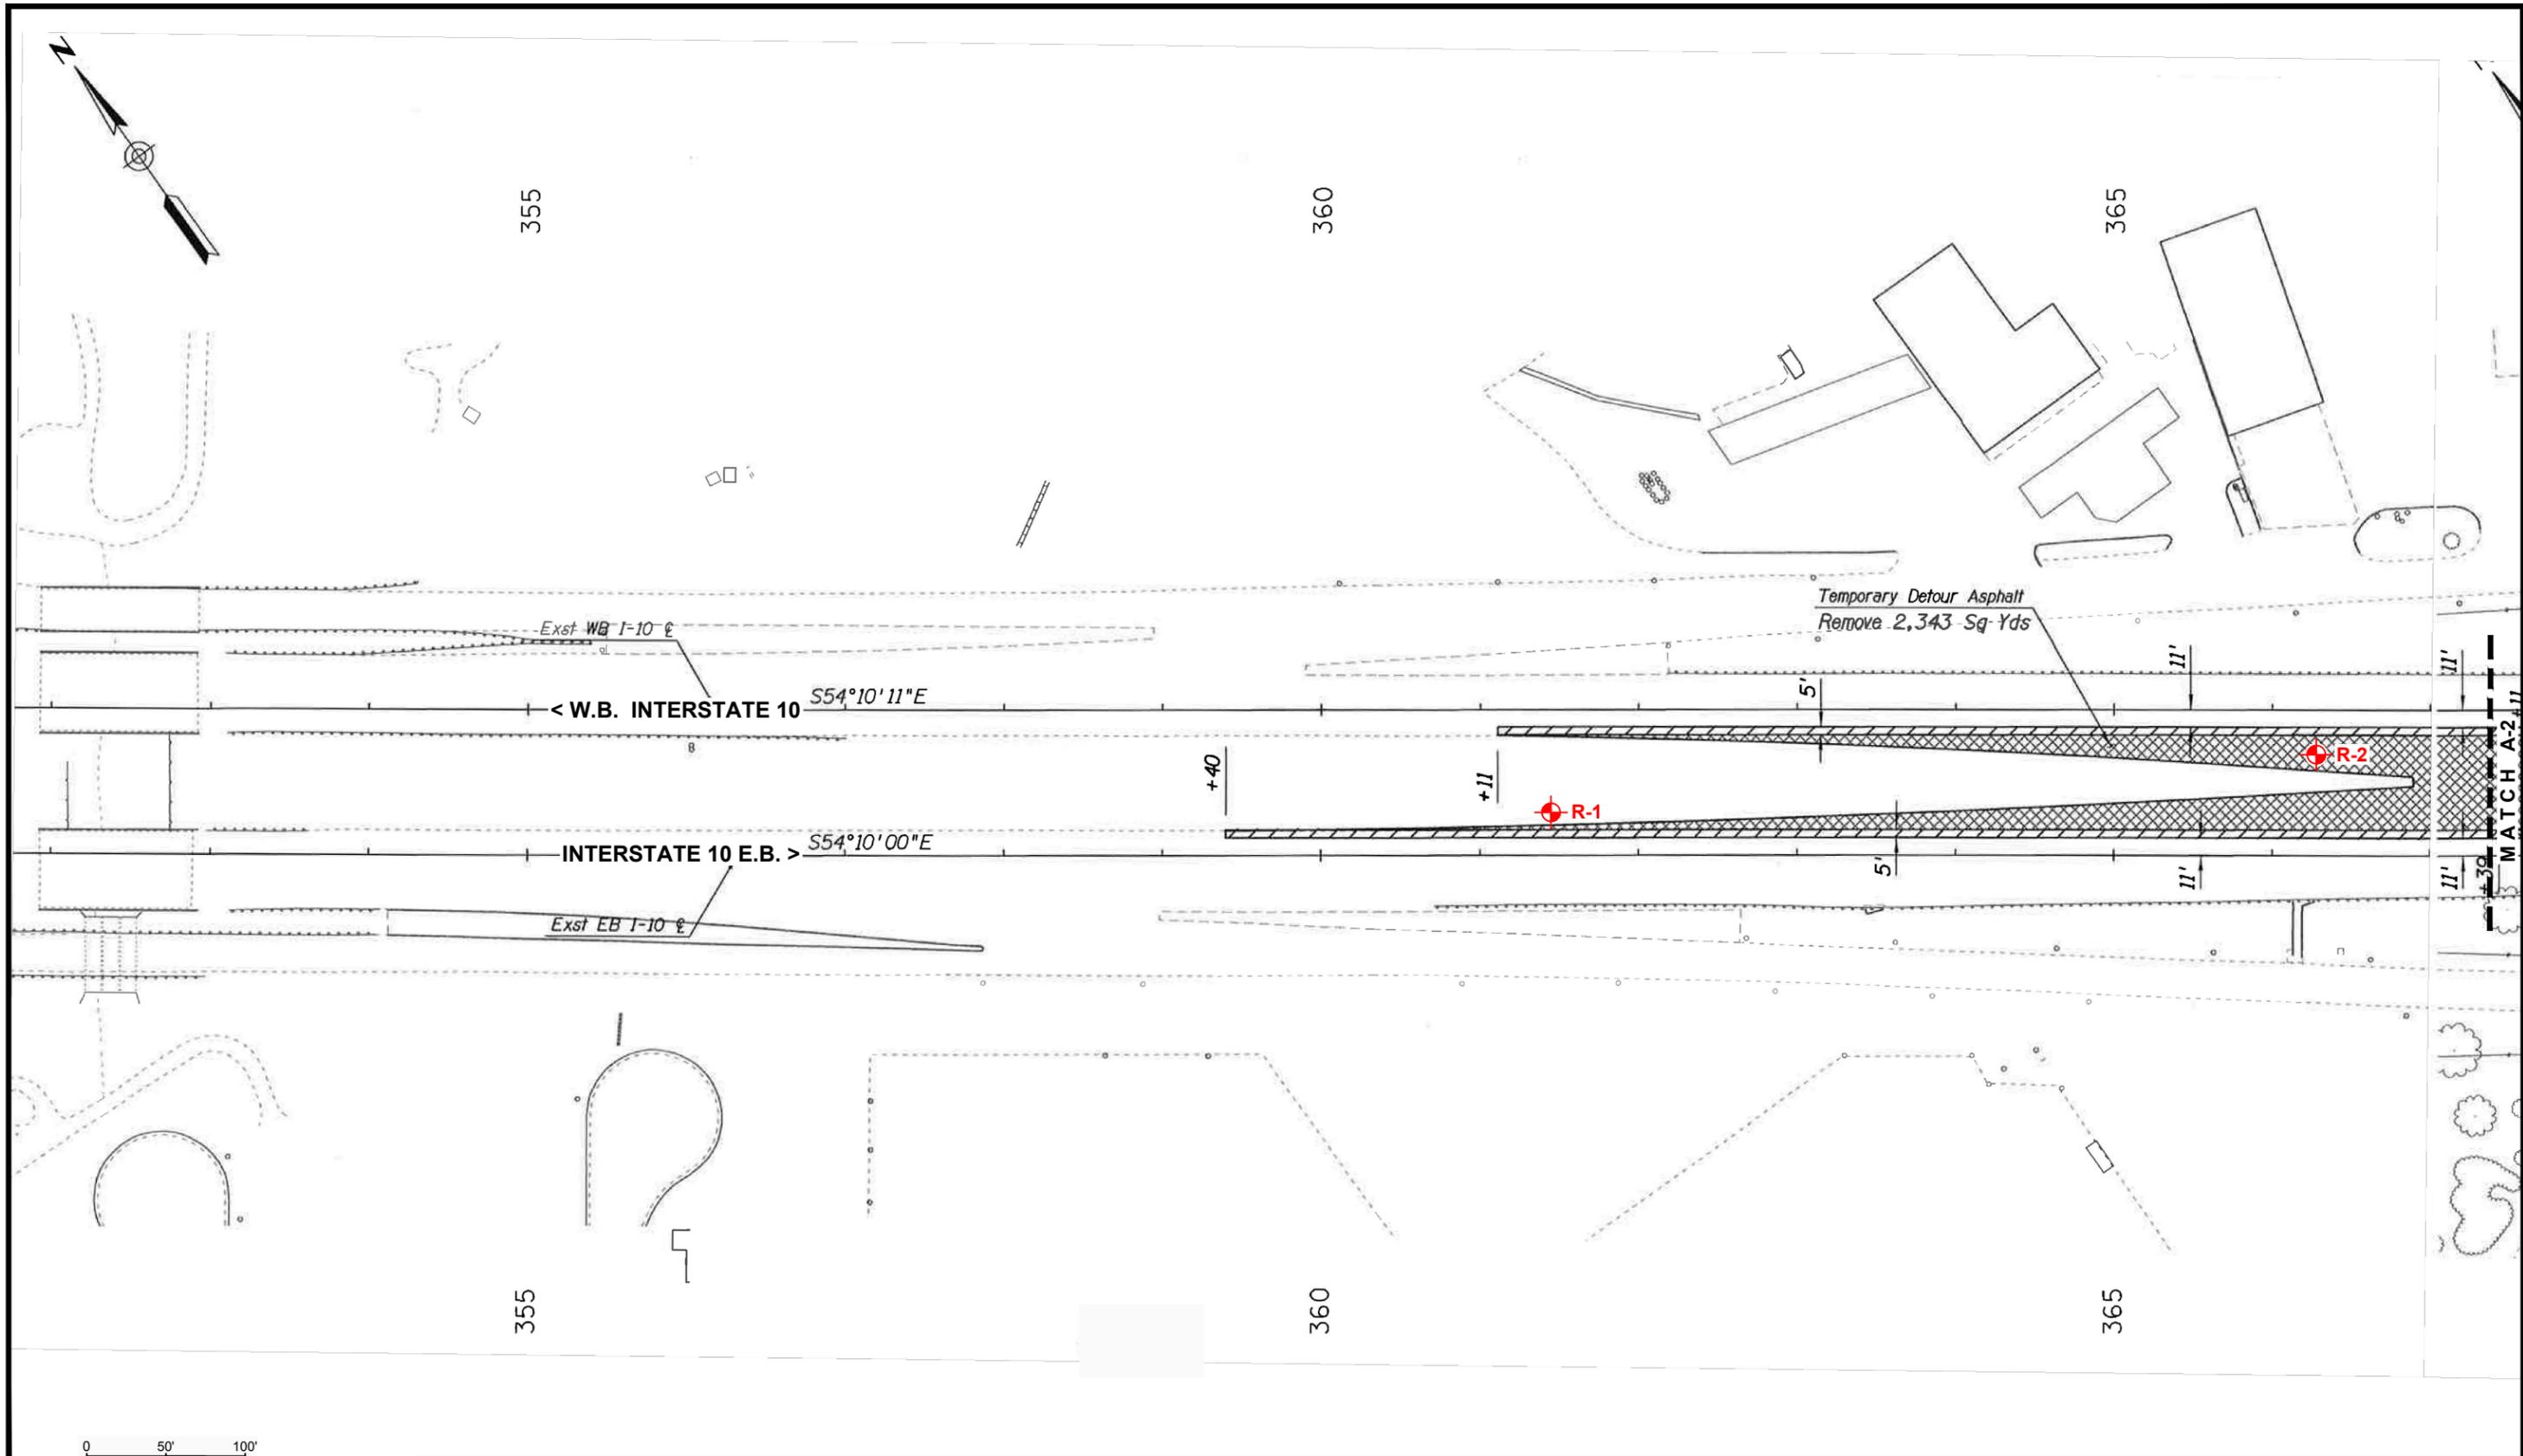
APPROXIMATE BORING LOCATION

ITEM	DESCRIPTION
Project Layout	Refer to the Site Plan and Boring Location Diagrams (Exhibits A-1 through A-3, in Appendix A) for the specific locations of each boring within the project limits.
Proposed Improvements	The existing I-10 bridges over Craycroft Road will be rehabilitated and receive new decks. A new single-span temporary bridge will be constructed in the existing median to facilitate replacement of the bridge decks. Temporary pavement will be placed in the median leading to the temporary bridge during the construction period which is estimated not to exceed one year in duration.

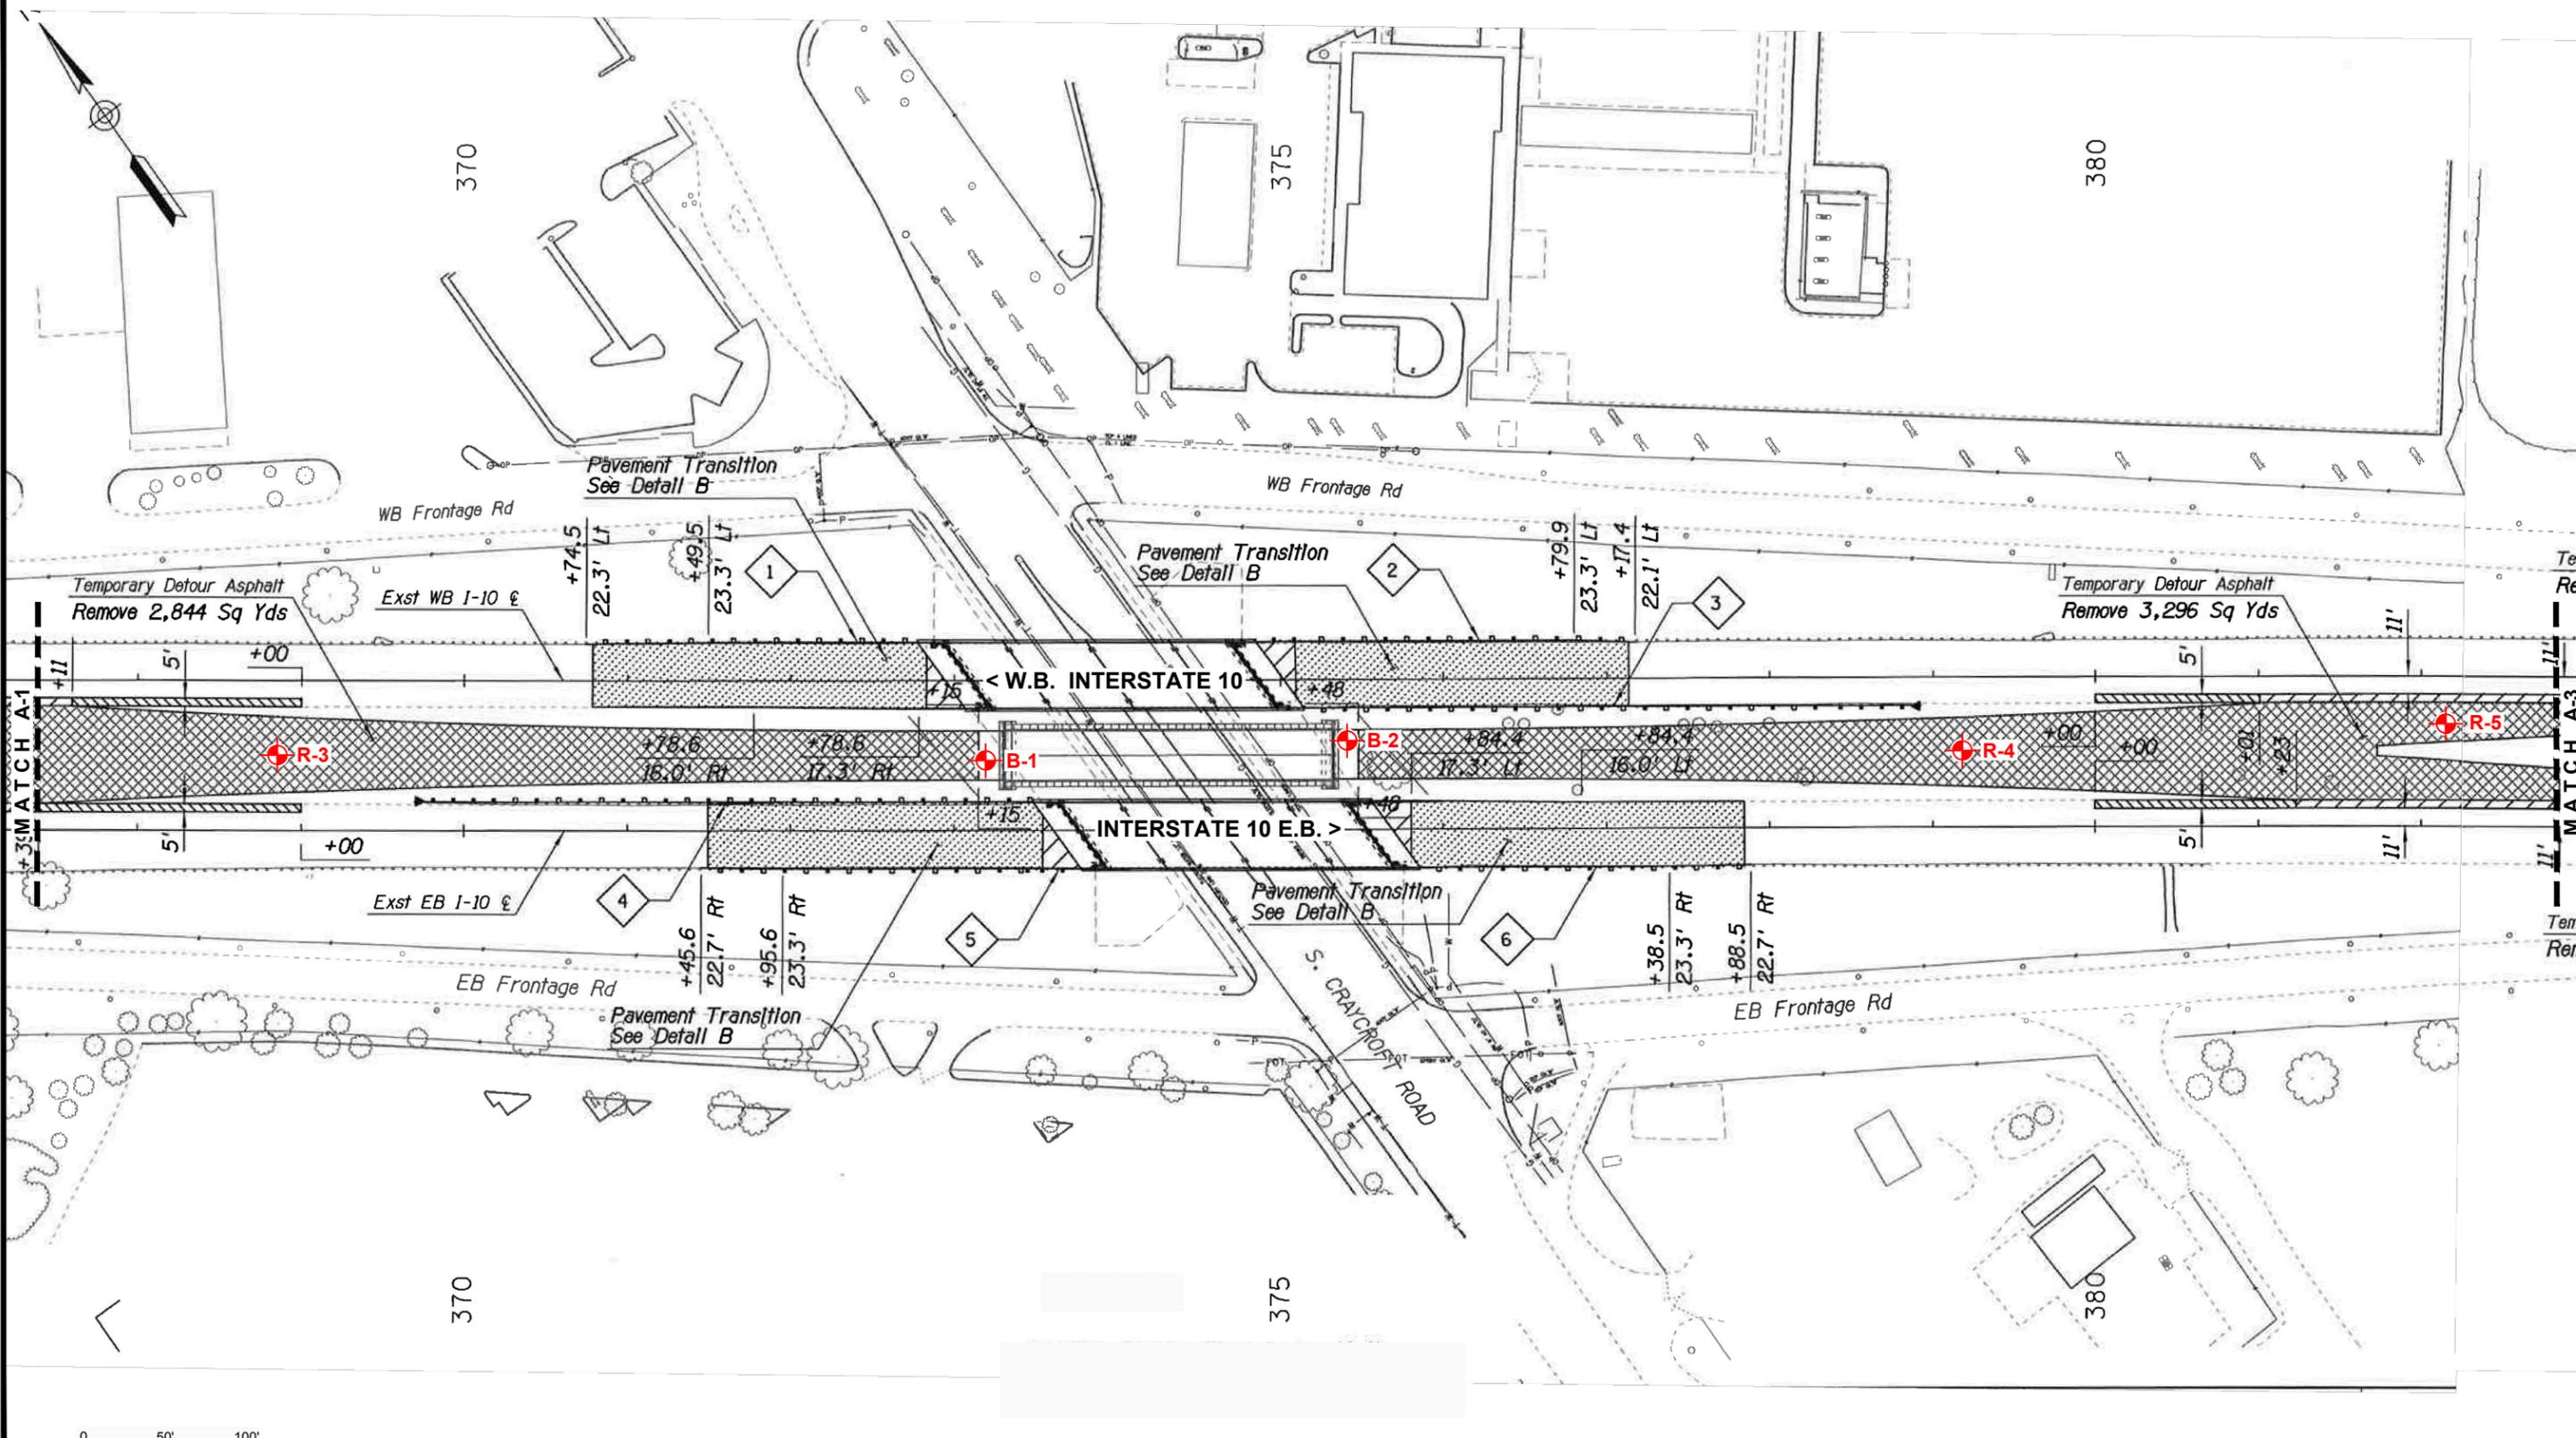
EXHIBIT
A-2

LEGEND:
 APPROXIMATE BORING LOCATION

SITE PLAN AND BORING LOCATIONS
CRAYCROFT RD TI OP STR #594 & #595
 I-10 TEMPORARY BRIDGE AT CRAYCROFT ROAD, TUCSON, ARIZONA
 ADOT TRACS No.: 010 PM 267 H8774 -01C Federal Aid Project No.: NHPP 010-E(219)T

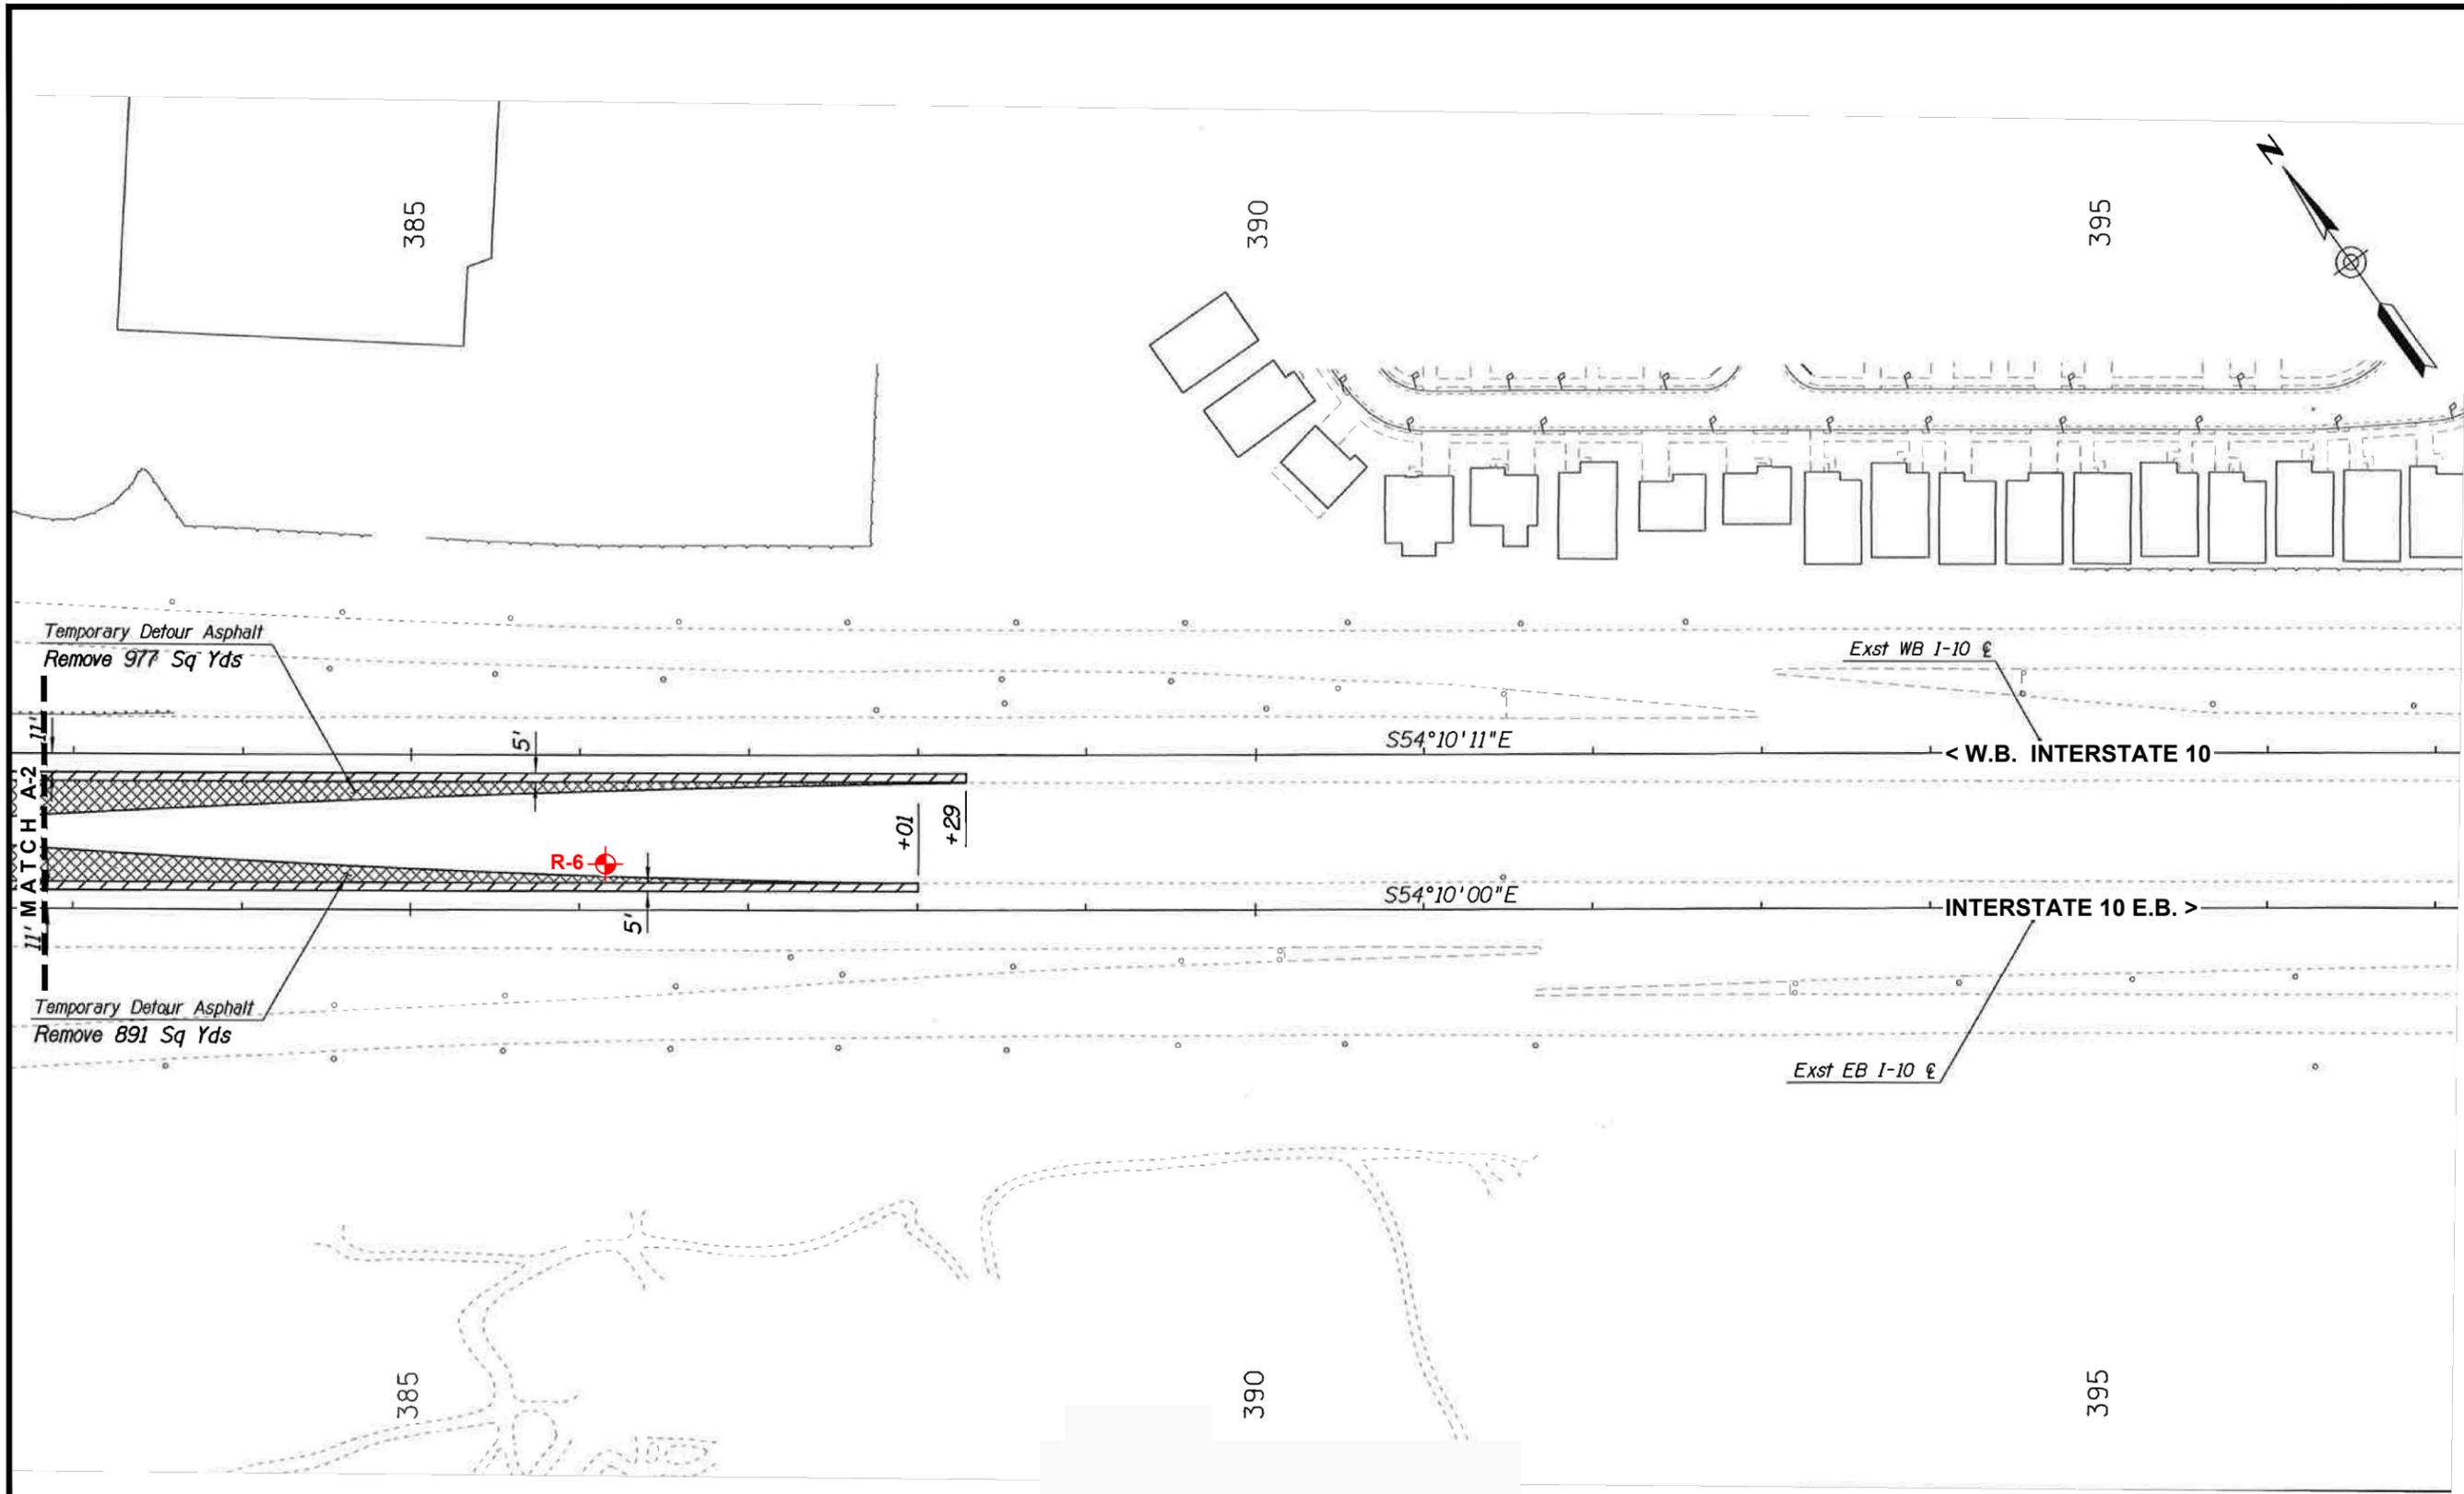
APPROXIMATE BORING LOCATION

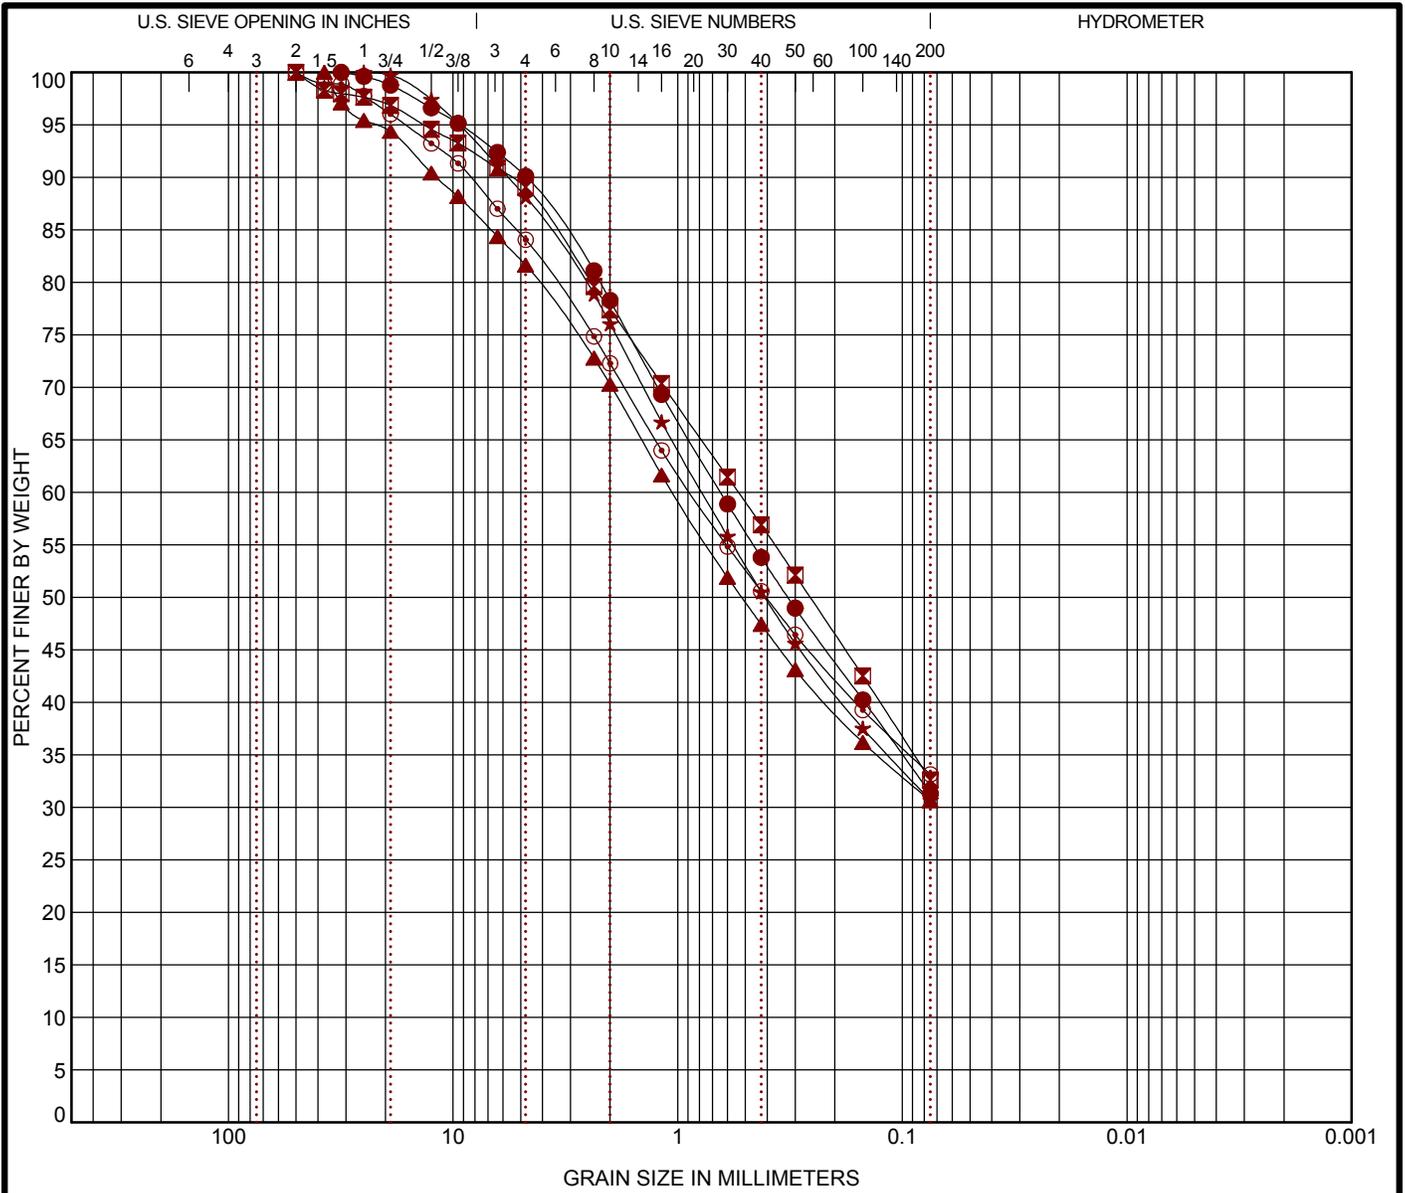
GRAIN SIZE DISTRIBUTION

COBBLES	GRAVEL		SAND			SILT OR CLAY
	coarse	fine	coarse	medium	fine

Boring ID	Depth	USCS Classification					LL	PL	PI	Cc	Cu
● B1	0 - 5	CLAYEY SAND (SC)					36	18	18		
■ B2	0 - 5	CLAYEY SAND (SC)					34	18	16		
▲ R1	0 - 3.5	CLAYEY SAND with GRAVEL (SC)					34	17	17		
★ R2	0 - 4	CLAYEY SAND (SC)					34	17	17		
⊙ R3	0 - 4	CLAYEY SAND with GRAVEL (SC)					38	16	22		
Boring ID	Depth	D ₁₀₀	D ₆₀	D ₃₀	D ₁₀	%Gravel	%Sand	%Fines			
● B1	0 - 5	31.5	0.645			9.9	58.8	31.3			
■ B2	0 - 5	50	0.537			11.0	56.4	32.6			
▲ R1	0 - 3.5	37.5	1.052			18.4	51.0	30.6			
★ R2	0 - 4	25	0.778			11.9	57.5	30.7			
⊙ R3	0 - 4	50	0.878			15.9	50.9	33.1

The Atterberg limits test results of the near surface embankment fill clayey sand soils exhibit medium plasticity characteristics (with plastic limits of 14 and 25). The gradation test results of the near surface embankment fill clayey sand soils indicate these soils contain percent fines (percent passing the sieve No. 200) ranging from approximately 21 to 42 percent, percent sand ranged from approximately 47 to 59 percent, and percent gravel ranged from about 5 to 32 percent.

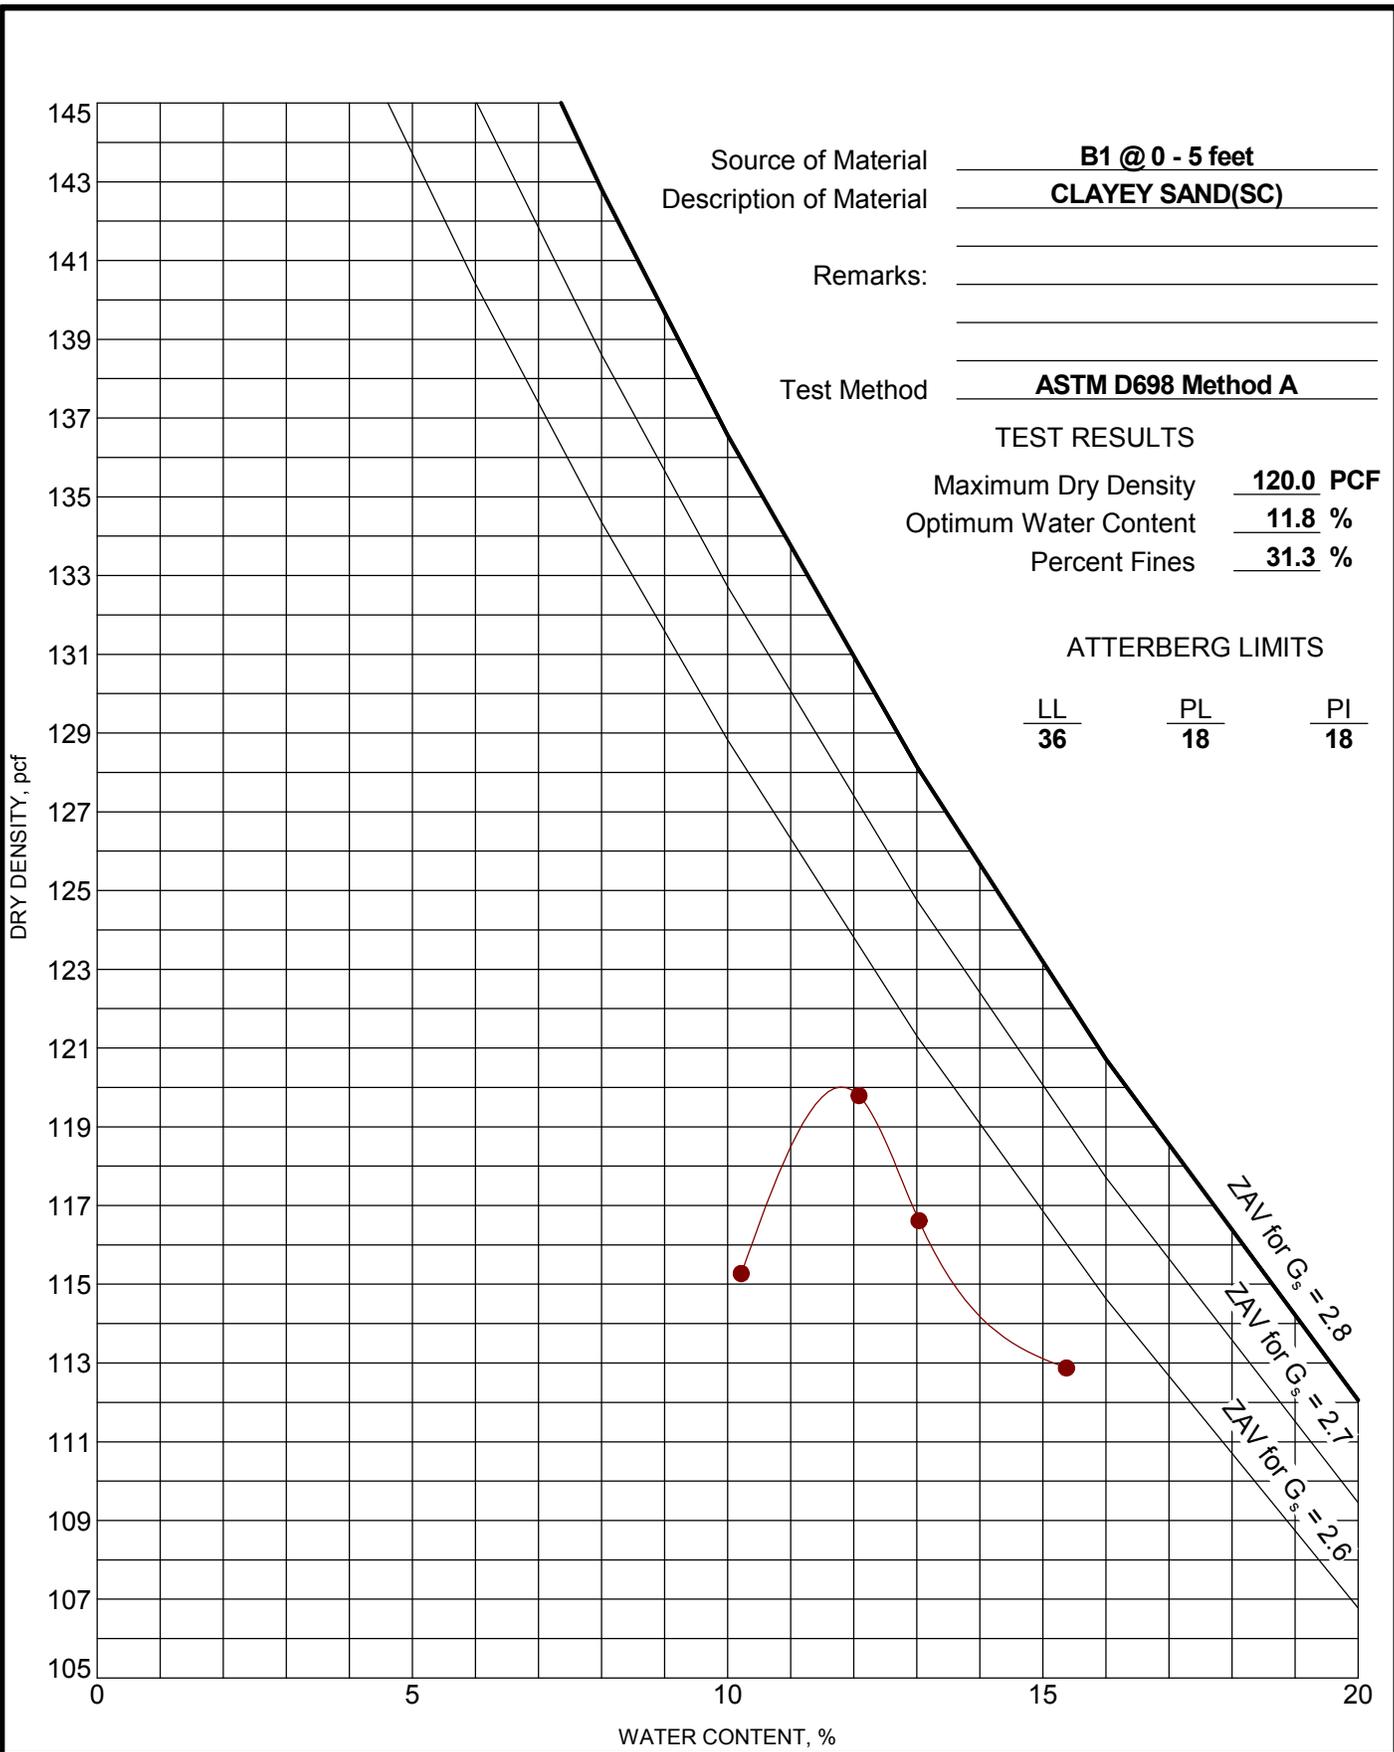
MOISTURE-DENSITY RELATIONSHIP

Source of Material B1 @ 0 - 5 feet
 Description of Material CLAYEY SAND(SC)
 Remarks: _____
 Test Method ASTM D698 Method A

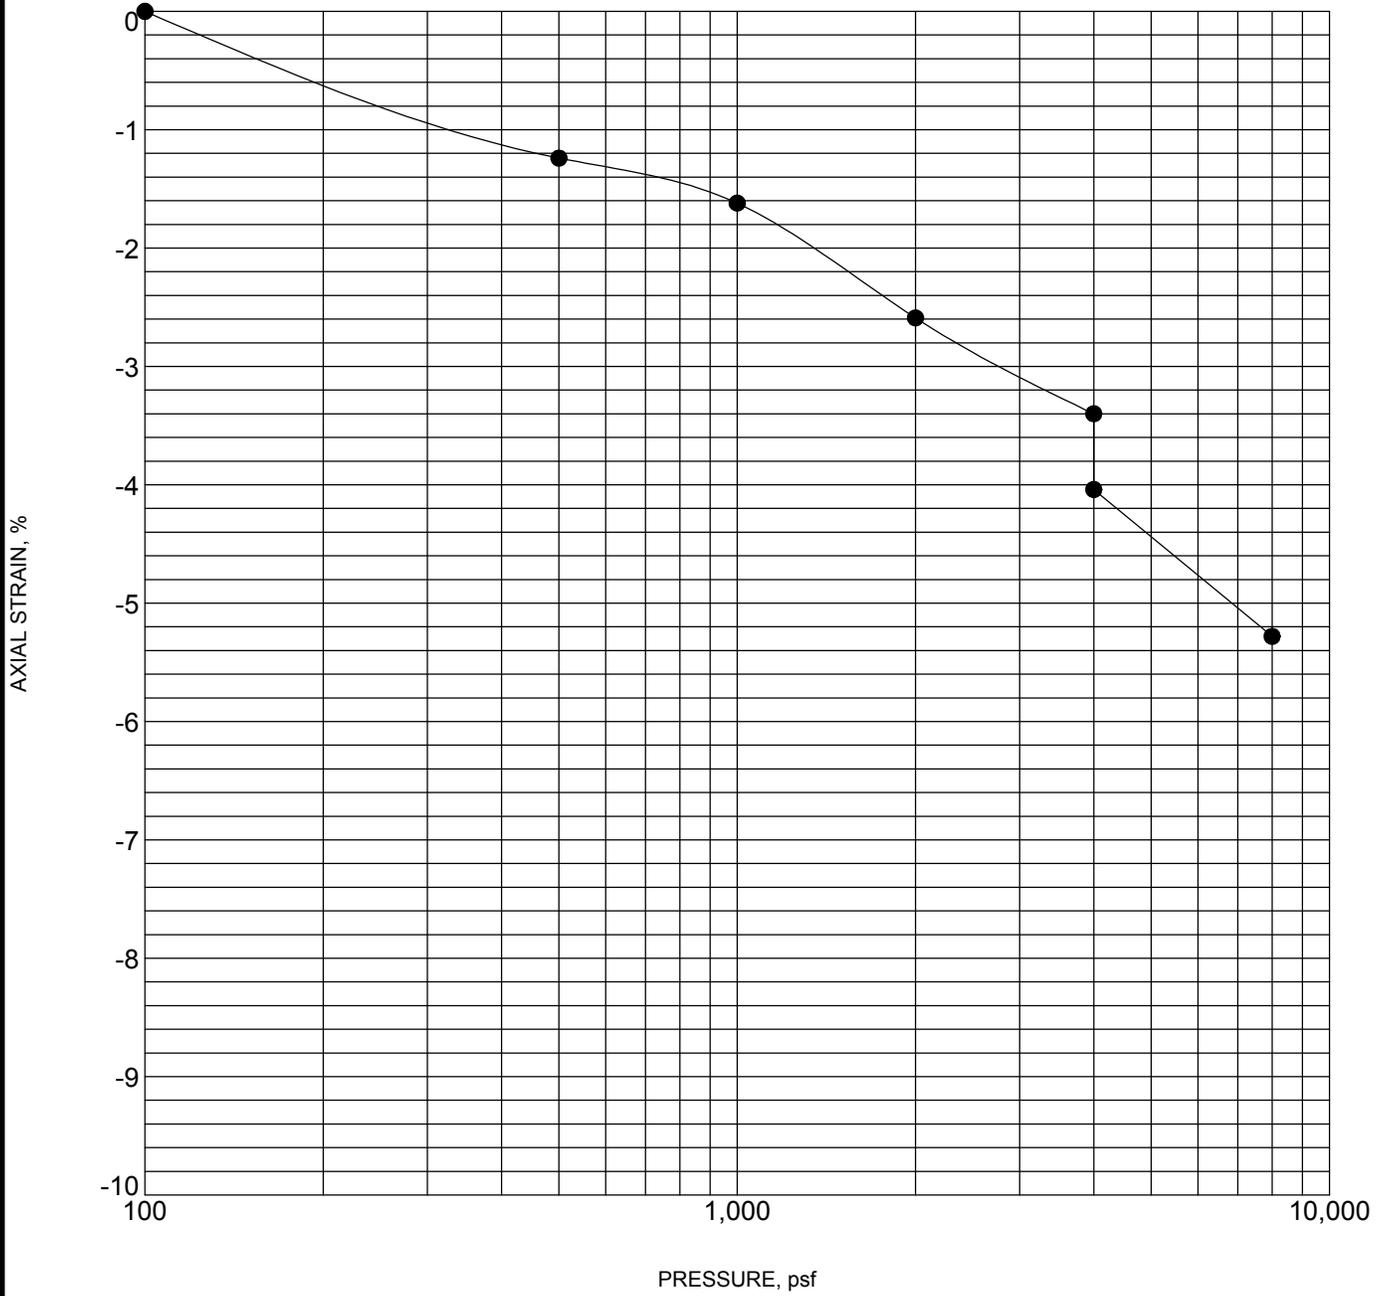
Specimen Identification	Classification	γ_d , pcf	WC, %
● B2 14.0 - 15.0 ft	CLAYEY SAND (SC)	120	10

NOTES: water added at 4,000 psf

In-situ samples of embankment fill soils tested for consolidation and response to wetting exhibited low hydro-compaction (collapse) potential when wetted while supporting typical foundation pressures. The percent collapse on the samples tested was less than 1 percent.

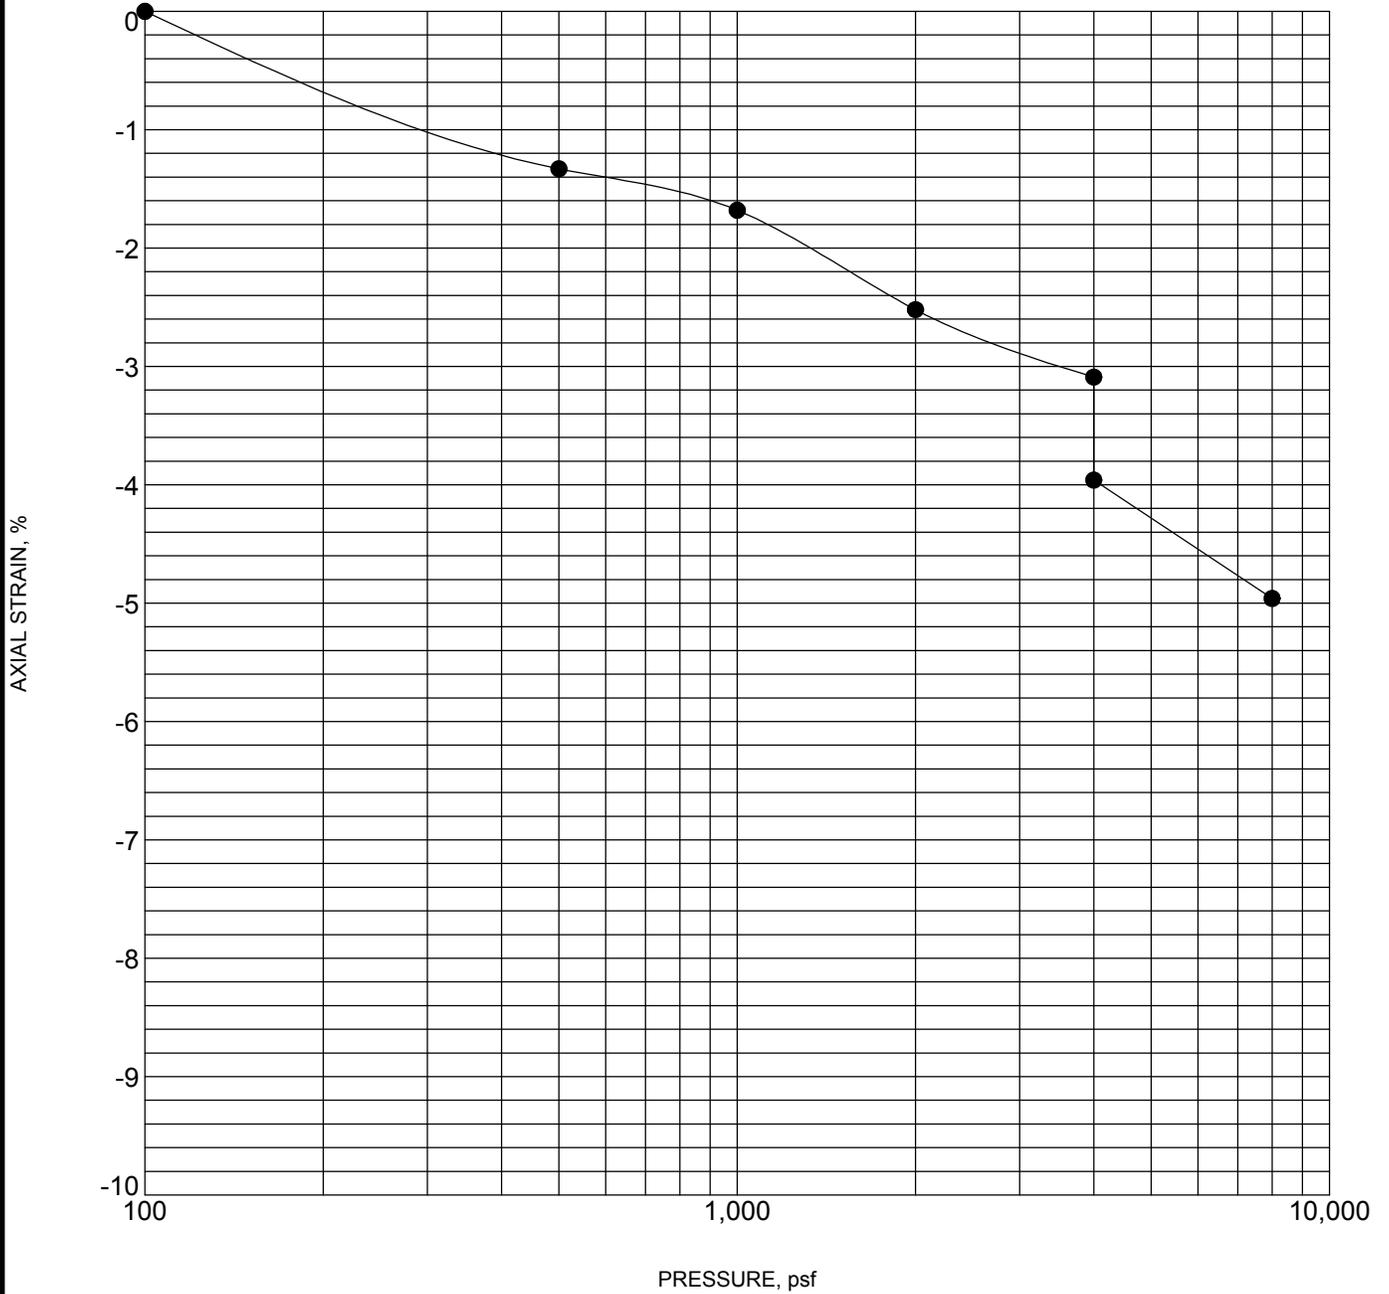
Specimen Identification	Classification	γ_d , pcf	WC, %
● B2 24.0 - 25.0 ft	SANDY LEAN CLAY (CL)	121	6

NOTES: water added at 4,000 psf

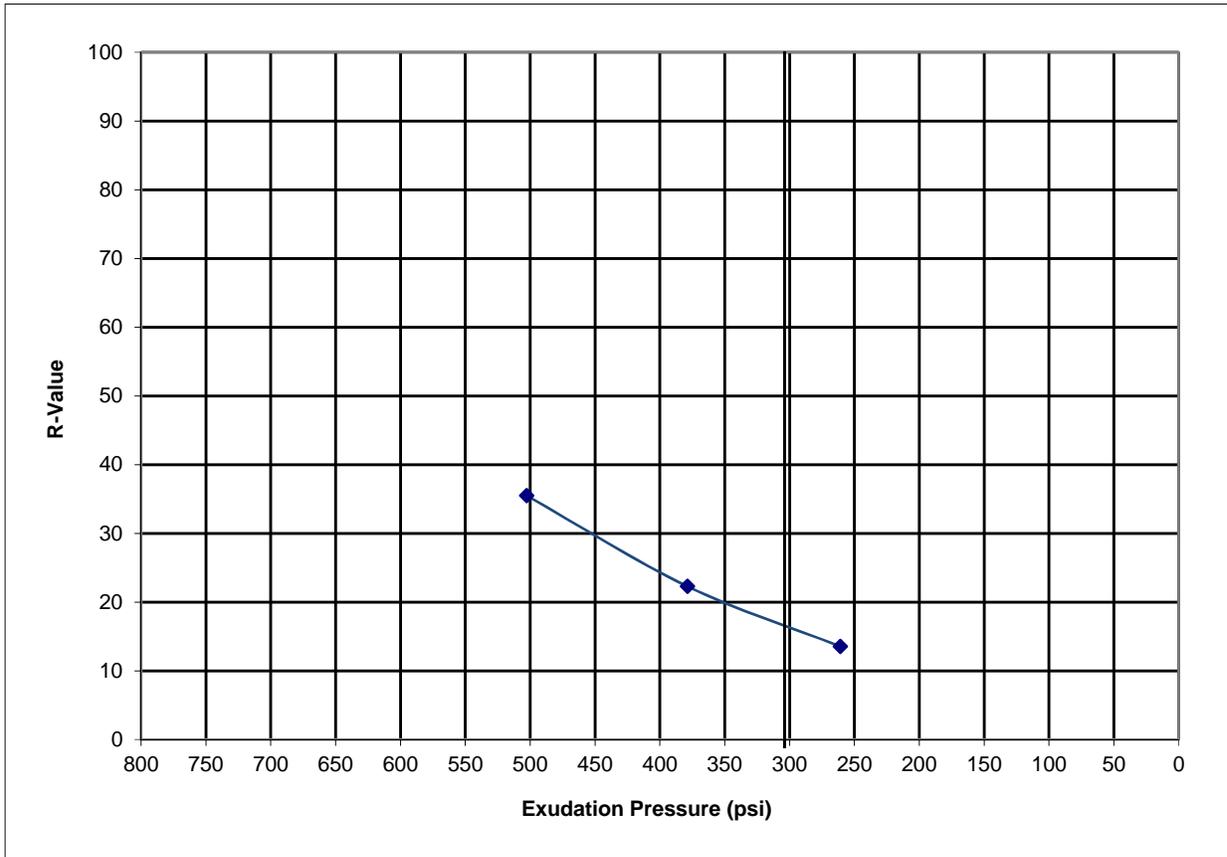
RESISTANCE R-VALUE AND EXPANSION PRESSURE OF COMPACTED SOILS (ASTM D2844)

SPECIMEN I. D.	A	B	C
Moisture Content	22.8%	20.9%	19.2%
Compaction Pressure (psi)	130	190	230
Specimen Height (inches)	2.58	2.53	2.52
Dry Density (pcf)	109.2	114.5	117.7
Horiz. Pres. @ 1000lbs (psi)	55.0	44.0	39.0
Horiz. Pres. @ 2000lbs (psi)	129.0	109.0	86.0
Displacement	4.14	4.08	3.91
Expansion Pressure (psi)	0.0	0.0	0.3
Exudation Pressure (psi)	261	379	503
R Value	14	22	35

R Value at 300 PSI = 16.0

The calculated mean R-Value for the project is 27; however, we recommend an R-value of 20 be used for design purposes. The corresponding resilient modulus is 8,819 pounds per square inch (psi) for a seasonal variation factor of 1.7 for Tucson, Arizona.

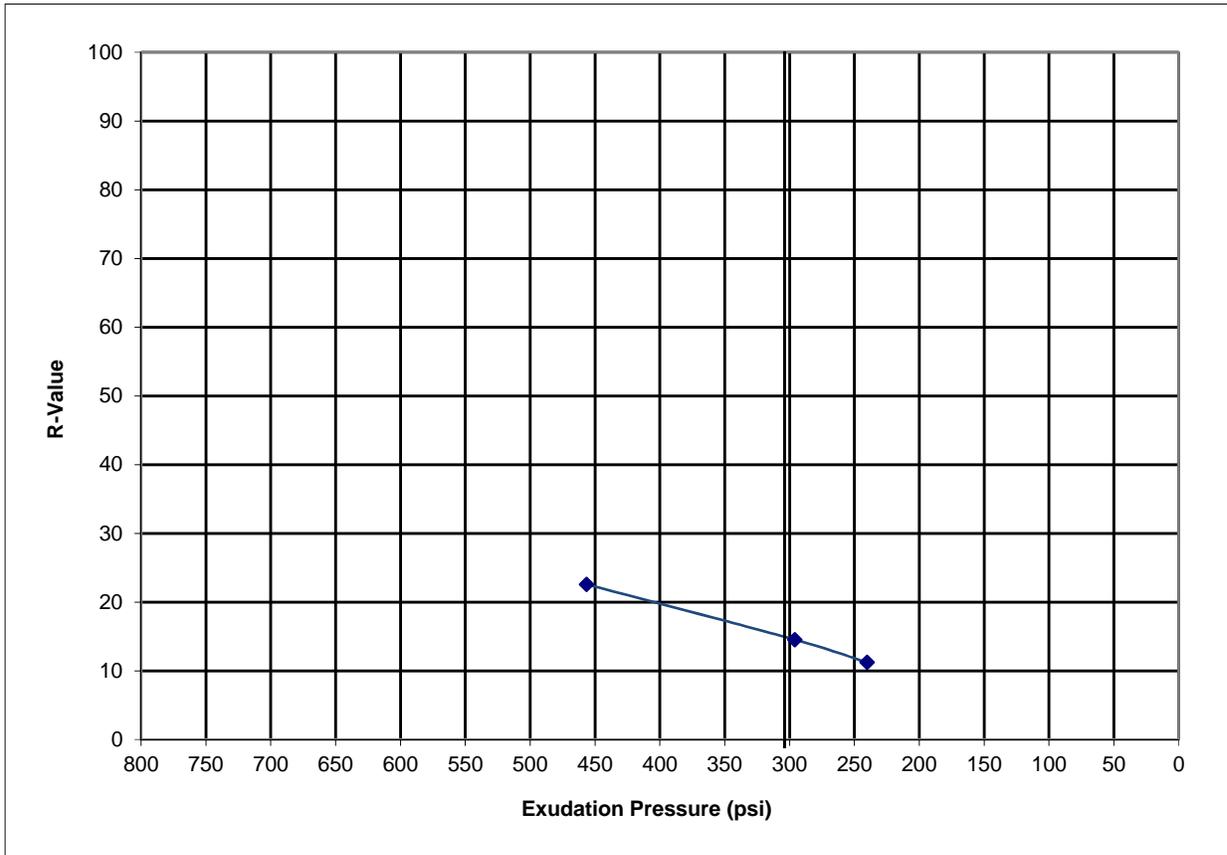
RESISTANCE R-VALUE AND EXPANSION PRESSURE OF COMPACTED SOILS (ASTM D2844)

SPECIMEN I. D.	A	B	C
Moisture Content	13.4%	13.0%	11.3%
Compaction Pressure (psi)	85	115	190
Specimen Height (inches)	2.57	2.58	2.49
Dry Density (pcf)	120.8	120.1	124.5
Horiz. Pres. @ 1000lbs (psi)	57.0	54.5	45.0
Horiz. Pres. @ 2000lbs (psi)	134.0	128.0	112.0
Displacement	4.11	3.97	3.67
Expansion Pressure (psi)	0.0	0.0	0.0
Exudation Pressure (psi)	240	296	457
R Value	11	15	23

R Value at 300 PSI = 14.8
