Roadway Geotechnical Engineering Report

CRAYCROFT RD TI OP STR #594 & #595
I-10 Temporary Bridge at Craycroft Road, Tucson, Arizona

ADOT TRACS No.: 010 PM 267 H8774 01C

Terracon Project No. 65155090R1

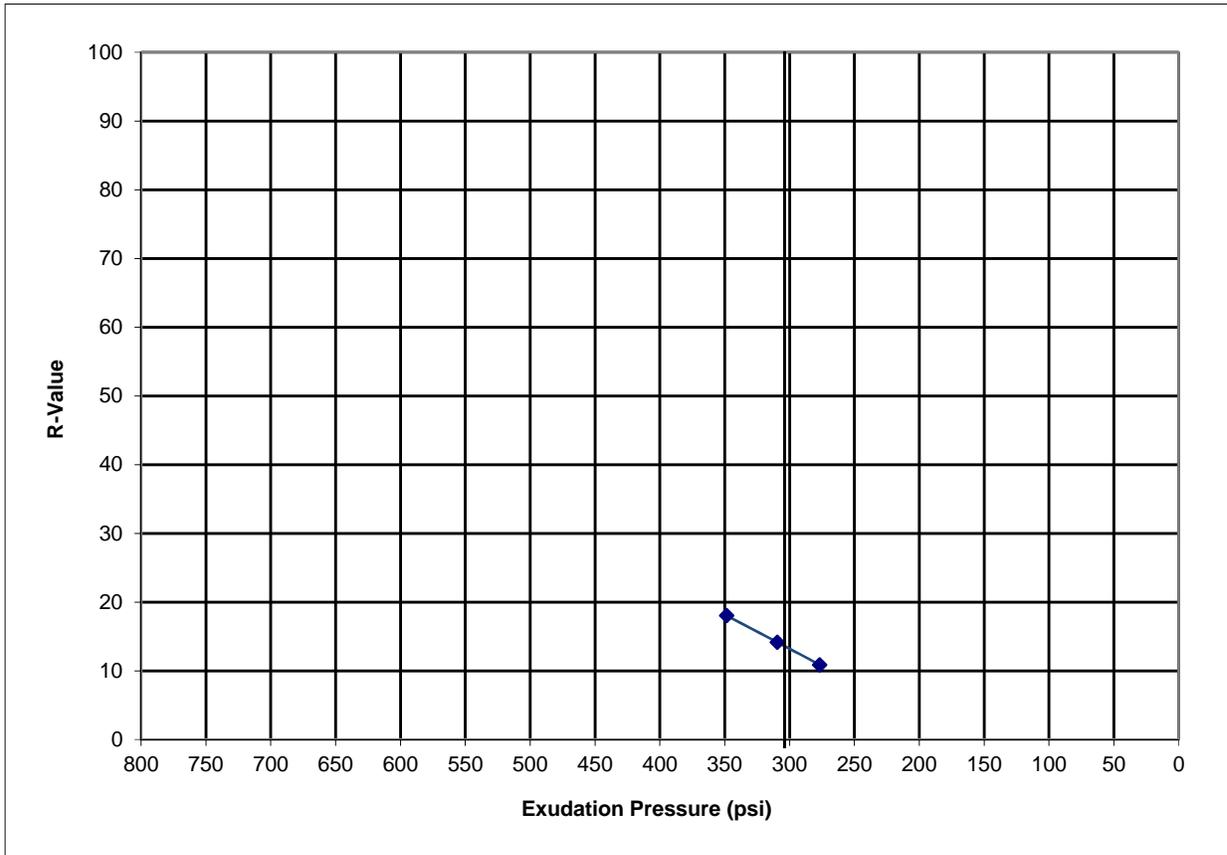
RESISTANCE R-VALUE AND EXPANSION PRESSURE OF COMPACTED SOILS (ASTM D2844)

SPECIMEN I. D.	A	B	C
Moisture Content	26.6%	24.7%	22.5%
Compaction Pressure (psi)	95	130	155
Specimen Height (inches)	2.57	2.58	2.49
Dry Density (pcf)	103.8	106.6	122.0
Horiz. Pres. @ 1000lbs (psi)	59.0	55.0	49.0
Horiz. Pres. @ 2000lbs (psi)	135.0	130.0	122.0
Displacement	4.06	3.78	3.54
Expansion Pressure (psi)	0.0	0.0	0.0
Exudation Pressure (psi)	277	309	348
R Value	11	14	18

R Value at 300 PSI = 13.2

The calculated mean R-Value for the project is 27; however, we recommend an R-value of 20 be used for design purposes. The corresponding resilient modulus is 8,819 pounds per square inch (psi) for a seasonal variation factor of 1.7 for Tucson, Arizona.

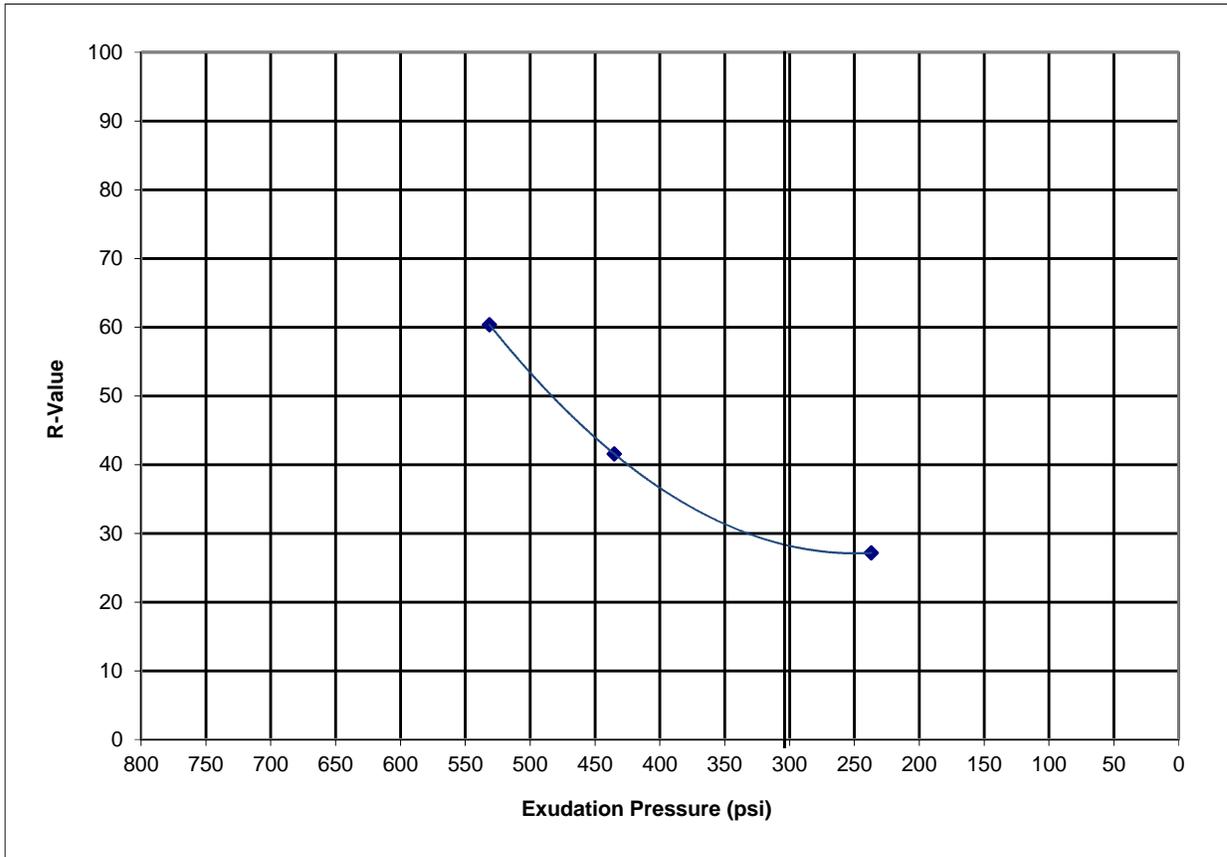
RESISTANCE R-VALUE AND EXPANSION PRESSURE OF COMPACTED SOILS (ASTM D2844)

SPECIMEN I. D.	A	B	C
Moisture Content	14.3%	13.3%	12.4%
Compaction Pressure (psi)	220	310	350
Specimen Height (inches)	2.58	2.50	2.54
Dry Density (pcf)	120.2	122.3	123.2
Horiz. Pres. @ 1000lbs (psi)	43.0	32.5	22.0
Horiz. Pres. @ 2000lbs (psi)	103.5	78.5	50.0
Displacement	3.96	3.65	3.61
Expansion Pressure (psi)	0.0	0.4	0.5
Exudation Pressure (psi)	237	435	531
R Value	27	42	60

R Value at 300 PSI = 28.2

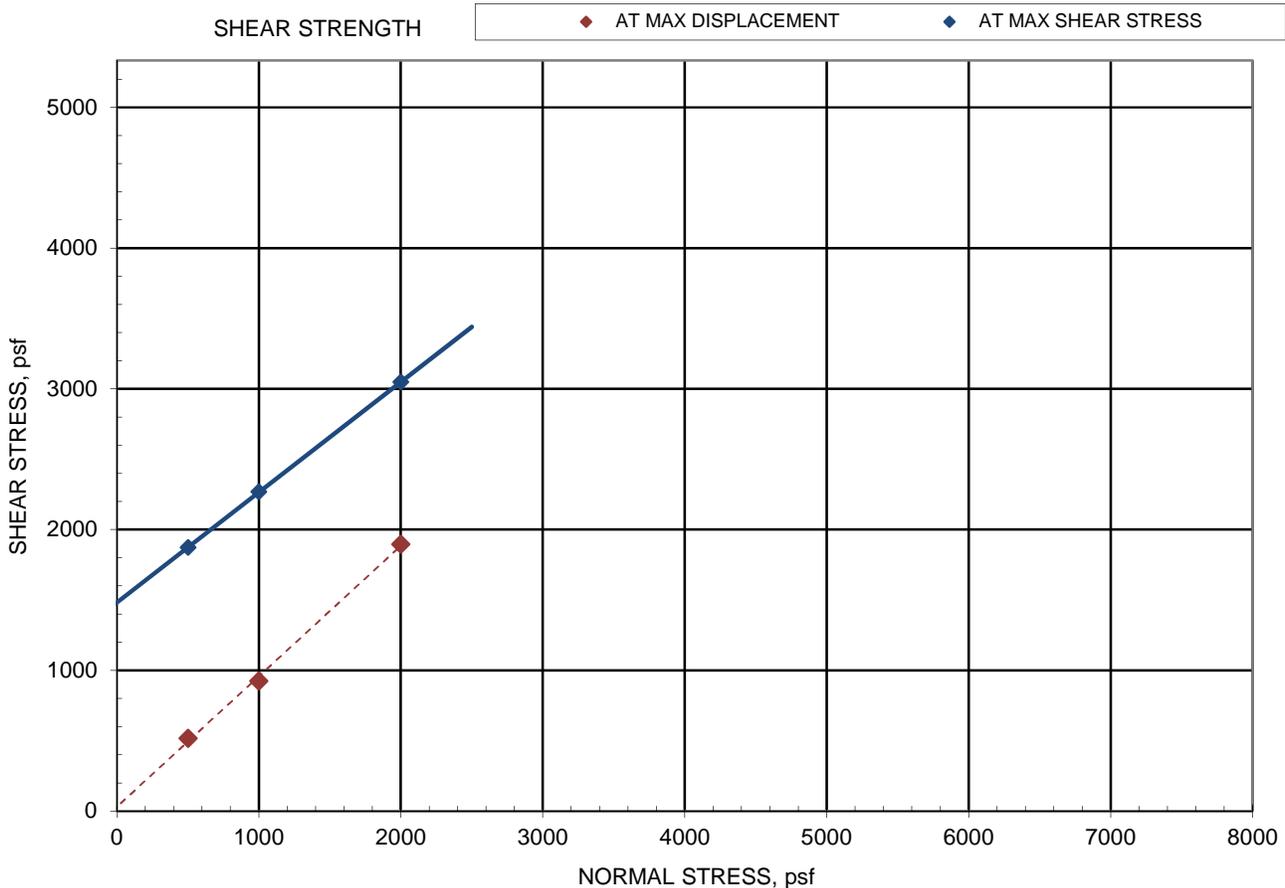
**DIRECT SHEAR TEST OF SOILS UNDER CONSOLIDATED
DRAINED CONDITIONS ASTM D3080**

Sample Preparation: Remolded to 95% max dry density at 2% below optimum moisture. Max dry density D698A 120.0 pcf @ 11.8% opt. moisture. Specimens consolidation and shear on unsaturated condition.

FRICTION ANGLE	COHESION
AT MAX SHEAR STRESS	38.1	1482
Specs:		
AT MAX DISPLACEMENT	42.8	30
Specs:

Note: The friction angle presented is applicable only to the load ranges and sample conditions tested

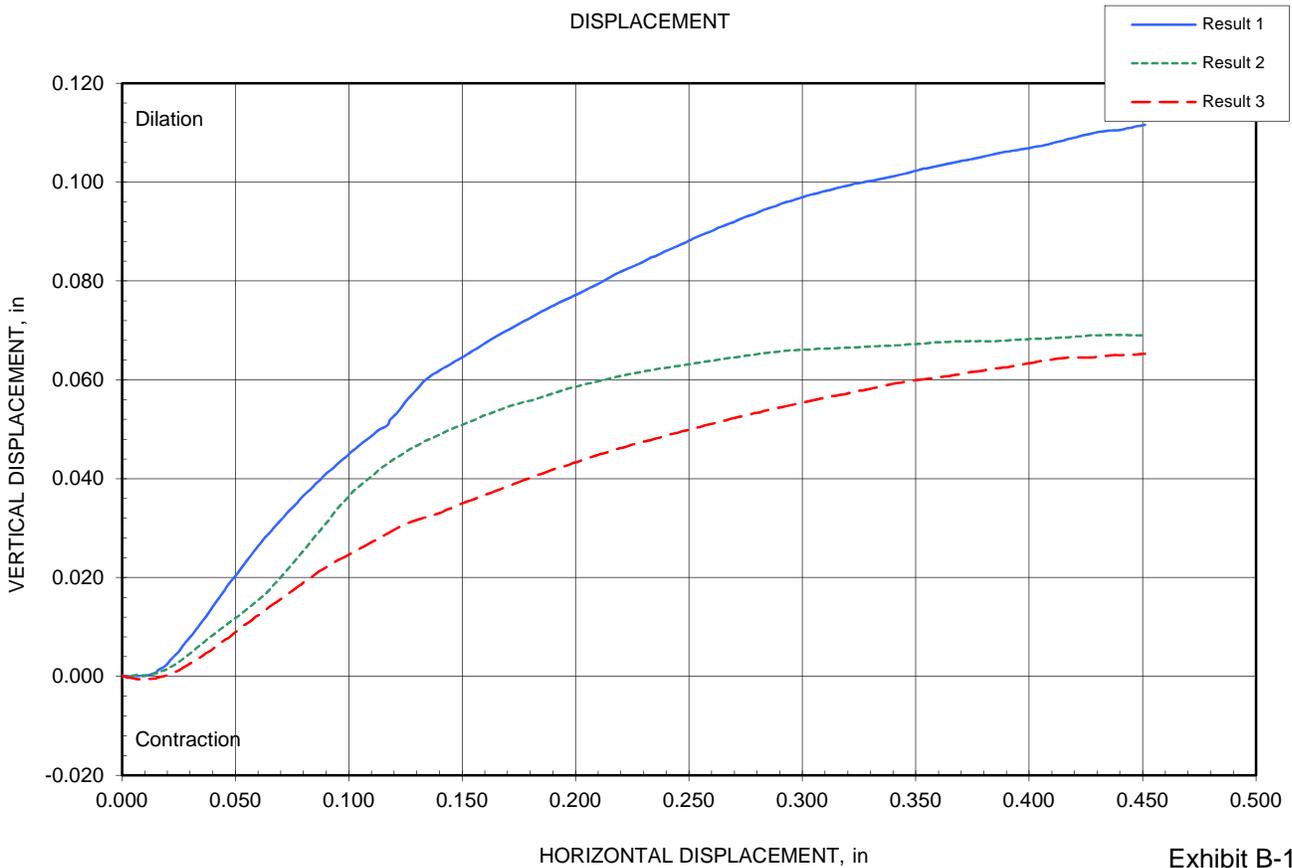
PROJECT:	I-10 Temporary Bridge at Craycroft Road	JOB NO:	65155090
LOCATION:	Tucson, Arizona	WORK ORDER NO:	65155090
MATERIAL:	Composite Sample, Clayey Sand	LAB NO:	N/A
SAMPLE SOURCE:	B2@0-5'; B2@9'; B2@14'-15'	DATE SAMPLED:	3/4/2016
