**ROADWAY
and
FOUNDATION
GEOTECHNICAL DESIGN REPORT
Ehrenberg Port of Entry
TRACS No. 010 LA 003 H6161 01C
Federal Aid No. IM-010-A(221)T**

**Prepared by:
Geotechnical Section
Materials Group
Arizona Department of Transportation**

Subject:
Geotechnical Report
Ehrenberg Port of Entry
010 LA 003 H6161 01C

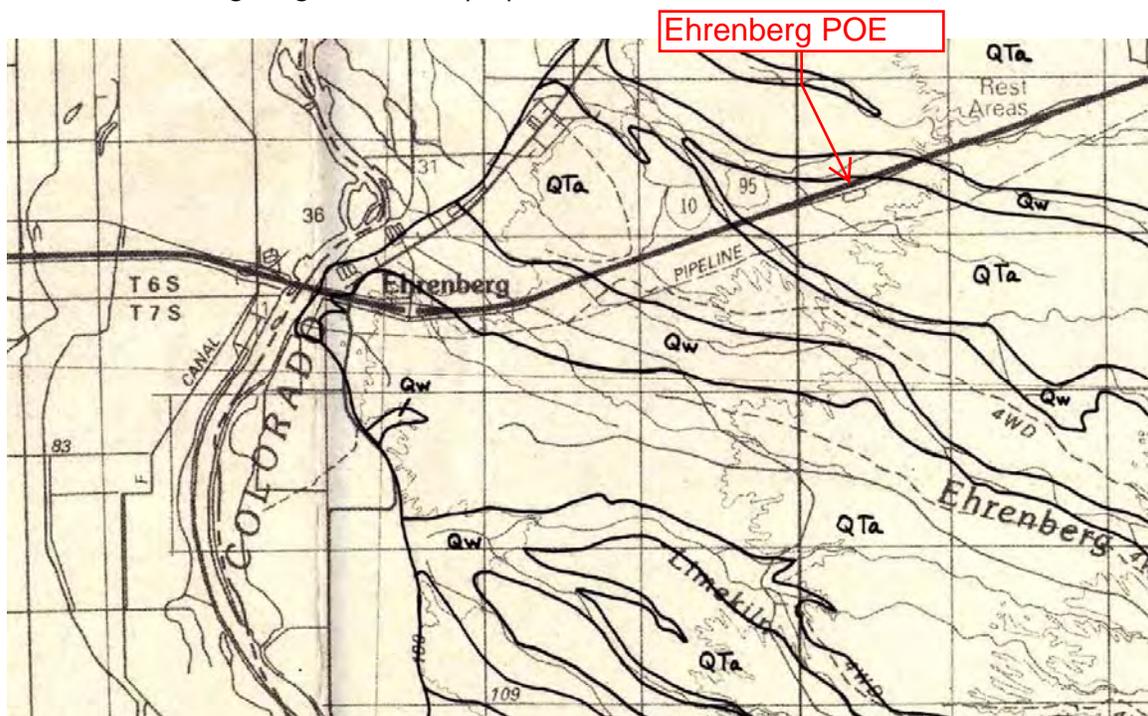
The project site is located on a deep alluvial fan (QTa) where deposits from the nearby Dome Rock Mountains have been transported via washes toward the Colorado River. The alluvial fan is reported by Tosdal (1989) to date from the middle Pleistocene to Latest Pliocene geologic period. Tosdal (1989) reports that the "Alluvial fan deposits consist of angular, poorly sorted gravel and sand derived from local mountains". The geologic map below from the US Geologic Service details the geologic unit at the proposed construction:

The alluvial deposits originate from the nearby Dome Rock Mountains. The Dome Rock Mountains are described by Tosdal (1989): “Volcanic rocks of the Dome Rock sequence are composed of Rhyolitic to Dacitic deposits, commonly referred to as Quartz Prophyry. They are foliated and metamorphosed to Green Schist and Lower Amphibolite Facies.”

The geotechnical investigation confirms the geologic mapping descriptions by Tosdal (1989). The project native soils consist of angular gravel and sand composed of Schist and Amphibolite.

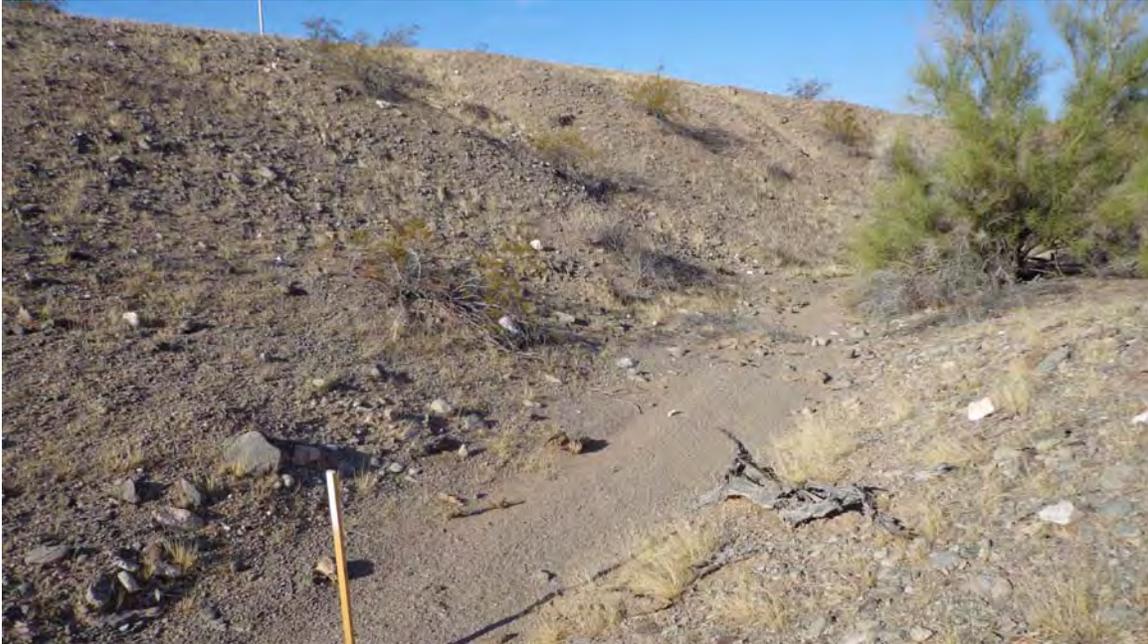
The location of the inspection building, truck scales, and water storage tanks is located on the hill south and overlooking the existing inspection station building. Elevation difference between the proposed new buildings and the existing building is approximately 10-15 feet. A earth retaining wall is planned on the North edge of the project to provide pavement support and stabilization of the slope. The terrain at the proposed building site has deeply incised erosional channels as shown in the photos below:

The photo above is located near one of the Inspection Building boring locations. Note the erosional channel present at the site of the building.

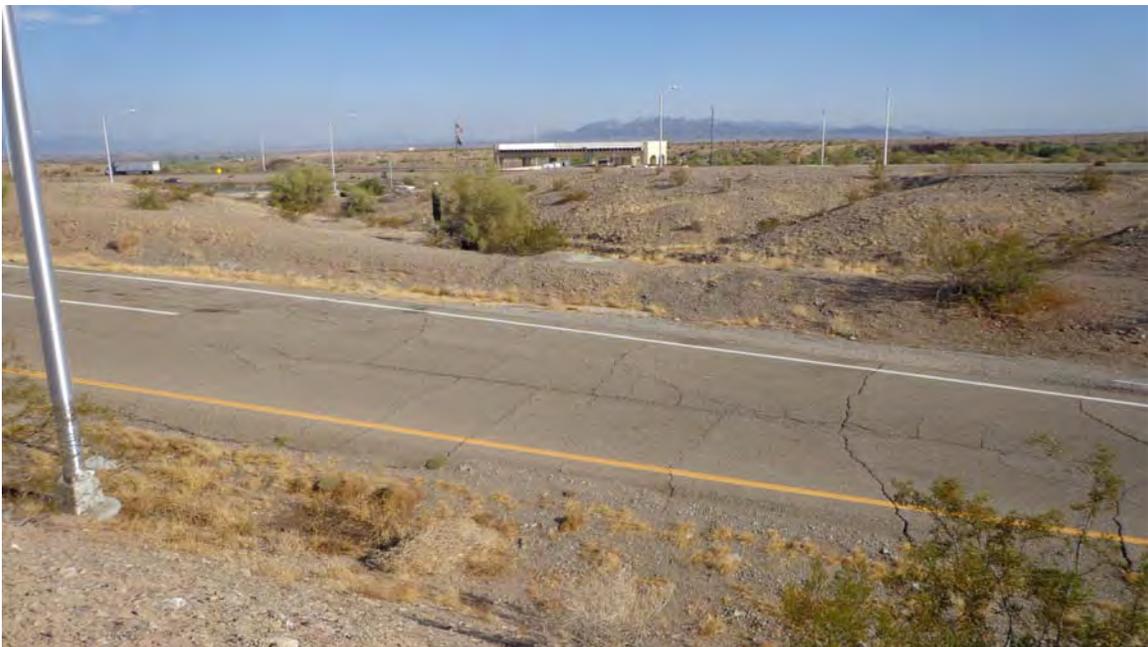
The photo below is located South of the proposed building site looking toward the existing Port of Entry facilities. A large erosional channel bisects the proposed building pad.

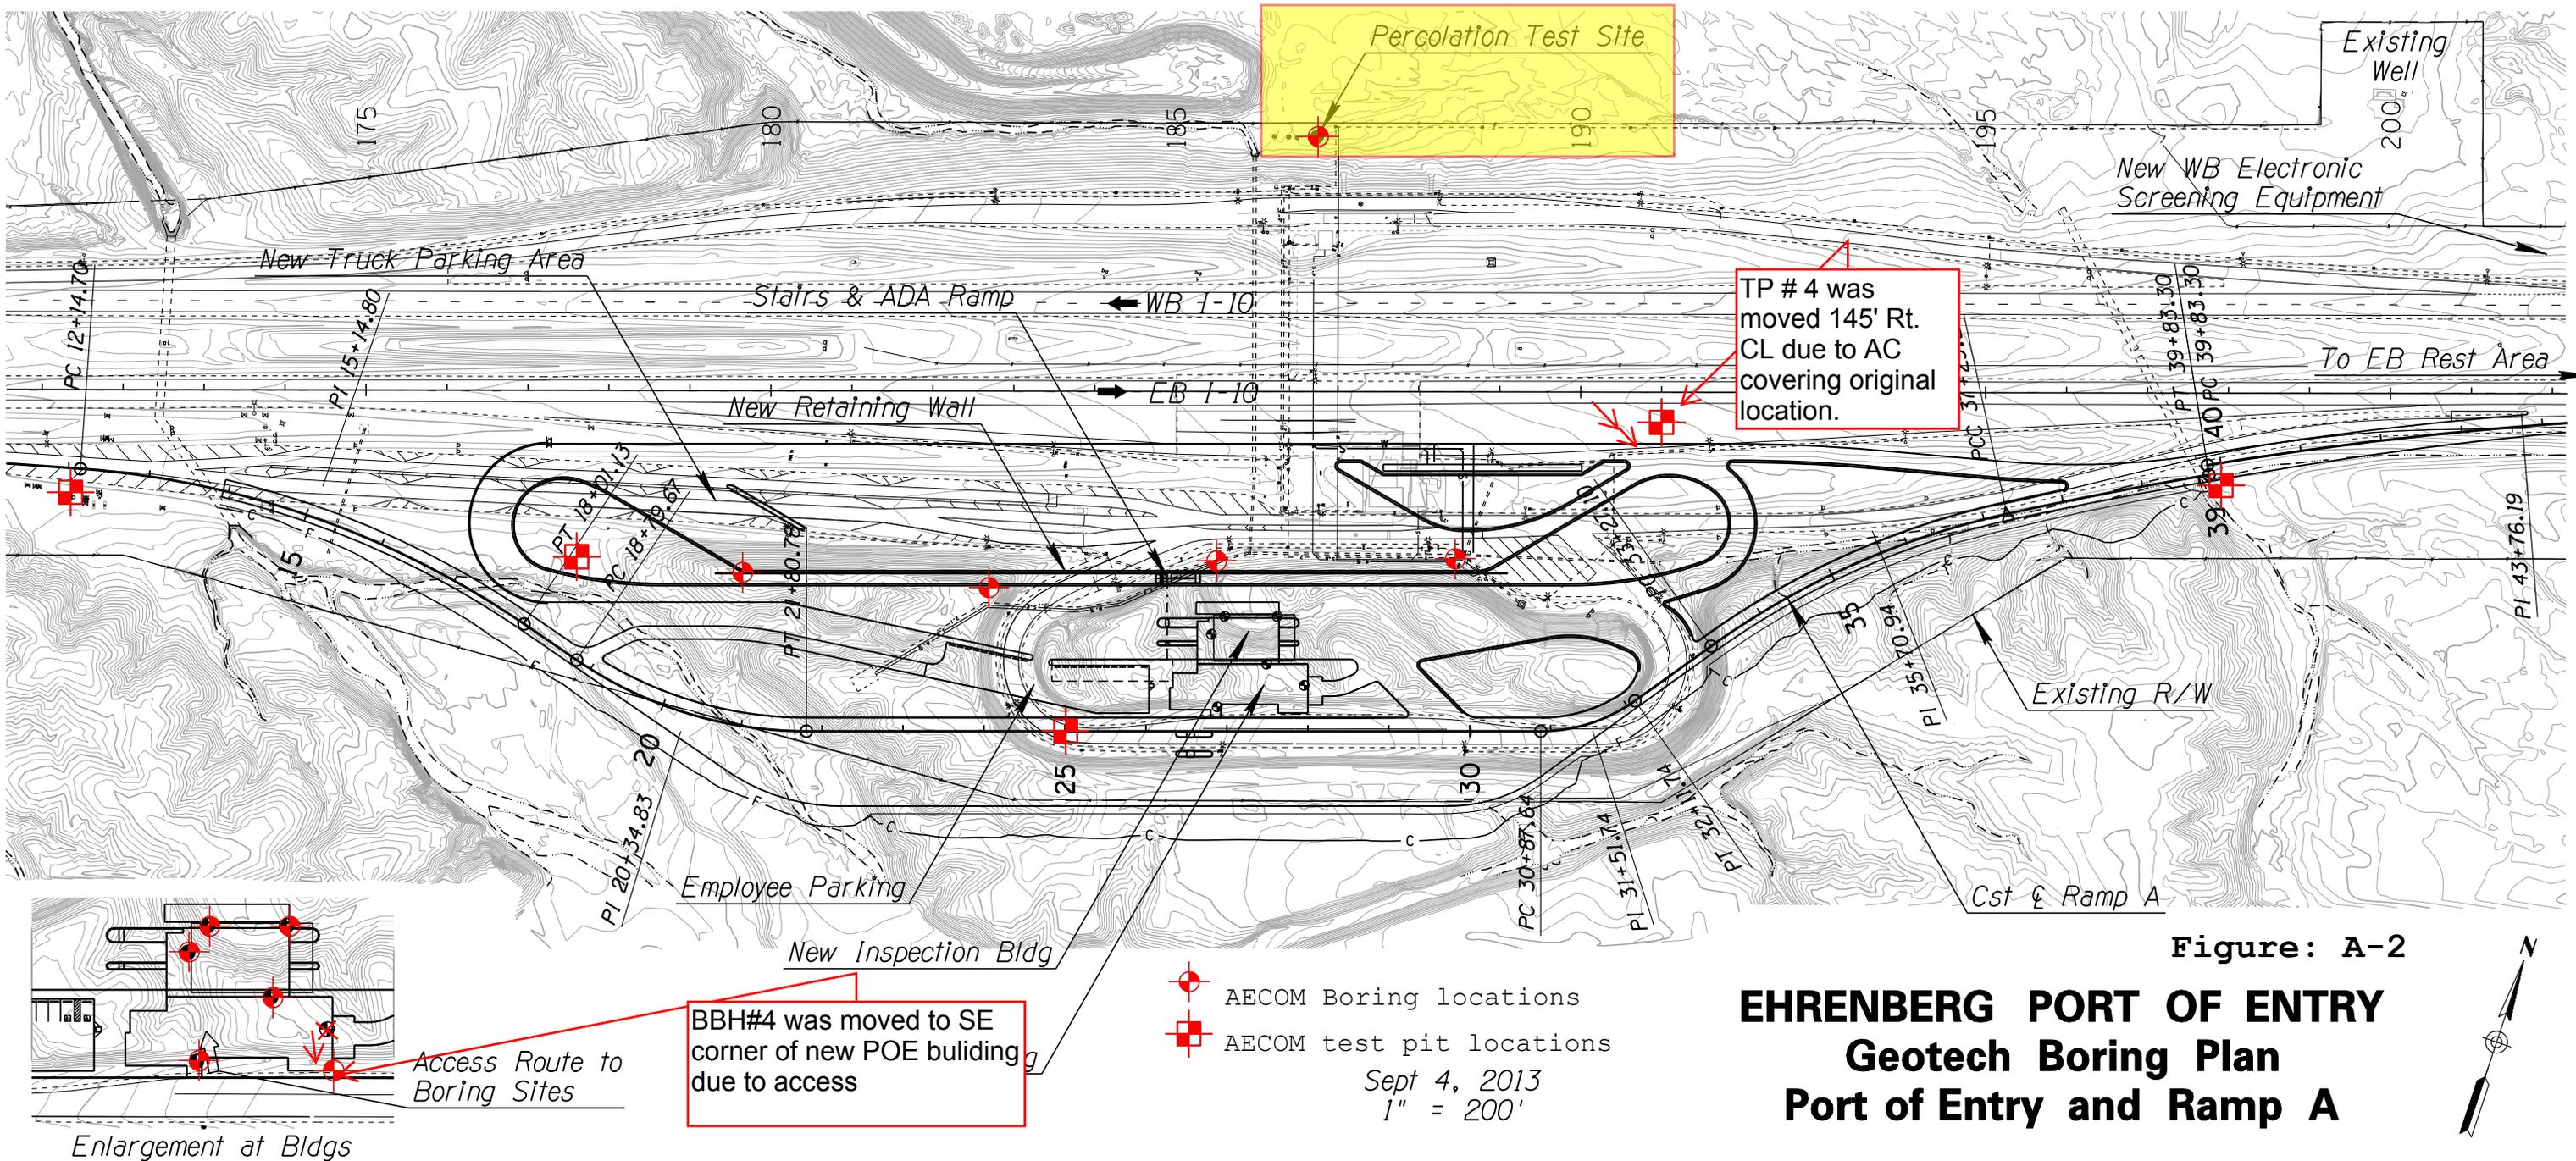
Figure: A-2
EHRENBERG PORT OF ENTRY
Geotech Boring Plan
Port of Entry and Ramp A

- AECOM Boring locations
 - AECOM test pit locations
- Sept 4, 2013
 1" = 200'

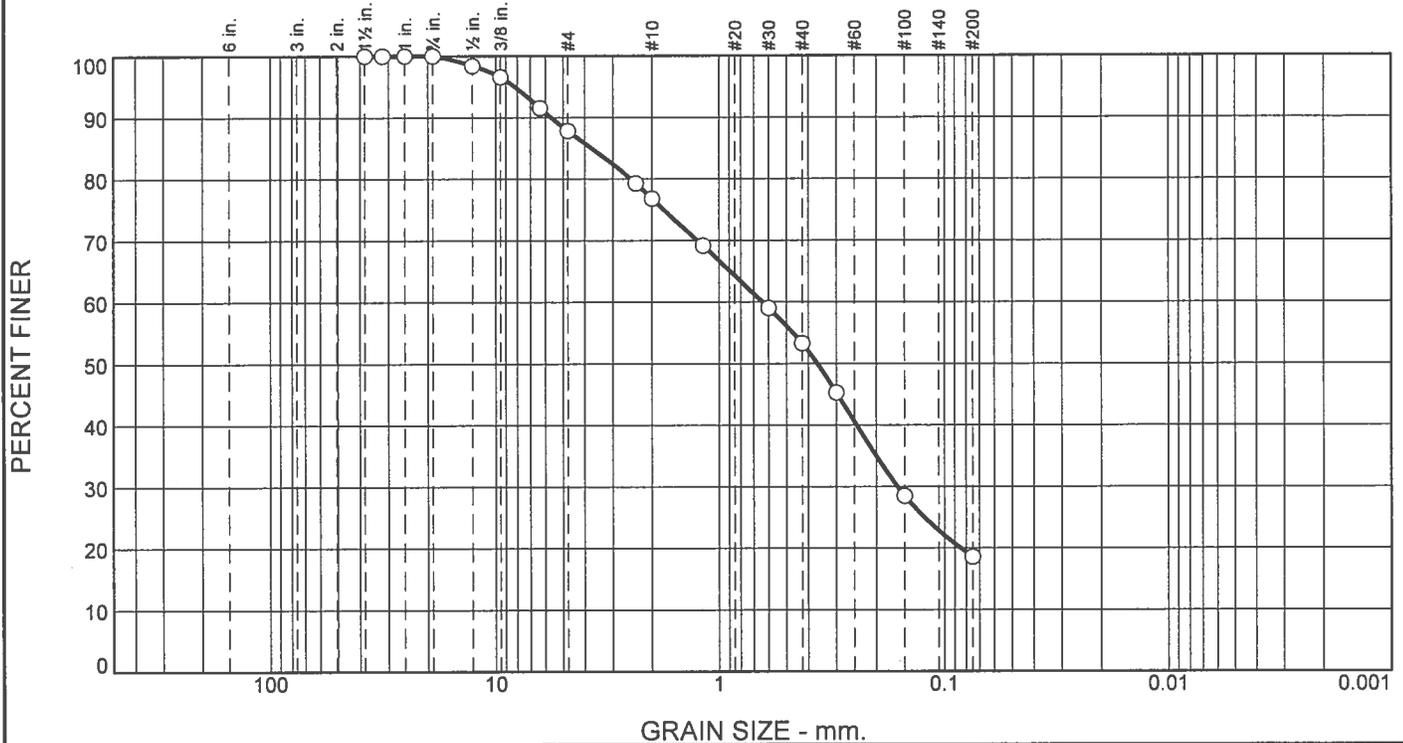
Particle Size Distribution Report

% +3"	% Gravel		% Sand			% Fines	
	Coarse	Fine	Coarse	Medium	Fine	Silt	Clay
0	0	12	11	24	34	19

TEST RESULTS			
Opening Size	Percent Finer	Spec.* (Percent)	Pass? (X=Fail)
1.5	100		
1.25	100		
1	100		
3/4"	100		
1/2"	98		
3/8"	97		
1/4"	92		
#4	88		
#8	79		
#10	77		
#16	69		
#30	59		
#40	53		
#50	45		
#100	28		
#200	19

Silty Sand
Moisture Content: 2.1%

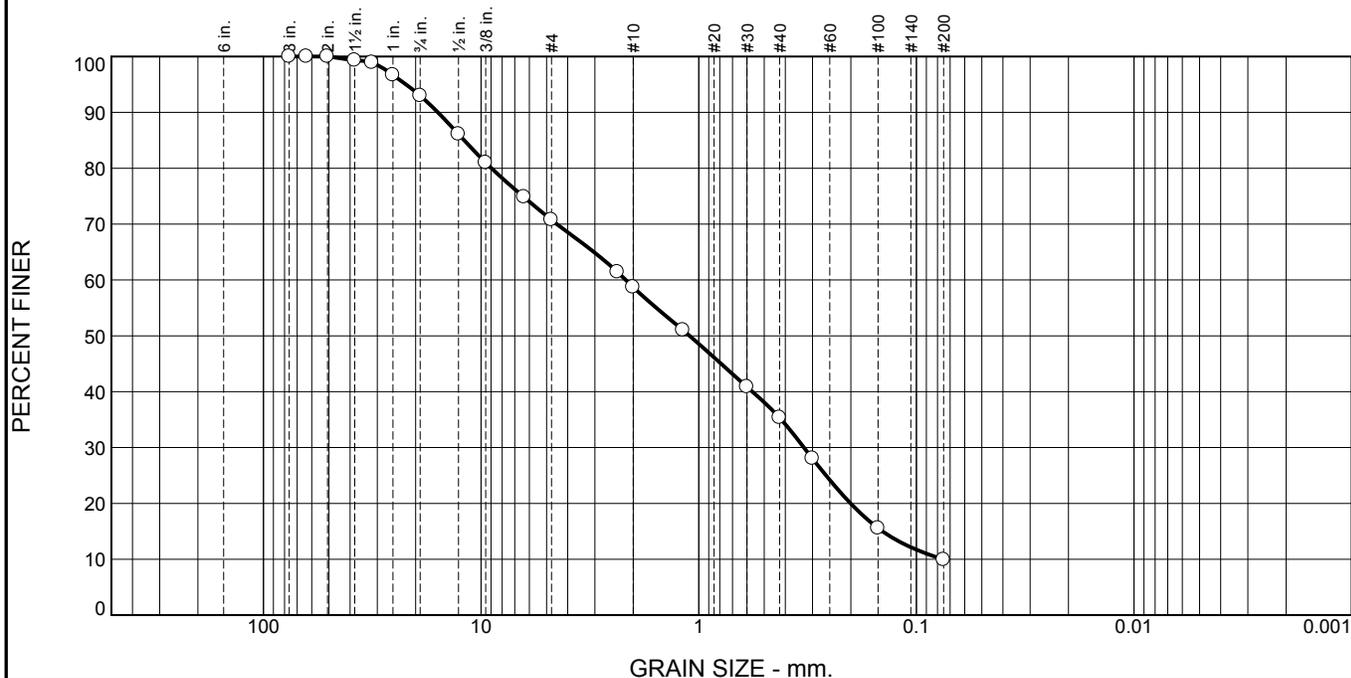
Particle Size Distribution Report

% +3"	% Gravel		% Sand			% Fines	
	Coarse	Fine	Coarse	Medium	Fine	Silt	Clay
0	7	22	12	24	25	10

TEST RESULTS			
Opening Size	Percent Finer	Spec.* (Percent)	Pass? (X=Fail)
3"	100		
2.5"	100		
2"	100		
1.5"	99		
1.25"	99		
1"	97		
3/4"	93		
1/2"	86		
3/8"	81		
1/4"	75		
#4	71		
#8	61		
#10	59		
#16	51		
#30	41		
#40	35		
#50	28		
#100	16		
#200	9.9

Poorly graded Sand with Silt and Gravel
Moisture Content: 2.0%

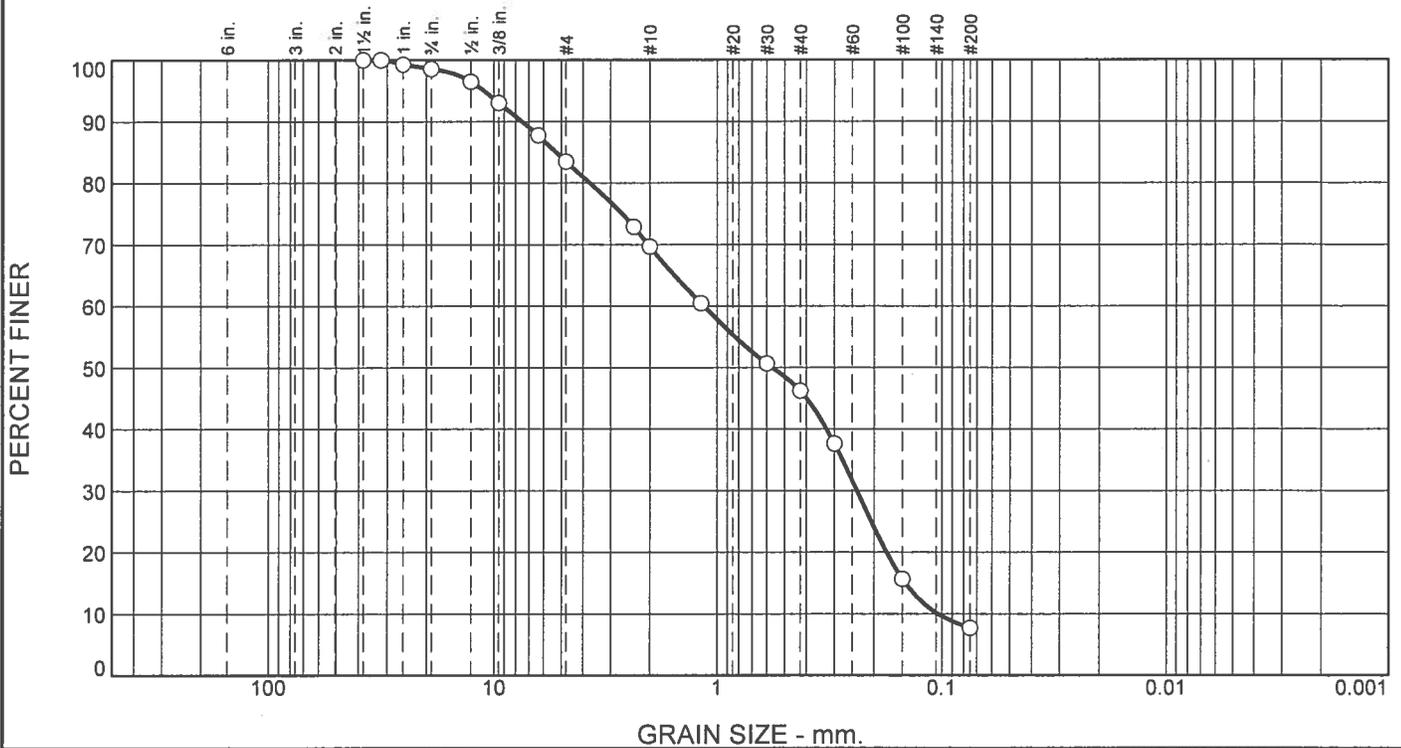
Particle Size Distribution Report

% +3"	% Gravel		% Sand			% Fines	
	Coarse	Fine	Coarse	Medium	Fine	Silt	Clay
0	1	16	13	24	38	8

TEST RESULTS			
Opening Size	Percent Finer	Spec.* (Percent)	Pass? (X=Fail)
1.5	100		
1.25	100		
1	99		
3/4"	99		
1/2"	97		
3/8"	93		
1/4"	88		
#4	83		
#8	73		
#10	70		
#16	60		
#30	51		
#40	46		
#50	38		
#100	16		
#200	7.7

Poorly Graded Sand with Silt and Gravel
Moisture Content: 1.5%

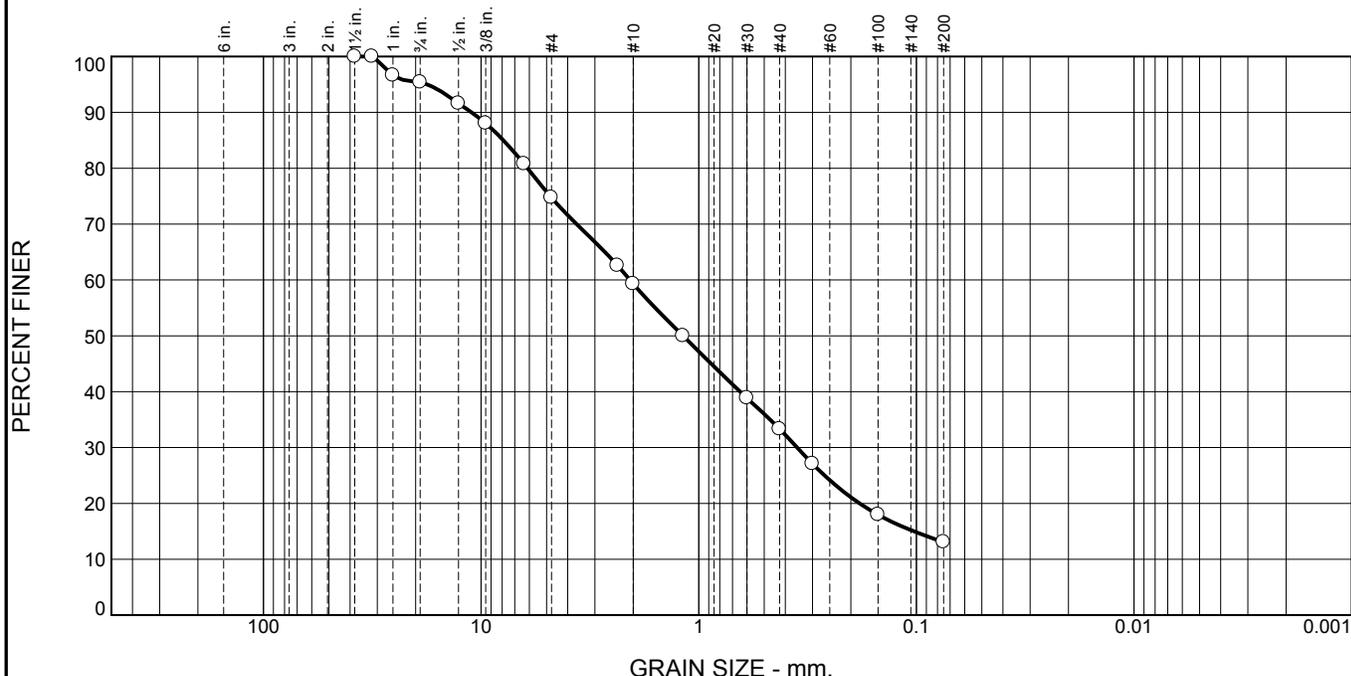
Particle Size Distribution Report

% +3"	% Gravel		% Sand			% Fines	
	Coarse	Fine	Coarse	Medium	Fine	Silt	Clay
0	5	20	16	26	20	13

TEST RESULTS			
Opening Size	Percent Finer	Spec.* (Percent)	Pass? (X=Fail)
1.5	100		
1.25	100		
1	97		
3/4"	95		
1/2"	92		
3/8"	88		
1/4"	81		
#4	75		
#8	63		
#10	59		
#16	50		
#30	39		
#40	33		
#50	27		
#100	18		
#200	13

Silty Sand with gravel
Moisture Content: 1.0%

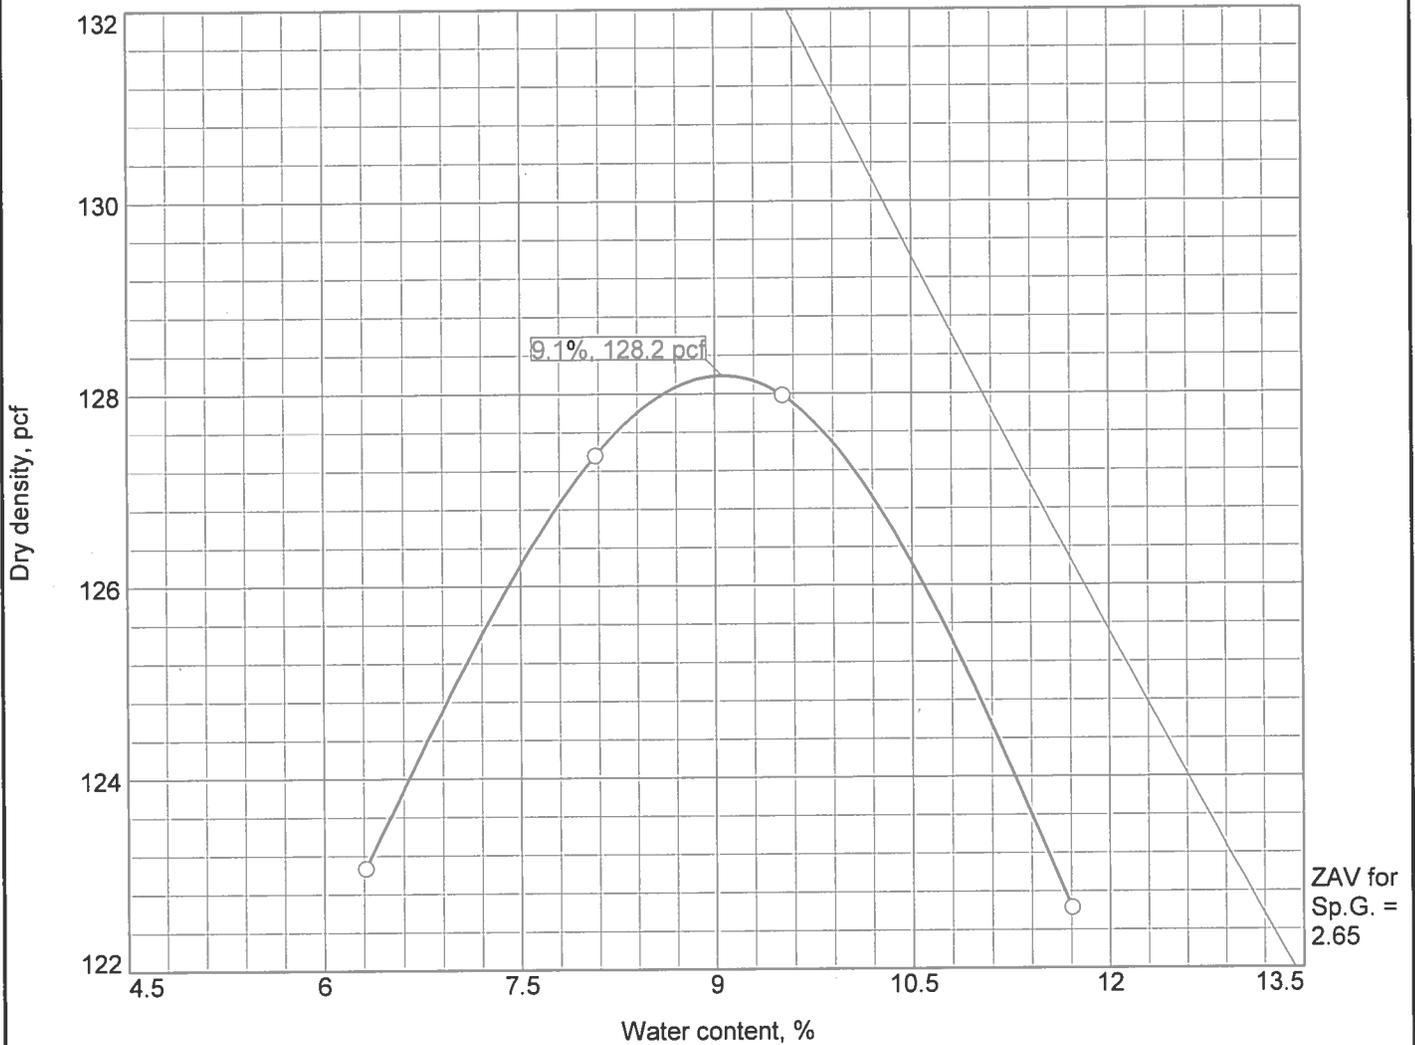
COMPACTION TEST REPORT

Test specification: ASTM D 698-91 Procedure A Standard

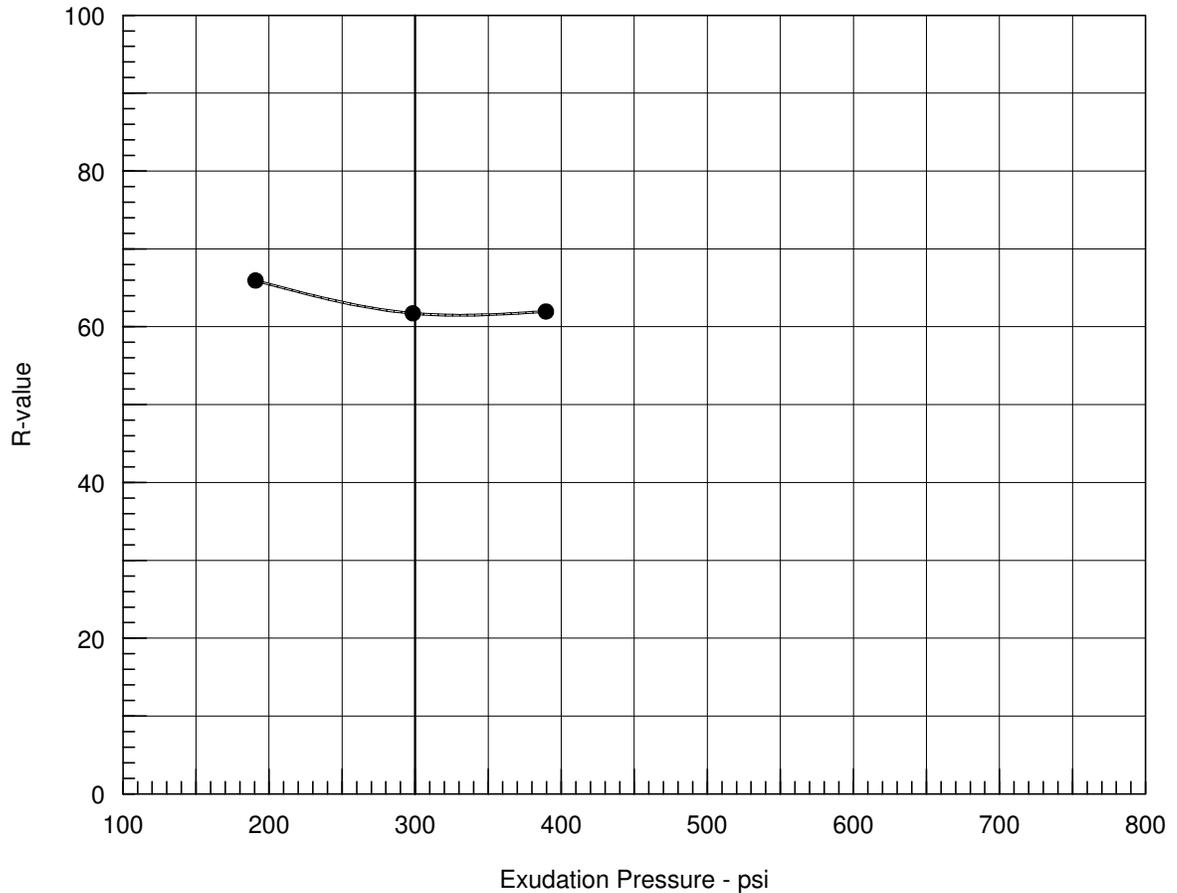
R-VALUE TEST REPORT

Resistance R-Value and Expansion Pressure - ASTM D 2844

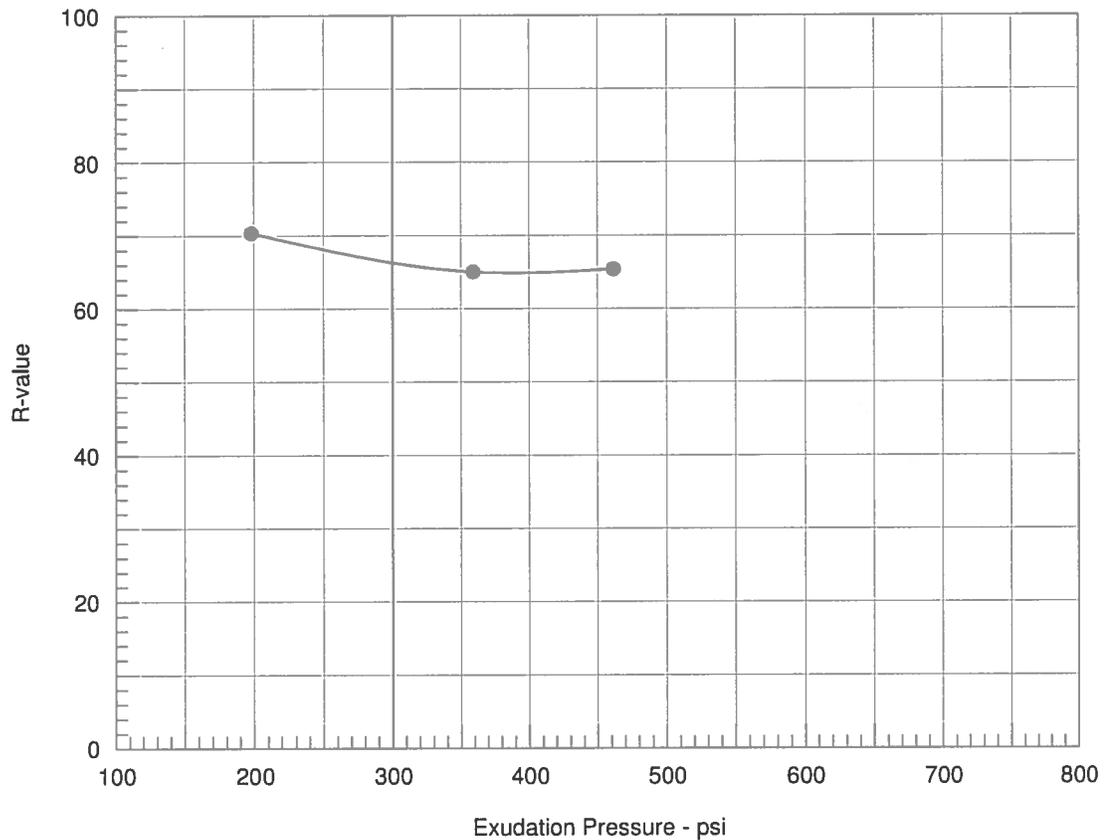
Resistance R-Value and Expansion Pressure - ASTM D 2844

Test Results	Material Description
R-value at 300 psi exudation pressure = 66.3	Poorly Graded Sand with Silt and Gravel Moisture Content: 0.8%
Project No.: 213020-03 Project: ADOT ECS On-Call Ehrenberg, H616101D Source of Sample: TP 3 @ 0.0' - 3.0' Sample Number: 14-0201 Date: 7/16/2014	Tested by: A. Capper Checked by: A. Capper Remarks:
R-VALUE TEST REPORT ATL, Inc.	Figure _____

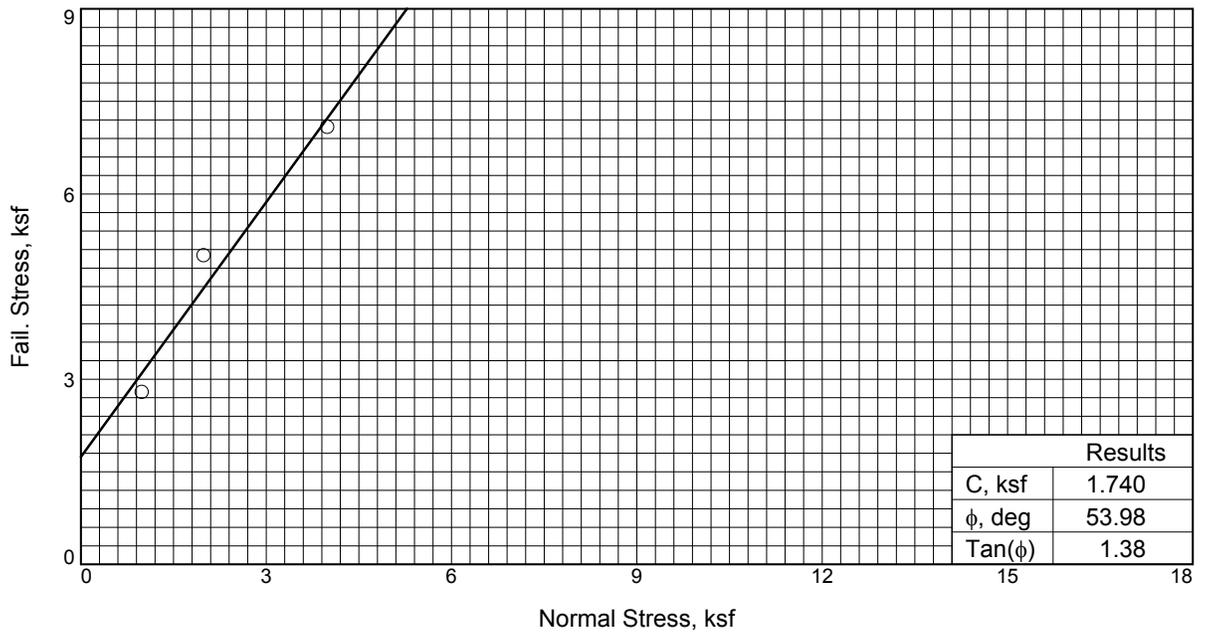
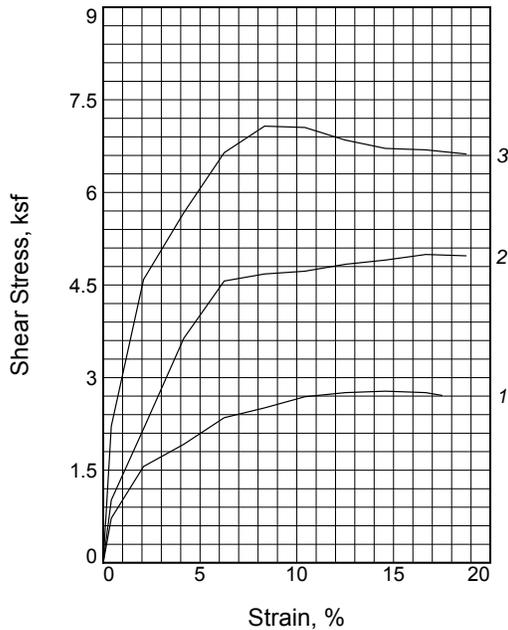
Sample No.	1	2	3	
Initial	Water Content, %	6.5	5.8	6.8
	Dry Density, pcf	125.6	125.9	125.7
	Saturation, %	54.6	49.1	56.8
	Void Ratio	0.3172	0.3141	0.3158
	Diameter, in.	2.400	2.400	2.400
	Height, in.	1.000	1.000	1.000
At Test	Water Content, %	6.5	5.7	6.8
	Dry Density, pcf	125.6	125.9	125.7
	Saturation, %	54.2	48.5	57.4
	Void Ratio	0.3172	0.3141	0.3158
	Diameter, in.	2.400	2.400	2.400
	Height, in.	1.000	1.000	1.000
Normal Stress, ksf	1.000	2.000	4.000	
Fail. Stress, ksf	2.780	4.995	7.074	
Strain, %	14.6	16.7	8.3	
Ult. Stress, ksf				
Strain, %				
Strain rate, in./min.	0.020	0.020	0.020

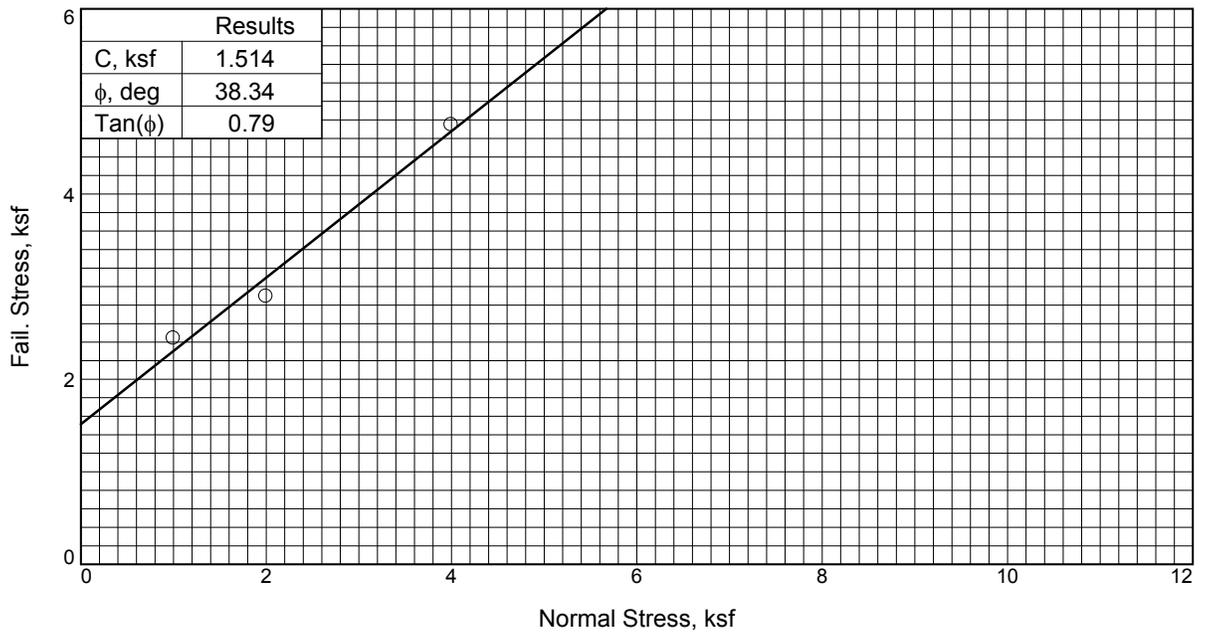
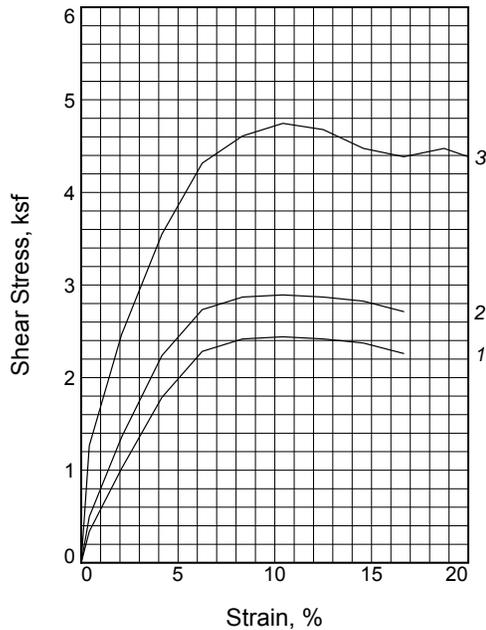
Sample No.	1	2	3	
Initial	Water Content, %	2.2	2.5	2.7
	Dry Density, pcf	114.2	114.7	113.5
	Saturation, %	13.2	15.1	15.7
	Void Ratio	0.4481	0.4428	0.4579
	Diameter, in.	2.400	2.400	2.400
	Height, in.	1.000	1.000	1.000
At Test	Water Content, %	2.7	2.3	2.4
	Dry Density, pcf	114.2	114.7	113.5
	Saturation, %	15.9	13.8	13.9
	Void Ratio	0.4481	0.4428	0.4579
	Diameter, in.	2.400	2.400	2.400
	Height, in.	1.000	1.000	1.000
Normal Stress, ksf	1.000	2.000	4.000	
Fail. Stress, ksf	2.441	2.893	4.746	
Strain, %	10.4	10.4	10.4	
Ult. Stress, ksf				
Strain, %				
Strain rate, in./min.	0.020	0.020	0.020
