# TECHNICAL MEMORANDUM ELIGIBILITY ASSESSMENT

**Project Name:** Loop 202 South Mountain Freeway, 57<sup>th</sup> Ave. and Van Buren St.

**Regarding:** Eligibility Assessment for Two Residential Properties

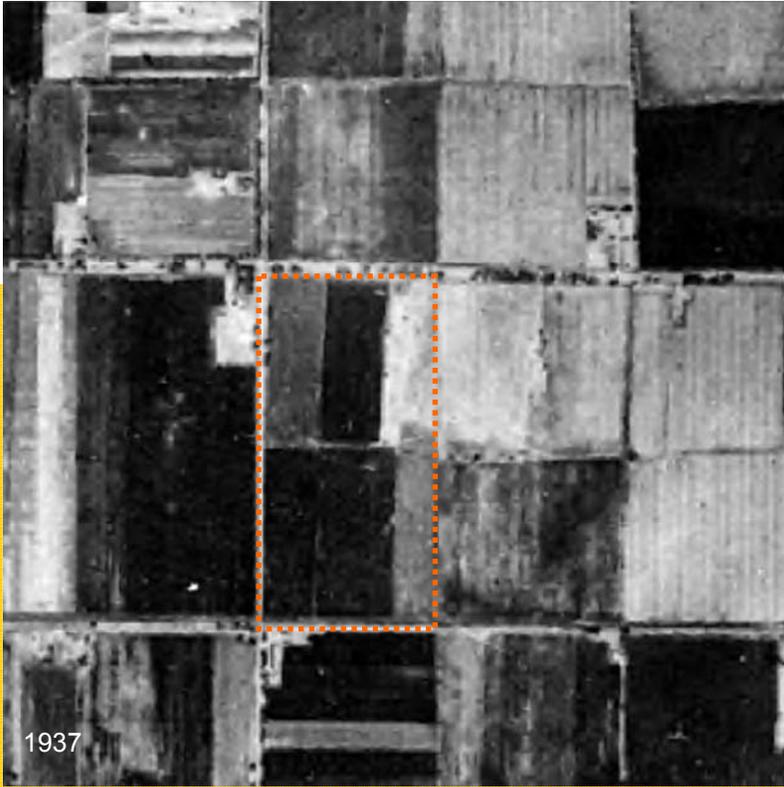
Figure 2. Jackson farmstead.  
Original setting

original parcel

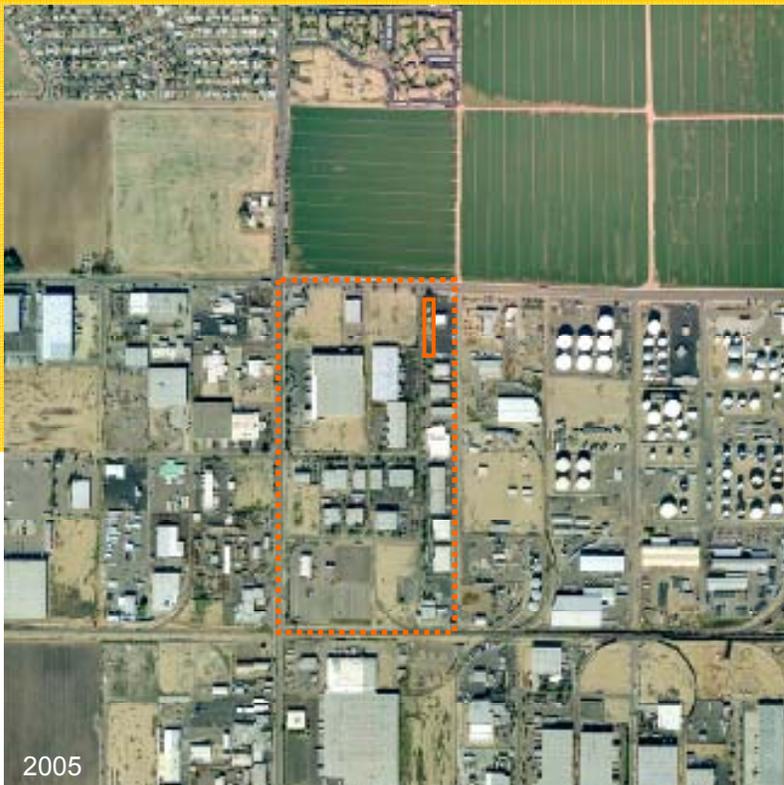
Figure 3. Jackson farmstead.  
Current setting

current parcel

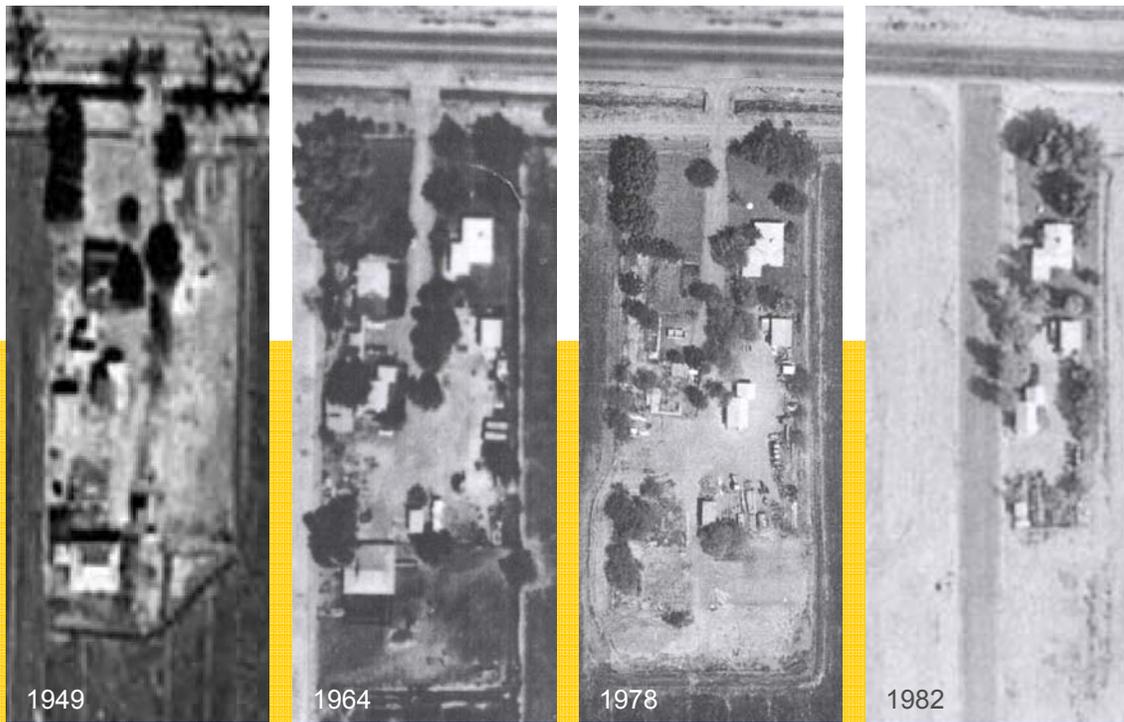
**Figure 4. Jackson farmstead. The site over time**

Because land subdivision changed over time, the site refers to the area of the original farmstead, which was associated with surrounding agricultural fields, and includes the parcel where the remaining farmstead buildings are located.

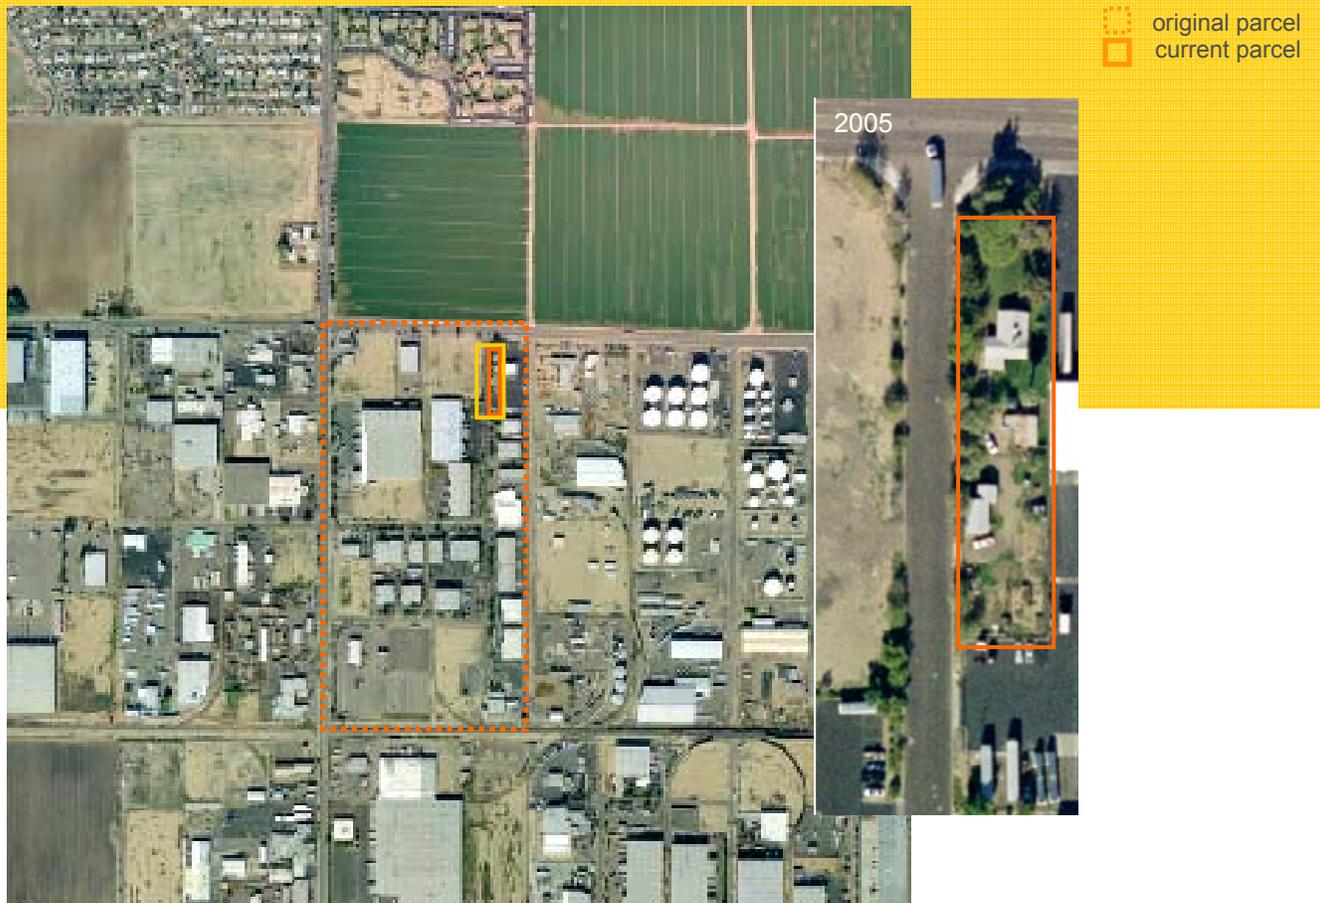
**Figure 5. Jackson farmstead. Site and setting as they look today**

original parcel  
 current parcel

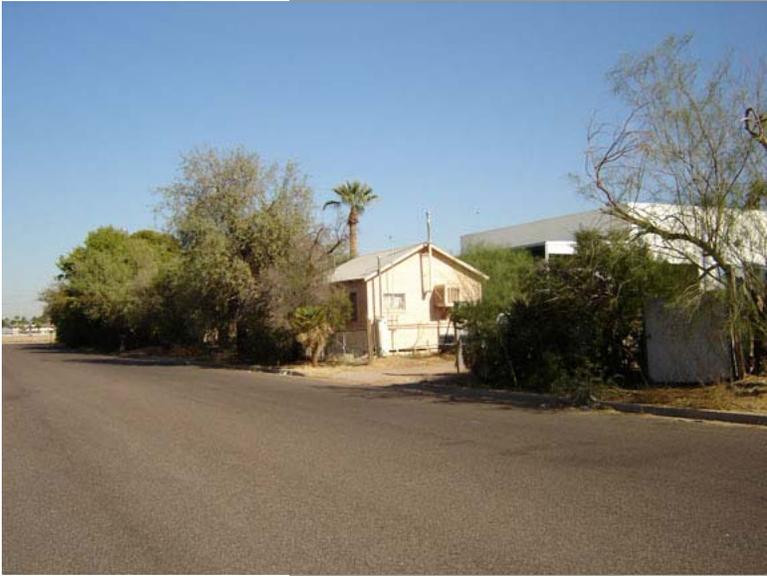
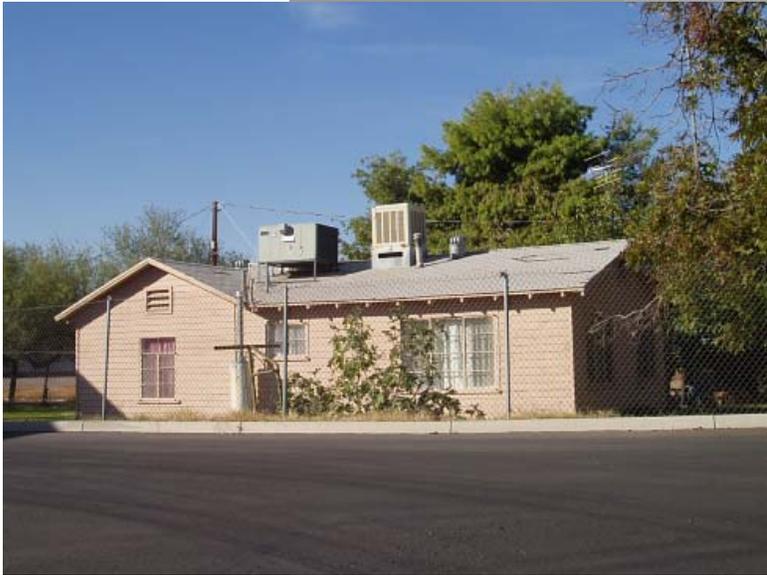
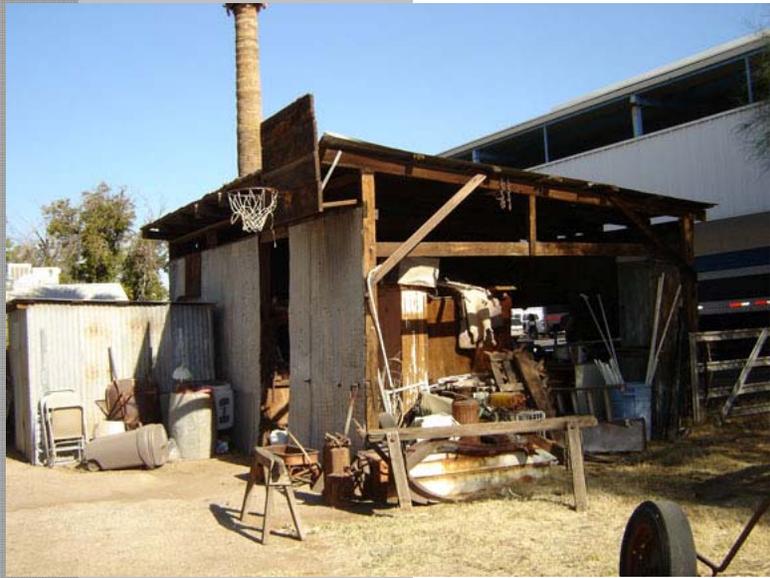
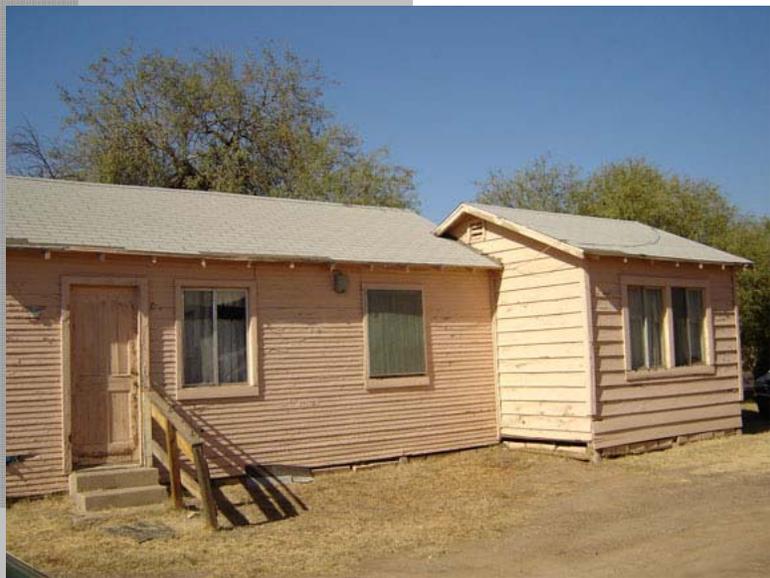
The north house is a one story early ranch house, with an L-shaped floor plan. A porch to the south appears enclosed. The house has a wood frame and wide wood horizontal boarding. A cross-gabled low pitched roof covers the house; the porch is covered by a dropped roof that extends from the main one, all with asphalt shingles. Most windows in the house are small paned steel casement windows. The porch—enclosed subsequent to initial construction—and the southeast corner of the house have aluminum sliding or sash-type windows. The front door, made of wood, does not have any detail. Another door, in the enclosed porch area, has fixed glazed panes in the top part. Air conditioning units are located on the roof. There are ventilation openings in the gables and two metal vents near the roof ridge. As is normally the case with farmhouses in general in this area, and of ranch houses in particular, this house is very simple and unpretentious. It is in good condition. The shed between the north and south houses is wood frame with corrugated metal panels as roof and walls.

The south house is a shotgun house with a unit added subsequent to initial construction at its northeast corner. The building, which was moved from its original location, is positioned on bricks. This house too has a wood frame and wood horizontal boarding, with narrow boards in the house, and wide boards in the added unit. The house and the added unit are covered by low pitched gable roofs with asphalt shingles. The building has sliding aluminum windows, and a wood side door with simple moldings. An air conditioning unit occupies part of a window in the southern wall. There are ventilation openings in the gables. As normally occurs with shotgun houses, this house is of extreme simplicity. It is in good condition.

**Figure 7. Jackson farmstead**  
entire property, looking northeast  
north house, looking southwest

shed, looking northeast  
south house, looking northwest

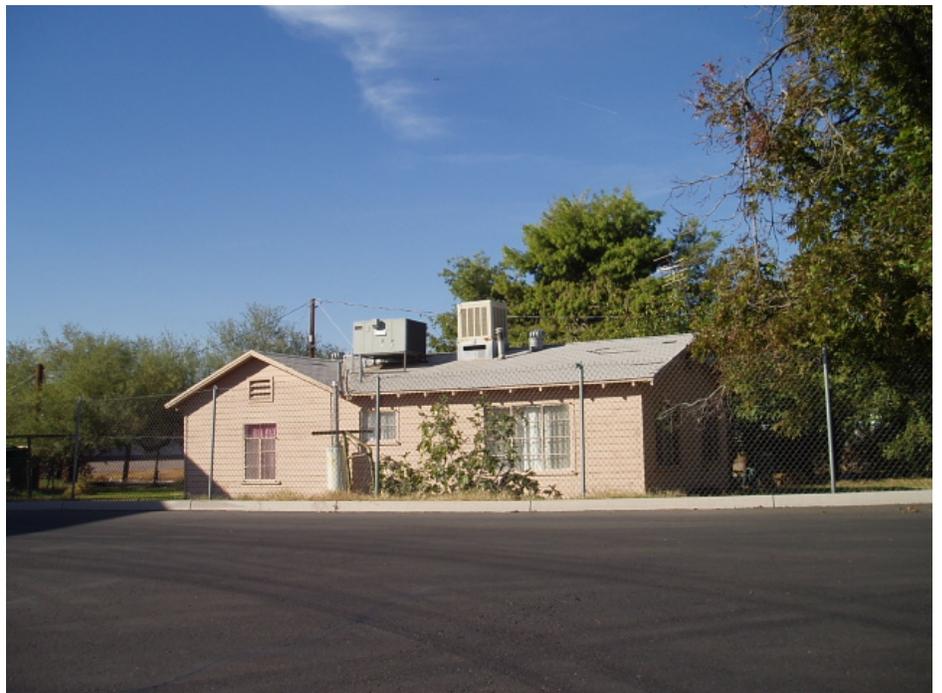
Date of photo: 11.21.06
View Direction (looking towards)
Southwest
Negative No.:

- 1. LOCATION     Original Site     Moved (date \_\_\_\_\_) Original Site: \_\_\_\_\_
- 2. DESIGN (Describe alterations from the original design, including dates—known or estimated—when alterations were made)  
Early ranch house of simple manufacture with enclosed porch at southeast corner.

- 4. MATERIALS (Describe the materials used in the following elements of the property)  
Walls (structure): wood                      Foundation: concrete                      Roof: asphalt shingles  
Windows: small-paned steel casement, sliding aluminum, and sash-type  
If the windows have been altered, what were they originally? \_\_\_\_\_  
Wall Sheathing: painted horizontal wood boarding  
If the sheathing has been altered, what was it originally? \_\_\_\_\_

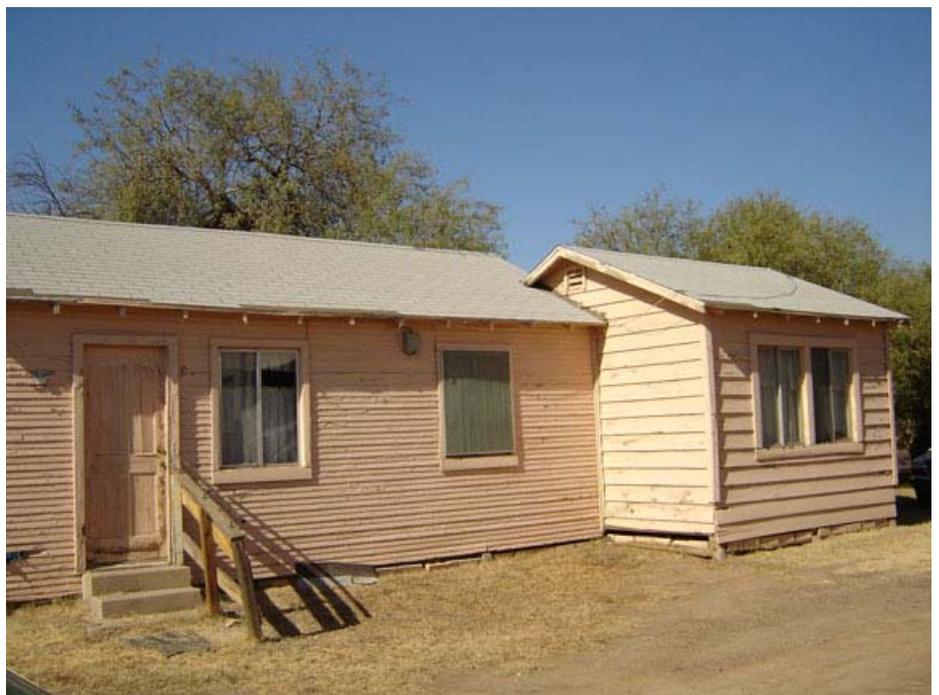
Date of photo: 11.21.06

Northwest

- 1. LOCATION     Original Site     Moved (date 1975/78) Original Site: west of 57<sup>th</sup> Dr.
- 2. DESIGN (Describe alterations from the original design, including dates—known or estimated—when alterations were made)  
Shotgun house of simple manufacture with added unit at northeast corner.

- 4. MATERIALS (Describe the materials used in the following elements of the property)  
Walls (structure): wood                      Foundation: bricks                      Roof: asphalt shingles  
Windows: sliding aluminum  
If the windows have been altered, what were they originally? \_\_\_\_\_  
Wall Sheathing: painted horizontal wood boarding  
If the sheathing has been altered, what was it originally? \_\_\_\_\_
