**Arizona Department of Transportation
Environmental Planning Group**

**South Mountain Transportation
Corridor Study:
Evaluation of Four Historic Buildings
and Districts, Maricopa County, Arizona**

**RAM-202-C-200
202L MA 054 H5764 01L**

**April 3, 2012
Submittal Number 1**

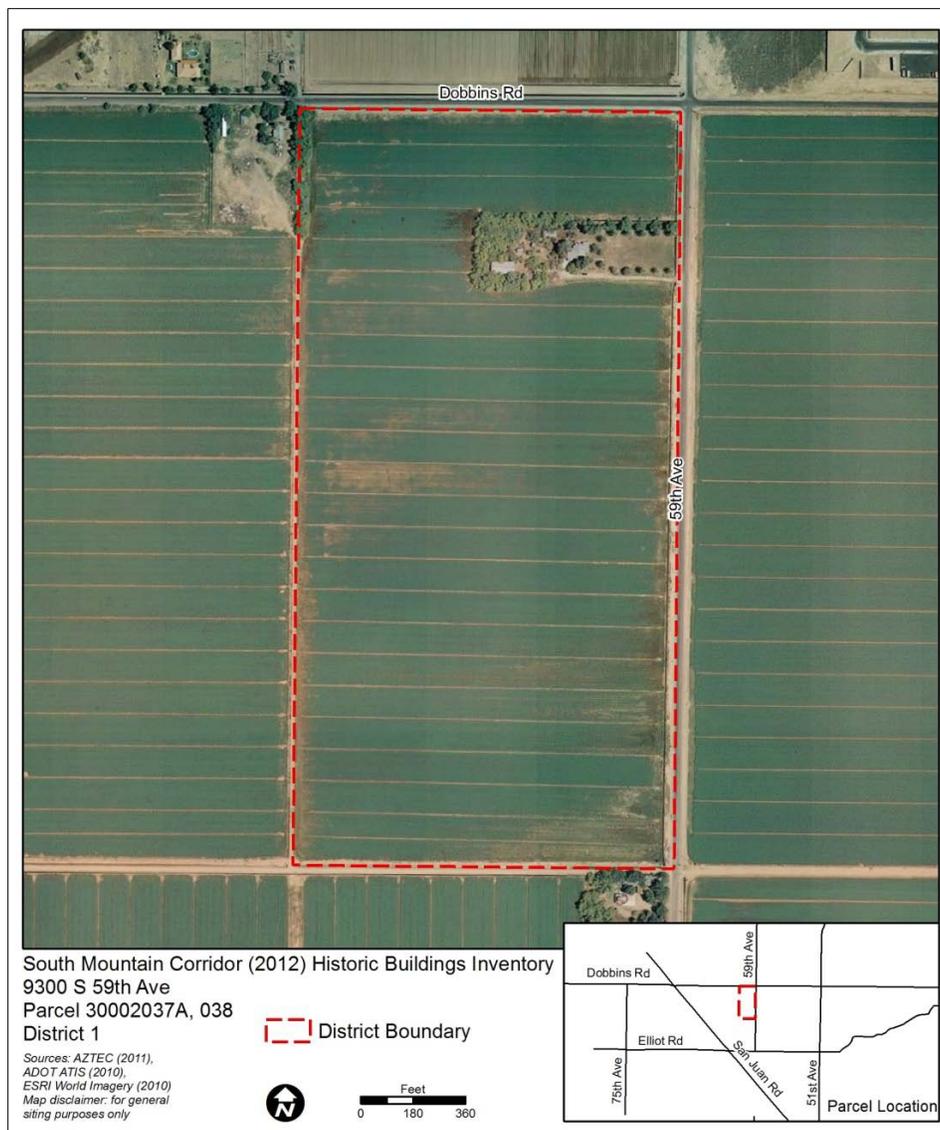
Figure 8. Hudson Farm boundaries.

The Hudson Farm (Figure 8), located at 9300 South 59th Avenue, was evaluated as a historic district and is recommended as eligible for the National Register under Criteria A. It is an outstanding example of a historic farmstead in Laveen. The layout of buildings and structures around a central work yard and the associated farmland has survived virtually unchanged since the early 1950s. The only modern intrusions on the property are a palm-lined drive and stone-faced entry piers to the east of the farmhouse; these were added shortly after the period of significance and do not detract from the historic appearance of the farmstead. The farmhouse was built about 1926 but was enlarged and remodeled in the late 1940s and early 1950s; it exhibits a high degree of workmanship (Figure 9). The other structures on the property, built in the late 1940s and early 1950s, and reflect the vernacular tradition of design and construction that was typical in the Laveen area during the period of significance.

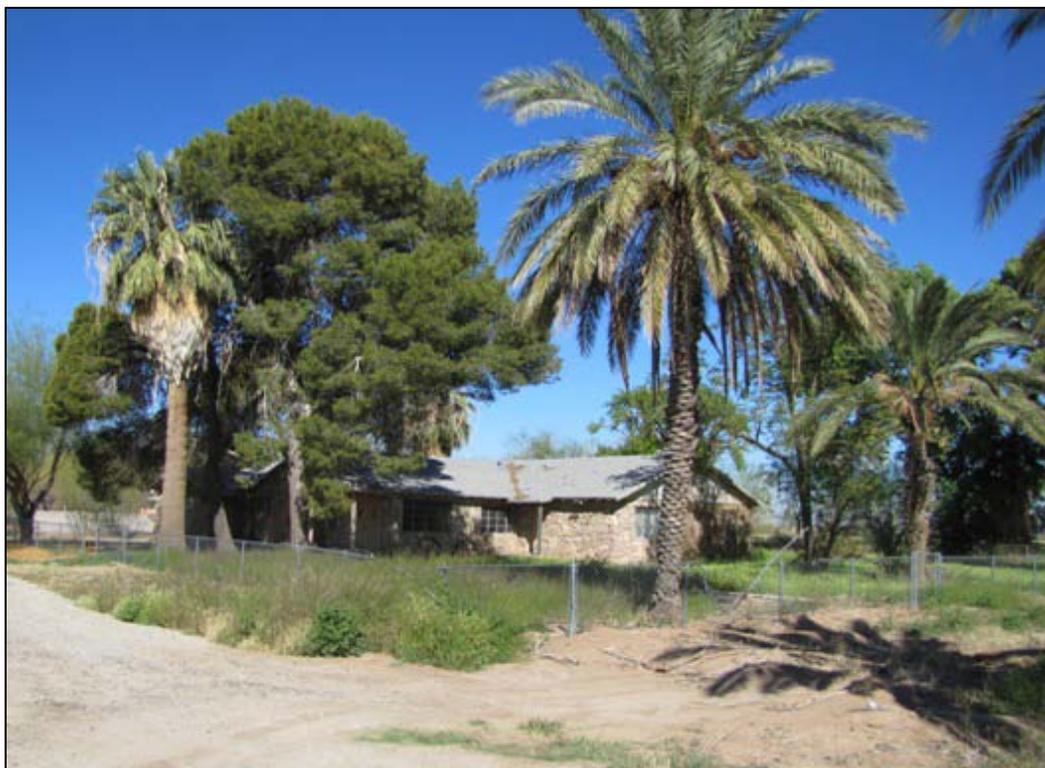
Figure 9. Hudson Farm (Inventory No. 1).

We generally concur with the previous assessment of the Hudson Farm property regarding the eligibility of the farm as a whole and of the silos individually (discussed below). However, based on additional historic research we conclude that some features of the property are not eligible as contributors. A 1969 aerial photograph provides the earliest evidence of the palm-lined drive and stone-faced entry piers being present. The palm trees are very small and appear to have been recently planted. This suggests that the redesign of the landscaping and entry east of the farmhouse was carried out in the late 1960s, just after the period of significance. As such, they are more representative of the visible face of the farm for the past 40 years and, therefore, are not eligible as contributing features due to age (c.f., Figure 10, Figure 11, and Figure 12).

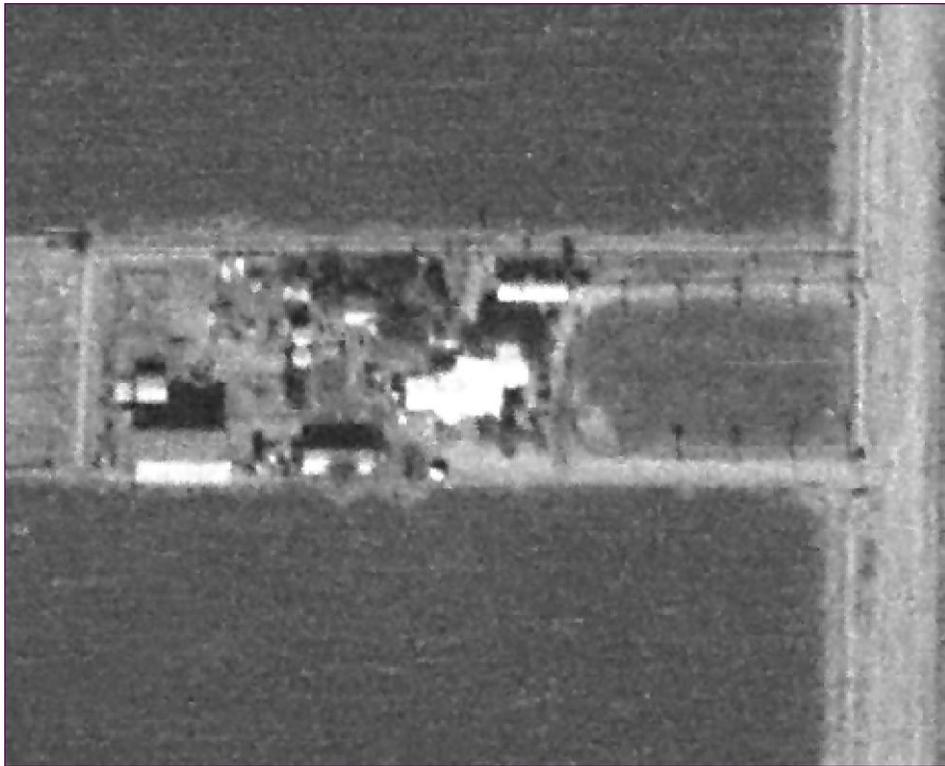
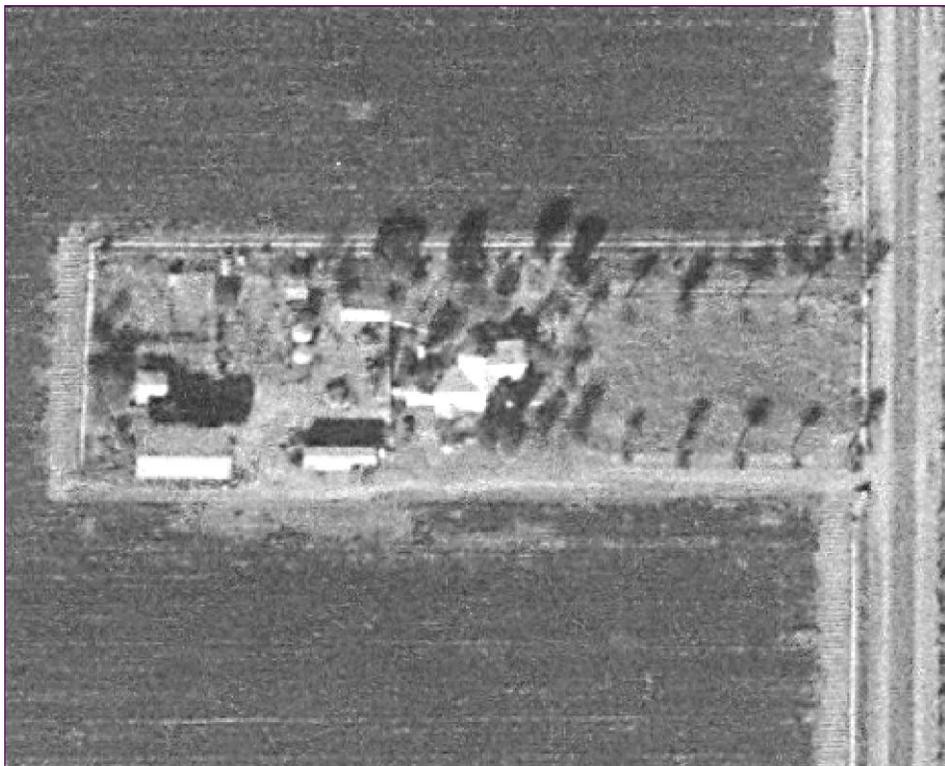
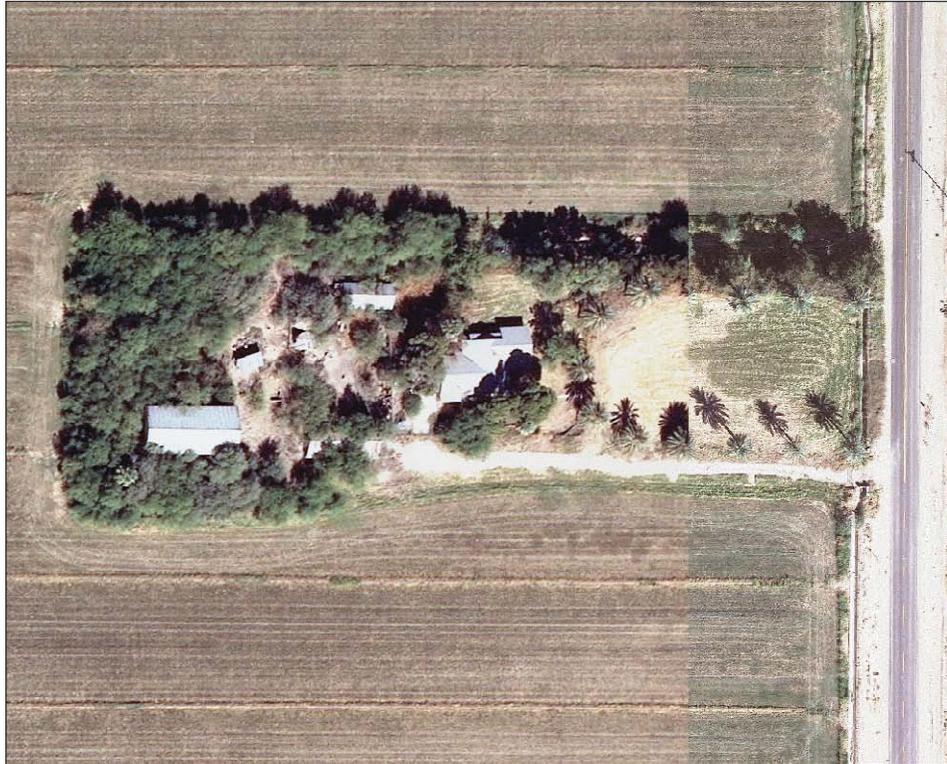
Figure 10. Hudson Farmstead in 1969.
(Aerial photograph from Flood Control District of Maricopa County)

Figure 11. Hudson Farmstead in 1979.
(Aerial photograph from Flood Control District of Maricopa County)

Figure 12. Hudson Farmstead in 2009.
(Aerial photograph from Flood Control District of Maricopa County)

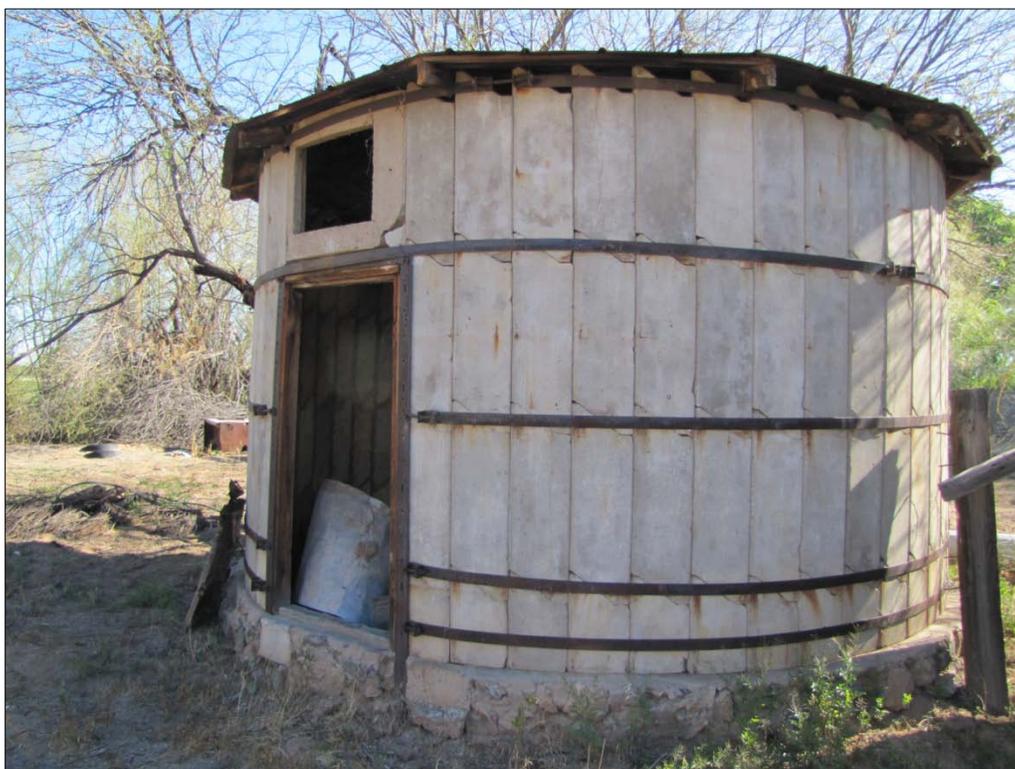
Figure 14. A cement stave silo on the Hudson Farm (Inventory No. 1.03).

The pair of cement stave silos on the Hudson Farm (Figure 14) is recommended as individually eligible for the National Register under Criteria C. They were constructed of small cast concrete blocks, measuring 28" × 10", that were made with molds manufactured by the Interlocking Cement Stave Silo Company of Des Moines, Iowa (Hanson 1916:134–135; Marietta Silos 2012). The vertical stave blocks have alternating concave and convex edges and an offset bevel on the ends that interlock. Mortar was applied between the staves, and the entire structure was held together with steel hoops, with each hoop binding the upper ends of one course of staves and the lower ends of the overlying course. Interior walls were finished with a cement coating. Concrete door frames, measuring 28" × 40", with 20" × 28" openings for grain doors, were installed on the east sides of the structures, and wood frame walk-in doors were placed on the west sides. This silo design, which dates to the early 20th century, made them inexpensive and easy to build. These small silos are quite distinct from large modern silos, which are made of slipform cast concrete, steel, or corrugated sheet metal.

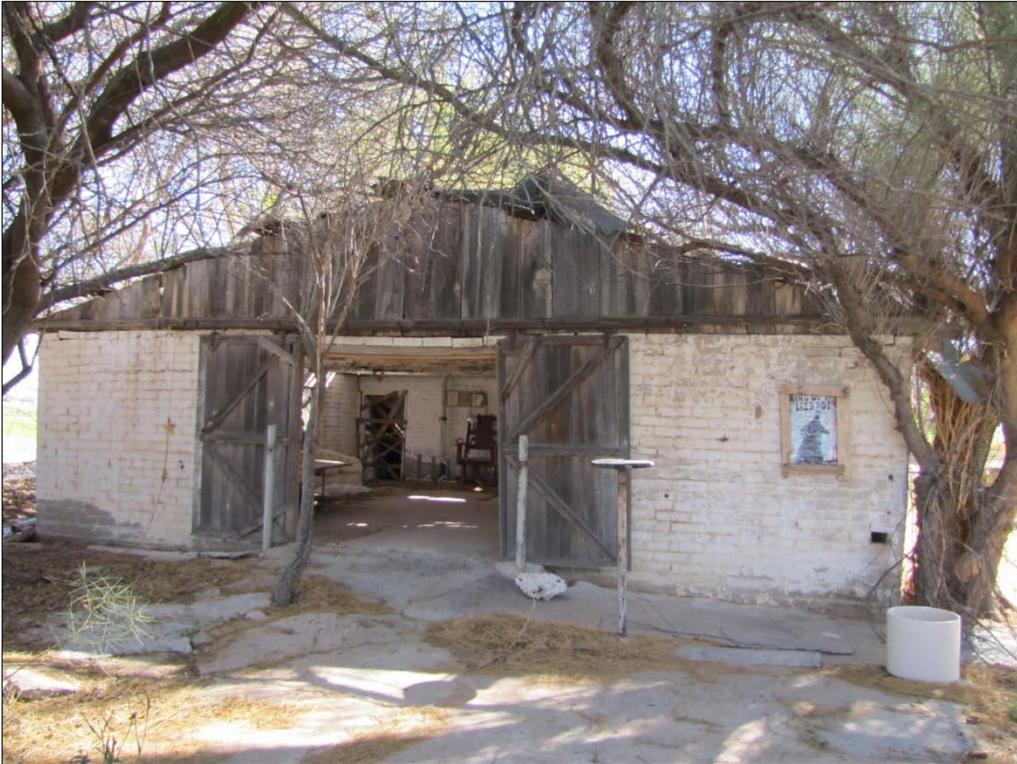
Figure 15. Dairy flat barn on the Hackin Farmstead/Dairy (Inventory No. 2.03).

Dairy farming has been a primary industry in Laveen since the early 20th century. The flat barn on the Hackin Farmstead/Dairy (10048 South 59th Avenue) (Figure 15) and the head-to-toe barn on the Tyson Farmstead/Barnes Dairy (6159 West Dobbins Road) (Figure 16) are recommended as individually eligible for the National Register under Criteria C. Both are excellent examples of the small family-operated dairy that was once common throughout the area, but is now very rare. These buildings are representative of the two common styles of dairy barn in Laveen during the post-World War II era.

The character-defining features of the flat barn include the plan, the concrete floor, and fenestration patterns that were designed not just for milking but also for the continuous movement of cows into and out of the barn (Reinemann et al. 2011). Typically, there would be a separate room in the flat barn used as a holding area for cows, but the small size of the Hackin barn indicates that this was most likely done in an area outside the barn.

While milking stalls, stanchions, and equipment have been removed from both of the barns, marking and wear patterns on walls and floors give clear indications of where these features were located. Both of these dairy barns reflect a simple vernacular design that was suitable for a small family-operated dairy. Since the 1960s, these types of dairies have been replaced with modern mechanized dairies that are designed to move a large number of cows through the milking process more efficiently. Modern dairies have much larger milking barns with mechanical vacuum milking units, pipelines, crowd gates to control cows in a large holding area, and continuous circulation patterns.

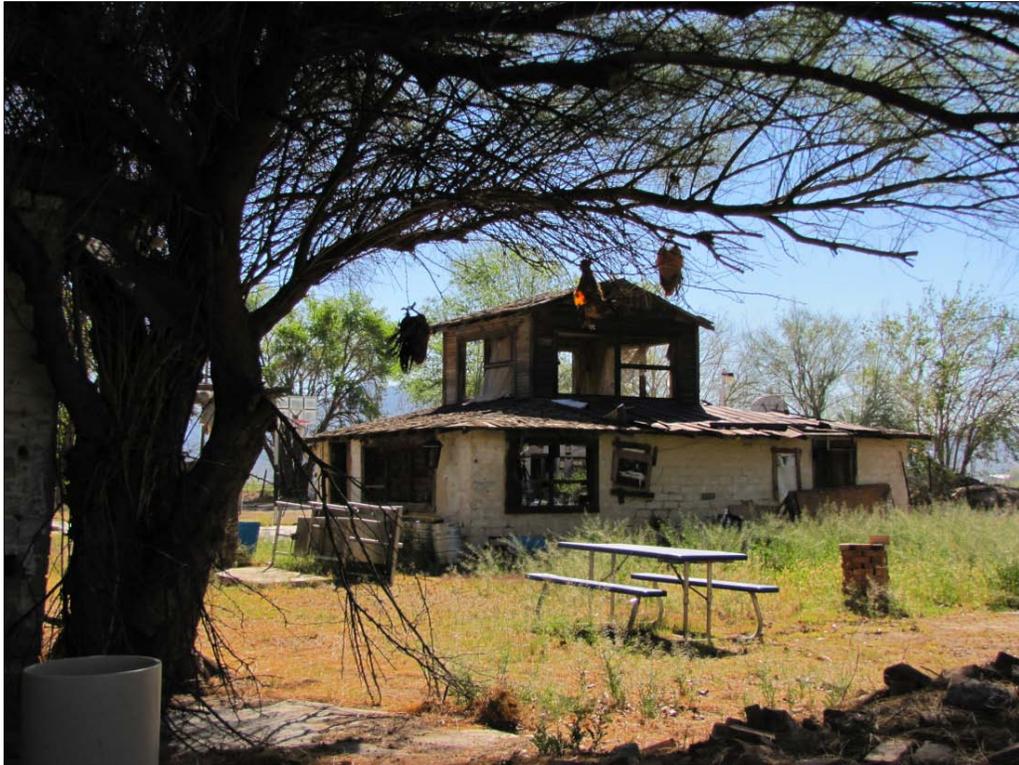
Three properties that were evaluated as historic districts—Hackin Farmstead/Dairy, Tyson Farmstead/Barnes Dairy, and Dobbins Road Streetscape—are recommended as not eligible for the National Register. AZTEC concurs with the previous evaluations of Hackin Farmstead/Dairy (10048 South 59th Avenue) and Tyson Farmstead/Barnes Dairy (6159 West Dobbins Road). Most of the historic buildings on these two properties have been substantially modified and no longer possess the level of integrity necessary to convey their significance (Figure 17). There is not enough of a concentration of contributing buildings and structures on either property to merit consideration as a historic district (Figure 18). Note that the Tyson Farmstead/Barnes Dairy is no longer identified as the Colvin-Tyson Farmstead/Barnes Dairy because the 1921 Colvin Farmhouse that was documented in the 2005 survey has been demolished and the property no longer has any structures dating to the period that the Colvins owned the farm.

Figure 17. One of the derelict buildings at the Hackin Farmstead.

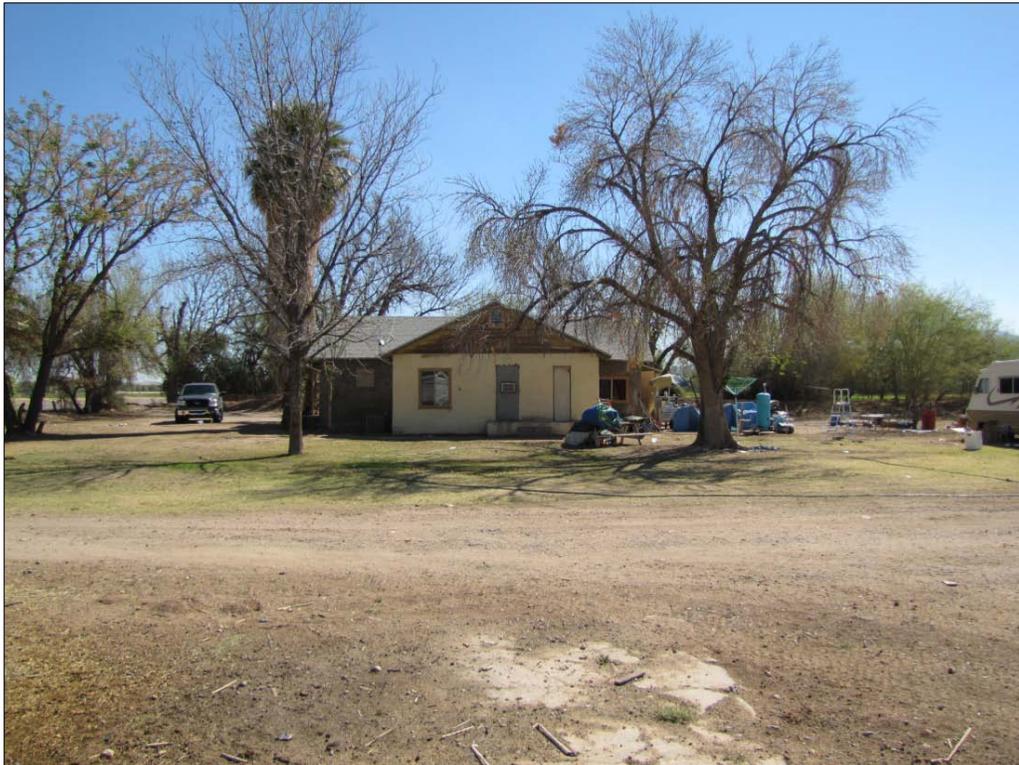
Figure 18. One of the few buildings left of the on Farmstead/Barnes Dairy.

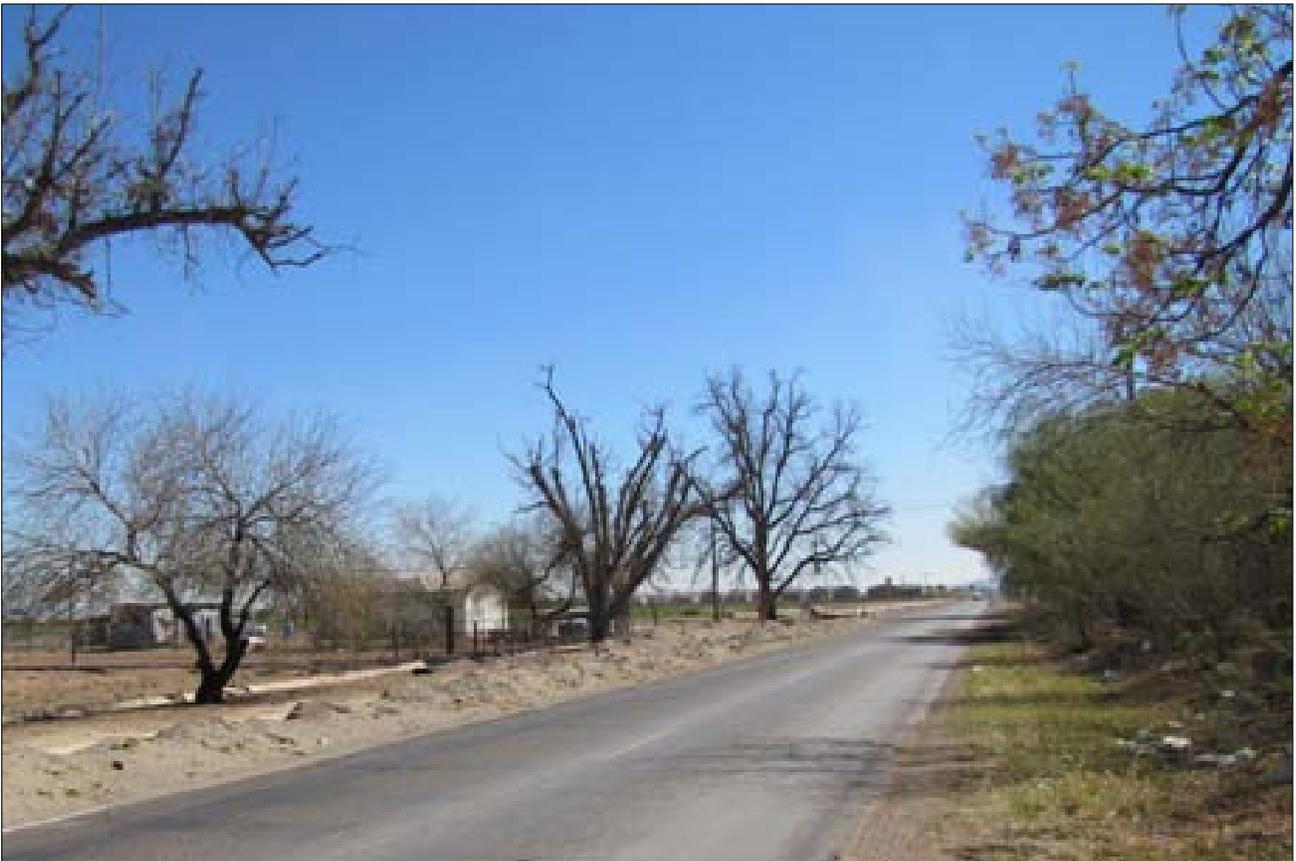
The previous survey (Brodbeck 2005) recommended the Dobbins Road Streetscape (6100 Block of West Dobbins Road) as eligible for the National Register, but in reevaluating this district we recommend that it is not eligible. There are several characteristics of the Dobbins Road Streetscape that impact the integrity of the resource as a rural agricultural streetscape. Evaluation of this property was done according to the criteria outlined in National Register Bulletin # 30, *Guidelines for Evaluating and Documenting Rural Historic Landscapes* (McClelland et al. 1999:1-2), which defines a rural historic landscape as “a geographical area that historically has been used by people, or shaped or modified by human activity, occupancy, or intervention, and that possesses a significant concentration, linkage, or continuity of areas of land use, vegetation, buildings and structures, roads and waterways, and natural features.” It also points out that “[l]arge acreage and a proportionately small number of buildings and structures differentiate rural historic landscapes from other kinds of historic properties” (McClelland et al. 1999:2). Such landscapes often include miles of roadway and surrounding agricultural properties. The 325 feet of roadway included in this streetscape is of inadequate length to truly convey the rural agricultural character that once dominated this area. In addition, there are modern intrusions easily visible from the streetscape. At the west end there is a prominent 1977 house on the north side of the road and a mobile home on the south side of the road that was moved onto the site about 1970. A recently constructed subdivision of two-story houses is located just over a quarter-mile east of the streetscape, and is clearly visible from within the streetscape boundaries (Figure 19).

Figure 19. Dobbins Streetscape with the modern subdivision visible in the background.

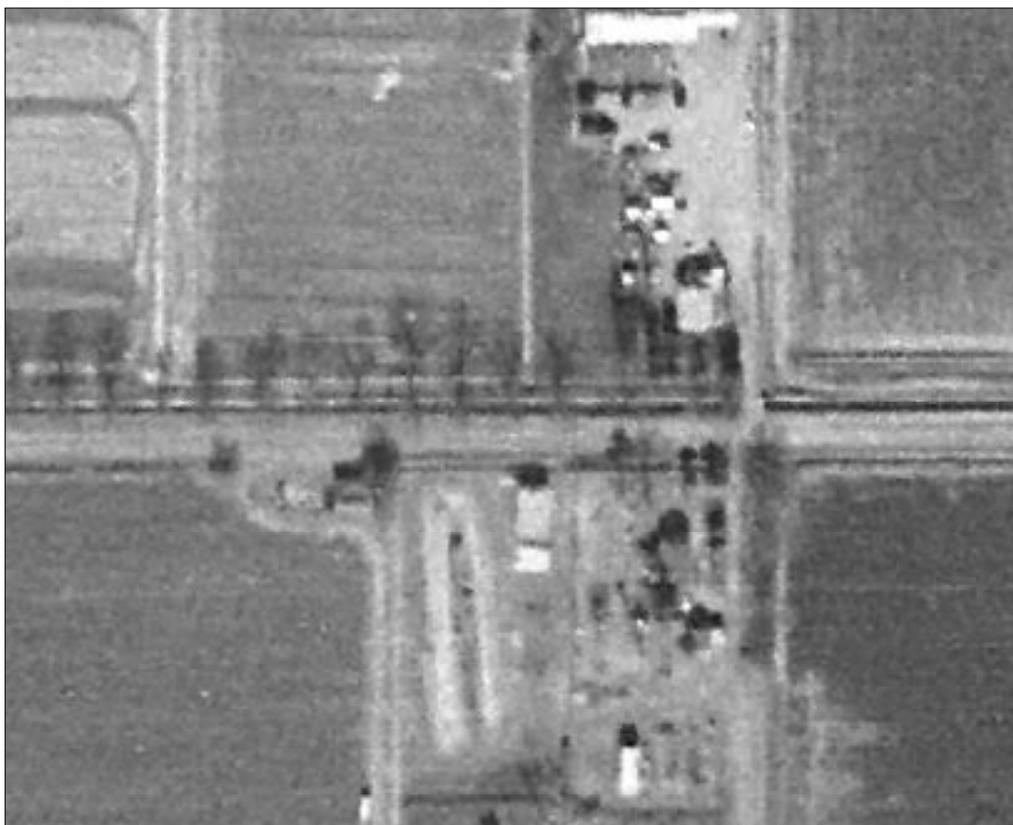
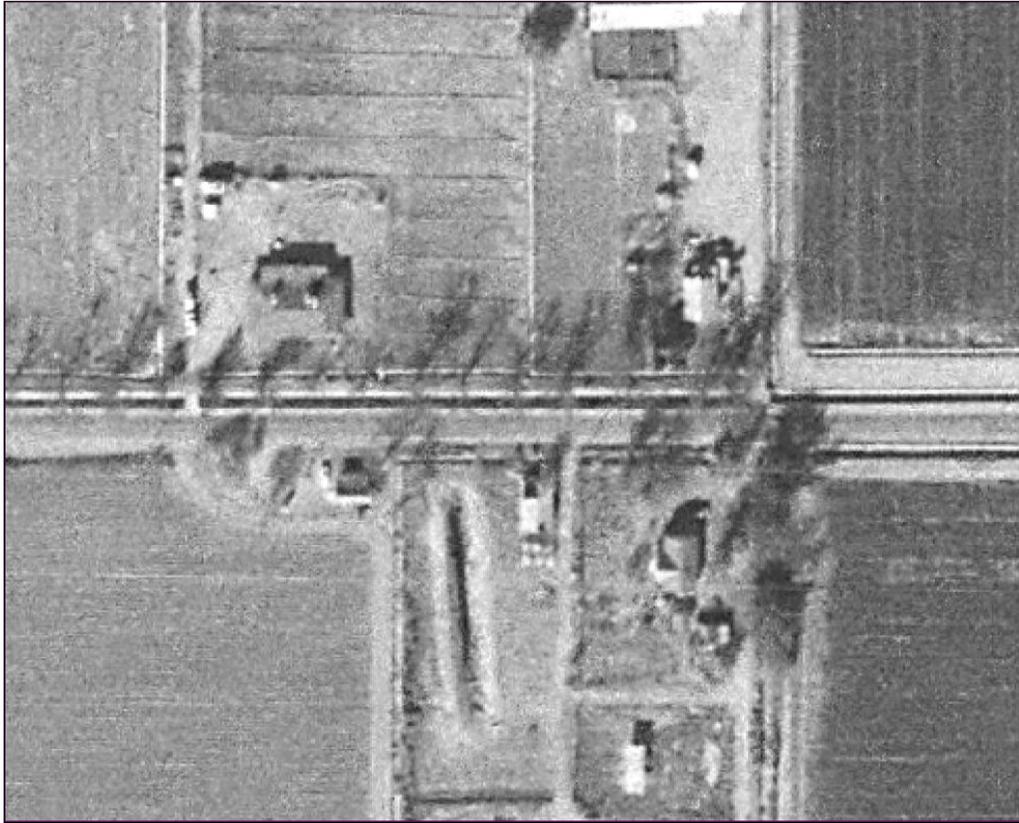
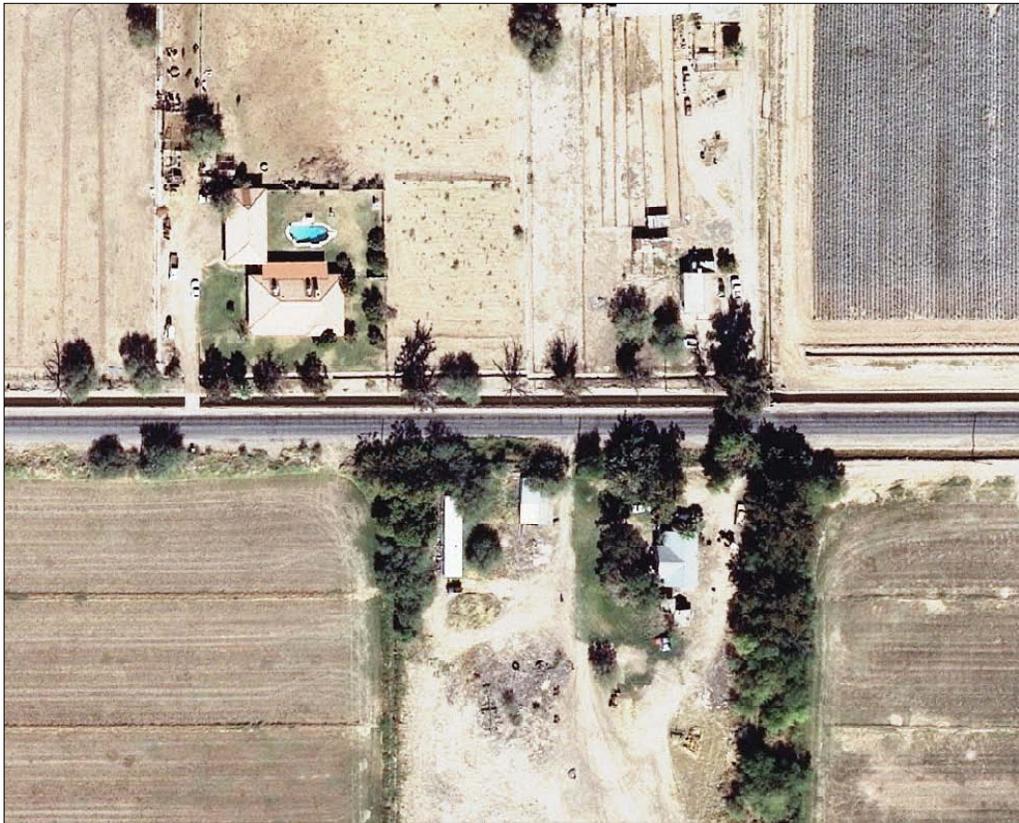
Many of the components of the streetscape have lost their historic character. Individual resources the boundaries include three farmstead buildings; however, two of these three buildings no longer possess historic integrity. The Tyson Farmhouse (ca. 1930) on the south side of Dobbins Road and the Dad Farmhouse (ca. 1940) on the north side of the road have been so altered they no longer exhibit their historic character. Only the Barnes Dairy Head-to-Toe Barn, which is recommended as being individually eligible for the National Register, has retained its integrity. Other elements within the streetscape are likewise not representative of the period of significance. An analysis of historic aerial photographs since 1949 shows the dense vegetation on the south side of the road did not exist 40 years ago. The 1969 aerial photograph shows that the area bordering the Dobbins Road Streetscape was open with very little vegetation (Figure 20). By 1979 the trees and hedge row that are now on the property were present, but they were young with very sparse foliage (c.f., Figure 21 and Figure 22). Likewise, there have been substantial changes in the row of pecan trees along the north side of the road, which are only a small remnant of the trees that once extended more than a half mile to the west. Of the few remaining pecan trees, at least two appear to be dead and the others seem to be in poor health. Finally, the most obviously missing element of a rural agricultural streetscape is a view of agricultural fields, which would have been visible from this segment of Dobbins Road during the period of significance but are now obscured by the more recent vegetation on the south side of the road.

Figure 20. 6100 block of West Dobbins Road in 1969.

Figure 21. 6100 block of West Dobbins Road in 1979.

Figure 22. 6100 block of West Dobbins Road in 2009.

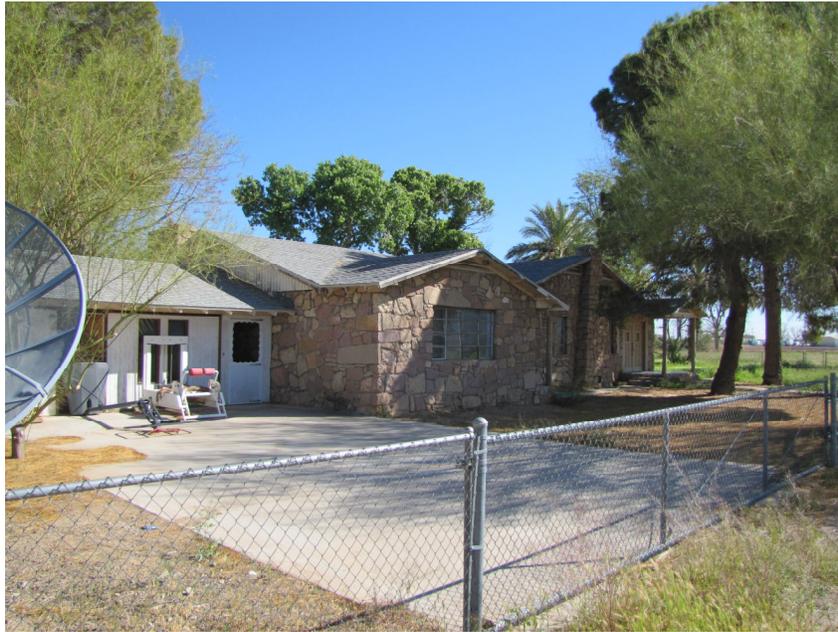
Two added wings on west end of house, photo 016, view looking northeast

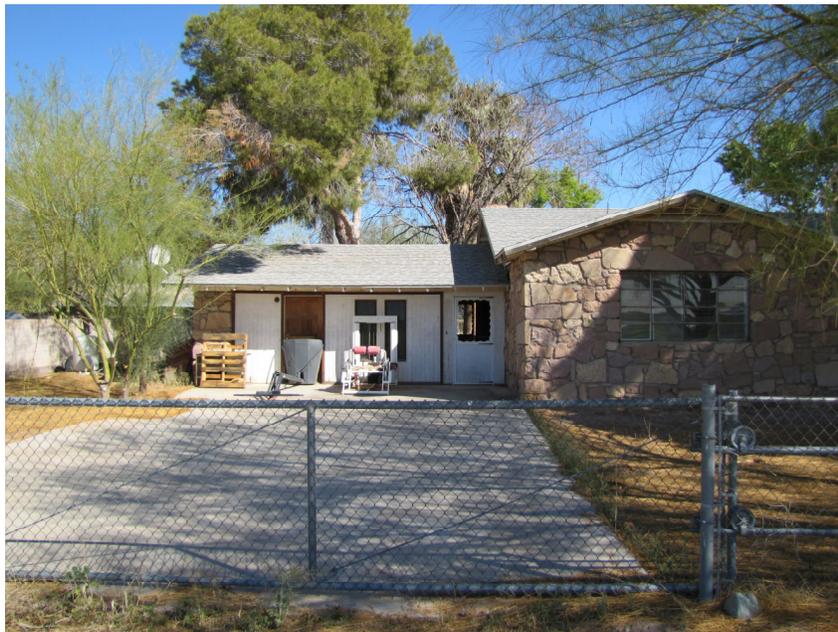
Westernmost added wing, photo 017, view looking north

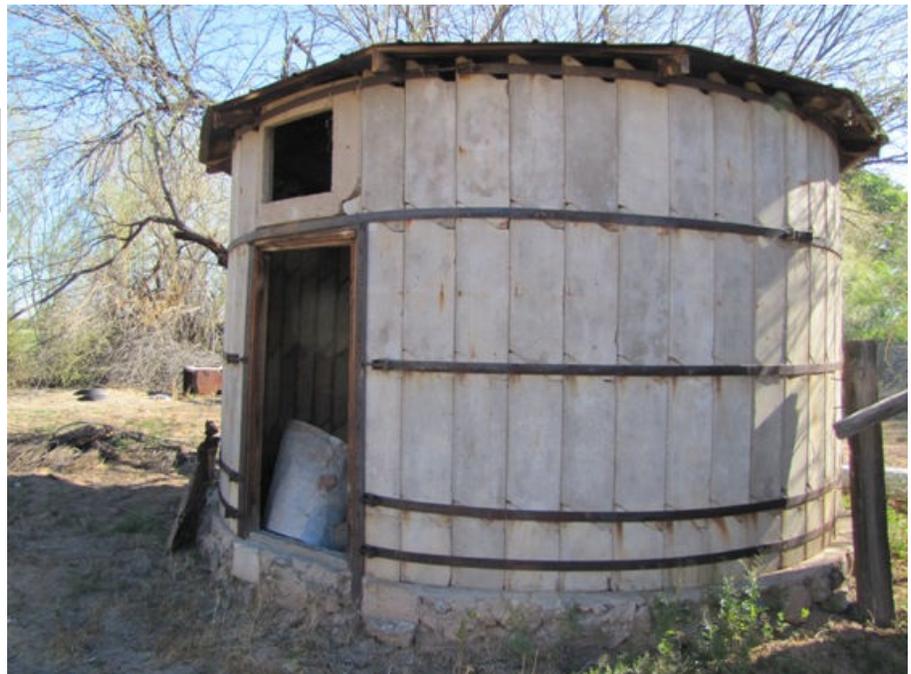
Survey Site No.: 1.03

Describe: loss of doors, minor deterioration of materials

Two round silos built with interlocking cast concrete staves bound together with iron bands. Low pitched conical truss roof. Cement plaster on interior walls. Door on west side and small rectangular openings on east side; doors and opening covers are missing.

Walls (structure): concrete staves Foundation: stone, concrete Roof: corrugated metal

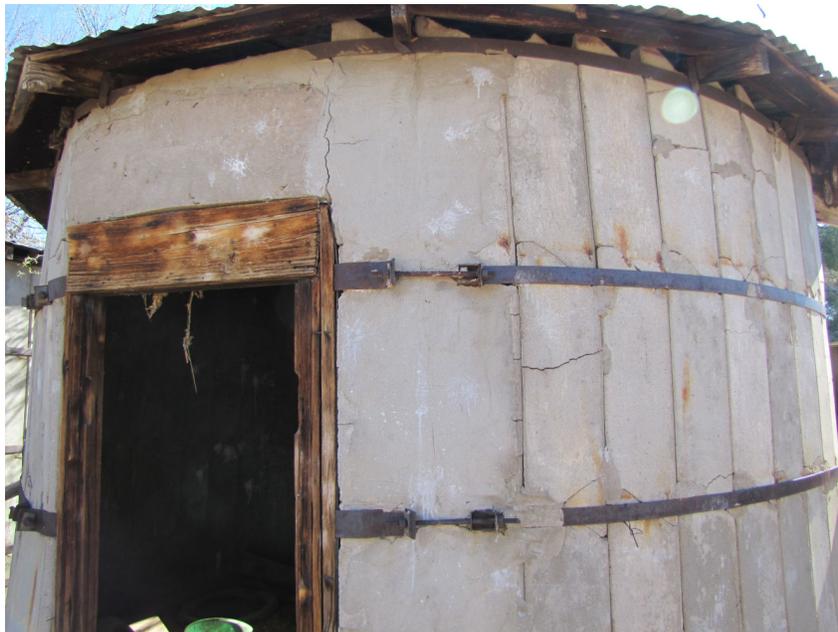
South silo, photo 007, view looking east

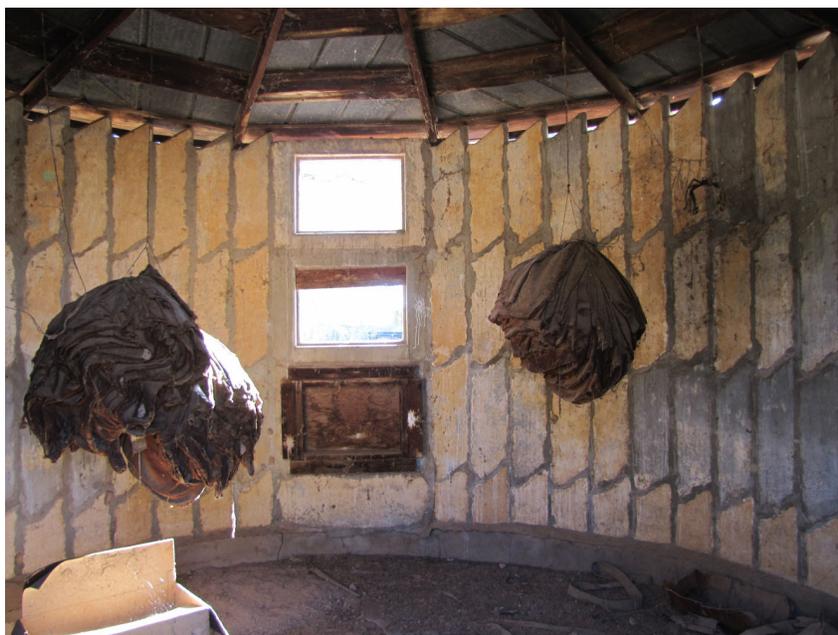
Interior of north silo, photo 002, view looking east

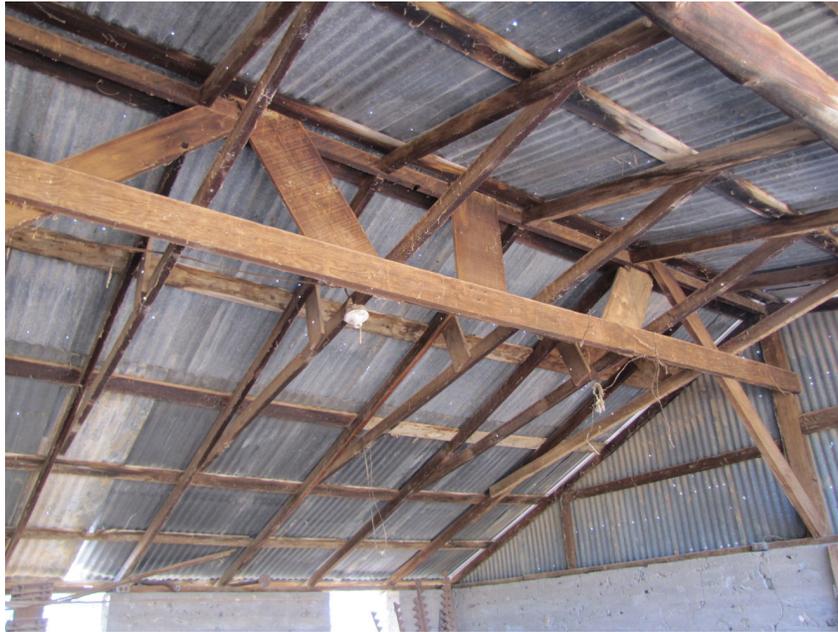
Roof trusses, photo 010, view looking southwest

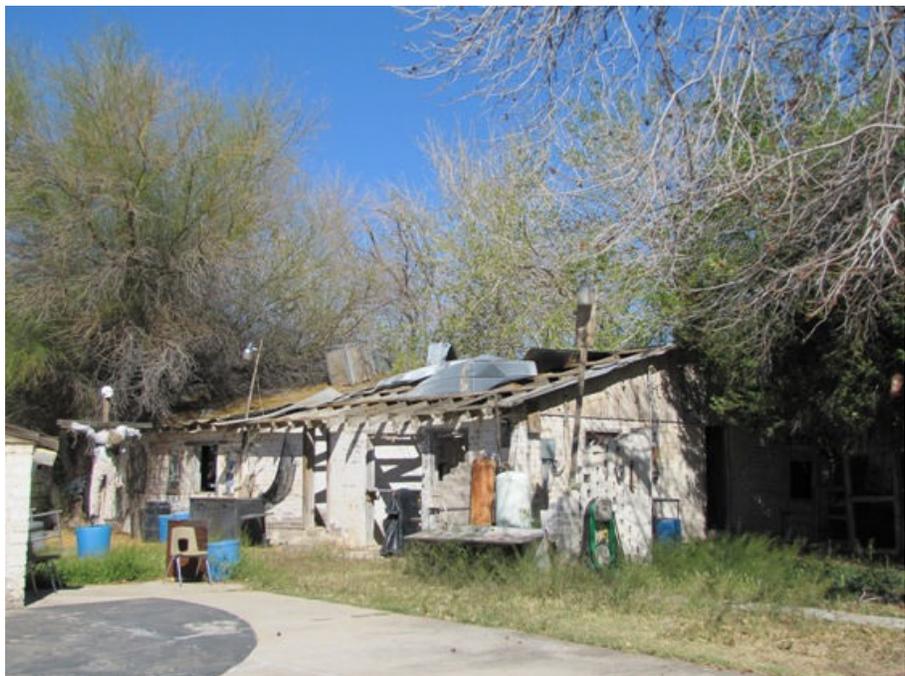
GOOD (Well-maintained; no serious problems apparent)
 FAIR (Some problems apparent)
Describe: _____
 POOR (Major problems; imminent threat)
Describe: Severe deterioration of materials, loss of windows, doors, and roofing
 RUIN / UNINHABITABLE

This one-story dairy flat barn has a rectilinear plan and a low pitched gable roof over a wood truss frame. The building has deteriorated significantly, with loss of doors, windows, much of the roofing material, but has had only minimal alterations since its construction and still retains integrity of location, design, and materials.

Walls (structure): concrete block Foundation: concrete Roof: corrugated metal

Windows: missing If altered, original windows: unknown

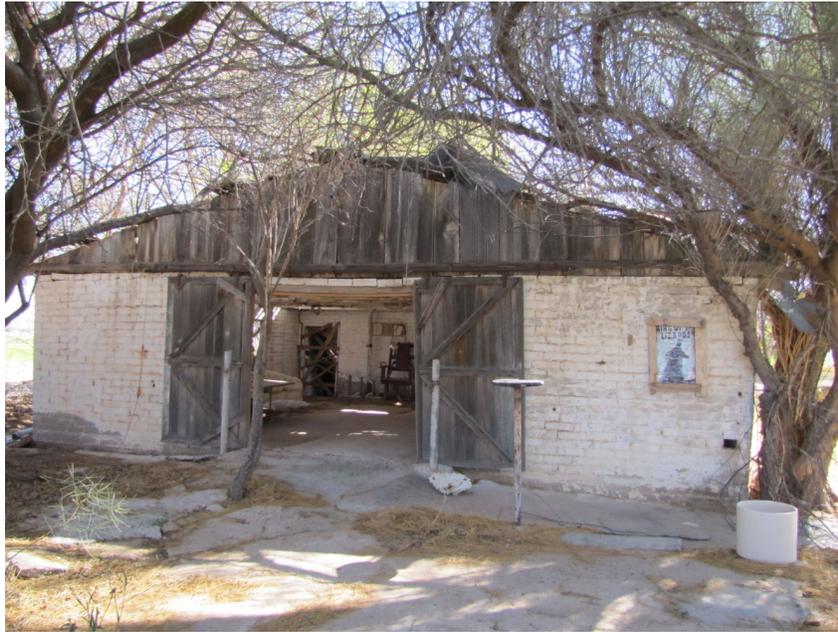
West end of dairy flat barn, photo 024, view looking east

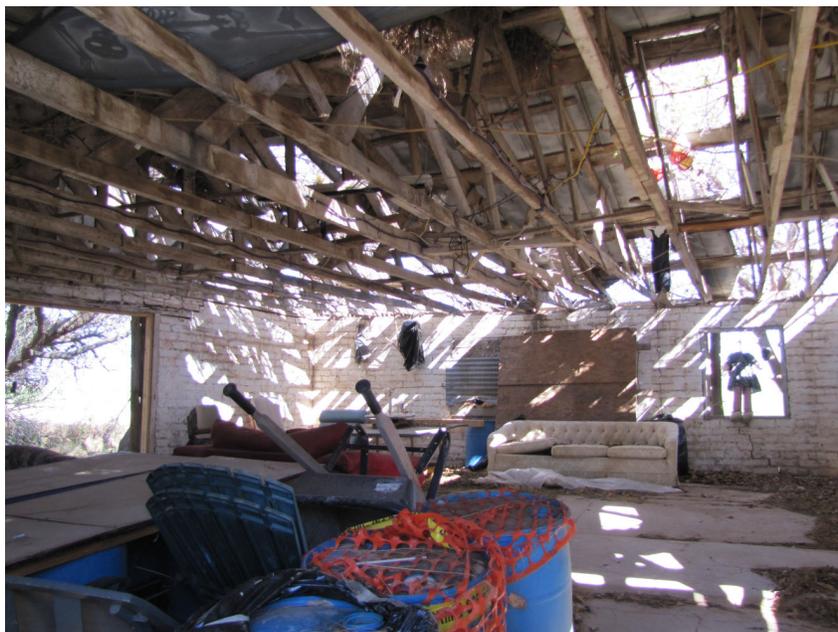
Interior of dairy flat barn, photo 023, view looking north

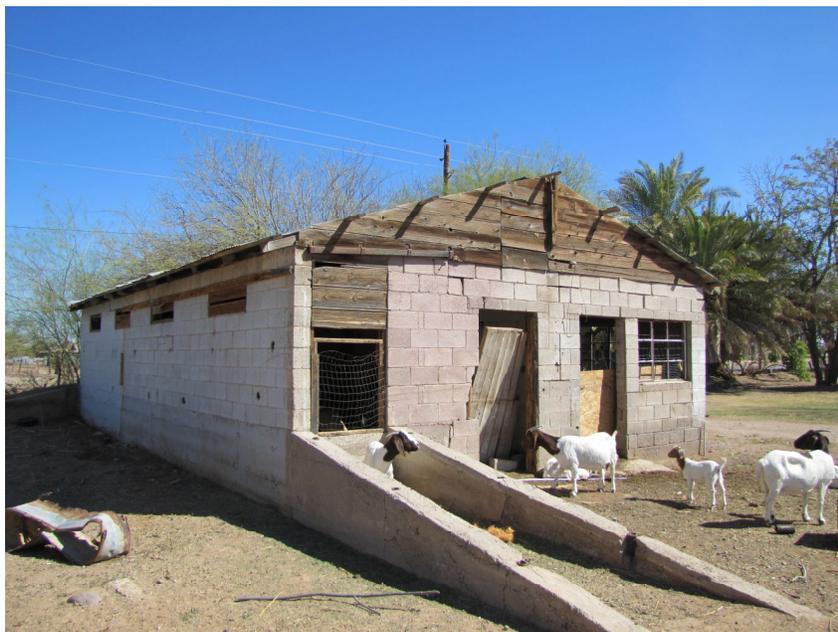
Ramp at the south end of the dairy head-to-toe barn, photo 056, view looking north northeast
