REPORT NUMBER: FHWA/AZ AZ88/227

# **POROUS PAVEMENT FOR CONTROL OF HIGHWAY RUNOFF**

## **First Annual Monitoring Report**

**July 1988**

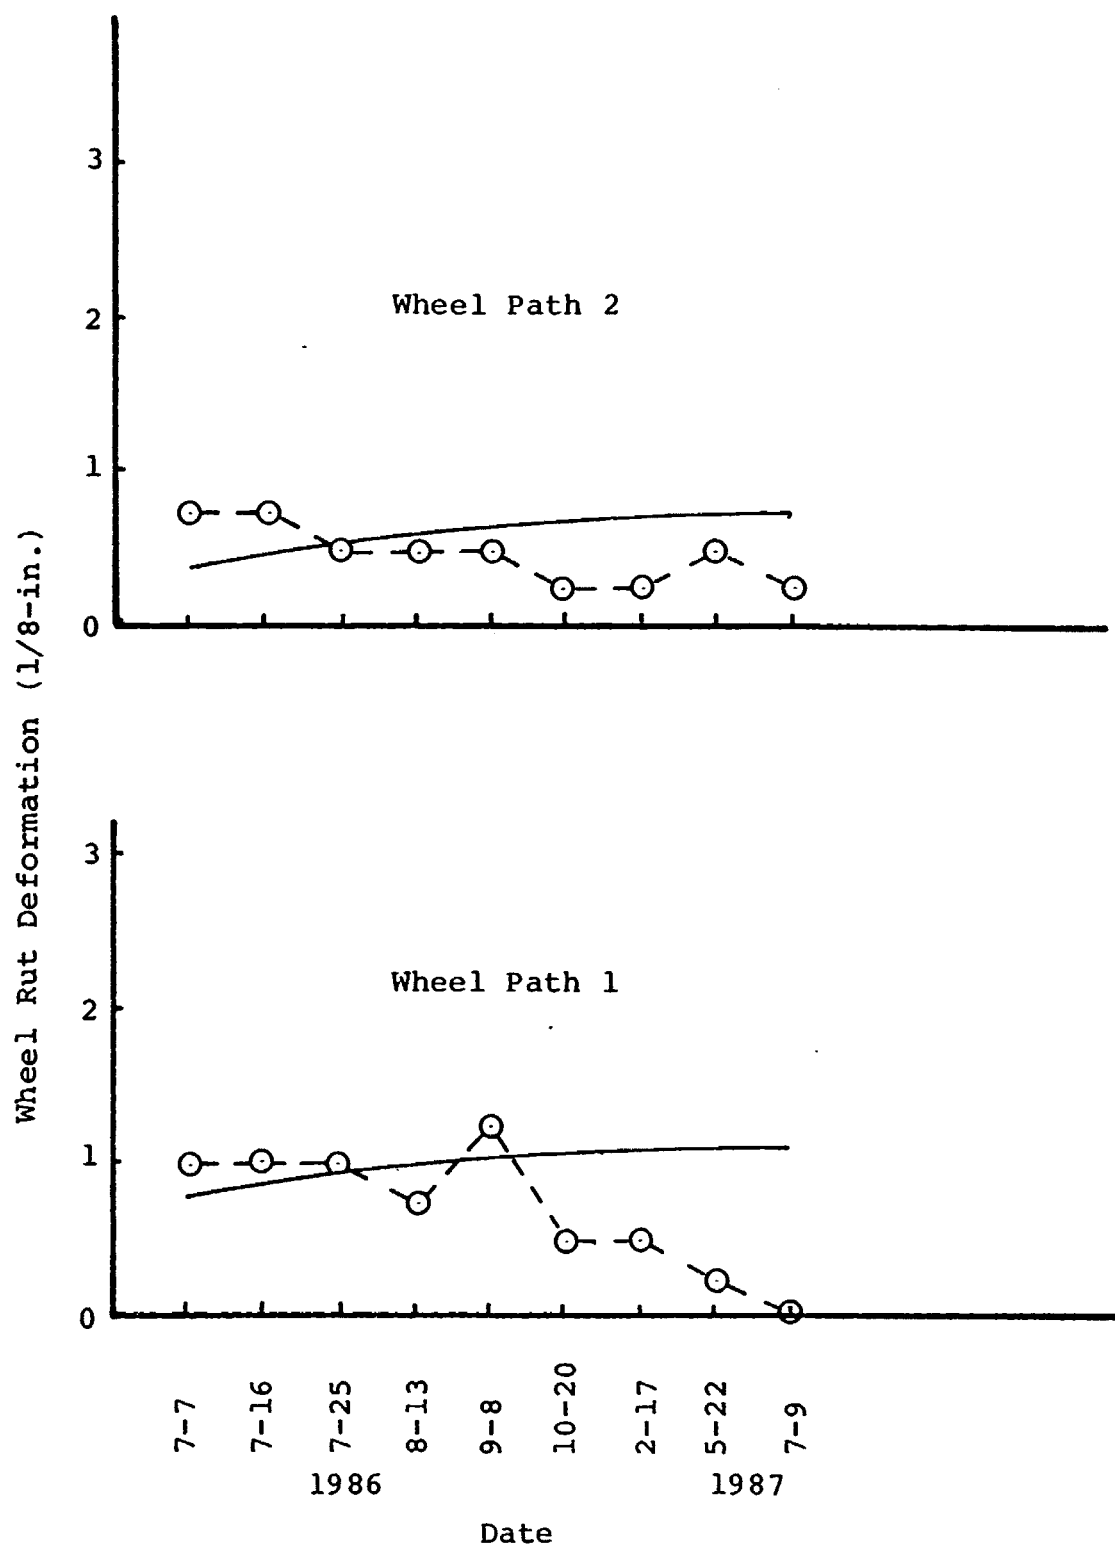
FIGURE 6. WHEEL RUT DEFORMATIONS  
CONVENTIONAL PAVEMENT  
Lane 1

Appendix C and Figures 3, 4 and 5 outline information on each lane and wheel path in the porous pavement section. The average wheel path deformation for the porous pavement is slightly over  $3/16$  in. Appendix D and Figures 6, 7 and 8 outline information on each lane and wheel path in the conventional pavement section. The average wheel path deformation for the conventional pavement is slightly under  $1/8$  in.
