Performance Evaluation of Arizona's LTPP SPS-1 Project: Strategic Study of Flexible Pavement Structural Factors

Final Report 396-1 February 2012

Arizona Department of Transportation Research Center

Nichols Consulting Engineers 1885 South Arlington Avenue Suite 111 Reno, Nevada 89509

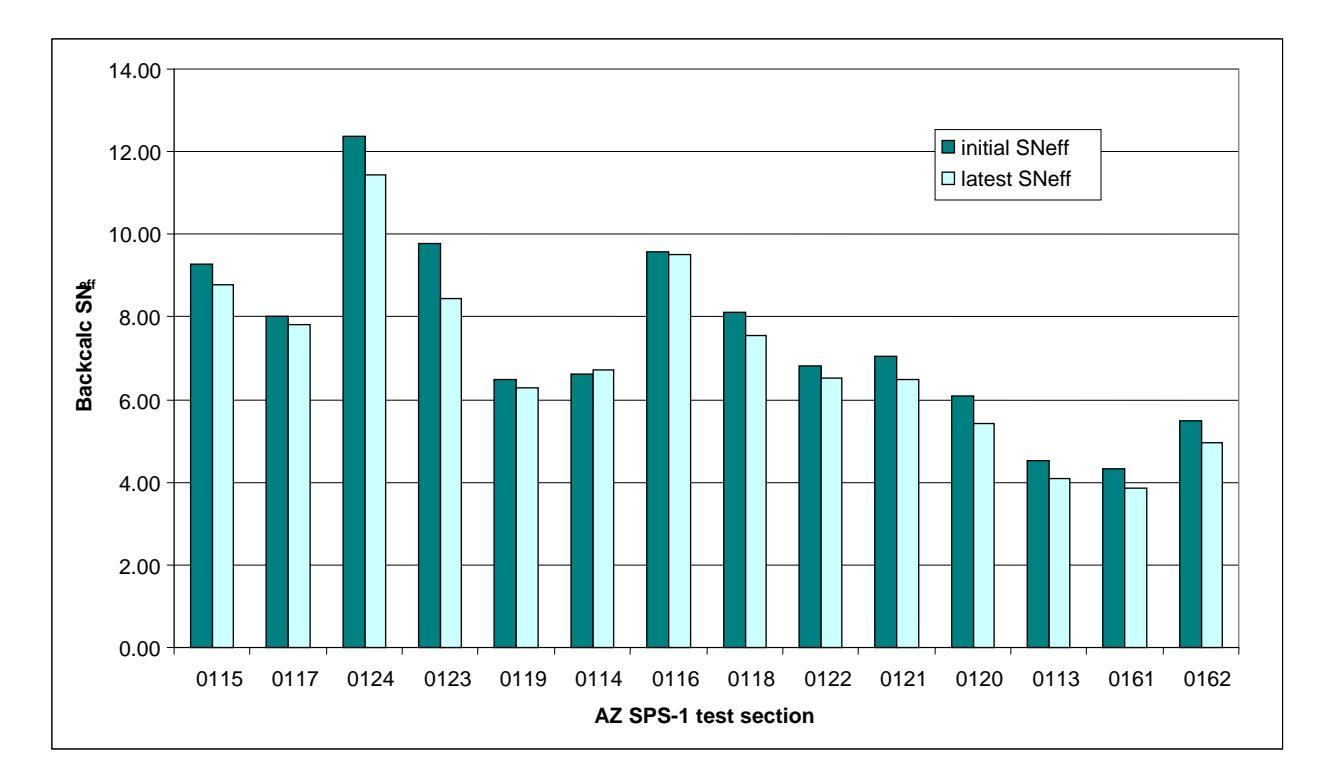
Figure 6. 1994 and 2004 backcalculated effective Structural Number by test section.

The deflection data were used to assess the initial structural capacity of each test section and the change in structural capacity over time, with structural capacity expressed as an effective Structural Number (SN_{eff}). The initial and last average backcalculated SN_{eff} values are shown by test section in Figure 6 and Table 7. All but one of the test sections showed a decrease in backcalculated SN_{eff} between 1994 and 2004. This is presumed to be due to damage from traffic loadings. No correlation was detected between the magnitude of the initial SN_{eff} and the magnitude of the decrease in SN_{eff} over time.

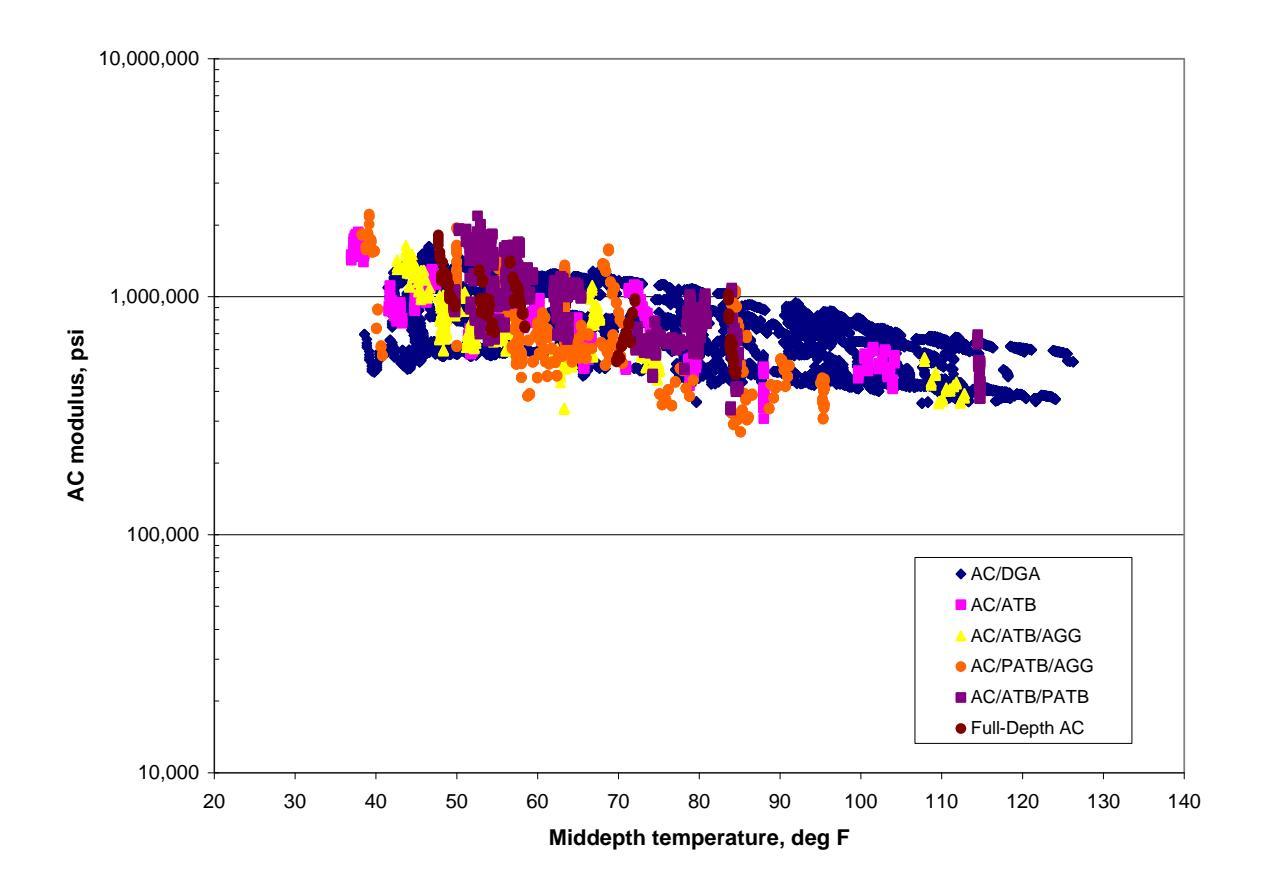
Figure 8. Backcalculated AC modulus versus temperature.

The combined backcalculation results from all testing between 1994 and 2004 were used to assess the relationship of AC modulus to temperature. Figure 8 shows the results grouped together for the six types of pavement structures considered:

It should be noted that these backcalculated values of AC modulus as a function of temperature were determined by judicious selection of realistic values for the ratio of AC surface modulus to base modulus. This was necessary to decompose the backcalculated effective modulus of the entire pavement structure above the subgrade into two components, the modulus of the AC surface and the modulus of the underlying base.

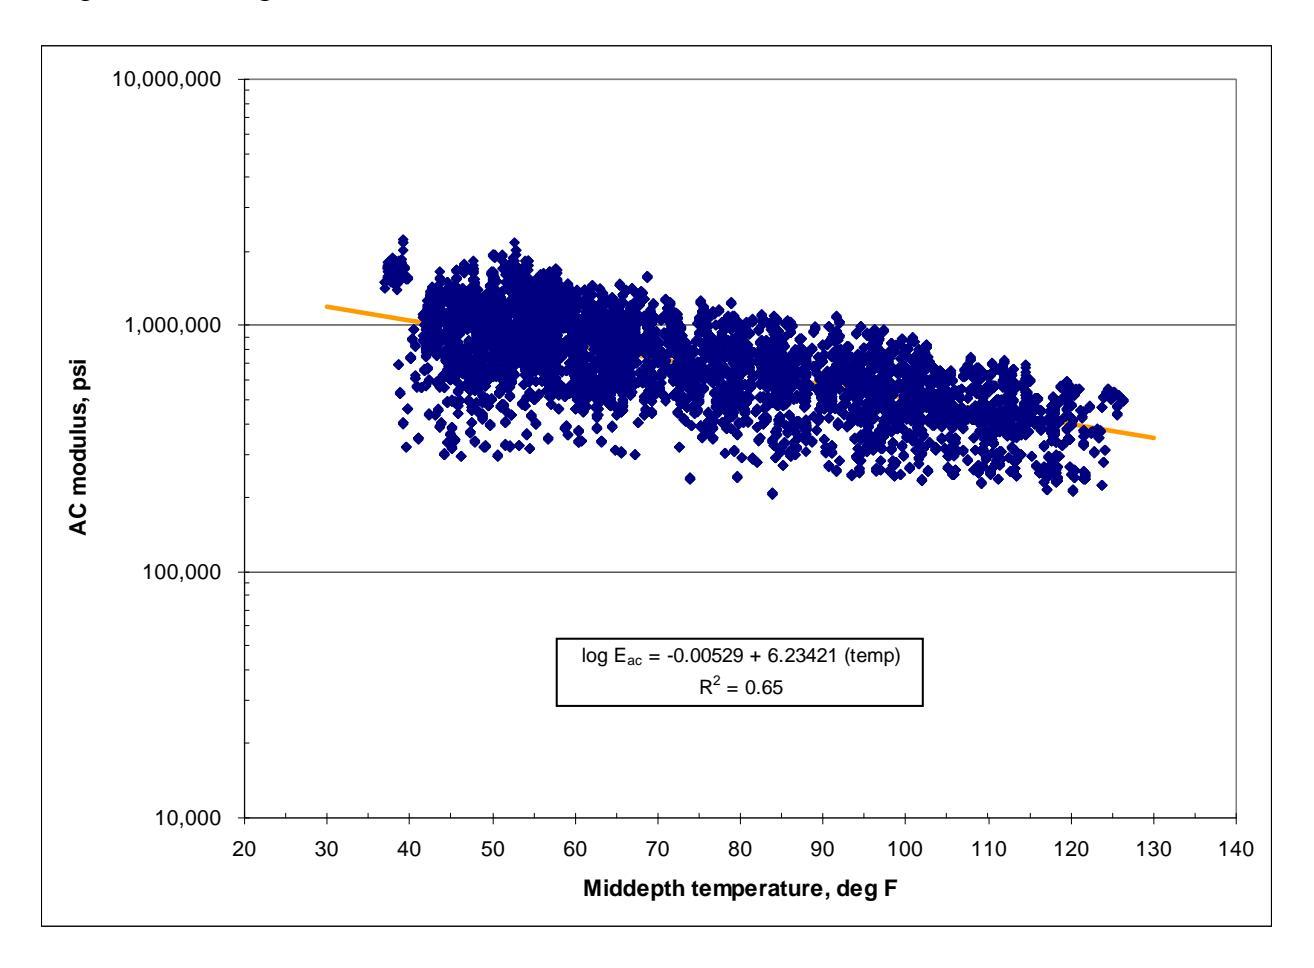
Figure 9. Backcalculated AC modulus versus temperature.

The relationship of backcalculated AC modulus to mid-depth AC temperature for all of the pavement structure groups combined is illustrated in Figure 9. The regression

equation obtained for the logarithm of E_{ac} in psi as a function of mid-depth AC temperature in degrees Fahrenheit is also shown.

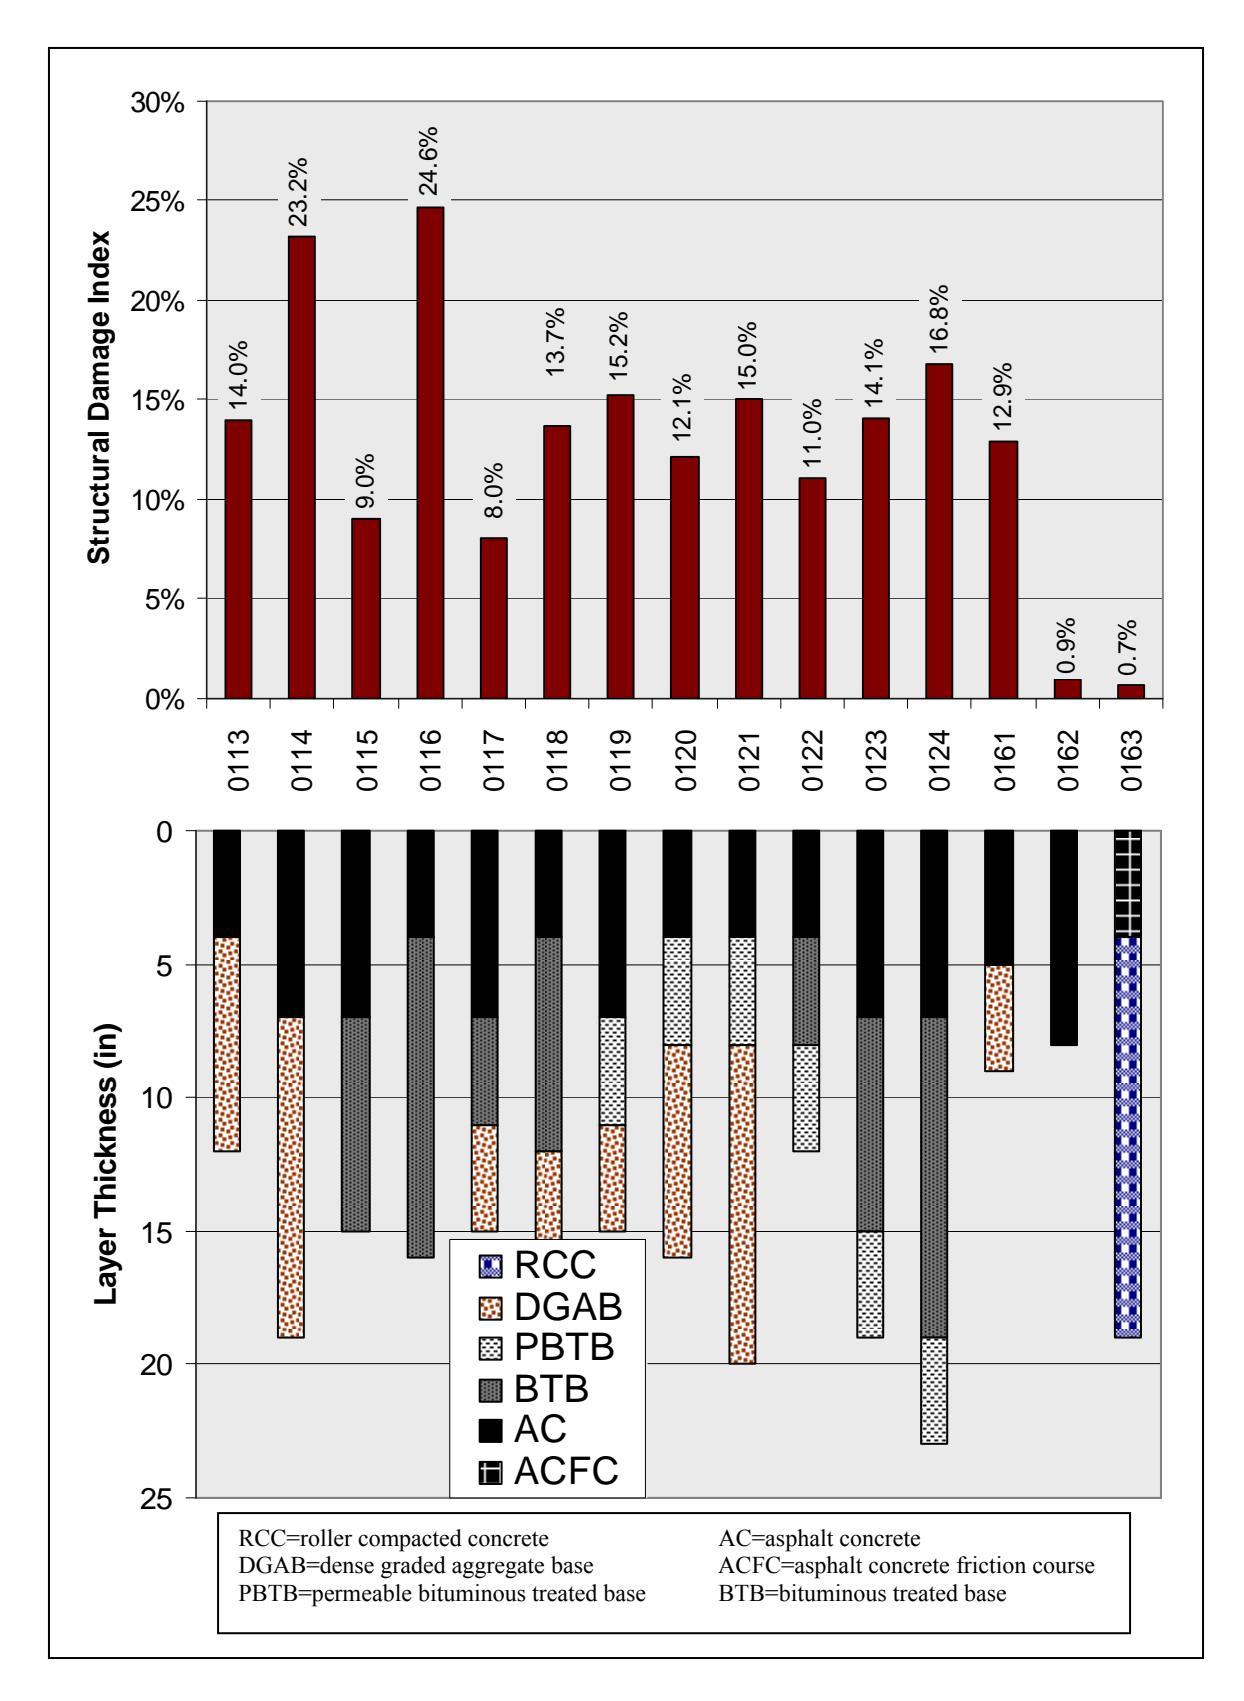
Figure 15. Structural Damage Index and pavement structure summary.

In-depth analyses and comparisons were conducted for all of the SPS-1 test sections. Figure 15 provides a summary of the structural damage index and pavement structure for each section while a summary of the environmental damage index and pavement structure can be found in Figure 16. Both damage indices reported are based on the data collected in March/April 2002 (just prior to the slurry seal).

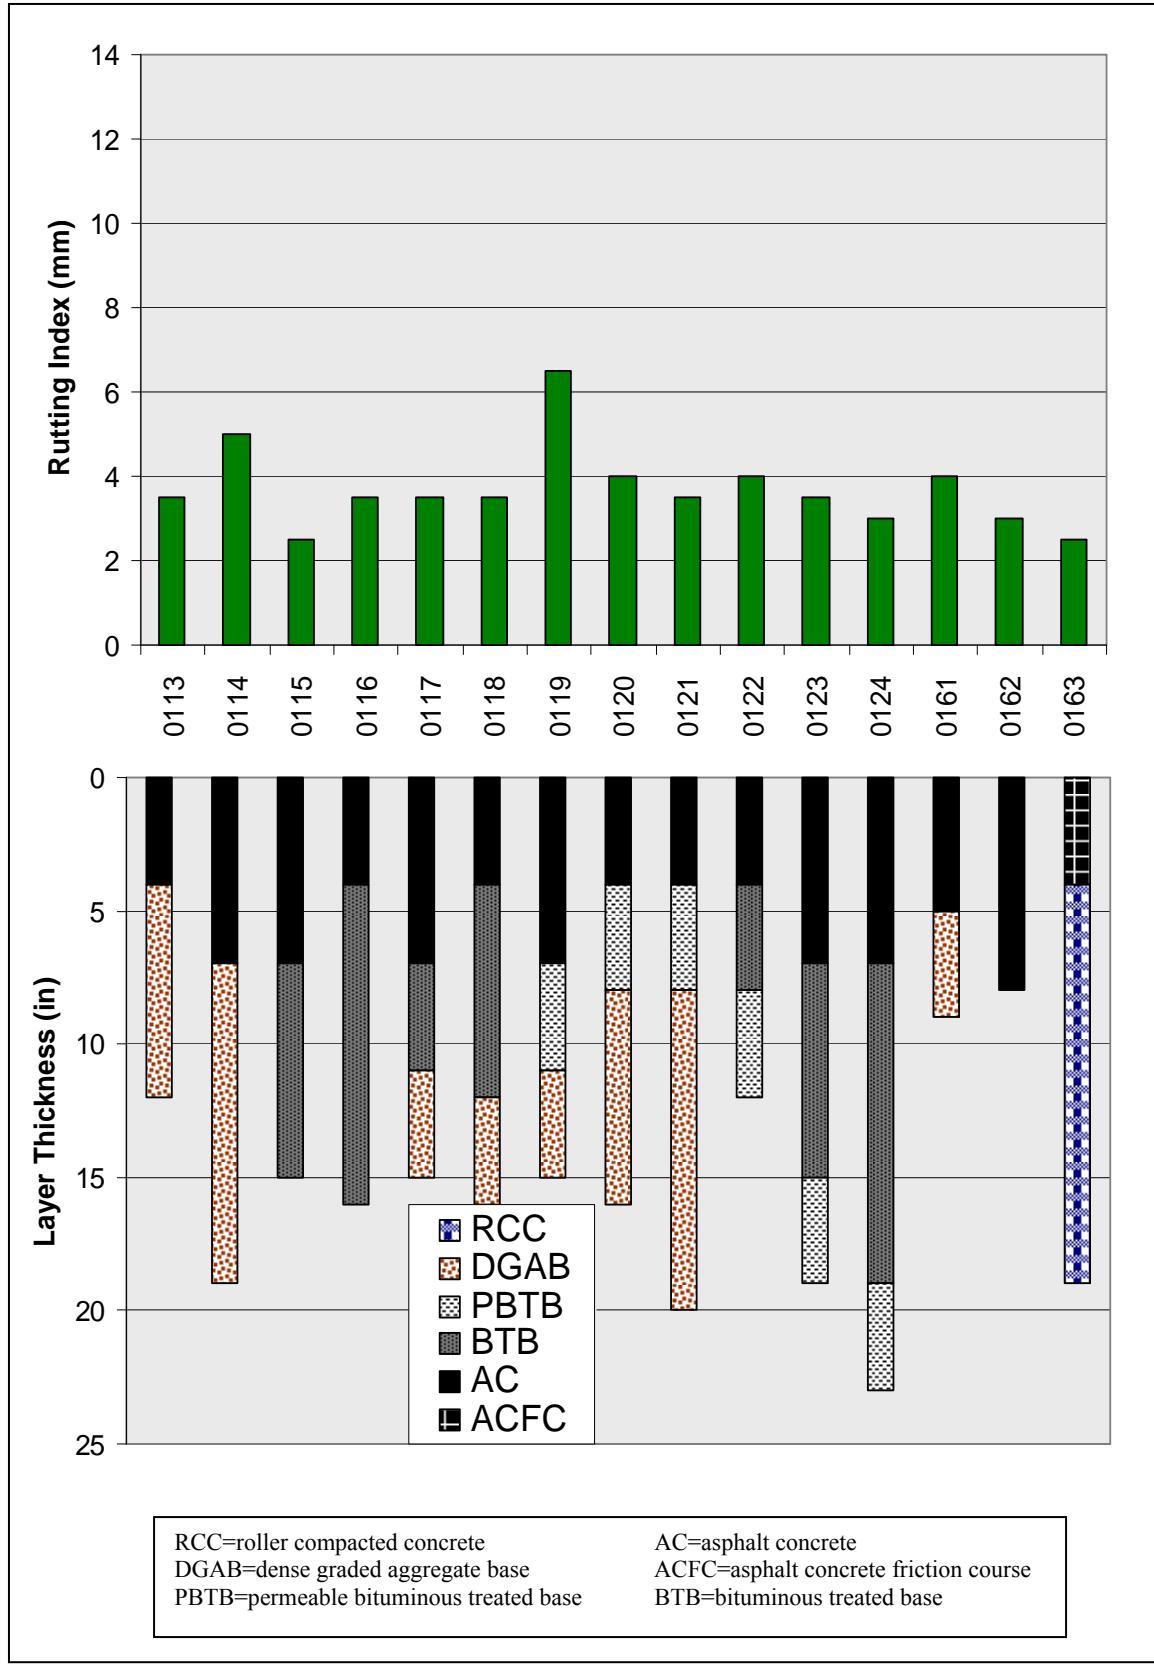
Figure 17. Rutting Index and pavement structure summary.

Figure 17 provides a summary of rutting and pavement structure for each section. Significant variation in rutting performance between the sections did not exist. All sections exhibited less than 7 mm of rutting after more than seven years in service, which is well below the level required to trigger improvements in most pavement management systems. Therefore, rutting was not the driving factor in the overall condition of the pavement.

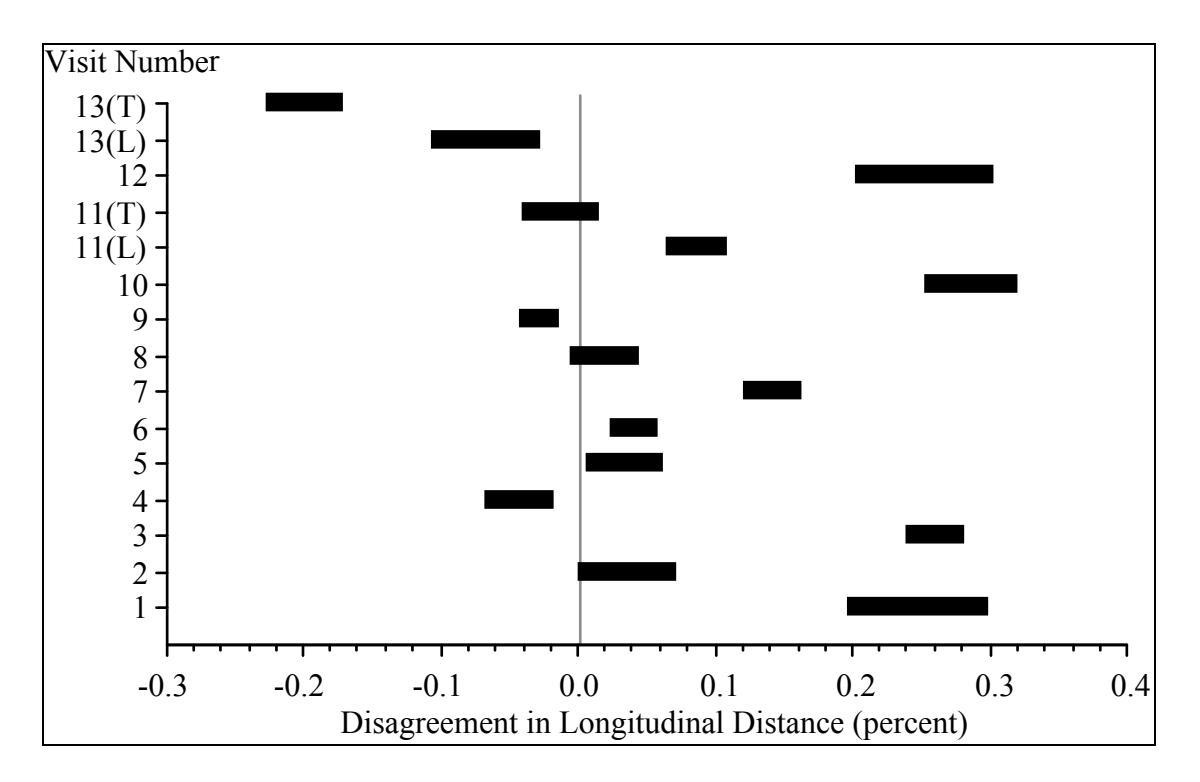
Figure 19. Consistency in longitudinal distance measurement.

Since the longitudinal distance measurement was based on the rotation of a drive wheel, the variations were most likely caused by variations in speed, lateral wander, and tire inflation pressure.¹¹ If tire inflation pressure were the dominant cause, the disagreement would grow more positive with each successive repeat measurement as the tire heated up and tire pressure increased. This is because the tire rolling radius would increase, and the profiler would register less wheel rotation for the same travel distance. This appeared to be the case for visits 03 through 08, but the effect was never greater than 0.05 percent of the overall distance. Note that the field procedures require the operator to warm up the tire prior to the measurements. That accounts for the high level of agreement among visits 03 through 13.

The variation between visits in Figure 19 is caused by differences in distance measurement instrument calibration. The longitudinal distance measured by a profiler is not true horizontal distance. It always includes some additional component because the profiler must travel up and down the undulations in the road. This component can be minimized by calibrating the profiler to true horizontal distance. However, if a profiler operates on a road with grade changes and roughness that are not similar to the site used for longitudinal distance measurement calibration, some error will exist. Tire inflation

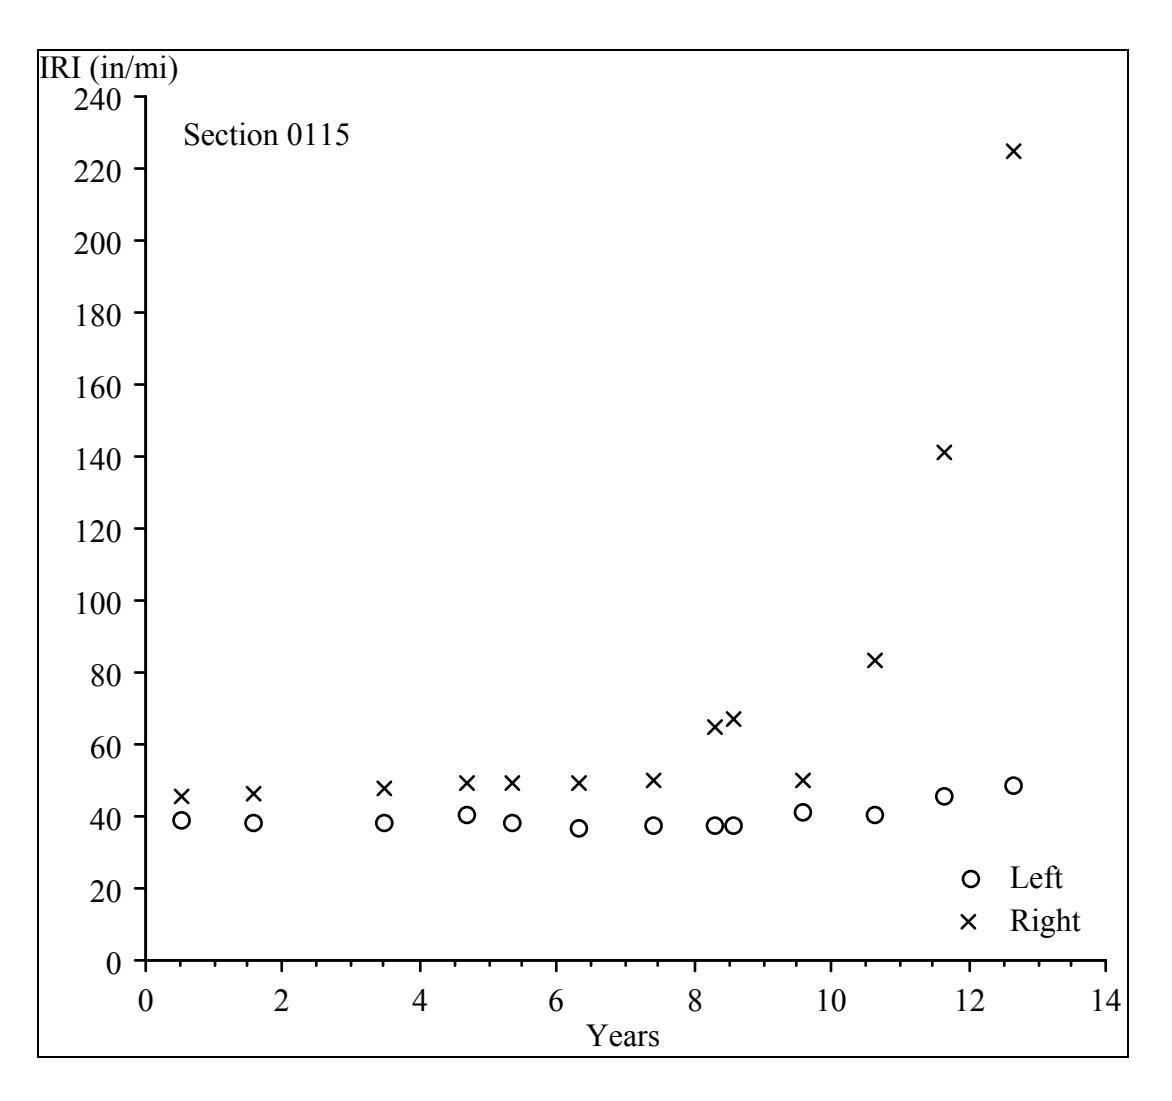
Figure 21. IRI progression, section 0115.

<u>Section 0115:</u> This section was very smooth on the left side throughout the entire monitoring period and was smooth on the right side through the first 10 visits. The roughness increased very aggressively on the right side over the last three visits because of longitudinal cracking. By the final visit the average IRI was 225 in/mi. However, the profile measurements of the right side were not very consistent with each other in the last three visits. This was because the profiler used height sensors with a narrow footprint and wandered above the cracks.

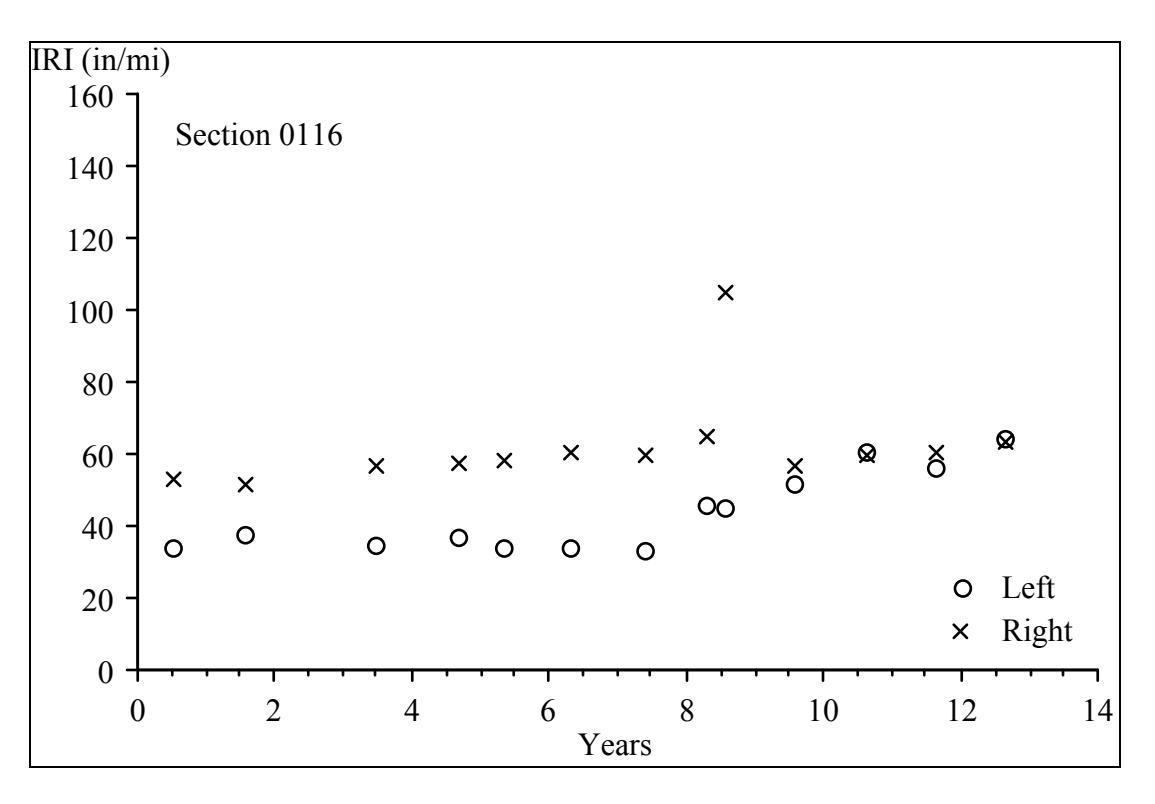
Figure 23. IRI progression, section 0116.

<u>Section 0116</u>: This section remained smooth over the entire monitoring period, with the exception of three small areas. In all three cases, deep dips appeared in the profiles that added significant roughness to the section. In August 2001 patches were placed over all three dips, but the patches were often at least as rough as the dips they replaced. One patch on the right side of the lane from 150 to 170 ft from the start of the section was so rough that it temporarily added more than 25 in/mi to the roughness of the entire section.

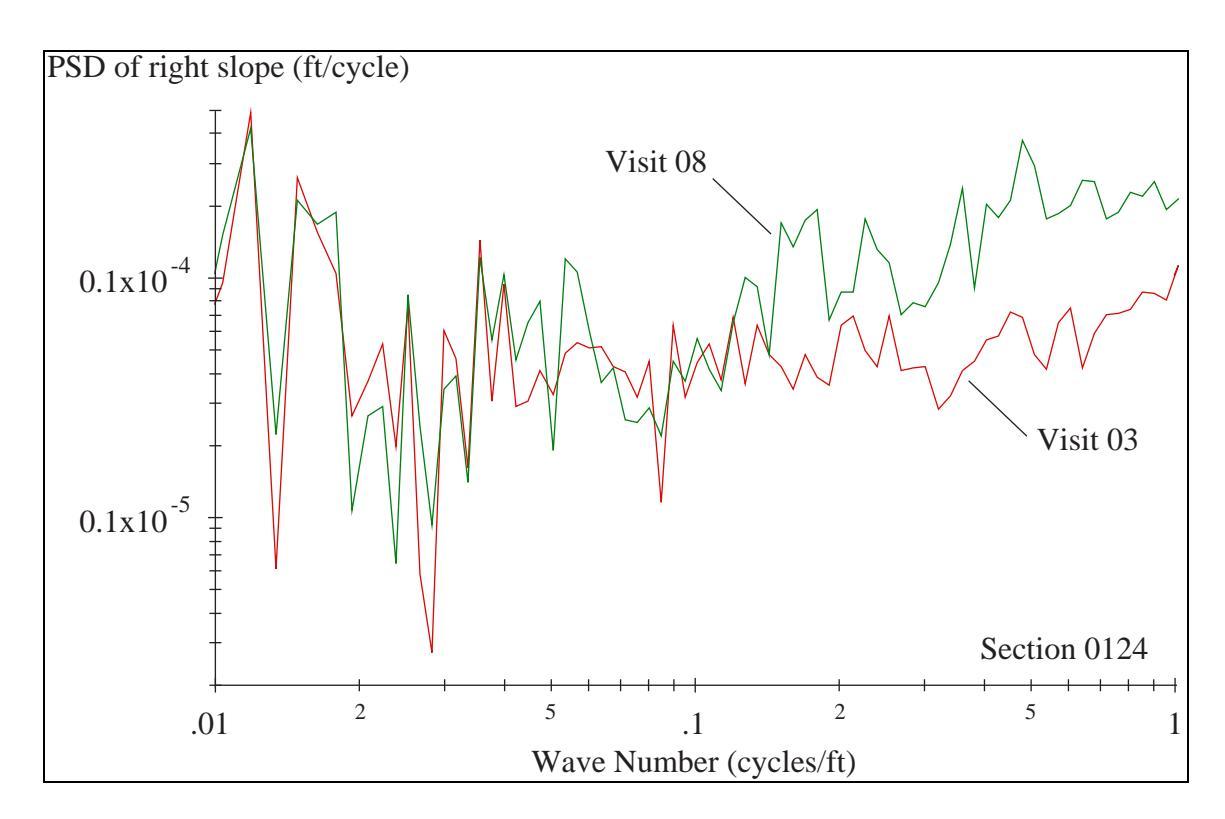
Figure 36. PSD plot of section 0124 profile, right side.

The PSD plots provided a very useful breakdown of the content within a profile. In particular, the plots reveal: (1) cases in which significant roughness is concentrated within a given waveband, (2) the type of content that dominates the profile (e.g., long, medium, or short wavelength), (3) the effectiveness of maintenance in eliminating roughness over each waveband, (4) the type of roughness that increases with time, and (5) the type of roughness that is stable with time. Figure 36 shows the PSD plot of the right profile for section 0124 during visits 03 and 08.

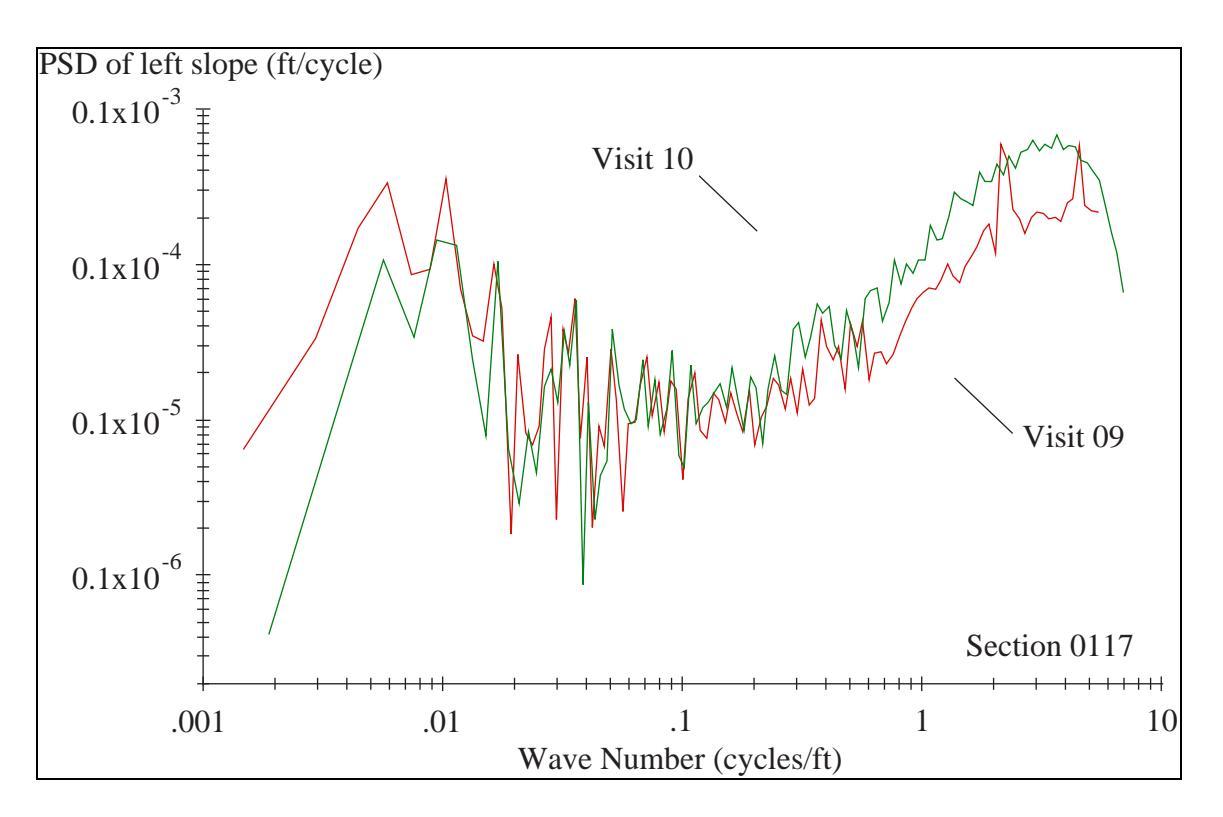
Figure 37. PSD plot of section 0117 profile, left side.

The PSD plot also provides insight into the filtering practices of the profiler that made the measurements. Figure 37 shows the PSD plot of the left profile for section 0117 during visits 09 and 10 over the maximum range allowed by the section length and sample interval. This plot includes several noteworthy features:

The wave number where the left-most spike occurred ranged from about 1.62 cycles/ft to 2.80 cycles/ft. A similar effect was present in the profile used in visits 01 and 02, and the spikes occurred from about 0.40 cycles/ft to 0.42 cycles/ft.

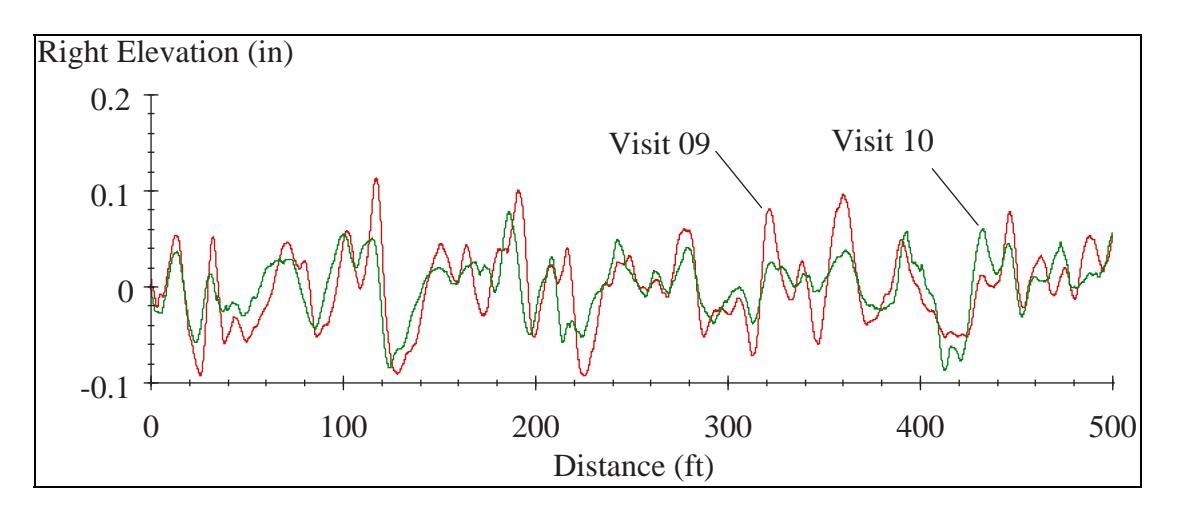
Figure 40. Medium wavelength profiles of section 0122.

Filtered profile plots also helped to characterize the effects of maintenance operations. For example, a slurry seal was applied to nine of the sections on the SPS-1 site in May 2002 (between visit 09 and 10). In most cases, this caused a complete change to the short wavelength profile plots and a significant change to the medium wavelength profile plots. Figure 40 shows an example of the change in the medium wavelength content on section 0122. Local peaks and troughs occur in roughly the same place before and after the slurry seal, but the shape and severity of bumps and dips are heavily altered. This, and the submerging of narrow dips at cracks under the seal, is the source of the change in roughness that occurred after the slurry seal.
