Evaluation of Salvage and Replanted Native Plants on ADOT Projects

Final Report 587
June 2012

Arizona Department of Transportation
Research Center

Logan Simpson Design, Inc.
51 West Third Street, Suite 450
Tempe, AZ 85281

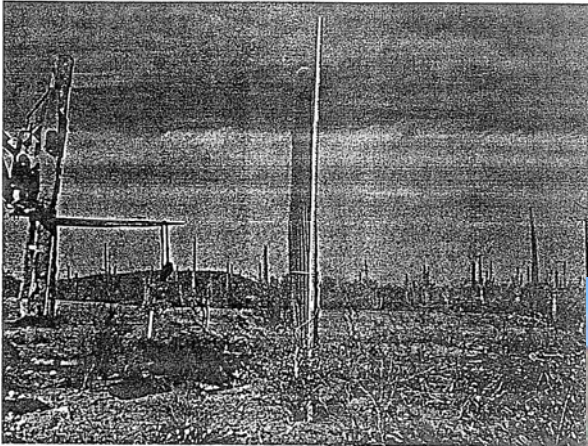
Right: Saguaro dead at time of inventory, January 28, 2008. Original tag #82, LSD #101.

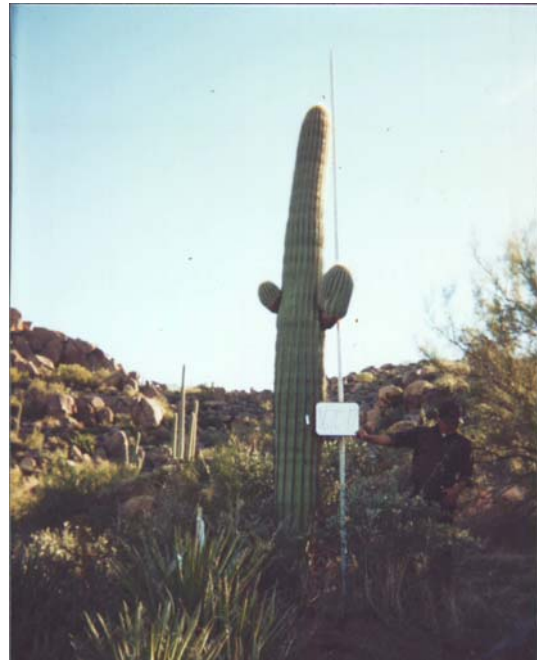
Right: Contractor's presalvage photo of saguaro tag #1670-17.

Below: Saguaro dead at time of inventory, June 19, 2008.
Original tag #1670-17, LSD

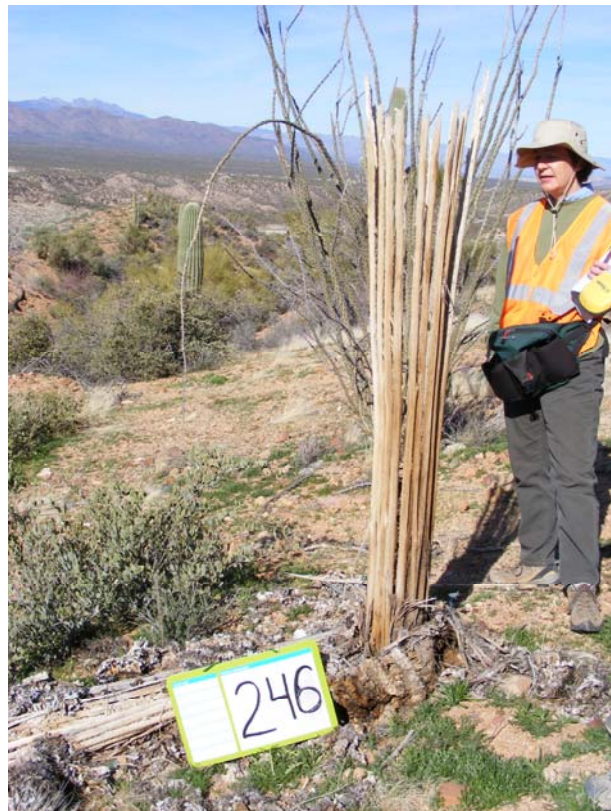
Above: Contractor's presalvage photo of saguaro tag #530.
Right: Saguaro dead at time of inventory, February 13, 2008. Original tag #530, LSD #246.

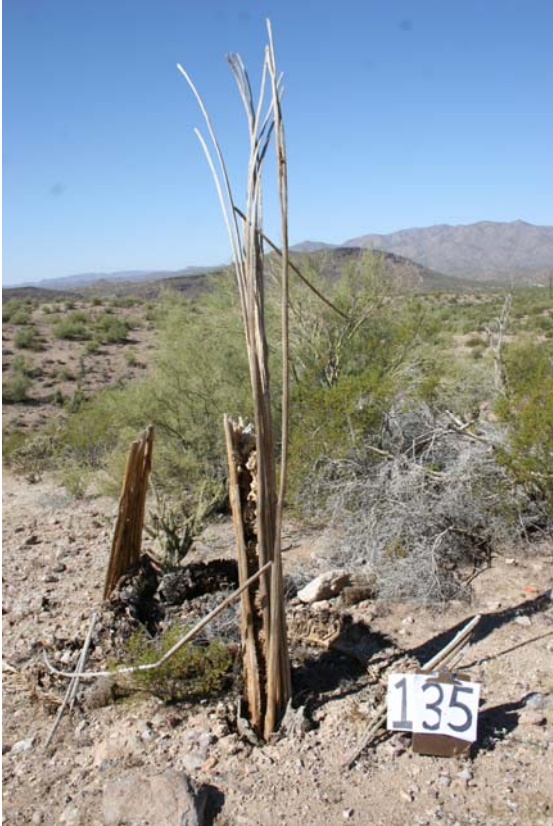
Left: Contractor's presalvage photo of saguaro tag #8372.
Below: Saguaro dead at time of inventory, October 9, 2008. Original tag #8372, LSD #135.
