## ARIZONA DEPARTMENT OF TRANSPORTATION

REPORT NUMBER: FHWA-AZ89-260

# SIZING RIPRAP FOR THE PROTECTION OF APPROACH EMBANKMENTS & SPUR DIKES AND LIMITING THE DEPTH OF SCOUR AT BRIDGE PIERS & ABUTMENTS

**Volume I: Literature Review & Arizona Case Histories**

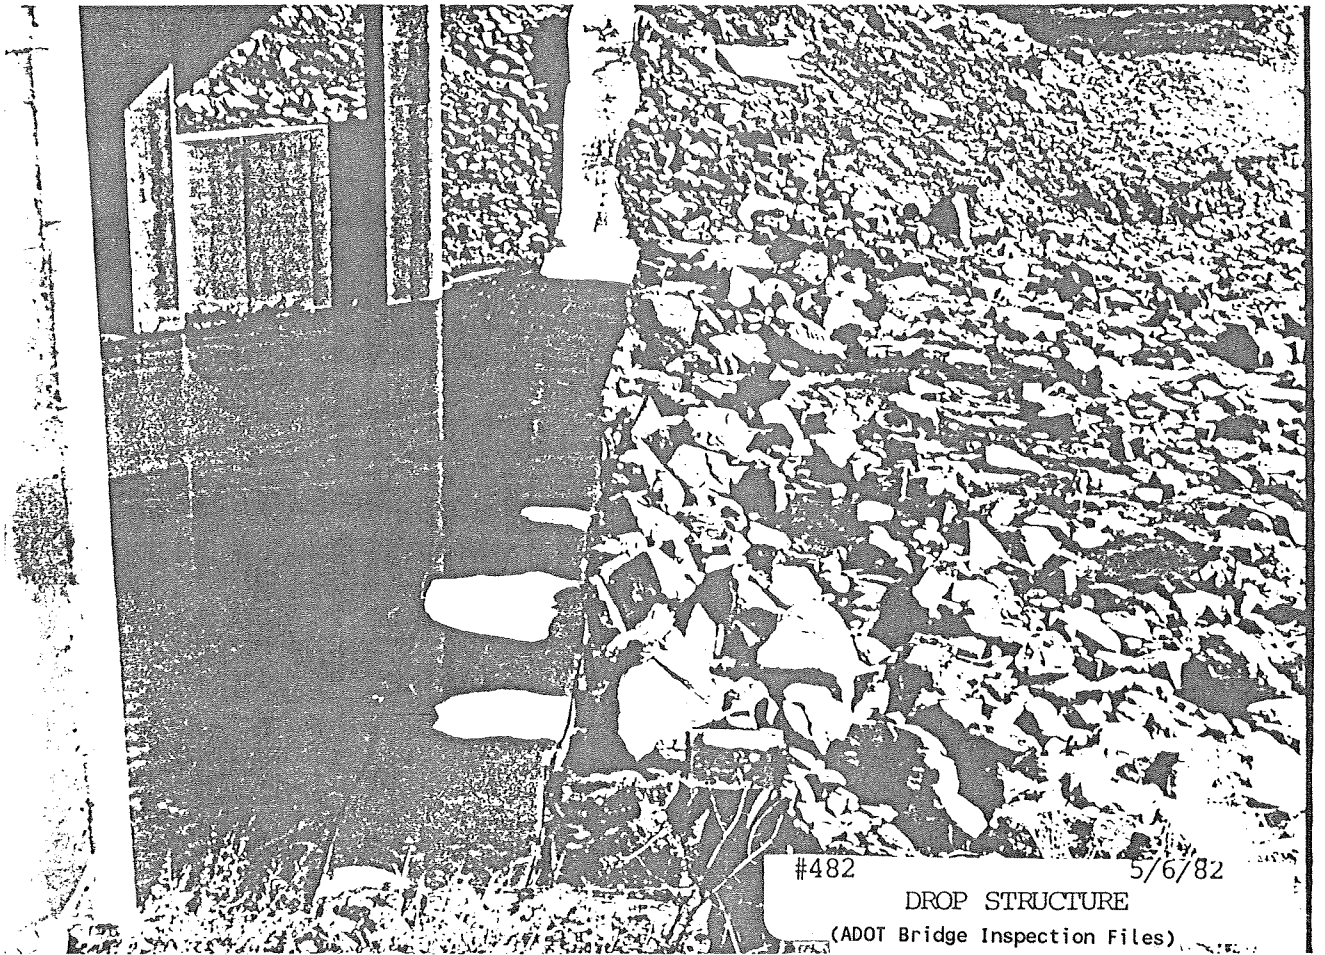
#482 5/6/82  
DROP STRUCTURE  
(ADOT Bridge Inspection Files)

Bridge inspection report: The downstream drop structure and stilling basins are working well. The channel has remained stable.

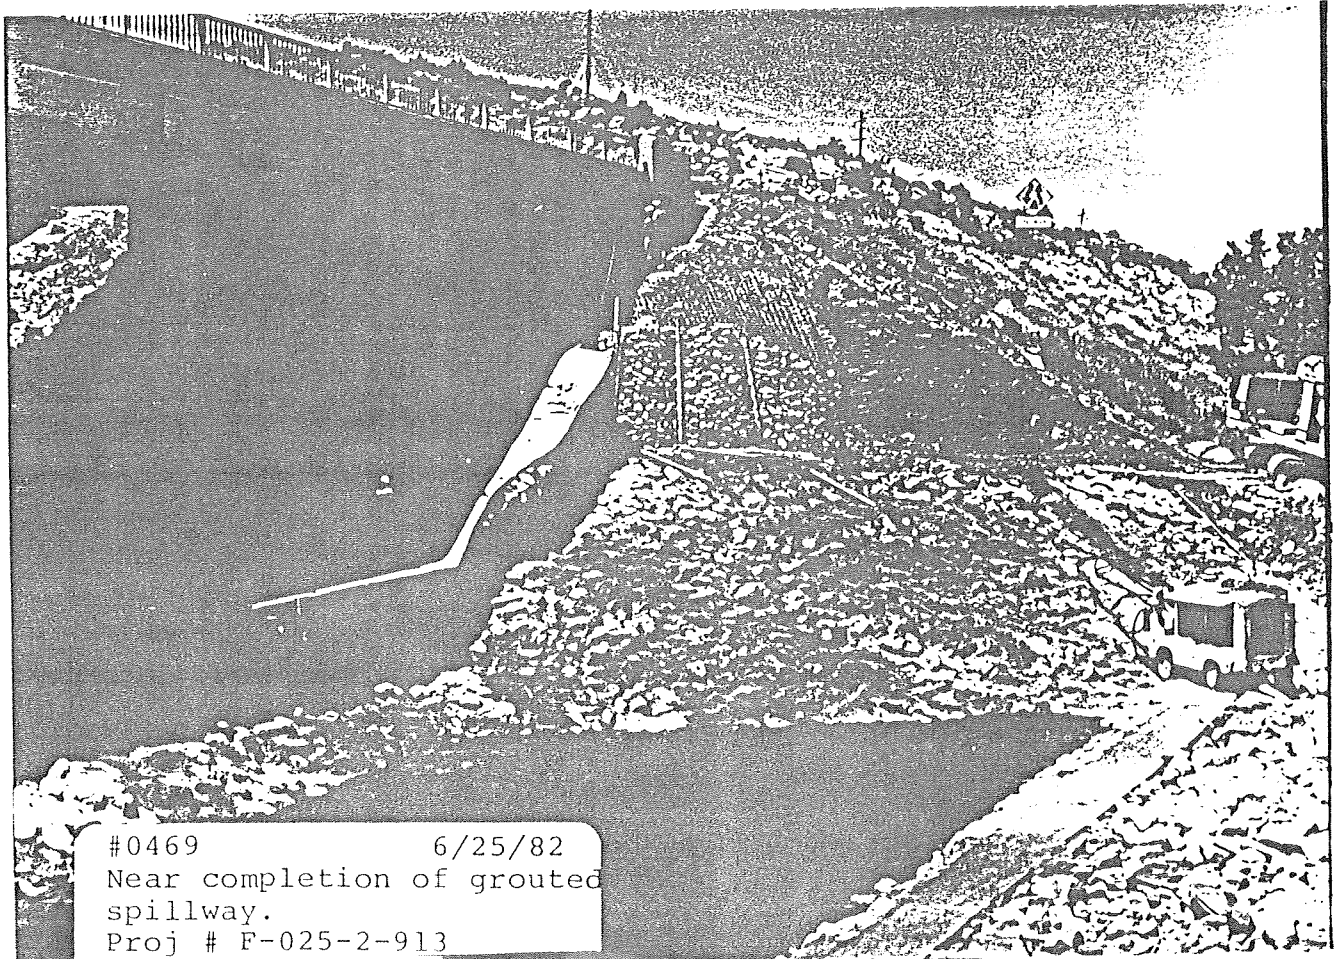
#0469 6/25/82  
Near completion of grouted  
spillway.  
Proj # F-025-2-913  
(ADOT Bridge Inspection Files)

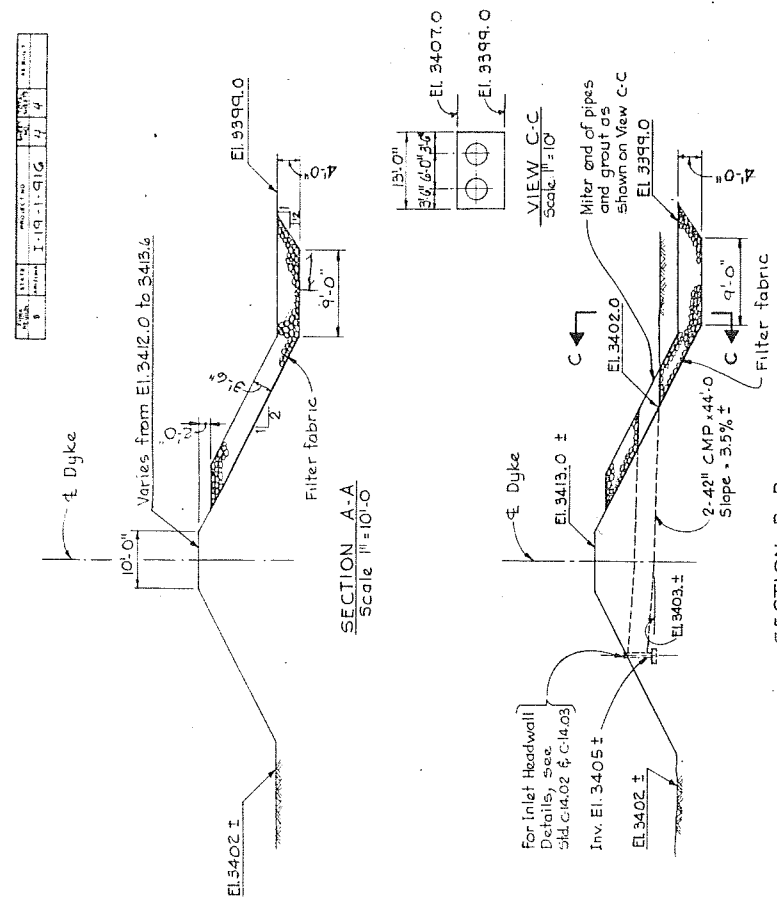
Rip Rap Rock Gradation	% Passing	Size
	100	36"
	40-60	24"
	20-40	18"
	5-20	12"
	0-5	6"

Rock shall be durable & angular  
with minimum Sp. gravity = 2.48

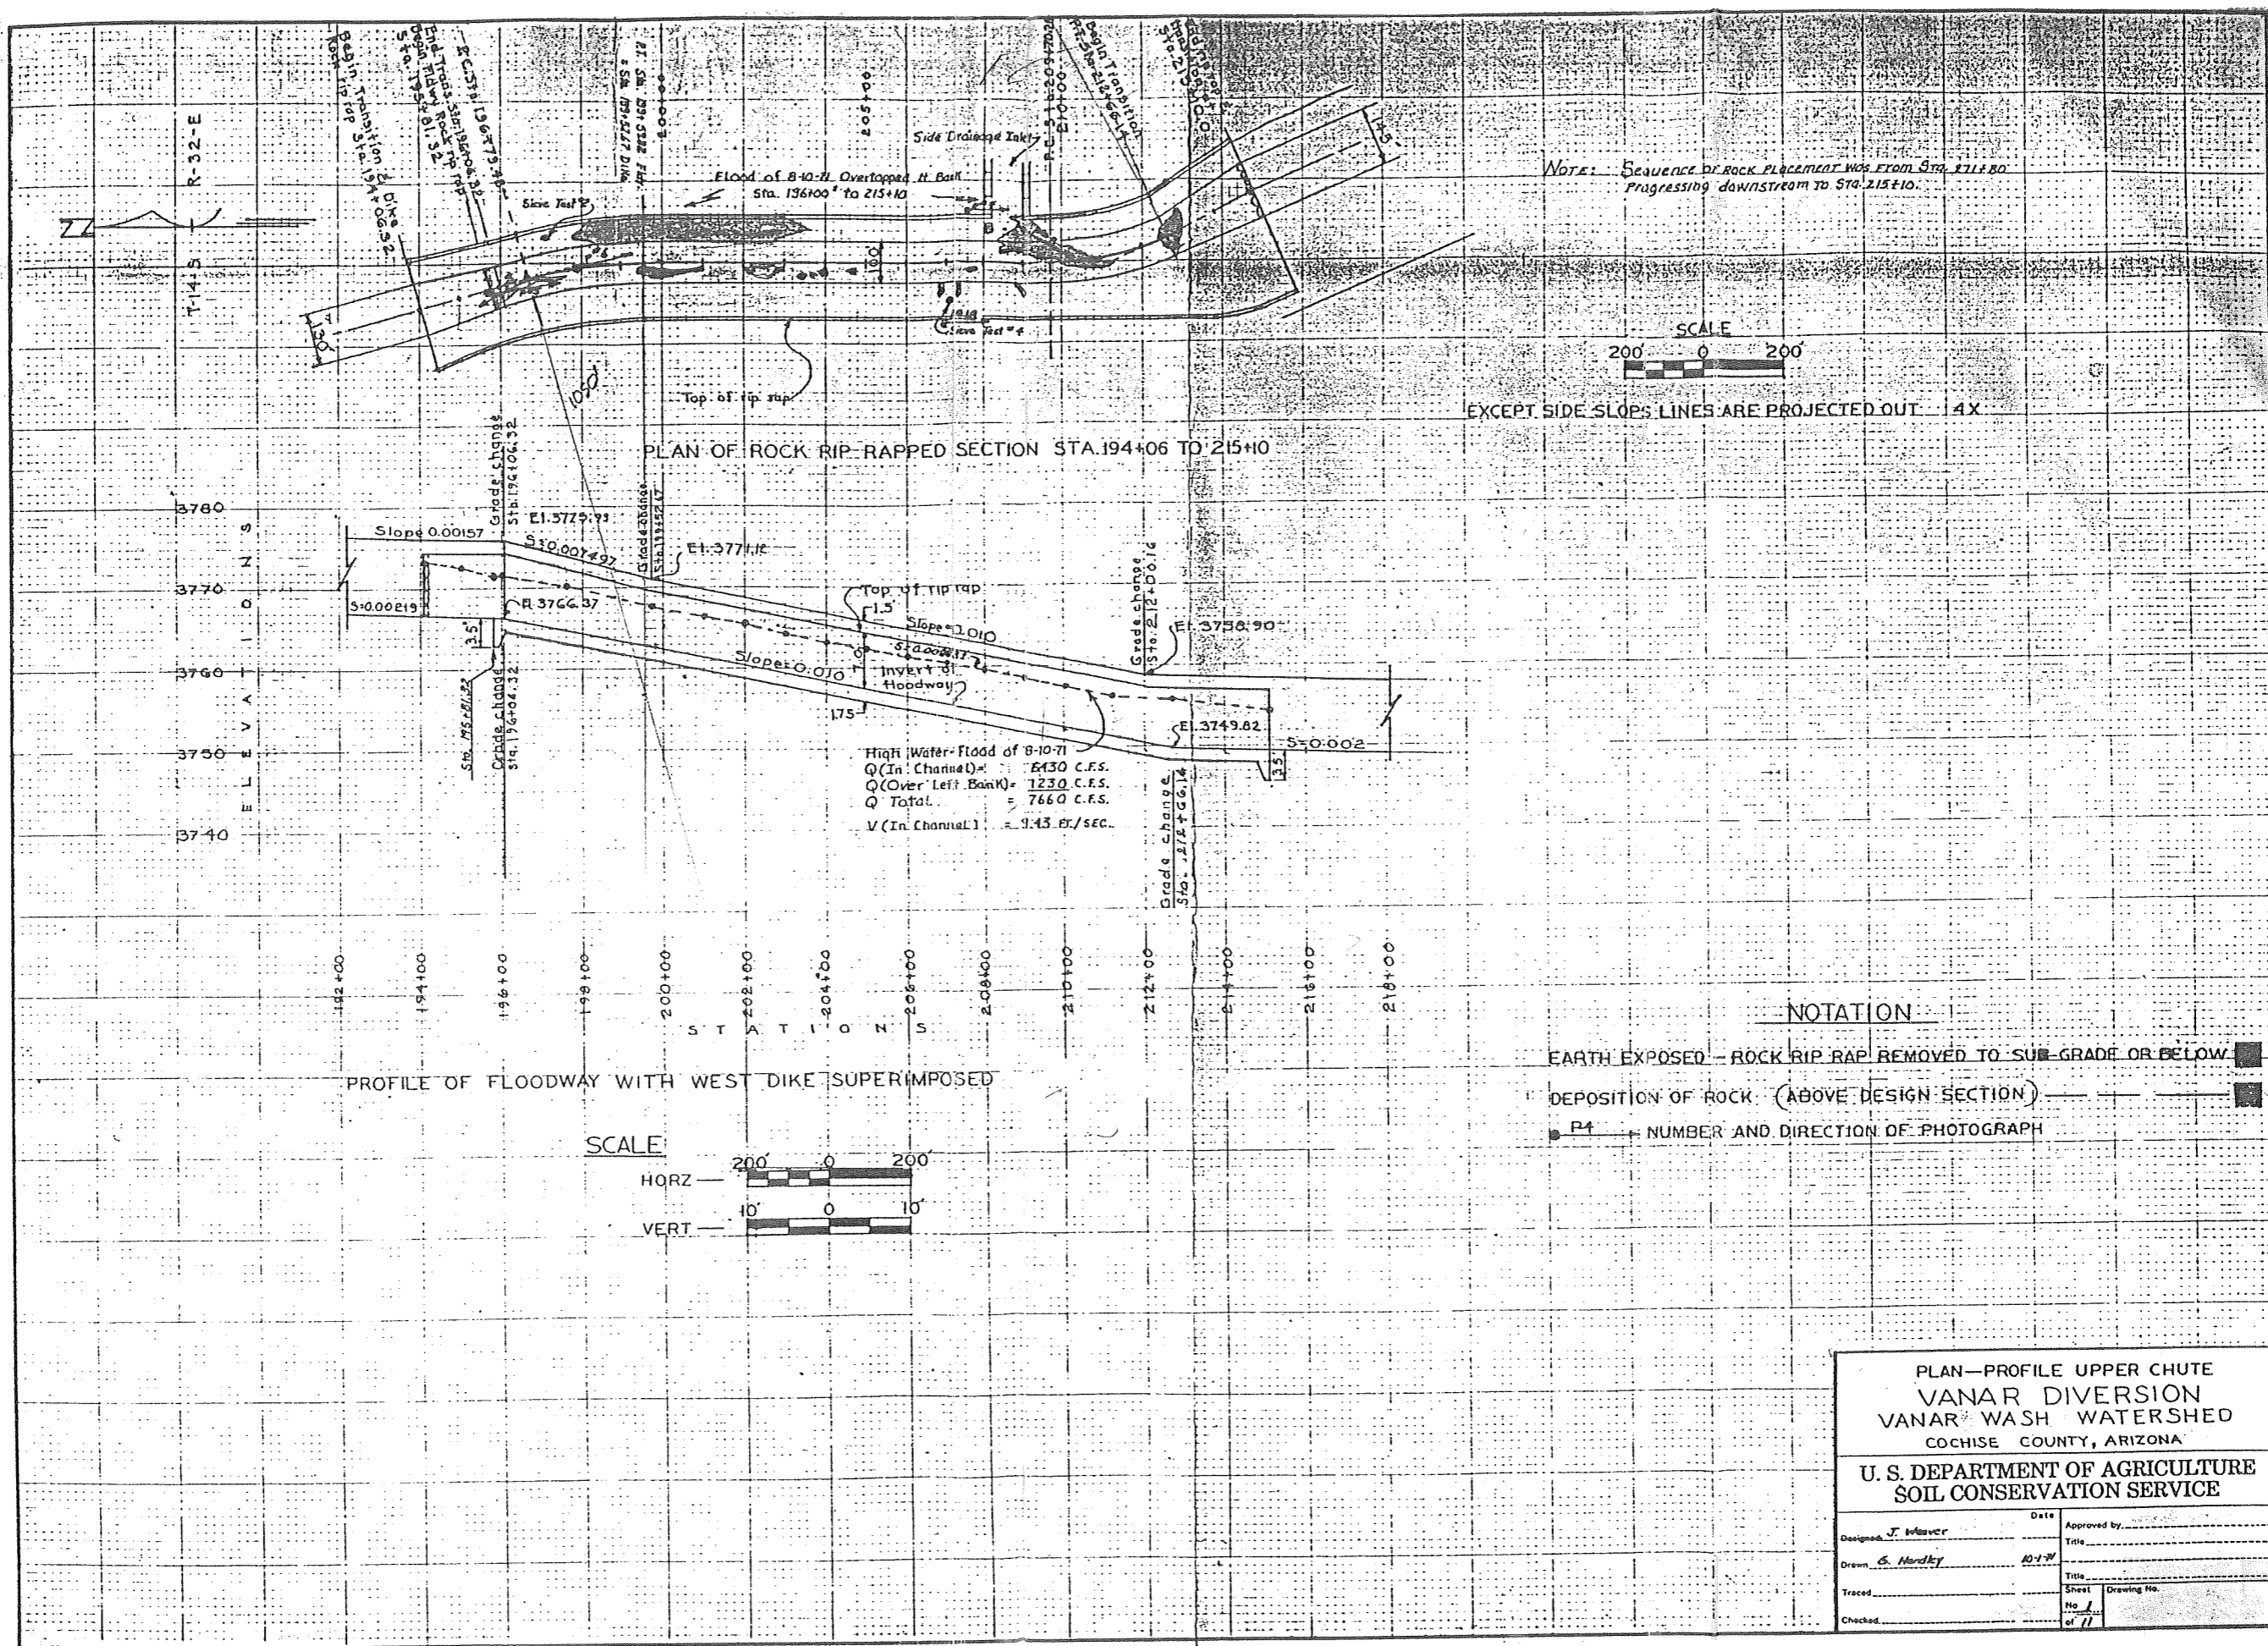
NOTE: SEQUENCE OF ROCK PLACEMENT WAS FROM STA. 211+80 PROGRESSING DOWNSTREAM TO STA. 215+10.

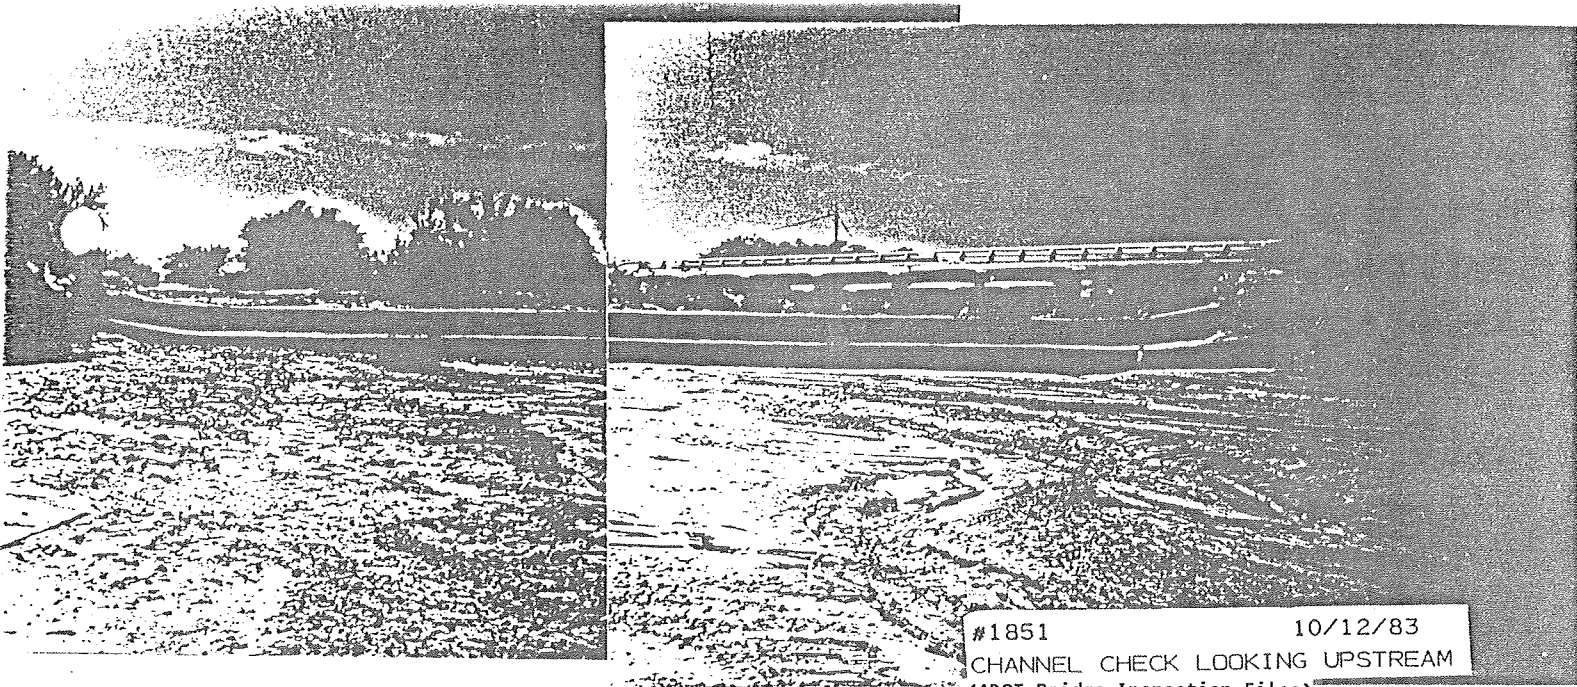
#1851 10/12/83  
CHANNEL CHECK LOOKING UPSTREAM  
(ADOT Bridge Inspection Files)
