PERFORMANCE EVALUATION OF COLD IN-PLACE RECYCLING PROJECTS IN ARIZONA

Final Report 460

March 2006

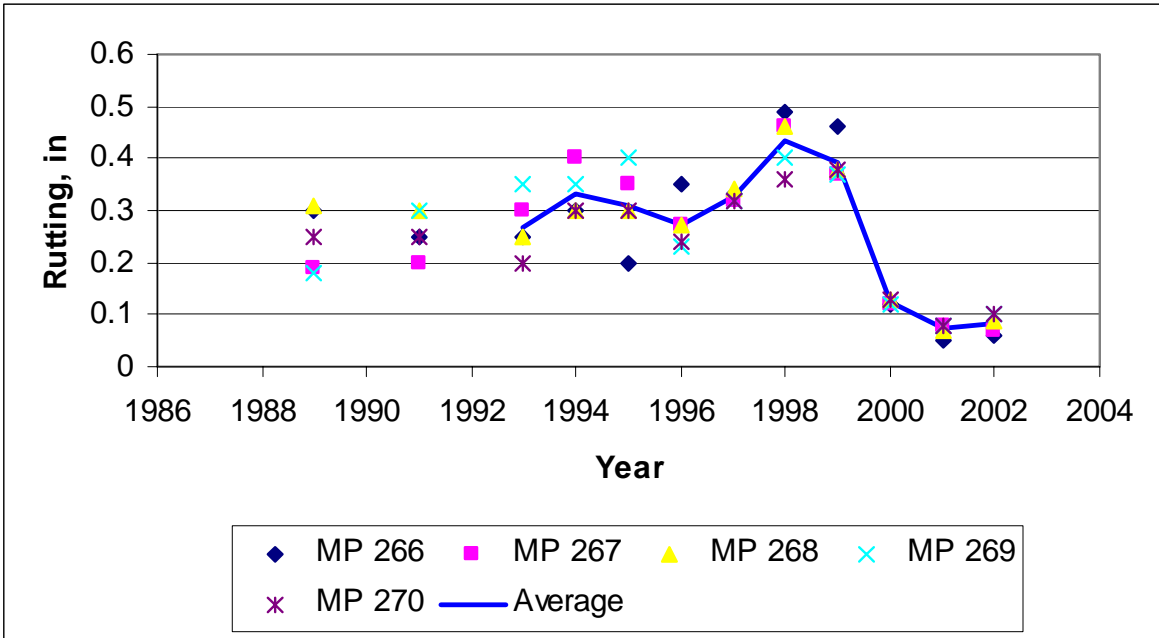
Figure 4. Rutting data for CIR Project 1—US 70 EB (ADOT Project No. F-22-4-517).

- The magnitude of rutting, shown in figure 4, also increases with time and assumes relatively high magnitudes towards the end of the project. The quantities drop in 2000, suggesting that a major rehabilitation occurred at this time.

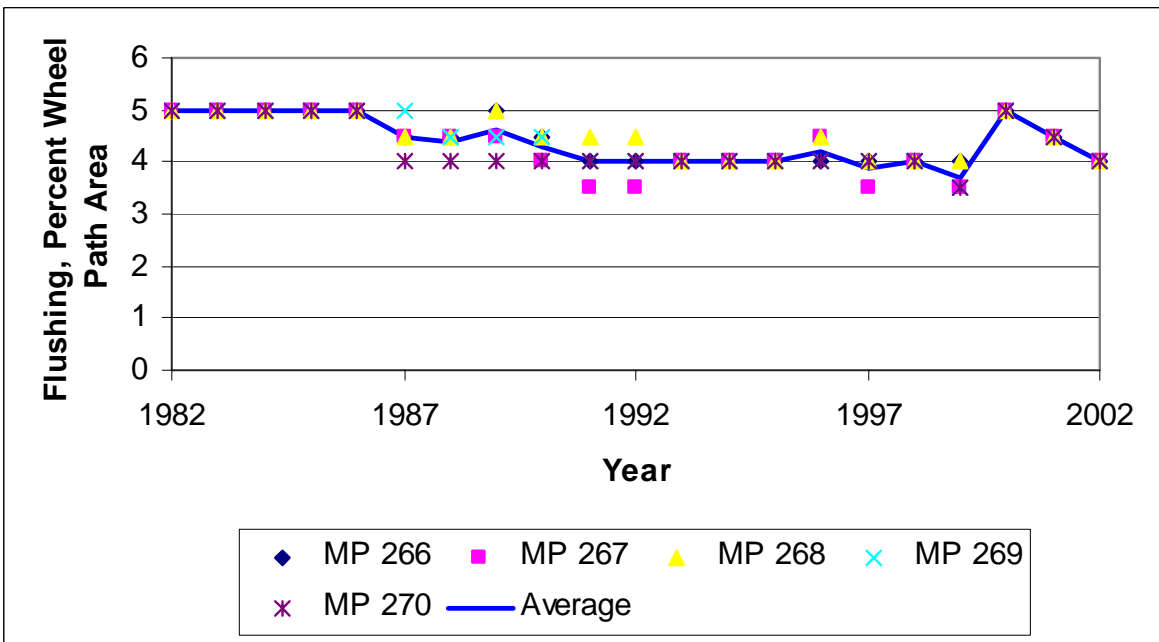
Figure 5. Flushing data for CIR Project 1—US 70 EB (ADOT Project No. F-22-4-517).

- The ride values also show a generally increasing trend until 2000, with a sharp improvement noticed at this time.
- The flushing quantities shown in figure 5 remain fairly uniform over time, except when maintenance is applied or rehabilitation work is performed.

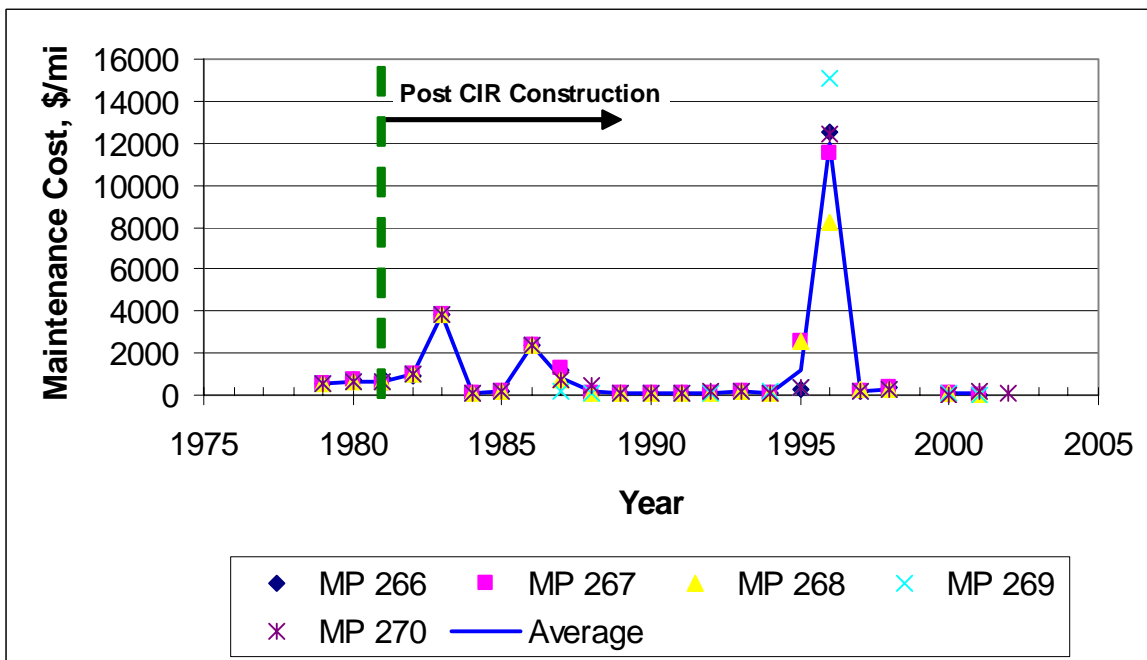
Figure 7. Maintenance costs for CIR Project 1—US 70 EB (ADOT Project No. F-22-4-517).

- Figure 7 suggests that maintenance costs have been relatively low over time, except in 1996, in which significant costs were incurred. The cumulative maintenance cost shown in figure 8 generally increases over time, reaching a sharp peak value in 1996, which is perhaps due to the routine maintenance action taken to address the increased cracking. After 2000, the costs remained relatively stable, pointing to the efficacy of the rehabilitation undertaken at this time.

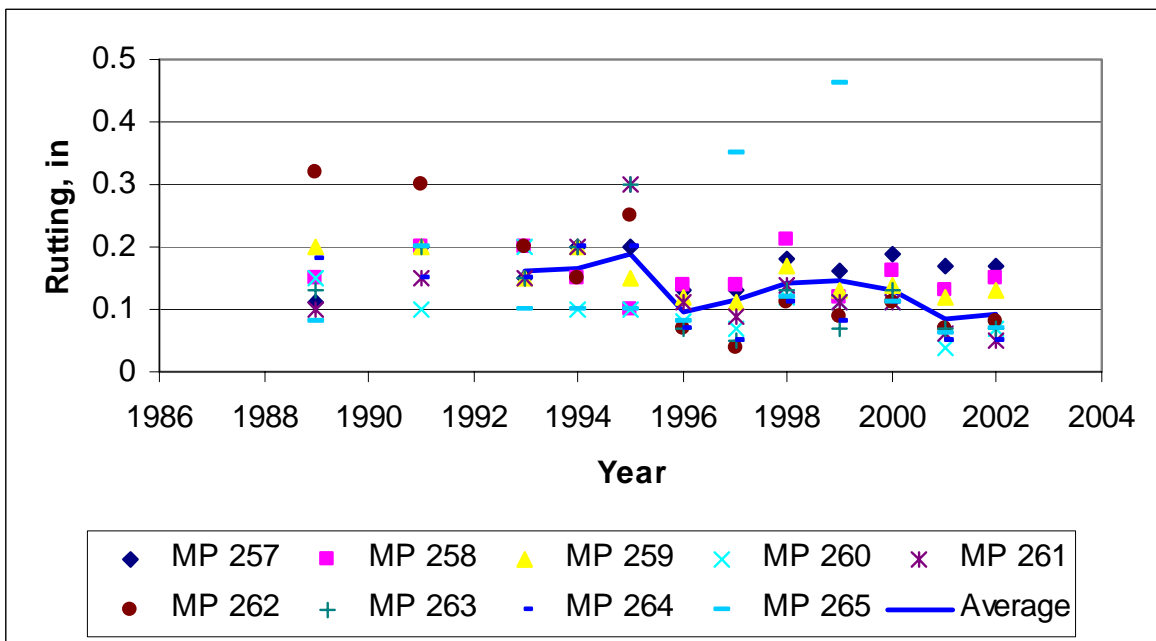
Figure 12. Rutting data for CIR Project 2—US 70 EB (ADOT Project No. BP-22-4-519).

- The rutting values plotted in figure 12 generally decrease with time, with relatively noticeable drops occurring in 1996 and 2000; this confirms that a relatively major rehabilitation action was likely undertaken in 2000.

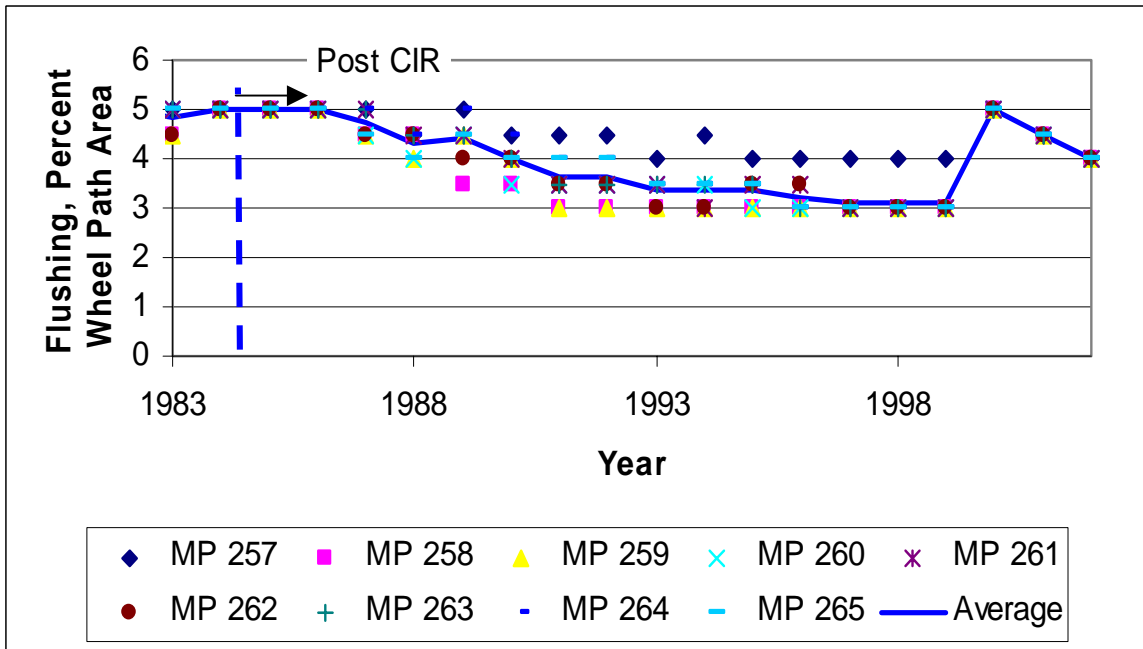
Figure 13. Flushing data for CIR Project 2—US 70 EB (ADOT Project No. BP-22-4-519).

- Figure 13 shows that the flushing quantities increase with time, with a noticeable increase occurring in 2000—the approximate year when a rehabilitation action is assumed to have taken place.

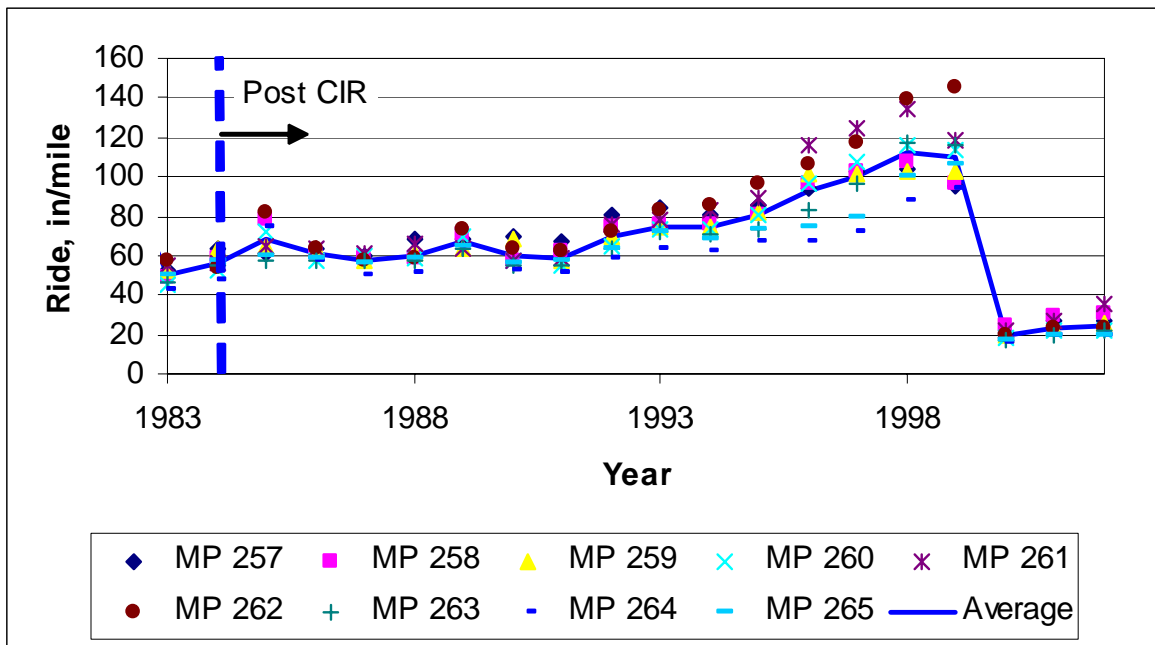
Figure 14. Ride quality information (Mays Ridemeter) for CIR Project 2—US 70 EB (ADOT Project No. BP-22-4-519).

- The ride values shown in figure 14 show a generally increasing trend until the year 2000, with a sharp improvement noticed at this time.
- Figure 15 suggests that, after the CIR work, maintenance costs remained relatively low over time, except in 1987, when significant costs were incurred. Figure 16 suggests that the cumulative maintenance cost generally increased over time, reaching a sharp peak value in 1987, perhaps due to the routine maintenance action taken to address the increasing cracking. Two relatively stable periods—between 1986 and 1994 and between 1999 and 2002—are observed in terms of cumulative maintenance cost. This is perhaps a reflection on the efficacy of the maintenance or rehabilitation work undertaken immediately preceding these time intervals in response to increasing pavement distress.

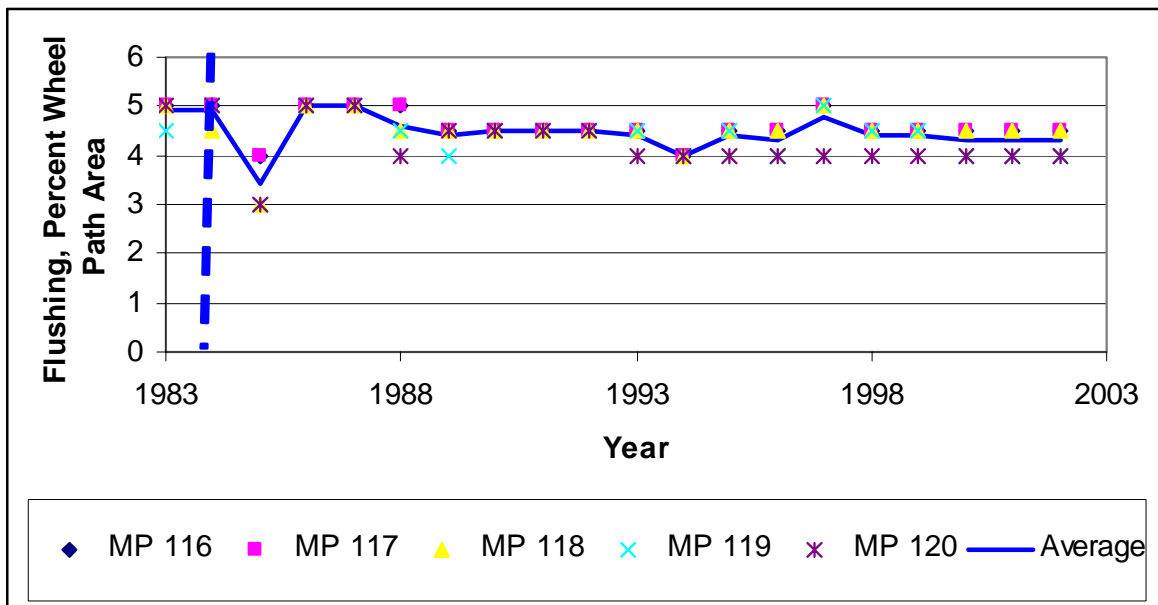
Figure 21. Flushing data for CIR Project 3—SR 87 NB (ADOT Project No. FR-55-1(4)).

- Figure 21 shows that the flushing quantities remain low and stable over time.
- Figure 22 shows that immediately following the CIR work in 1983, the ride quality improved and stayed relatively stable until 2002. In 2002, perhaps due to some rehabilitation action, the ride quality appears to have improved dramatically. The cracking and rutting values also register a “flattening” of slope around this time, supporting this presumption.

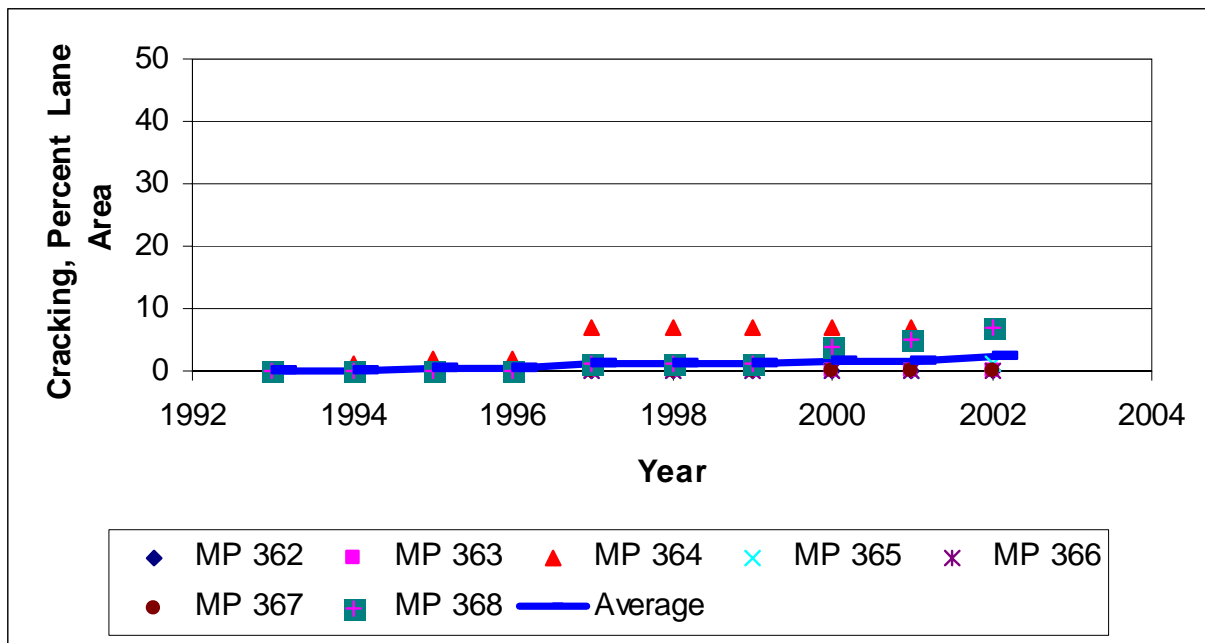
Figure 27. Cracking data for CIR Project 6— SR 87 NB (ADOT Project No. S-244-513).

- Figure 27 clearly shows that that the cracking quantities are close to zero over a majority of the monitoring period. However, they increase slightly towards the end of the reporting period.

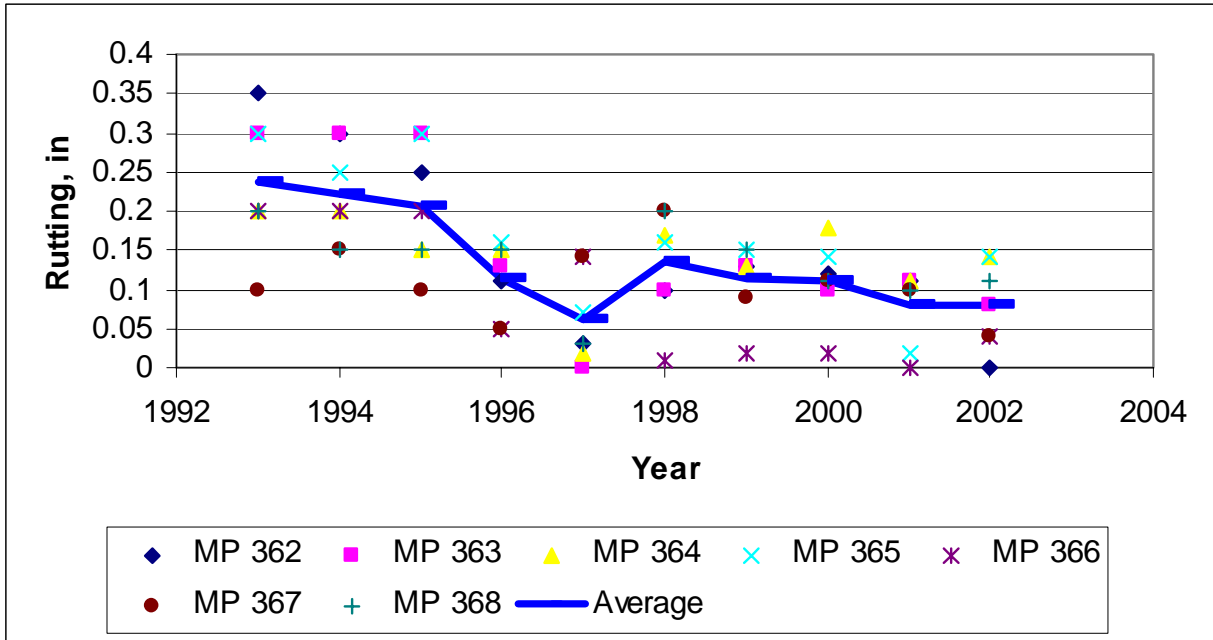
Figure 28. Rutting data for CIR Project 6—SR 87 NB (ADOT Project No. S-244-513).

- Figure 28 shows that rutting generally decreases over time—an unexpected occurrence. There appears to be a sharp fall in the rutting values in 1997 (this observation was also noted on most other projects where pre- and post-1997 data are available). The project history database does not indicate any major maintenance or rehabilitation action around this time that would cause rutting to decrease.

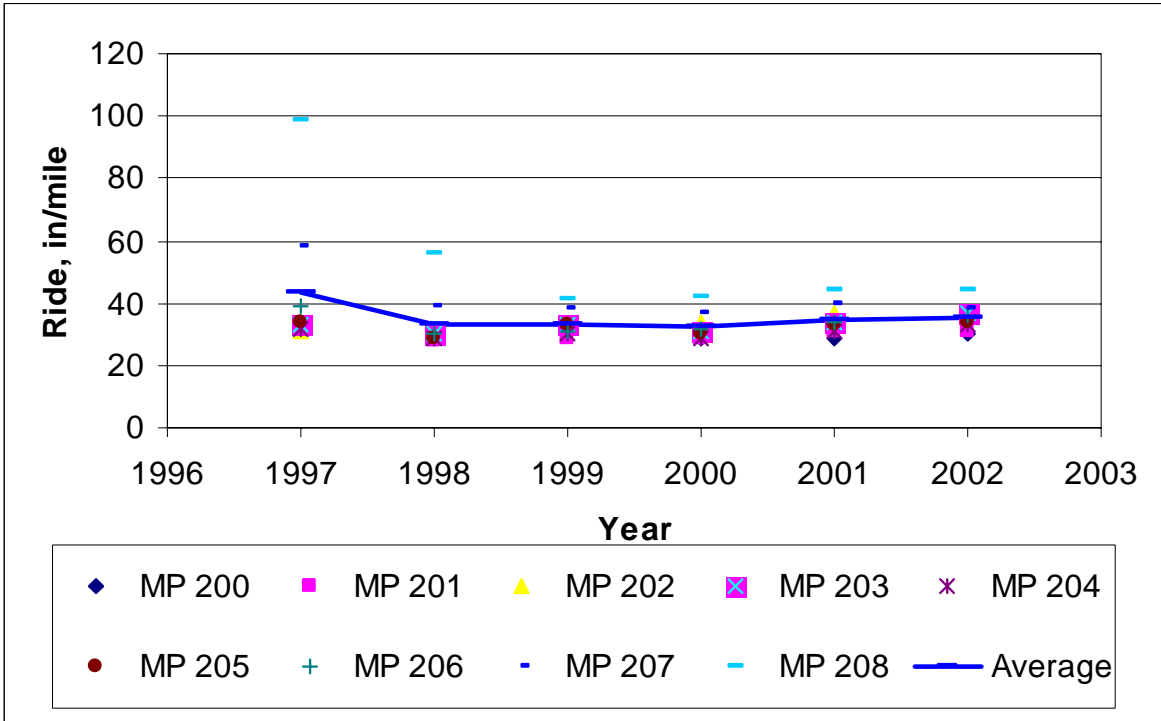
Figure 45. Flushing data for CIR Project 8— US 60 EB (ADOT Project No. STP-022-3(79)P).

- Figure 45 indicates that the flushing quantities remain relatively low and decrease slightly with time.
- Figure 46 shows that the ride values, particularly between MP 208 and 209, remained high in 1997, immediately following the CIR and HMA overlay work in 1996. The reasons for this are unknown. However, on an average basis, the ride quality remained stable over the reporting period and in a relatively satisfactory condition.

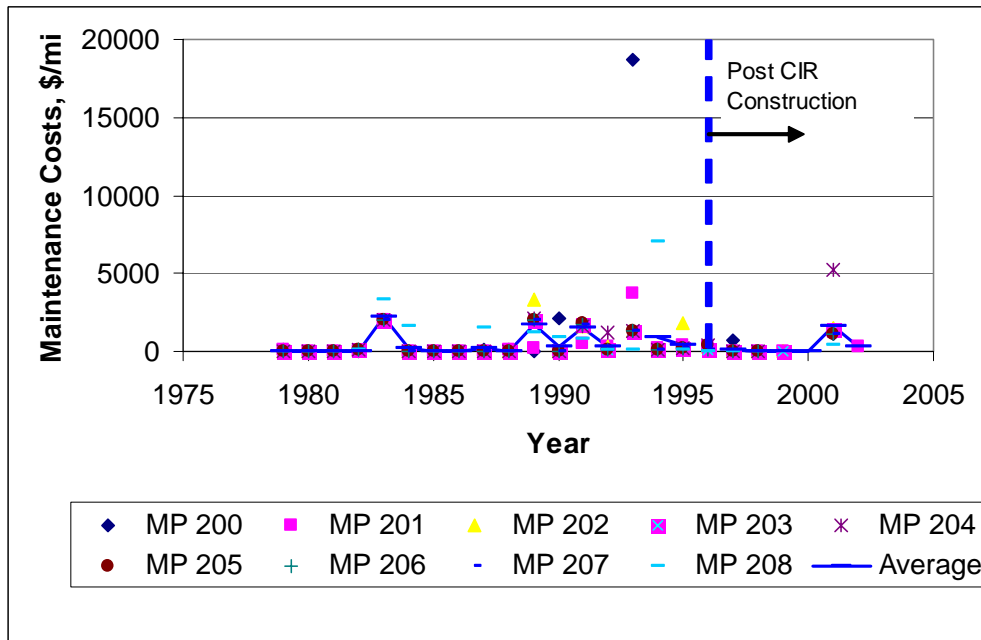
Figure 47. Maintenance costs for CIR Project 8— US 60 EB (ADOT Project No. STP-022-3(79)P).

- Figure 47 suggests that the mile-by-mile maintenance costs after the CIR work have been dramatically lower compared to the earlier years.
- The cumulative maintenance costs, shown in figure 48, rise steadily leading up to the time the CIR work was performed in conjunction with the HMA overlay and level off considerably after that. The effect is marked when considering the sections between MP 200 and 201 and MP 208 and 209.

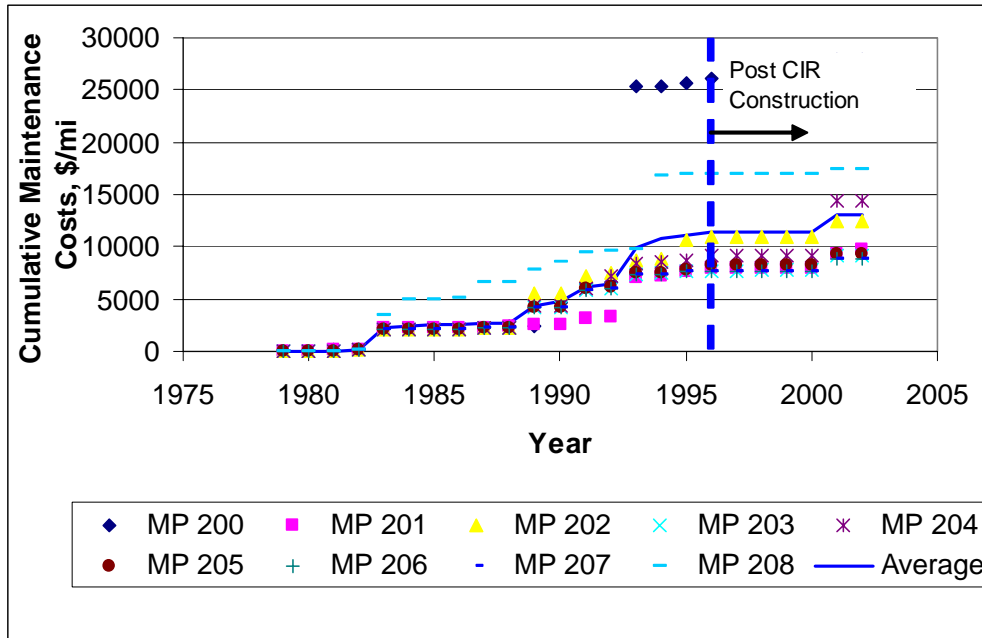
Figure 48. Cumulative maintenance costs for CIR Project 8— US 60 EB (ADOT Project No. STP-022-3(79)P).

- An interesting comparison in figure 48 is the rate of cumulative cost accumulation, on both an average basis and mile-by-mile basis, before and after the CIR plus HMA overlay construction. The figure clearly demonstrates the value of the rehabilitation work in minimizing routine maintenance costs.

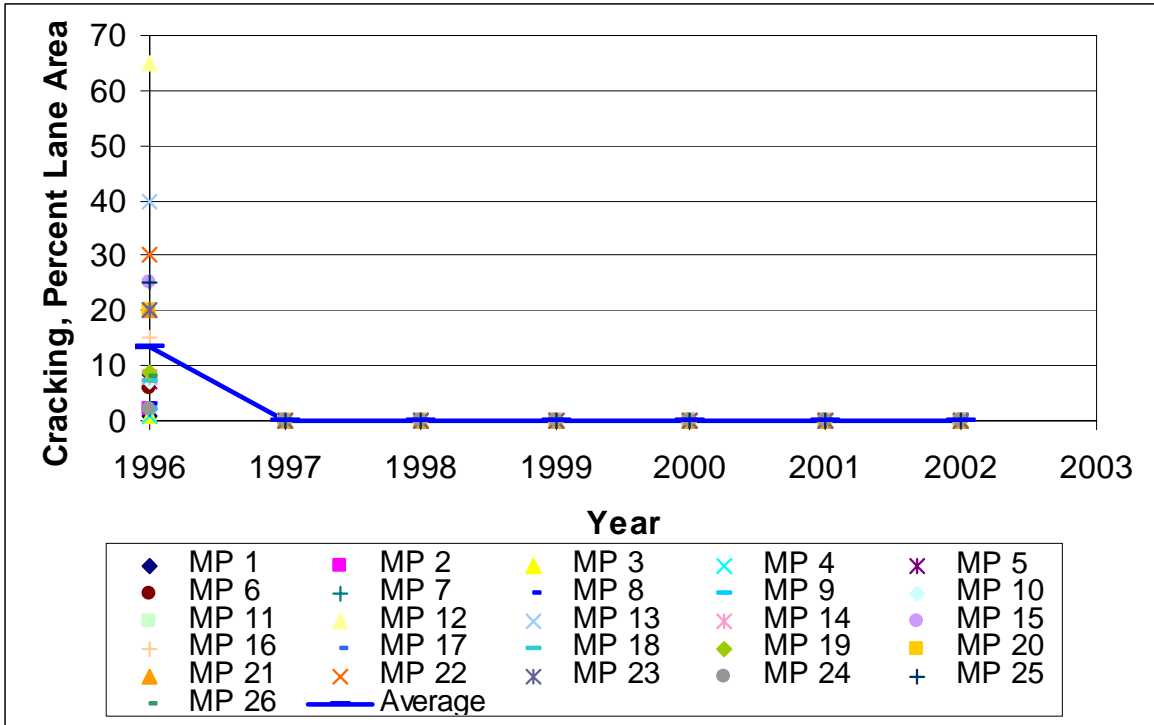
Figure 51. Cracking data for CIR Project 9—SR 389 NB (ADOT Project No. STP-213-(5)P).

- Figure 51 shows that the cracking quantities are close to zero over the entire reporting period after the placement of the conventional overlay in 1997.

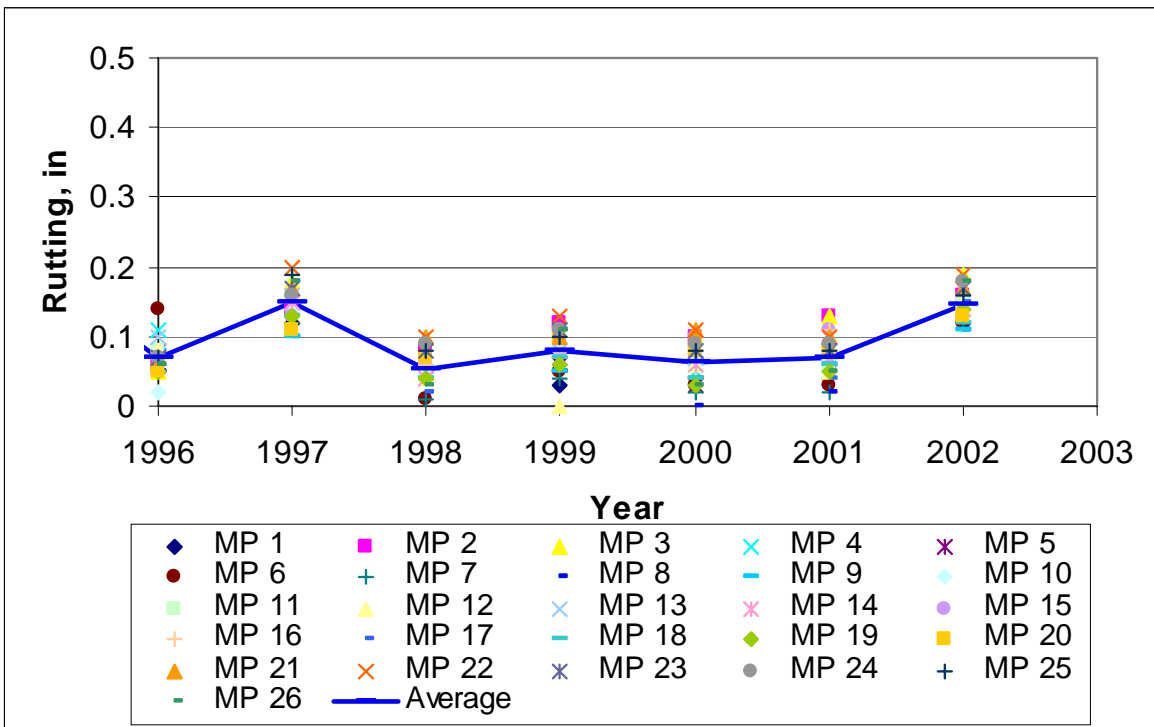
Figure 52. Rutting data for CIR Project 9—SR 389 NB (ADOT Project No. STP-213-(5)P).

- Figure 52 shows that rutting is generally low and stable over the reporting period, with a slight increasing trend towards the end.
- Figure 53 shows that flushing quantities remain relatively low over time.

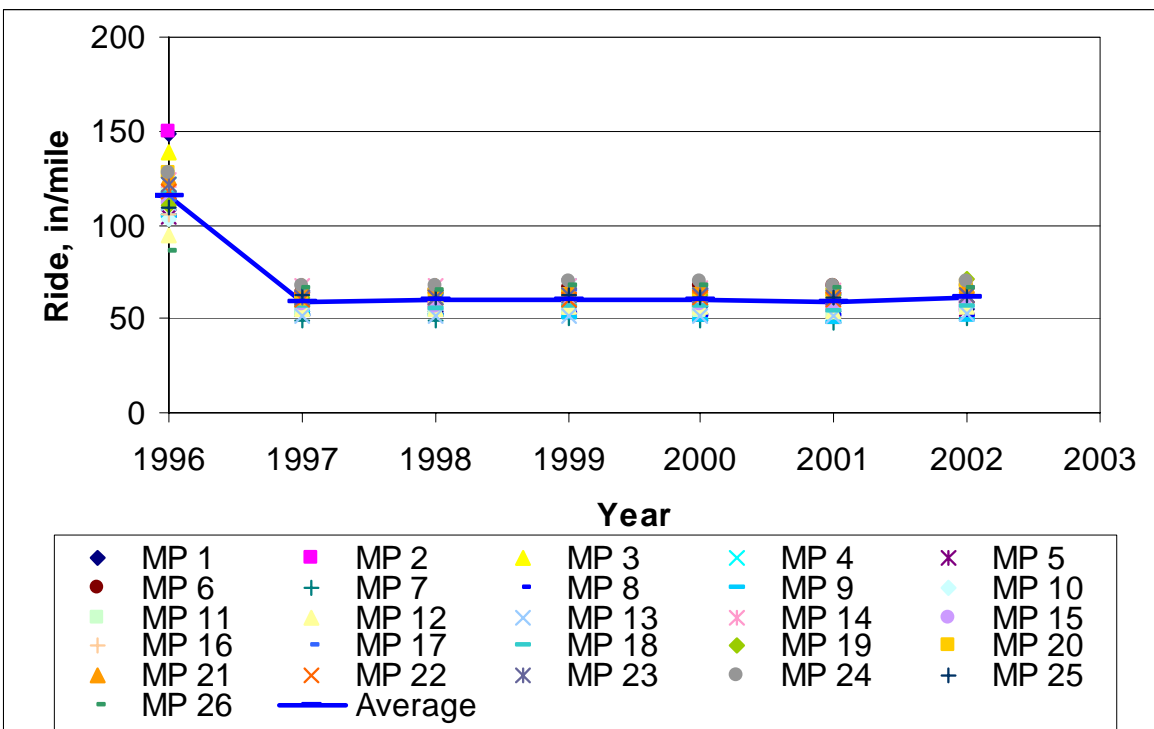
Figure 54. Ride quality information (Mays Ridemeter) for CIR Project 9—SR 389 NB (ADOT Project No. STP-213-(5)P).

- Figure 54 shows that, immediately following the CIR work in 1996, the ride quality was still relatively poor; however, based on the information contained in the pavement management system database, it is unknown if the 1996 condition data were collected before or after the CIR work was completed. There was a marked improvement in ride values after the conventional overlay was placed in 1997.

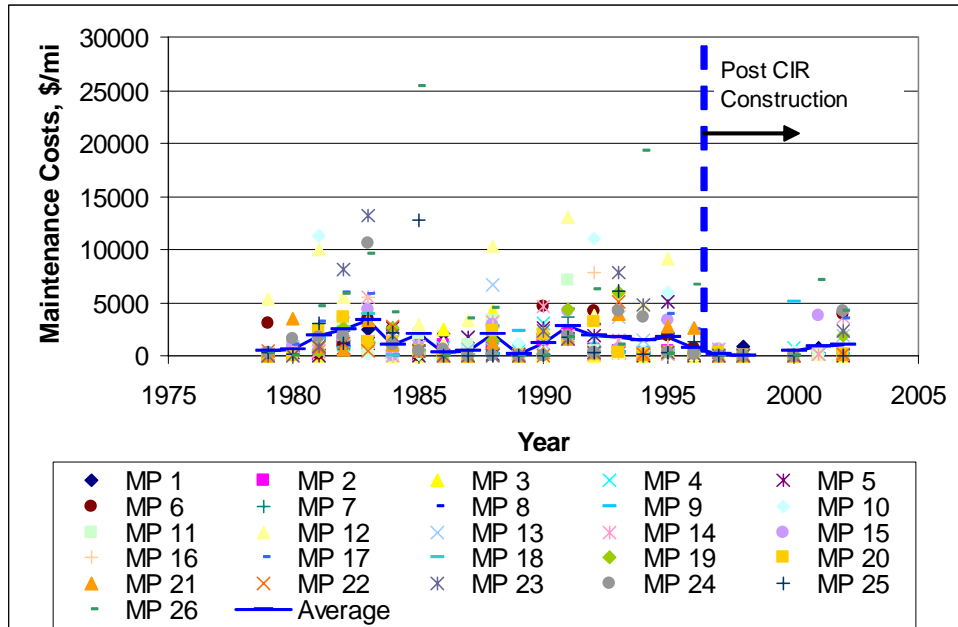
Figure 55. Maintenance costs for CIR Project 9—SR 389 NB (ADOT Project No. STP-213-(5)P).

- Figure 55 suggests that the mile-by-mile maintenance costs after the CIR work remain very low—close to negligible—until towards the end of the reporting period, where they increase slightly. Likewise, the cumulative maintenance costs, shown in figure 56, level off after the CIR work and increase slightly at the end of the reporting period. An interesting comparison in figure 56 is the rate cumulative cost accumulation pre- and post-CIR. The figure clearly demonstrates the value of CIR in conjunction with conventional overlay as a viable rehabilitation strategy.

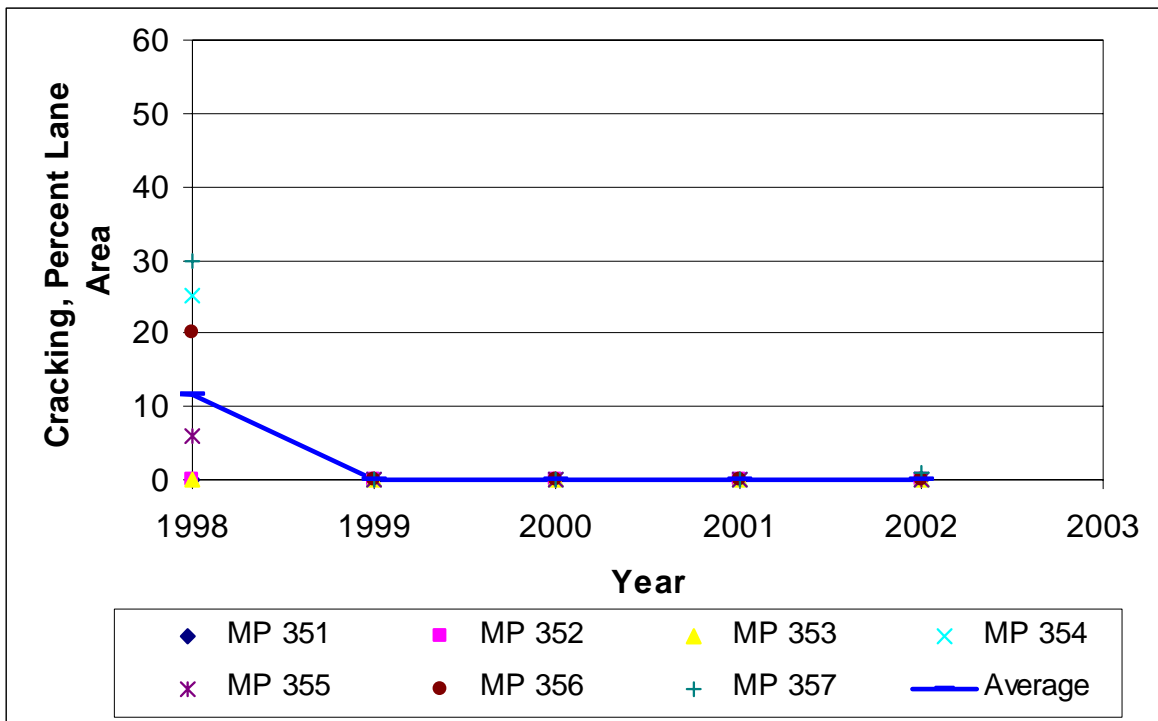
Figure 59. Cracking data for CIR Project 10—SR 73 NB (ADOT Project No. STP-215-(4)P).

- Figure 59 shows that the cracking quantities are close to zero over the entire reporting period after the placement of the conventional overlay in 1999.

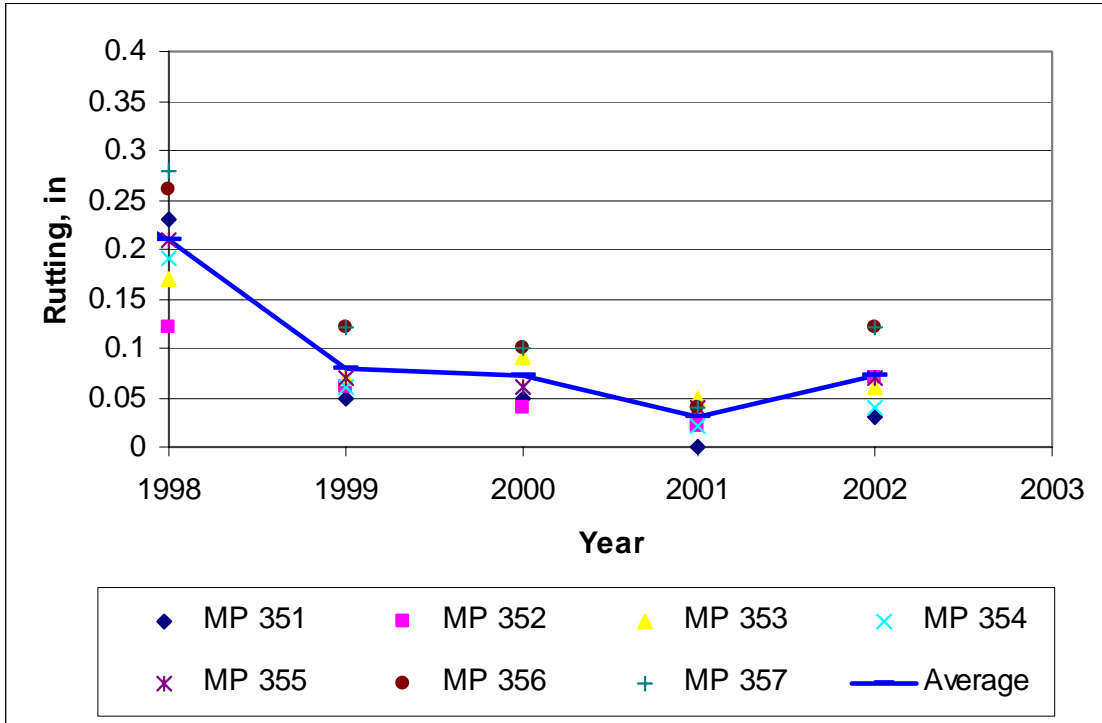
Figure 60. Rutting data for CIR Project 10—SR 73 NB (ADOT Project No. STP-215-(4)P).

- Figure 60 shows that rutting is generally low over the reporting period, with a slight decreasing trend. The latter finding is unexpected.
- Figure 61 shows that the flushing quantities remain relatively low and stable over time.

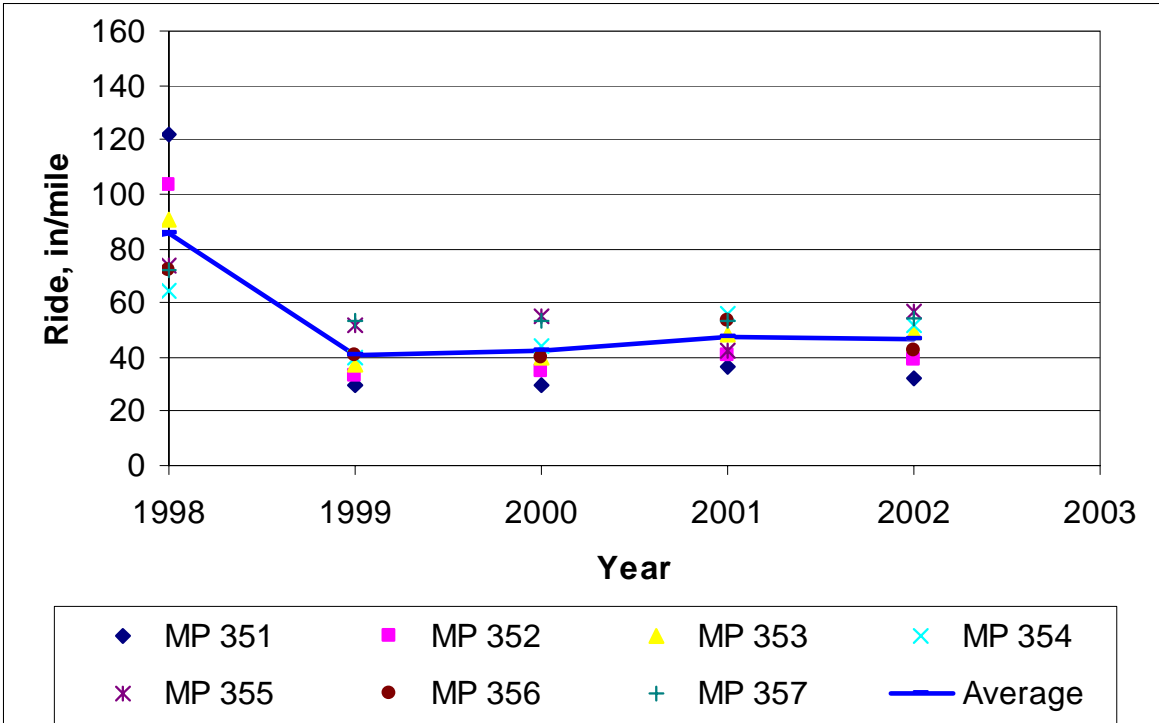
Figure 62. Ride quality information (Mays Ridemeter) for CIR Project 10—SR 73 NB (ADOT Project No. STP-215-(4)P).

- Figure 62 shows that, immediately following the CIR work in 1998, the ride quality was still relatively poor; however, it is unknown if the 1998 condition data were collected before or after the CIR work was completed). There was a marked improvement in ride values after the conventional overlay was placed in 1999.

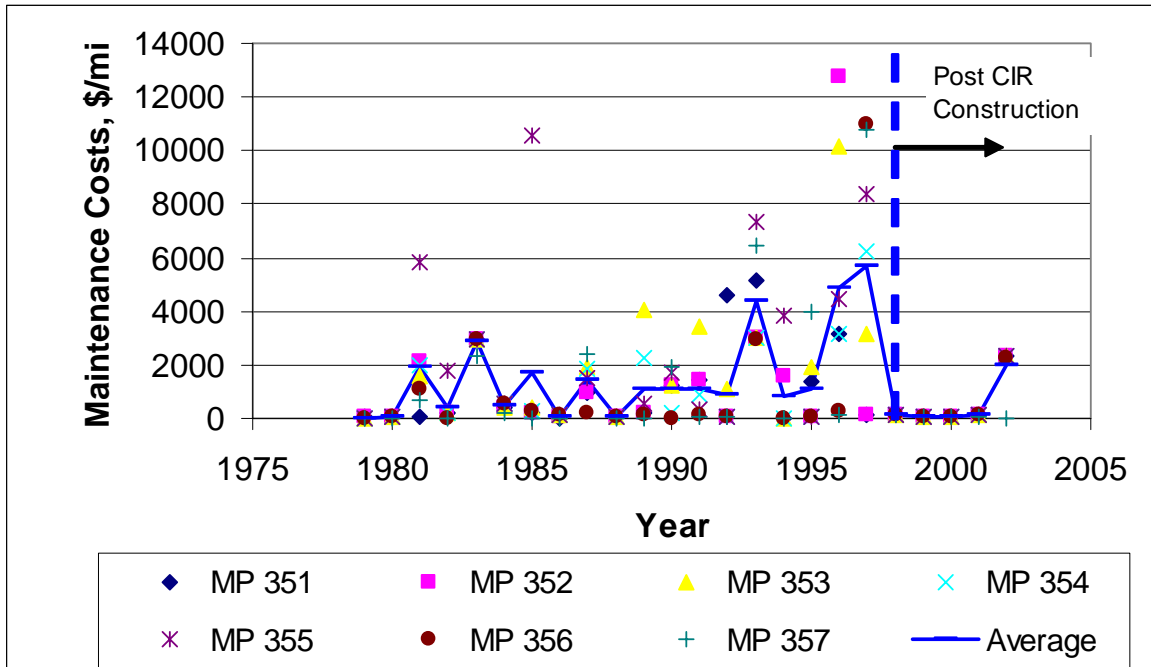
Figure 63. Maintenance costs for CIR Project 10—SR 73 NB (ADOT Project No. STP-215-(4)P).

- Figure 63 suggests that the mile-by-mile maintenance costs after the CIR work remain very low—close to negligible—until towards the end of the reporting period, where they increase slightly. Likewise, the cumulative maintenance costs, shown in figure 56, level off after the CIR work only to increase slightly at the end of the reporting period.

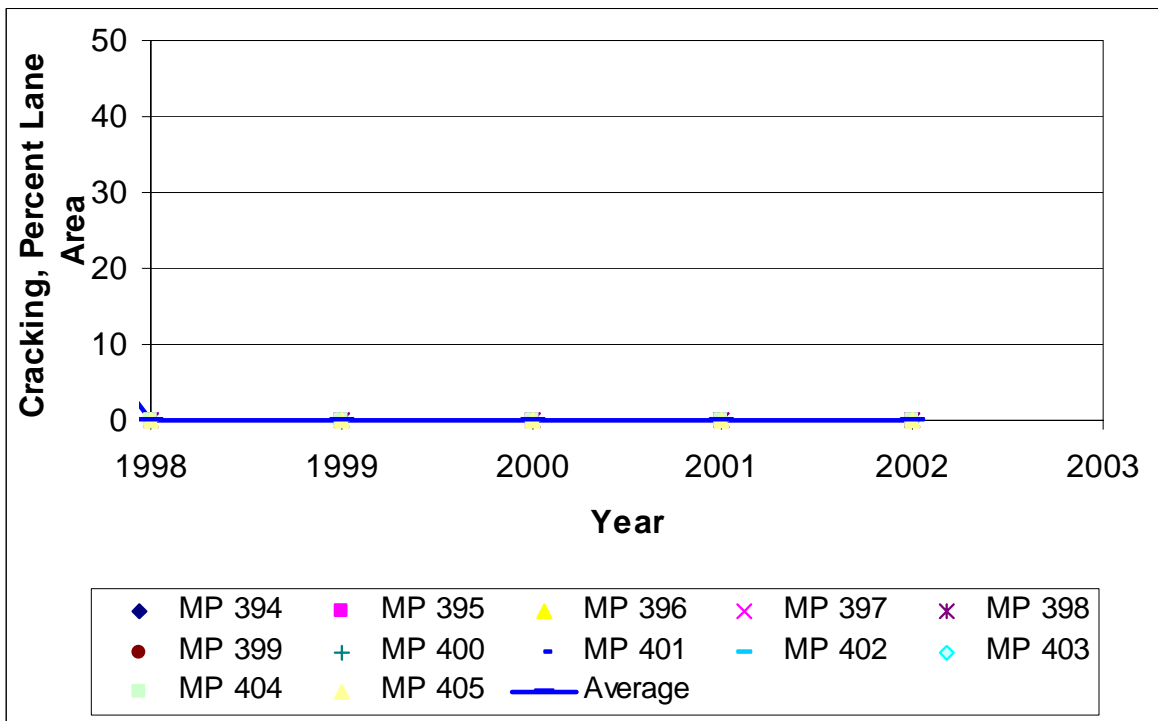
Figure 67. Cracking data for CIR Project 11—SR 87 NB (ADOT Project No. STP-244-(4)P).

- Figure 67 shows that no cracking, of any kind, was observed over the entire reporting period.
- Figure 68 shows that rutting is generally low. Further rutting values decrease slightly over time—an unexpected trend.

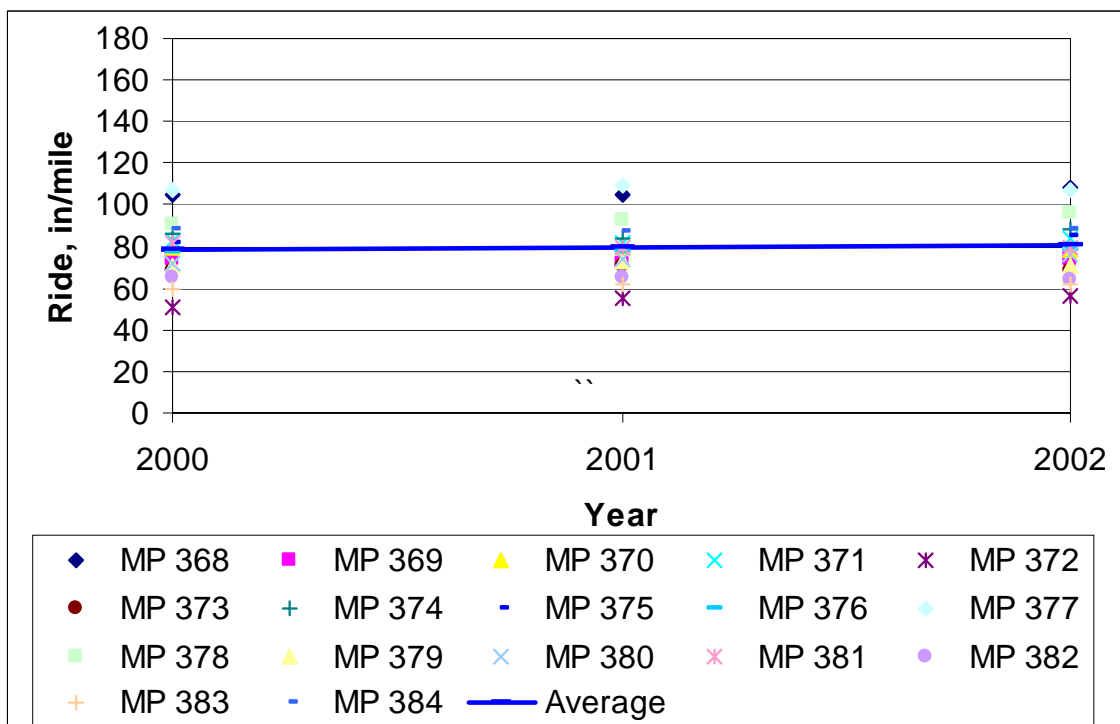
Figure 84. Ride quality information (Mays Ridemeter) for CIR Project 13—SR 87 (ADOT Project No. STP-244-(6)P).

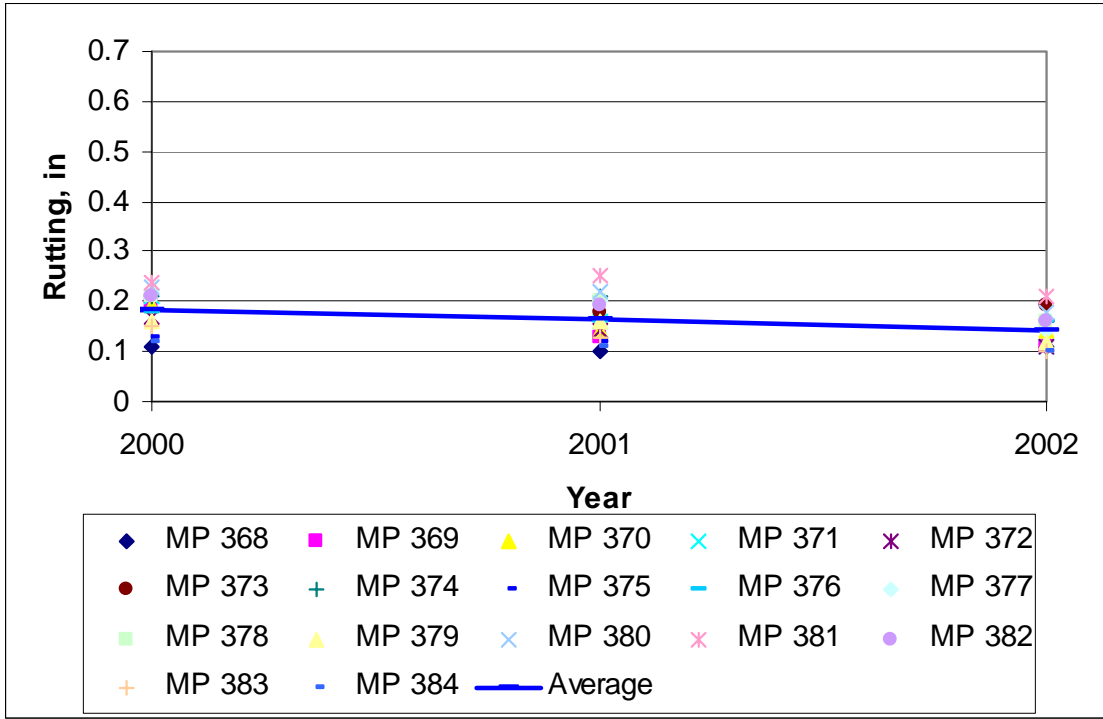
Figure 85. Rutting data for CIR Project 13—SR 87 (ADOT Project No. STP-244-(6)P).

- Figures 83, 85, and 86 show no significant increases in distress, and the amount of distress present is negligible. In fact, the amount of rutting and flushing actually decreases with time. Also, there are no potholes or maintenance/rehabilitation activities that would result in patching being present.
- Figure 84 shows no significant change in ride quality since the CIR construction project.
- Figure 87 shows a considerable drop in maintenance cost after CIR. Figures 83 through 86 also show that the distress data are low to non-existent and the ride is smooth, and have not required any maintenance.

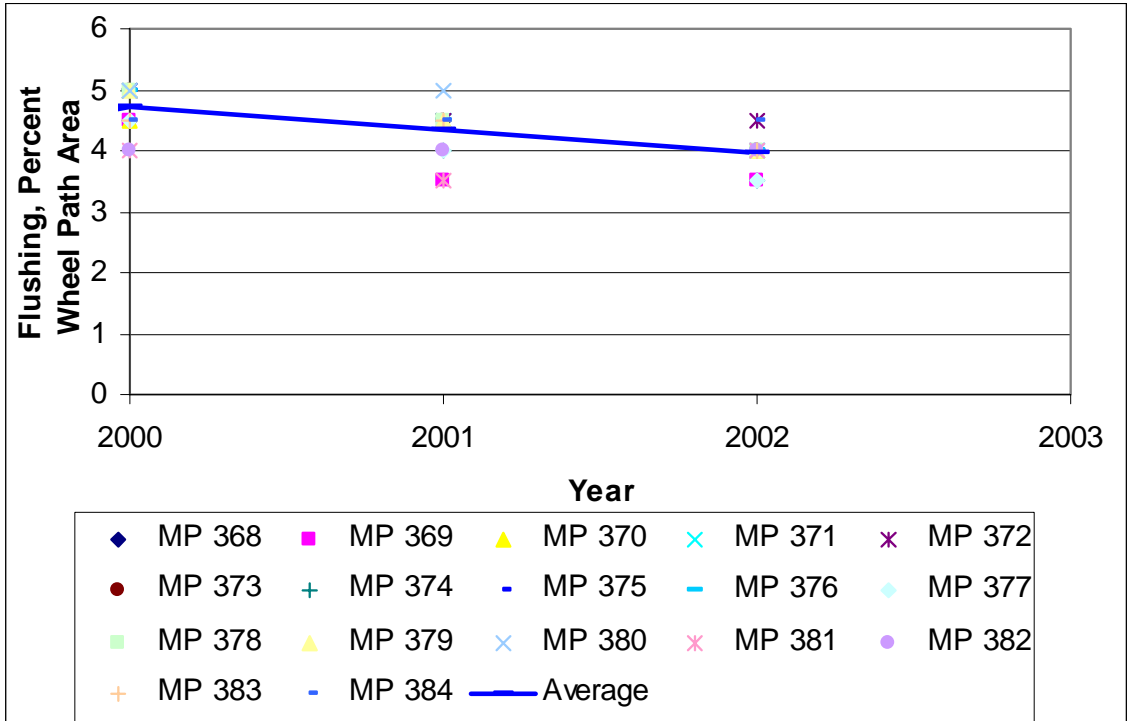
Figure 86. Flushing data for CIR Project 13—SR 87 (ADOT Project No. STP-244-(6)P).

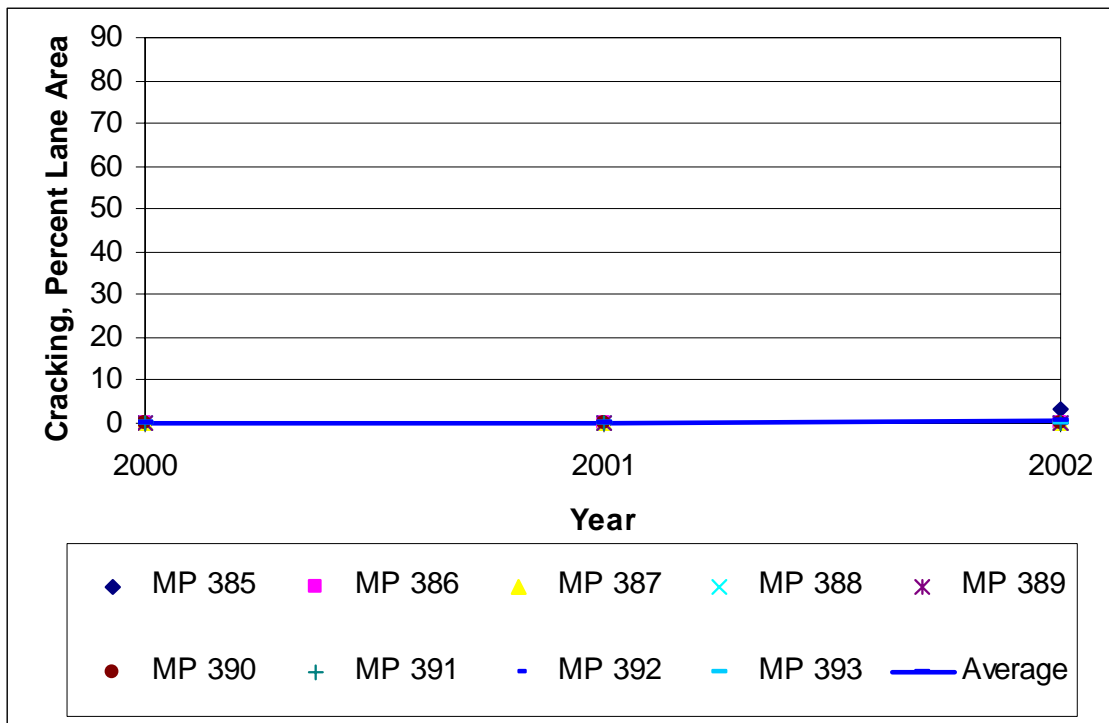
Figure 91. Cracking data for CIR Project 14—SR 87 (ADOT Project No. STP-244-(5)P).

- Figures 91, 93, and 94 show no significant changes in distress, and the amount of distress present is negligible. Also, there are no potholes or maintenance/rehabilitation activities that would result in patching being present.
- Figure 92 shows no significant change in ride quality after CIR.
- Figure 95 suggests a very significant drop in maintenance cost after CIR. This is in agreement with the distress, ride, and maintenance information presented in figures 91 through 94. The cumulative maintenance costs shown in figure 96 generally increase over time, reaching a sharp peak value in 1999, which is perhaps due to the routine maintenance action taken to address pavement deterioration prior to CIR. The post-CIR increases in maintenance cost are not significant.
