PERFORMANCE EVALUATION OF COLD IN-PLACE RECYCLING PROJECTS IN ARIZONA

Final Report 460

March 2006

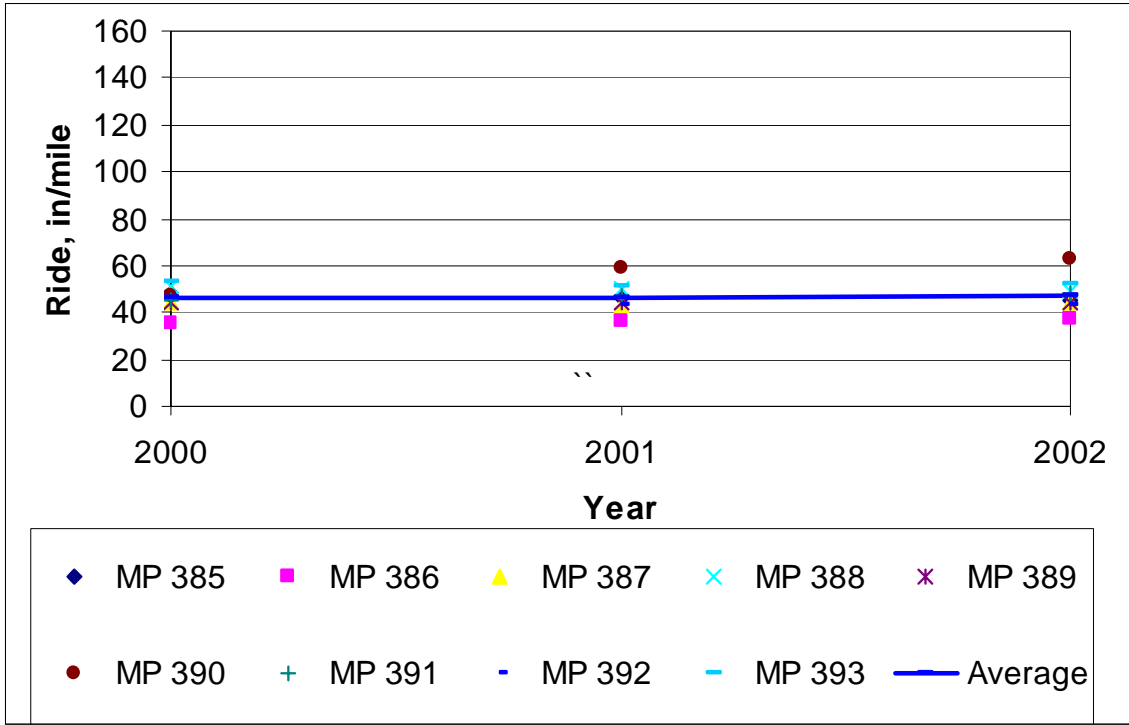
Figure 92. Ride quality information (Mays Ridemeter) for CIR Project 14—SR 87 (ADOT Project No. STP-244-(5)P).

- Figures 91, 93, and 94 show no significant changes in distress, and the amount of distress present is negligible. Also, there are no potholes or maintenance/rehabilitation activities that would result in patching being present.
- Figure 92 shows no significant change in ride quality after CIR.
- Figure 95 suggests a very significant drop in maintenance cost after CIR. This is in agreement with the distress, ride, and maintenance information presented in figures 91 through 94. The cumulative maintenance costs shown in figure 96 generally increase over time, reaching a sharp peak value in 1999, which is perhaps due to the routine maintenance action taken to address pavement deterioration prior to CIR. The post-CIR increases in maintenance cost are not significant.

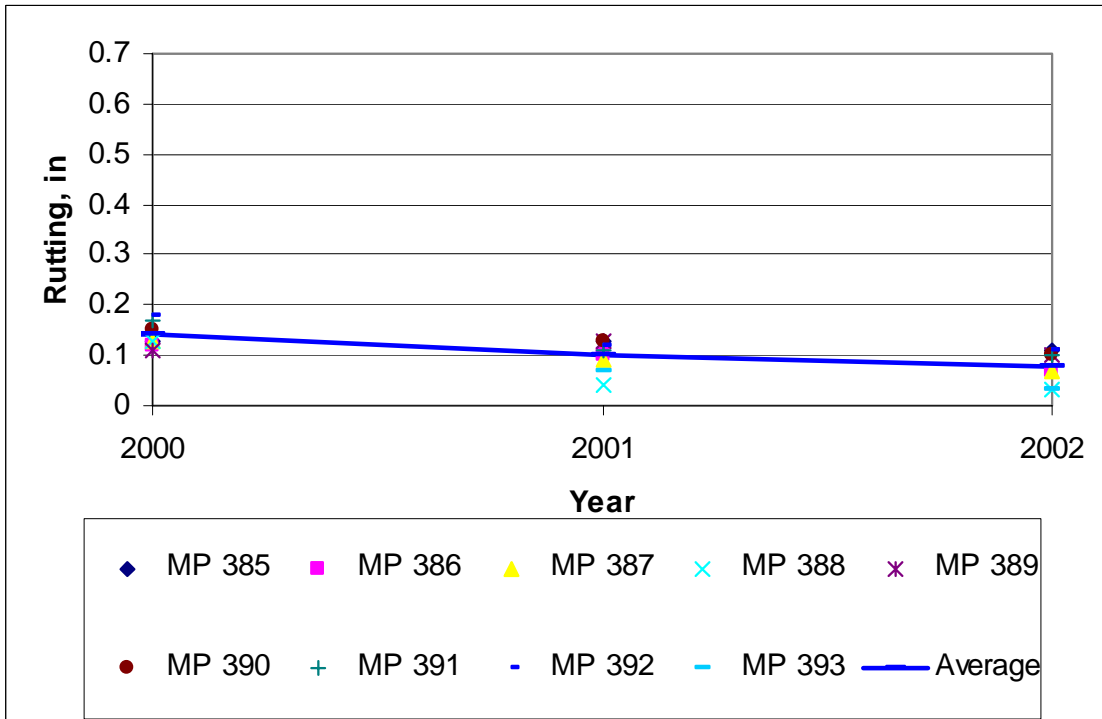
Figure 93. Rutting data for CIR Project 14—SR 87 (ADOT Project No. STP-244-(5)P).

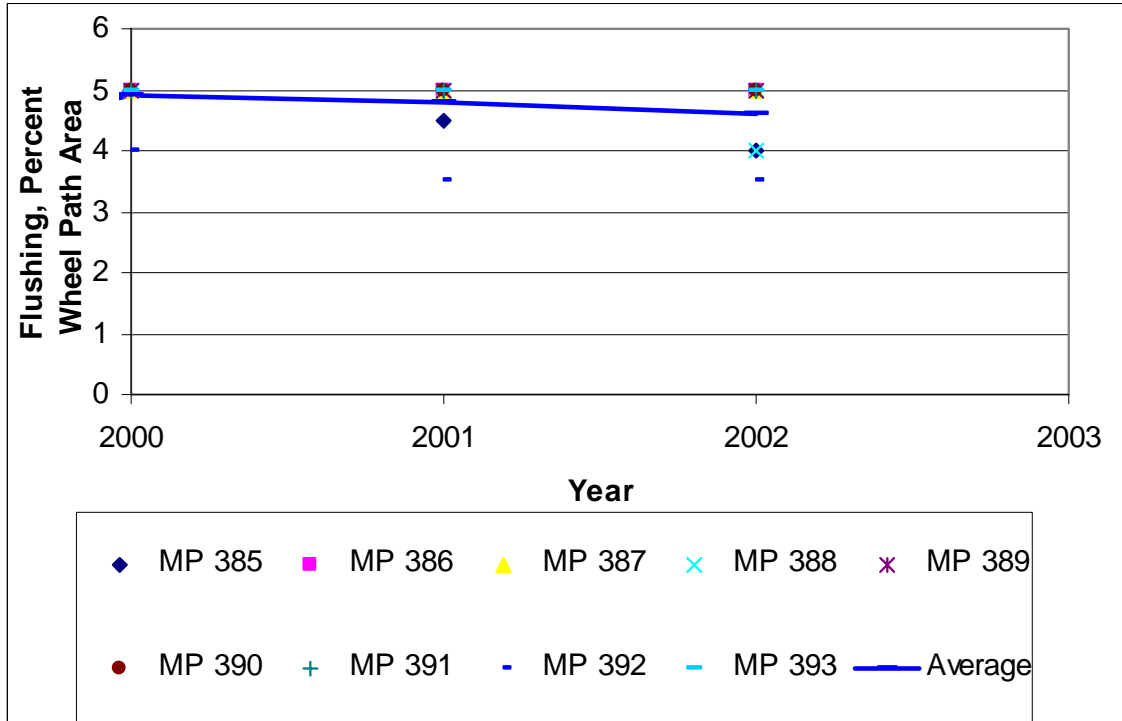
Figure 94. Flushing data for CIR Project 14—SR 87 (ADOT Project No. STP-244-(5)P).

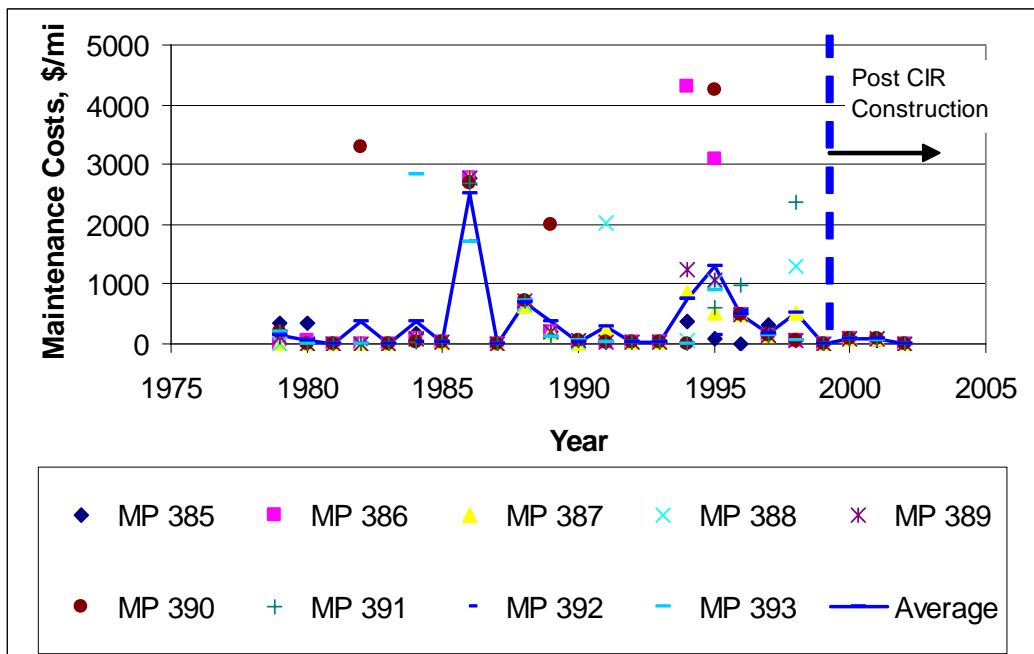
Figure 95. Maintenance costs for CIR Project 14—SR 87 (ADOT Project No. STP-244-(5)P).

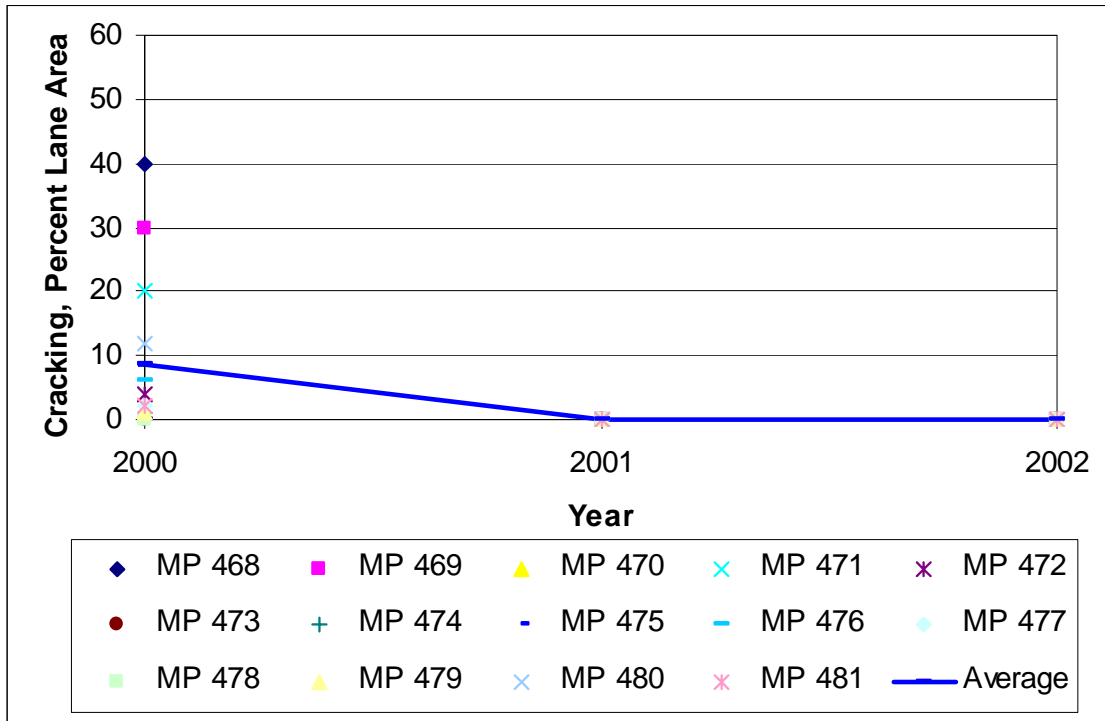
Figure 99. Cracking data for CIR Project 15—US 191 (ADOT Project No. STP-077-1(10)P).

- Figures 99, 101, and 102 show no significant increases in distress, and the amount of distress present is negligible. In fact, the amounts of cracking and rutting actually decrease with time. Also, there are no potholes or maintenance/rehabilitation activities that would result in patching being present.
- Figure 100 shows no significant change in ride quality after CIR.
- Figure 103 suggests a very significant drop in maintenance cost after CIR. This is in agreement with the distress, ride, and maintenance information presented in figures 99 through 102. The cumulative maintenance cost shown in figure 104 generally increases over time, reaching a sharp peak value in 1999, which is perhaps due to the routine maintenance action taken to address pavement deterioration prior to CIR. The post-CIR increases in maintenance cost are not significant.

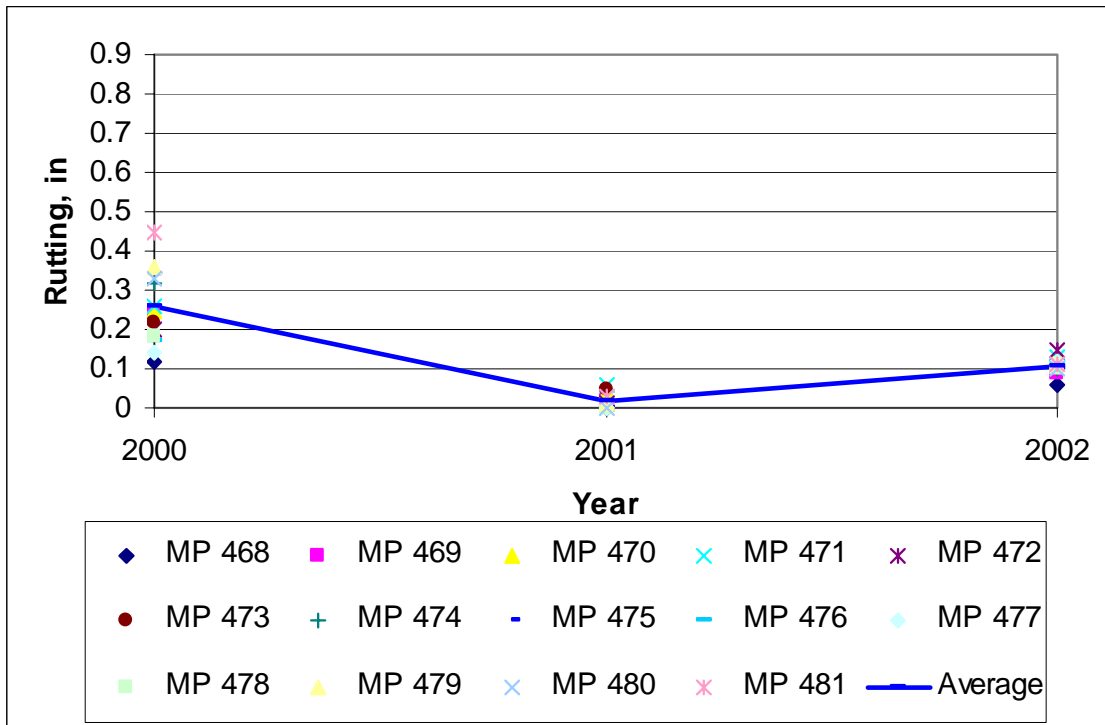
Figure 101. Rutting data for CIR Project 15—US 191 (ADOT Project No. STP-077-1(10)P).

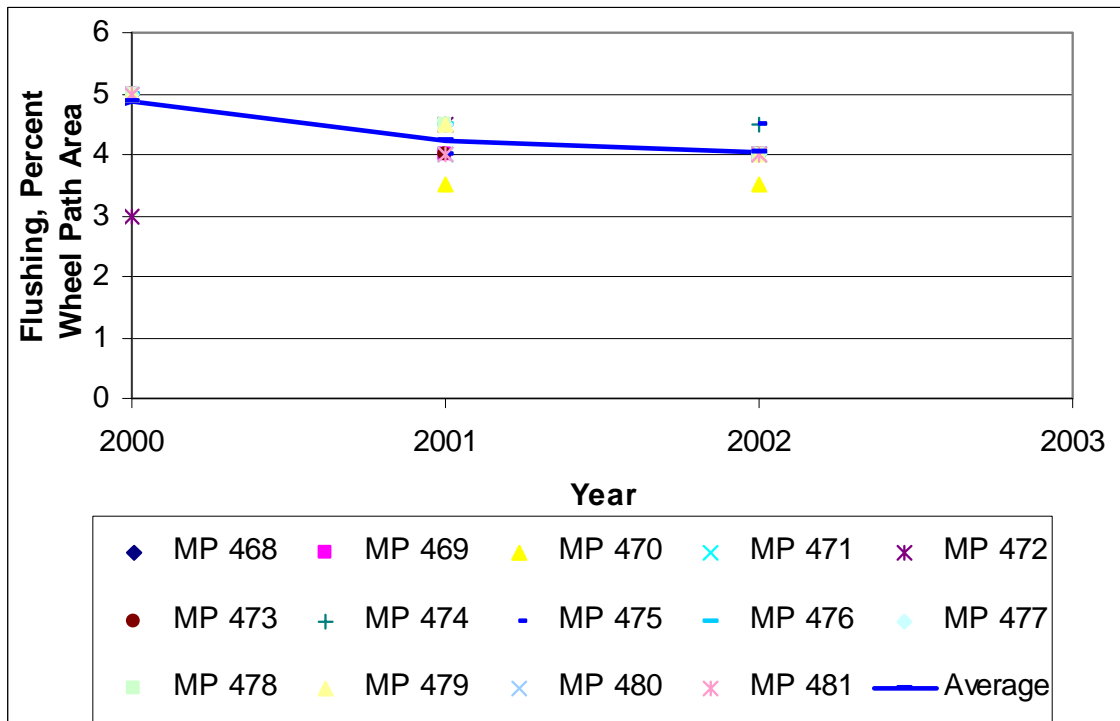
Figure 102. Flushing data for CIR Project 15—US 191 (ADOT Project No. STP-077-1(10)P).

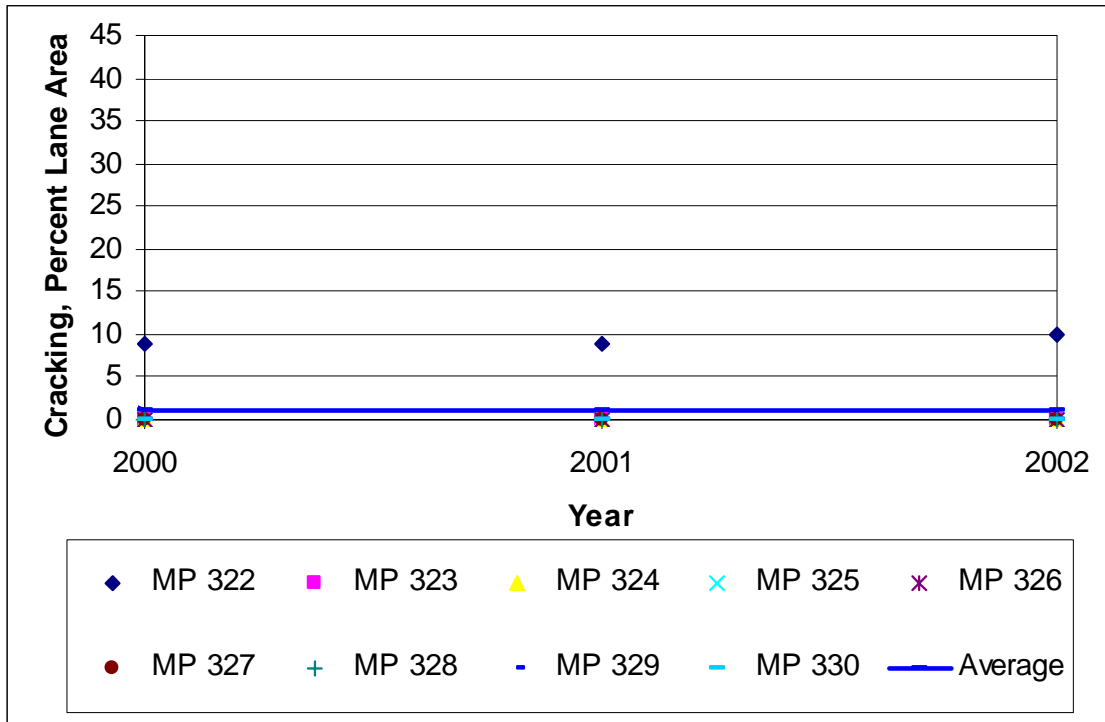
Figure 107. Cracking data for CIR Project 16—US 160 (ADOT Project No. STP-064-1(P)).

- Figures 107, 109, and 110 show that while cracking was non-existent over the entire reporting period, both rutting and flushing did show a significant decrease in 2001 when compared to the respective quantities in the year 2000. It is possible that the performance data in 2000 were collected prior to the CIR work (could not conclusively prove it from the data); hence, the performance data from this year should not be used in evaluating the effectiveness of the CIR. The data from 2001 and 2002 show that, as expected, CIR was effective in eliminating the rutting and flushing distress.

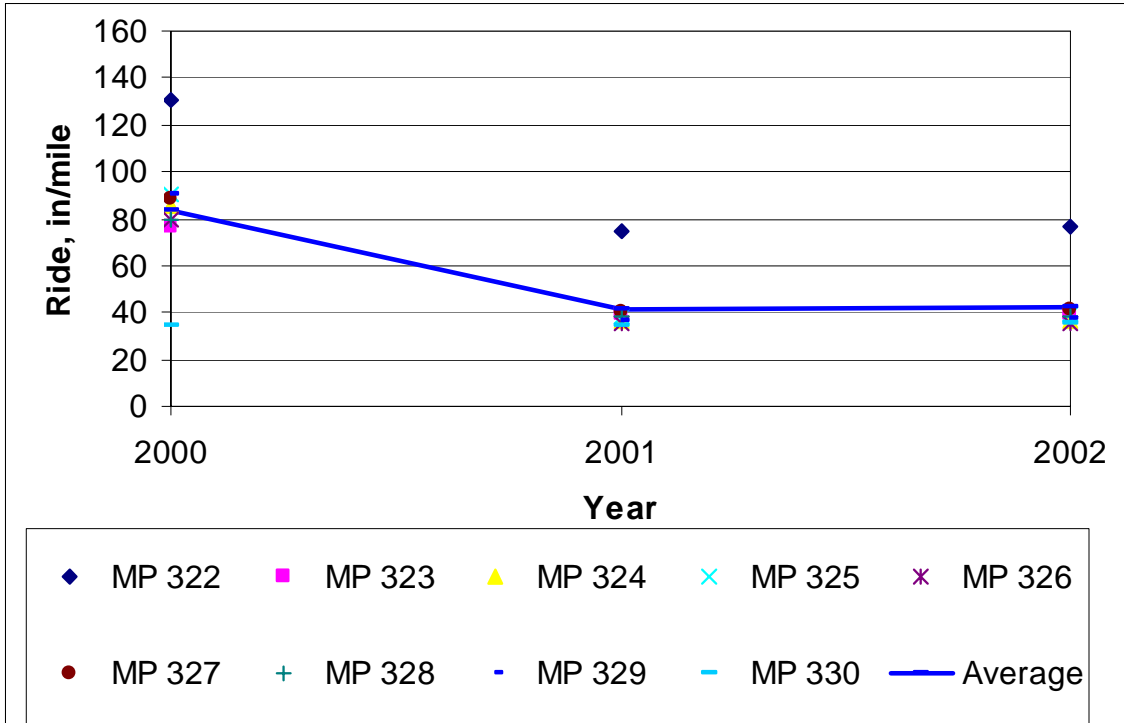
Figure 108. Ride information (Mays Ridemeter) for CIR Project 16—US 160 (ADOT Project No. STP-064-1(P)).

- Figure 108 shows that the ride quality significantly improved after the CIR work, as expected, and did not change significantly in the 2 years after the work was completed (i.e., if data from only 2001 and 2002 are used for evaluation purposes).

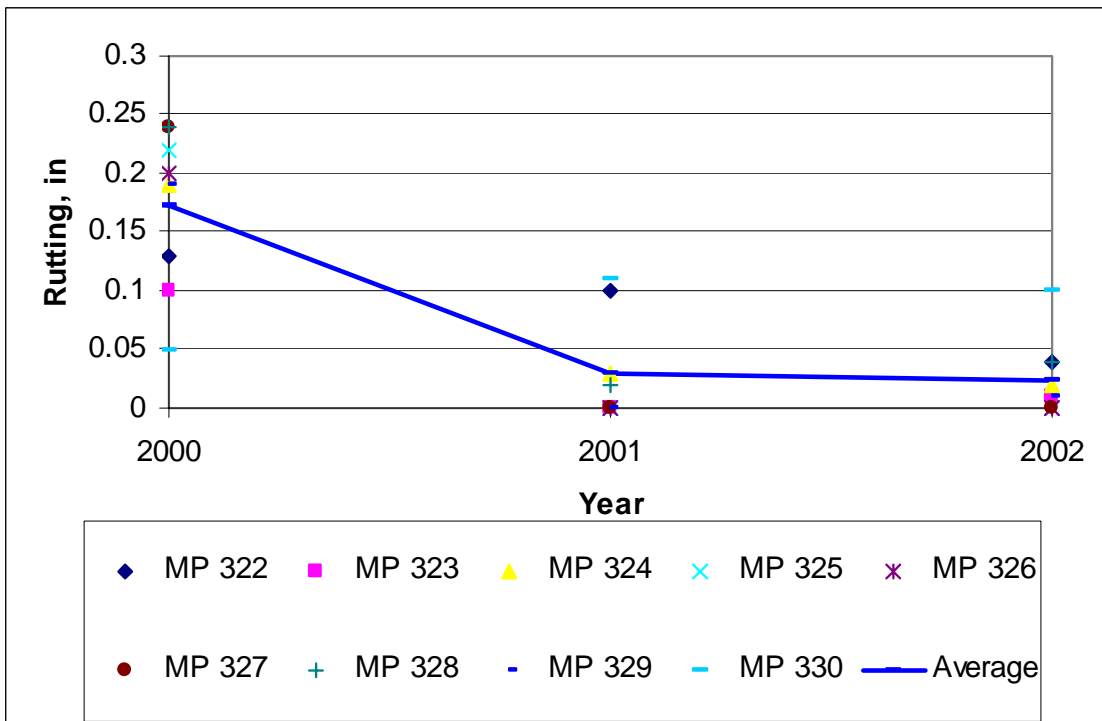
Figure 109. Rutting data for CIR Project 16—US 160 (ADOT Project No. STP-064-1(P)).

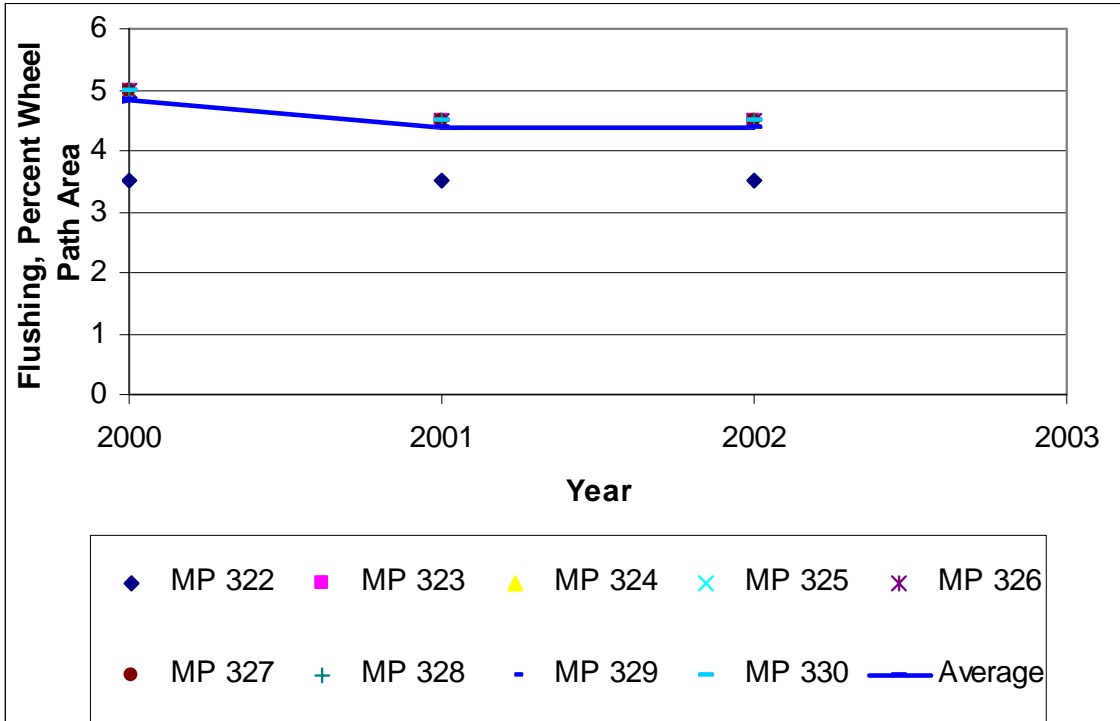
Figure 110. Flushing data for CIR Project 16—US 160 (ADOT Project No. STP-064-1(P)).

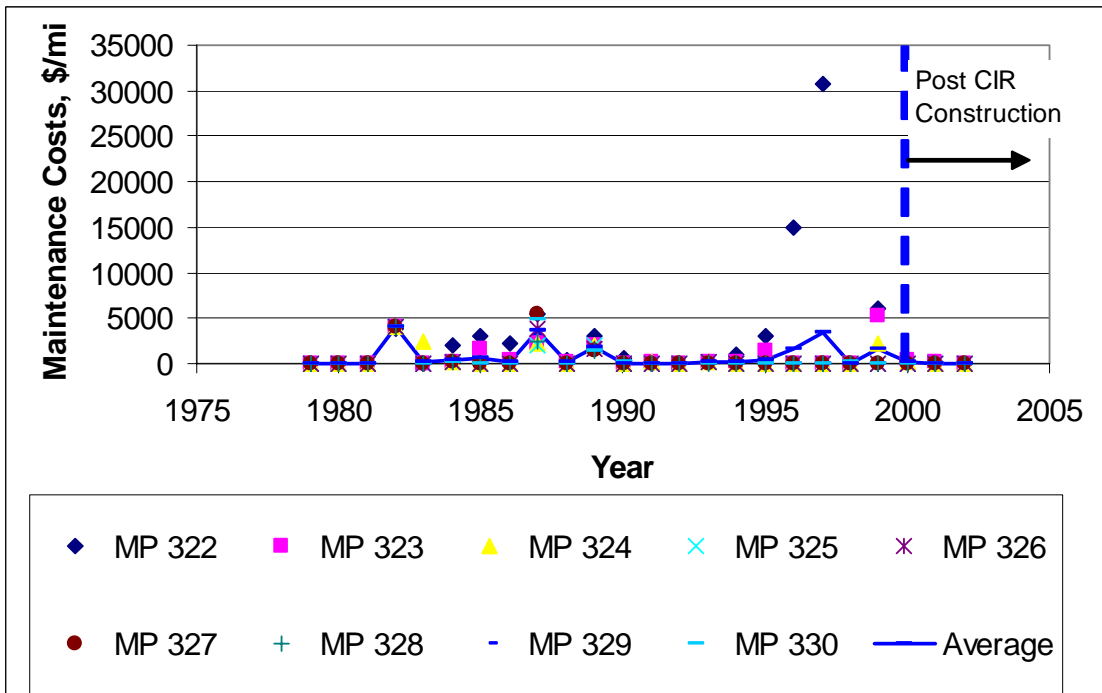
Figure 111. Maintenance costs for CIR Project 16—US 160 (ADOT Project No. STP-064-1(P)).

- Figure 111 suggests a very significant drop in maintenance cost after CIR. This is in agreement with the distress, ride, and maintenance information presented in figures 107 through 110. The cumulative maintenance costs shown in figure 112 generally increase over time, reaching a sharp peak value in 1999, which is perhaps due to the routine maintenance action taken to address pavement deterioration prior to CIR. The post-CIR increases in maintenance cost are not significant.

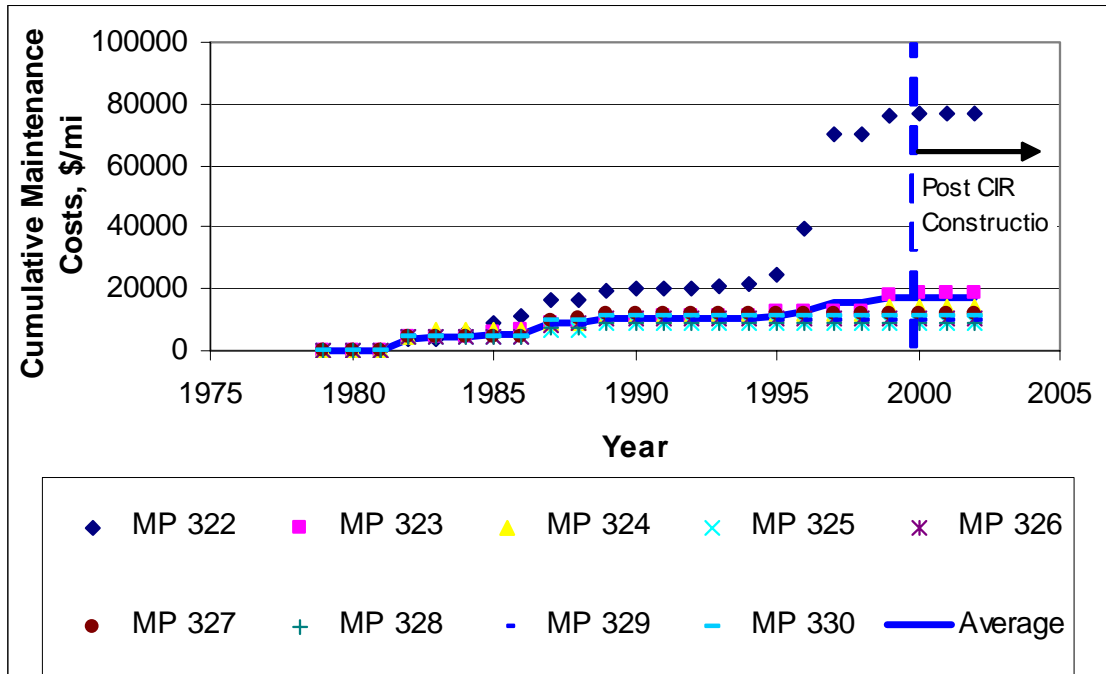
Figure 112. Cumulative maintenance costs for CIR Project 16—US 160 (ADOT Project No. STP-064-1(P)).

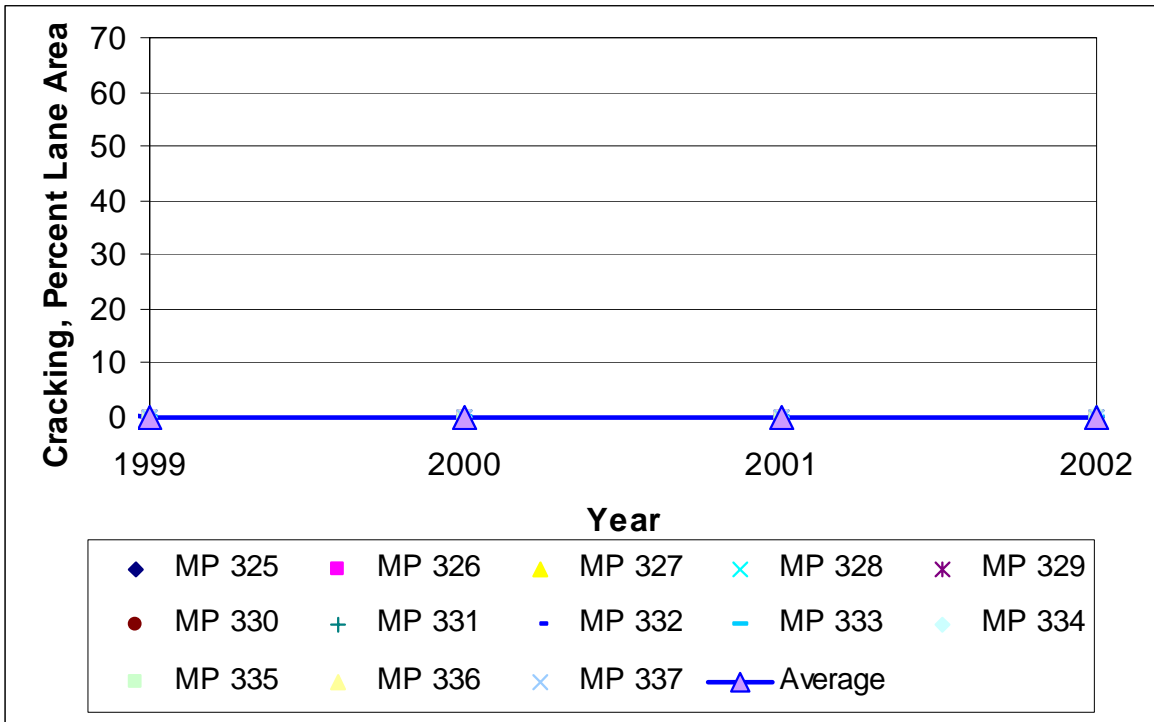
Figure 115. Cracking data for CIR Project 17—US 180 EB (ADOT Project No. STP-051-1(17)P).

- Figure 115 shows that no cracking, of any kind, was observed over the entire reporting period.
- Figure 116 shows that rutting is low at the present time but has an increasing trend.
- Figure 117 shows that the flushing quantities remain relatively low and stable over time.
- Figure 118 shows that the ride quality is satisfactory over the entire reporting period.
- Figure 119 suggests that the mile-by-mile maintenance costs are negligible after the CIR work was done and the HMA overlay placed. Likewise, the cumulative maintenance costs, shown in figure 120, level off after 1998.

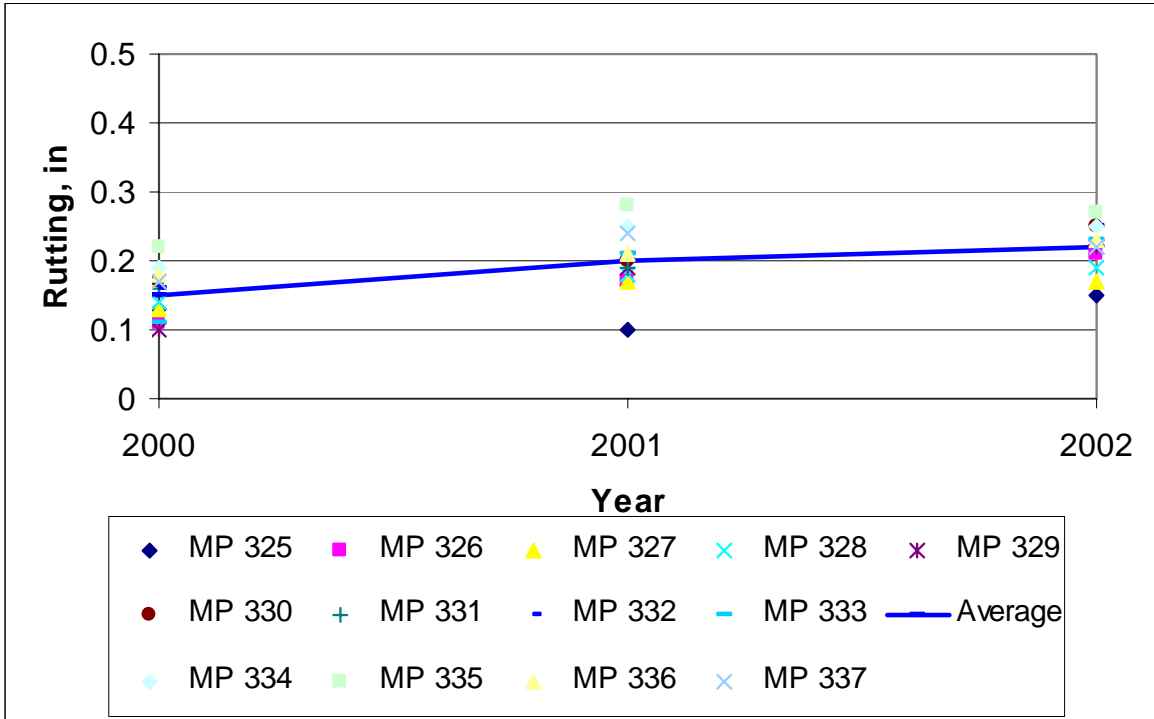
Figure 116. Rutting data for CIR Project 17—US 180 EB (ADOT Project No. STP-051-1(17)P).

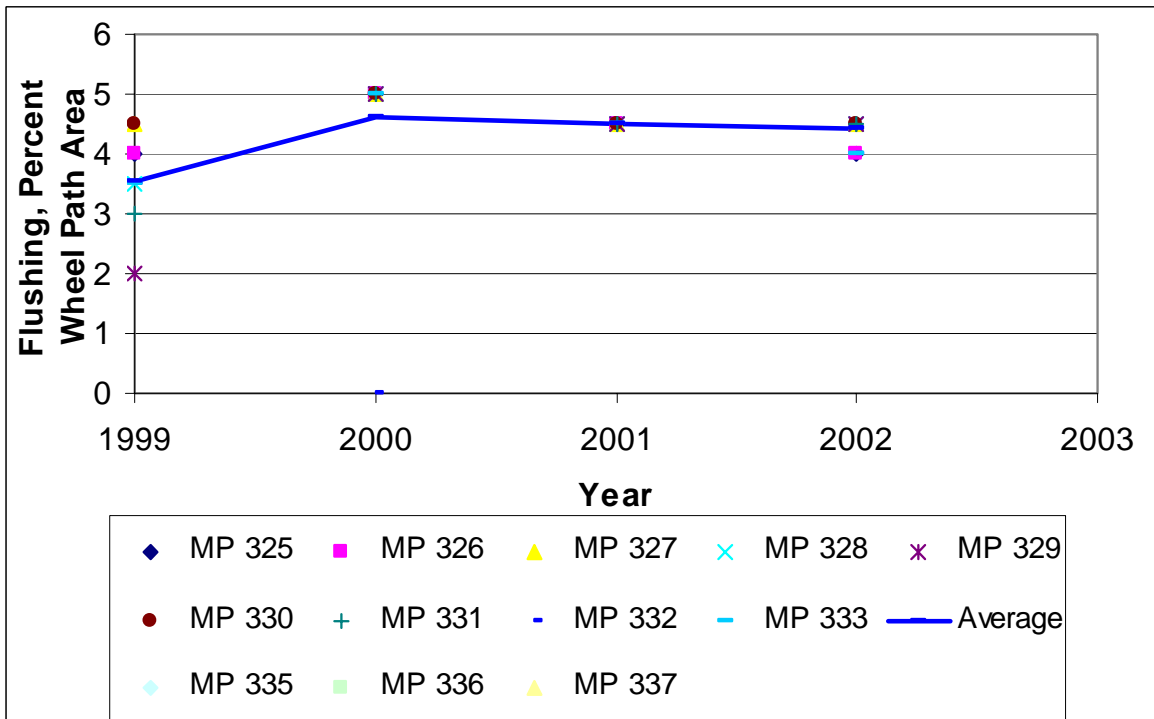
Figure 117. Flushing data for CIR Project 17—US 180 EB (ADOT Project No. STP-051-1(17)P).

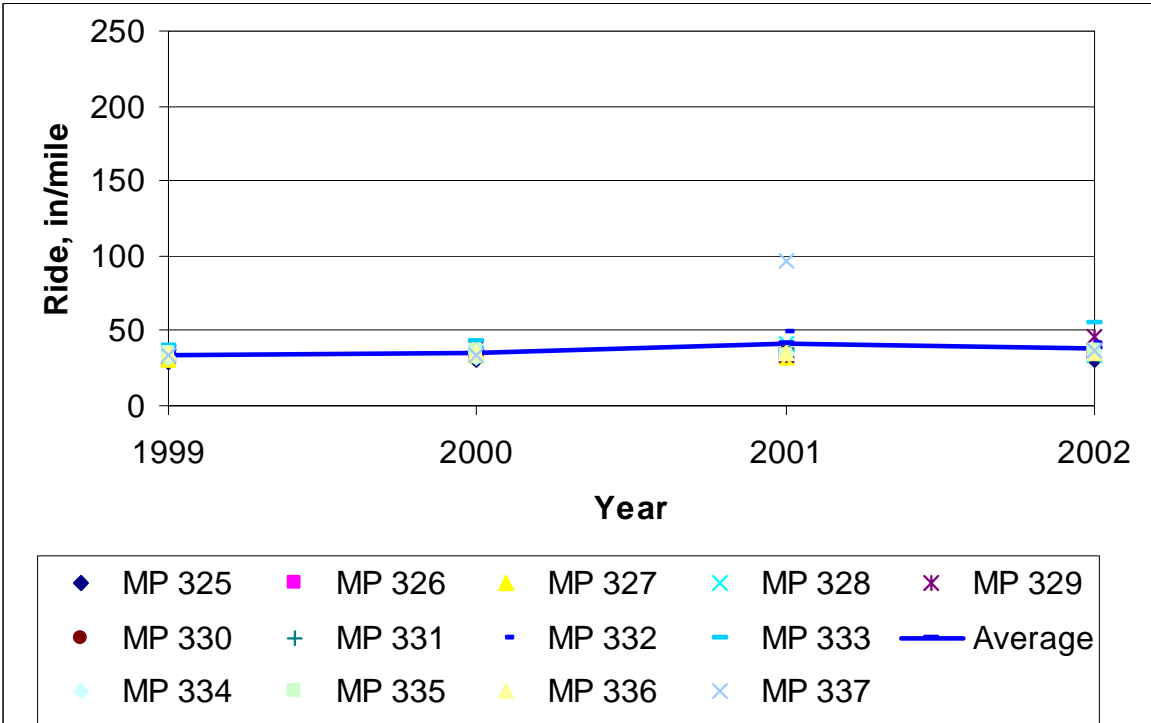
Figure 118. Ride quality information (Mays Ridemeter) for CIR Project 17—US 180 EB (ADOT Project No. STP-051-1(17)P).

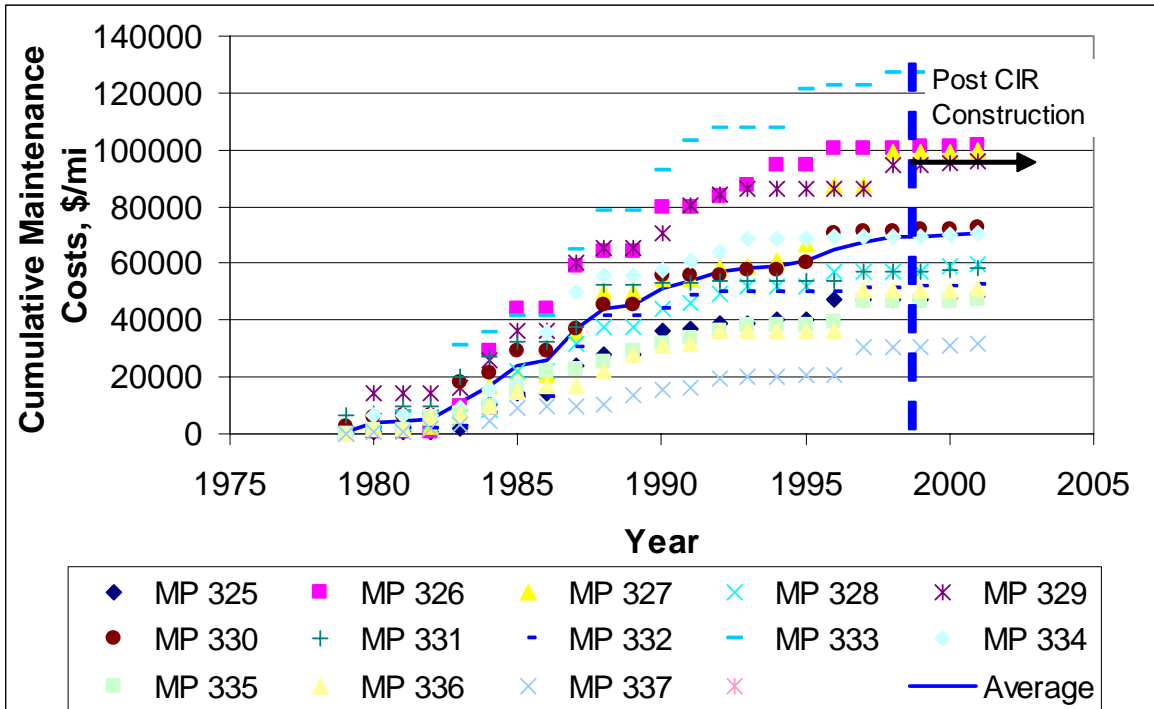
Figure 120. Cumulative maintenance costs for CIR Project 17—US 180 EB (ADOT Project No. STP-051-1(17)P).

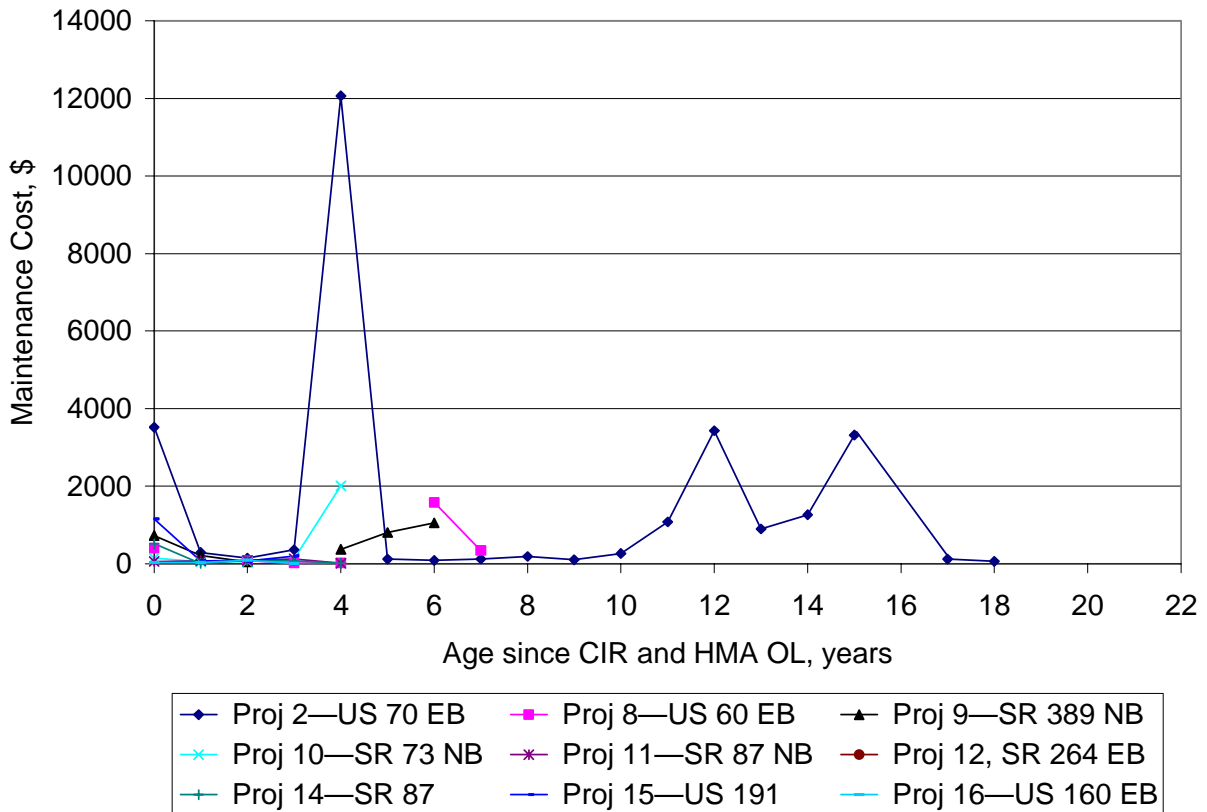
Figure 127. Plot showing maintenance cost (projects with CIR only).

Figure 127 shows that four of the six projects subjected to CIR alone experienced moderate levels of maintenance (cost < \$1,000/mile) up to 10 years post-rehabilitation. For projects subjected to both CIR and HMA overlay (figure 128), maintenance costs were moderate for eight out of the nine projects evaluated. The information presented is reasonable, as the projects subjected to AC overlays along with CIR are expected to require less maintenance.
