Performance Evaluation of Arizona's LTPP SPS-6 Project: Strategic Study of Rehabilitation Techniques

**Final Report 396-6
October 2013**

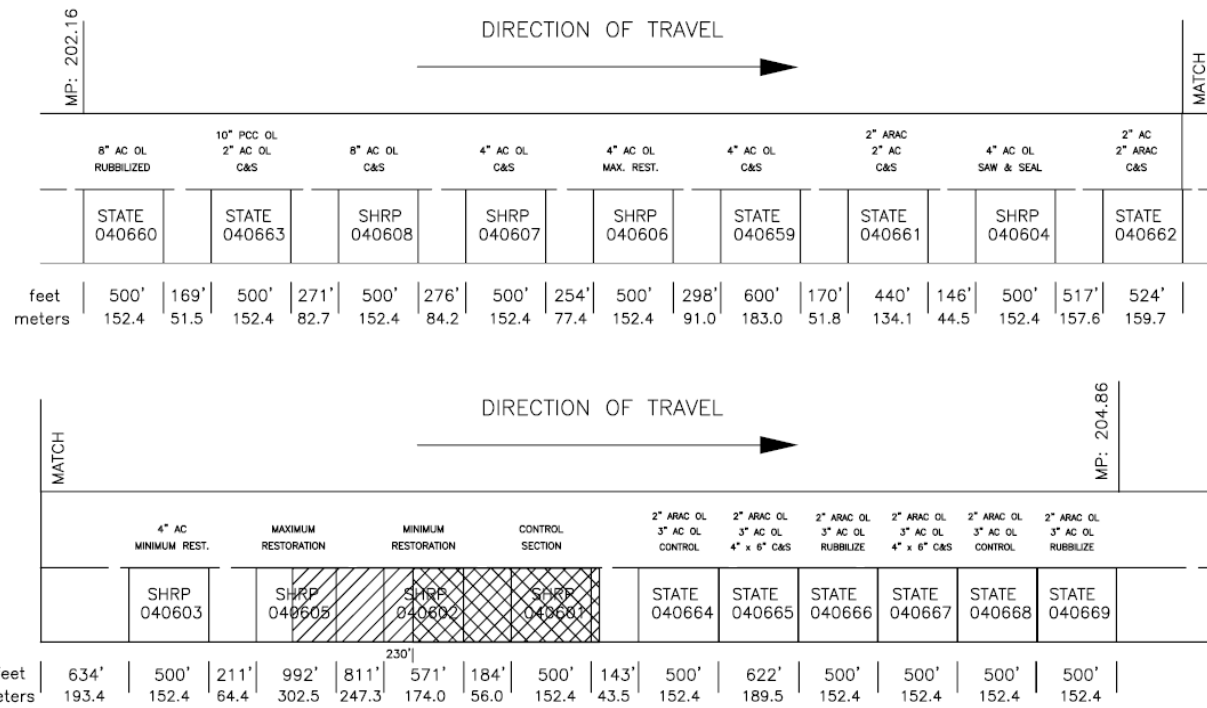
Figure 3. Layout of the SPS-6 Project.

The SPS-6 project was constructed in a 2.7 mi segment of this 10 mi rehabilitation project and extends from MP 202.16 to MP 204.86 (Figure 3). The site is located in a forested, mountainous area on a longitudinal grade that varies from shallow fill to sandstone cut, to deep fill over a culvert, and back to an increasingly deep sandstone cut. The average length of each test section is approximately 500 ft, which does not include transitional segments between sections. The average elevation of the project is 6900 ft, with a latitude of 35° 13' and longitude of -111°34'. The location and layout of the SPS-6 project are shown in Figures 2 and 3. The test section properties are shown in Table 1.

SPS-6 LAYOUT (ARIZONA)
 I-40 EASTBOUND NEAR FLAGSTAFF
 07/18/05
 NOT TO SCALE

Overlaid 8/93
 Patched with 1.5" cold mix on 04/30/92

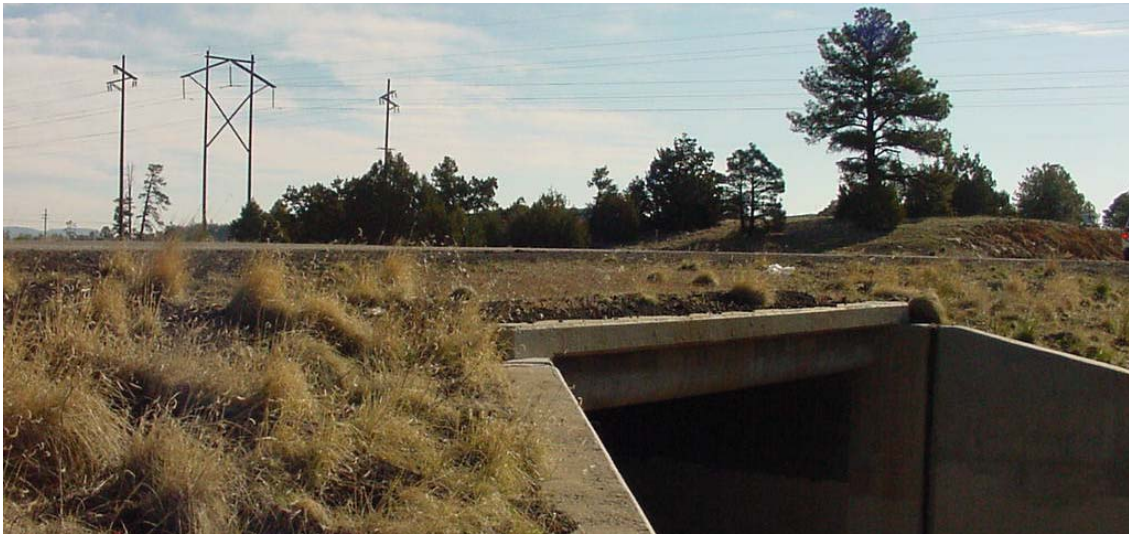
Figure 4. Box Culvert in Section 040660.

The photographs in Figures 4 through 8 show the terrain of the SPS-6 project site. Figure 4 shows a box culvert in Section 040660, the first test section on the west end of the project site. Fill material is on both sides of the culvert, and the grade transitions from fill to cut near the end of the test section (as shown in the right side of the photo).

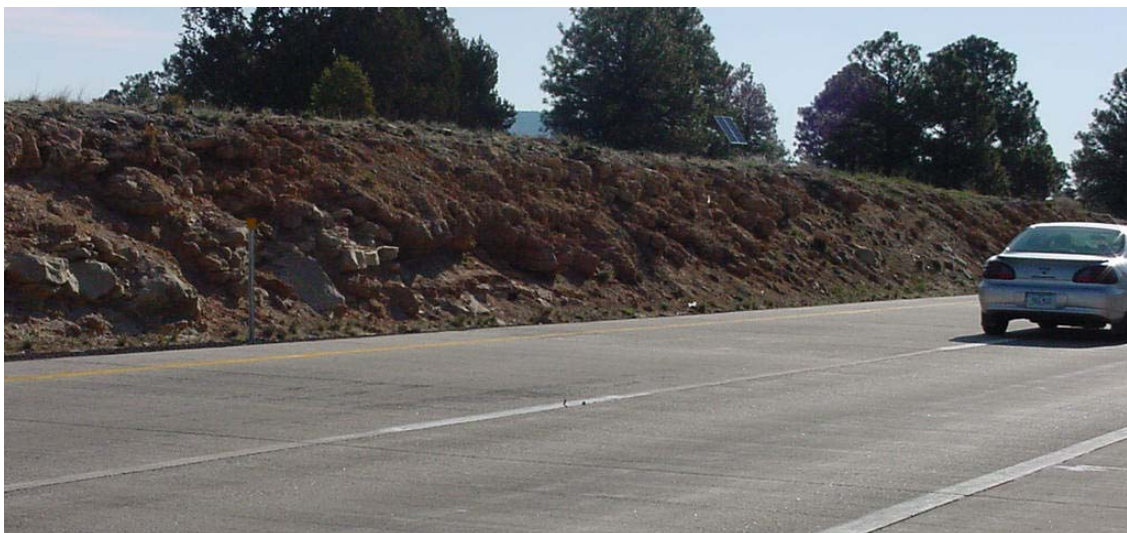
Figure 5. Shallow Sandstone Cut in Unbonded Overlay Section 040663.

Figure 5 shows the unbonded overlay section (040663), the next test section at the west end of the site, in a shallow cut. As the photo indicates, the sandstone is not solid rock, but rather considerably weathered material. The LTPP database does not report that bedrock was encountered within the depth to which borings were obtained. Figure 6 is a photograph taken in Section 040662, the ninth test section along the project length, located over a substantial fill.

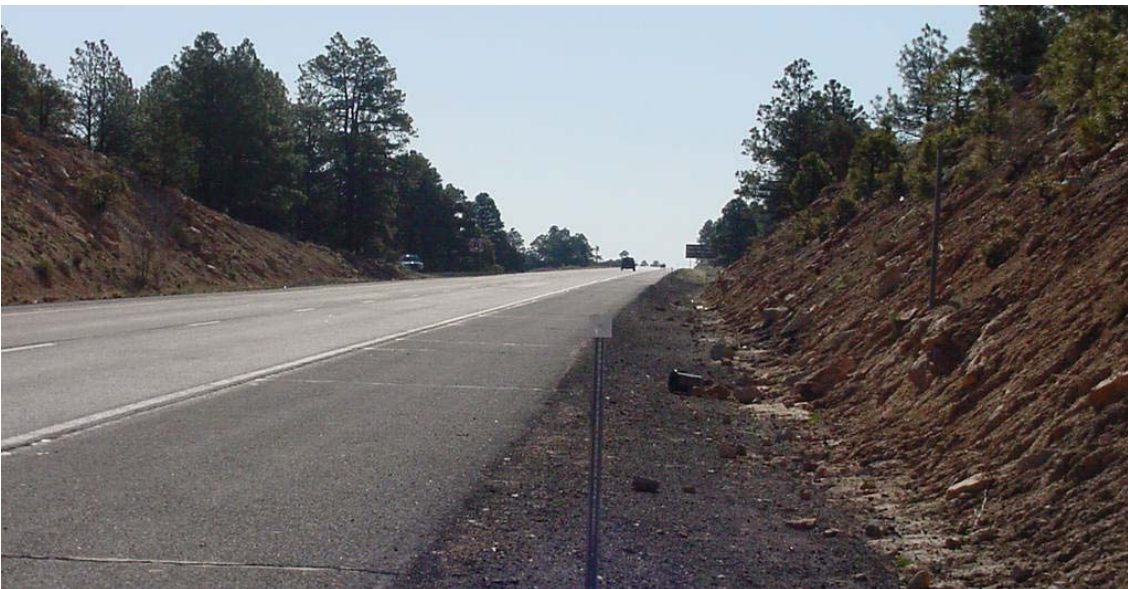
Figure 7. Cut and Grade in Section 040605.

Figure 7 shows the depth of fill and uphill grade in Section 040605, the 11th test section along the project length.

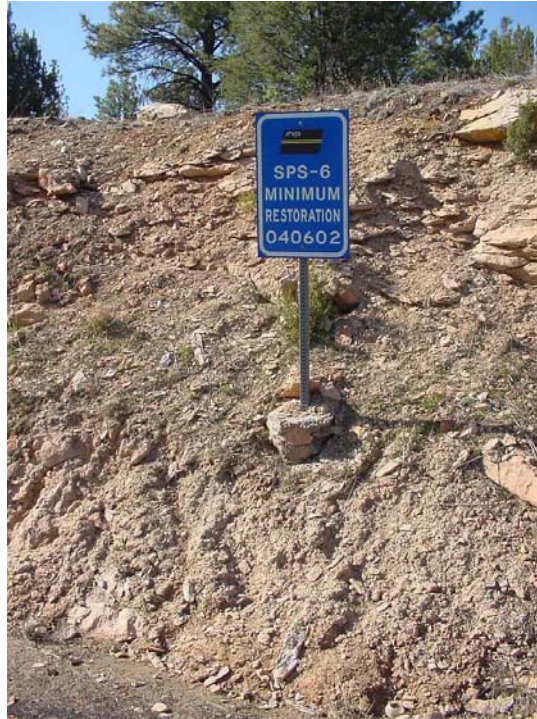
Figure 8. Cut in Section 040602.

The photograph in Figure 8 was taken in Section 040602, the 12th test section along the project length, and shows the depth of cut and the weathering of the sandstone.

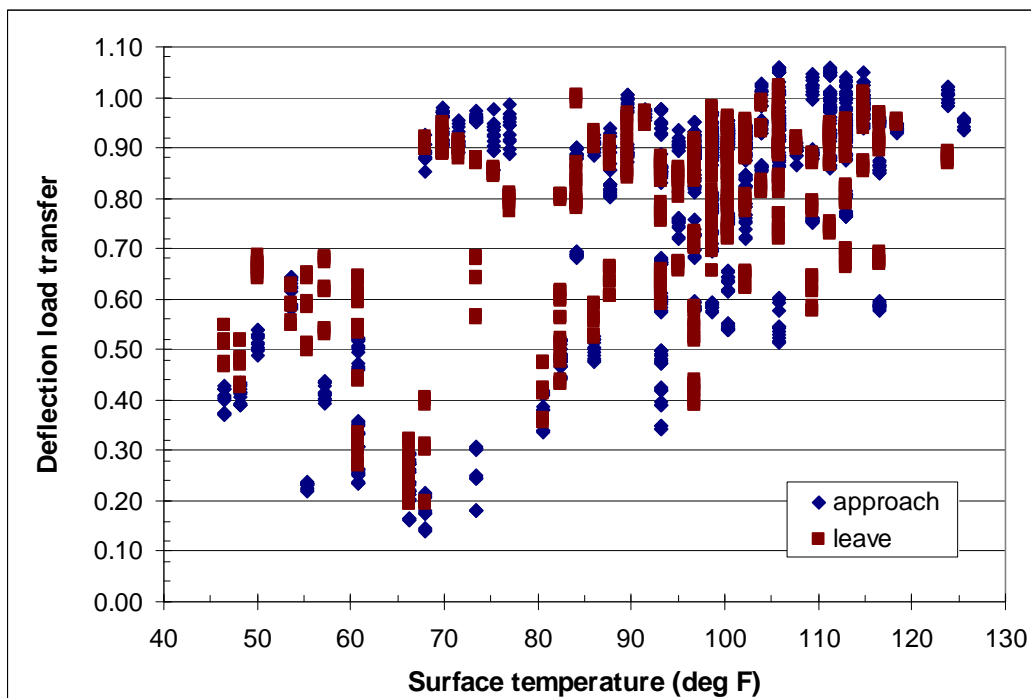
Figure 11. Joint Deflection Load Transfer as a Function of Pavement Surface Temperature, June 1990.

Given the approximate nature of the FWD's air and surface temperature measurements, the large percentage of load transfer measurements that were obtained at high temperatures, and the likely contribution of numerous working midslab cracks to variation in joint opening as a function of temperature, it is not surprising that the measured approach and leave joint load transfers show considerable variability as a function of temperature. The graph in Figure 11, which illustrates this variability, suggests three groups of data points:

- Points that follow an upward trend from about 20 percent load transfer at surface temperatures of 70 °F and below, up to load transfers in excess of 80 percent at surface temperatures above about 95 °F.
- A cluster of points with load transfer above 80 percent at surface temperatures in the range of 65 °F to 75 °F.
- A cluster of points with load transfer of about 40 percent to 70 percent at surface temperatures in the range of 45 °F to 60 °F.

Most of the data points in the first group probably represent working joints. The data points in the second group (and perhaps some in the first group as well) represent joints that are not working much at all, perhaps because of the proximity of midslab cracks. The data points in the third group probably represent joints that are working to some degree, but are not opening and closing in response to temperature changes as much as the joints in the first group.

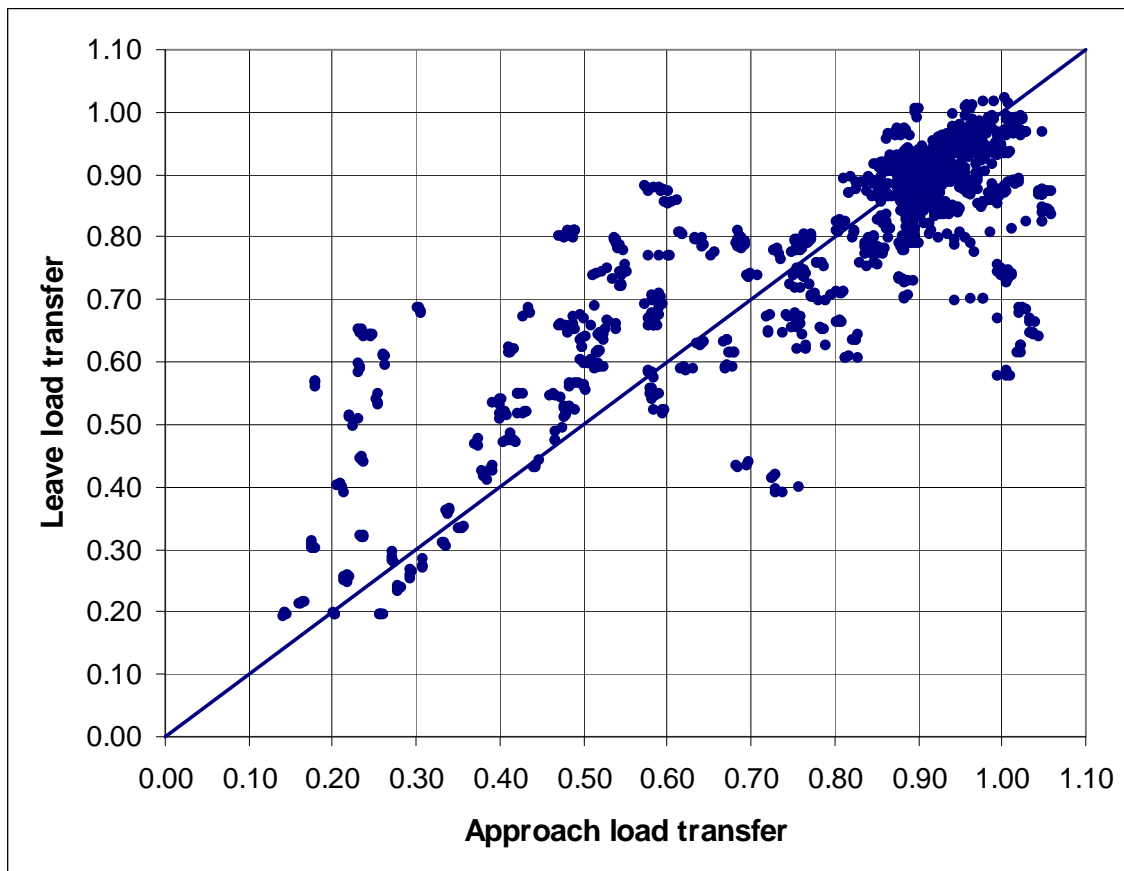
Figure 12. Approach Versus Leave Joint Load Transfer, June 1990.

Another aspect of load transfer to consider is how approach side and leave side load transfers compare, joint by joint, at this site. As illustrated in Figure 12:

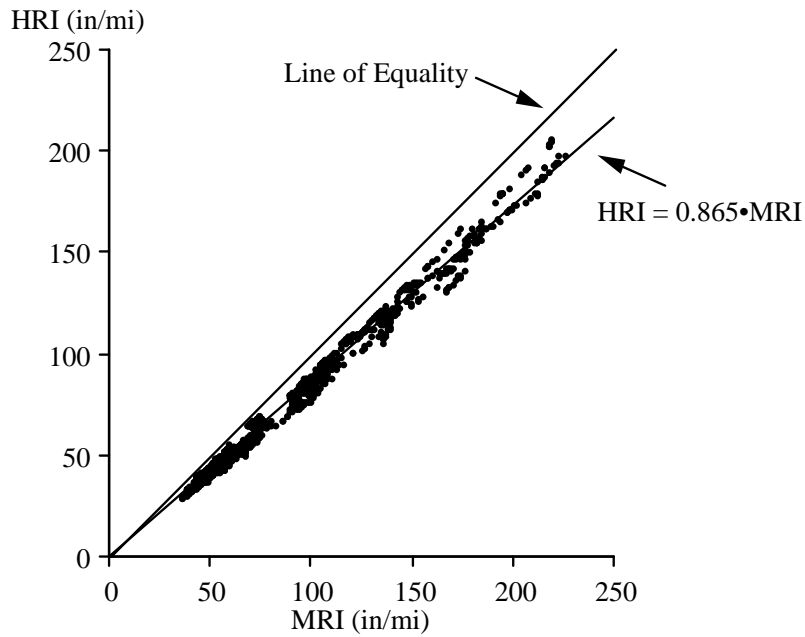
Figure 81. Comparison of HRI to MRI.

Figure 81 compares the HRI to MRI for all of the profile measurements that are covered in this appendix. This includes 1225 pairs of roughness values. The figure shows a best fit line and a line of equality. The slope of the line is 0.865. This is close to values observed for asphalt pavement.
