ARIZONA DEPARTMENT OF TRANSPORTATION

REPORT NUMBER: FHWA/AZ-82/181/FINAL REPORT

PAVEMENT CRACKING INVENTORY STUDY

James S. MacKenzie
Novak Dempsey & Associates

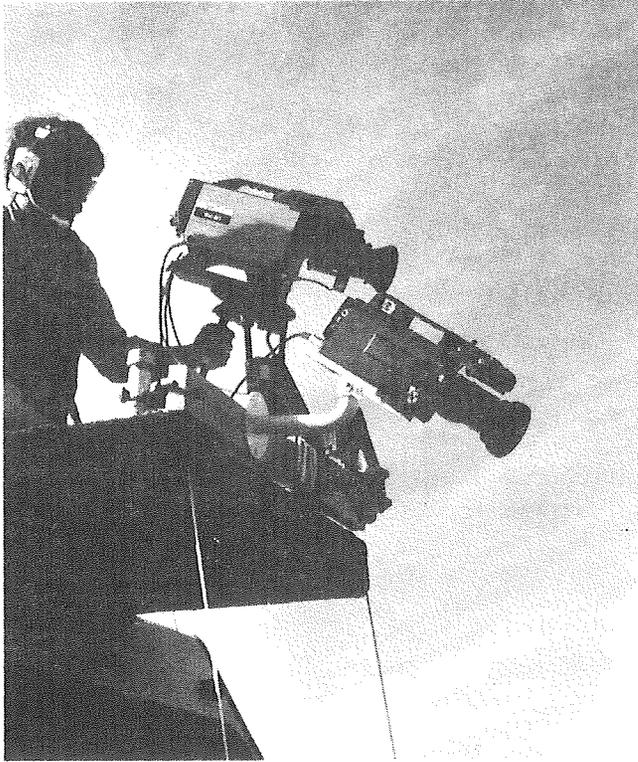
**FIGURE 1.
SIDE VIEW,
VIDEO CAMERA
SET UP.**

A 25 foot (762 cm) recreational vehicle with a built-in 125 volt power source was used for the test program. A platform was mounted on the top of the front of the vehicle to support the camera operator and the various video cameras. The height of the camera lens was 10 feet (304 cm). The Steadicam system and the rigid camera mount were mounted on the front of the platform. The general view of the camera arrangement is shown in Figures 1 and 2. The Steadicam system, which is designed to steady the camera in any position, was hand supported by the operator. A video console system and VTR's were installed in the vehicle. An intercom system was used by the video technician to monitor and direct the video taping. The driver had a nine inch color monitor mounted on the dashboard to view the recorded scene and comment on the pavement conditions as the tests progressed.

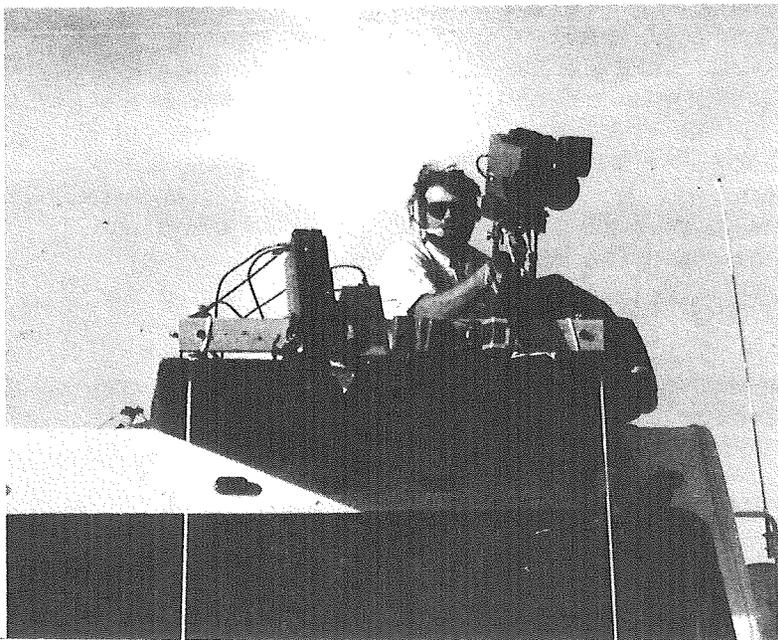
**FIGURE 2.
FRONT VIEW,
VIDEO CAMERA
SET UP.**

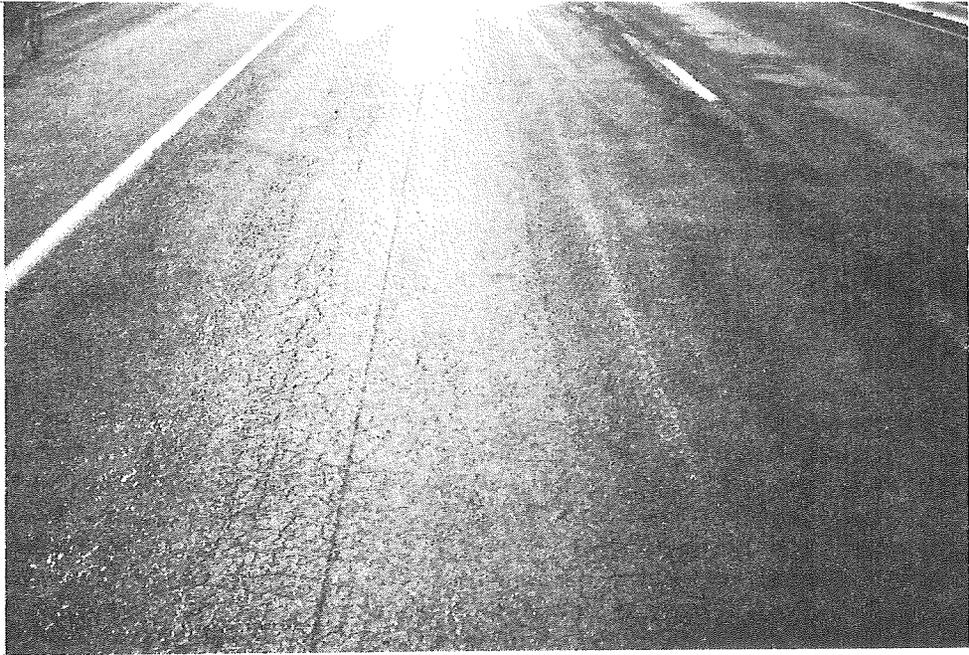
FIGURE 4.
TEST SITE 1, SR 87-OUTSIDE N BOUND LANE.

(a) The first test site was on State Route 87, a north-south rural inter-city highway south of Chandler, Arizona between Mileposts 160 and 161. This is a 4-lane asphalt highway. The pavement surface cracking condition is characterized by fine to medium alligator cracking with some longitudinal cracking in the wheel tracks as shown in Figure 4. The video test was taken on the morning of the 15th of December shooting with the sun behind the vehicle which was proceeding in the north bound direction.

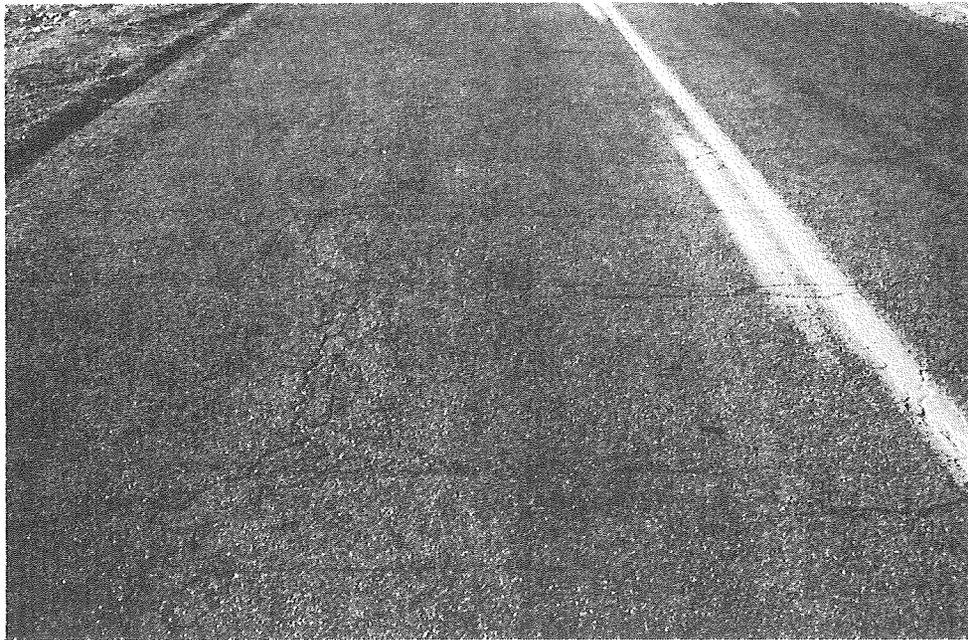
FIGURE 5.
TEST SITE 2, SR 287-E BOUND LANE.

(b) The second test site was on State Route 287, from Mileposts 135 to 136. This is an east-west route located west of the city of Florence, Arizona. The pavement is characterized by transverse cracking, block cracking and random cracking as shown in Figure 5. The video test was taken in the afternoon of the 15th of December in the east bound direction with the sun at the right rear of the vehicle.

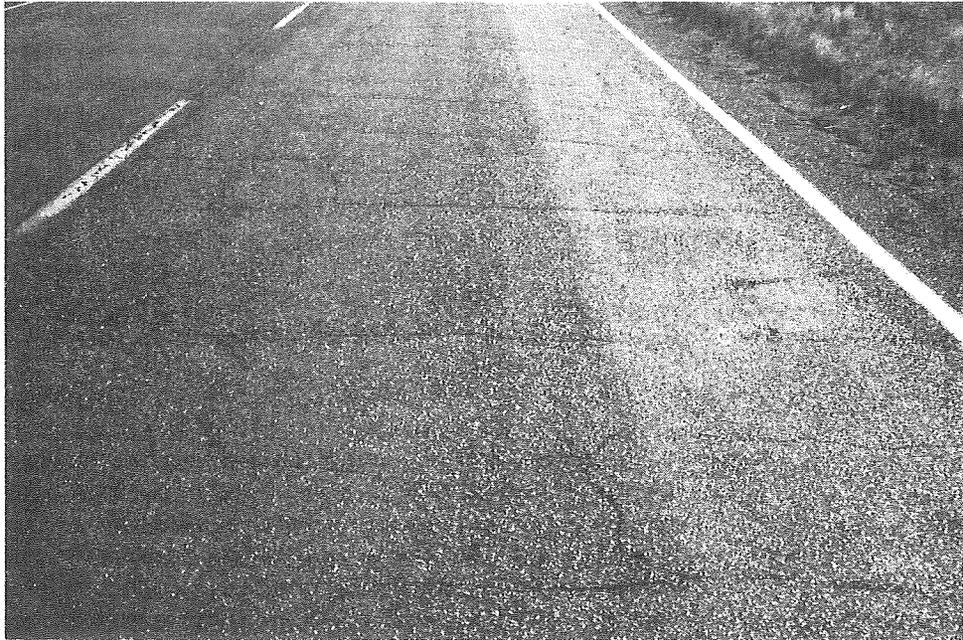
FIGURE 6.
TEST SITE 3, US 89 SE BOUND LANE.

(c) The third test site was on U.S. Route 89, from Milepost 130 to 129. This is a north-south route south of Florence, Arizona. The pavement is characterized by transverse and random cracking and some patching as shown in Figure 6. This test site was selected for the detailed surface evaluation study because of the clarity of the video images obtained at this test site. The video test was conducted on the morning of the 16th of December on the south bound lane shooting into the sun.

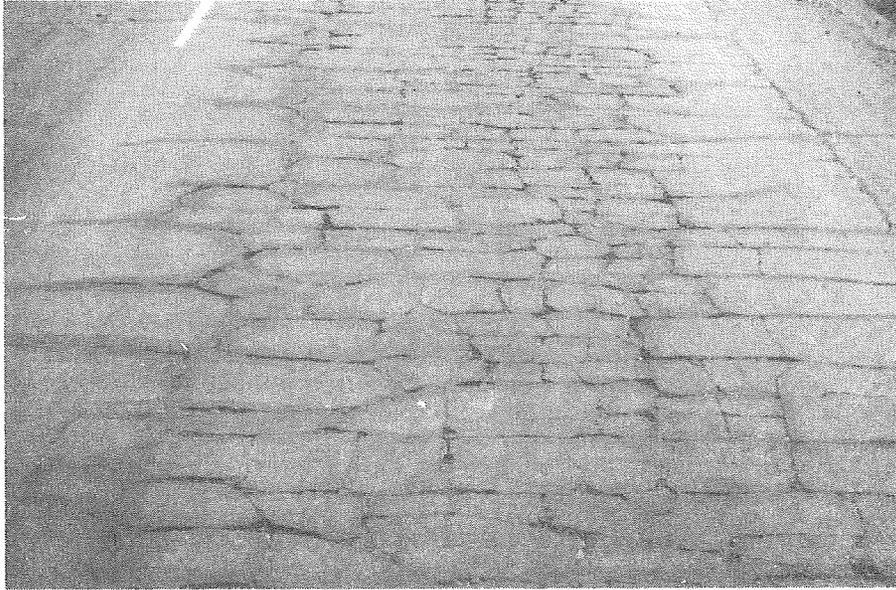
FIGURE 8.
ORIGINAL ADOT REFERENCE PICTURE
64.4% of IMAGE CONTAINS CRACKING.

picture, Figure 8, was digitized. A software program (BOXCAR) was used with a 32 by 32 matrix to remove the fine detail (cracks). The filtered picture was then subtracted from the original image to yield the image shown in Figure 9. The shading in the picture is due to the uneven lighting and broad tire marks. The enhanced image shown in Figure 9 clearly defined the areas of cracked pavement.
