### A-3-7. Test 7

A 1979 Honda Civic, pictured in Figure A-60, was directed into the sign installation at 60.5 mph. Test inertia mass of the test vehicle was 1,800 lb and its gross static mass was 1,965 lb. Impact point was 15 in. to the left of the vehicle centerline. Relative positions of the test vehicle and sign installation are shown in Figure A-61.

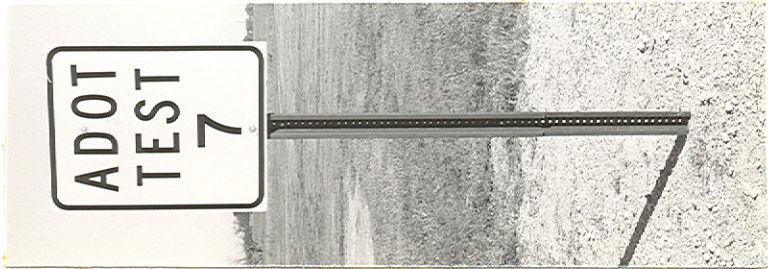
FIGURE A-65. SUMMARY OF RESULTS FOR TEST 7.

Test results are given in Figure A-65. Change in the vehicle's velocity during the impulse period was 2.1 mph and change in momentum was 169 lb-sec. There was no occupant impact during the impulse period.

Test No. . . . .	7024-7	Impact Speed. . . . .	60.5 mph (97.3 kph)
Date . . . . .	11/6/84	Change in Velocity. . . . .	2.1 mph (3.4 kph)
Test Article . . . . .	Single-leg Sign Support of 3 lb H.C. Billet Steel U-Channel	Change in Momentum. . . . .	169 lb-sec
Vehicle. . . . .	1979 Honda Civic	Occupant Impact Velocity	
Vehicle Weight		Longitudinal. . . . .	No Contact
Test Inertia . . . . .	1,800 lb (817 kg)	Lateral . . . . .	No Contact
Gross Static . . . . .	1,965 lb (892 kg)	Occupant Ridedown Accelerations	
Vehicle Damage Classification		Longitudinal. . . . .	N/A
TAD. . . . .	12FL1	Lateral . . . . .	N/A
SAE. . . . .	12FLEE1	Vehicle Crush	
		Bumper Height . . . . .	3.5 in. (8.9 cm)
		Hood Height . . . . .	None

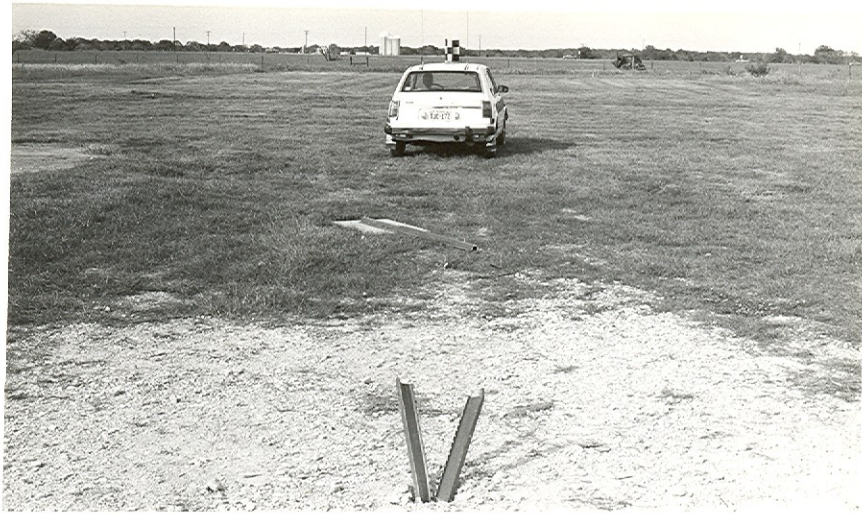
FIGURE A-68. SIGN INSTALLATION AFTER TEST 8.

The support was split from ground level to 16.5 in. above the ground. At this point the support was fractured as shown in Figure A-68. The vehicle received a minimal amount of damage. As shown in Figure A-69 there was a slight indentation in the bumper and the parking light was also broken. (Damage to the left side was due to the previous test.) Sequentials of the test are presented in Figure A-70.

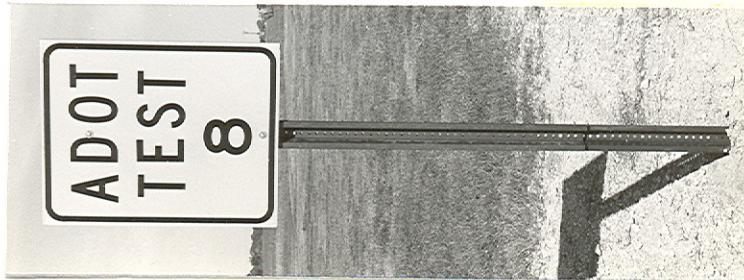
FIGURE A-71. SUMMARY OF RESULTS FOR TEST 8.

Test results are given in Figure A-71. Change in the vehicle's velocity during the impulse period was 4.1 mph and change in momentum was 339 lb-sec. There was no occupant impact during the impulse period.

Test No. . . . . 7024-8  
 Date . . . . . 11/6/84  
 Test Article . . . . . Single-leg Sign Support of 3 lb H.C. Billet Steel U-Channel  
 Vehicle . . . . . 1979 Honda Civic  
 Vehicle Weight . . . . .  
 Test Inertia . . . . . 1,800 lb (817 kg)  
 Gross Static . . . . . 1,965 lb (892 kg)  
 Vehicle Damage Classification  
 TAD . . . . . 12FR1  
 CDC . . . . . 12FLEE1

Impact Speed . . . . . 19.9 mph (32.0 kph)  
 Change in Velocity . . . . . 4.1 mph (6.6 kph)  
 Change in Momentum . . . . . 339 lb-sec  
 Occupant Impact Velocity  
 Longitudinal . . . . . No Contact  
 Lateral . . . . . No Contact  
 Occupant Ridedown Accelerations  
 Longitudinal . . . . . N/A  
 Lateral . . . . . N/A  
 Vehicle Crush  
 Bumper Height . . . . . Negligible  
 Hood Height . . . . . None

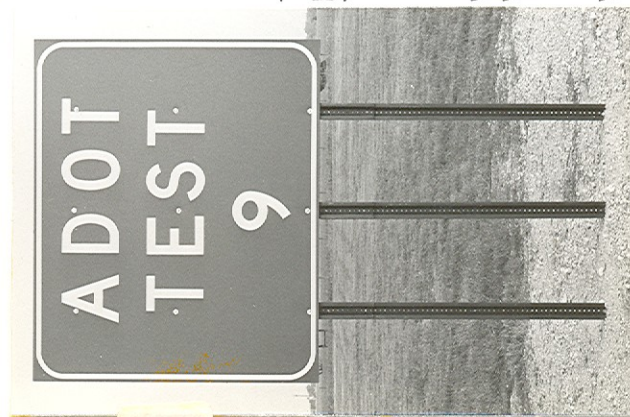
FIGURE A-77. SUMMARY OF RESULTS FOR TEST 9.

Test No. . . . .	7024-9	Impact Speed. . . . .	59.3 mph (95.4 kph)
Date . . . . .	11/8/84	Change in Velocity. . . . .	7.2 mph (11.6 kph)
Test Article . . . . .	Multi-leg Sign Support of 3 lb H.C. Billet Steel U-Channel	Change in Momentum . . . . .	590 lb-sec
Vehicle. . . . .	1979 Honda Civic	Occupant Impact Velocity	
Vehicle Weight		Longitudinal. . . . .	No Contact
Test Inertia . . . . .	1,800 lb (817 kg)	Lateral . . . . .	No Contact
Gross Static . . . . .	1,970 lb (894 kg)	Occupant Ridedown Accelerations	
Vehicle Damage Classification		Longitudinal. . . . .	N/A
TAD. . . . .	12FD1	Lateral . . . . .	N/A
SAE. . . . .	12FDEW2	Maximum Vehicle Crush	
		Bumper Height . . . . .	12.0 in. (30.5 cm)
		Hood Height . . . . .	1.5 in. (3.8 cm)

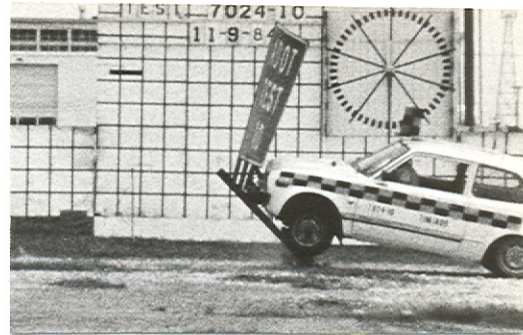
FIGURE A-81. SEQUENTIAL PHOTOGRAPHS FOR TEST 10.

The front of the vehicle was deformed as shown in Figure A-80. The right front quarter received 6.0 in. crush at bumper height. The center was crushed 2.0 in. at bumper height. The windshield was slightly cracked just below the visor and the visor was bent. Sequential photographs of the test are shown in Figure A-81.

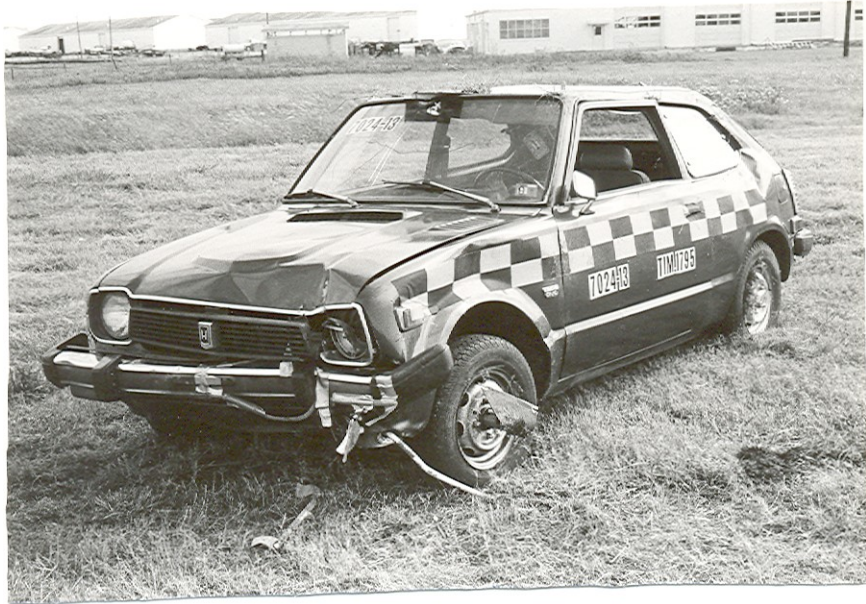
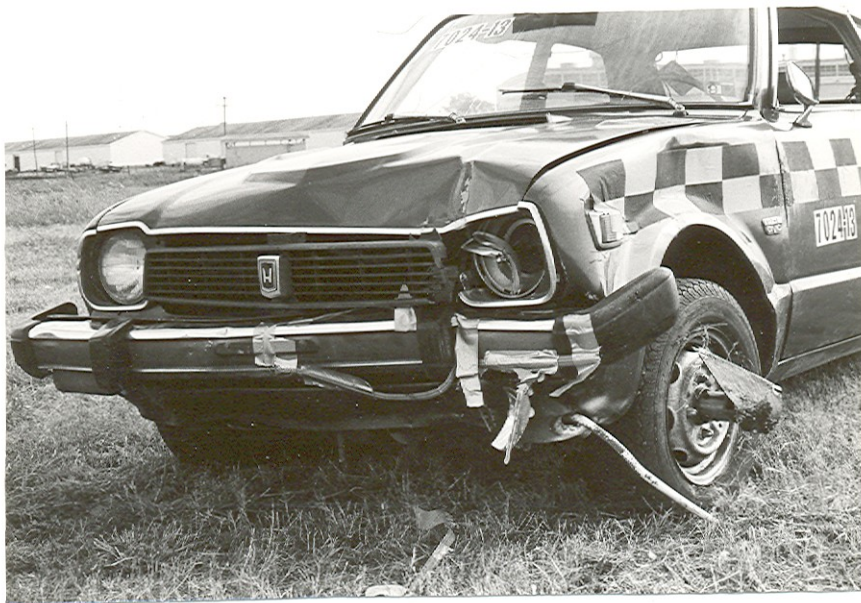
FIGURE A-97. TEST VEHICLE AFTER TEST 13.

Post-test roll attributed to  
unsymmetrical brake application  
and soil condition.

The lower section of the support was fractured 18 in. above the ground as shown in Figures A-95 and A-96. The vehicle received a maximum crush of 6.0 in. at bumper height and 2 in. at hood height. Photographs of the vehicle after the test are shown in Figure A-97 and sequentials of the test are presented in Figure A-98.

The vehicle remained upright and stable throughout the initial test period. Post-test roll was attributed to unsymmetrical brake application and subsequent tipping of the vehicle when the tires rutted the grassy sod.

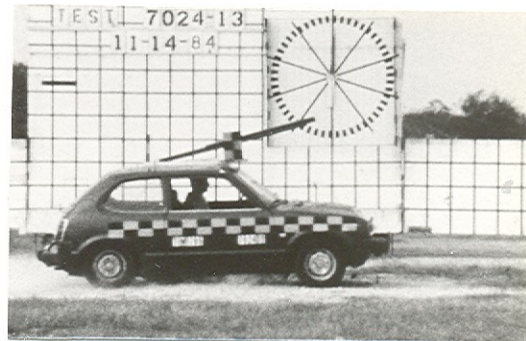
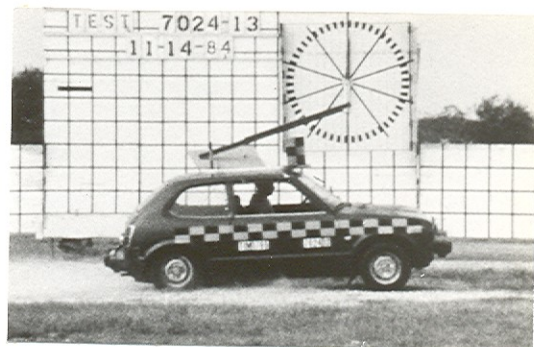
FIGURE A-98. SEQUENTIAL PHOTOGRAPHS FOR TEST 13.

Approximately 0.015 sec after impact the lower section of the support began to fracture at bumper height. At 0.040 sec the support lost contact with the front of the vehicle and the sign panel and part of the support began rising upward. The sign panel then impacted the left side of the roof of the vehicle at 0.077 sec. The sign lost contact with the vehicle at 0.125 sec and subsequently came to rest 90 ft behind and 30 ft to the left of the impact point. The vehicle left the test area in a stable mode yawing counterclockwise at 15 deg/sec (8 deg at 0.550 sec). Post-test brake application caused the vehicle to yaw violently in clockwise rotation and subsequently rolled one revolution.

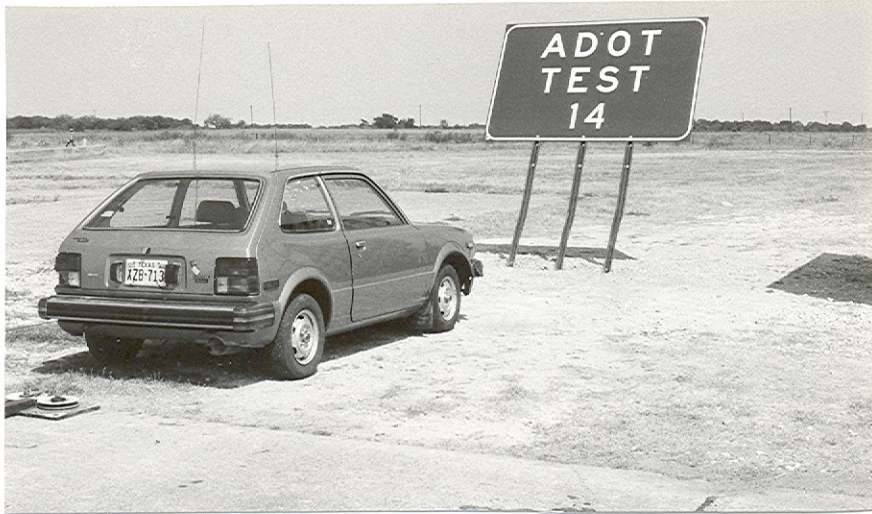
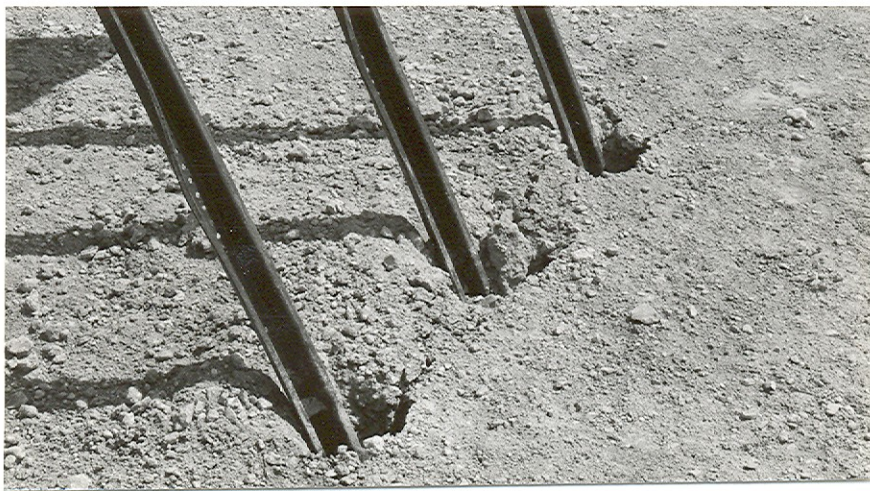
FIGURE A-102. TEST INSTALLATION AFTER TEST 14.

The sign installation was pushed back about 6.5 in. and was scratched and bent about 16 in. above the ground as shown in Figure A-102. As shown in Figure A-103, the vehicle sustained minor scrapes to the bumper with a maximum 1.5 in. crush at bumper height. Also the windshield was cracked.

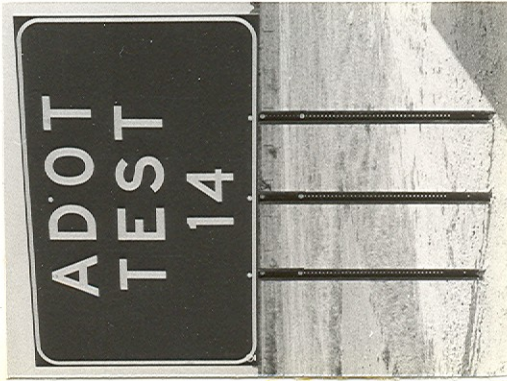
FIGURE A-104. SUMMARY OF RESULTS FOR TEST 14.

Test No. . . . .	7024-14	Impact Speed. . . . .	20.3 mph (32.7 kph)
Date . . . . .	9/03/85	Change in Velocity. . . . .	18.8 mph (30.2 kph)
Test Article . . . . .	Sign installation	Change in Momentum. . . . .	1,541 lb-sec
Support. . . . .	Three 3 lb Rail Steel Channel Supports	Occupant Impact Velocity	
		Longitudinal. . . . .	26.9 ft/s (8.2 m/s)
		Lateral . . . . .	None
Vehicle. . . . .	1980 Honda Civic	Occupant Ridedown Accelerations	
Vehicle Weight		Longitudinal. . . . .	-1.6 g
Test Inertia . . . . .	1,800 lb (817 kg)	Lateral . . . . .	N/A
Gross Static . . . . .	1,970 lb (894 kg)	Maximum Vehicle Crush	
Vehicle Damage Classification		Bumper Height . . . . .	1.5 in. (3.8 cm)
TAD. . . . .	12FD1		
SAE. . . . .	12FDLW1

The results of the test are summarized in Figure A-104. Change in the vehicle's velocity was 18.8 mph and change in momentum was 1,541 lb-sec. Longitudinal occupant impact velocity was 26.9 fps and the maximum 0.010-second average occupant ridedown acceleration was -1.6 g.

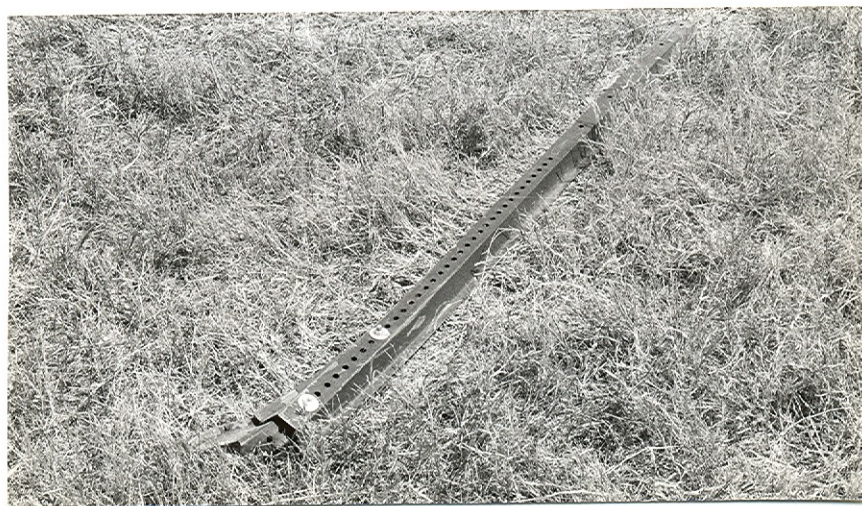
FIGURE A-106. TEST INSTALLATION AFTER TEST 15.

The lower sections of the left and right supports fractured 54 in. above the ground. The center support was pulled completely out of the ground. Damage to the sign supports is shown in Figure A-106.

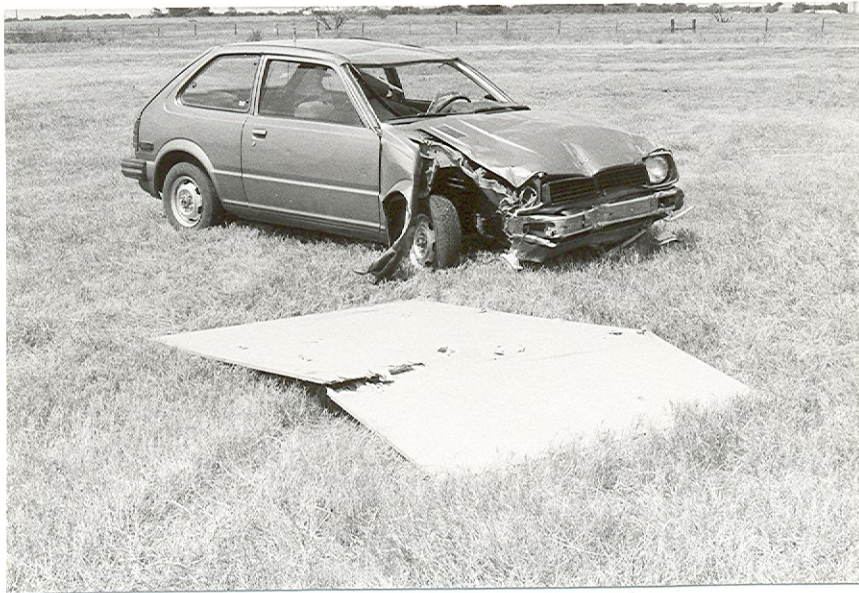
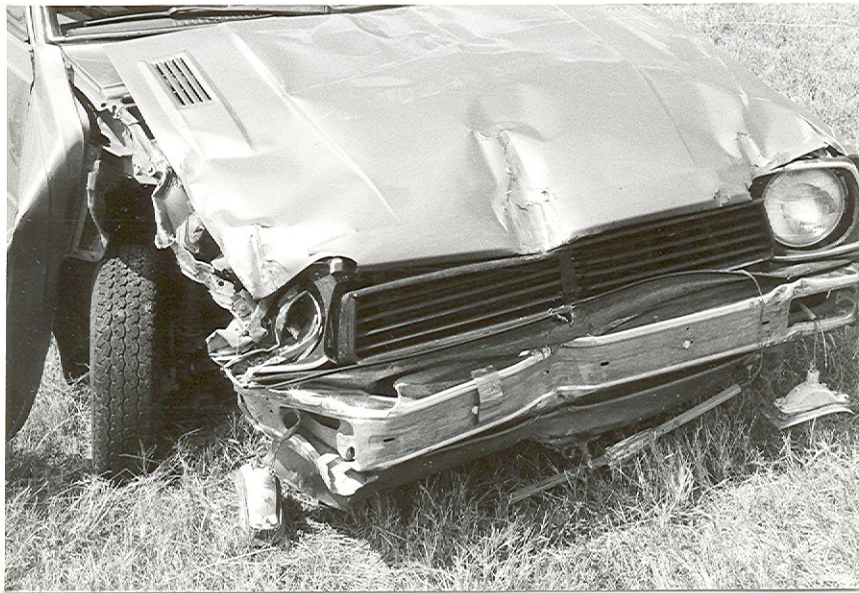
FIGURE A-107. VEHICLE AFTER TEST 15.

The front of the vehicle was deformed as shown in Figure A-107. The right front quarter received 10.0 in. crush at bumper height. The center was crushed 3.0 in. at bumper height and 1.0 in. on the left side. The windshield was also broken. Sequential photographs of the test are shown in Figure A-108.

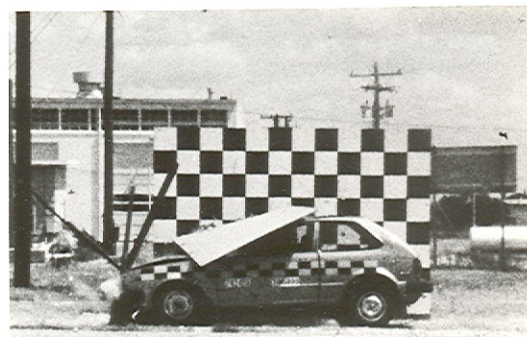
FIGURE A-108. SEQUENTIAL PHOTOGRAPHS FOR TEST 15.

Approximately 0.008 sec after impact the supports began to bend. At 0.060 sec the lower section of the left and right supports began to fracture. Shortly thereafter the dummy hit the windshield and the sign panel which had separated from the supports hit the hood and windshield. The sign panel rode with the vehicle which traveled 105 ft directly behind the impact point.

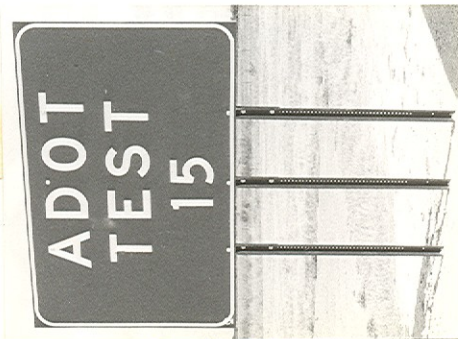
FIGURE A-109. SUMMARY OF RESULTS FOR TEST 15.

Test No. . . . .	7024-15	Impact Speed. . . . .	62.0 mph (99.8 kph)
Date . . . . .	9/9/85	Change in Velocity. . . . .	23.5 mph (37.8 kph)
Test Article . . . . .	Sign Installation	Change in Momentum . . . . .	1,927 lb-sec
Support. . . . .	Three 3 lb Rail Steel Channel Supports	Occupant Impact Velocity	
Vehicle. . . . .	1980 Honda Civic	Longitudinal . . . . .	31.2 fps (9.5 m/s)
Vehicle Weight		Lateral. . . . .	No Contact
Test Inertia . . . . .	1,800 lb (817 kg)	Occupant Ridedown Accelerations	
Gross Static . . . . .	1,970 lb (894 kg)	Longitudinal. . . . .	4.6 g
Vehicle Damage Classification		Lateral . . . . .	N/A
TAD. . . . .	12FD3	Maximum Vehicle Crush	
SAE. . . . .	12FDAW7	Bumper Height . . . . .	10.0 in. (25.4 cm)

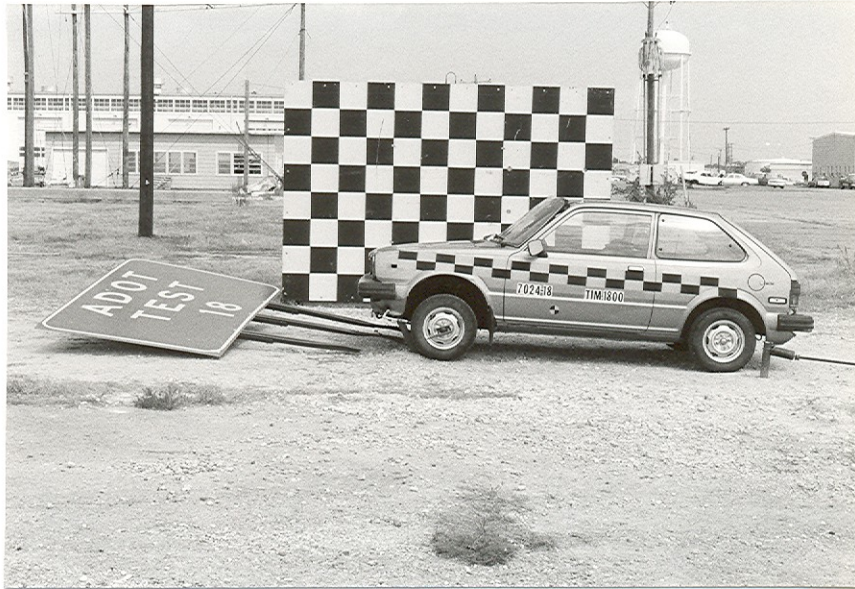
FIGURE A-122. TEST INSTALLATION AFTER TEST 18.

The left support was fractured 19.5 in. above the ground as shown in Figure A-122. The center and right supports were split longitudinally but did not fracture. As shown in Figure A-123, the vehicle sustained minor scrapes to the bumper and a broken windshield.

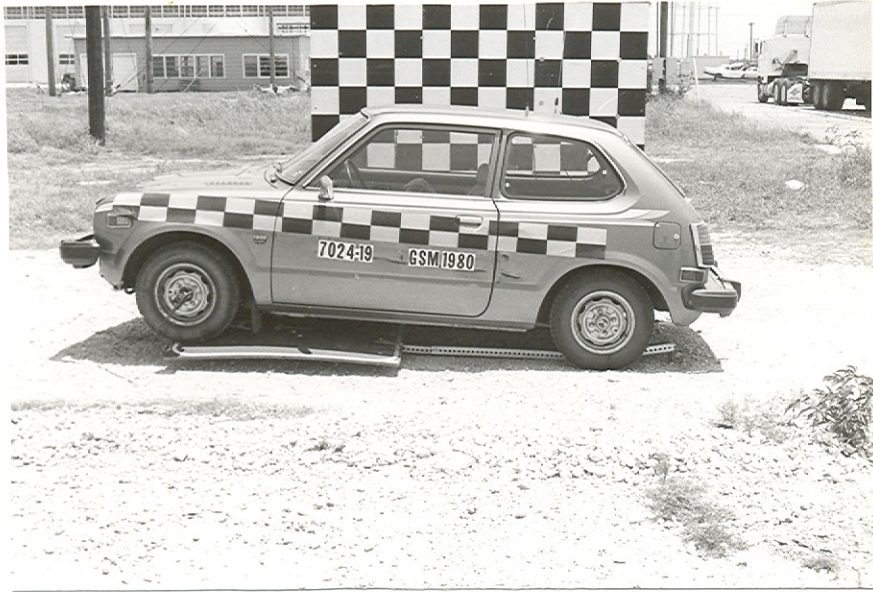
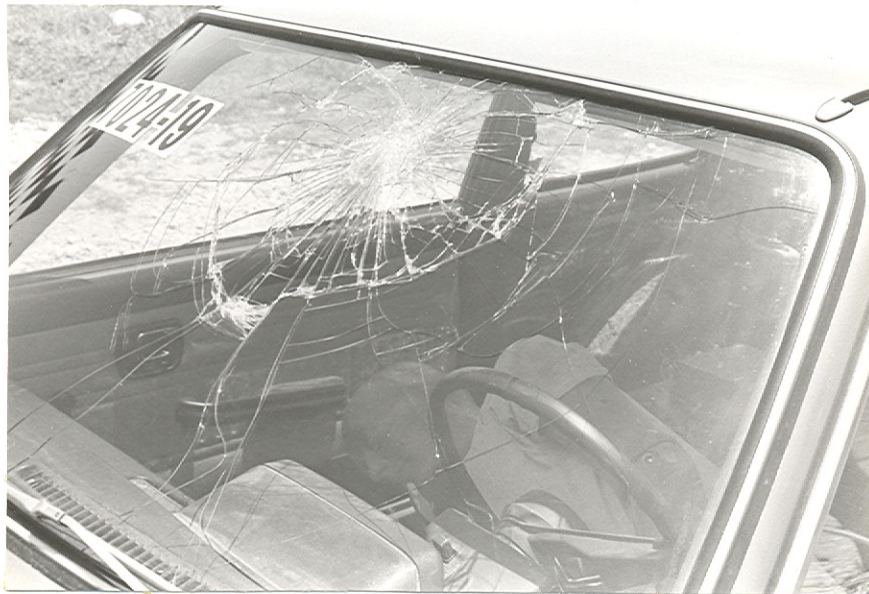
FIGURE A-126. TEST VEHICLE AFTER TEST 19.

As shown in Figure A-128, the supports were fractured at the base. The left support also had a slight fracture about 16.0 in. above the ground. The vehicle (see Figure A-126) received minor scrapes on the bumper with a maximum crush of 4.5 in. on the right side at bumper height. The windshield was also cracked.

At approximately 0.015 sec after impact the left support of the installation began to bend. Shortly thereafter the right support began to bend and at 0.045 sec the left support fractured. At 0.171 sec the dummy hit and cracked the windshield. The vehicle continued to roll forward and subsequently came to rest over the sign as shown in Figure A-126. Sequential photographs of the test are shown in Figure A-127.

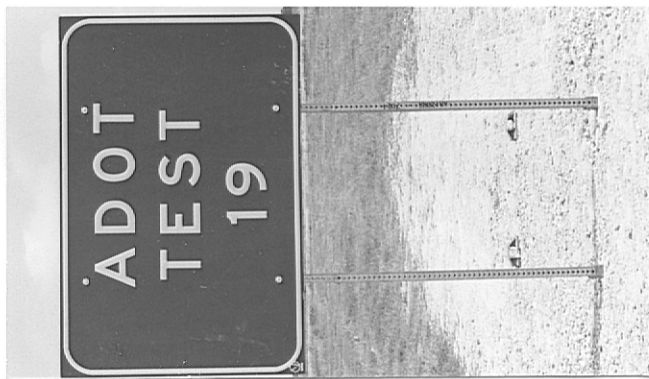
FIGURE A-129. SUMMARY OF RESULTS FOR TEST 19.

Test No. . . . .	7024-19	Impact Speed. . . . .	18.9 mph (30.4 kph)
Date . . . . .	5/31/85	Change in Velocity. . . . .	10.0 mph (16.1 kph)
Test Article . . . . .	Sign Installation	Change in Momentum . . . . .	825 lb-sec
Support. . . . .	Two square tube (Unistrut) P2 posts	Occupant Impact Velocity	
Vehicle. . . . .	1979 Honda Civic	Longitudinal. . . . .	14.1 fps (4.3 m/s)
Vehicle Weight		Lateral . . . . .	None
Test Inertia . . . . .	1,808 lb (821 kg)	Occupant Ridedown Accelerations	
Gross Static . . . . .	1,980 lb (899 kg)	Longitudinal. . . . .	-2.5 g
Vehicle Damage Classification		Lateral . . . . .	N/A
TAD. . . . .	12FD1	Maximum Vehicle Crush	
SAE. . . . .	12FDLN1	Bumper Height . . . . .	4.5 in. (11.4 cm)
		Hood Height . . . . .	0.0 in. (0.0 cm)

The results of this test are summarized in Figure A-129. Change in the vehicle's velocity at 0.300 seconds was 10.0 mph and change in momentum was 825 lb-sec. Occupant impact velocity in the longitudinal direction was 14.1 fps and the highest 0.010-second longitudinal occupant ridedown acceleration was -2.5 g.

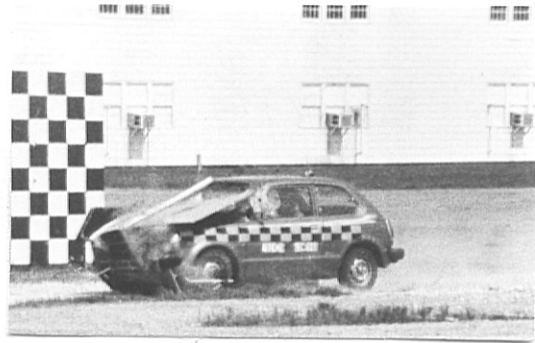
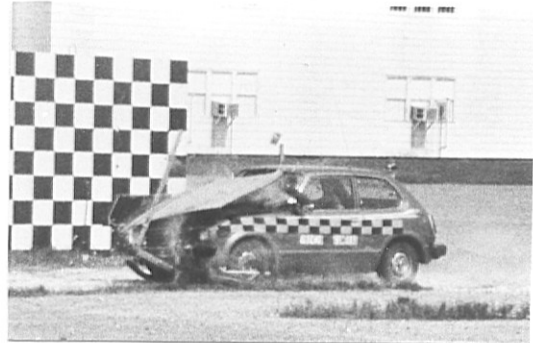
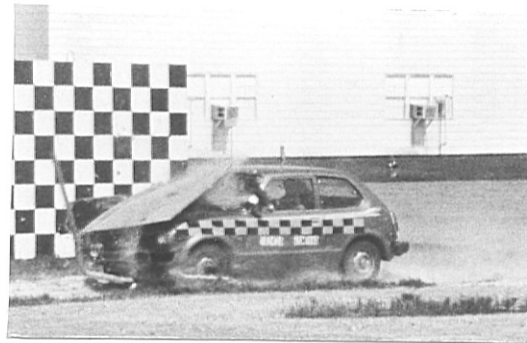
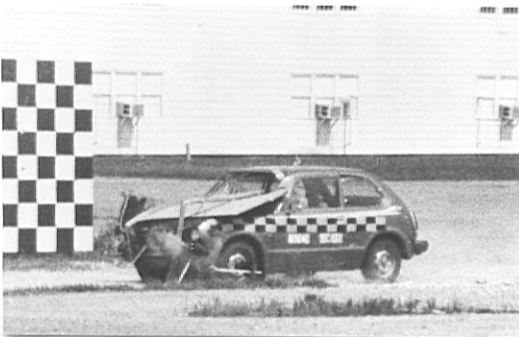
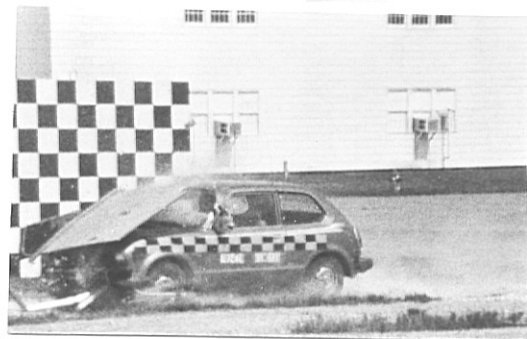
FIGURE A-131. SEQUENTIAL PHOTOGRAPHS FOR TEST 20.

The left support of the sign installation fractured at bumper height approximately 0.010 sec after impact. Both supports then began to deform around the front of the vehicle and at 0.045 sec the right support fractured at hood height. At 0.056 sec the sign panel impacted the windshield. As the vehicle continued forward, it carried the whole installation with it. Sequential photographs of the test are shown in Figure A-131.

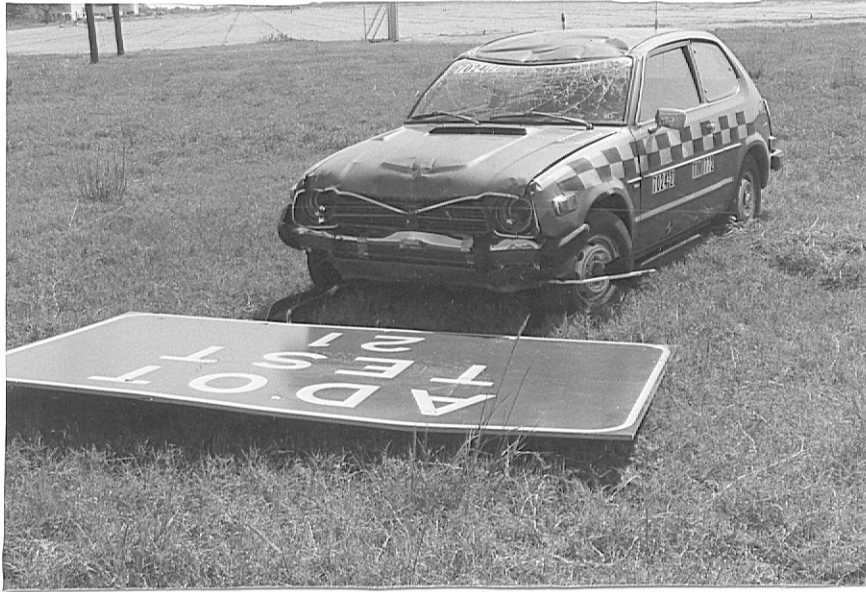
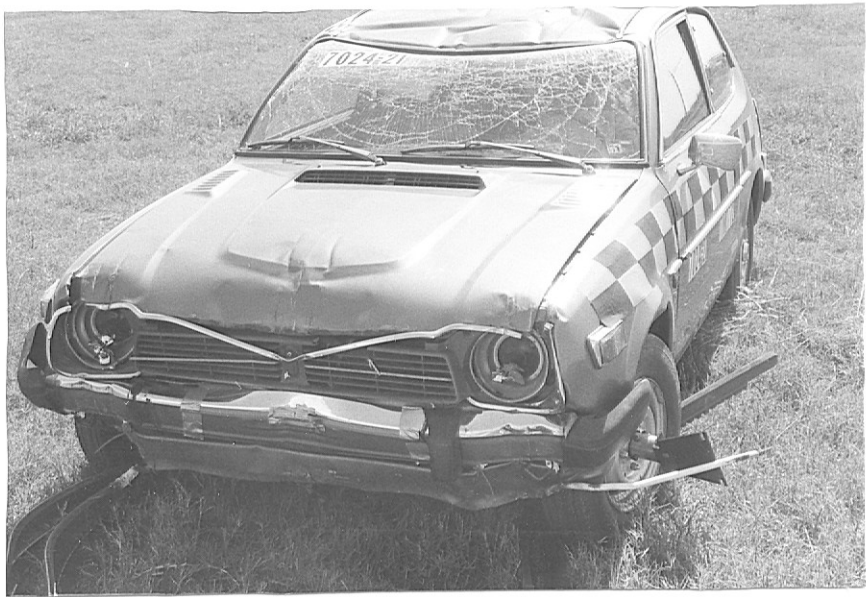
FIGURE A-137. VEHICLE AFTER TEST 21.

The front of the vehicle was deformed as shown in Figure A-137. The left front quarter received 6.0 in. crush at bumper height. The center and right side was crushed 3.0 in. at bumper height. The windshield also was broken. Sequential photographs of the test are shown in Figure A-138.

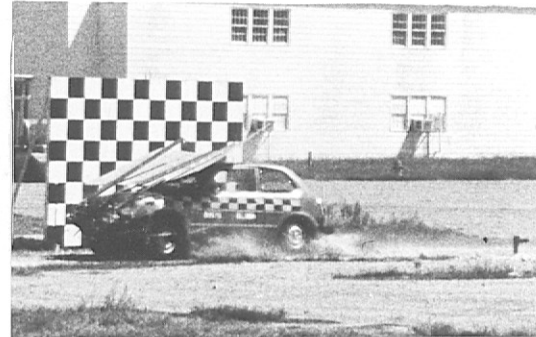
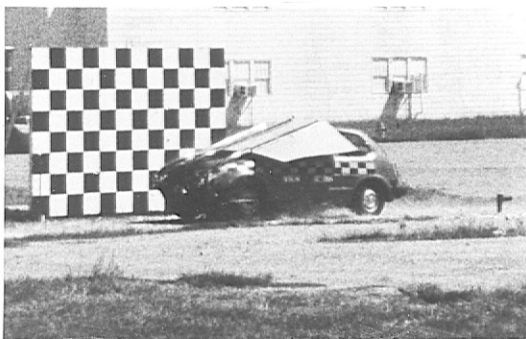
FIGURE A-138. SEQUENTIAL PHOTOGRAPHS FOR TEST 21.

Shortly after impact the supports began to deform around the front of the vehicle and by 0.063 sec the front wheels left the ground. By 0.089 sec the supports had bent sufficiently to cause the sign panel to hit the hood and windshield. The whole sign installation pulled out of the ground and rode with the vehicle which traveled 175 ft directly behind the impact point.

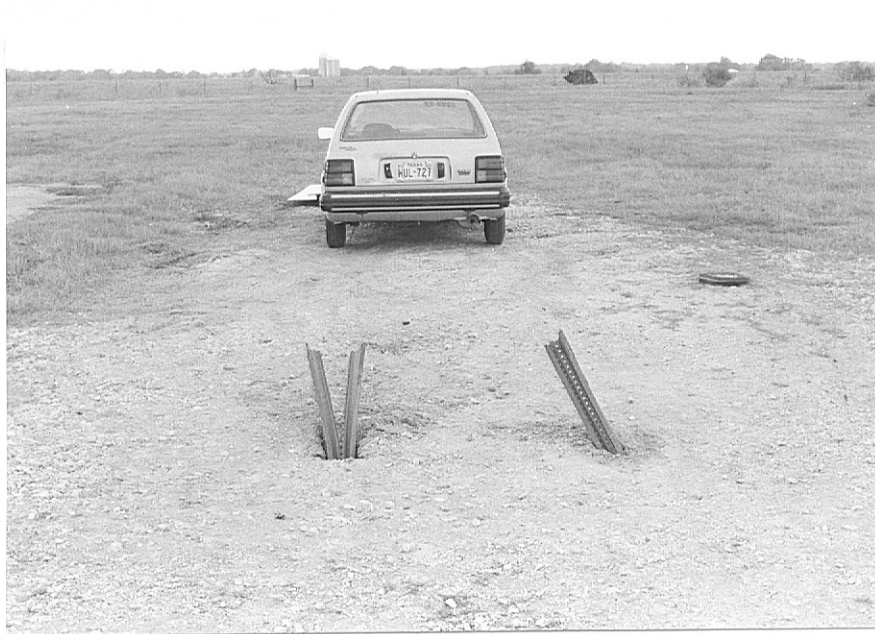
FIGURE A-142. SIGN INSTALLATION AFTER TEST 22.

The right support was fractured 19 in. above the ground and the left support was fractured 20 in. above the ground as shown in Figure A-142. As shown in Figure A-143, the vehicle sustained minor scrapes to the bumper and hood.

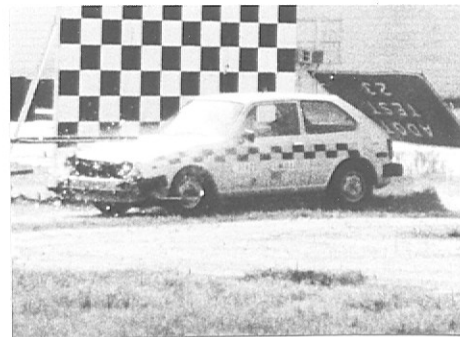
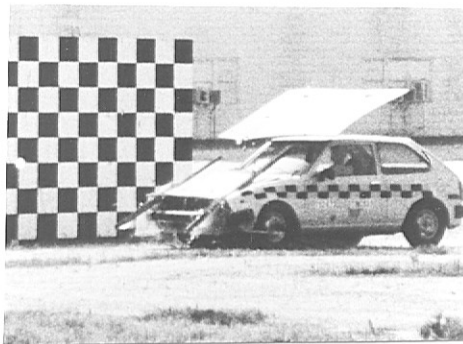
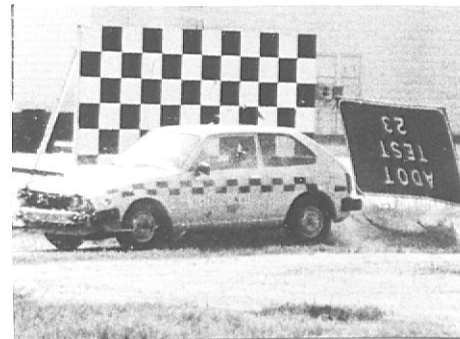
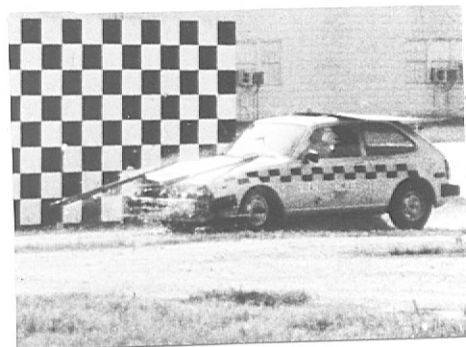
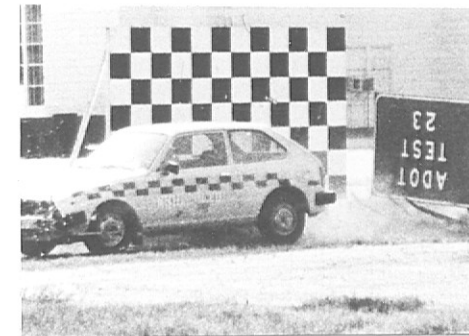
FIGURE A-146. SEQUENTIAL PHOTOGRAPHS FOR TEST 23.

0.141 sec

0.035 sec

0.177 sec

0.071 sec

0.212 sec

0.106 sec

0.248 sec

Approximately 0.010 sec after impact the supports began to split longitudinally and the sign panel separated from the supports. At 0.045 sec the lower sections of the supports began to fracture. By 0.096 sec the panel was on the roof and the supports were riding horizontally on the hood of the vehicle as shown in Figure A-146. The vehicle continued to travel 198 ft before coming to a stop.

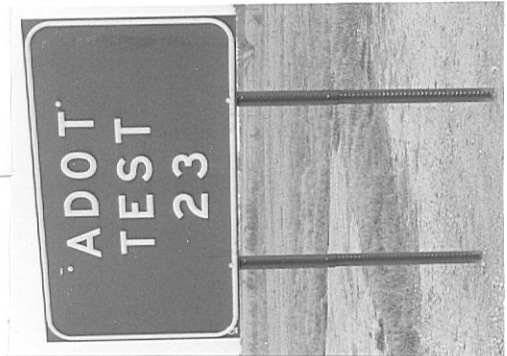
FIGURE A-149. SUMMARY OF RESULTS FOR TEST 23.

0.212 sec

0.141 sec

0.071 sec

0.000 sec

198 ft

Test No. . . . .	7024-23	Impact Speed. . . . .	62.8 mph (101.0 kph)
Date . . . . .	9/13/85	Change in Velocity. . . . .	8.0 mph (12.9 kph)
Test Article . . . . .	Sign Installation	Change in Momentum . . . . .	668 lb-sec
Support. . . . .	Two 3 lb High Carbon Billet Steel Supports	Occupant Impact Velocity Longitudinal . . . . .	11.8 fps (3.6 m/s)
Vehicle. . . . .	1980 Honda	Lateral. . . . .	No Contact
Vehicle Weight		Occupant Ridedown Accelerations	
Test Inertia . . . . .	1,833 lb (832 kg)	Longitudinal. . . . .	-0.8 g
Gross Static . . . . .	2,003 lb (909 kg)	Lateral . . . . .	N/A
Vehicle Damage Classification		Maximum Vehicle Crush	
TAD. . . . .	12FD2	Bumper Height . . . . .	5.0 in. (2.5 cm)
SAE. . . . .	12FDAW1
