# TECHNICAL MEMORANDUM ELIGIBILITY ASSESSMENT

**Project Name:** I-10 Reliever

**Regarding:** Eligibility Assessment for Two Residential Properties

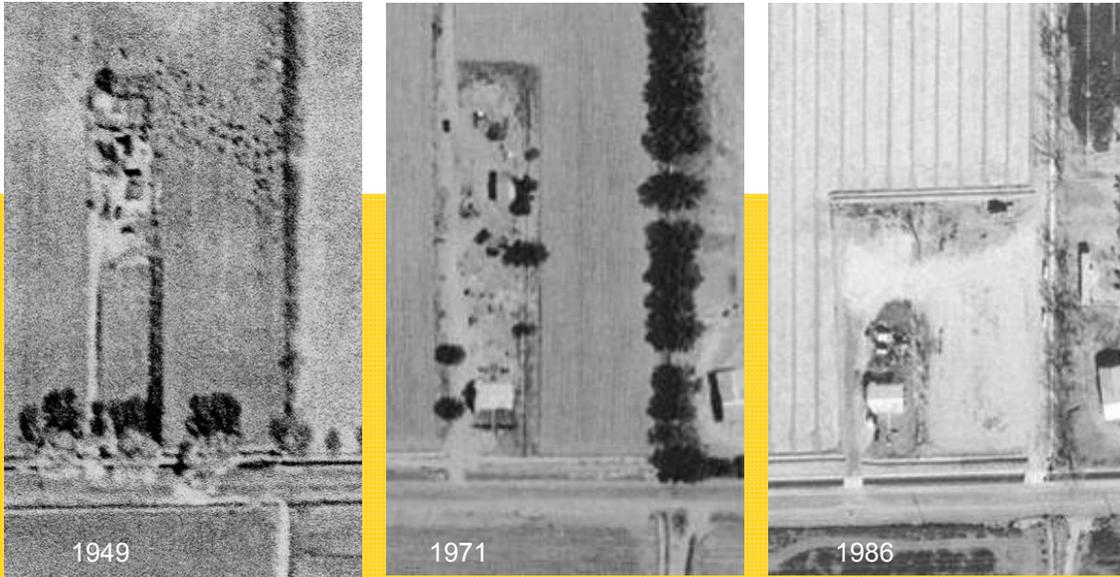
**Figure 2. Rich farmhouse. The site over time**

Because land subdivision and ownership change over time, the site refers to the area where the house is located, although it has been, and still is, associated with surrounding agricultural fields.

Before the Rich house was built the parcel was occupied by older buildings (refer to Figure 2). According to Real Estate Solutions records, and corroborated by historic aerial photographs, the house was built in 1950. Sometime between the 1970s and early 1980s—probably related to changed ownership—the site where the house is located was altered, from an elongated to a more square site, and trees near the house were removed. (Because land subdivision and ownership change over time, the “site” refers to the area where the house is located.) From the aerial photographs it appears that there were several small outbuildings associated with the house at that time. Normally, the residential component of an agricultural property is located amid a cluster of trees. The fact that there are no trees surrounding the building, and that none appear to have been present since the mid 1980s, may indicate that it has not had a residential use in recent years. The house does not appear to be currently occupied.

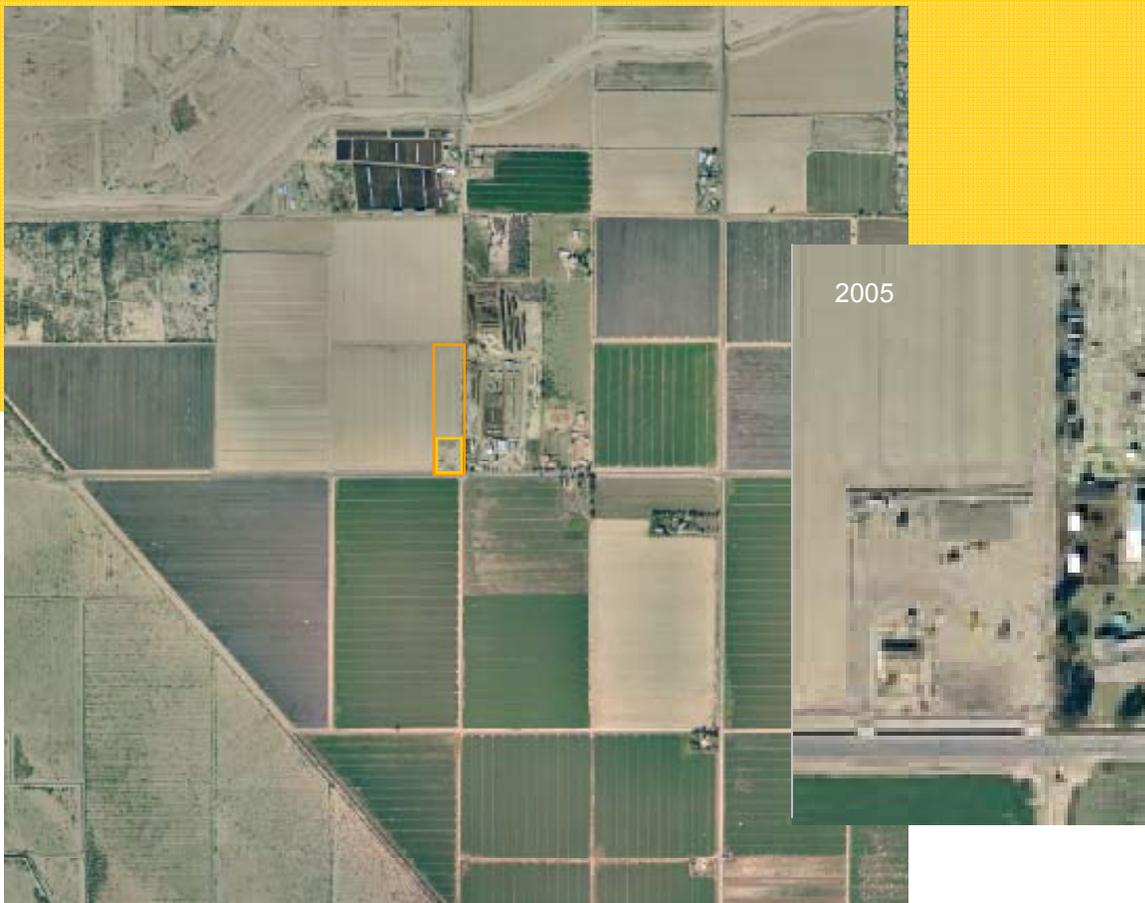
**Figure 3. Rich farmhouse. Site and setting as they look today**

□ current parcel

The Rich house, depicted in Figures 2 – 5, is located in the Laveen area, with the Salt River to the north, the Gila River to the west and south, and South Mountain to the east and south. The property is within the City of Phoenix limits, although the area had not been incorporated when the property was built. The Rich house is located on the north side of West Dobbins Rd., on the NW corner of Dobbins Rd. and 63<sup>rd</sup>. Ave. (if 63<sup>rd</sup> Ave. continued north), on a subdivided 10-acre parcel. Although changes have occurred in the surrounding area since the house was built—a dairy and a house to the east of the property are of more recent construction, the area still maintains a rural character. The house occupies the SW corner of the 325 by 1270 feet elongated parcel. The property is currently associated with surrounding agricultural fields (refer to Figure 3).

The property is separated from Dobbins Rd. by two irrigation canals, a concrete canal with bridges over it to access the property next to the road, and an unlined canal, parallel to the first one and north of it. Another canal at the rear of the house separates the house area from the agricultural fields. Trees separate the house from the newer house to the east. The parcel is fenced, with a lower fence around the house. A utility line east of the building traverses the property in a north-south direction. The house is set back approximately sixty feet from the property line. Behind the house there is a small outbuilding. No other buildings or structures are present on the parcel. The area immediately surrounding the house is overgrown with weeds. Crops are being grown on the rest of the parcel. (refer to Figures 3 and 4)

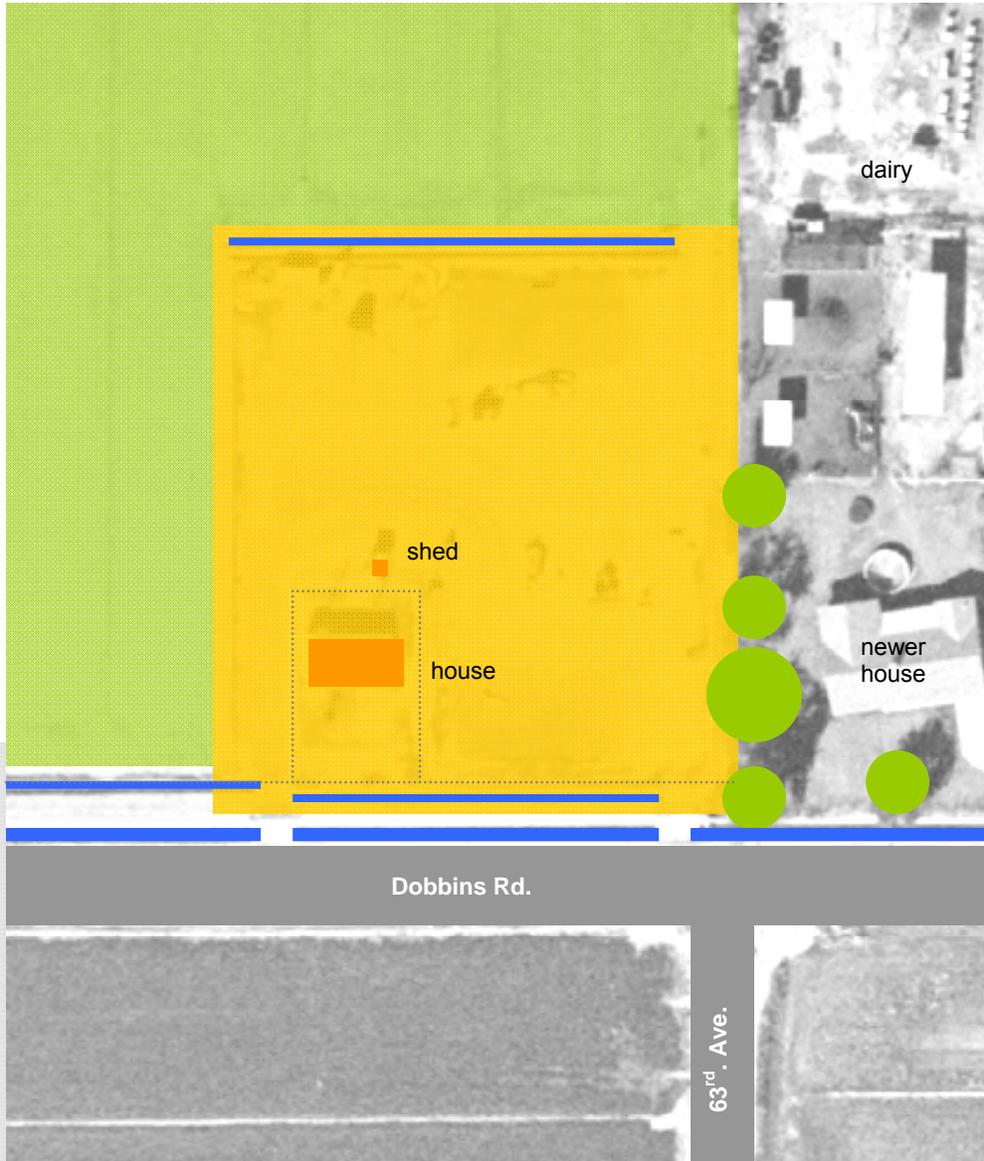
**Figure 4. Rich farmhouse**

- road
- canal
- site
- fence
- building/structure
- agricultural field
- tree

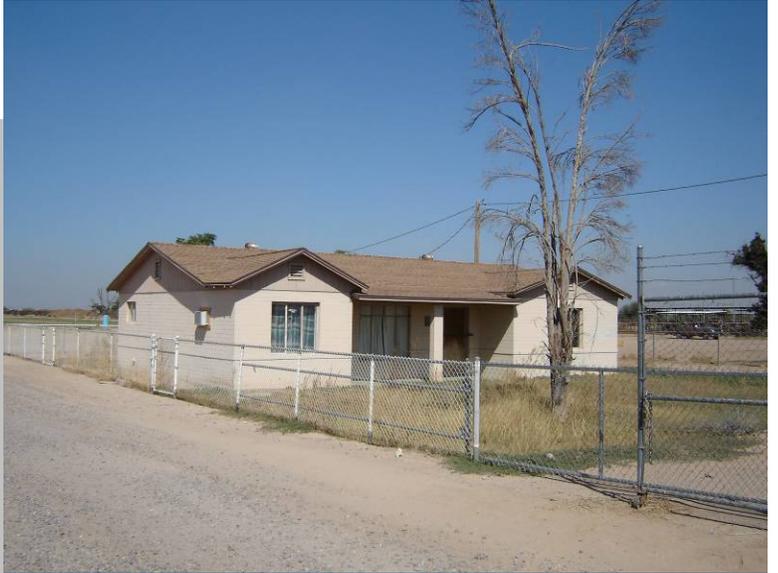
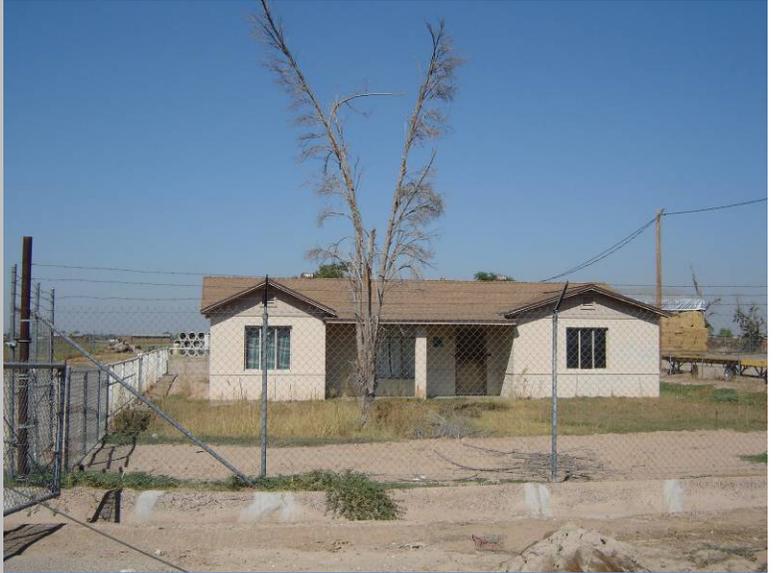
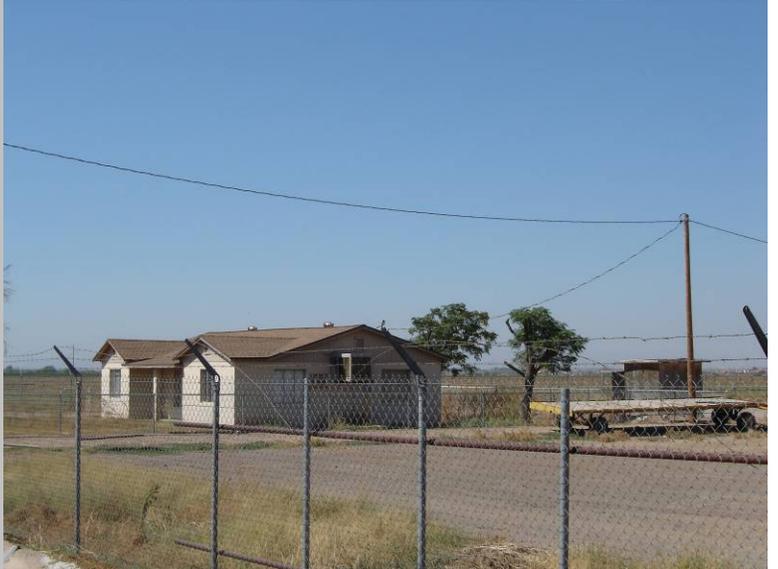
**Figure 5.**  
Rich farmhouse  
looking northeast  
looking north  
looking northwest

The building is a one story early ranch house, with a clear horizontal emphasis and a generally rectilinear and almost symmetrical layout. The house, facing south, has a shortened U shape floor plan with the right leg wider than the left one. A front porch is created between the two legs. A low pitched gable roof covers the house and extends over the porch. The U legs also are covered by low pitch gable roofs that intersect

the main one at right angles (cross-gabled roofs). The house is on a concrete slab foundation. The painted brick walls have a break (protruding brick line), approximately at a third of their height, which constitutes the only detail of the walls. A brick column stands in the center of the porch, aligned with the exterior walls. The gables, which have ventilation openings, are composed of board-and-batten wood siding painted the same color as the brick. Asphalt shingles cover the roof. Two metal vents are located near the roof ridge. Metal casement windows with a fixed central pane and operable sides characterize the house. A window in the porch, next to the front door, has a larger fixed central pane and smaller panes at the top. The front door, made of wood, does not have any detail. Air conditioning units are located at the east and west sides of the house. As is normally the case with farmhouses in general and of ranch houses in particular, this house is very simple and unpretentious. The house is in very good condition.

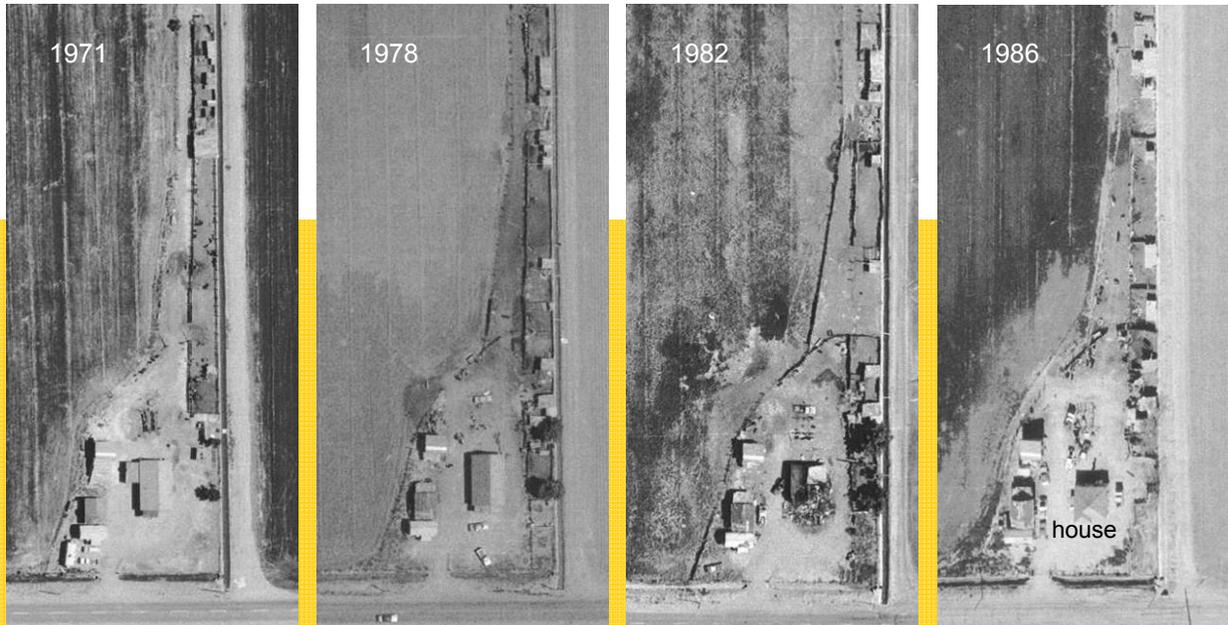
**Figure 6. Farmhouse at 7316 W Lower Buckeye Rd. The site over time**  
 These aerial photographs show the great alteration or either replacement of the original building in this site.

According to Maricopa County assessor's records the house was built in 1959. Historic aerial photographs corroborate that no other building occupied the same spot before that date. Nevertheless, historic aerial photographs reveal that the house either has been greatly altered, or a new house occupies the site of the one built in 1959. For that reason, the house cannot be definitively associated with a specific owner. The fact that the house appears, because of its architecture, to have been built even before 1959, suggests that this building was either moved, or perhaps that it could have been built with salvaged materials. Building records for this house are not available, and the current owner of the property could not be contacted. A sequence of historic aerial photographs shows the changes the site went through before it acquired its current characteristics (refer to Figure 6). It appears that there were outbuildings—other than the one mentioned below—associated with the earlier building on this site. Corrals or pens were always present on this property. The current house does not appear in aerial photographs until sometime in the 1980s.

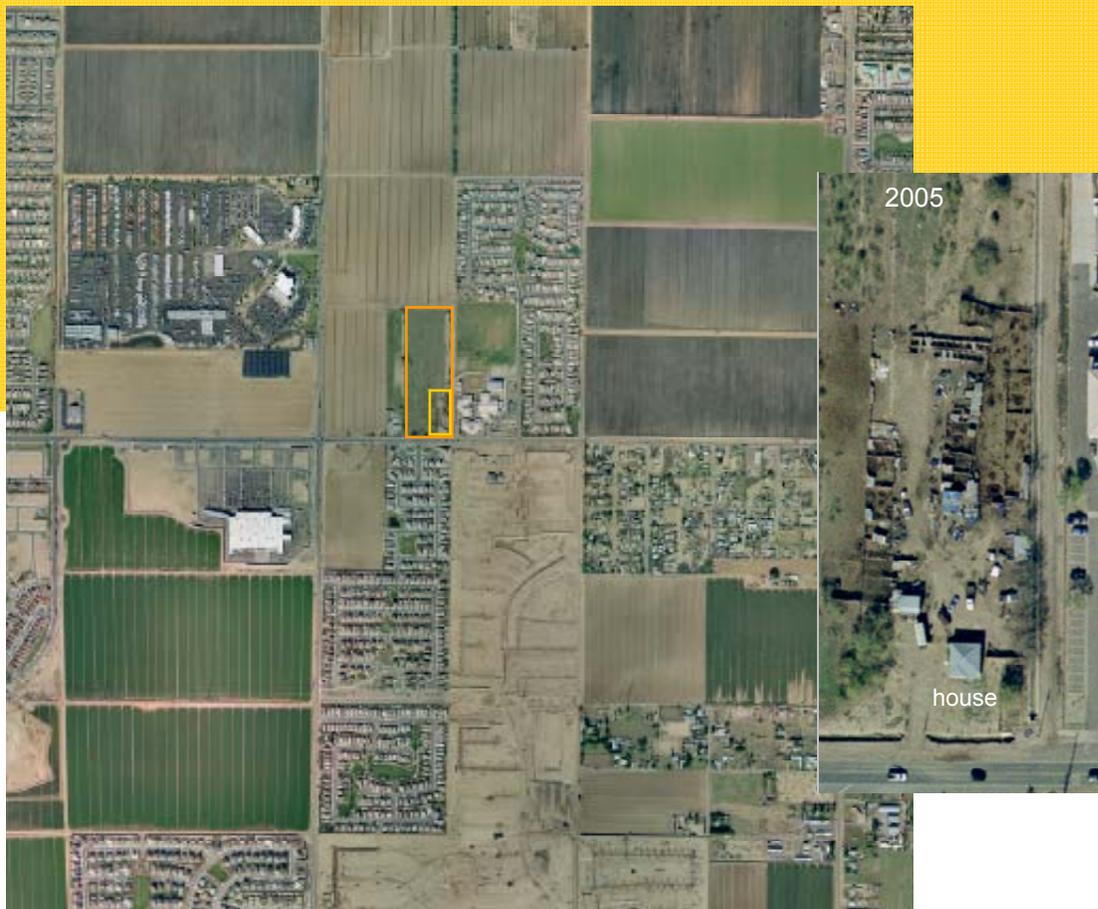
**Figure 7. Farmhouse at 7316 W Lower Buckeye Rd. Site and setting as they look today**

□ current parcel

Although some agricultural fields remain in the surrounding area, changes that have occurred since the house was built have considerably altered the rural character of the area (refer to Figure 7). Newer high-density subdivisions have appeared north and south of Lower Buckeye Rd.; a Wal-Mart store occupies the SW corner of Lower Buckeye and 75<sup>th</sup> Ave.; a house to the west, and a school to the east of the house, are of recent construction.

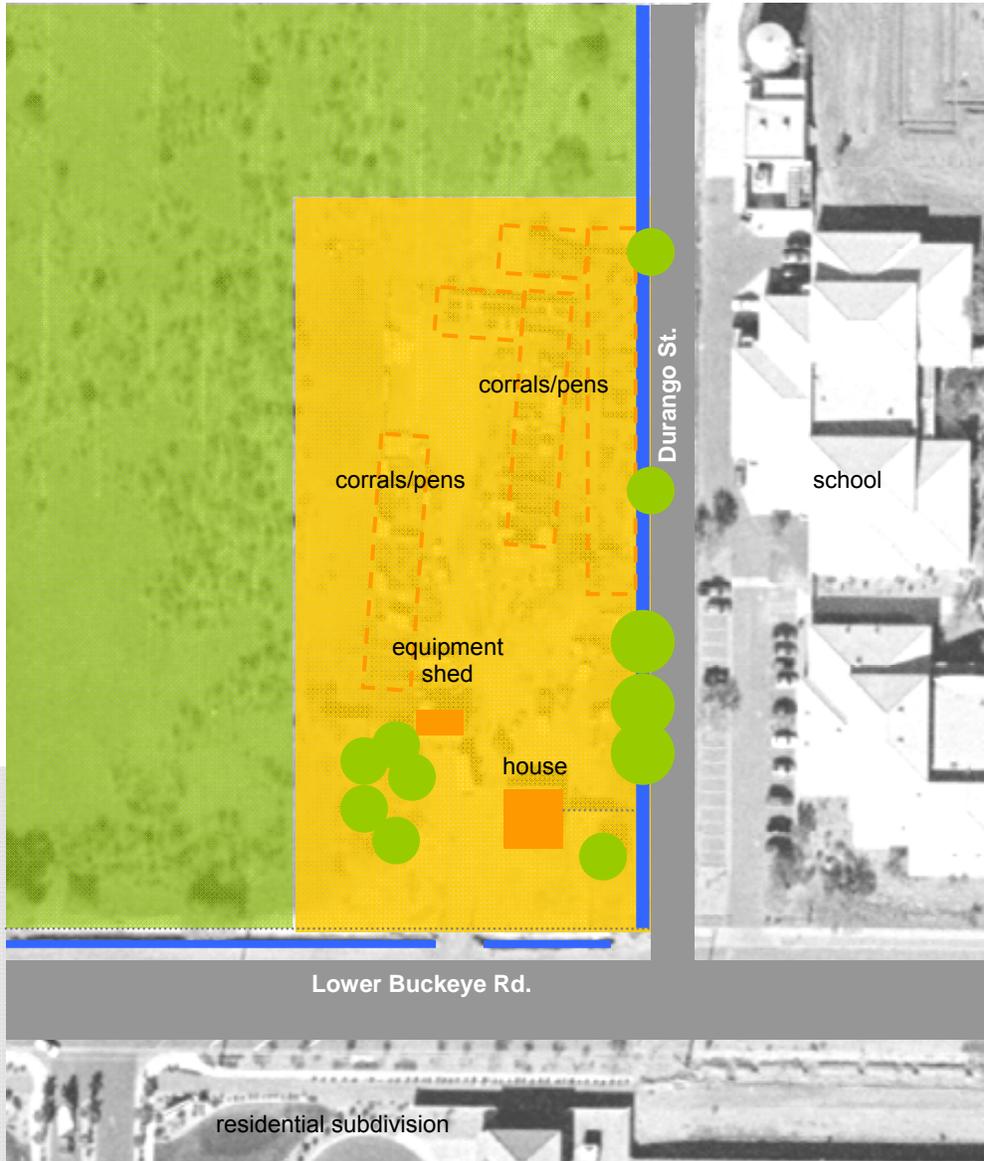
**Figure 8. Farmhouse at 7316 W Lower Buckeye Rd.**

- road
- canal
- site
- fence
- building/structure
- overgrown vegetation
- tree

The house is set back approximately sixty feet from the property line. To the southwest of the house there is a shed made of wood panels and corrugated metal. The area behind the house, to the east of the parcel, is occupied by pig pens in extremely poor condition; some of them have metal panels as roofing. Old vehicles occupy the area between the house and the pens. Some areas of the parcel are overgrown with weedy vegetation. The rest of the parcel is vacant. It is not clear whether the building is currently used as

a residence, but it appears that originally it had a residential use, and it was associated with agricultural lands surrounding it (refer to Figure 8).

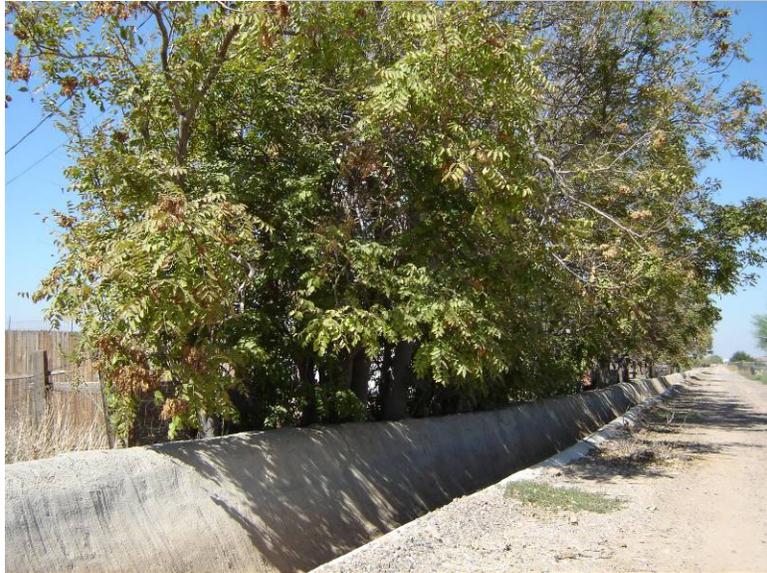
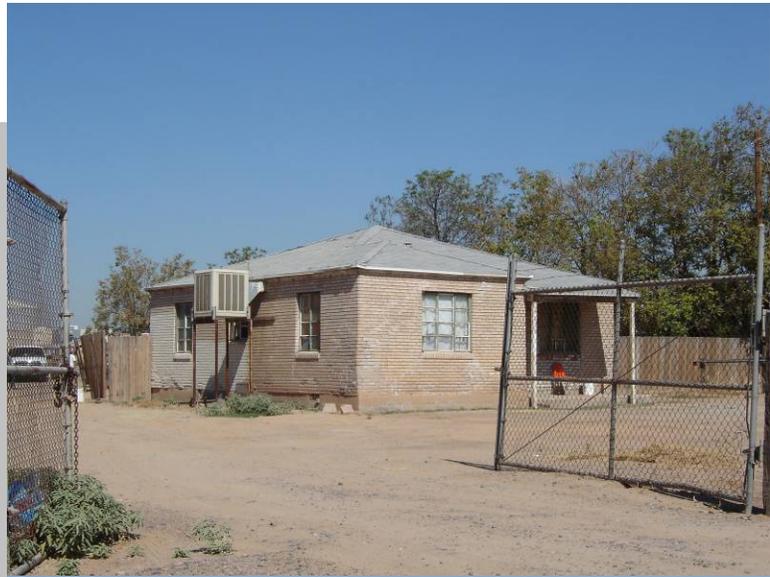
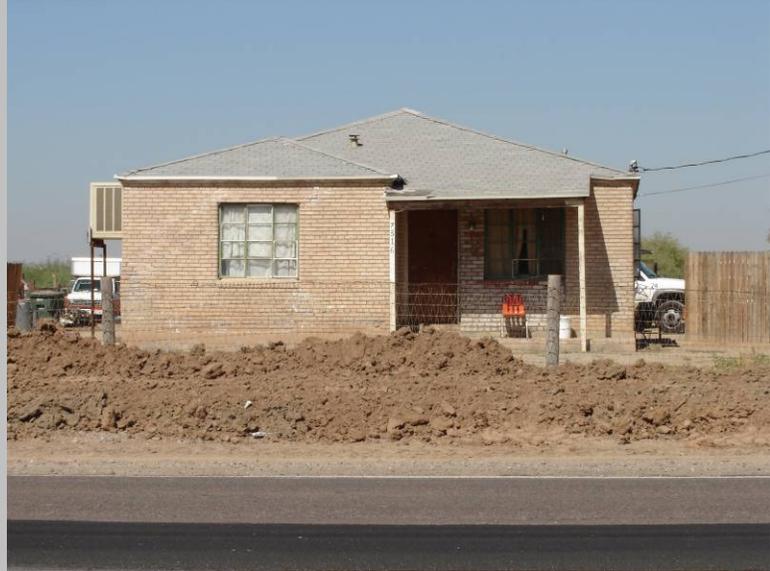
Figure 9. Farmhouse at  
7316 W Lower Buckeye Rd.  
looking northeast  
looking north  
looking northwest

The building is a one story transitional ranch house built on a concrete slab foundation. The house, facing south, is a compact, boxlike building, with an L-shaped floor plan. There is a wood columned porch over the entry, at the SE corner of the house. The walls are made of face golden brick; some areas are partially painted. The wall at the entrance shows signs of alterations. The window sills, also of face golden brick, constitute the only detail of the brick walls. A hip roof, covered with asphalt shingles, has a wing to adapt to the L-shaped plan, and extends over the entry to create the porch. The house has different sizes of metal casement windows with small glass panes. The front door, made of wood, does not have any detail. An air conditioning unit is located at the west side of the house. The house is in average condition. It is very simple and unpretentious. Given the condition of the building, it could have been built of salvaged materials (refer to Figures 9 and 10).

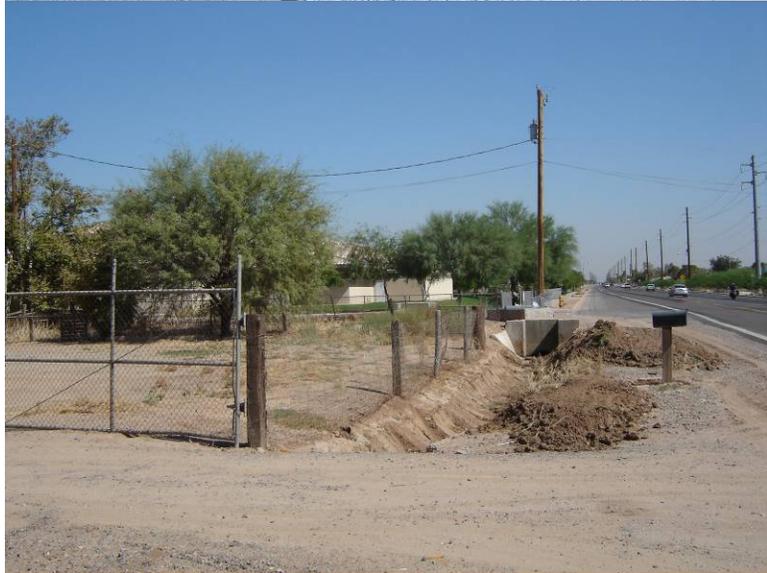
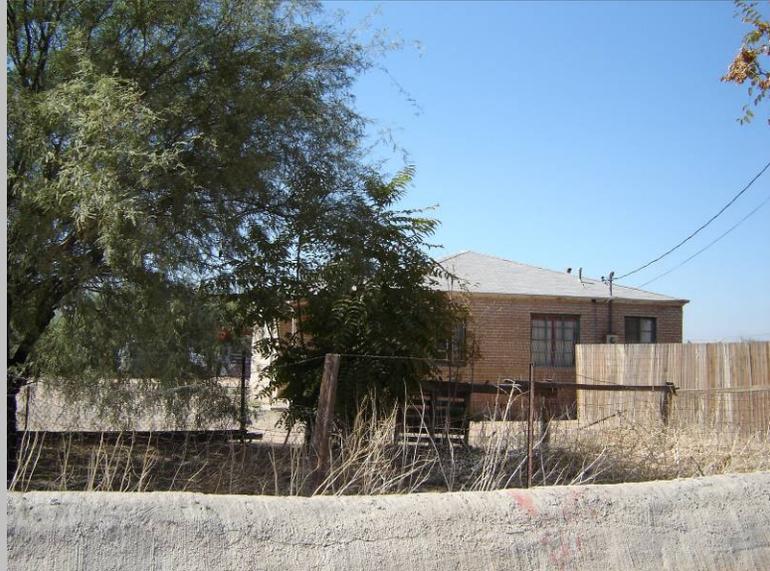
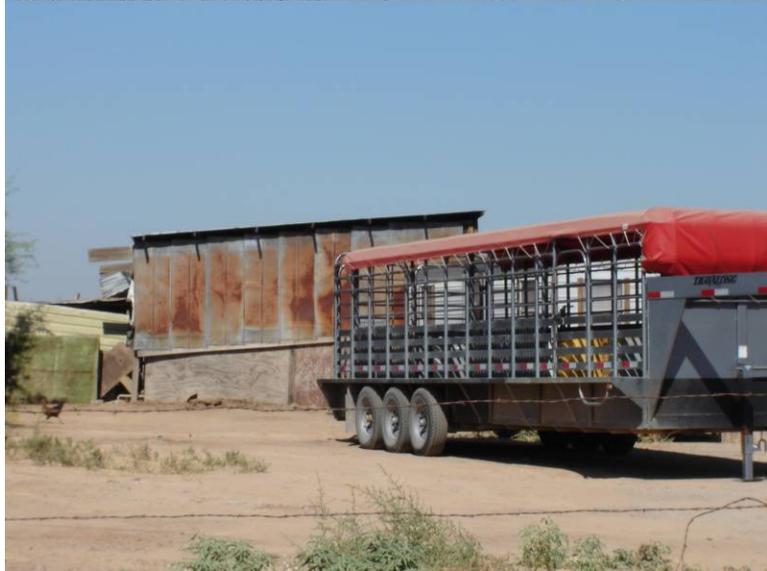
Figure 10. Farmhouse at  
7316 W Lower Buckeye Rd.  
concrete canal along Durango St.  
open ditch along Lower Buckeye Rd.  
machinery shed
