Tech Brief

Maintenance of Guardrail Systems

Midwest Guardrail System (MGS)

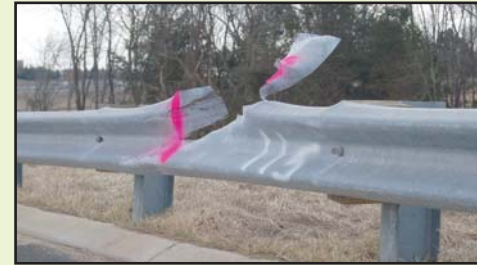
A

- Vertical tears in the W-beam (Photograph A) that extend to the top or bottom of the rail greatly reduce the capacity of the rail and create areas of high stress concentrations, both of which can cause the rail to tear completely through and allow vehicular penetration upon impact. Non-manufactured holes (e.g., those caused by crash damage, lug nut damage, or corrosion) in the rail element that intersect the top or bottom edges of the W-beam should also be considered a priority repair condition. Photograph B.
- Rail flattening with or without post deflection, increases the chances that an impacting vehicle will overturn upon contact and may increase the deflection distance. Any flattened panel that increases the W-beam section width to more than 18 inches (normal height is 12 inches) should be replaced.

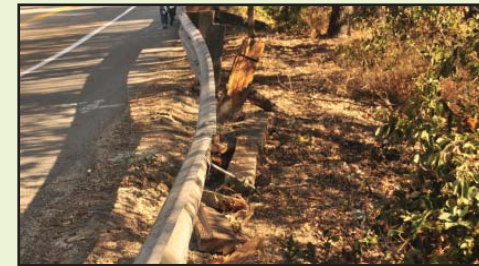
C

- If the barrier has been deflected more than 9 inches over a 25-foot length, its height has been reduced by 2 inches or more from its original height, or if any posts are missing or detached (Photograph C), prompt repairs should be made. These types of damage can result in greater vehicle instability in a crash, may leading to rollover, barrier rupture, or barrier overrides.

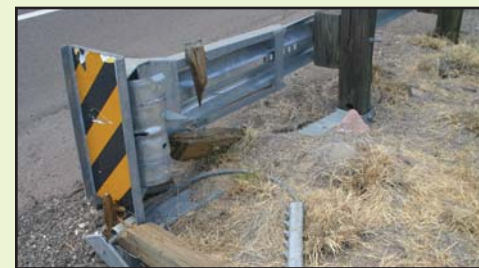
D

- If the end post is broken or if either the cable or steel bearing plate is missing (Photograph D), the anchorage is lost and any motorist striking the rail downstream from the terminal would likely penetrate the system rather than be redirected. Thus, if any of these components are deficient, repair work should be a very high priority.
- For those terminal designs that incorporate an energy-absorbing head, it is critical that this head be properly aligned and in position with the W-beam rail element so the rail will “feed” into it in any head-on crash. If the impact head cannot slide along the W-beam, its energy absorbing capacity is seriously compromised, probably resulting in a more severe crash. In Photograph E, the impact head and post #1 are misaligned, reducing or preventing its intended performance in an end-on impact.

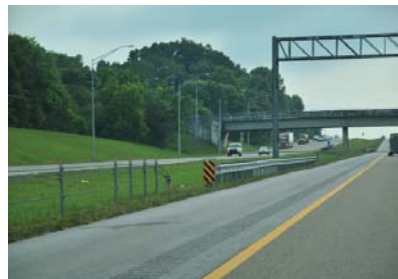
A pre-installation review should have found that this placement of two terminal resulted in a gap in the median shielding and recommended an overlapping design treatment.

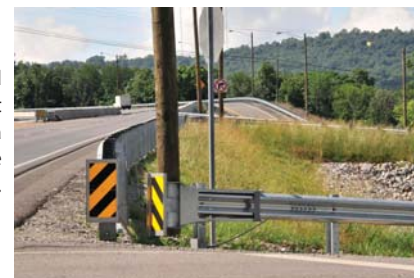
A pre-installation review should have found that this placement of two terminals created a situation where neither one could perform effectively if hit.

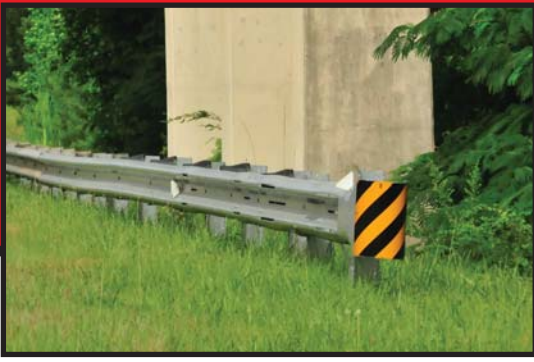
By understanding that an impact into a non-energy-absorbing terminal can result in a vehicle travelling more than 150 feet behind and beyond the terminal, a review team could have recommended extending this barrier.

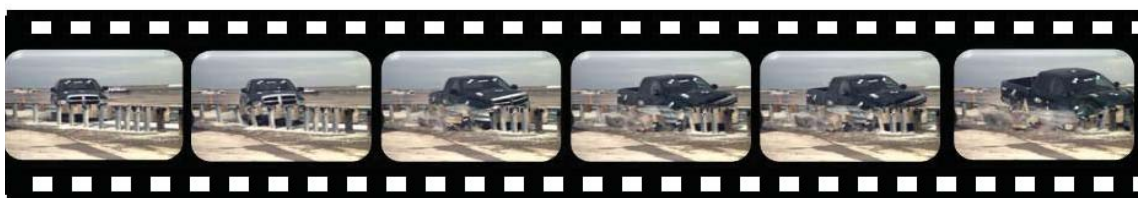
MASH TL-3 Test of MGS Transition to Thrie-beam

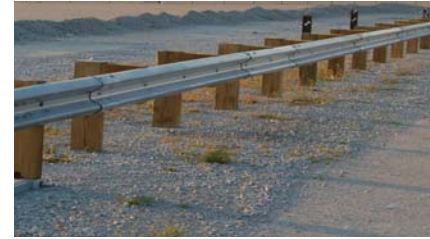
MGS uses the same steel or wood post and rail element (with five holes punched) as the standard guardrail; the wood post is 6' long. The blockout is now 12" deep (versus the 8" on the standard system). The standard MGS (6'-3" post spacing) resulted in a somewhat increased dynamic deflection when MASH tested. (Reference: FHWA letter B-212, dated 06/10/11). ADOT will select their specific criteria when the new system is adopted. ADOT requires the shoulder be widened and paved 2' – 8" from normal width of shoulder, this allows for the rail face to be placed over the paved roadway section.

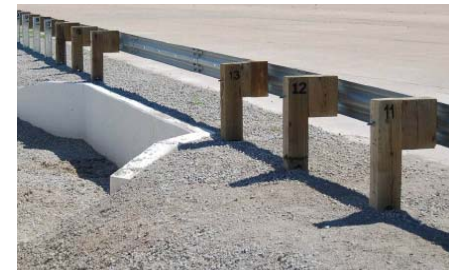
MGS LONG-SPAN GUARDRAIL AND OMITTED POST: As with standard guardrail (G4), an MGS design has been developed for use when guardrail posts must be "left out", e.g., when the guardrail crosses a low-fill culvert. Unlike standard guardrail (G4) missing post designs, the MGS system does not require nested rail in the clear span. Testing has shown that a single post can be omitted without any additional modification (i.e. no weakened wood posts or nesting). For 2 and 3 missing posts, three CRT posts with standard post spacing are placed on each side of the span (25-foot maximum) to reduce any snagging potential. Since larger deflections can be expected, nothing protruding more than 4" should be allowed behind the rail to avoid "tripping" the vehicle (Reference: FHWA letter B-189, dated 03/20/09). ADOT proposed standard for deflection are somewhat more restrictive. Adequate length, 50 ft. or more of standard MGS must extend on either side of the gap to maintain tension in the system. Terminal must not be placed any closer than 50 ft., from the rear of the system, to any omitted post installation. Omitted post designs should ONLY be used in standard guardrail runs and should be separated by a minimum of 50 ft, between additional missing post situations. Missing post should not be used with terminal or transition designs.

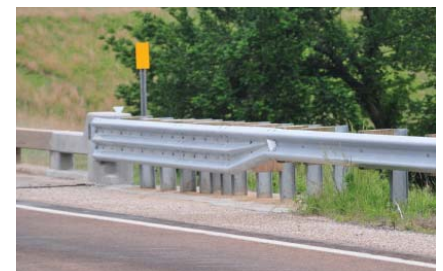
MGS TRANSITION DESIGN: The MGS system is compatible with most existing Thrie-beam to rigid barrier/bridge railing transition designs with the use of a non-symmetrical W-beam to Thrie beam 10-gauge transition section and a modified post layout upstream of the Thrie-beam. Steel or wood posts can be used. The recommended design was successfully crash-tested under MASH criteria (References: FHWA letters B-231, dated 01/27/12 and B-236, dated 05/30/12).

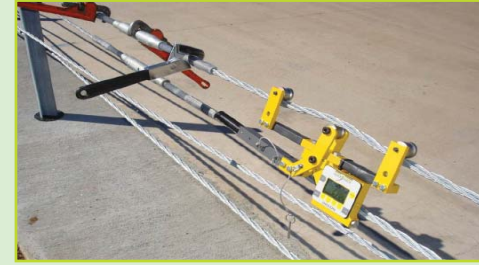
A

Cable Inspections: It is important that crews routinely check tension, even in the absence of an impact (photograph A), as per manufacturers' recommendations. This is particularly important during the first few years following cable installation. Cables can lose tension because of construction stretch, temperature changes, anchor creep, fitting slippage, and/or previous impacts elsewhere in the same run of HTCBB. Maintenance personnel should also check the tension and inspect the individual cables for kinks or broken strands as part of routine maintenance (at least annually), and also following any repair, in accordance with manufacturer guidelines.

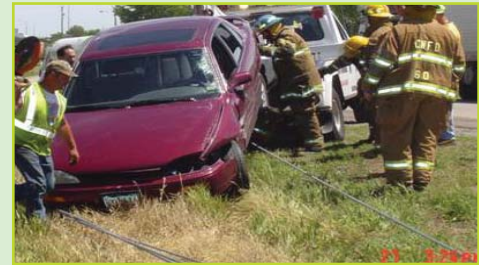
B

In situations where there is an impact and the vehicle becomes tangled in the cable (photograph B), it is important to keep the cable intact. In many situations, the vehicle can be removed by pulling it in the opposite direction from which it hit the system. Maintenance personnel (as well as emergency responders) should consider cutting the cables only under life-threatening situations and other alternatives for loosening the cables are not feasible. Alternatives to cutting the cable include:
